**REAL ESTATE CONDITION REPORT**

THIS CONDITION REPORT CONCERNS THE REAL PROPERTY LOCATED AT 700 Creekwood Drive  
IN THE City  
(CITY) (~~VILLAGE~~) (~~TOWN~~) OF West Bend COUNTY OF  
Washington STATE OF WISCONSIN.

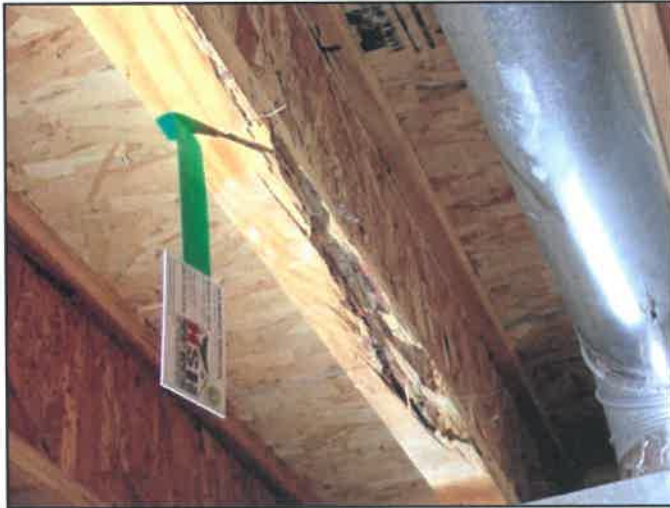
**DEFECT** - There is a damaged joist in the basement that needs to be repaired/replaced.

16. Split or damaged

*Repaired Sept. 2026*

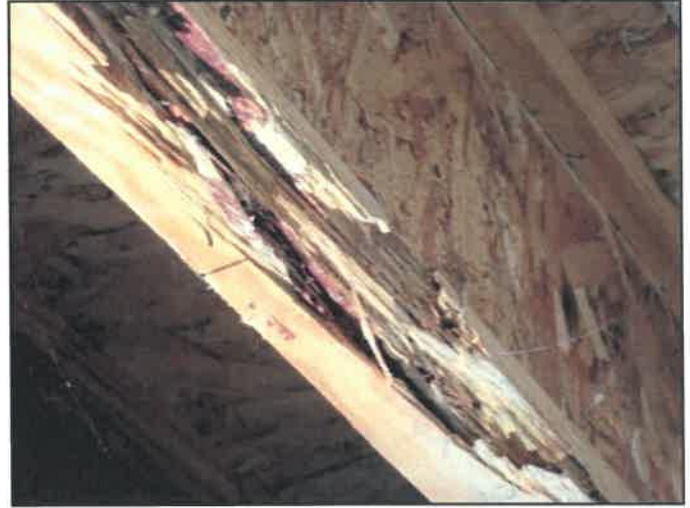
17. Split or damaged

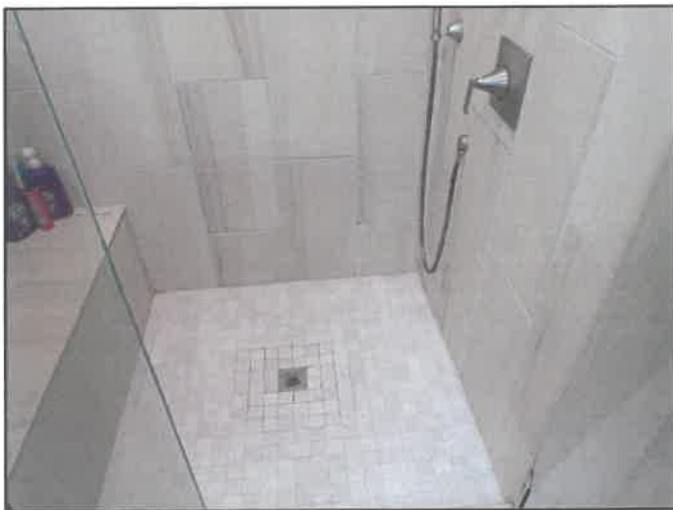
**DEFECT** - The tile work in the master bathroom was poorly done and is more likely to fail. The floor grout is failing and needs to be replaced.

21. Grout loose, missing or deteriorated

*Floor grouted  
September  
2026*

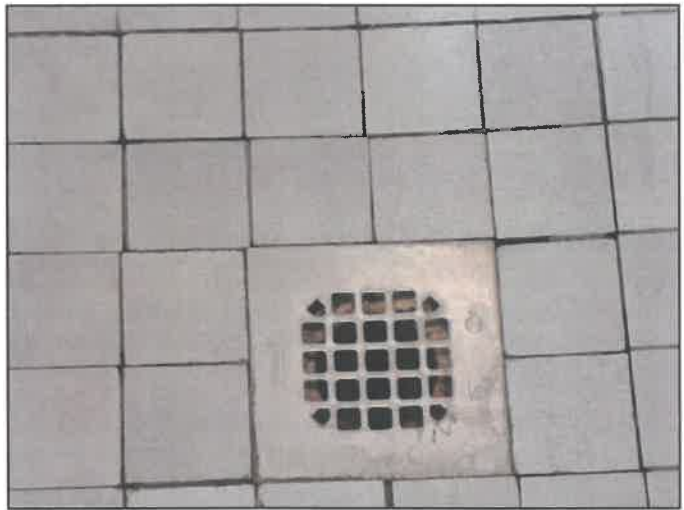
22. Grout loose, missing or deteriorated

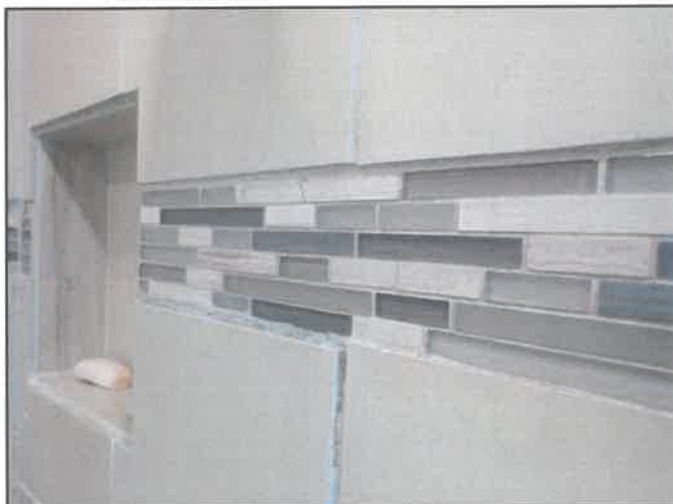
23. Grout loose, missing or deteriorated

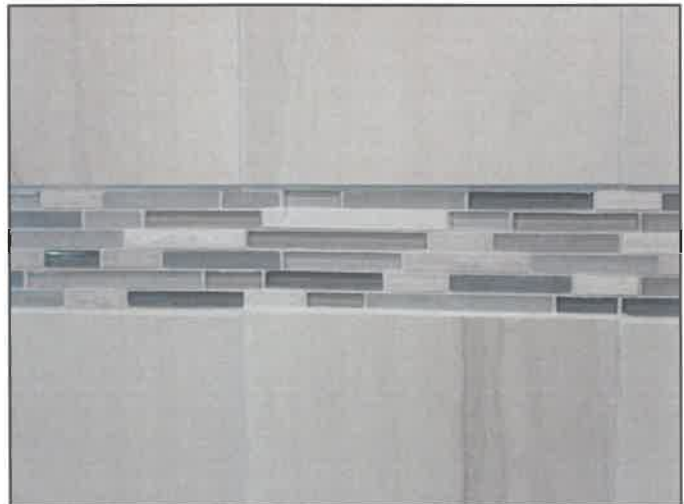
24. Grout loose, missing or deteriorated

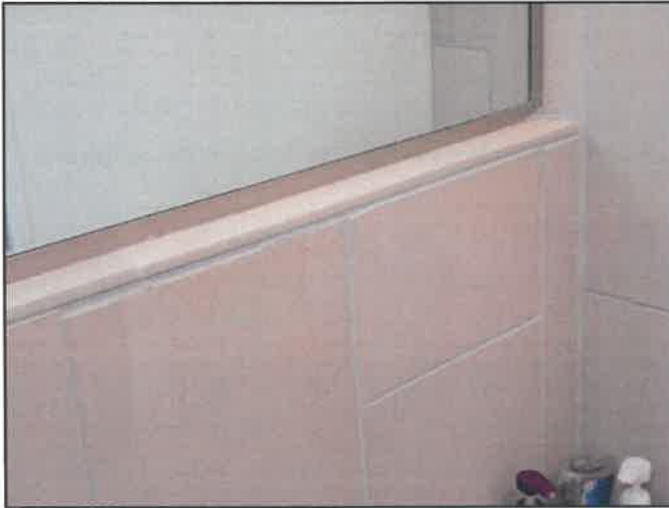
**25.** Grout loose, missing or deteriorated

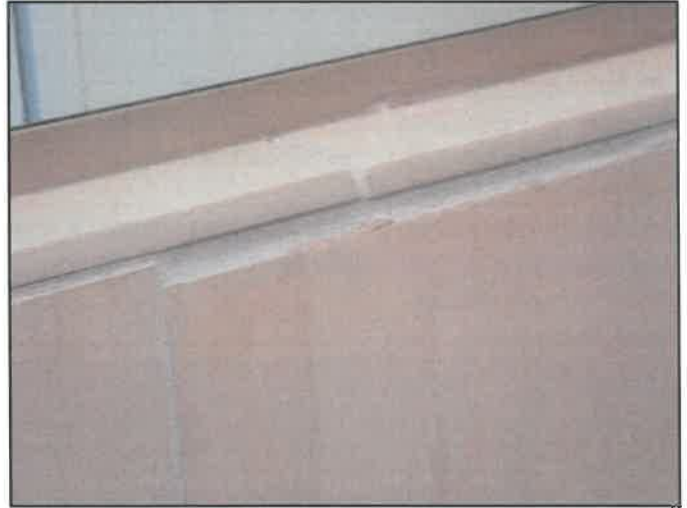
**26.** Grout loose, missing or deteriorated

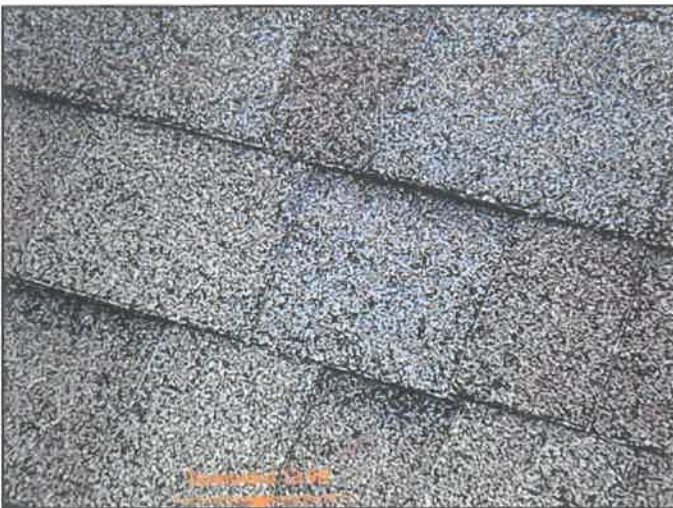
34. Granule loss

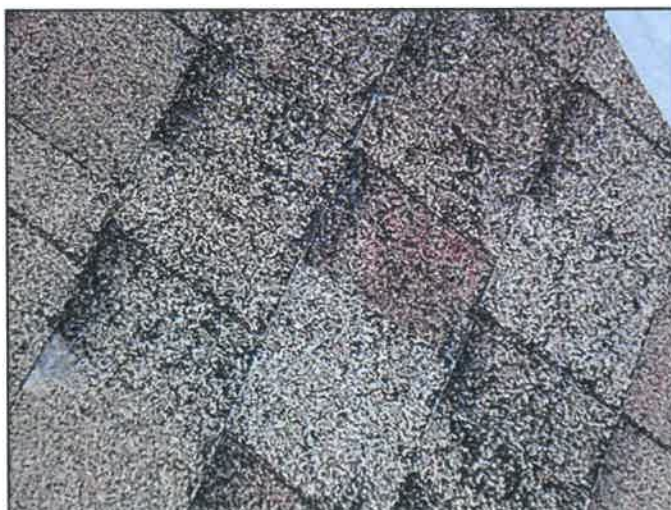
46. Granule loss

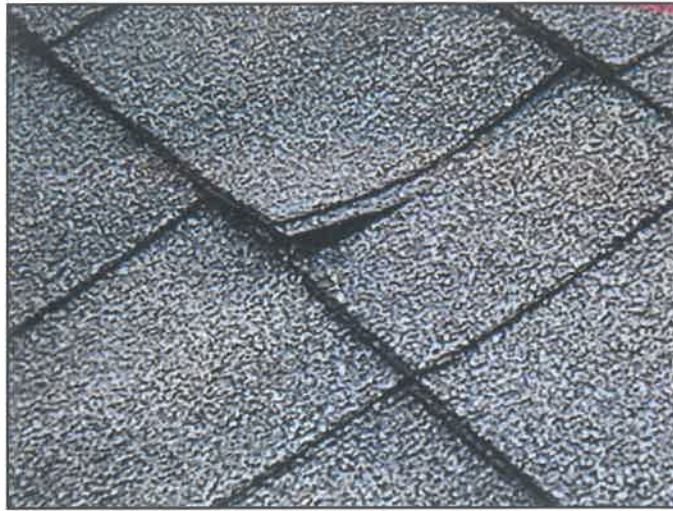
47. Missing, loose or torn

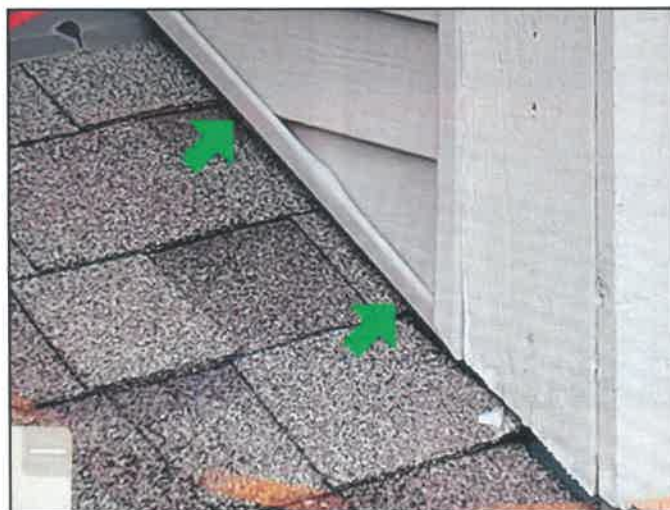
51. Siding not cut back

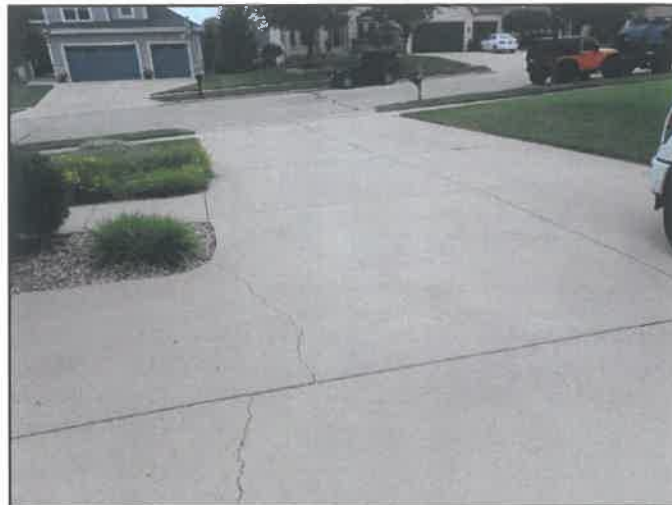
**56. Cracked or damaged surfaces**

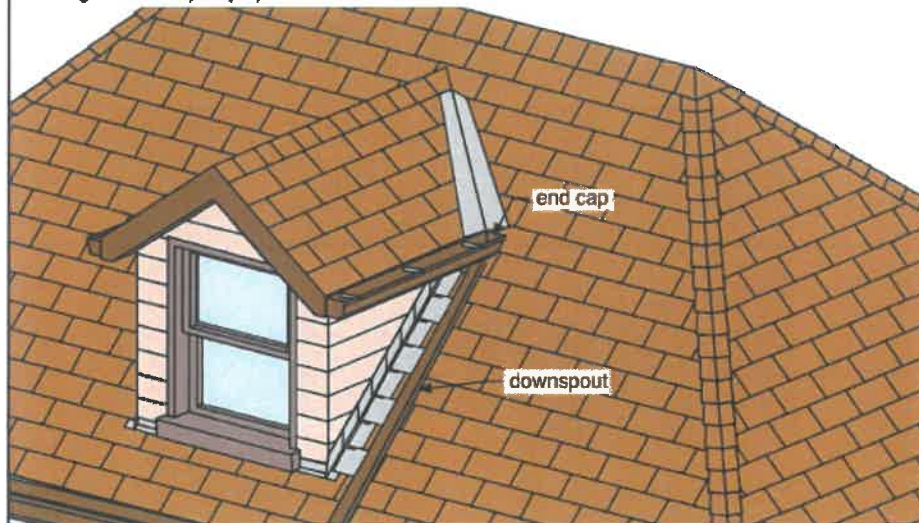
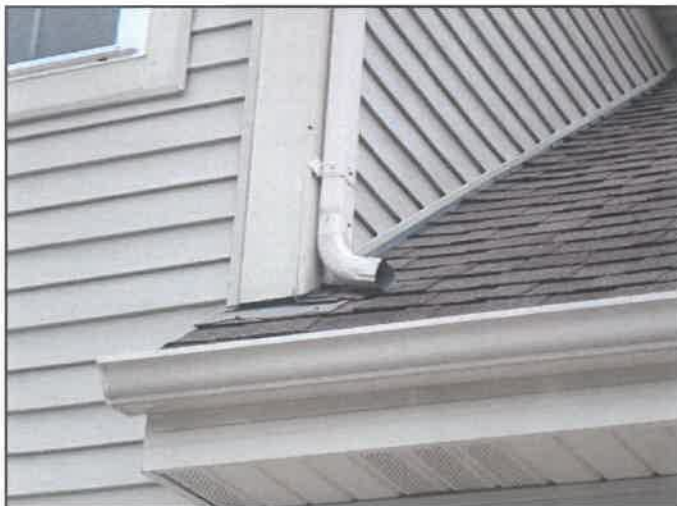
70. Discharge onto roofs

installing a downspout (from the secondary roof to the main gutter below) helps prevent localized roof wear

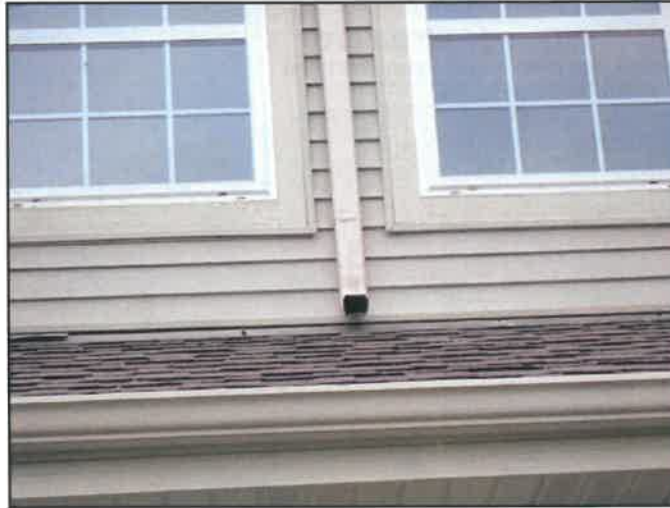
72. Discharge onto roofs

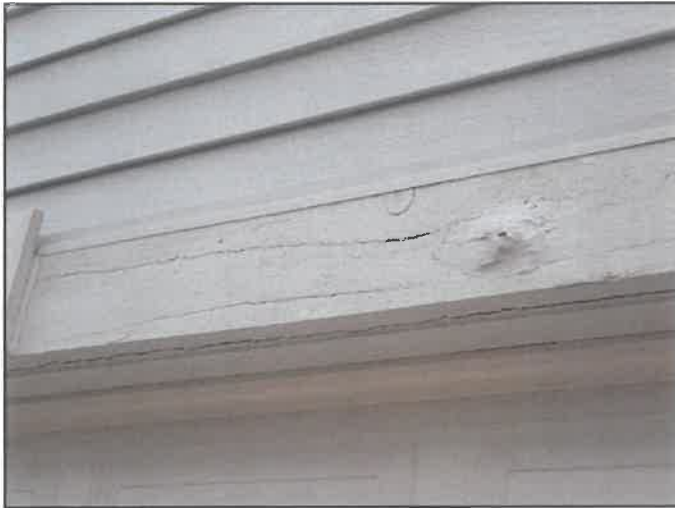
74. Rot or insect damage

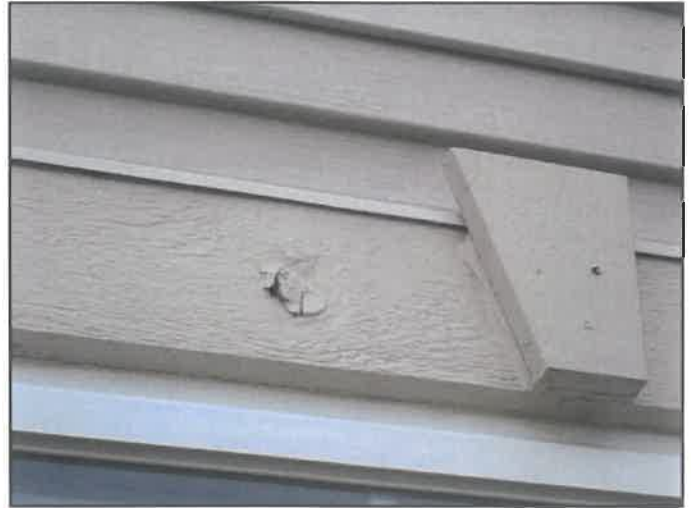
75. Rot or insect damage

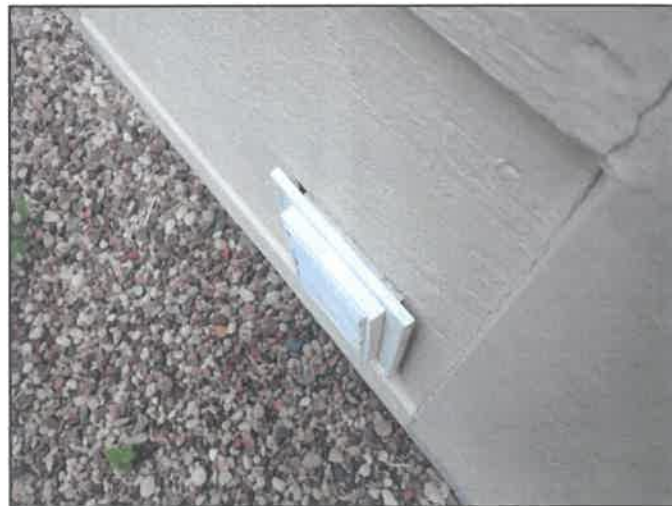
76. Caulking missing or deteriorated

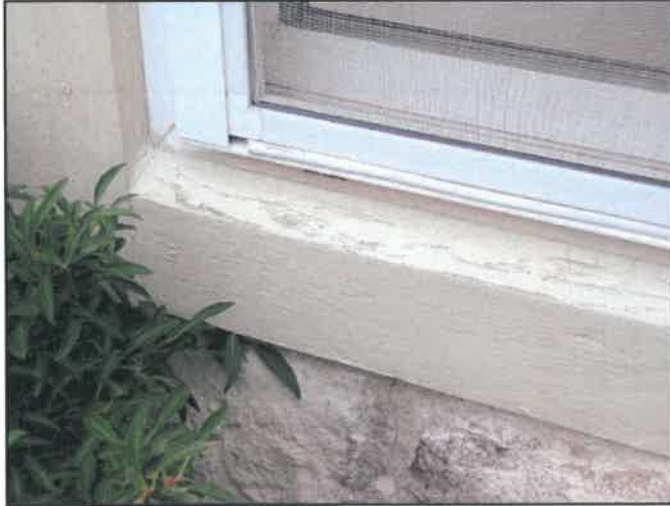
77. Paint or stain needed

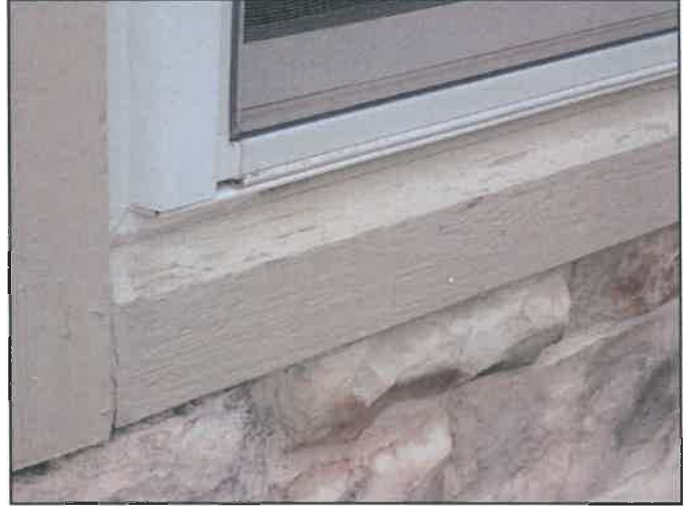
78. Paint or stain needed

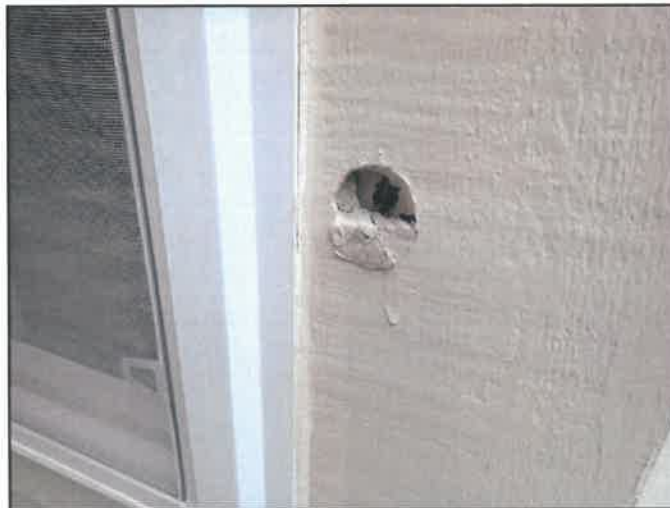
79. Paint or stain needed

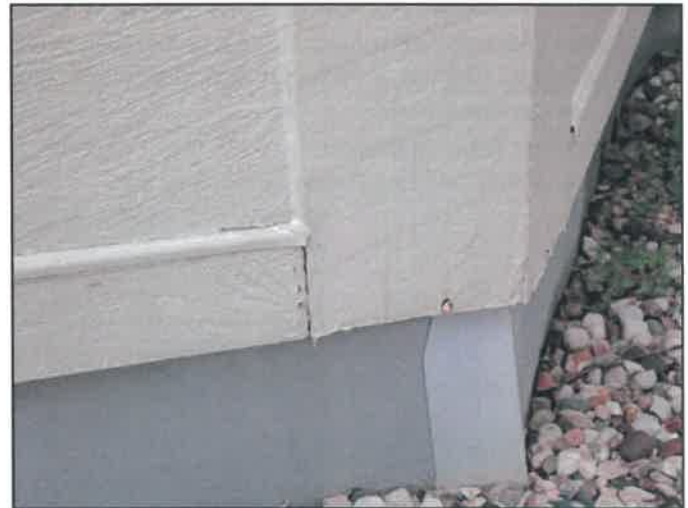
80. Paint or stain needed

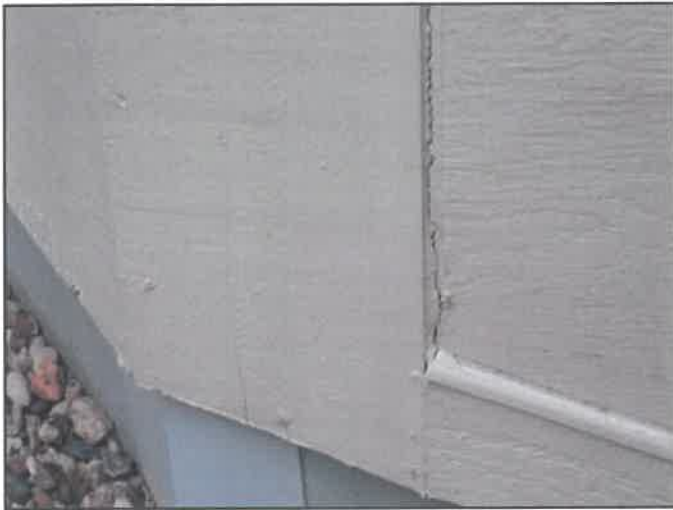
81. Paint or stain needed

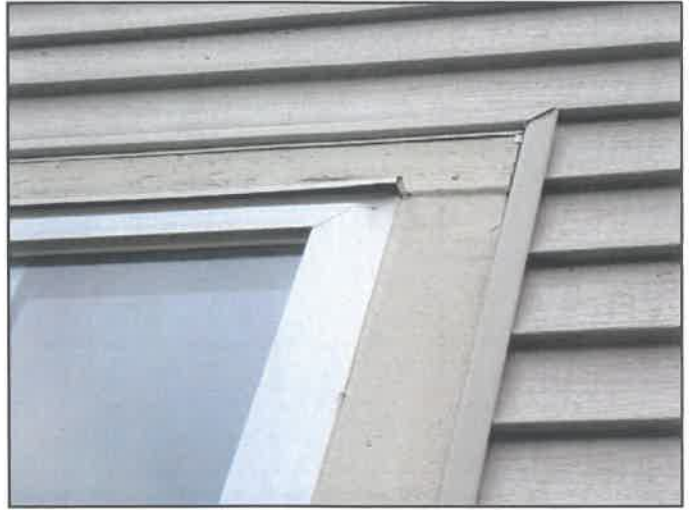
82. Paint or stain needed

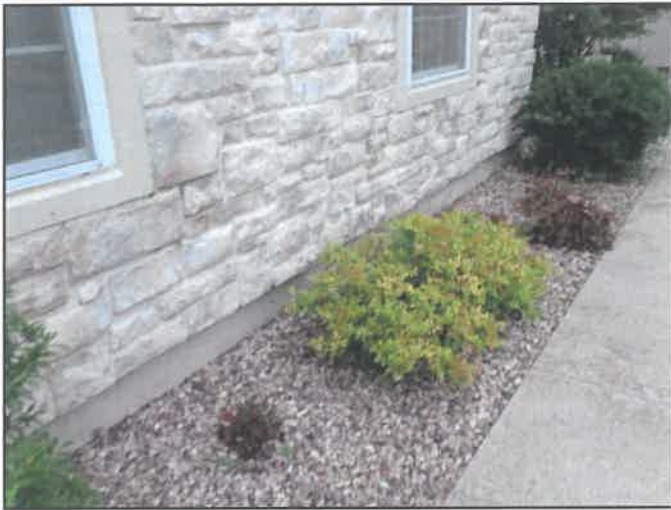
83. Missing, ineffective weep holes or flashings

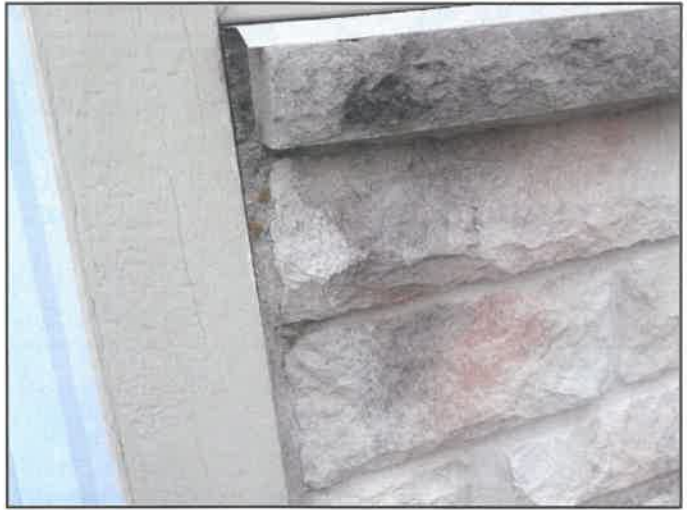
84. Missing, ineffective weep holes or flashings

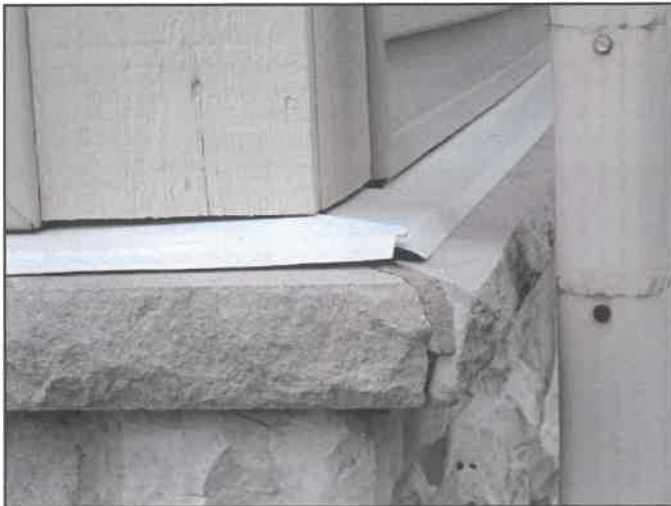
85. Missing, ineffective weep holes or flashings

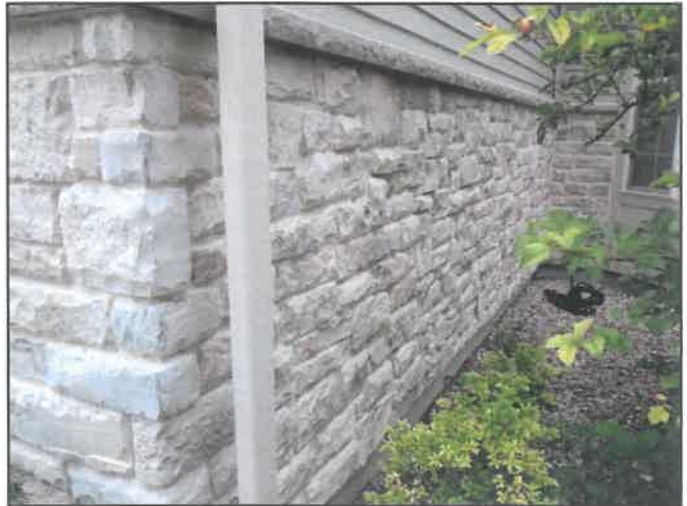
86. Missing, ineffective weep holes or flashings

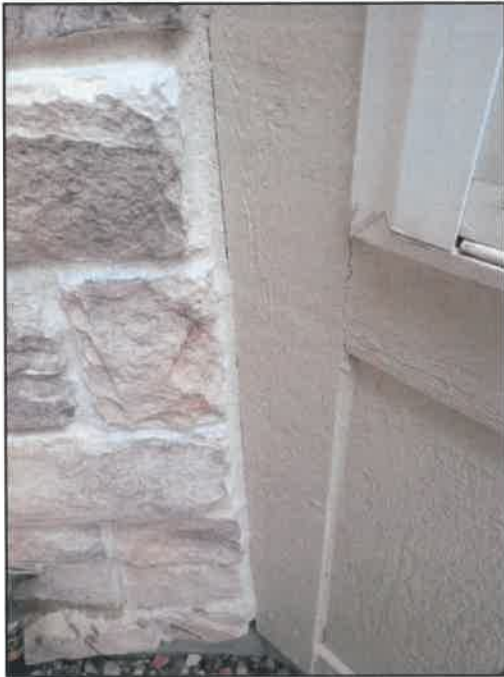
87. Missing, ineffective weep holes or flashings

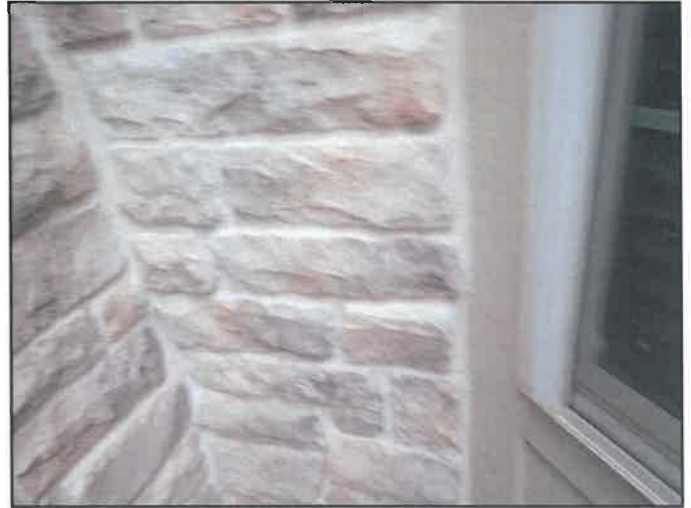
88. Missing, ineffective weep holes or flashings

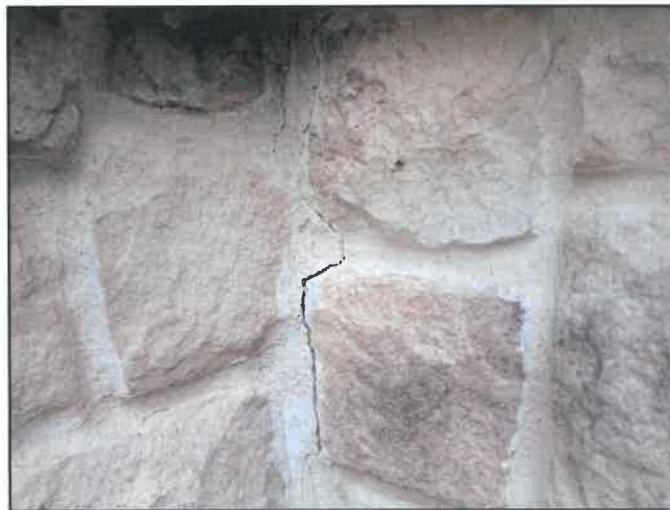
89. Missing, ineffective weep holes or flashings

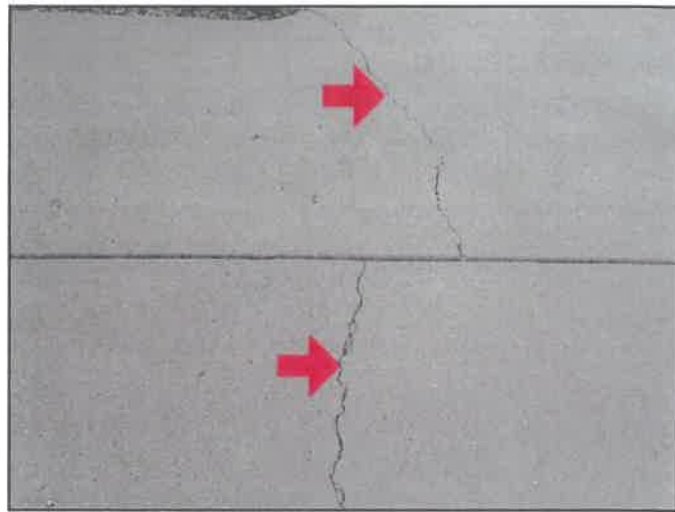
92. Cracked or damaged surfaces

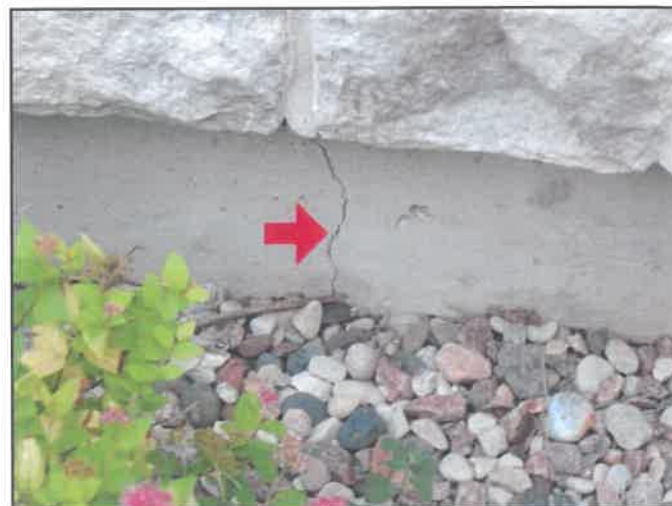
103. Cracked foundation

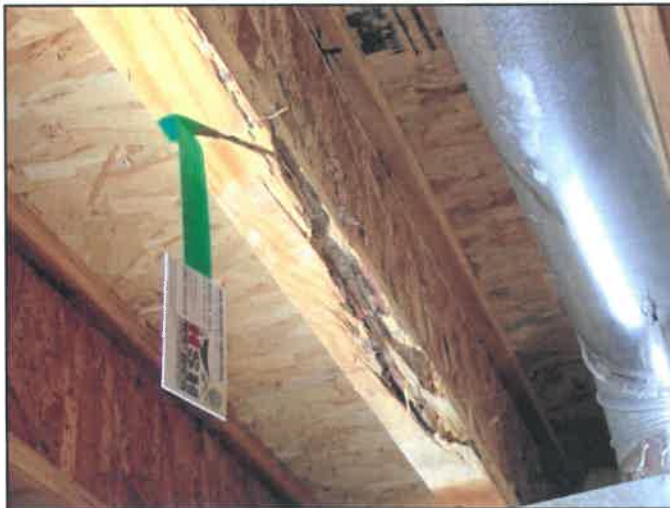
107. Split or damaged

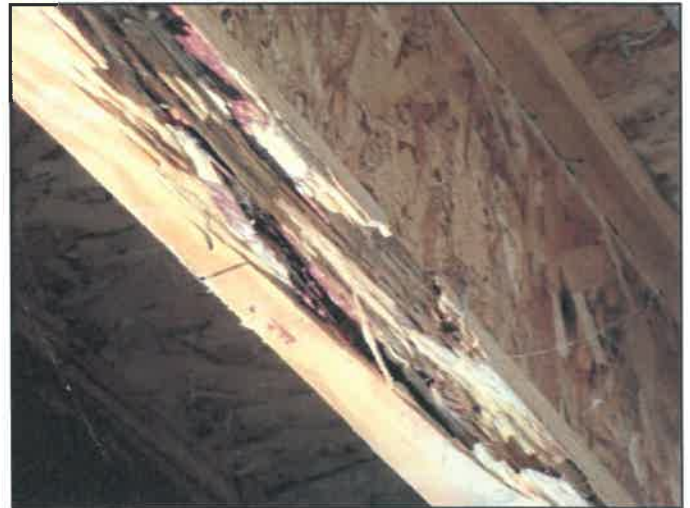
108. Split or damaged

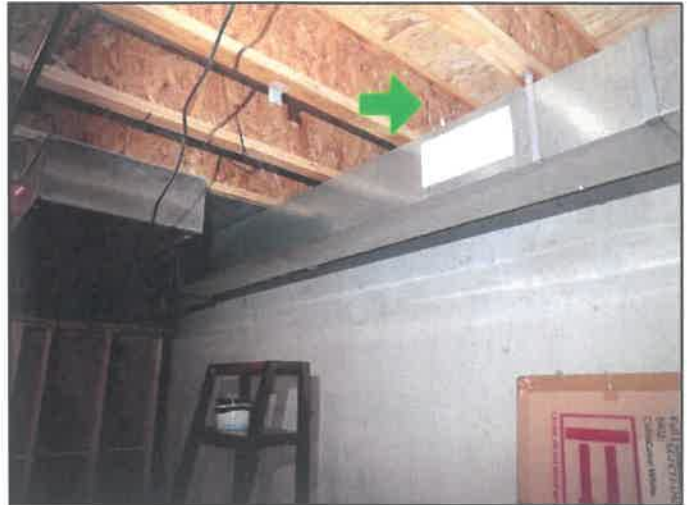
120. Open splices

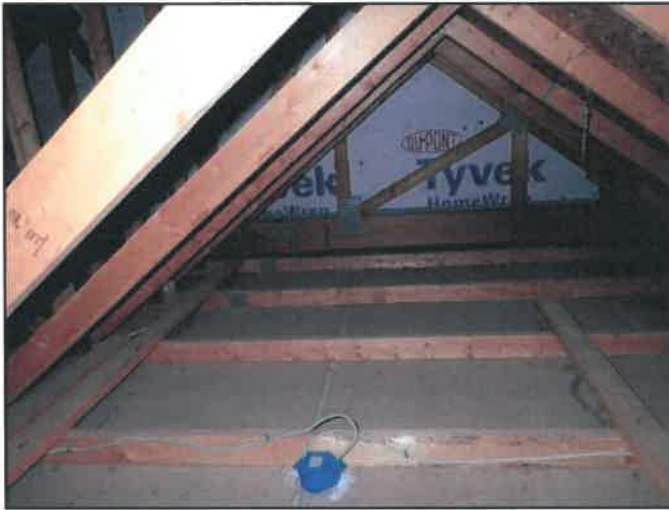
199. Amount inadequate above garage

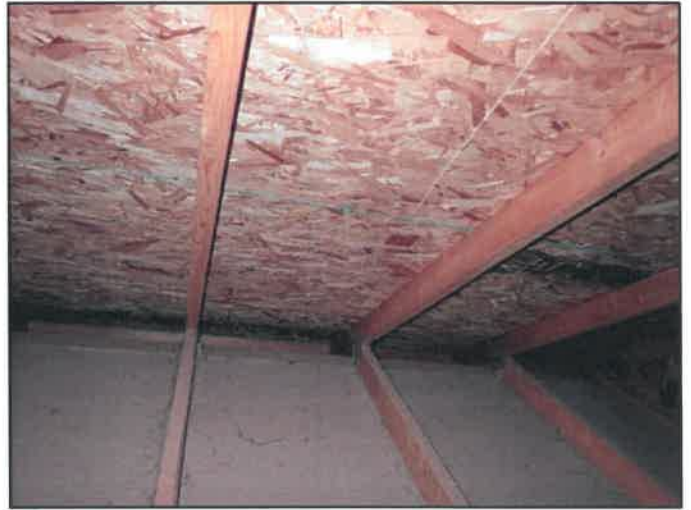
200. Amount inadequate above garage

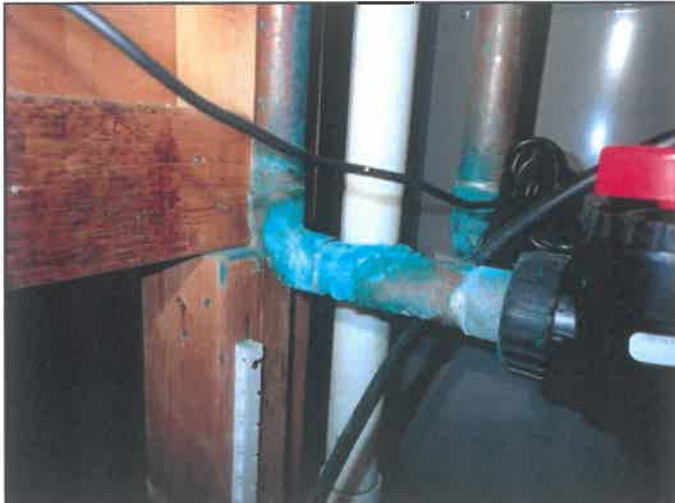
213. Leak

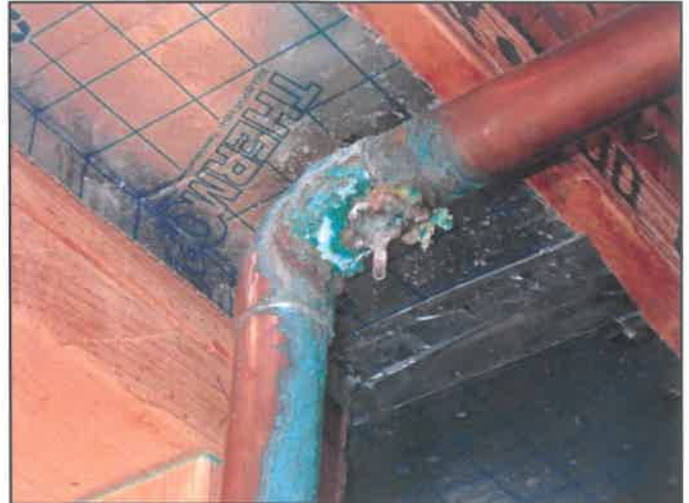
214. Leak

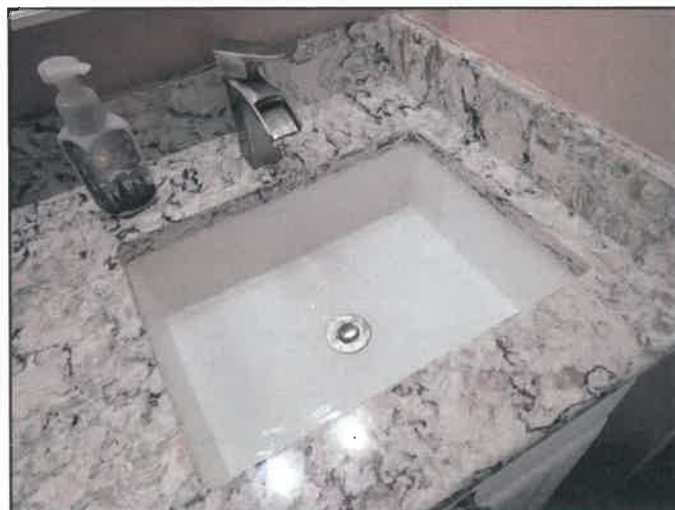
221. Slow drains

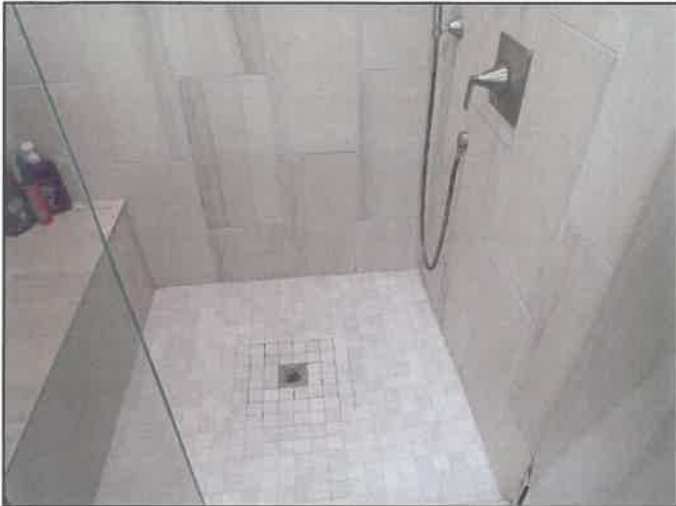
**223.** Grout loose, missing or deteriorated

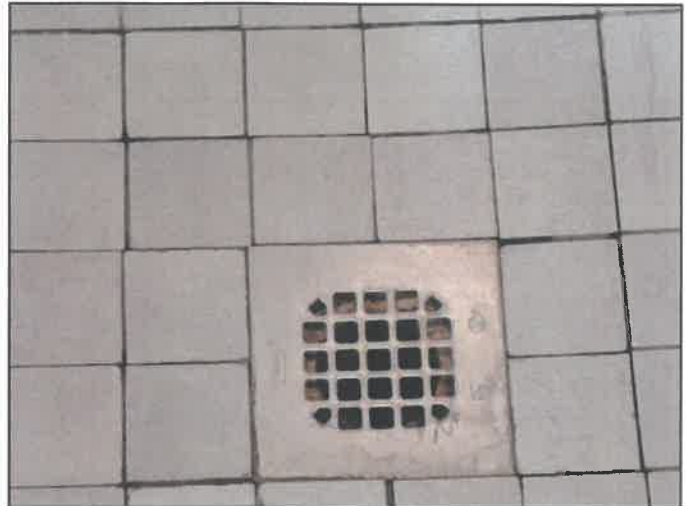
**224.** Grout loose, missing or deteriorated

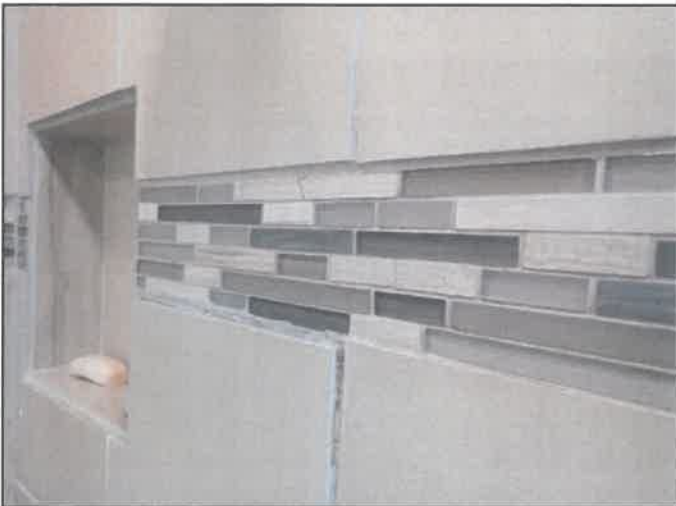
**225.** Grout loose, missing or deteriorated

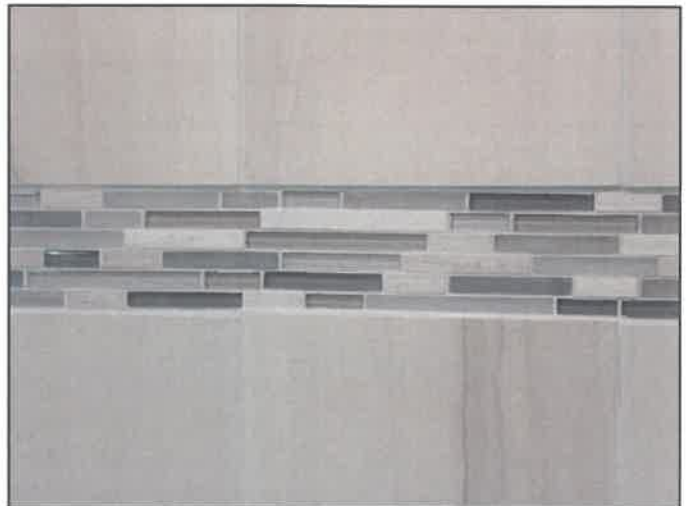
**226.** Grout loose, missing or deteriorated

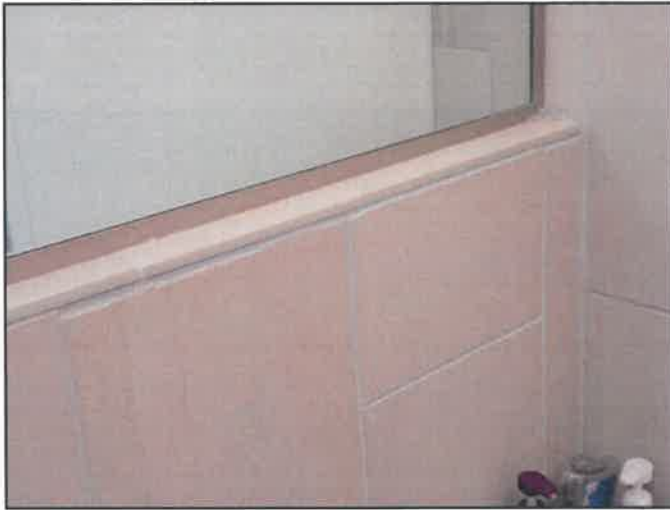
227. Grout loose, missing or deteriorated

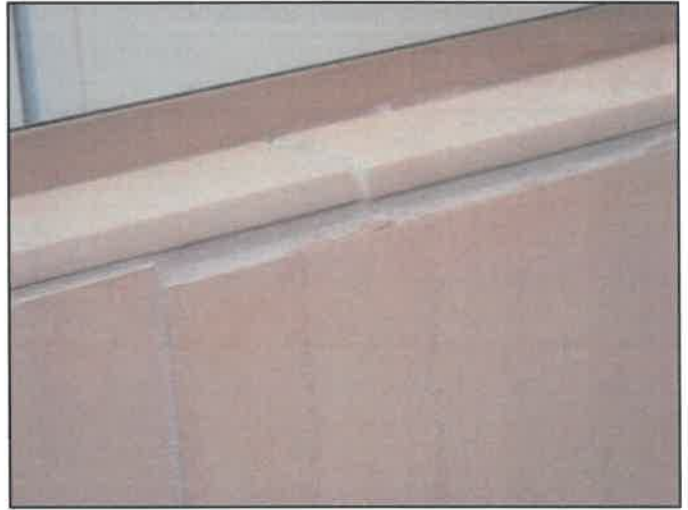
228. Grout loose, missing or deteriorated

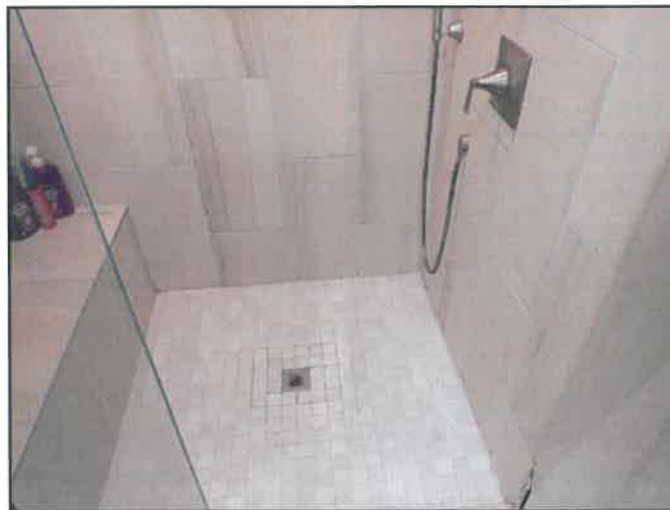
**32. Condition:** • Tile shower pans will eventually leak and will require regular maintenance. There was no signs of leaking observed at the time of the inspection.

229. seal shower pan tile

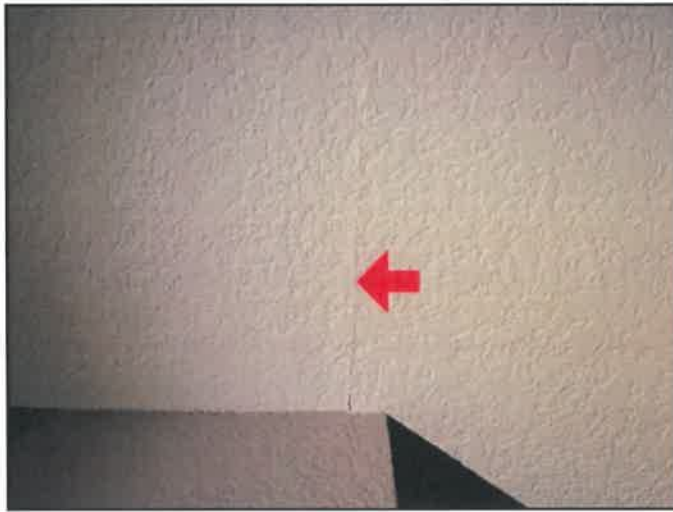
230. drywall cracked

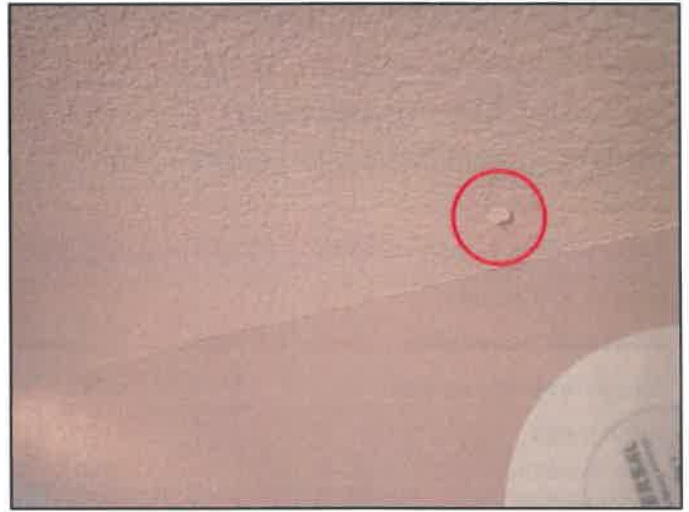
231. drywall cracked

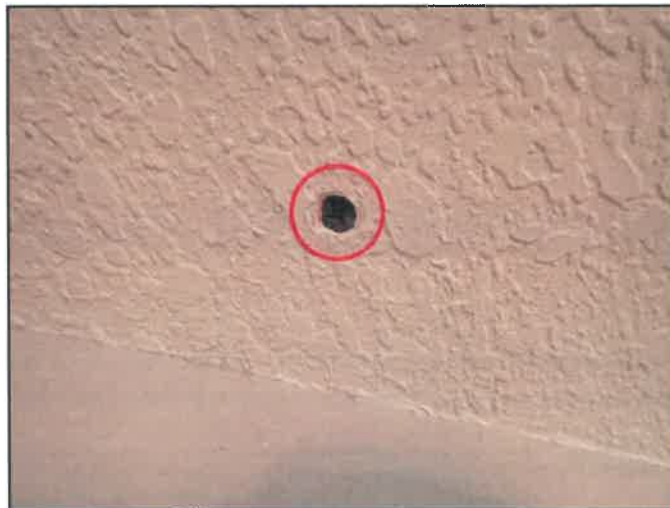
232. drywall damaged

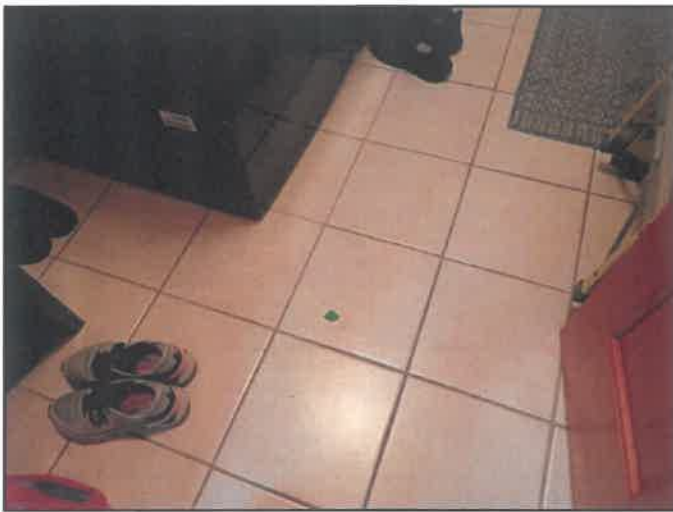
233. Tiles cracked

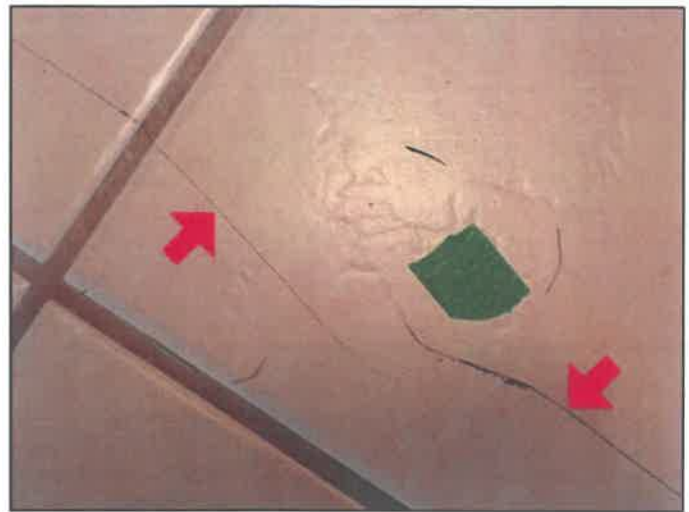
234. Tiles cracked

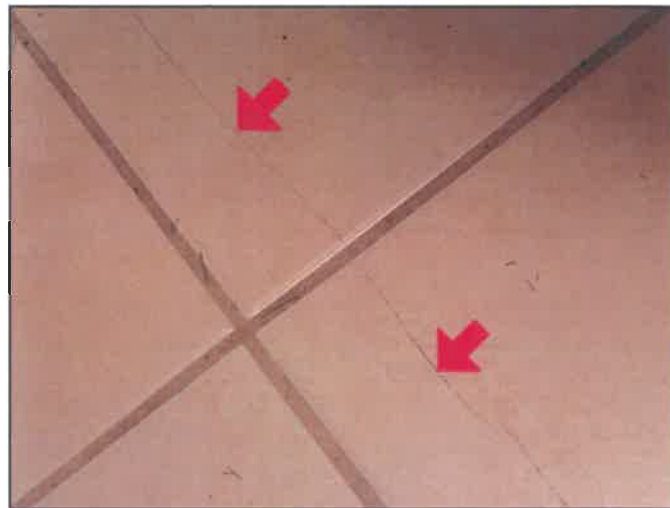
235. Tiles cracked

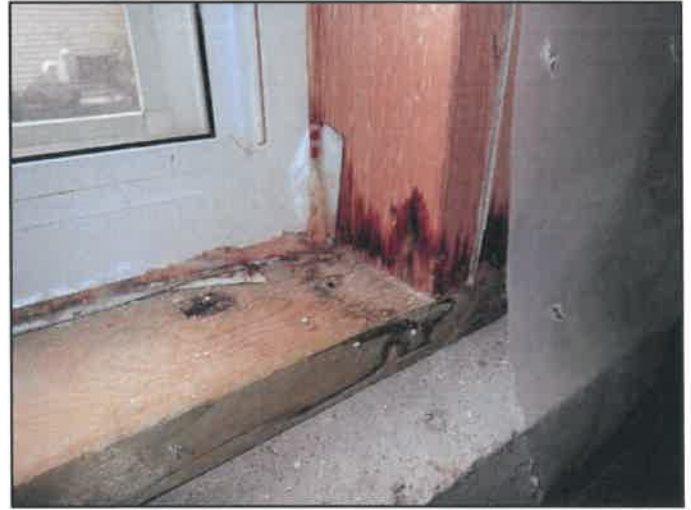
237. signs of moisture interior window trim

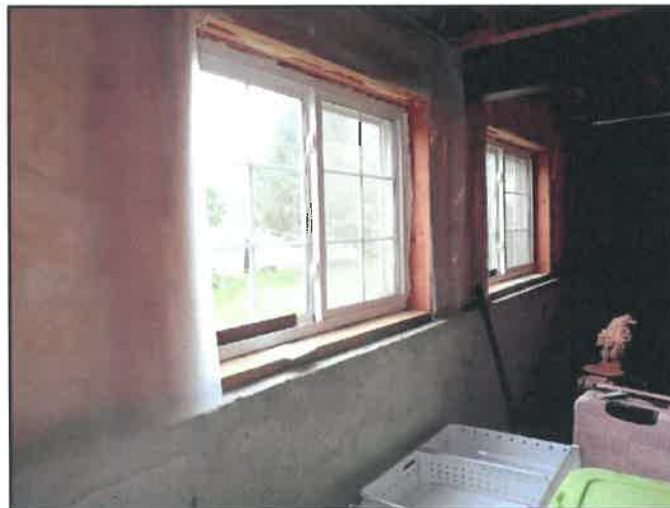
238. window flashing missing
