# ROOF INSPECTION REPORT

## *Lakefront Home Improvement*

| Property Address | 11233 Third Ave, Pleasant Prairie, WI 53158 |
| Inspection Date | August 10, 2026 |

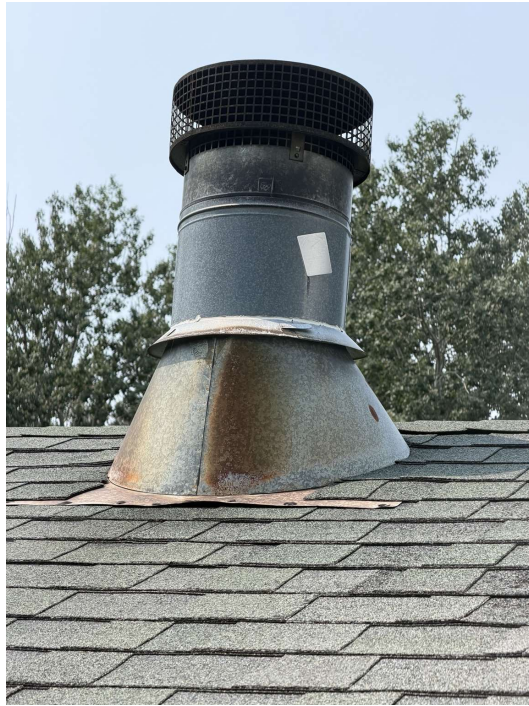
Several roof penetrations, vents, valleys, and roof transitions were also observed. Rust and corrosion are visible around one of the metal roof vents. This condition should be monitored and appropriately repaired or sealed to help prevent future moisture intrusion.

Photo 1. Metal roof vent/chimney assembly showing visible rust and corrosion.

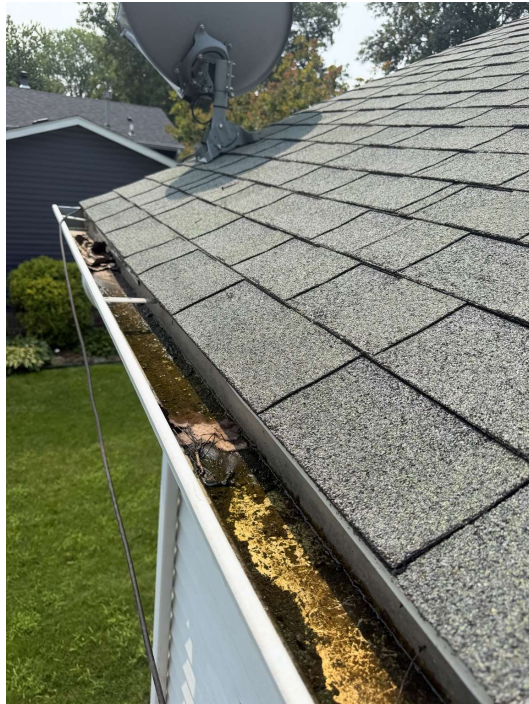
The home is equipped with standard aluminum gutters and downspouts. Debris and standing material were observed in portions of the gutter system. Cleaning is recommended to maintain proper drainage and help reduce water backup.

Photo 2. Standard aluminum gutter with accumulated debris and standing material.

Regular roof maintenance is recommended, including cleaning debris from the standard aluminum gutters and downspouts, keeping valleys clear of leaves and debris, maintaining proper roof drainage, monitoring roof penetrations and vents, and inspecting the roofing system following significant weather events.

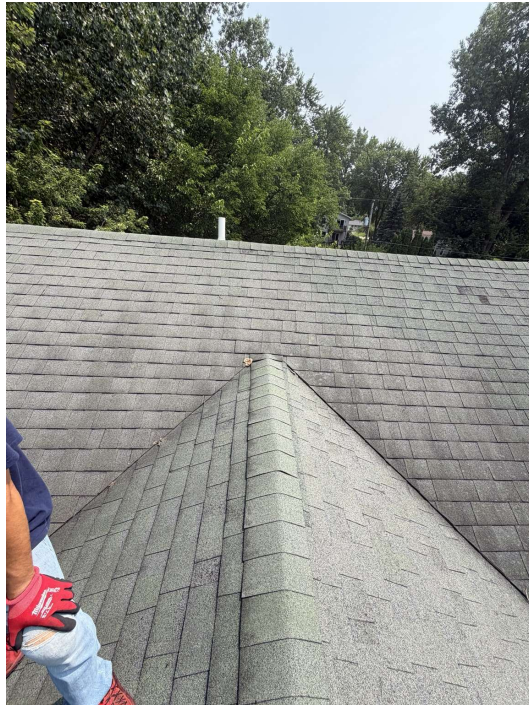
Photo 3. Overview of architectural asphalt shingles and roof planes.

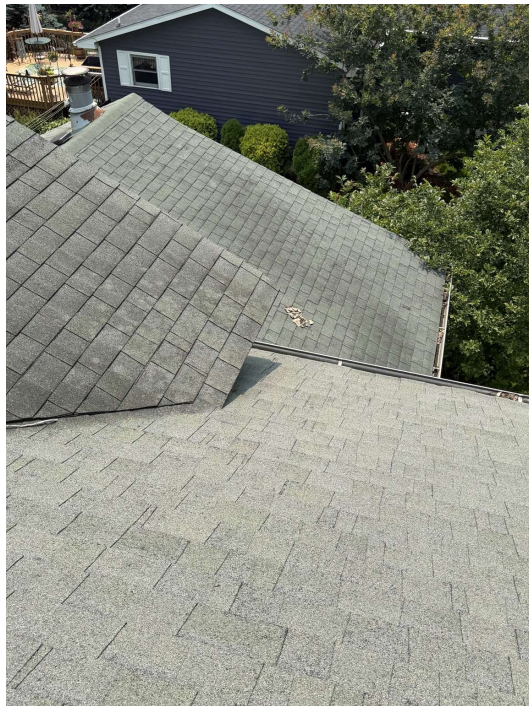
Visible conditions include general surface wear, weathering, discoloration, and staining in multiple areas of the roof. The property also has extensive tree coverage surrounding the structure. The surrounding trees and resulting environmental exposure appear to have contributed to accelerated weathering and deterioration of the roofing materials.

Photo 4. Roof overview showing shingles, transitions, and surrounding tree coverage.

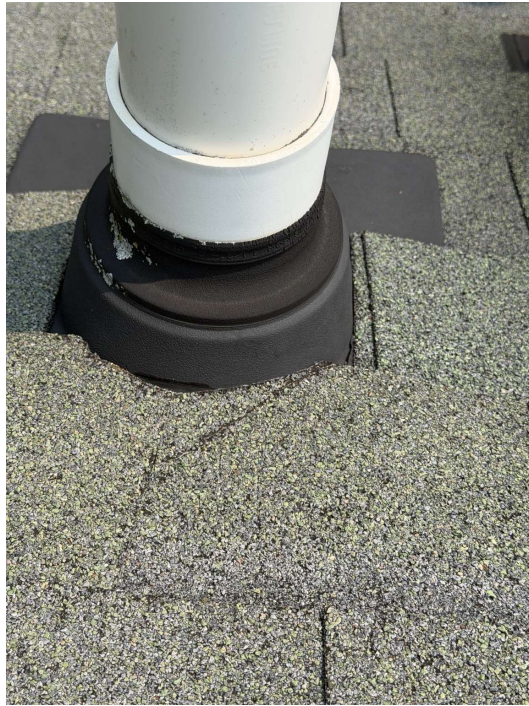
Photo 5. PVC roof penetration with rubber boot flashing.

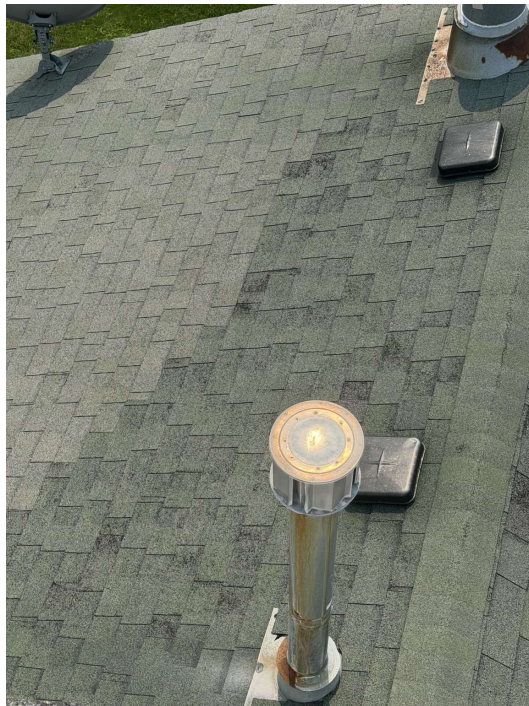
Photo 6. Roof overview showing shingles, vents, and metal roof penetration.

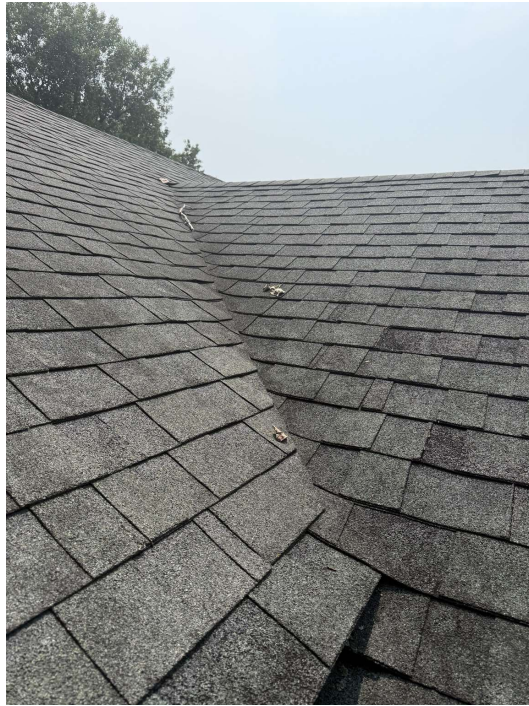
Photo 7. Roof valley and adjoining shingle surfaces.

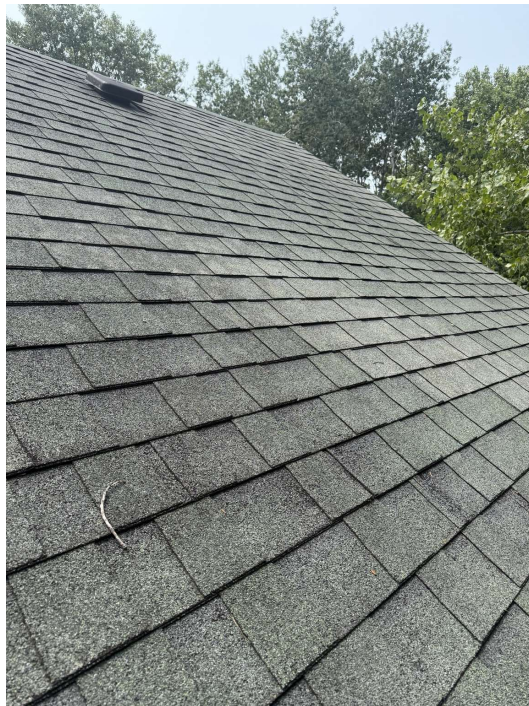
Photo 8. Shingle field showing general surface wear and weathering.

Based on the conditions observed during this inspection, immediate roof replacement does not appear to be required solely due to the visible conditions noted at the time of inspection. However, due to the roof's approximate 15-year age and the observed accelerated weathering and deterioration, replacement of the roofing system is recommended within the next 3-5 years, subject to continued evaluation of its condition.

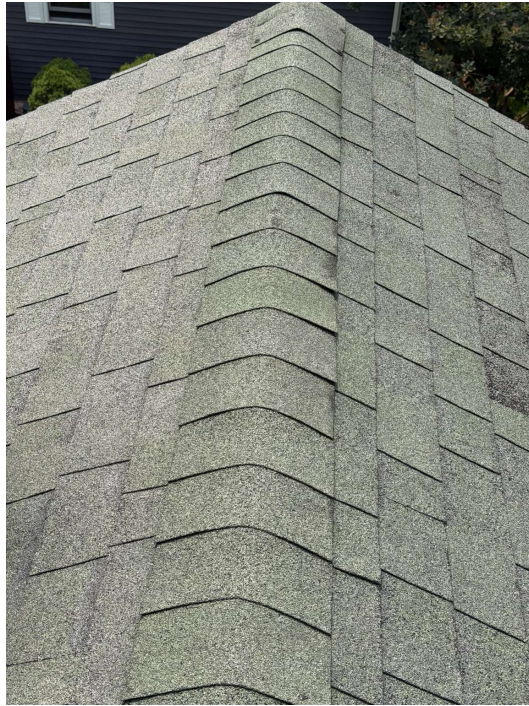
Photo 9. Hip/ridge shingle detail.

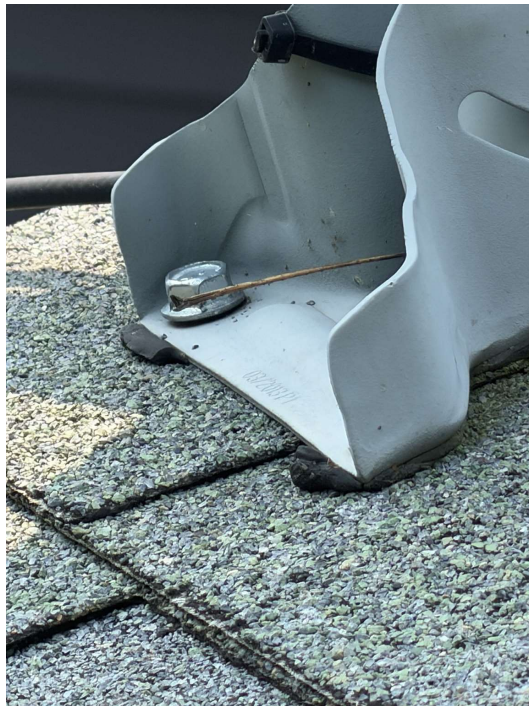
Photo 10. Roof-mounted satellite attachment and surrounding shingles.
