# Lead-Based Paint Risk Assessment Report

**Performed On: November 13, 2023 at 8:30 AM**

1721 Geneva St  
Racine, WI 53402

City of Racine Health Department  
Environmental Health Division  
730 Washington Avenue  
Racine, WI 53403  
(262) 636-9538  
DHS Lead Company #19440

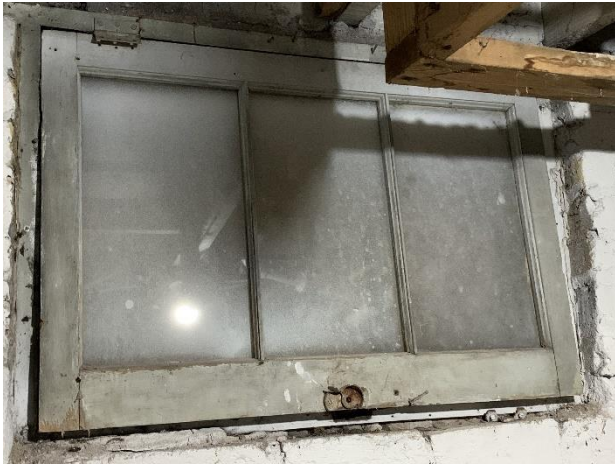
Basement Window Sash, Casing

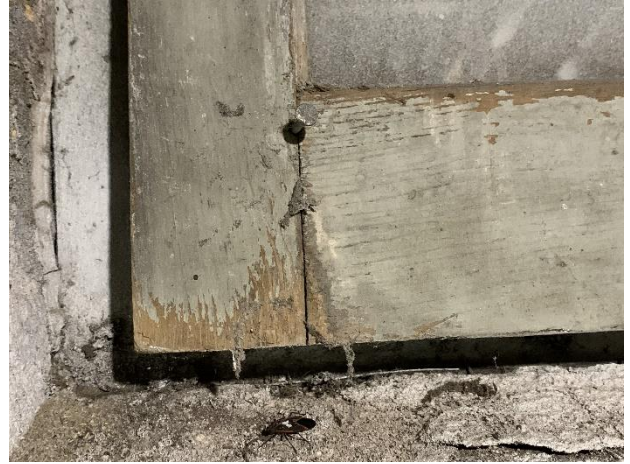
Basement Window Sash

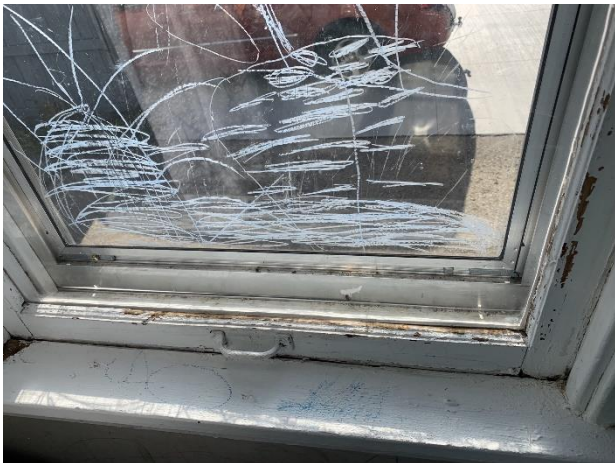
Window Sash  
Kitchen

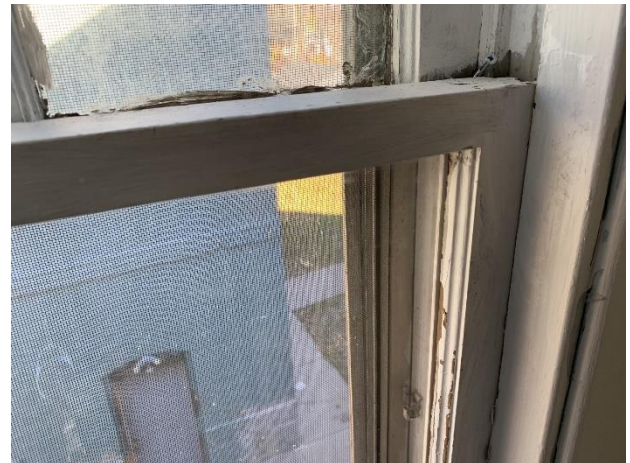
Window Sash  
Hallway

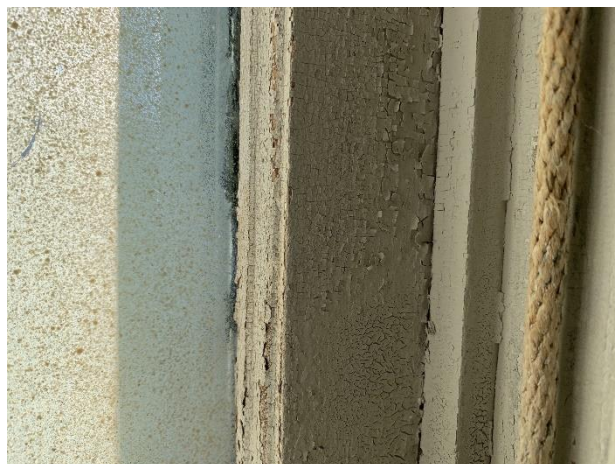
Window Sash  
Bedroom A Closet

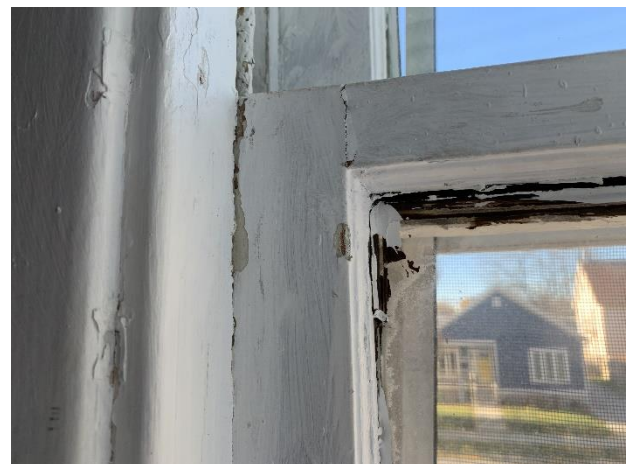
Window Sash  
Bedroom A

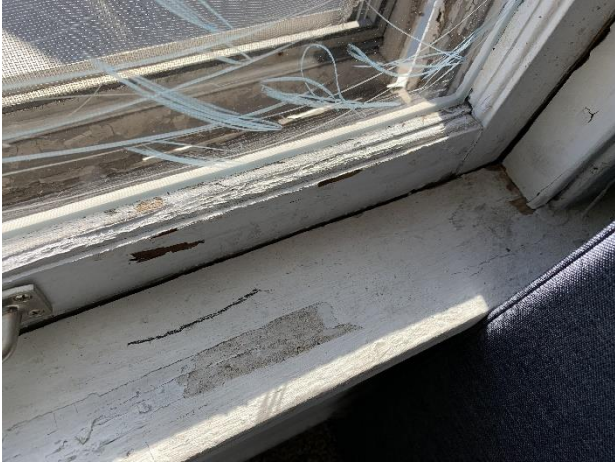
Window Sill, Sash  
Bedroom D

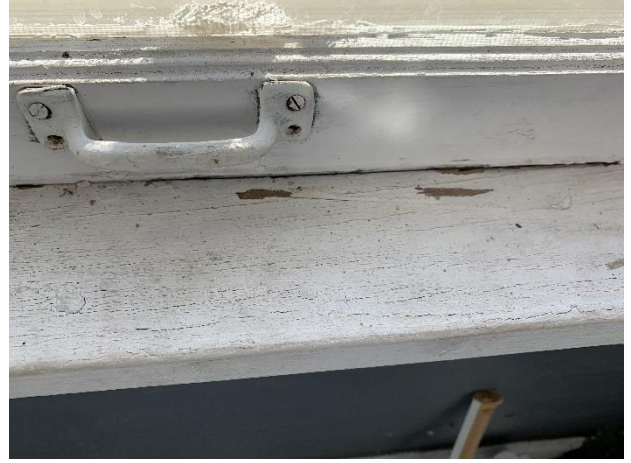
Window Sill  
Front Porch

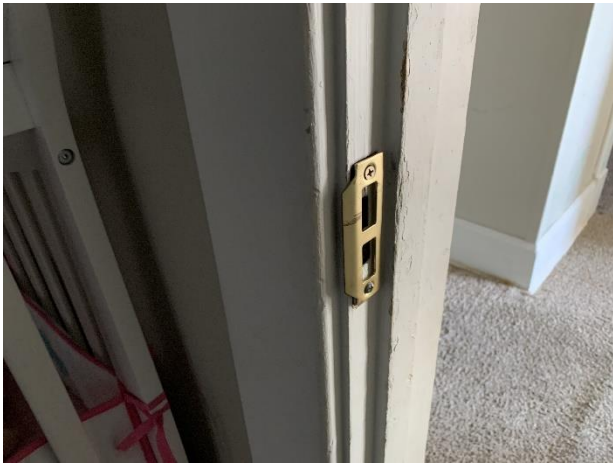
Door Stop  
Bedroom A/Hallway

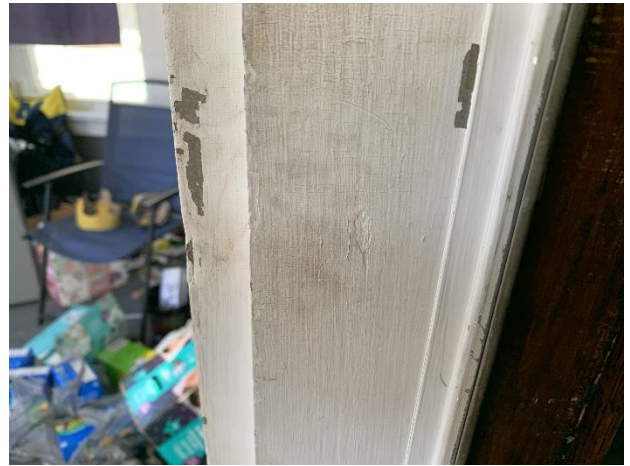
Door Stop  
Front Porch/Living Room

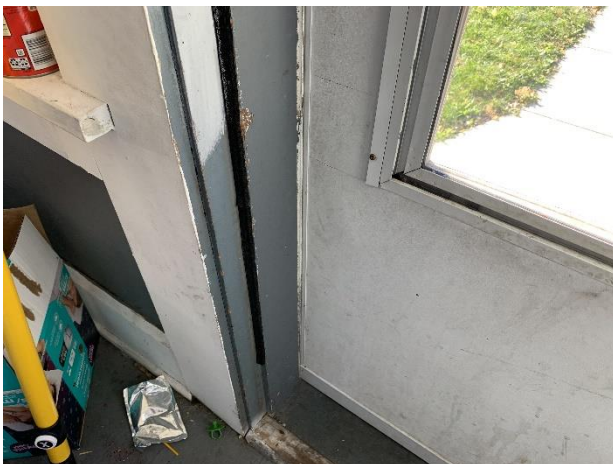
Door Stop  
Front Porch

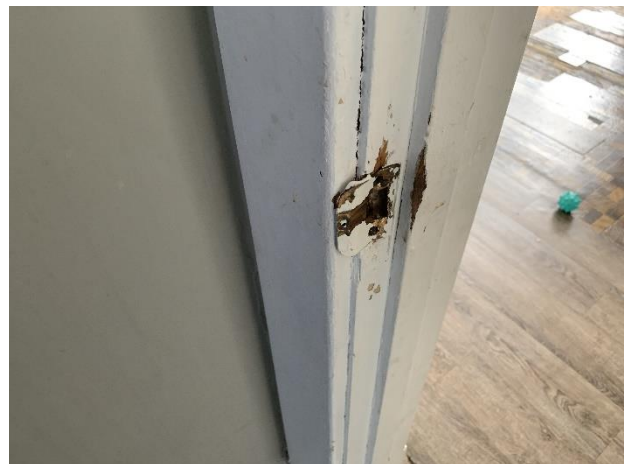
Door Jamb  
Lower Bathroom

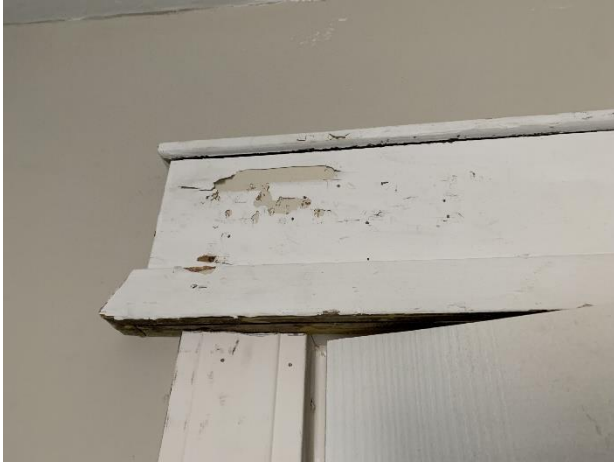
Door Casing  
Upper Bathroom

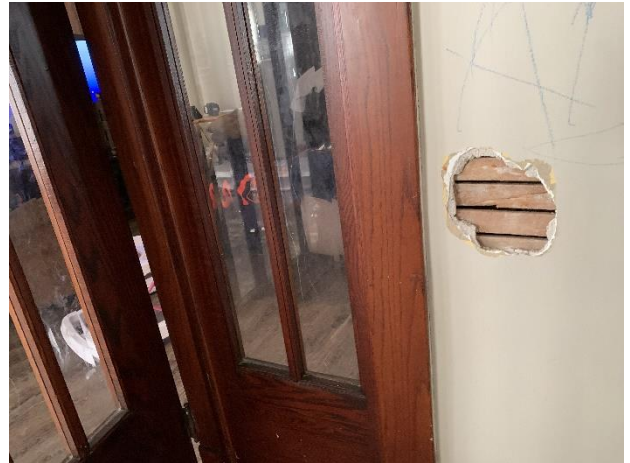
Wall  
Dining Room Side A

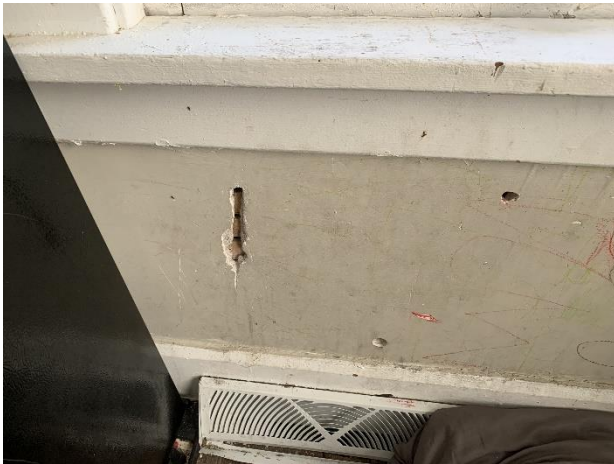
Wall  
Kitchen Side C

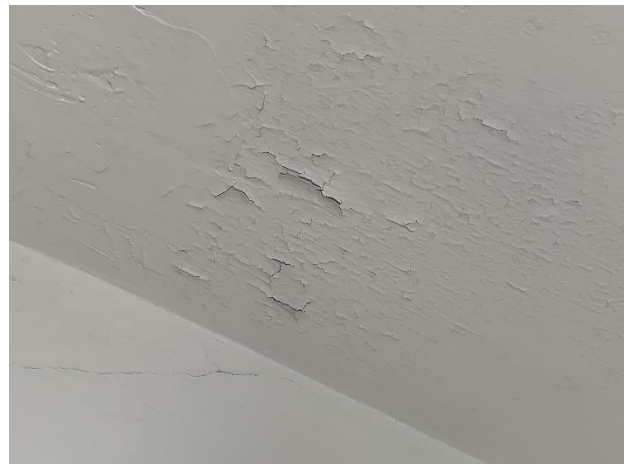
| Building Component | Paint Condition (Deteriorated, Intact, NA) | Deteriorated Due to Friction/Impact | Deterioration Due to Moisture | Specific Notes/ Component with Visible Bite Marks |
|---|---|---|---|---|
| Ceilings | Deteriorated | No | No | Bedroom D Closet |

Ceiling  
Bedroom D Closet

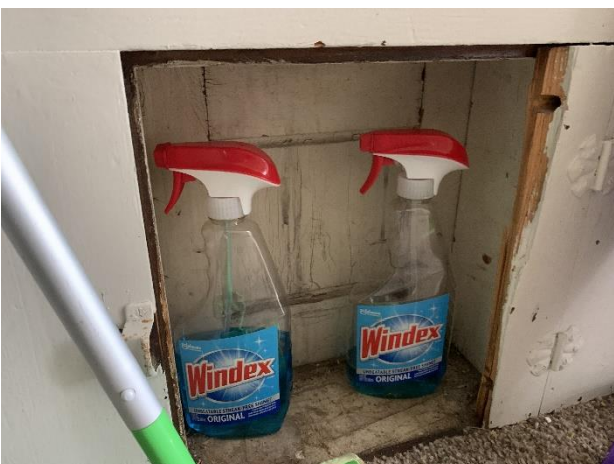
| Room: Back Entry | | | | | | | |
|---|---|---|---|---|---|---|---|
| Milkbox Door-Int | Wood | C | Deteriorated | Beige | First | Positive | 1.86 |

**Notes:** Milkbox door to interior broken, milkbox door tested above is located at back of opening.

Milkbox Door – Interior  
Back Entry

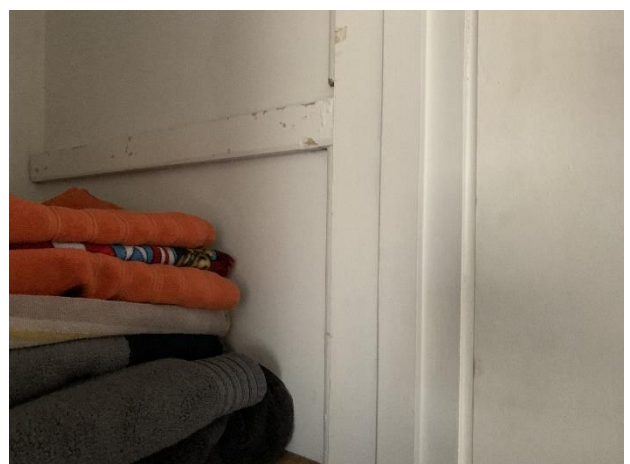
| Component | Substrate | Side | Condition | Color | Floor | Results | PbC |
|---|---|---|---|---|---|---|---|
| <b>Closet Bracket</b> | <b>Wood</b> | <b>A</b> | <b>Deteriorated</b> | <b>White</b> | <b>Second</b> | <b>Positive</b> | <b>7.02</b> |
| <b>Closet Bracket</b> | <b>Wood</b> | <b>C</b> | <b>Deteriorated</b> | <b>White</b> | <b>Second</b> | <b>Positive</b> | <b>7.23</b> |

Closet Brackets  
Hallway Closet

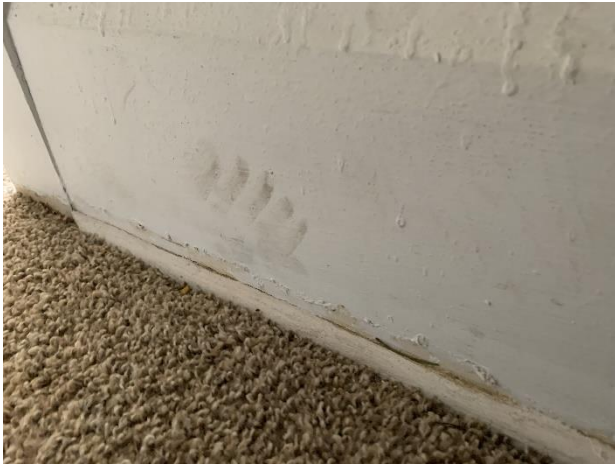
| <b>Baseboard</b> | <b>Wood</b> | <b>D</b> | <b>Deteriorated</b> | <b>White</b> | <b>Second</b> | <b>Positive</b> | <b>5.08</b> |

Baseboard  
Hallway Side D

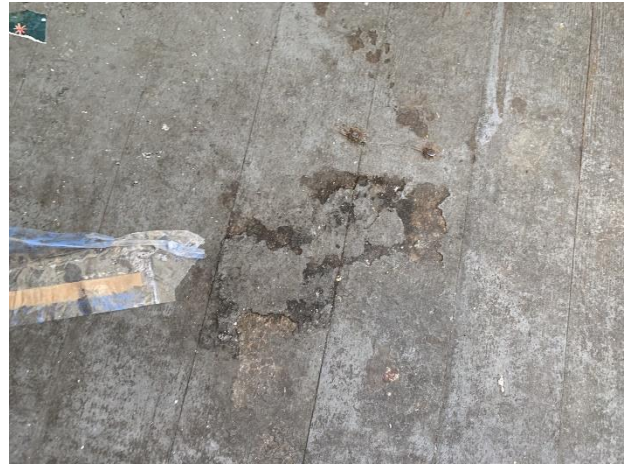
Floor  
Front Porch

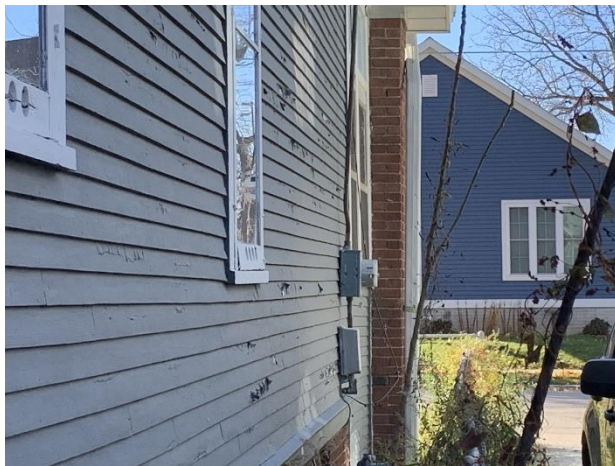
Siding  
Exterior Side B

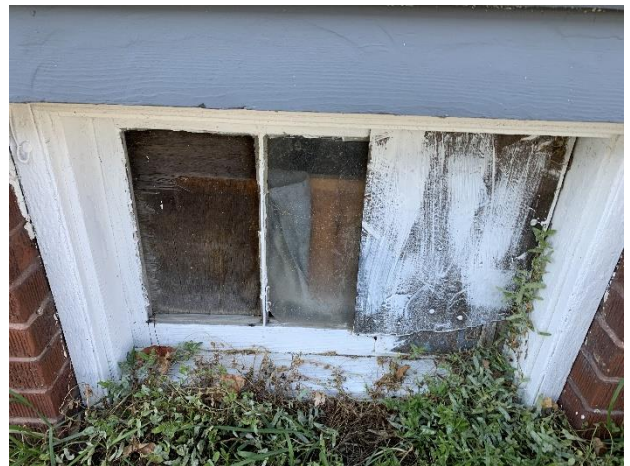
| Window Sash Int | Wood | D1 | Deteriorated | White | Ground | Positive | 3.71 |

Basement Window D1

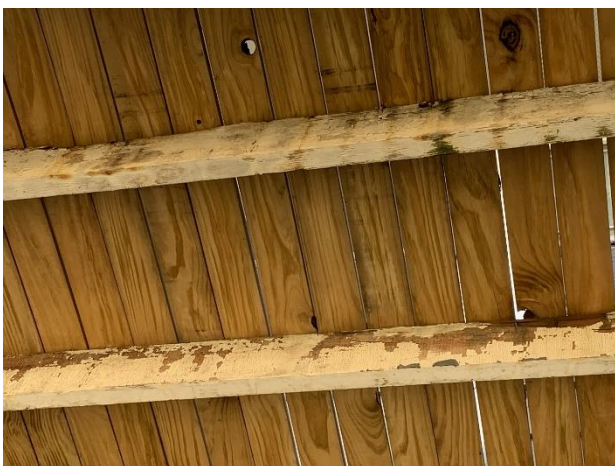
Porch Beams

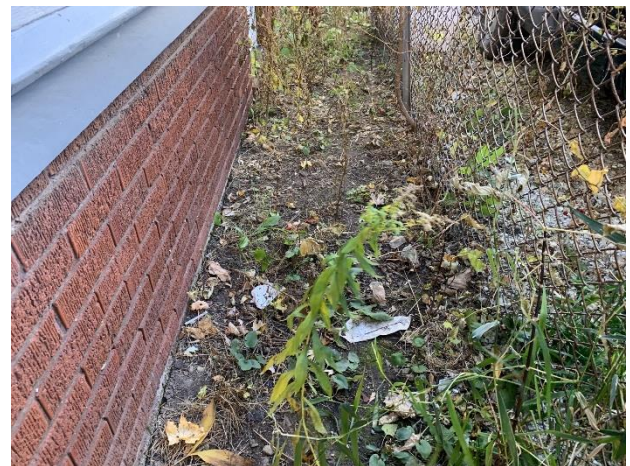
Bare Soil Side B
