# Home Inspection Report

3316 3 Mile Road  
Caledonia, WI 53404

Inspected by:  
Kenya Conley  
On Point Home Inspection

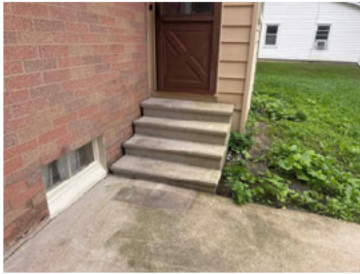
1. ☒ ☐ ☐ ☐ ☐ Driveway: Concrete, Asphalt
2. ☒ ☐ ☐ ☐ ☐ Walks: Concrete
3. ☒ ☐ ☐ ☐ ☐ Steps/Stoops: Concrete - Uneven risers and missing railing may be the cause of a safety accident

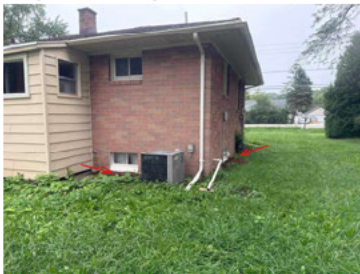
4. ☐ ☐ ☐ ☒ ☐ Swale: Flat or negative slope - Recommend improvements be made to the grade, swale slope and depth to improve water control

1. Swale: Flat or negative slope - Recommend improvements be made to the grade, swale slope and depth to improve water control

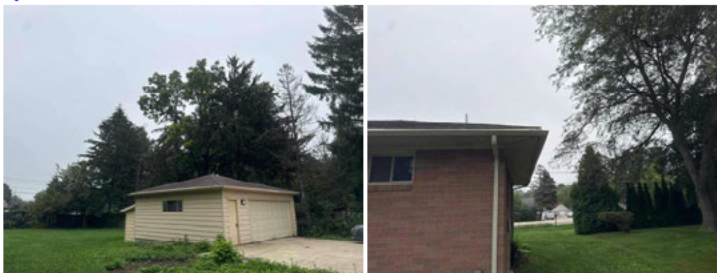
5. ☐ ☐ ☐ ☒ ☐ Vegetation: Trees - Tree limbs over hang the roof and should be cut back, An evaluation by a qualified arborist is recommended to estimate services required to repair this problem

2. Vegetation: Trees - Tree limbs over hang the roof and should be cut back, An evaluation by a qualified arborist is recommended to estimate services required to repair this problem

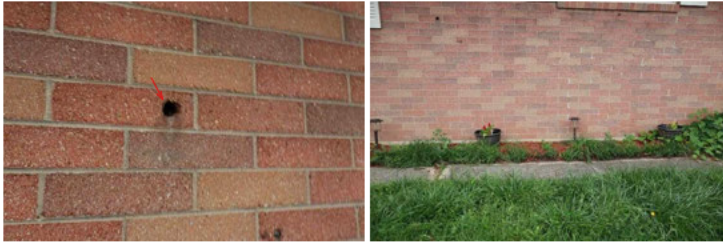
1. ☐☐☐☒☐ Type: Aluminum siding, Brick - **Suggest hole sealing and exterior crack(s) further evaluated/repared by a qualified professional**

3. Main Exterior Surface Type: Aluminum siding, Brick - Suggest hole sealing and exterior crack(s) further evaluated/repaired by a qualified professional

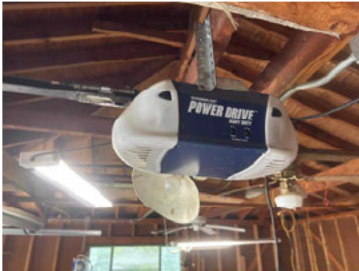
4. ☐ ☐ ☐ ☐ ☒ Door Opener: Chamberlain - Inoperative at time of inspection, A qualified professional is recommended to evaluate and repair/replace

2. Detached Garage Door Opener: Chamberlain - **Inoperative at time of inspection, A qualified professional is recommended to evaluate and repair/replace**

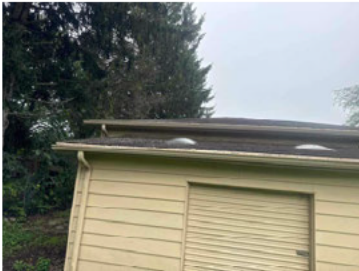
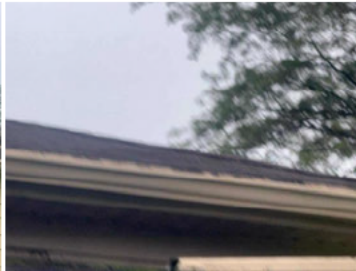
6. ☐ ☐ ☐ ☐ ☒ Roof: Asphalt shingle - Moss build up on roof can push under shingles and create leaks, Recommend further evaluation and moss/algae removal by a qualified roofing professional.

3. Detached Garage Roof: Asphalt shingle - **Moss build up on roof can push under shingles and create leaks, Recommend further evaluation and moss/algae removal by a qualified roofing professional.**

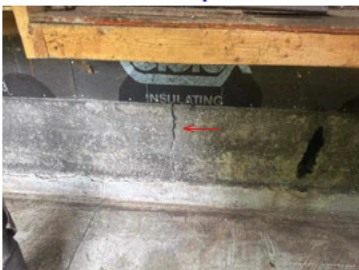
10. ☐ ☐ ☐ ☒ ☐ Walls: Exposed framing, Concrete - Cracks present, A qualified contractor is recommended to evaluate and repair

5. Detached Garage Walls: Exposed framing, Concrete - **Cracks present, A qualified contractor is recommended to evaluate and repair**

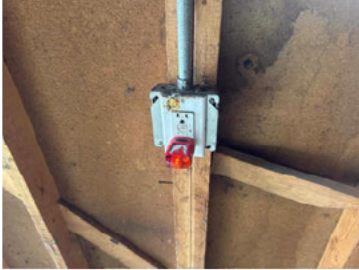
11. ☒ ☐ ☐ ☐ ☐ Floor/Foundation: Concrete
12. ☐ ☐ ☐ ☐ ☒ Electrical: 110 VAC GFCI - **Faulty GFCI outlet-replace, A licensed electrician is recommended to evaluate and repair/replace**

4. Detached Garage Electrical: 110 VAC GFCI - **Faulty GFCI outlet-replace, A licensed electrician is recommended to evaluate and repair/replace**

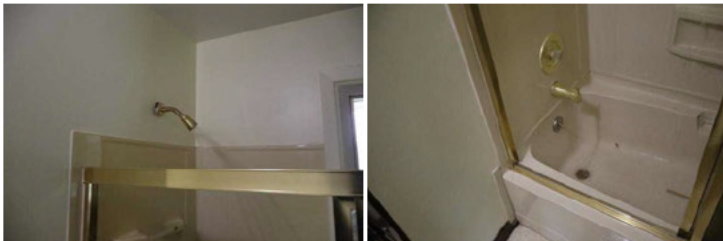
8. ☒ ☐ ☐ ☐ ☐ Counter/Cabinet: Composite and wood  
9. ☒ ☐ ☐ ☐ ☐ Sink/Basin: Molded single bowl  
10. ☐ ☐ ☐ ☐ ☒ Faucets/Traps: Metal with PVC trap - Shower diverter not functioning properly, all water is not flowing to showerhead, A licensed plumber is recommended to evaluate and repair/replace

7. All baths Bathroom Faucets/Traps: Metal with PVC trap - **Shower diverter not functioning properly, all water is not flowing to showerhead, A licensed plumber is recommended to evaluate and repair/replace**

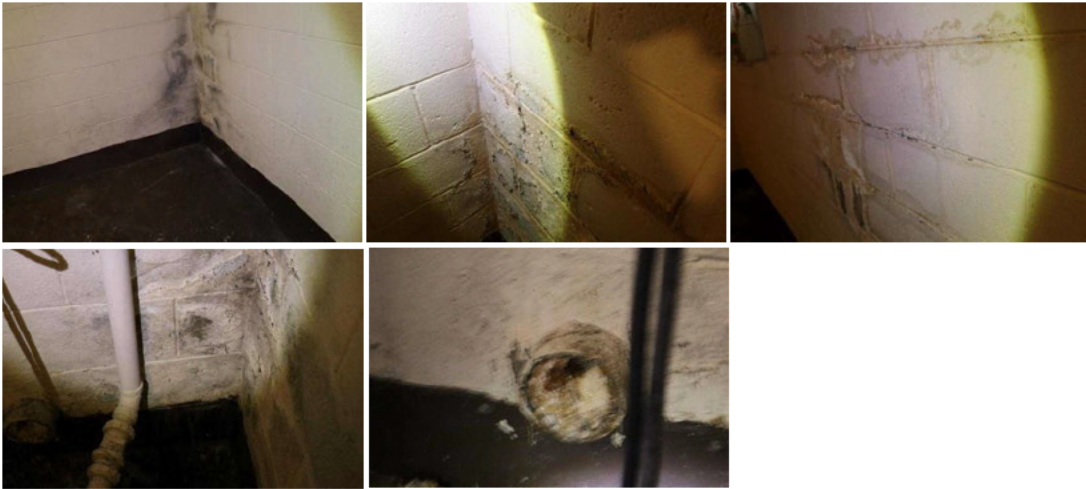
1. ☒ ☐ ☐ ☐ ☐ Unable to Inspect: 30%
2. ☒ ☐ ☐ ☐ ☐ Ceiling: Exposed framing, Covered
3. ☐ ☐ ☐ ☐ ☒ Walls: Brick - Evidence of present water leakage, A qualified foundation specialist is recommended to evaluate and repair/replace

11. Main Basement Walls: Brick - Evidence of present water leakage, A qualified foundation specialist is recommended to evaluate and repair/replace

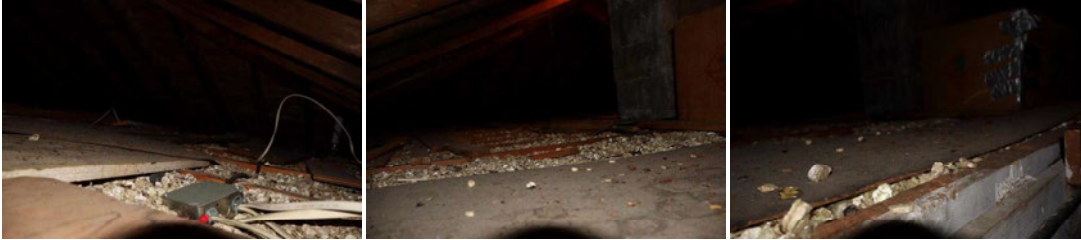
6. ☐ ☐ ☐ ☐ ☒ Insulation: Vermiculite - **Asbestos like insulation noted, Recommend further testing/removal by a qualified environmental specialist and additional insulation and air sealing be installed**

5. Main Attic Insulation: Vermiculite - **Asbestos like insulation noted, Recommend further testing/removal by a qualified environmental specialist and additional insulation and air sealing be installed**

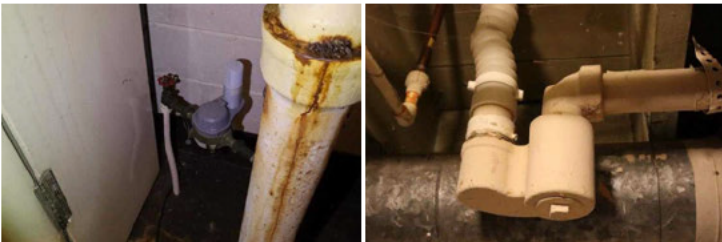
1. ☒☐☐☐☐ Service Line: Copper  
2. ☒☐☐☐☐ Main Water Shutoff: Basement  
3. ☒☐☐☐☐ Water Lines: Copper  
4. ☐☐☐☐☒ Drain Pipes: Cast iron, PVC - **Leaking main, handyman plumbing and older style drum trap noted at time of inspection. Suggest main drain repair and handyman plumbing upgraded by a licensed plumber**

13. Drain Pipes: Cast iron, PVC - Leaking main, handyman plumbing and older style drum trap noted at time of inspection. Suggest main drain repair and handyman plumbing upgraded by a licensed plumber
