# SMS BASEMENT REPAIR

Owner DEE Conrad Phone 414-975-0424

Address 21300 Astorhatch Dr. City Brookfield Zip 53045

Analysis north Garage wall has sunk and cracked  
crawl space wall / GARAGE steps have cracked  
and sunk

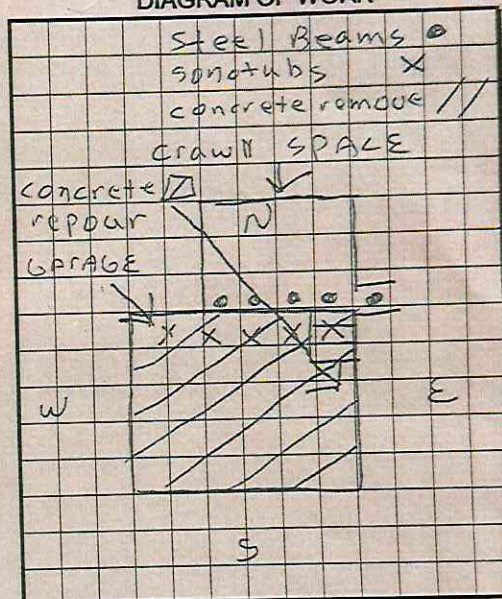
## DIAGRAM OF WORK

Full basement - Dry and shows no wall movement

- ☒ Install 7" x 5" steel beams
- ☒ Space approx. 32"
- ☒ Chip out - tuck-point interior cracks
- ☒ Grout behind beams

- 1) remove entire Garage Floor
- 2) EXCAVATE has needed along north Garage wall to install 6" Sonotubs / Fill with concrete next wall to piers
- 3) repair entire Garage Floor / 7" stone bed / 4" concrete
- 4) rebar entire Area - connect to existing curb
- 5) Pour 18" x 18" concrete footing for steel Beams in crawl space
- 6) cover crawl space floor thick plastic vapor barrier
- 7) Provide engineer report
- 8) contractor to pull permits

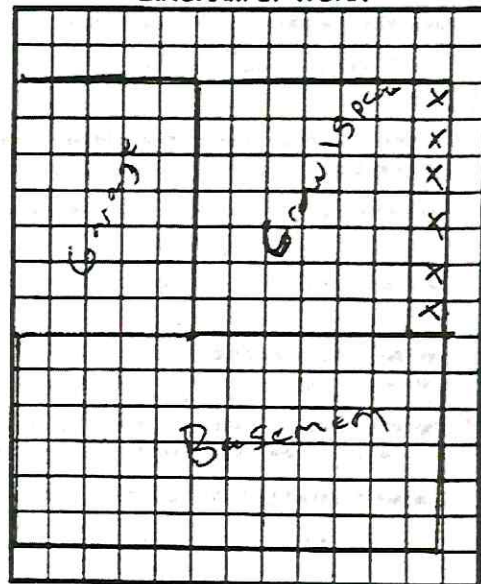
DIAGRAM OF WORK

Analysis Per Attached Engineer Report,

Beams need on North wall of

Crawl space

- ☒ Install 2 x 5 steel beams
- ☒ Space approx. Per Report
- ☒ Chip out - tuck-point interior cracks
- ☒ Grout behind beams
