# Lead-Based Paint Risk Assessment Report

**Performed On: October 8, 2024 at 10:00 AM**

228 Howland Ave  
Upper  
Racine, WI 53404

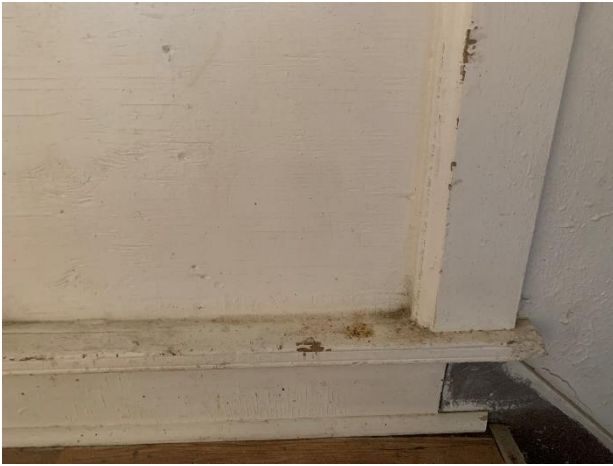
| Room: Back Entry | | | | | | | |
|---|---|---|---|---|---|---|---|
| <b>Window Casing-Outer</b> | <b>Wood</b> | <b>C</b> | <b>Deteriorated</b> | <b>White</b> | <b>Second</b> | <b>Positive</b> | <b>3.15</b> |

Window Casing (Outer)  
Back Entry

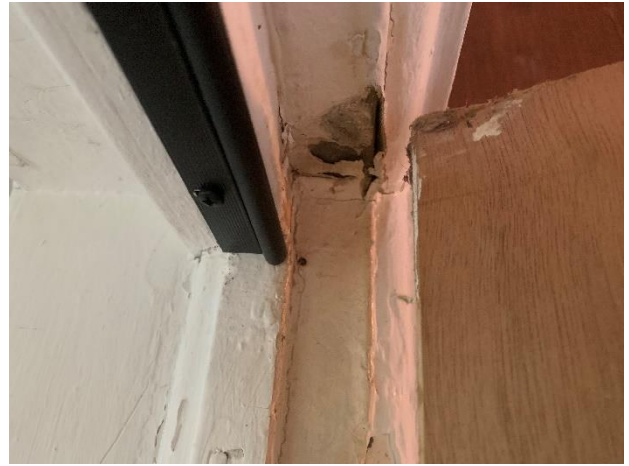
| <b>Door Jamb</b> | <b>Wood</b> | <b>C</b> | <b>Deteriorated</b> | <b>White</b> | <b>Second</b> | <b>Positive</b> | <b>2.82</b> |

Door Jamb  
Kitchen Side C

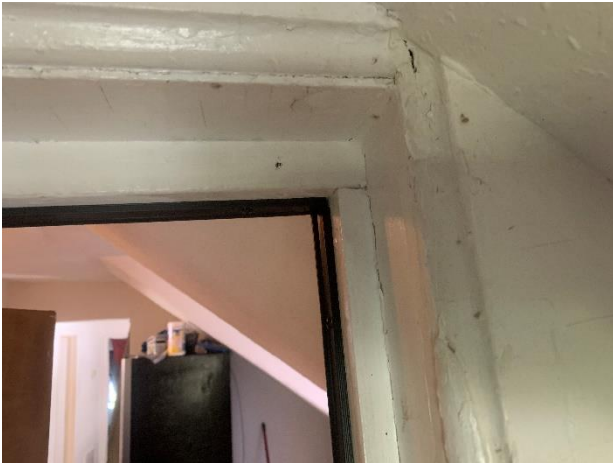
| Room: Back Entry | | | | | | | |
|---|---|---|---|---|---|---|---|
| <b>Door Jamb</b> | <b>Wood</b> | <b>A</b> | <b>Deteriorated</b> | <b>White</b> | <b>Second</b> | <b>Positive</b> | <b>5.35</b> |

Door Jamb  
Back Entry Side A

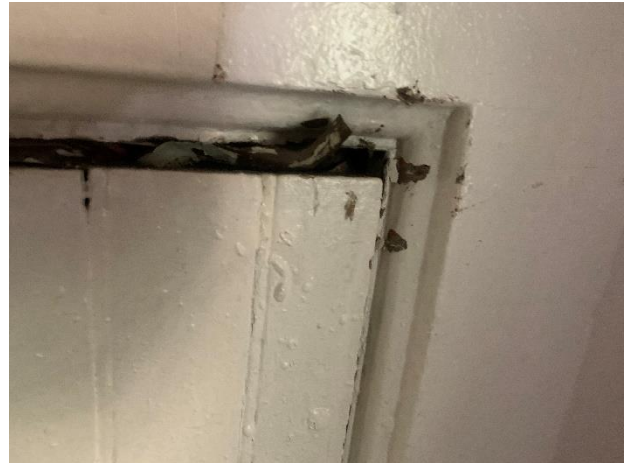
| Room: Back Entry | | | | | | | |
|---|---|---|---|---|---|---|---|
| <b>Door Casing</b> | <b>Wood</b> | <b>B</b> | <b>Deteriorated</b> | <b>White</b> | <b>Second</b> | <b>Positive</b> | <b>7.49</b> |
| <b>Door</b> | <b>Wood</b> | <b>B</b> | <b>Deteriorated</b> | <b>White</b> | <b>Second</b> | <b>Positive</b> | <b>5.1</b> |

Door, Door Casing  
Back Entry Side B-Hatch

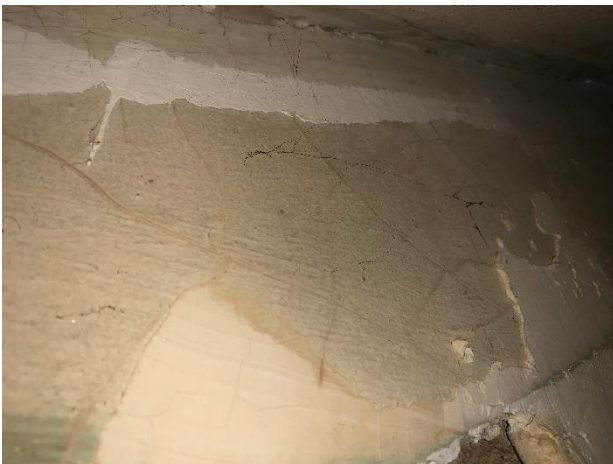
| Room: Storage | | | | | | | |
|---|---|---|---|---|---|---|---|
| <b>Wall</b> | <b>Plaster</b> | <b>B</b> | <b>Deteriorated</b> | <b>White</b> | <b>Second</b> | <b>Positive</b> | <b>3.17</b> |
| <b>Wall</b> | <b>Plaster</b> | <b>A</b> | <b>Deteriorated</b> | <b>White</b> | <b>Second</b> | <b>Positive</b> | <b>2.87</b> |
| <b>Wall</b> | <b>Plaster</b> | <b>D</b> | <b>Deteriorated</b> | <b>White</b> | <b>Second</b> | <b>Positive</b> | <b>2.3</b> |

Wall  
Storage

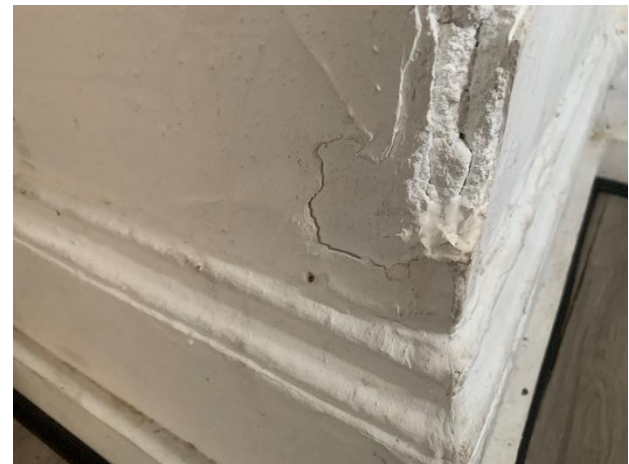
| <b>Wall</b> | <b>Plaster</b> | <b>B</b> | <b>Deteriorated</b> | <b>White</b> | <b>Second</b> | <b>Positive</b> | <b>1.4</b> |

Wall  
Kitchen Side B

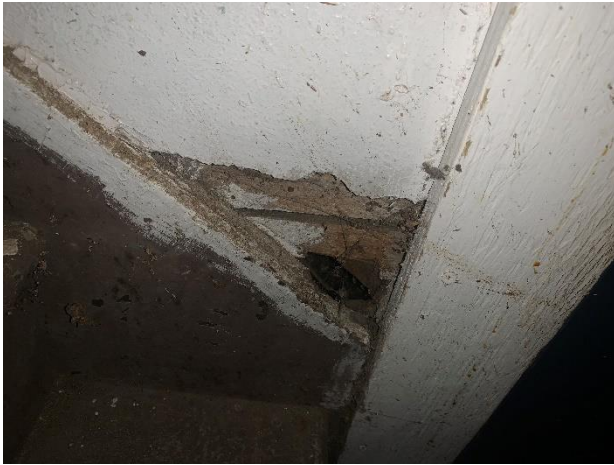
Wall  
Back Entry Side C

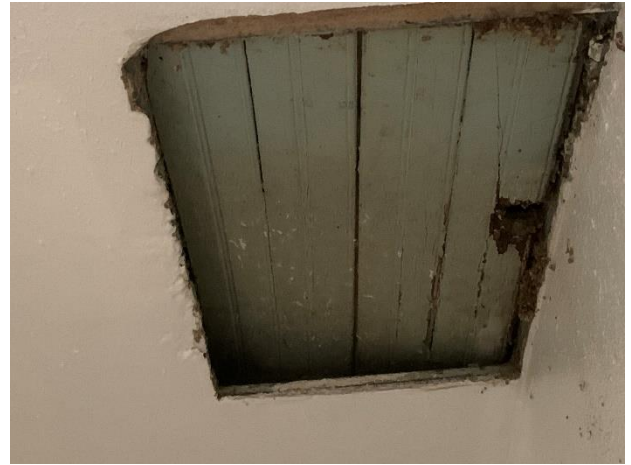
| Room: Back Entry | | | | | | | |
|---|---|---|---|---|---|---|---|
| <b>Ceiling</b> | <b>Wood</b> | <b>Ceiling</b> | <b>Deteriorated</b> | <b>Green</b> | <b>Second</b> | <b>Positive</b> | <b>1.03</b> |

Ceiling  
Back Entry

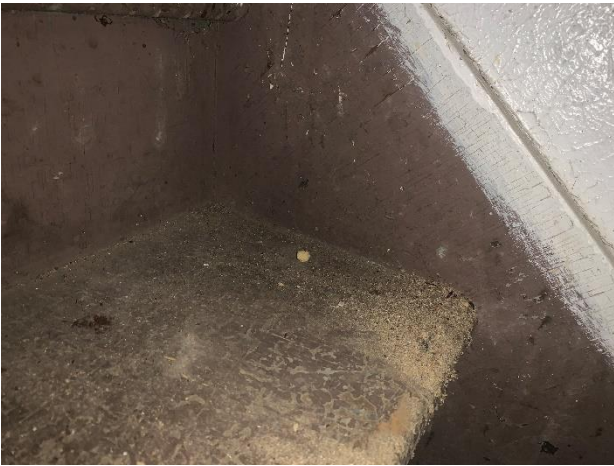
| Room: Back Entry | | | | | | | |
|---|---|---|---|---|---|---|---|
| <b>Stair Stringer</b> | <b>Wood</b> | <b>C</b> | <b>Deteriorated</b> | <b>Brown</b> | <b>First</b> | <b>Positive</b> | <b>2.41</b> |
| <b>Stair Stringer</b> | <b>Wood</b> | <b>A</b> | <b>Deteriorated</b> | <b>Brown</b> | <b>First</b> | <b>Positive</b> | <b>3.81</b> |

Stair Stringer  
Back Entry

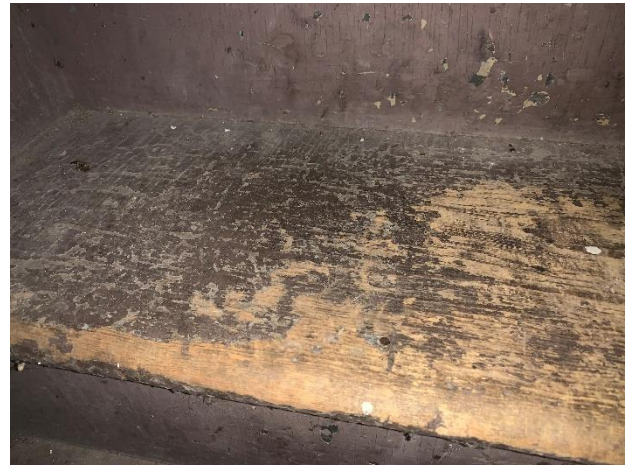
| Room: Back Entry | | | | | | | |
|---|---|---|---|---|---|---|---|
| <b>Stair Riser</b> | <b>Wood</b> | <b>A</b> | <b>Deteriorated</b> | <b>Brown</b> | <b>First</b> | <b>Positive</b> | <b>2.39</b> |
| <b>Stair Tread</b> | <b>Wood</b> | <b>A</b> | <b>Deteriorated</b> | <b>Brown</b> | <b>First</b> | <b>Positive</b> | <b>2.48</b> |

Stair Tread, Riser  
Back Entry

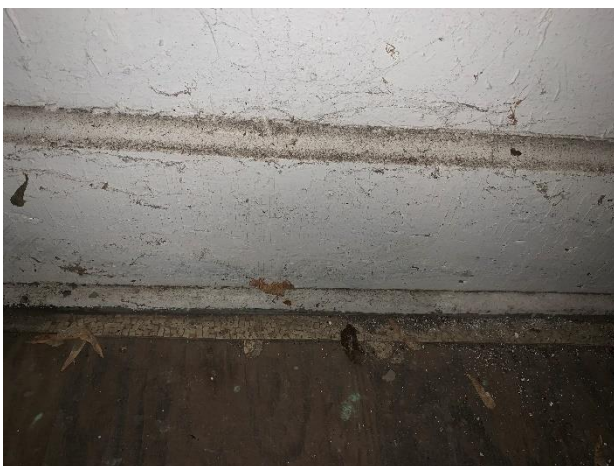
Baseboard  
Back Entry Side C

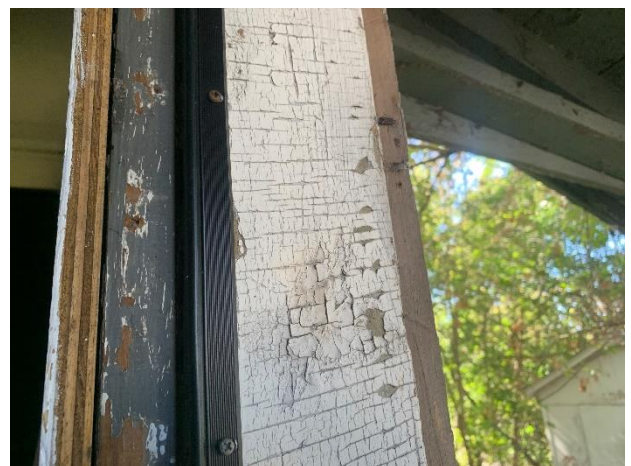
Door Stop  
Back Entry Side C  
Interior/Exterior Door

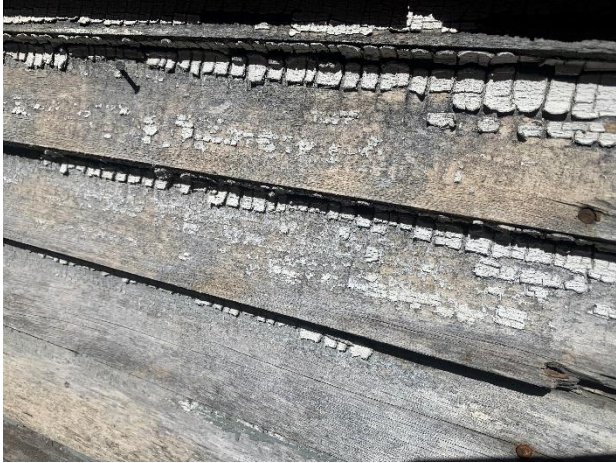
Siding  
Upper Porch

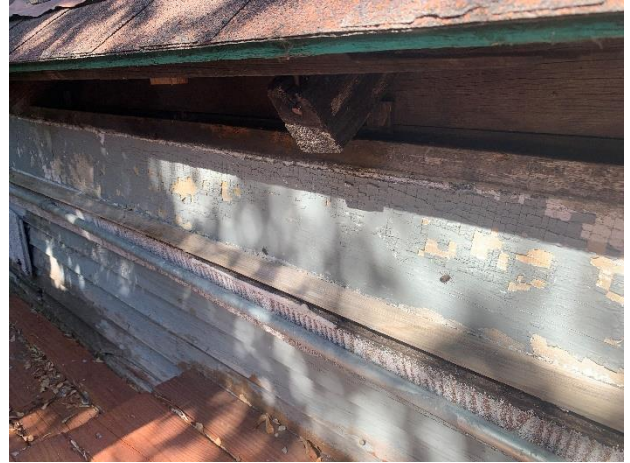
Siding  
Upper Porch

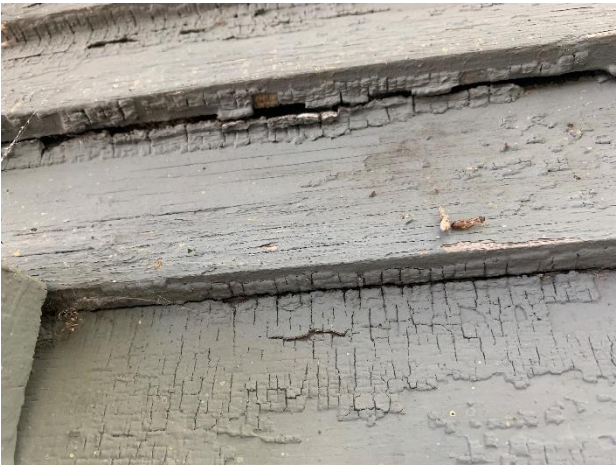
Typical Siding  
Exterior

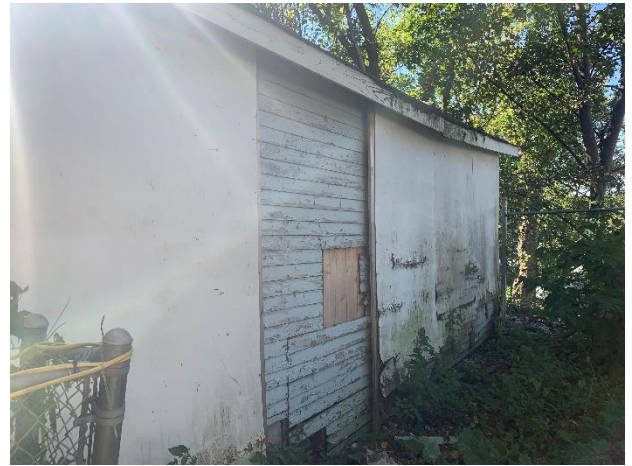
Siding  
Garage

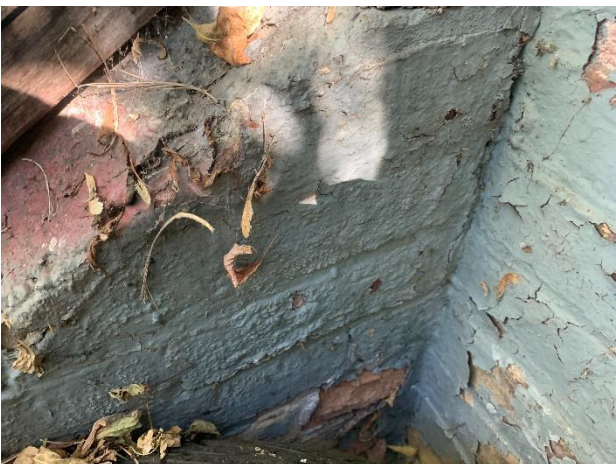
Foundation, Basement Entry Hatch  
Exterior Side C

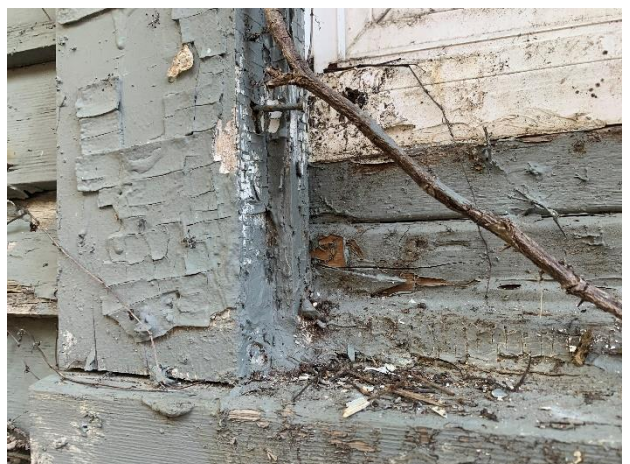
Typical Window Casing, Sill  
Exterior

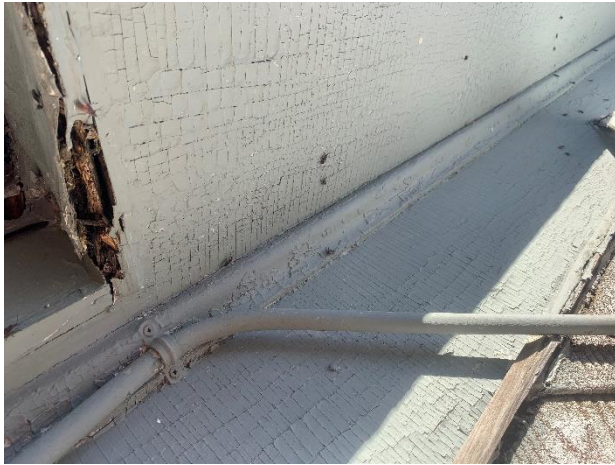
| <b>Soffit</b> | <b>Wood</b> | <b>D</b> | <b>Deteriorated</b> | <b>Gray</b> | <b>Second</b> | <b>Positive</b> | <b>3.87</b> |
| <b>Frieze Board</b> | <b>Wood</b> | <b>D</b> | <b>Deteriorated</b> | <b>Gray</b> | <b>Second</b> | <b>Positive</b> | <b>3.46</b> |

Soffit, Frieze Board  
Exterior

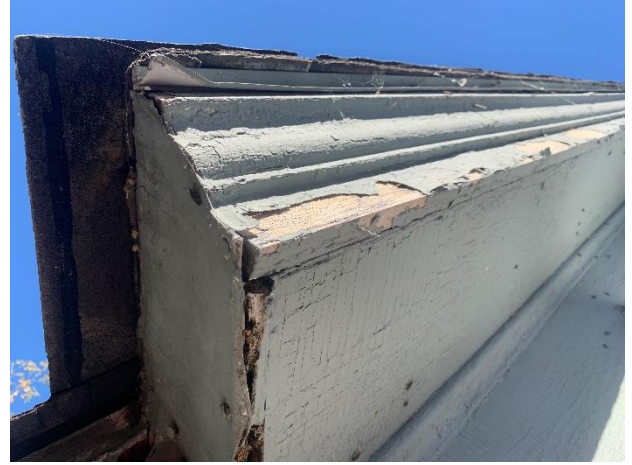
| <b>Fascia</b> | <b>Wood</b> | <b>D</b> | <b>Deteriorated</b> | <b>Gray</b> | <b>Second</b> | <b>Positive</b> | <b>2.34</b> |

Fascia, Soffit  
Exterior

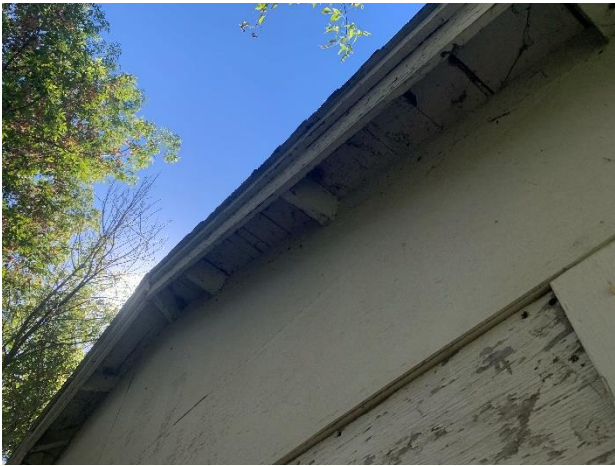
Soffit, Fascia  
Garage Side A

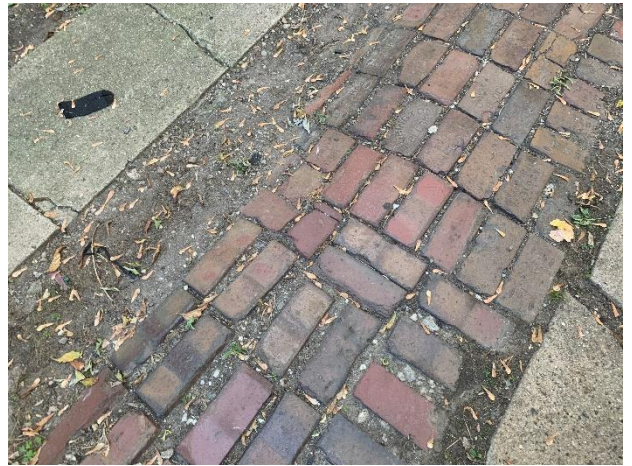
Bare Soil  
Driveway Side B

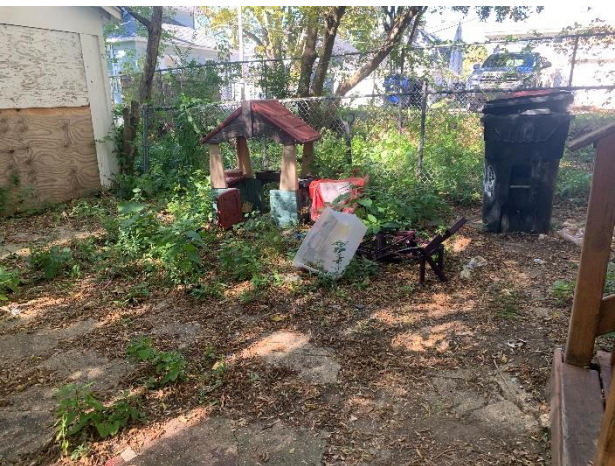
Bare Soil  
Backyard/Play Area Side C

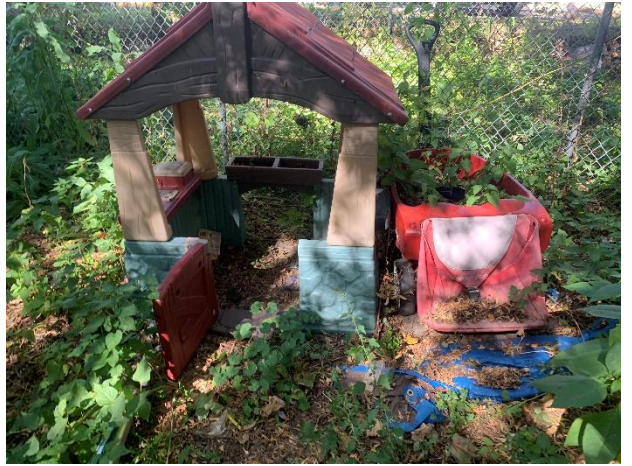
Bare Soil  
Backyard/Play Area Side C
