# *Top Choice Home Inspections*

## Property Inspection Report

E6993 Cty. Rd. Y, Viroqua , WI 54665

Date of Inspection: 4/14/2026 Time: 9:00 a.m.

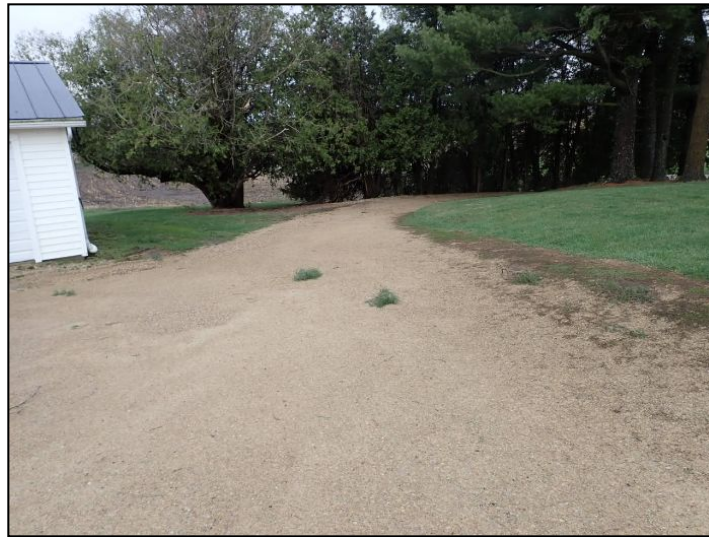
- Gravel driveways need occasional maintenance. Monitor periodically and repair as needed.

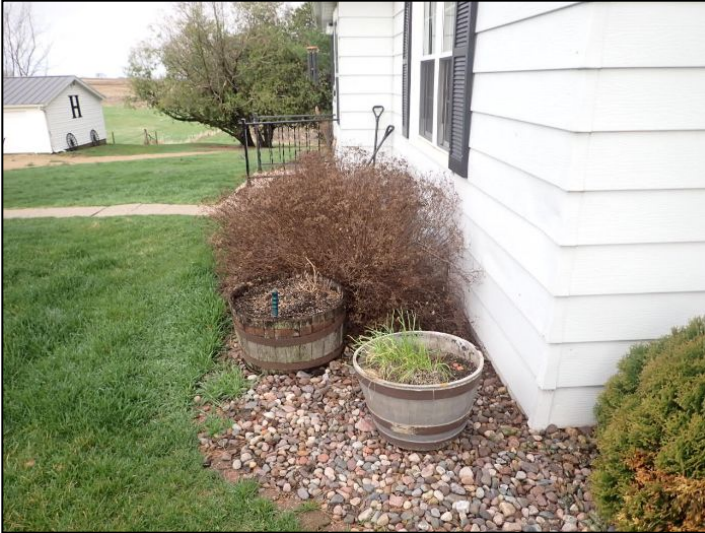
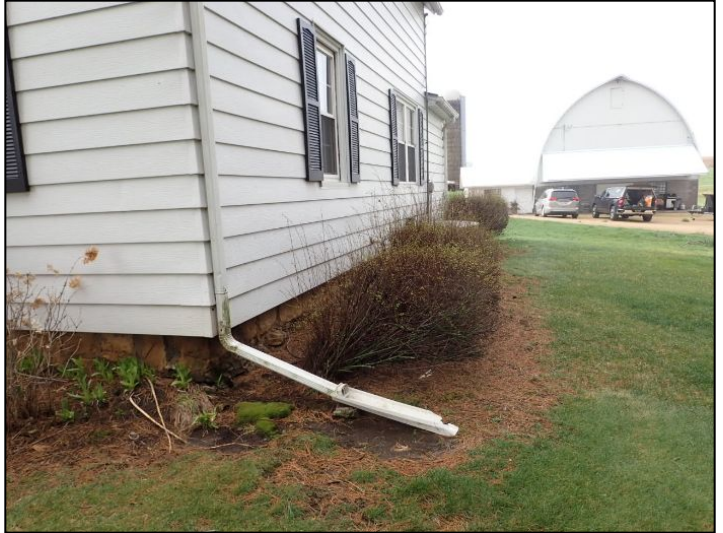
- Recommend tree branches and vegetation are kept trimmed away from the house. Vegetation can hold excess moisture against the house, possibly causing damage to the sheathing below the siding and/or making a pathway for insects. Tree branches can deposit debris on the roof which can shorten the roof covering life or cause physical damage to the roof. This will be a recurring maintenance item.

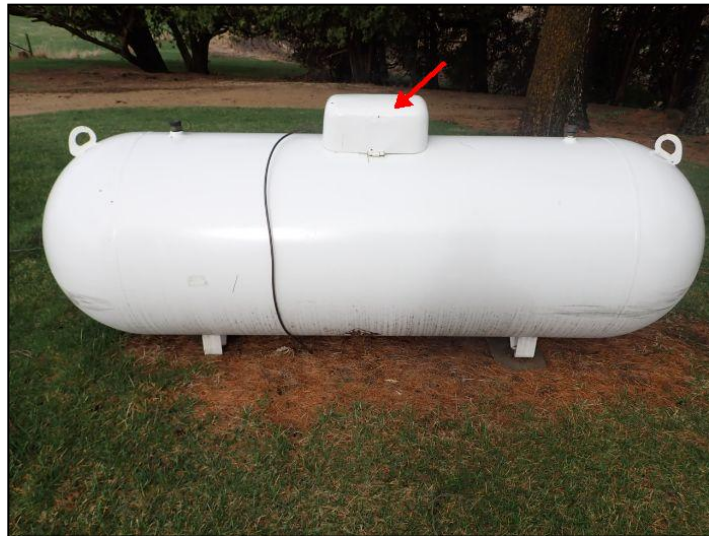
- The main shut off valve for an L.P. tank is under the lid. Care should be used when lifting the lid in warmer weather, as bees often build nests within the lid.

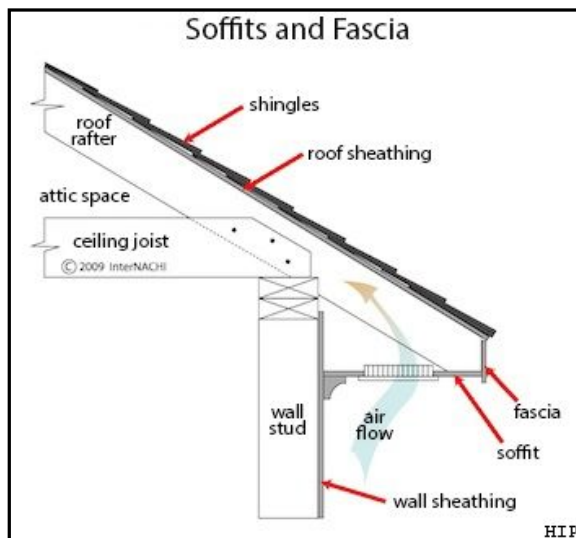
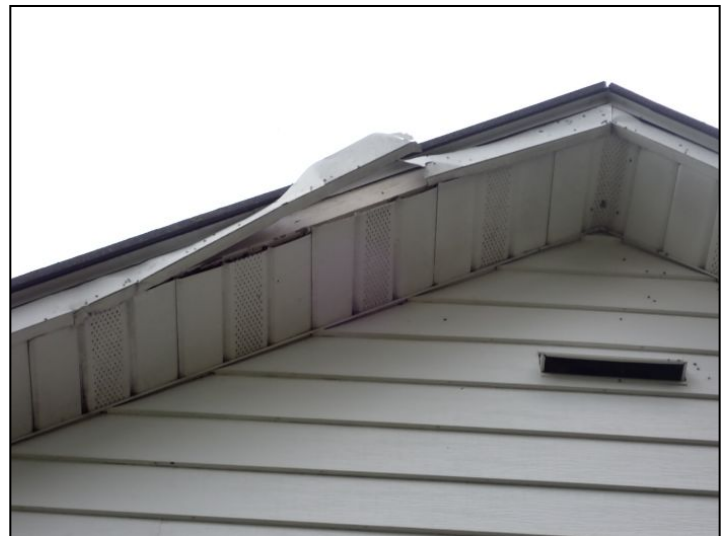
• The soffit/fascia was loose on the north side. Recommend reattaching to help prevent storm water intrusion.

| Exterior Areas | | |
|---|---|---|
| Page 6 Item: 3 | Fascia and Soffit Observations | • The soffit/fascia was loose on the north side. Recommend reattaching to help prevent storm water intrusion. |

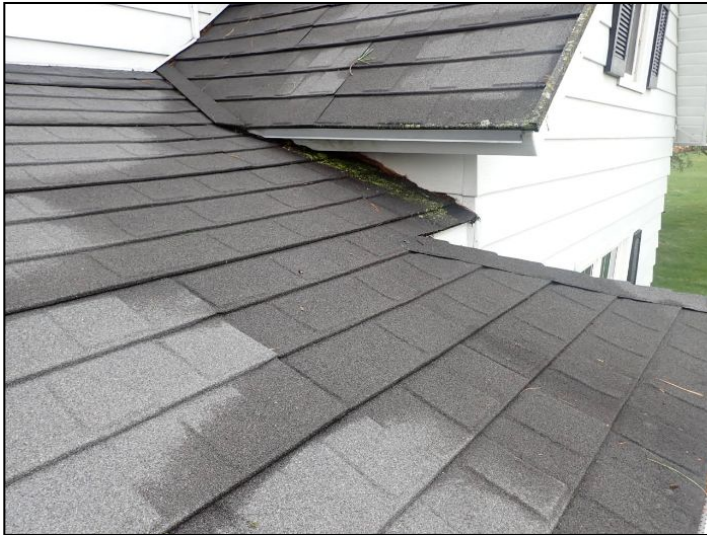
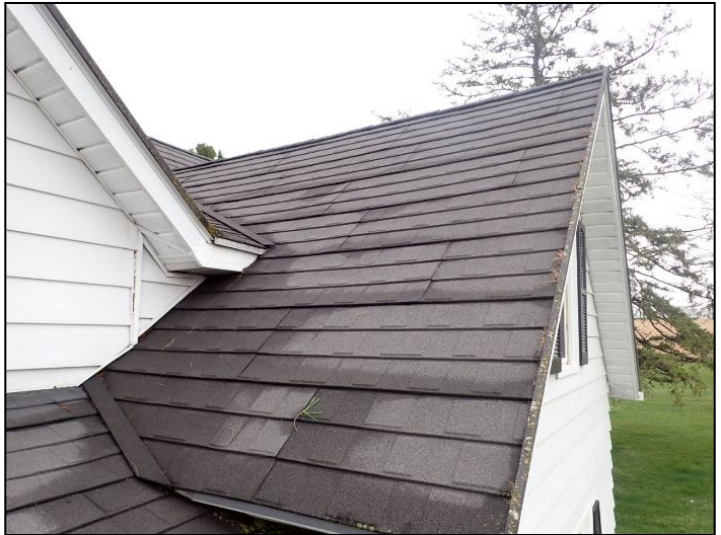
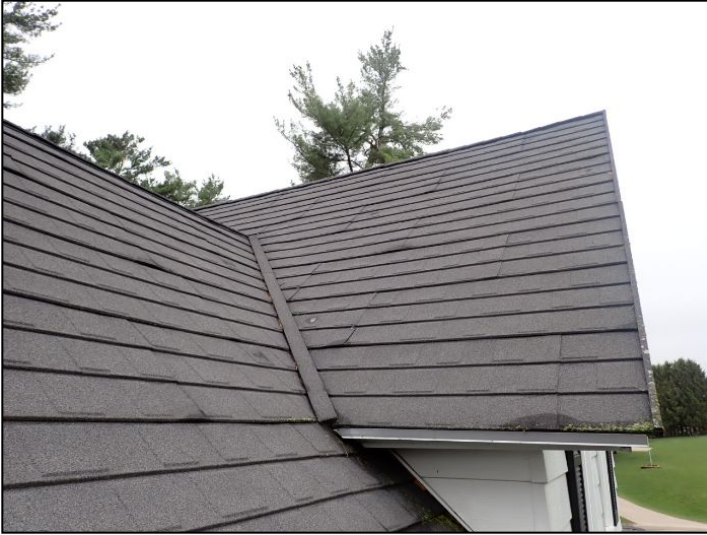
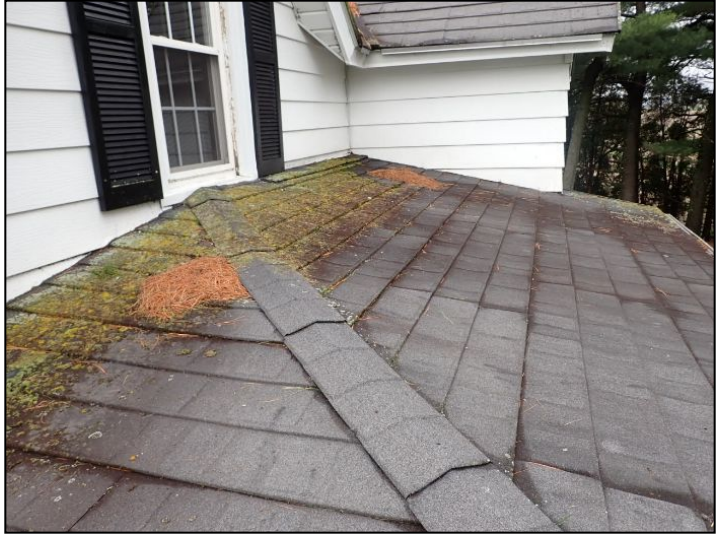
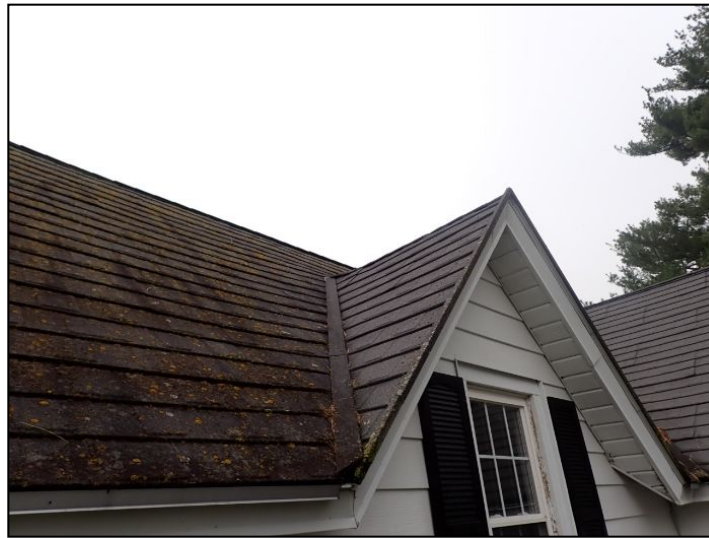
- The first pictures show the general roof condition (a visual of what we saw the day of the inspection, if you will), and not necessarily highlighting any issue.
- Moss was noted on the roofing. This can lead to the premature failure of the roof and subsequent leaks. Recommend treating moss during its growing season (wet months) with a moss killer. For information on various moss treatment products and their pros and cons, visit <http://bryophytes.science.oregonstate.edu/page24.htm>. The moss can be from excess shade/exposure side, trees/vegetation too close or a combination. Recommend correcting as much as possible. Cleaning these areas may be a periodic maintenance item.

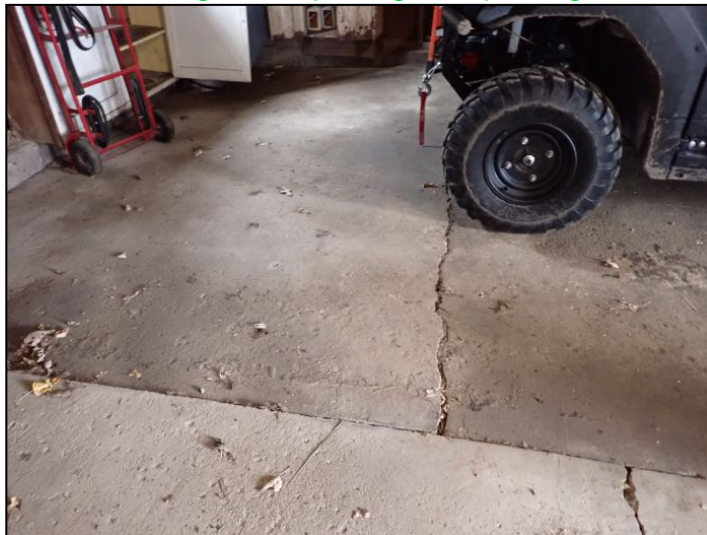
• Cracking was noted in the garage floor. Cracks more than 1/8th" could present a trip area. Recommend monitoring and repairing or replacing if ever needed.

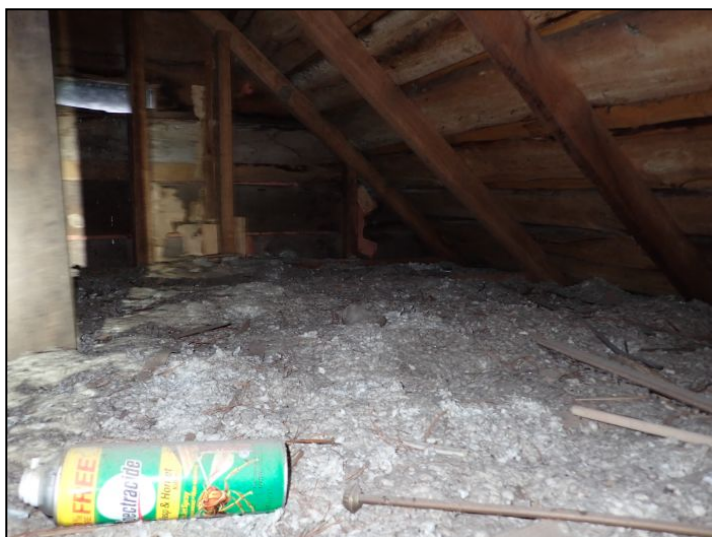
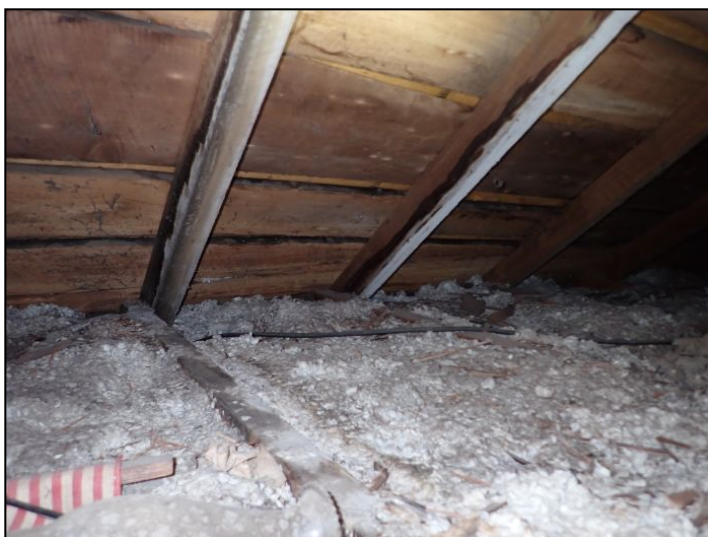
- The pictures show the general condition (a visual of what we saw the day of the inspection, if you will) of the attic insulation, and not necessarily highlighting any issue.
- Recommend considering the addition of more insulation in the attic area. Check local standards for insulation requirements in new construction if interested, but standard energy efficiency is reported to be at least R-50 and high energy efficiency is reported to be at least R-60 in the attic.

| Exterior Areas | | |
|---|---|---|
| Page 12 Item: 3 | Insulation Condition | • Recommend considering the addition of more insulation in the attic area. Check local standards for insulation requirements in new construction if interested, but standard energy efficiency is reported to be at least R-50 and high energy efficiency is reported to be at least R-60 in the attic. |

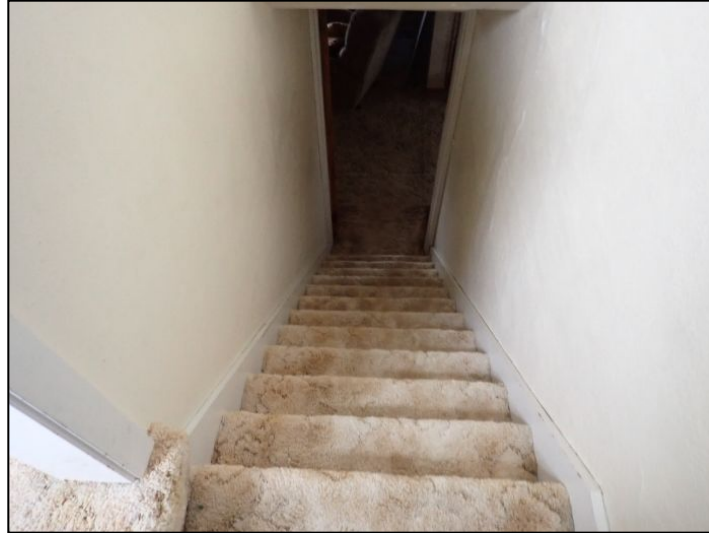
- Recommend adding a proper, graspable handrail to the stairway for added safety.

| Exterior Areas | | |
|---|---|---|
| Page 13 Item: 7 | Railing and Handrail Observations | • Recommend adding a proper, graspable handrail to the stairway for added safety. |

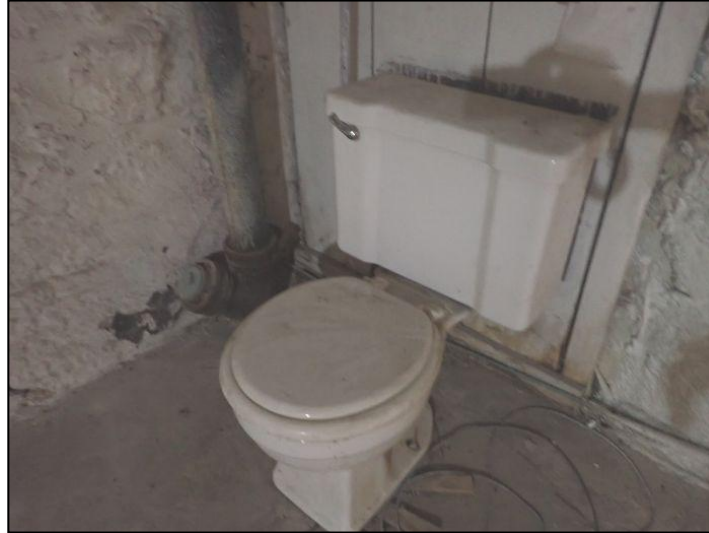
- The toilet in the basement wasn't filling the tank. Recommend repair or replacement as desired/needed.

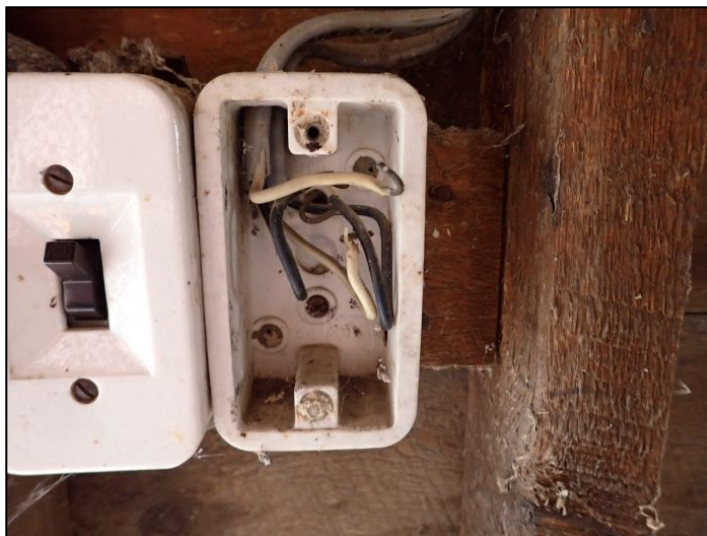
- Any junction boxes should have properly fitted cover plates for added safety. The picture is from the garage.

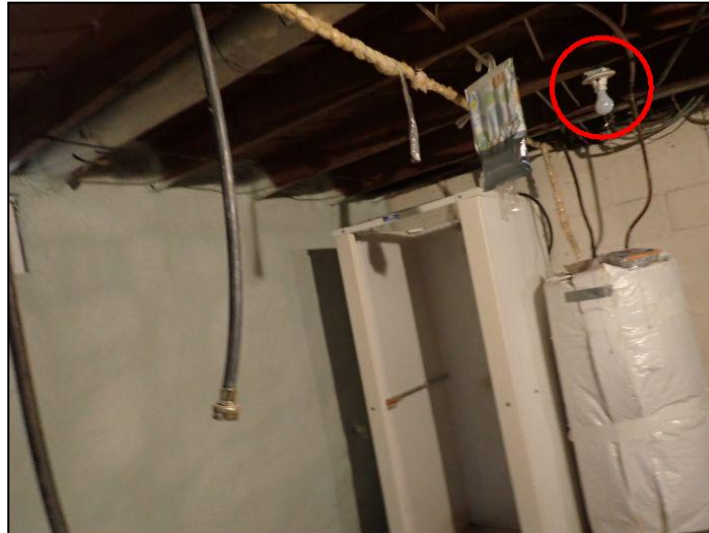
- The light near the water heater in the basement was inoperative at the time of the inspection. Sometimes the cause is as simple as a blown light bulb, but it is also possible the correct light switch was not found. Recommend consulting the current owner for more information and if needed, repairing as needed.

| Page 17 Item: 11 | Light Observations | <ul style="list-style-type: none"> <li>• The light near the water heater in the basement was inoperative at the time of the inspection. Sometimes the cause is as simple as a blown light bulb, but it is also possible the correct light switch was not found. Recommend consulting the current owner for more information and if needed, repairing as needed.</li> </ul> |

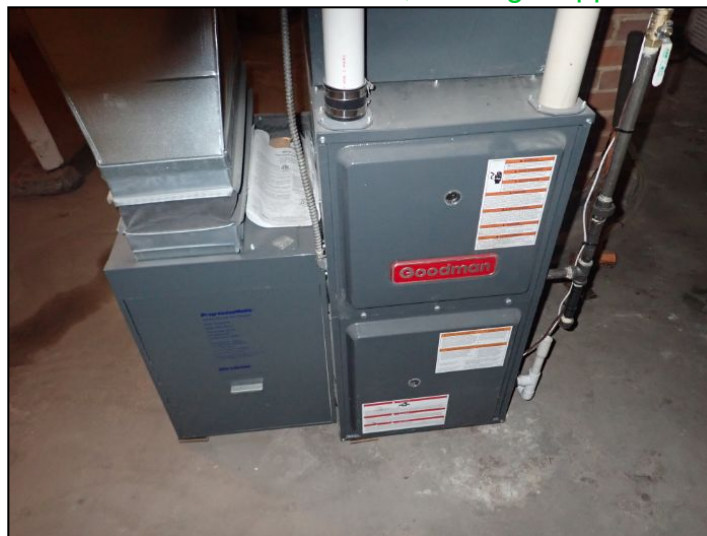
- **Maintenance:** Annual service of the heating system by a qualified HVAC technician is recommended.
- The furnace was running throughout the time of the inspection and it appeared to run properly during that time.
- If the serial number is being deciphered correctly the furnace was manufactured in 2022 and the recorded installation date was 2022, making it approximately 4 years old.

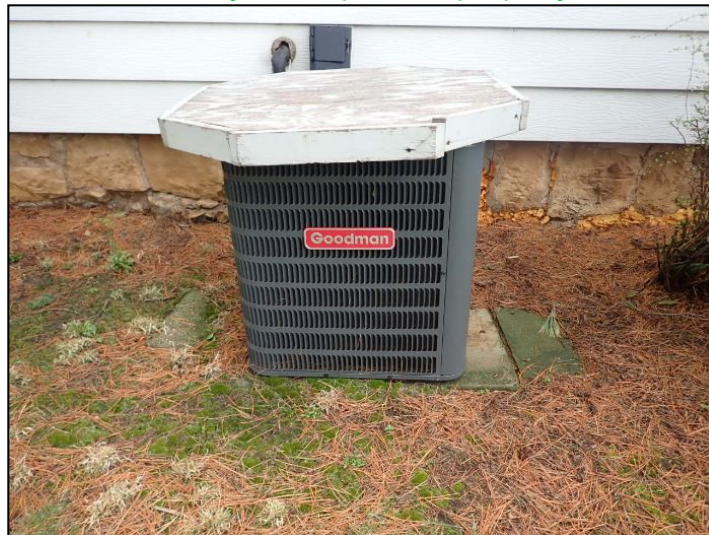
- **Maintenance:** Annual service of the air conditioning system by a qualified HVAC technician is recommended.
- If the serial number is being deciphered correctly the outside unit of the air conditioning system was manufactured in 2022, making it approximately 4 years old.
- The air conditioning system was not tested during the inspection as the room temperature was 64F and the cooling side of the thermostat would not go that low to be able to operate the system (not unusual or an issue). Recommend the current owner is consulted for confirmation the system operates properly.

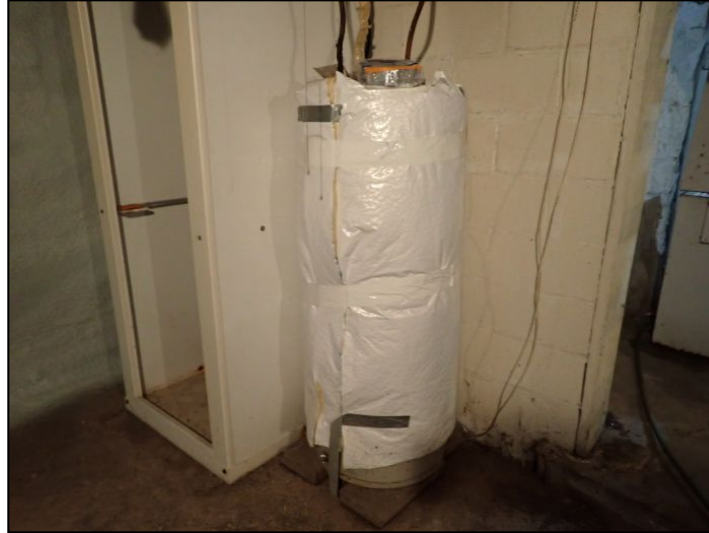
- If the serial number is being deciphered correctly, the water heater was manufactured in 1997, making it approximately 29 years old.
- Water heaters have a typical life expectancy of approximately 12 to 14 years. The existing unit appears to be approximately 29 years old. One cannot predict with certainty when replacement will become necessary.

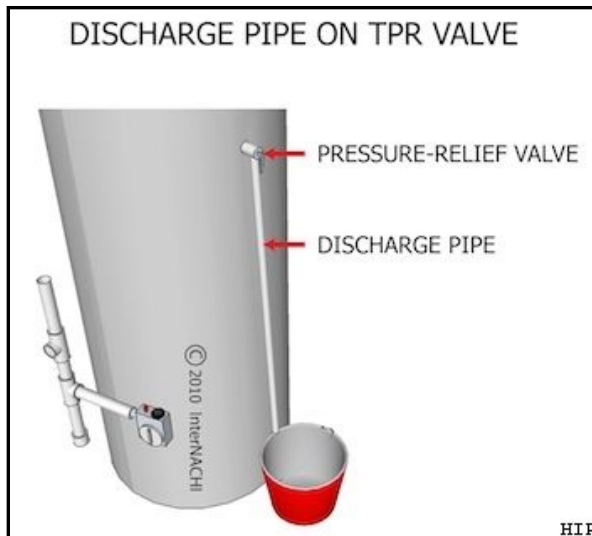
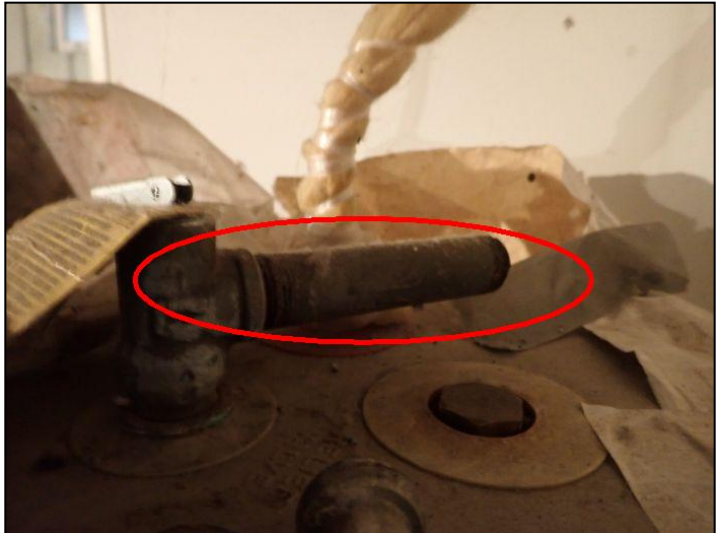
- No relief valve extension was installed. Recommend adding the extension to terminate no more than 6" above the floor for added safety. Temperature and pressure relief valves are factory set to trip at 210 degrees F and could easily scald someone nearby.

| Page 22 Item: 4 | Extension Observations | <ul style="list-style-type: none"> <li>• No relief valve extension was installed. Recommend adding the extension to terminate no more than 6" above the floor for added safety. Temperature and pressure relief valves are factory set to trip at 210 degrees F and could easily scald someone nearby.</li> </ul> |

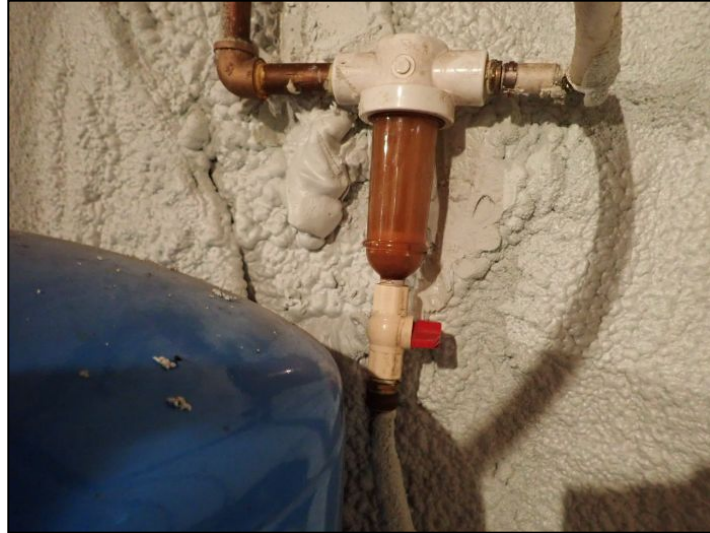
• **Maintenance:** The "spin down" water filter will need flushed periodically. Frequency will vary according to water usage and the amount of sediment in the water system. This type of filter contains a screen which is replaceable, but typically flushing the sediment from the filter is all that is needed.

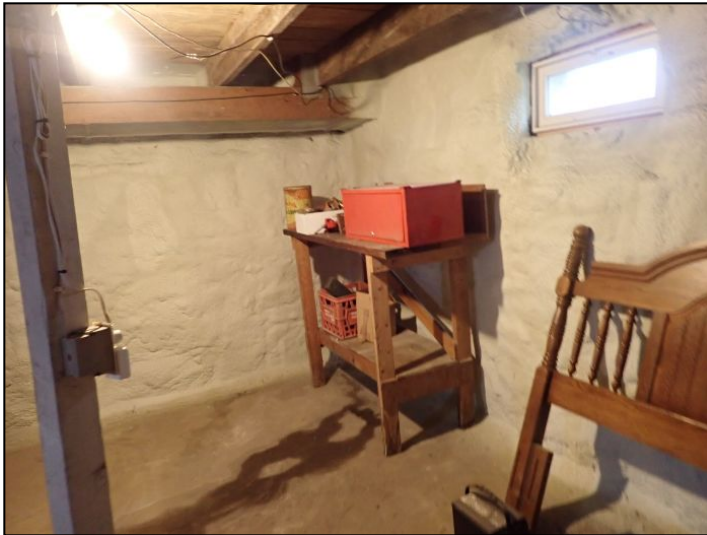
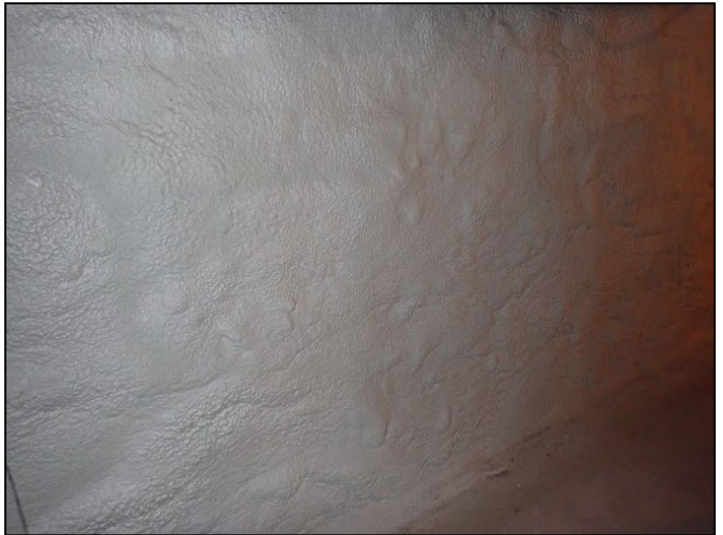
- The basement shows evidence of moisture penetration or seepage. Often, basement seepage is the result of storm water penetration and can be relatively common in an older stone foundation. Recommend ensuring proper grading and properly functioning gutters and downspouts exist as a first step. The grading should slope away from the house at a rate of 1 inch per foot for the first 10' (where possible) from the house and the downspouts should direct storm water at least 6' away from the house and should be clear of obstruction.
- Spray insulation was noted, so most of the foundation walls were not directly visible.

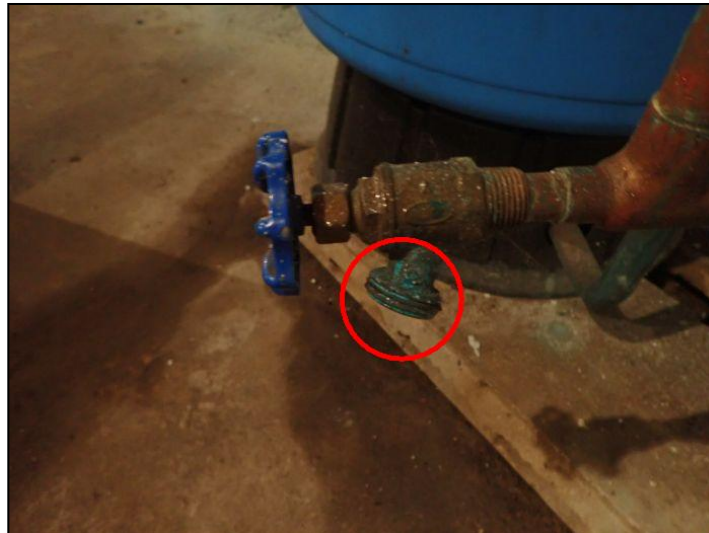
- The sampling valve at the pressure tank should not have hose threads on the end and it should be replaced with a proper sampling valve.

| Page 28 Item: 1 | Well Observations | <ul style="list-style-type: none"> <li>• The sampling valve at the pressure tank should not have hose threads on the end and it should be replaced with a proper sampling valve.</li> </ul> |

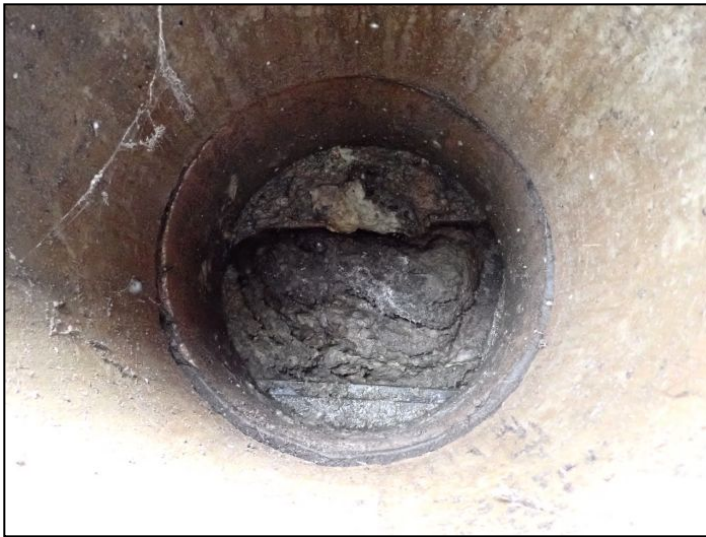
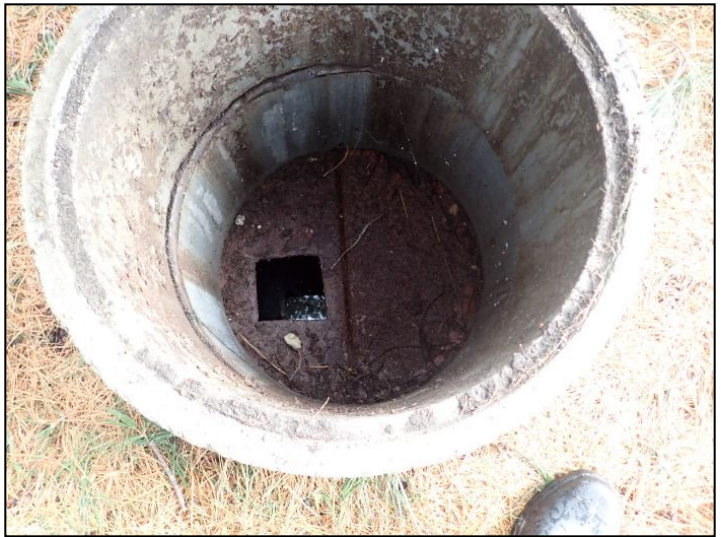
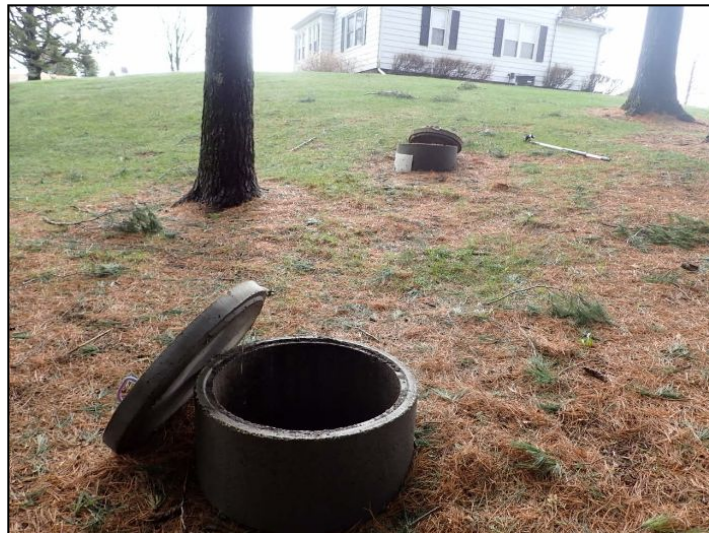
- It was noted that the septic tank appears to be metal. Most counties will allow metal tanks, but the tank needs to be water tight. A pumper would need to completely empty the tank and examine it empty, to determine if the tank is water tight.
- The liquid (effluent) level in the septic tank measured more than 1/3 solids so the tank needs pumped. The State of Wisconsin requires the tank to be checked by a professional a minimum of once every 3 years and when the solids level reaches 1/3, the tank is to be pumped. The measured solids level during the inspection was approximately 50%.
- The exposed septic tank lids need chains on each side, going through the handles and meeting in the middle with a lock joining the chains.
