## Structural Inspection Report

| Property Inspected | |
|---|---|
| Address: 3428 S. 119 <sup>th</sup> Street, West Allis, WI 53227 | |
| Inspection Date: 11/14/2018 | Report Date: 12/13/2018 |

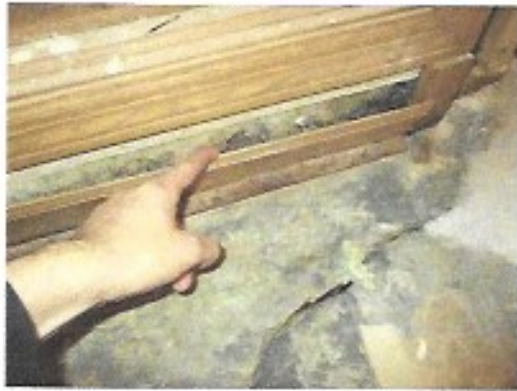
The carpeting and drywall was removed to reveal a large vertical crack on the south wall of the office. In addition, I observed what appears to be mold on the west office partition wall (below).

3. The vertical crack has been patched at least three times and was likely patched prior to the finishing of the basement in 1995. Based on the observed appearance of mold, it is my opinion that there has been water infiltration for some time.

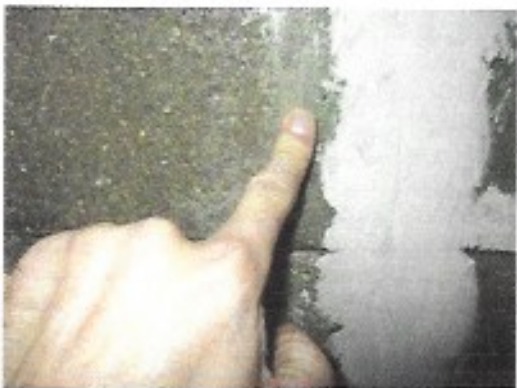
The vertical crack was patched. I did observe at least two other older patches to this crack.

1. The fundamental cause of the vertical crack in the office is excess moisture in the soil, and the subsequent expansion, especially frost expansion. This was caused by poor grading near the house, settled concrete, perhaps combined with poor maintenance (such that the gutters became clogged and over-flowed) allowing excess moisture near the house.

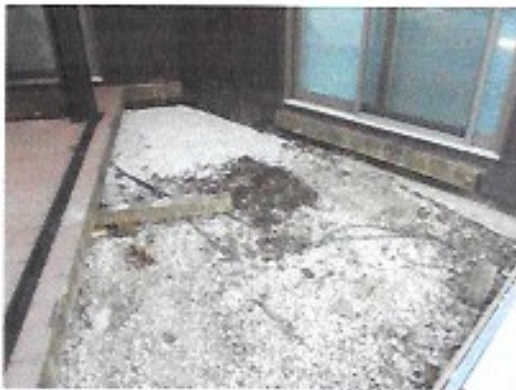
The homeowner hired Accurate Basement repair to install new interior drain tile along the southern portion of the basement. A second sump crock and pump were also installed. In addition, the south office wall was excavated, waterproofed, and backfilled with stone.

2. The steps taken to excavate, waterproof, and backfill the wall with stone will alleviate the pressure on the wall and significantly reduce the likelihood of future cracking and seepage. The new interior drain tile will also manage any water that may get into the basement.

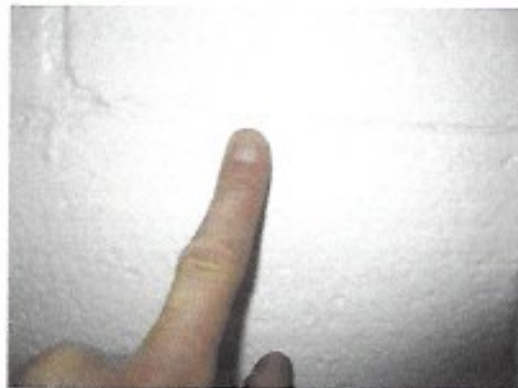
The north wall is completely covered. Most of the south wall abuts the garage. This portion of the wall is crack free. This wall is off plumb  $5/8"$ .

The other section of wall abuts exterior soil. I did observe cracks filled with caulk; the patching and paint appears new. This portion of the wall is off plumb  $3/8"$ .

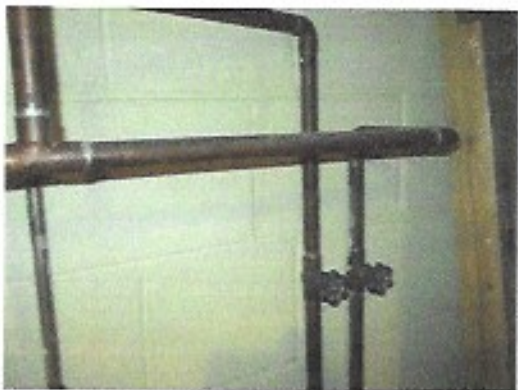
Most of the west wall is also covered. A small area is visible and contains small vertical and step cracks. The wall is tipped out  $5/16"$  at this location. A small area at the NW corner is also visible. This area is crack free. The sump pump is located at this corner and was functional at the time of the inspection. The float level is incorrect.

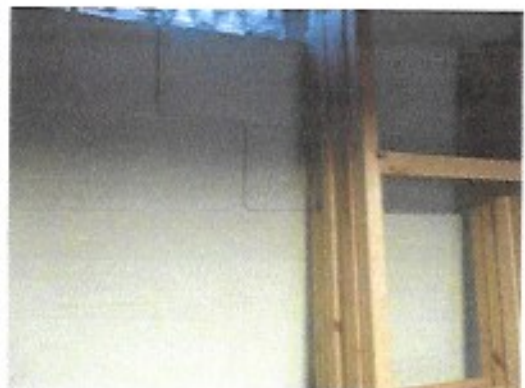
The east wall is mostly covered with the exception of a small area in the mechanical room. This wall contains a step crack and is tipped out  $1/4"$ .

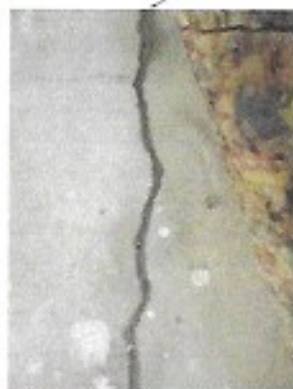
I did observe large cracks in the floor that appeared to be indicative of settlement. The outward tipping of the walls is also indicative of foundation settlement. I set a LASER level on a tripod took several measurements. The measurements vary by 1 5/8".

5. I consider the visible portions of the foundation walls to be stable at this time. No opinion can be made on the covered portions of the walls.
6. There has been some settlement of the foundation although it is my opinion that it has slowed significantly or stopped altogether. It does appear that the site was filled prior to the construction of the home, and there had been some settlement shortly after construction. The fundamental cause of this problem is that the footings were not adequately sized (initially) for the actual soil conditions. The soil conditions very likely included un-compacted fill material, or of an organic materials. The information regarding the materials found during the pool replacement indicated wood was found in the fill under the pool.

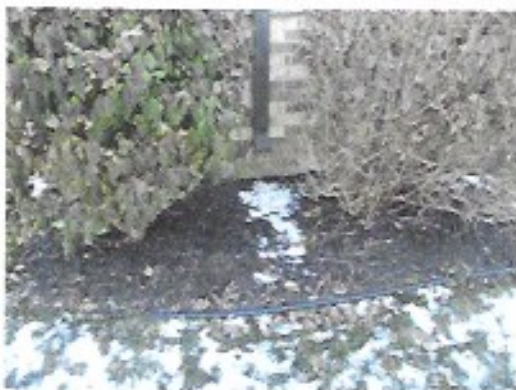
North

On the exterior I did observe areas of flat soil near the house allowing surface water to accumulate near the foundation. I could not observe the grade under the deck.

Note the downspout discharging at the foundation wall.

4. Elsewhere, steps should be taken to improve grade by adding soil so that surface water can effectively drain away from the house. The desired pitch is 6" over 6'. This will require the removal and reinstallation of the mulch. The north downspout should also be extended away from the house.
