# PRO-VIEW, INC.

## HOME INSPECTION REPORT

514 Alverno Rd. Manitowoc, WI 54220

18134

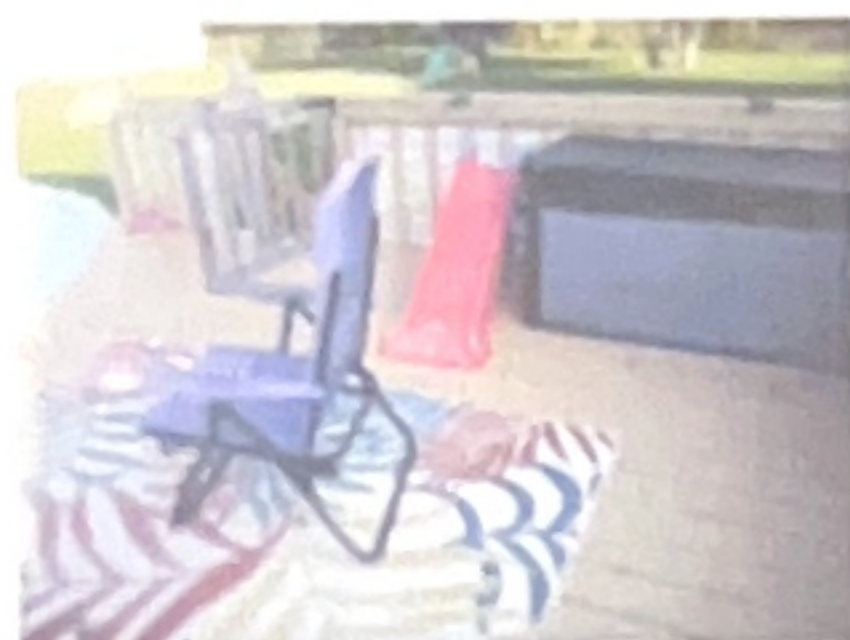
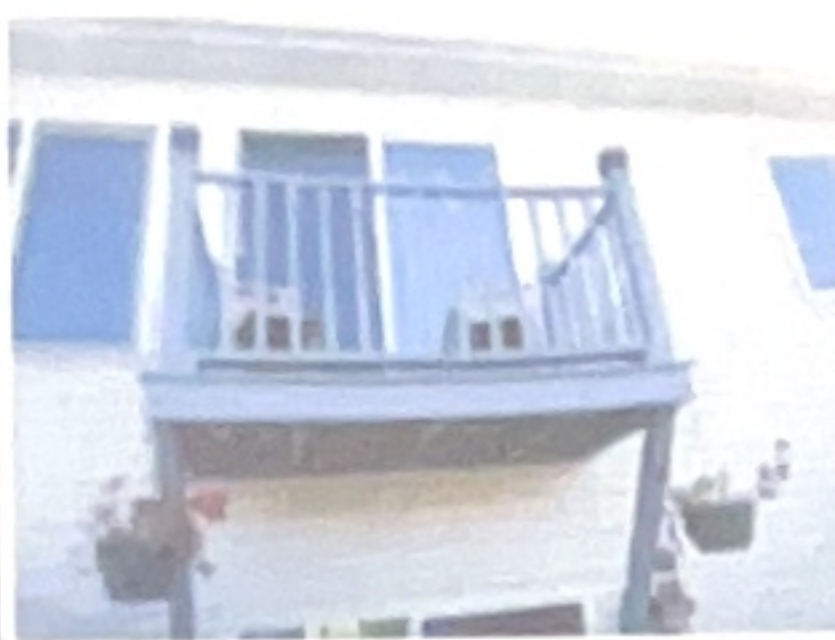
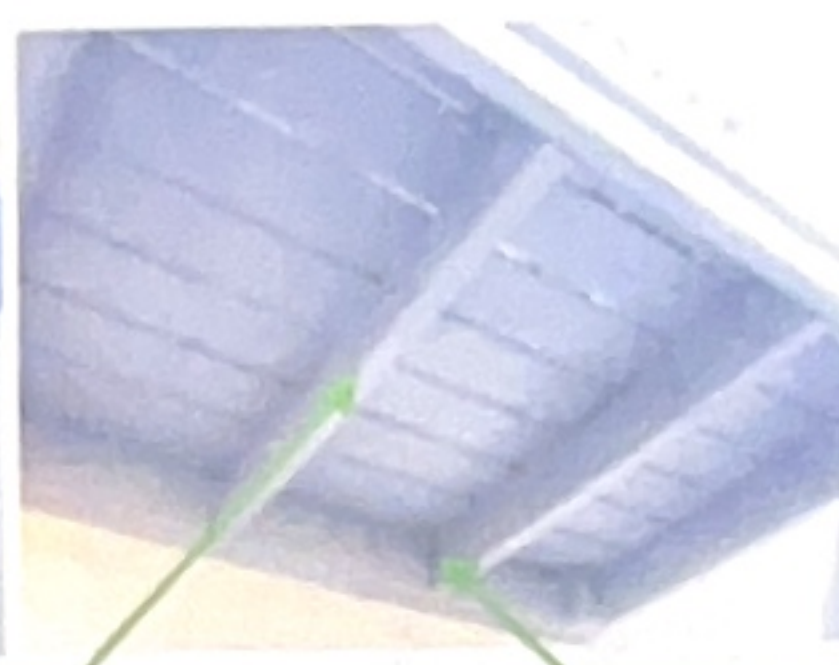
\* this was noted on previous home inspection in 2021 and remains unchanged

Balcony appears to be sagging in the middle. Joist was slightly warped and was pulling away from the ledger board. Recommend evaluation by a certified contractor and support as needed.

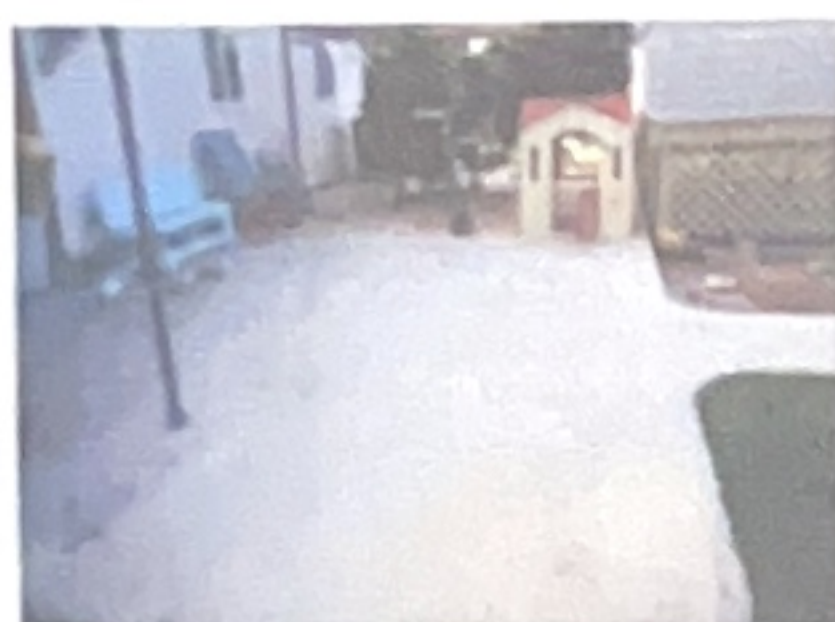
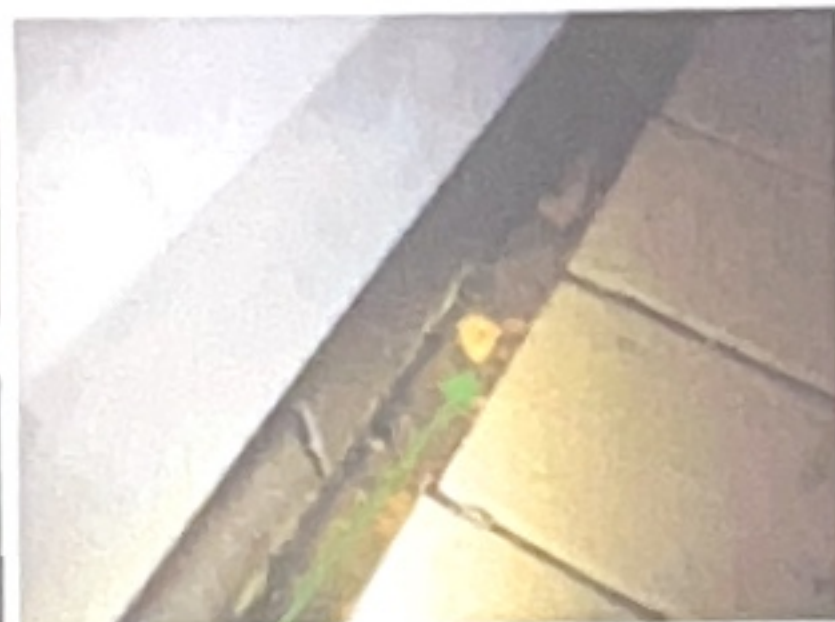
\* this was due to the water softener discharge line, which has since been redirected away from foundation and the area restored with gravel

Standing water between the wood patio and the foundation. Recommend improving drainage as needed.

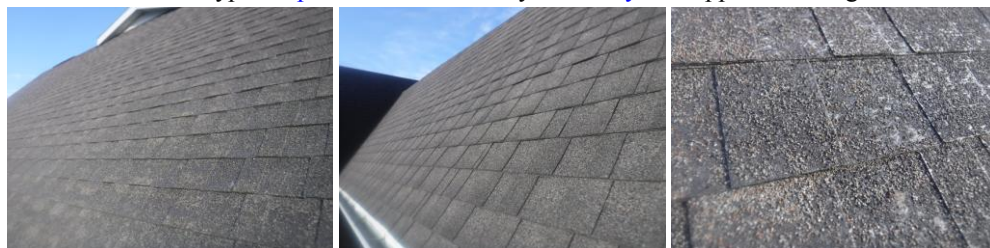
The approximately 25-year-old asphalt shingle roof has areas of granule loss consistent with age and wear. Recommend monitoring the roof condition and budgeting for replacement as needed.

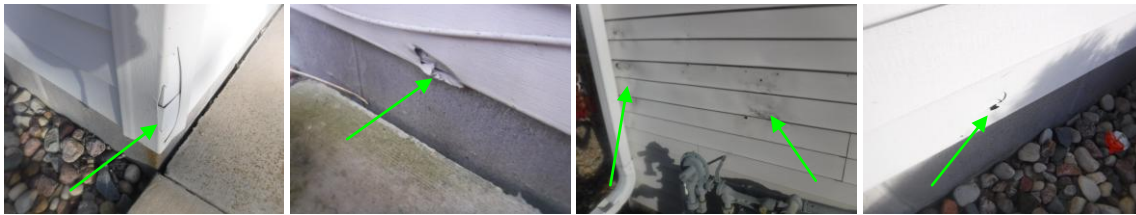
Siding had some minor damage in some areas. Repair as needed.

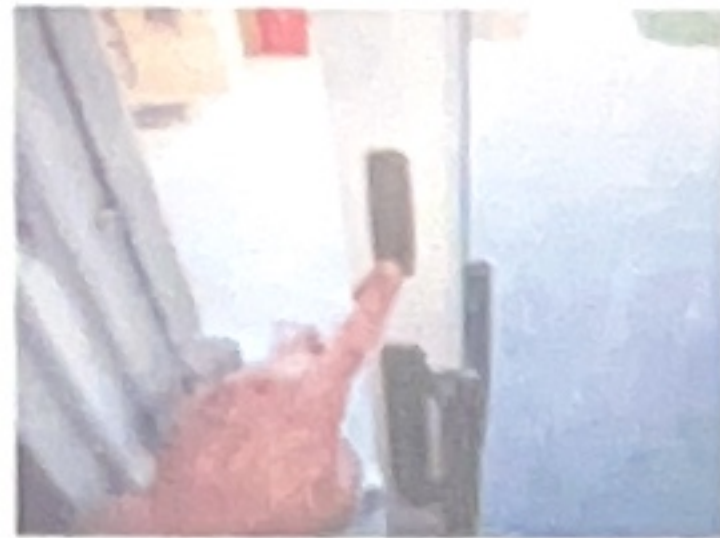
*replaced*

Lock/latch was missing on patio door. Repair as needed.

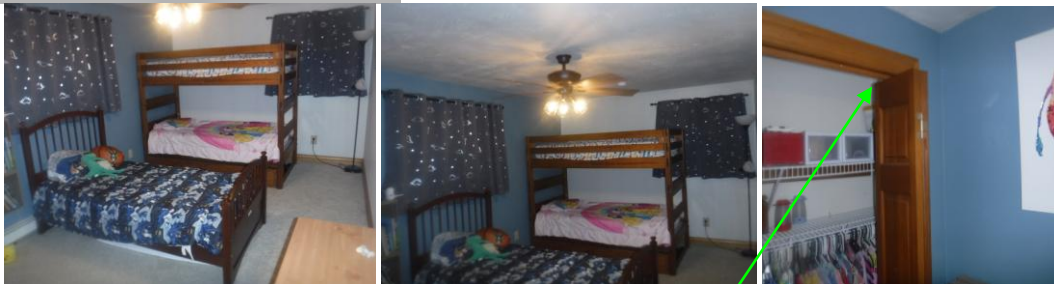
Folding closet door appeared jammed in its track and would not close.

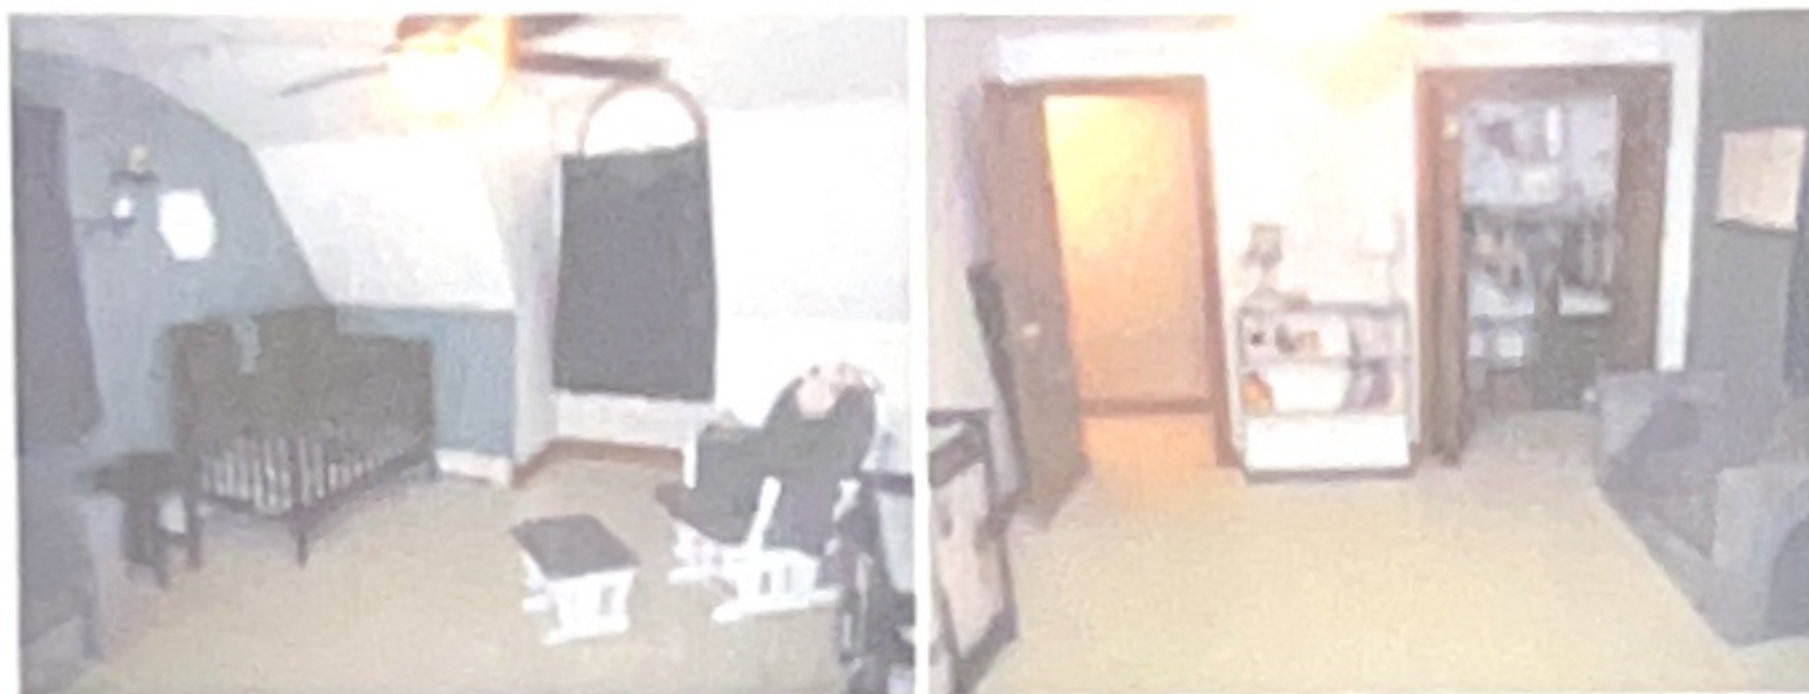
Folding closet door appeared jammed in its track and would not close.

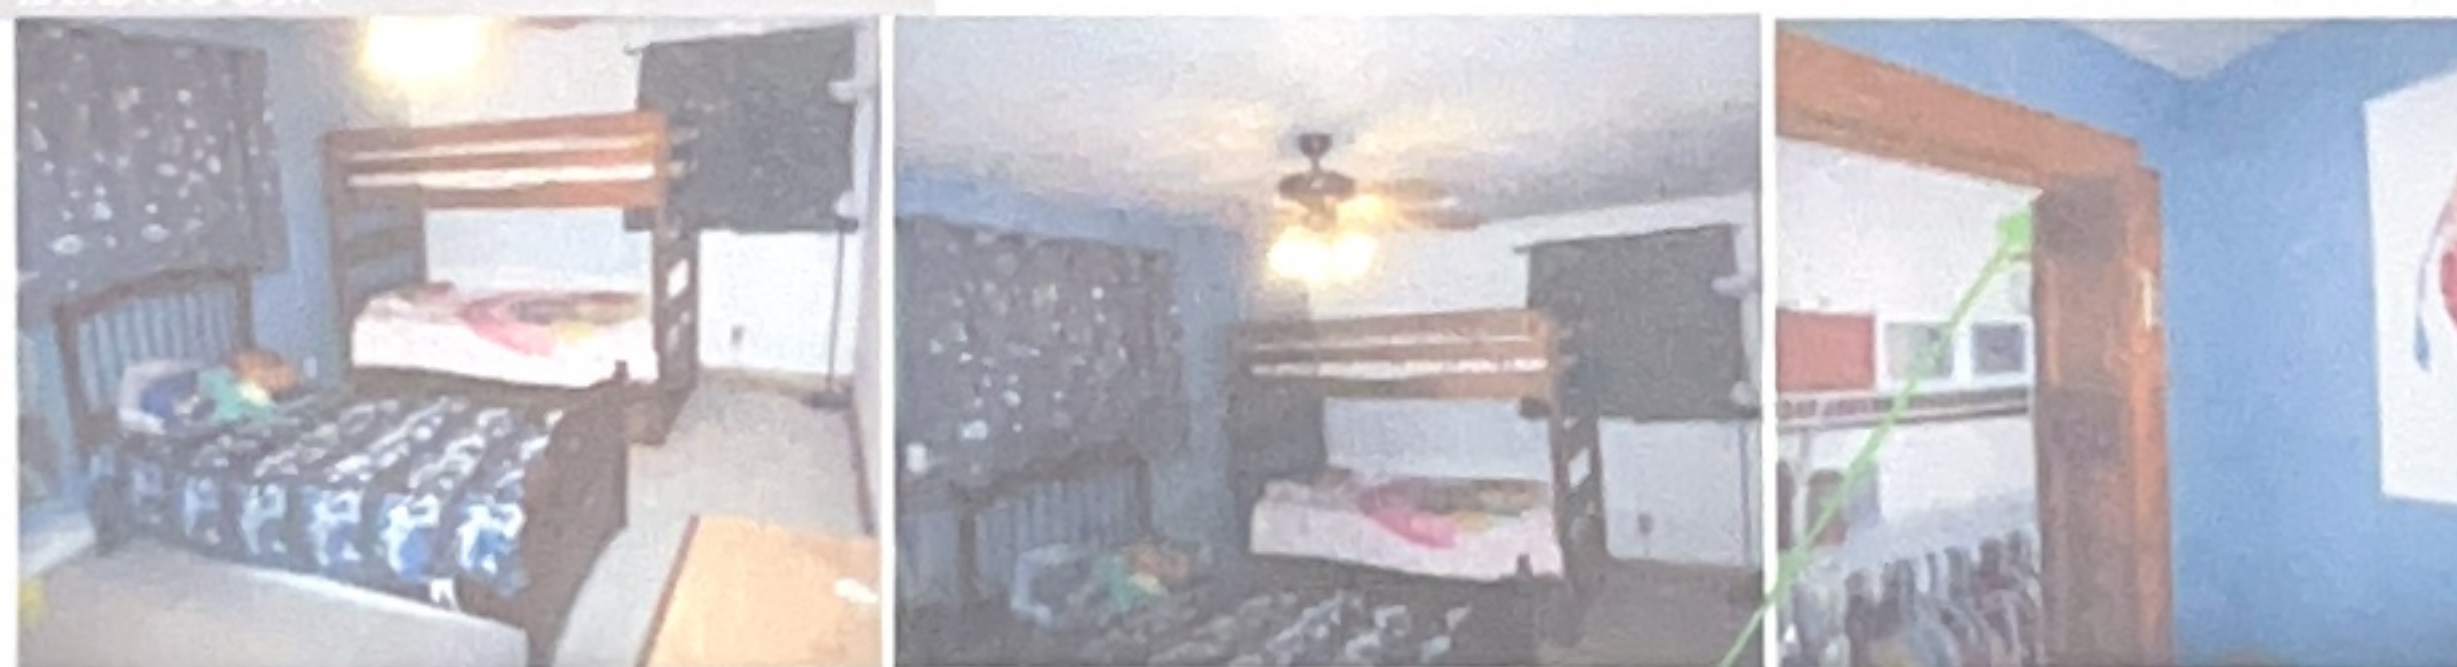
Folding closet door appeared jammed in its track and would not close.

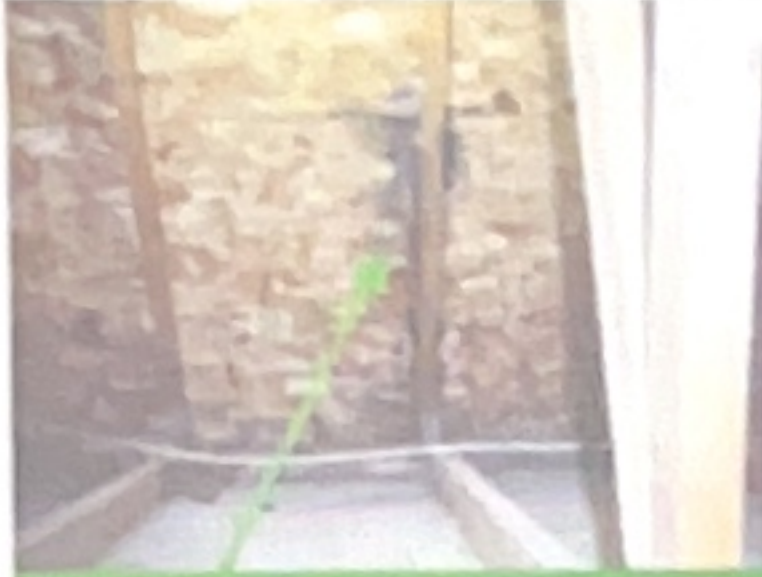
\* this is unchanged from previous home inspection in 2021

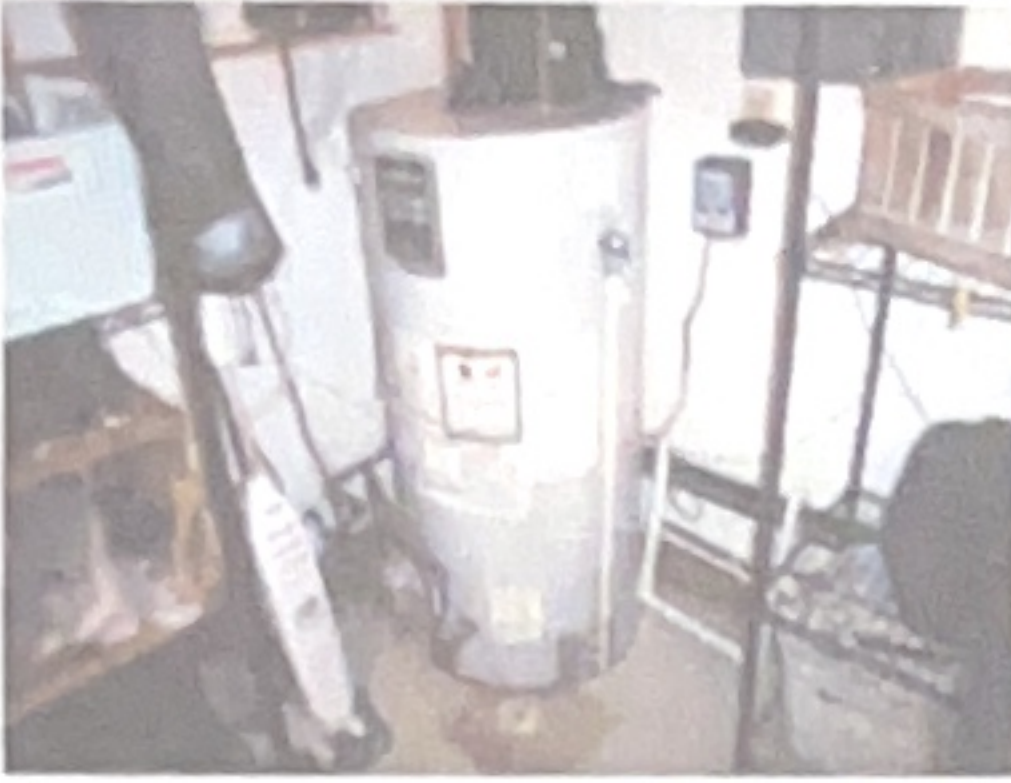
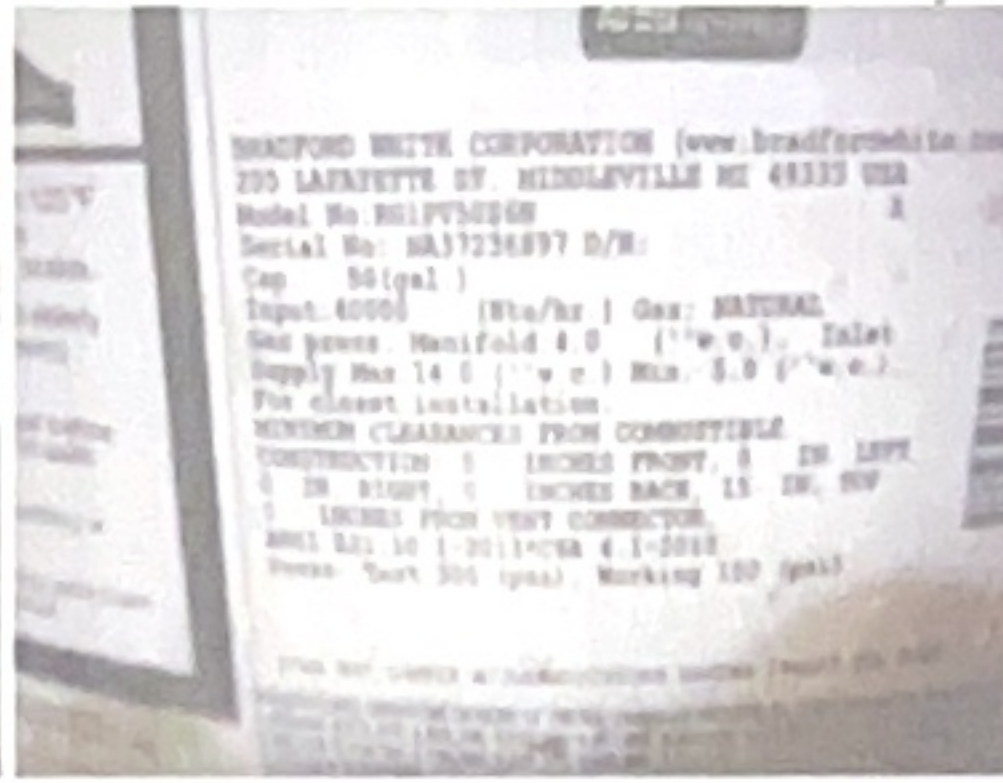
\*We just had this looked at and it is functioning well, we've never had an issue with hot water

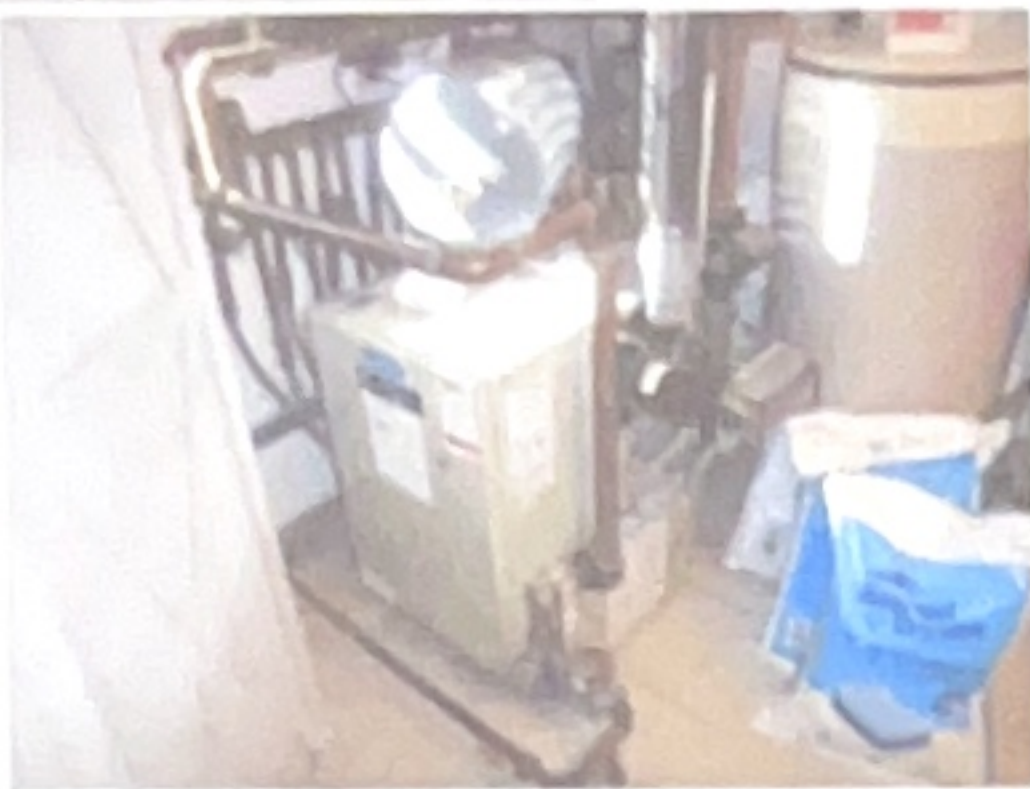
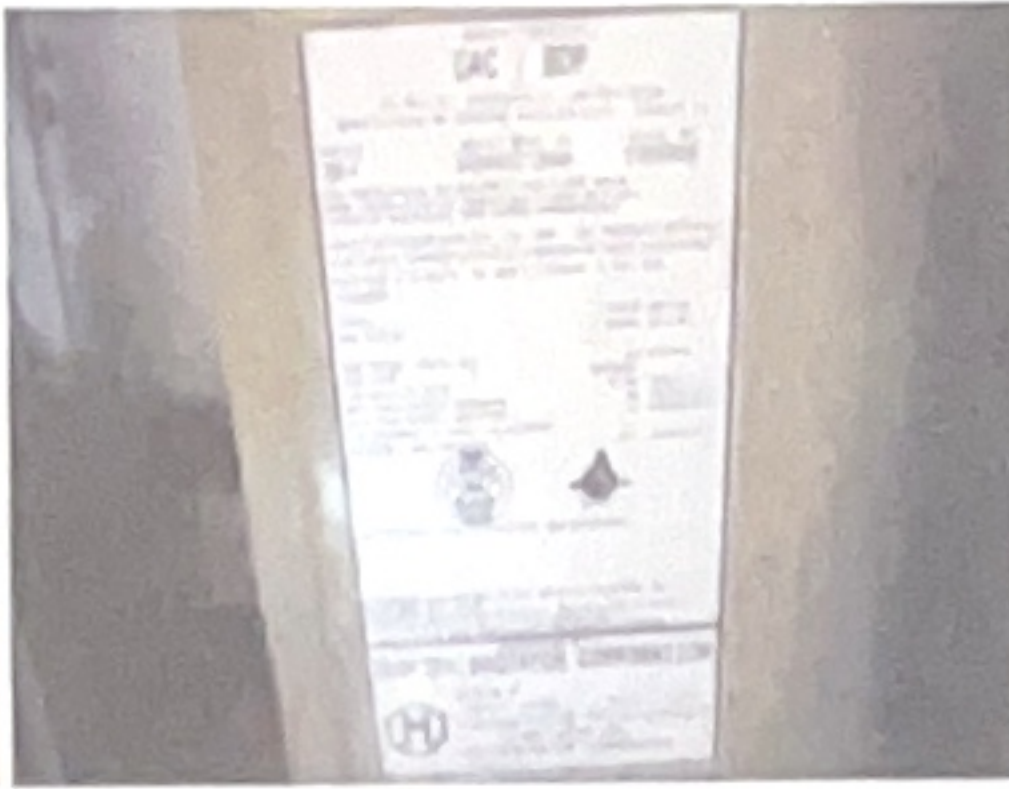
\* we just had this serviced and inspected by Manitowoc Heating and it is functioning well

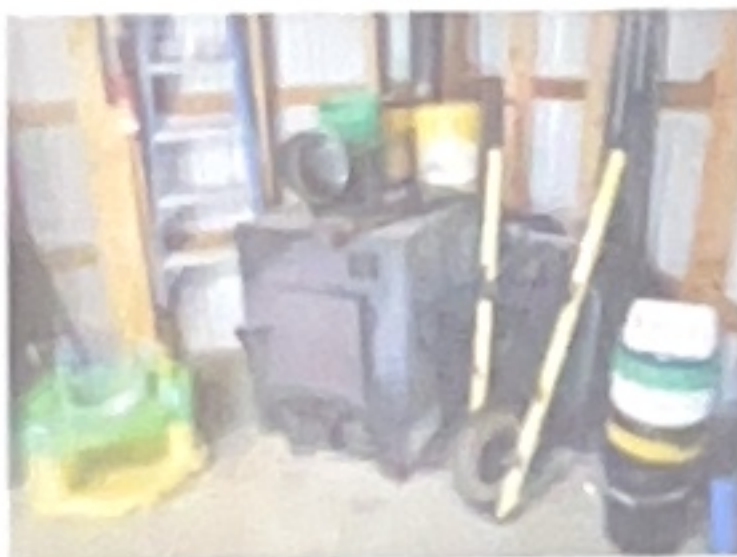
Wood burner in detached garage not tested.
