Proposal for: Geotechnical Engineering Exploration and Analysis  
Burns Residence  
W288 N8053 Park Drive  
Merton, Wisconsin  
Proposal No. 1GP-2602025

Geotechnical Engineering Exploration and Analysis  
Burns Residence  
Merton, Wisconsin  
Proposal No. 1GP-2602025

**PROJECT: Retaining Wall Evaluation for Catherine Burns**  
**W288N8053 Park Drive**  
**Merton, Wisconsin**

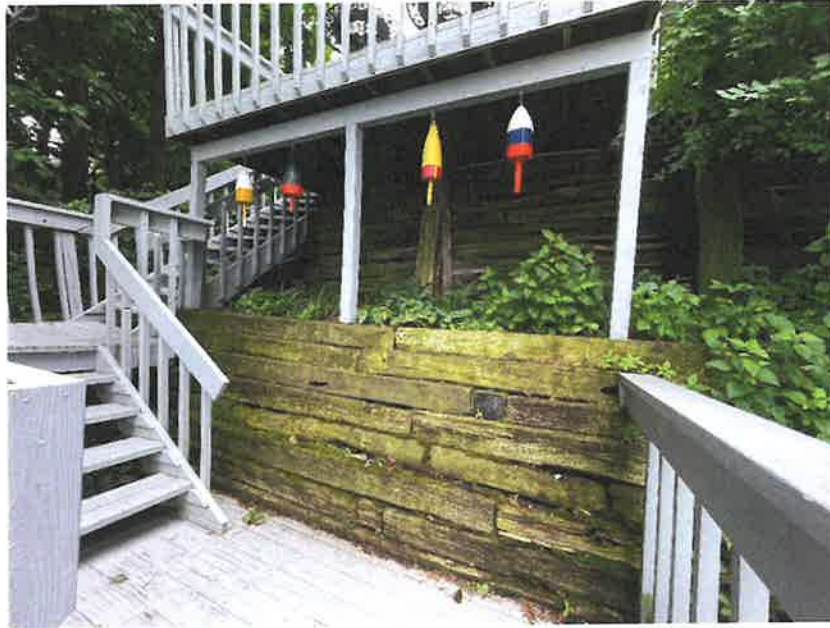
**Photo 4 – Portion of Retaining Wall 1, Looking North from Wood Stairs (Retaining Wall 2 Visible in Beyond)**

**Retaining Wall 1** is the lowest retaining wall. It is constructed out of wood timbers, approximately 8" wide and 6" tall. The timbers are stacked on top of each other, and each timber is set back slightly, so that the wall has a stepped appearance. There are 8 courses of visible timbers, attached with metal "spikes".

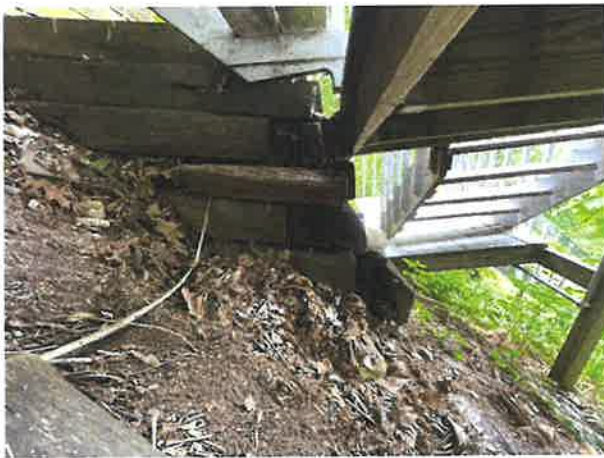
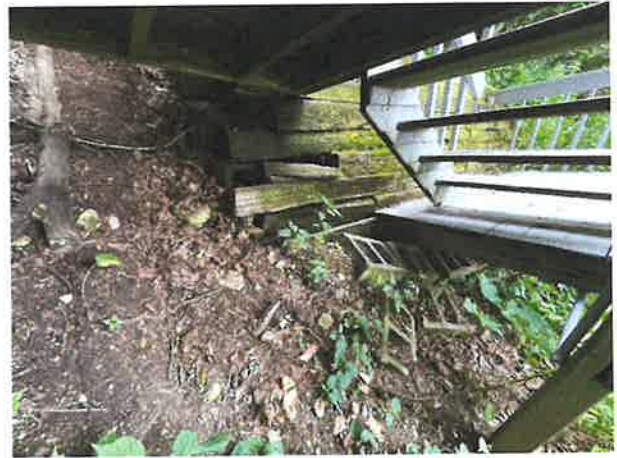
The wood timbers are showing significant signs of deterioration. The wood is green in appearance, and there are large portions that have rotted away. The east end of Retaining Wall 1 is located below the wood stairs. Retaining Wall 1 turns a 90 degree corner and continues south. Several timbers have rotted away completely and/or fallen out of the wall. Several of the remaining timbers show signs of tipping, bulging, and settling. The west end of Retaining Wall 1 is similar, with missing, loose, and failing timbers

**Photo 5 – Retaining Wall 1, East Corner Deterioration**

**Photo 6 – Retaining Wall 1, East Corner Deterioration**

Both of these wood timber walls have deteriorated to the point that they have already experienced local failures, and will continue to fail. They have lost their structural integrity and are no longer serving their intended purpose of retaining the soil on the slope of the property directly north of the house.

1. Hiring a Geotechnical Engineering Consultant to perform soil boring tests, provide a report of findings, and provide recommended corrective measures in the report
1. Hiring an Design Professional (Architect) to assess the existing site conditions and structures, and develop a new site plan. This site plan will coordinate location(s) of new retaining walls, new decks, new stairs, etc. This design professional would also be responsible for designing the new wood decks, stairs, railings, etc. to work with the new retaining walls.

Hiring a Design Professional (Engineer) to design a new retaining wall system for the north slope (see example images below) (this service is often provided by the retaining wall supply company, for example using precast concrete retaining wall blocks and related components)

2. Hiring a Contractor to demolish and remove the existing wood decks, stairs, and railings in the area
3. Hiring a Landscaping Contractor to remove the existing Retaining Walls, prepare the site, and install new precast concrete retaining wall block system
4. Hiring a Contractor to install new wood decks, railings, and stairs

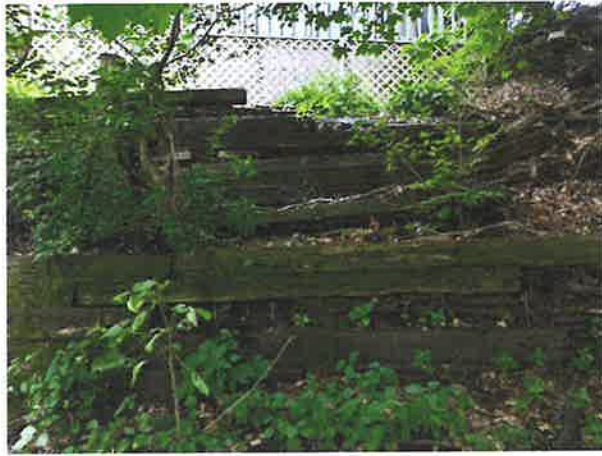
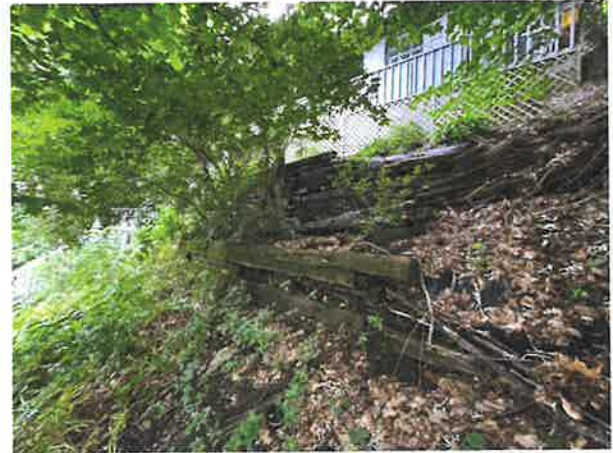
Photo 7 – Retaining Wall 1, West End Deterioration

Photo 8 – Retaining Wall 1, West End Deterioration

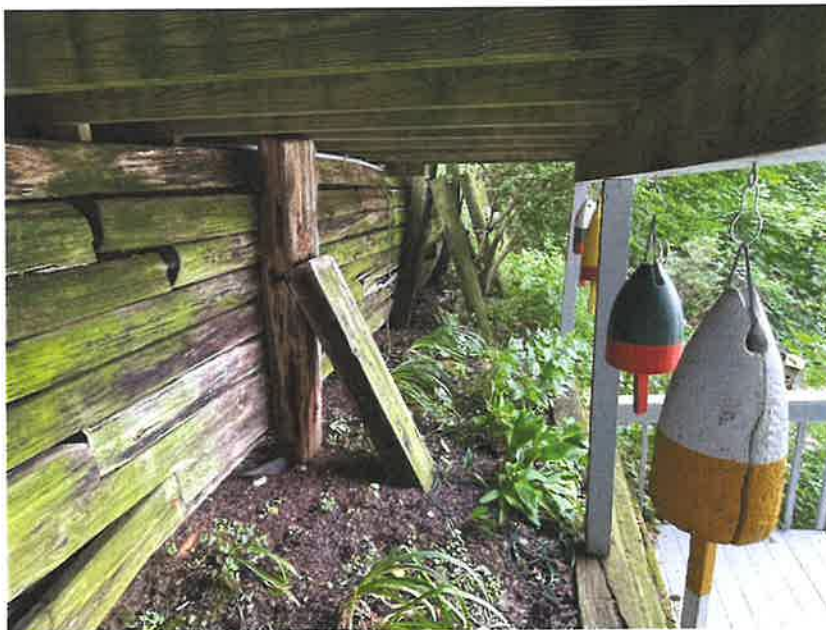
Photo 9 – Retaining Wall 2, Viewing Southwest from below Upper Deck

**Retaining Wall 2** is the next tier above **Retaining Wall 1**, upslope and approximately 5 feet horizontally towards the Residence. It is constructed out of wood timbers, approximately 8" wide and 6" tall. These timbers are aligned vertically, not stepped back like **Retaining Wall 1**. The wood timbers are showing significant signs of deterioration. The wood is green in appearance, and there are large portions that have rotted away.

**Retaining Wall 2** also has approximately 5 "supports". These supports consist of a vertical "post", likely driven into the ground directly against the outside face of the wall timbers. The "posts" each have a diagonal "strut", likely to provide additional resistance against the push of the retaining wall. It is known how deep the "support" timbers go into the ground, or what the foundation condition of them is. Several of the "supports" have deteriorated wood, and all show signs of leaning/tipping, curving/bowing, and some show signs of splitting.

I measured several of the vertical "posts" of the "supports". My measurements were between 10% and 20%. Assuming these support "posts" were installed vertically, these "supports" are leaning significantly.

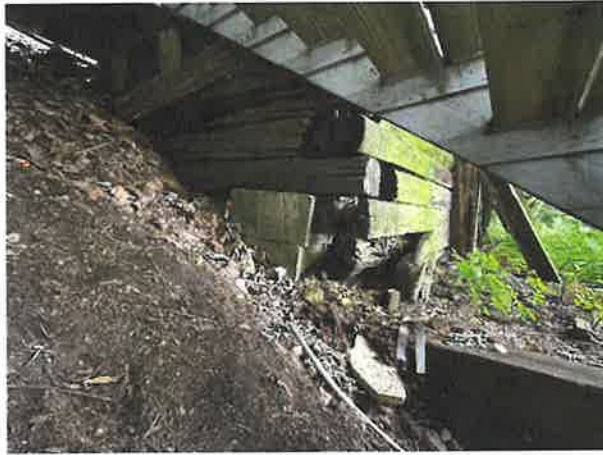
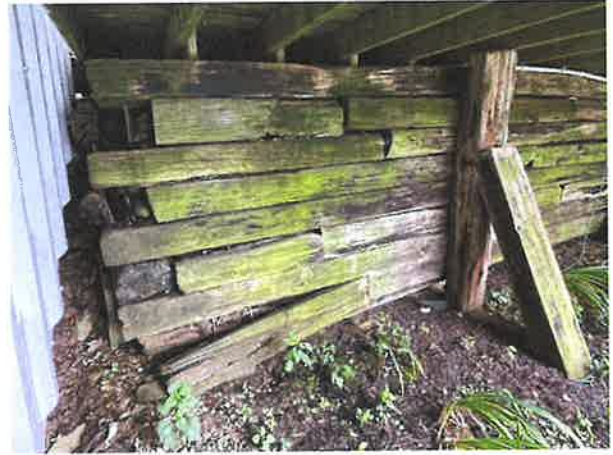
**Photo 10 – Retaining Wall 2, East Corner Deterioration**

**Photo 11 – Retaining Wall 2, East Corner Deterioration**

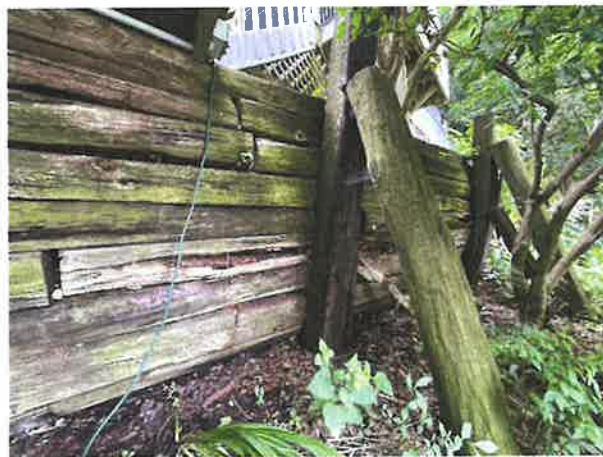
**Photo 12 – Retaining Wall 2, Deterioration and Leaning Support**

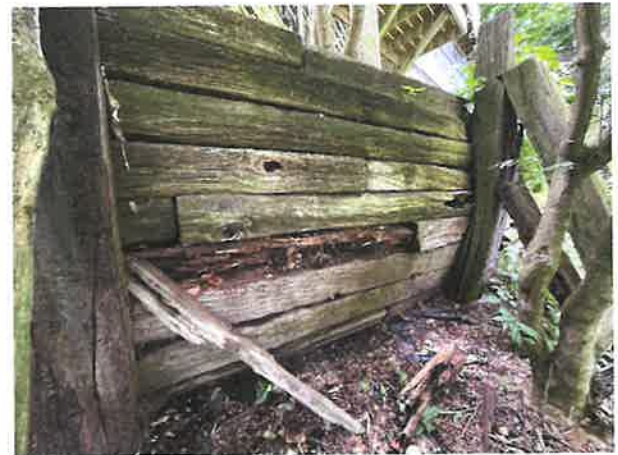
**Photo 13 – Retaining Wall 2, Deterioration and Bowed Support**

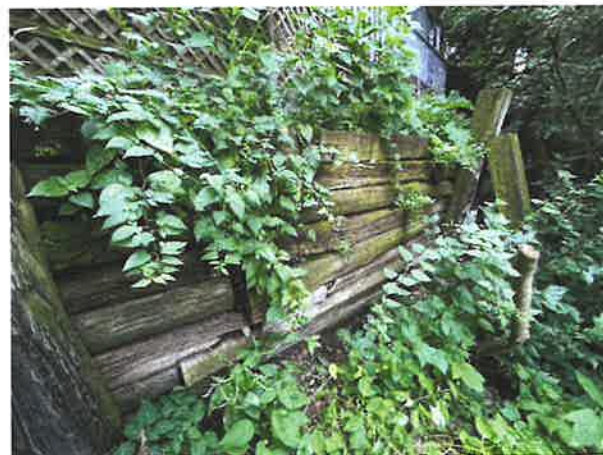
**Photo 14 – Retaining Wall 2, Deterioration and Leaning Support**

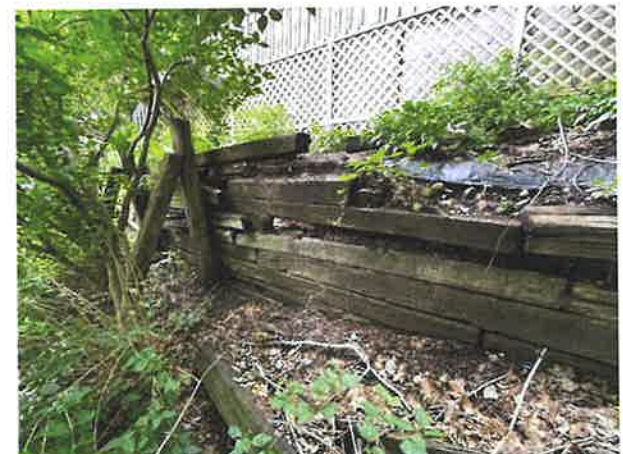
**Photo 15 – Retaining Wall 2, Deterioration at West End**

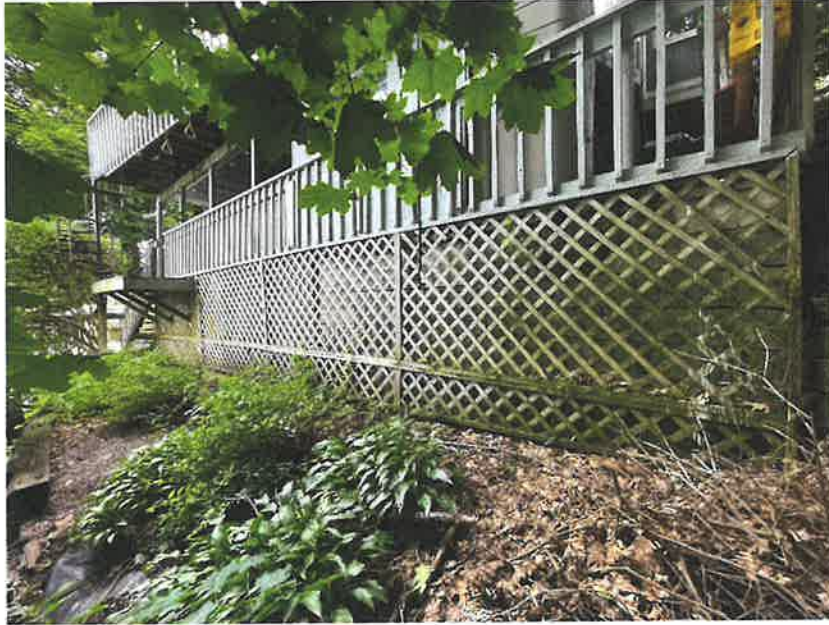
**Photo 16 – Portion of Retaining Wall 3 below Patio, Viewing Southeast**

**Retaining Wall 3** is the last tier above Retaining Wall 2. Retaining Wall 3 is constructed out of concrete blocks (known as Concrete Masonry Units, often abbreviated "CMUs", I will use "concrete blocks" in this report for simplicity). **Retaining Wall 3** begins on the west end at the corner of the slab-on-grade patio of the Residence. It continues east, paralleling the Residence and patio. It turns to the south at an approximately 90 degree angle the end of the patio, and then turns east again and curves, convexly, around the northeast corner of the Residence.

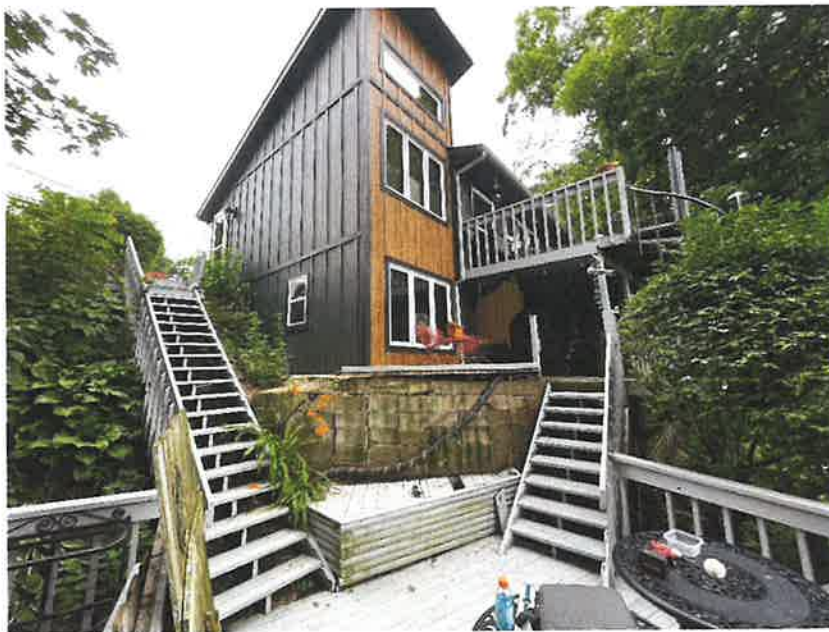
**Photo 17 – Portion of Retaining Wall 3 at Curve, Viewing Southwest**

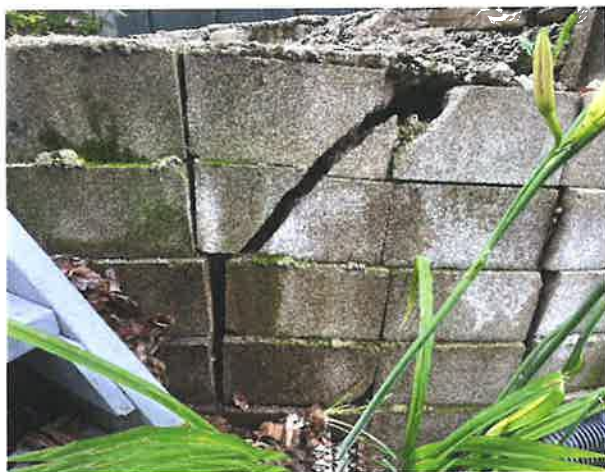
There are several conditions I observed at Retaining Wall 3 that are evidence that it is overstressed, moving, and failing. From west to east, these conditions include:

- A. Large diagonal cracks in concrete blocks at east end of curved section of wall
- B. Cracks and settlement of concrete on top of east end of curved section of wall
- C. Leaning, tipping, shifting concrete blocks at concave curve (concave geometry allows the soil to "push" the stacks of concrete walls apart at continuous vertical joints)
- D. Cracks in concrete slab-on-grade patio, long crack parallel to exterior wall, shorter crack at east end of patio, at start of curved portion of wall
- E. Vertical separation and vertical cracks in concrete blocks at inside corner of wall (below east end of patio)
- F. Hollow area below portion of wall, no dirt or other support below wall
- G. Visible gaps, offsets, shifting concrete blocks in straight portion of wall

Photo 18 – Condition A

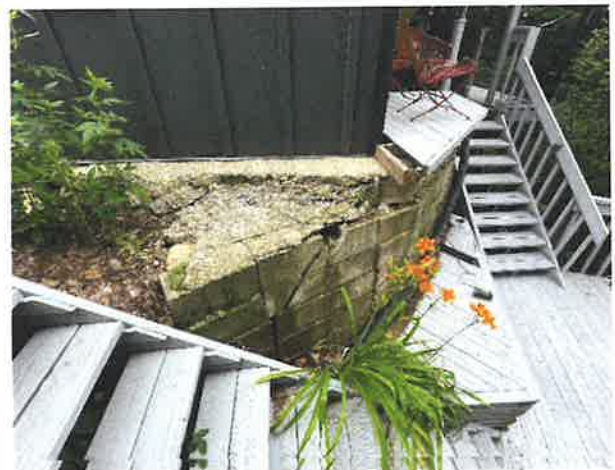
Photo 19 – Condition B

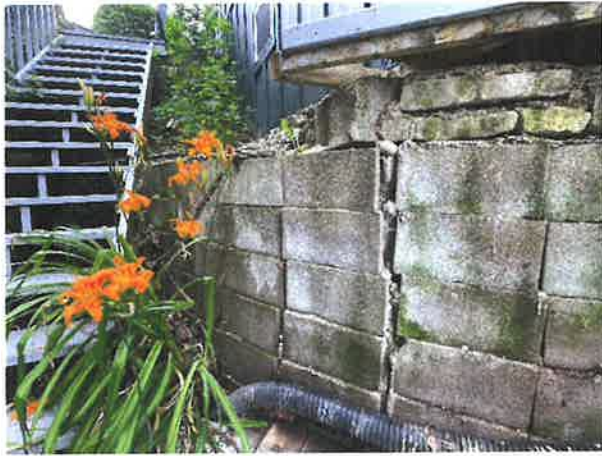
**Photo 19 – Condition C**

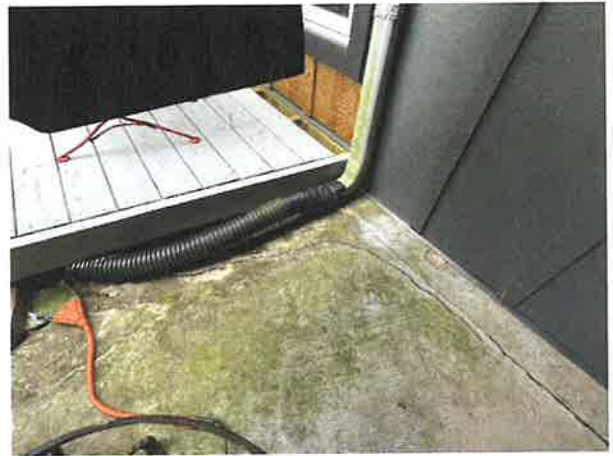
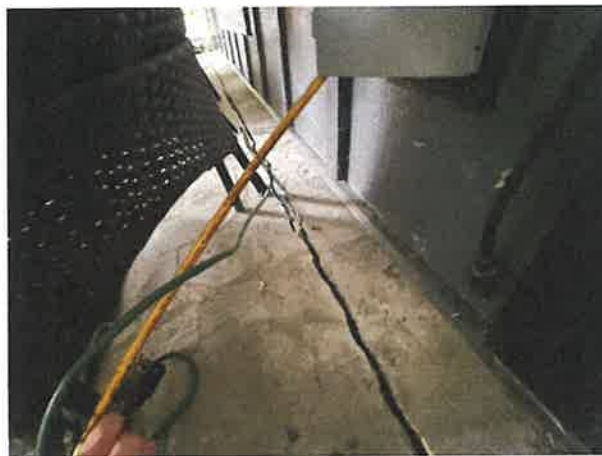
**Photo 18 – Condition D, Southeast Corner of Patio**

**Photo 19 – Condition D, Along South End of Patio**

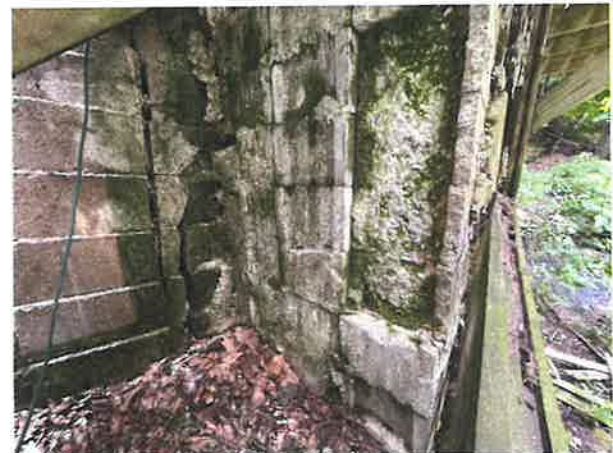
**Photo 20 – Condition E**

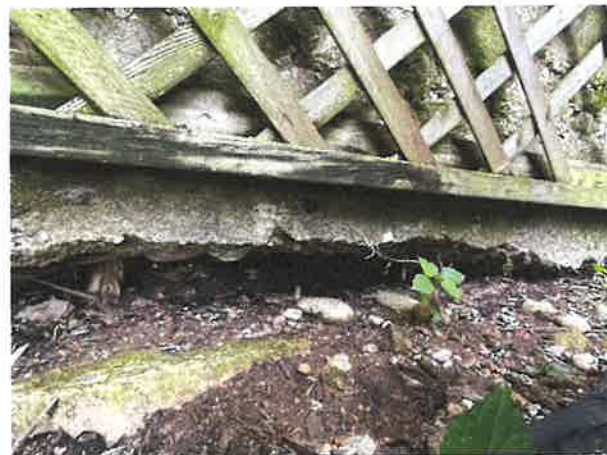
**Photo 21 – Condition F**

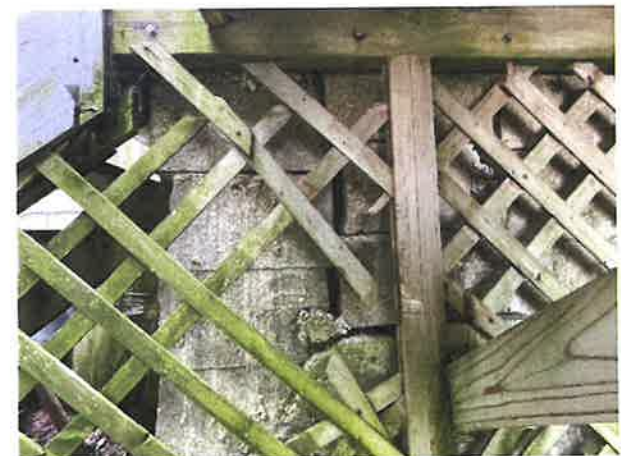
**Photo 22 – Condition G, One Example**

Much of this wall is only partially observable. The visible areas of this wall are showing signs of movement, settlement, tipping, and cracking. This is significant, because CMU Retaining Wall 1 directly retains the soil that the house is bearing on. It is highly likely that further investigation will find more issues. It is also likely that significant structural work will be required to restore stability to the house’s foundation, and the retaining system directly to the north of the house.

2. Hiring a Geotechnical Engineering Consultant to perform soil boring tests, provide a report of findings, and provide recommended corrective measures in the report

3. Hiring a Design Professional (Architect) to assess the existing site conditions and structures, and develop a new site plan. This site plan will coordinate location(s) of new retaining walls, new decks, new stairs, etc. (if this work is required, it would be considered as part of the comprehensive site plan from the previous section)

4. Hiring a Design Professional (Engineer) to design an underpinning solution for the house foundation, if required (see example images of helical piers below)

6. Hiring a Contractor to demolish and remove the existing wood decks, stairs, and railings in the area.
7. Hiring a Landscaping Contractor to remove the existing Retaining Wall, excavate to the Residence’s foundation, prepare the site, and install new precast concrete retaining wall block system
