PROPERTY INSPECTION REPORT

FOUR POINT
HOME INSPECTION INC.

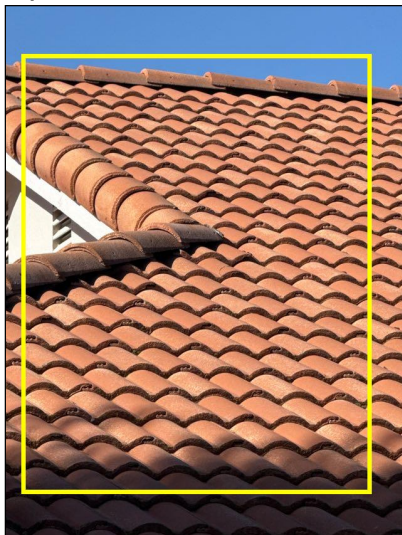
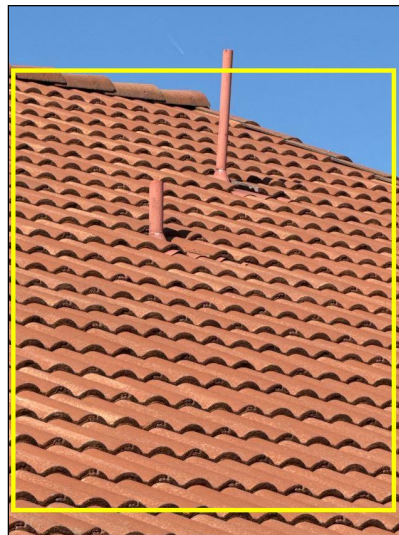
The inspector observed no deficiencies in the condition of the roof structure exterior.

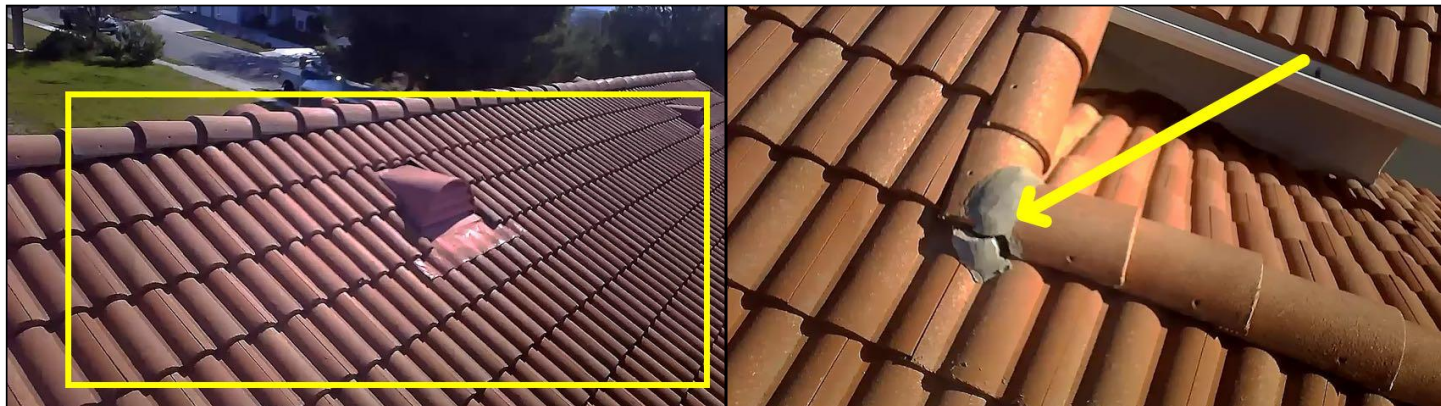
Roof ridge cap tiles are mortar sealed at intersections, the mortar is cracked

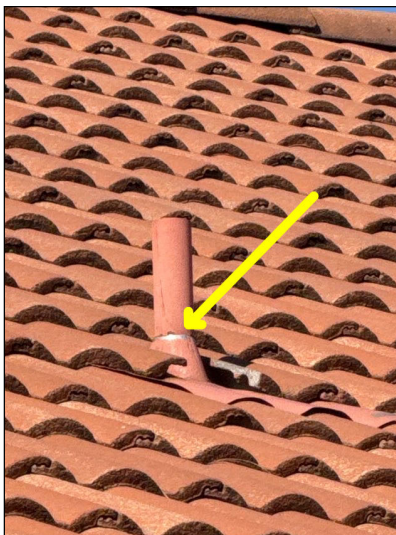
Maintenance Needed: Plumbing vent flashings are mastic covered and some are showing signs of cracked mastic/mastic deterioration from sun exposure.

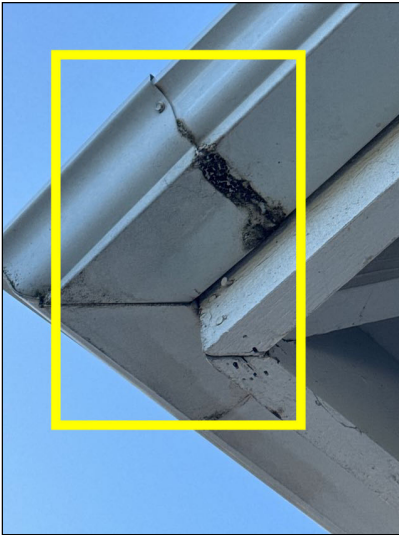
Maintenance Needed: Gutters had corrosion visible at seams.

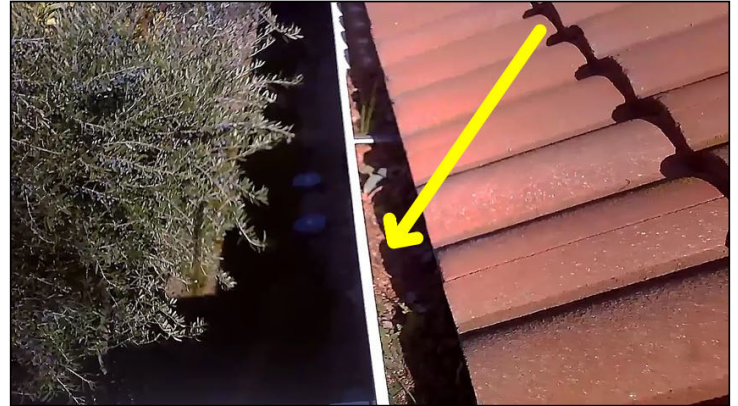
Maintenance Needed: Debris visible in the gutters at the time of the inspection should be removed to encourage proper drainage.

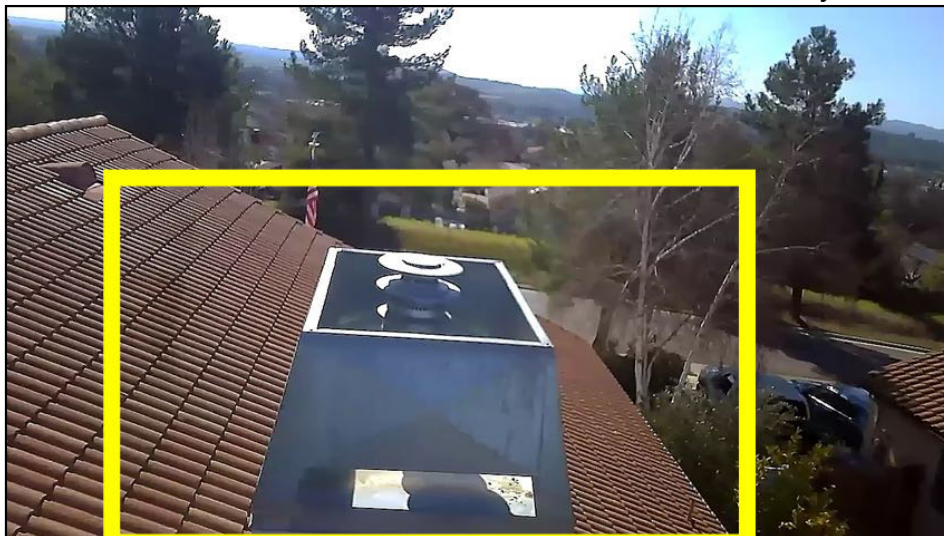
The Inspector observed no deficiencies in the condition of the chimney crown.

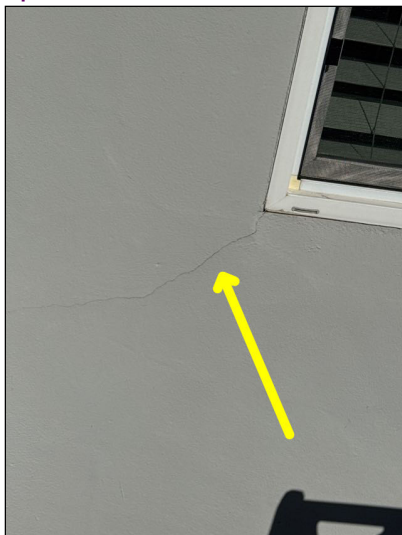
Monitor: Normal cracking was visible in stucco covering exterior walls of the home at the time of the inspection.

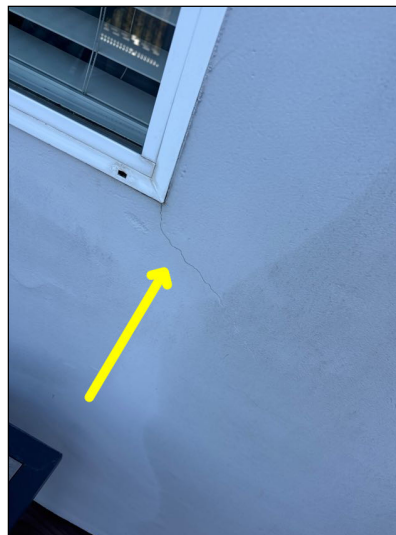
Monitor: Normal cracking was visible in stucco covering exterior walls of the home at the time of the inspection.

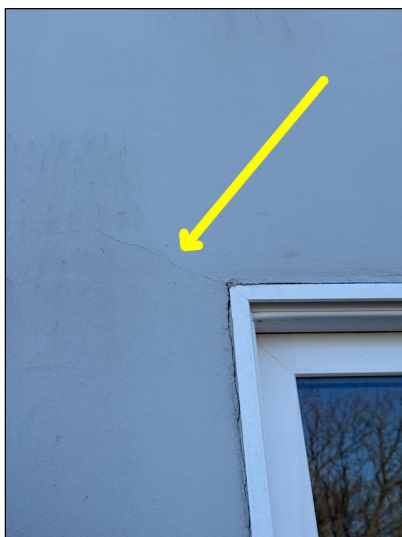
Monitor: Normal cracking was visible in stucco covering exterior walls of the home at the time of the inspection.

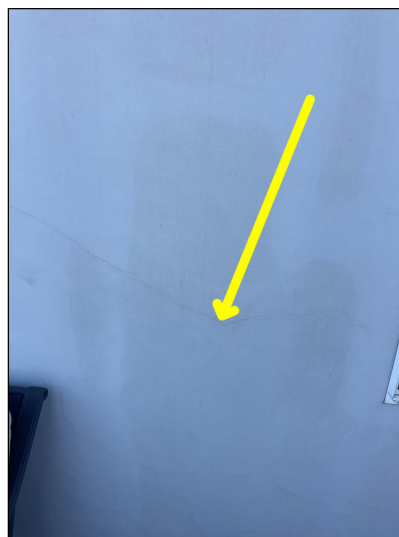
Monitor: Normal cracking was visible in stucco covering exterior walls of the home at the time of the inspection.

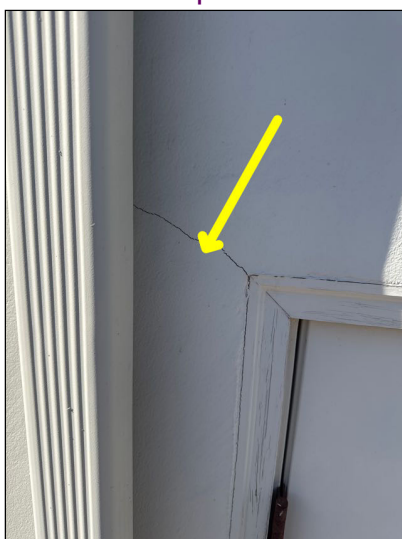
Monitor: Normal cracking was visible in stucco covering exterior walls of the home at the time of the inspection.

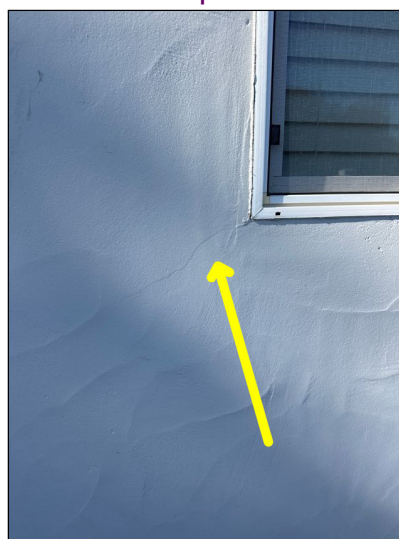
Monitor: Normal cracking was visible in stucco covering exterior walls of the home at the time of the inspection.

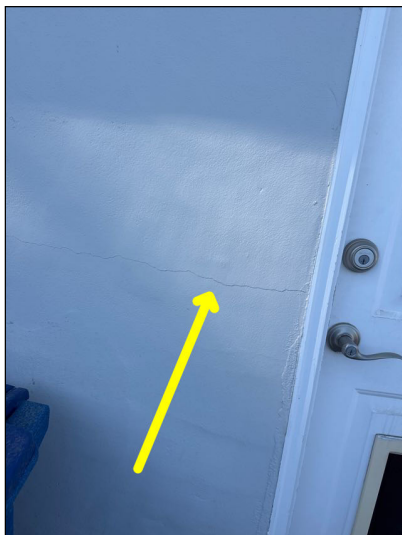
Monitor: Normal cracking was visible in stucco covering exterior walls of the home at the time of the inspection.

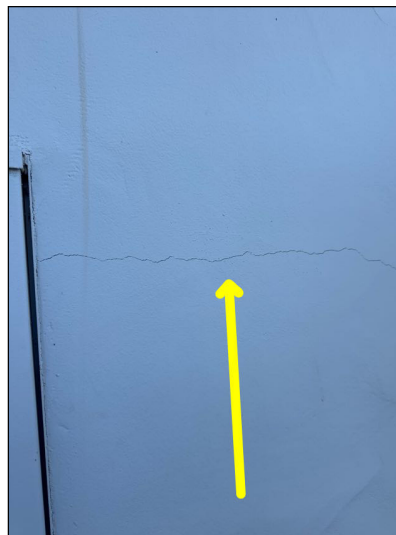
Monitor: Normal cracking was visible in stucco covering exterior walls of the home at the time of the inspection.

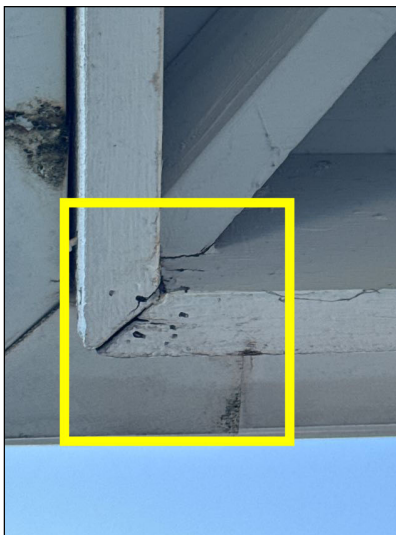
Monitor: Minor moisture damage, wood rot, observed. Refer to pest report for further details and repair damage as needed.

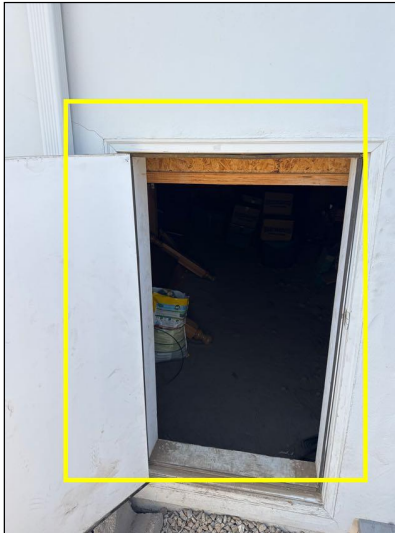
Materials: The Inspector examined the crawlspace from the inside the crawlspace.

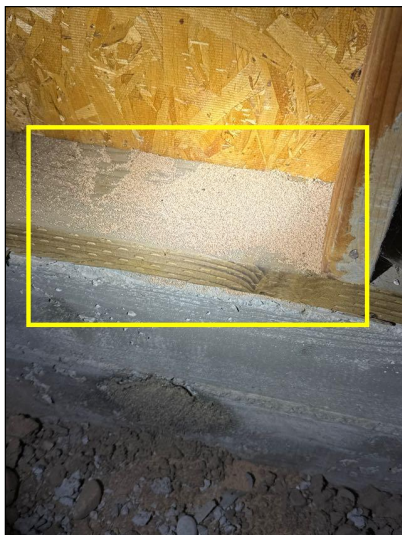
Termite dropping visible in the crawlspace walls indicated infestation by wood-destroying insects.

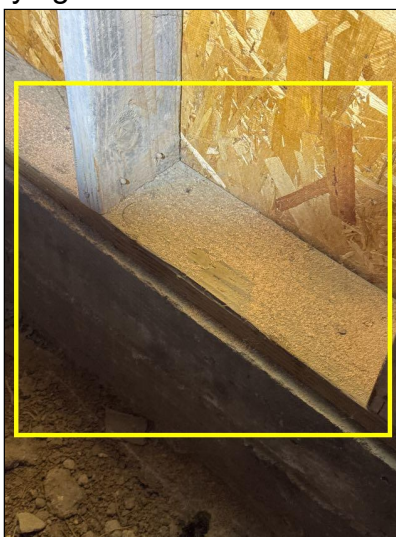
Termite dropping visible in the crawlspace walls indicated infestation by wood-destroying insects.

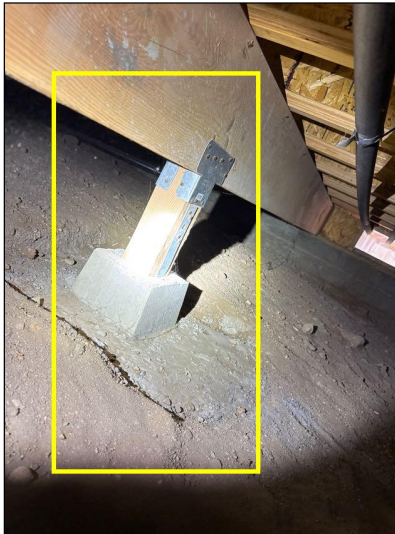
At the time of the inspection, the Inspector observed no deficiencies in the condition of the visible fasteners and hardware.

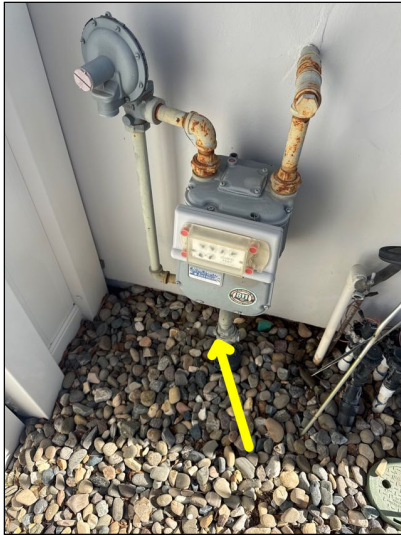
Main gas shut off to the home.

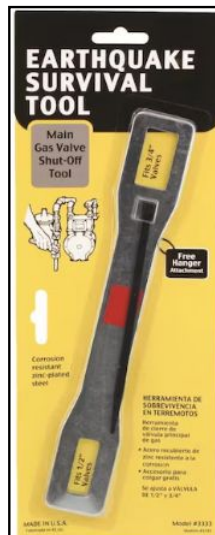
Having a gas shut off tool readily available in an emergency is a recommended safety improvement.

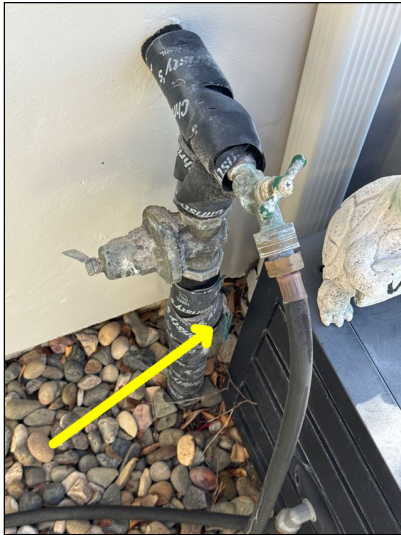
Main water shut off to the home where the main water line enters the home.

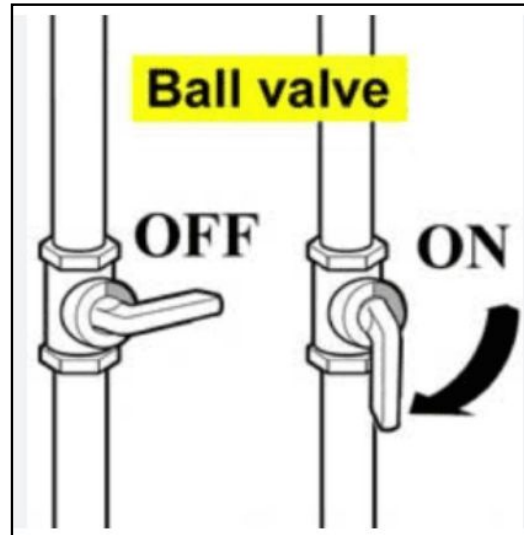
The basic operation for a ball valve shut off is pictured above.

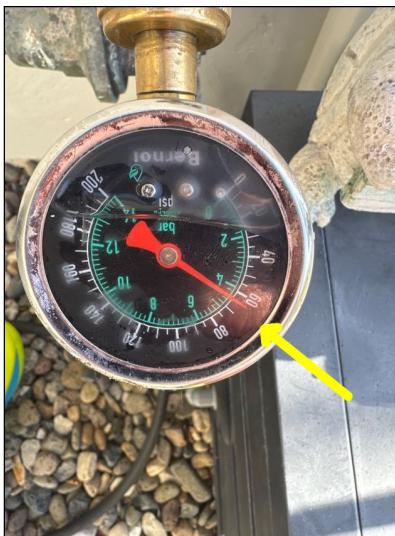
- ✓ • Recommend 40-80 PSI.
- Home water pressure measured 65 pounds per square inch (psi) at the time of the inspection.

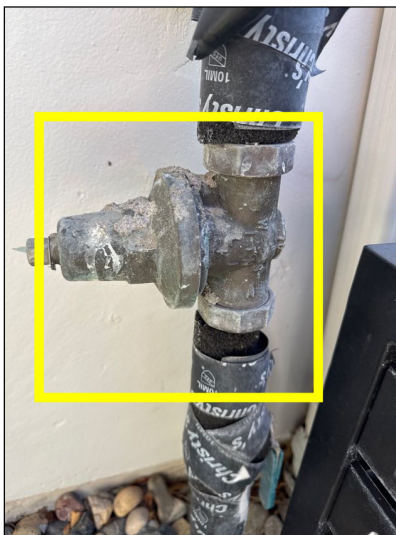
The water distribution system was equipped with a pressure regulator.

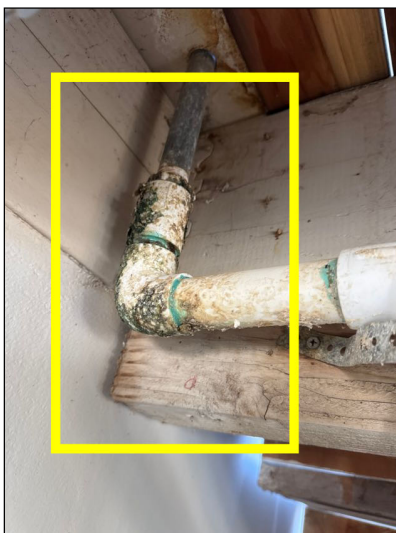
An exterior faucet at the Rear of the house had a leaking supply line. The Inspector recommends repair by a qualified plumbing contractor.

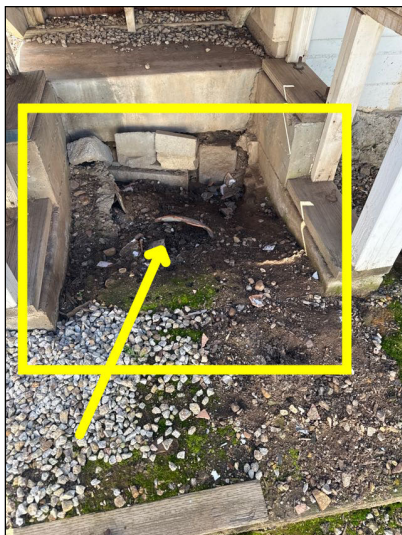
The home had areas of neutral or negative drainage that will route runoff from precipitation toward the foundation.

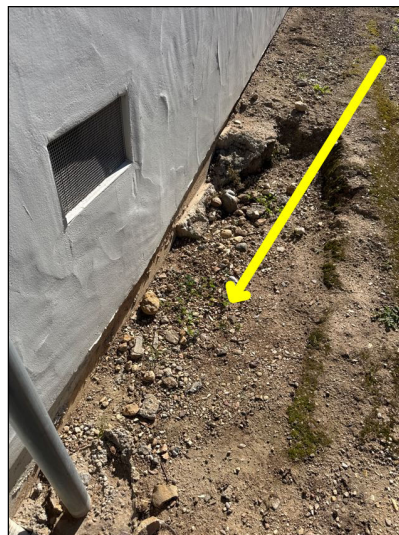
The home had areas of neutral or negative drainage that will route runoff from precipitation toward the foundation.

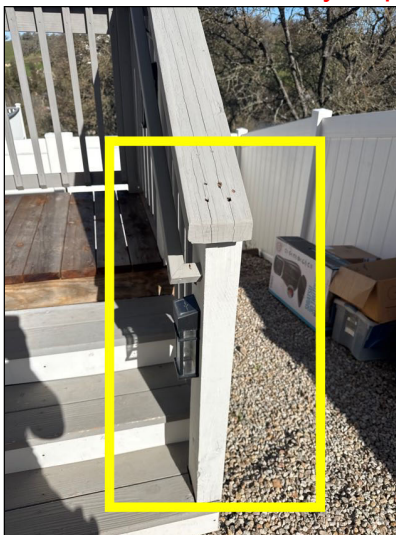
The handrail was loose and should be made secure by a qualified contractor.

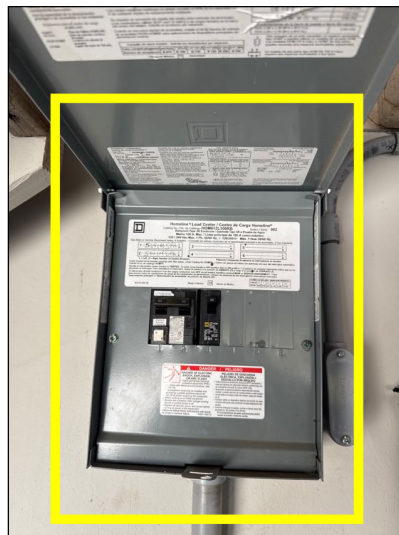
Sub panel to the pool/spa

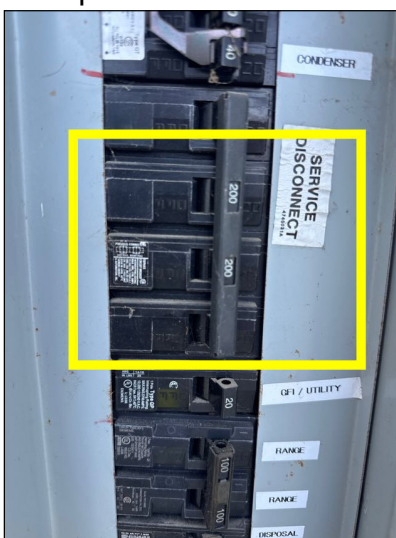
Main electrical shut off to the home

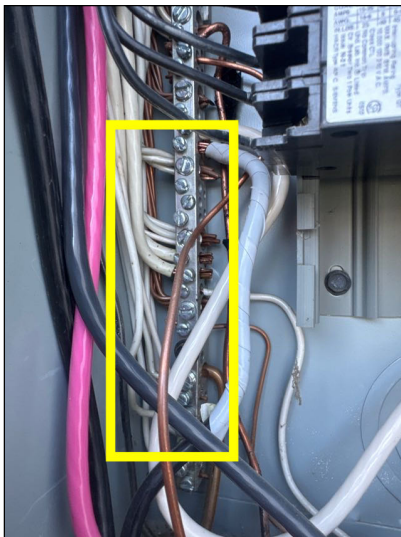
Multiple neutral conductors (white wire) from separate branch or separate feeder circuits cannot be installed in the same neutral terminal (lug screw)

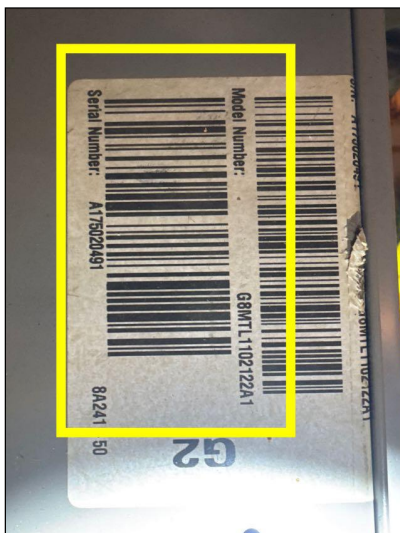
Heater model and serial number

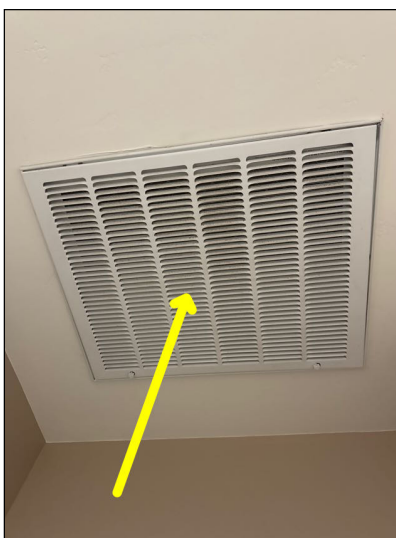
Note: Air filters are designed to keep you HVAC system clean and efficient. Most HVAC systems are not designed to improve indoor air quality. The inspector recommends using the cheap fiberglass filters as that are designed to stop dust, debris and hair from gunking up the system. Pleated more expensive air filters made from polyester or cotton will remove smaller particles, but the trade-off to cleaner air is that the system performance will drop which makes the system more expensive to operate. Pleated filters can also cause stress on the blower motor, which impacts the refrigeration in the evaporator coil, potentially causing the coil to ice up.

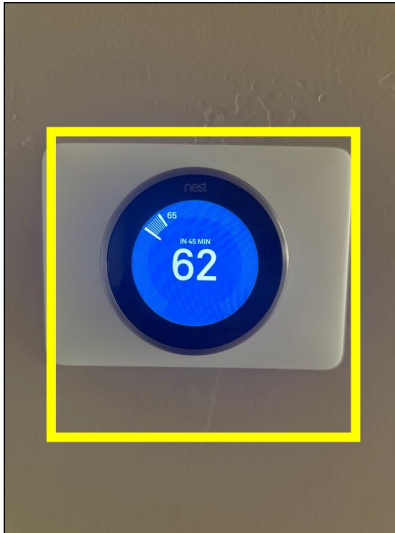
12. Condensate Drain/Overflow Pan

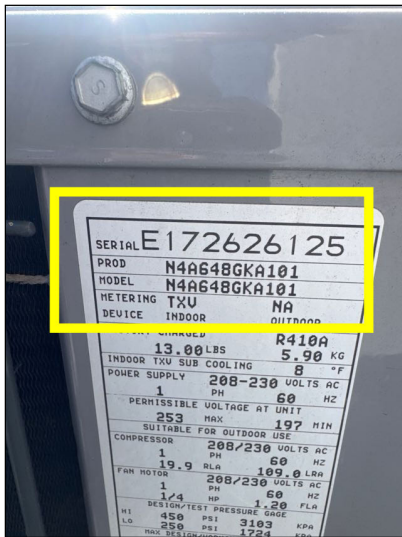
AC model and serial number

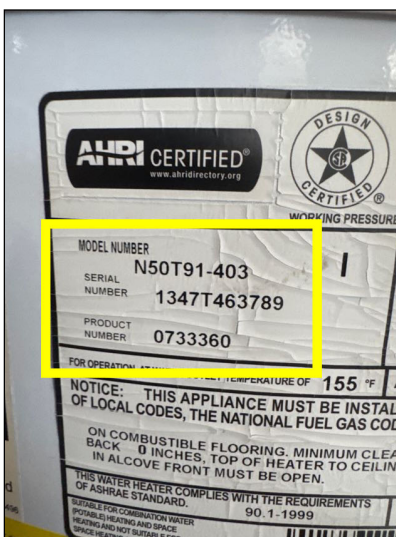
Water heater model and serial number

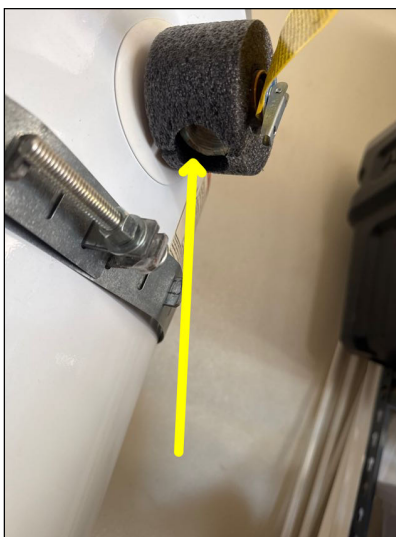
The discharge line is missing for the water heater relief valve (TPRV).

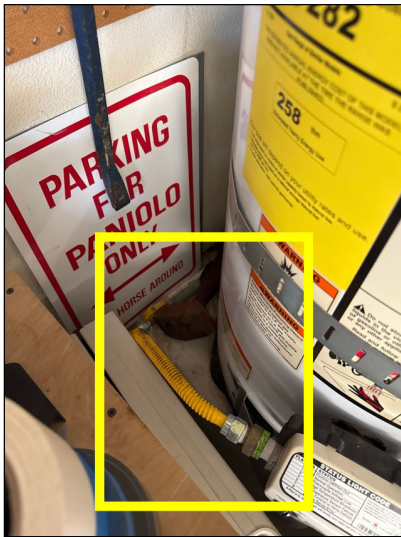
Improvement: The gas supply pipe contained no sediment trap.

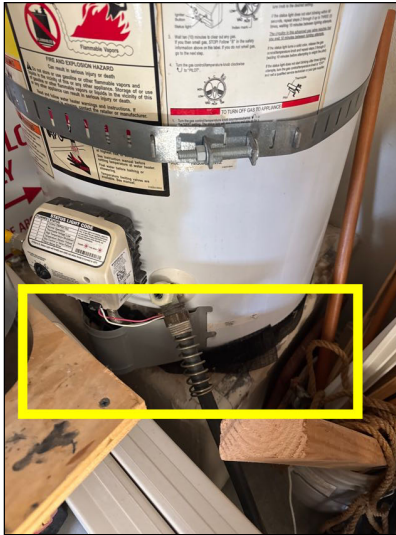
Water Heater (continued)

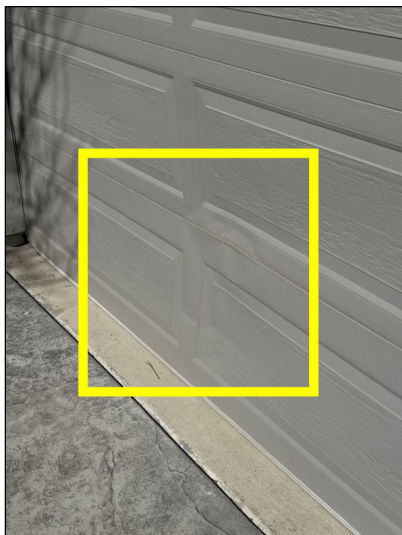
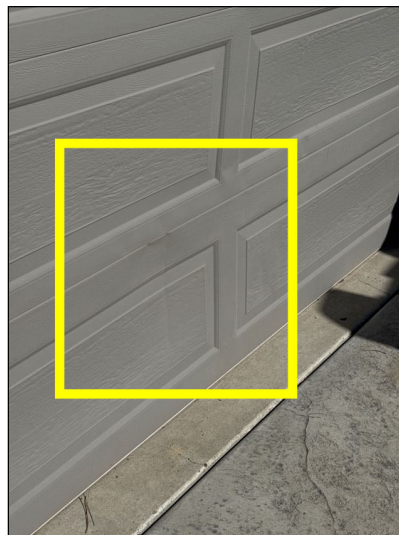
2. Garage Opener Status

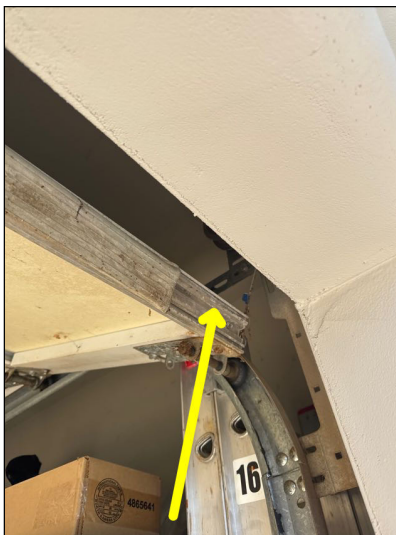
The bottom weather stripping on the overhead door is showing signs of deterioration or missing in areas.

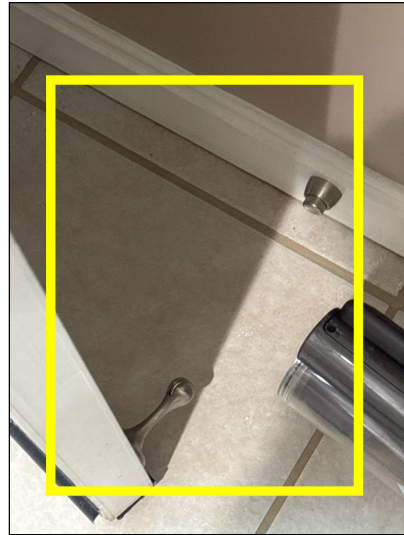
Door stops that prevent the door from self-closing are considered a breach in the firewall.

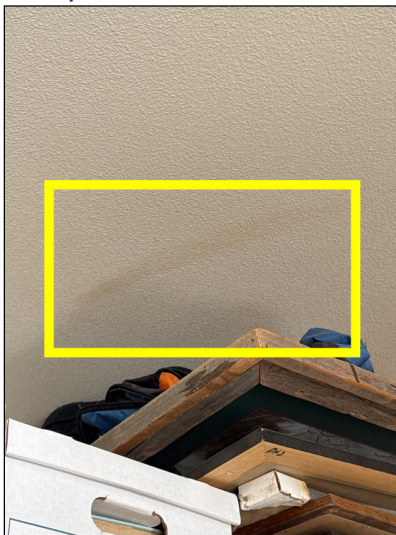
Monitor: Stains on the ceiling in the garage visible at the time of the inspection appeared to be the result of moisture intrusion.

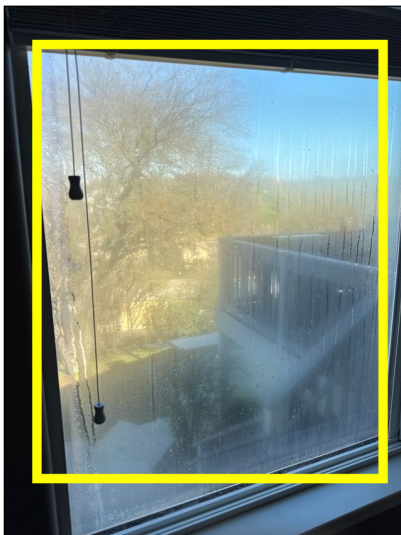
Staining and etching of the glass at the window indicated a loss of thermal integrity.

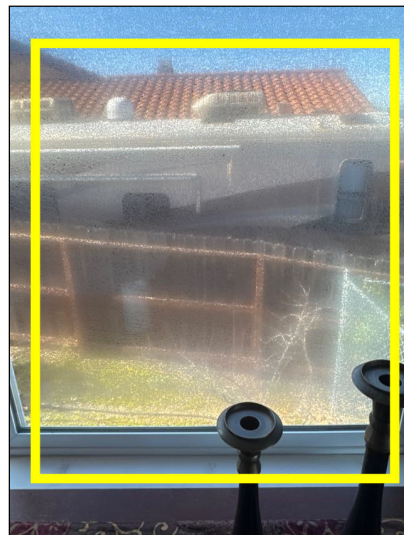
Staining and etching of the glass at the window indicated a loss of thermal integrity.

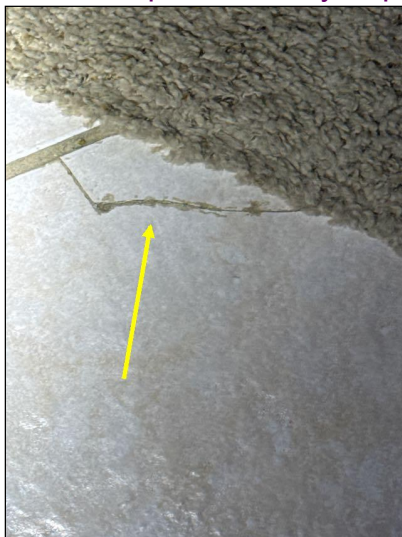
The Hallway had cracked floor tiles visible at the time of the inspection.

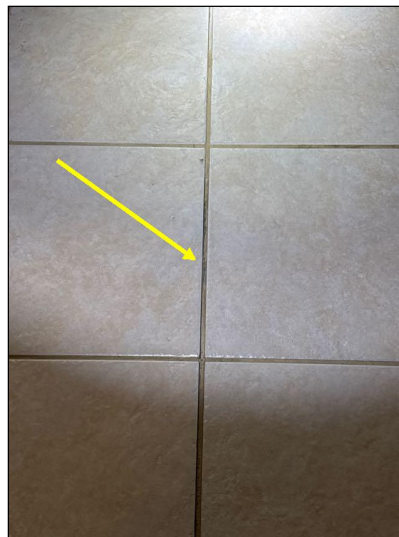
Grout lines in the tile floor of the Hallway needed maintenance at the time of the inspection.

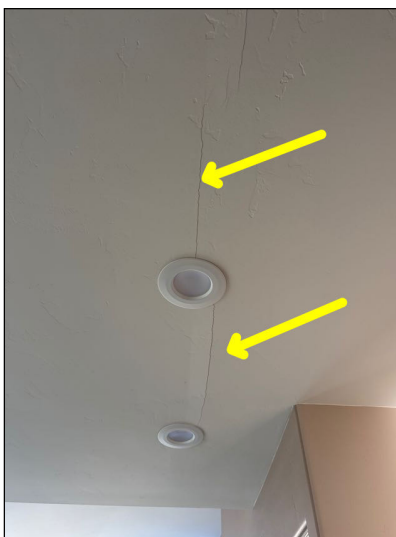
Monitor: Normal settlement cracking was visible in interior ceiling of the home at the time of the inspection.

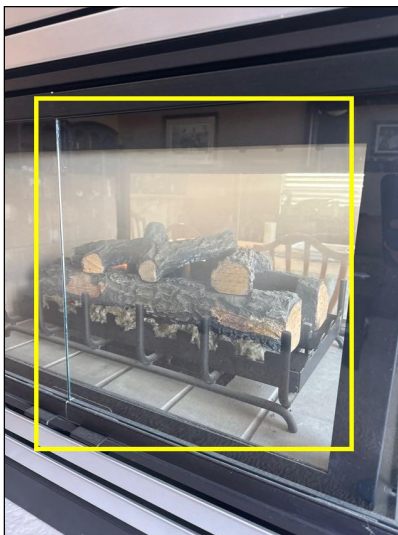
Interior Areas (continued)

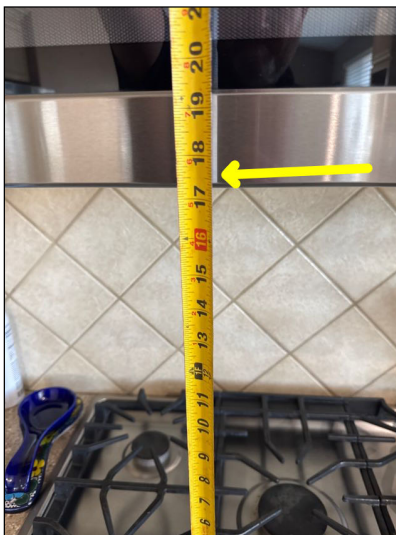
Safety: Any range hood, including microwaves, installed above the stove must be a minimum of 24 inches

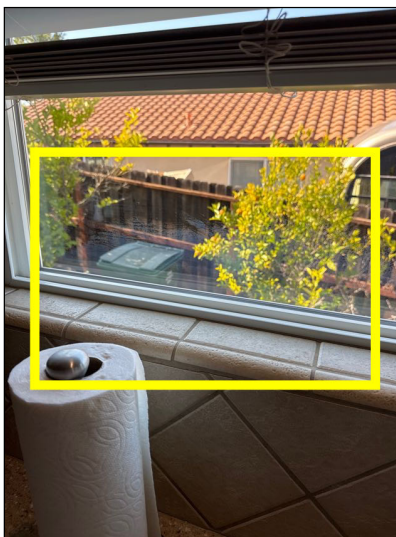
Staining and etching of the glass at the window indicated a loss of thermal integrity.

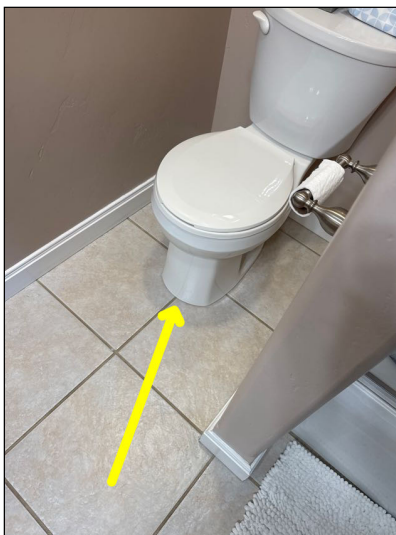
Bathroom #1 (continued)

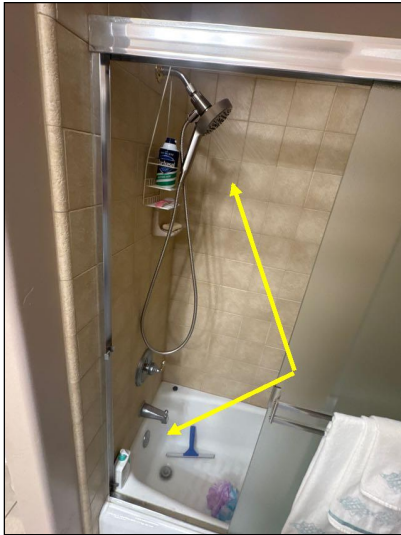
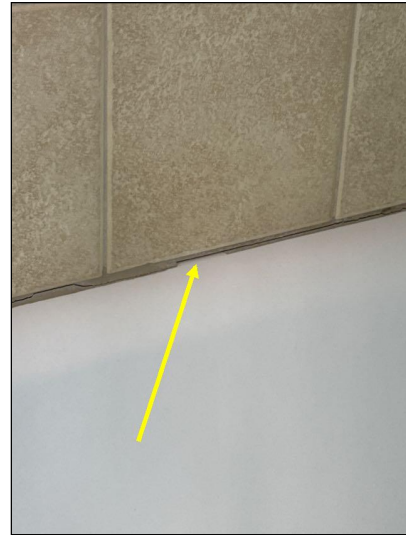
The diverter valve was leaking during operation or did not operate correctly (the diverter is the valve which diverts water from the tub faucet to the shower head).

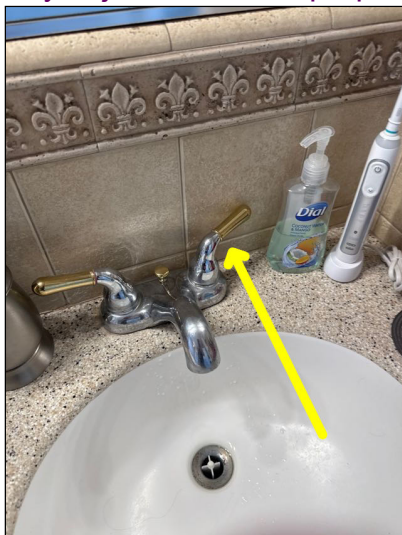
The sink in this bathroom had a loose faucet handle.

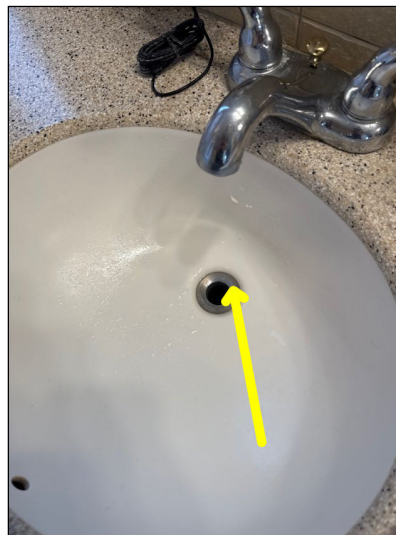
Maintenance Needed: Pop up drain assembly is inoperable. Recommend having pop up assembly adjusted to work properly.

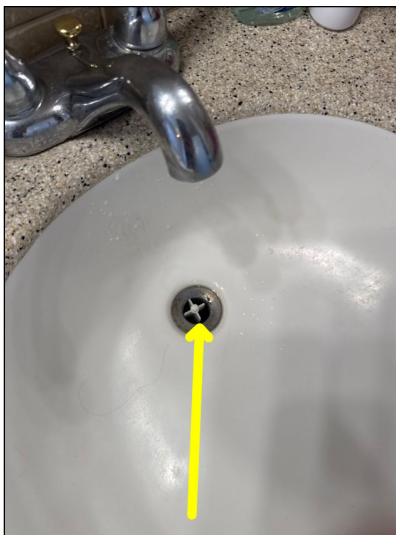
Maintenance Needed: Pop up drain assembly is inoperable. Recommend having pop up assembly adjusted to work properly.

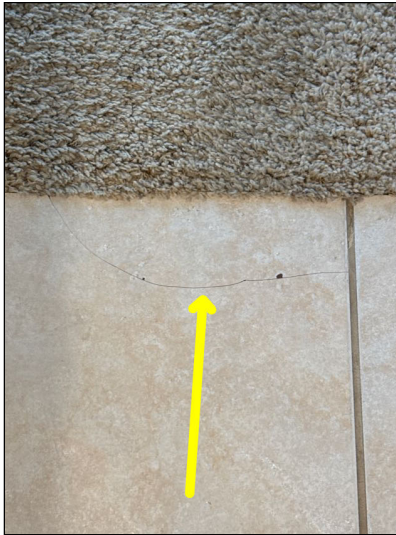
Bathroom #2 (continued)

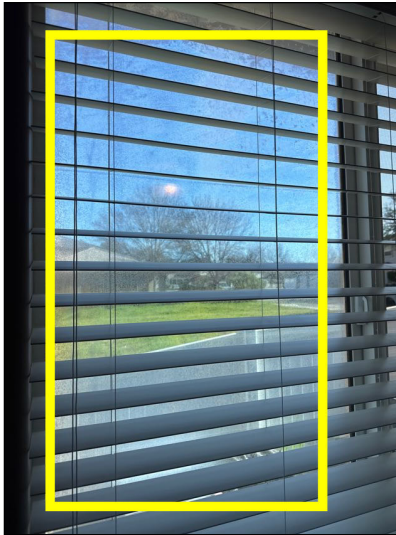
Staining and etching of the glass at the window indicated a loss of thermal integrity.
