# PROPERTY INSPECTION REPORT

**FOUR POINT**  
HOME INSPECTION INC.

**111 Twin Ridge Dr**

**Date of Inspection: 7/7/2026**

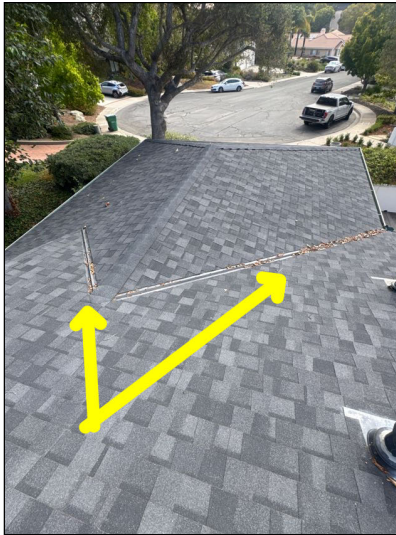
The inspector observed few deficiencies when inspecting valley flashing. Notable exceptions will be listed in this report.

**Maintenance Needed:** Debris visible in the valley flashing at the time of the inspection should be removed to encourage proper drainage.

***Maintenance Needed:*** Debris visible in the valley flashing at the time of the inspection should be removed to encourage proper drainage. Blocked flashing areas can allow moisture intrusion under the roof covering and damage the underlayment and/or roof sheathing.

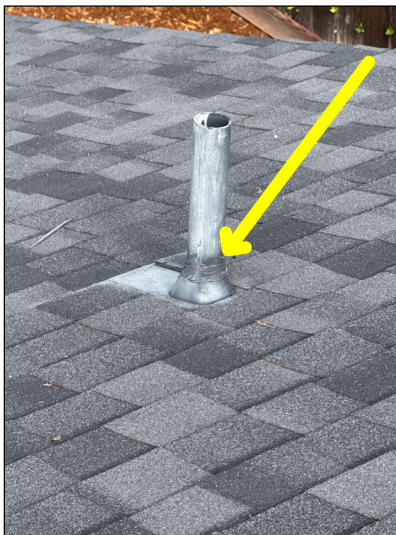
**Routine Maintenance:** Plumbing vent flashings are mastic covered and will start to show signs of mastic deterioration from sun exposure over time.

**Routine Maintenance:** Plumbing vent flashings are mastic covered and will start to show signs of mastic deterioration from sun exposure over time. Recommend re-sealing all through the roof vents and projections as a part of routine maintenance to prevent unwanted moisture intrusion.

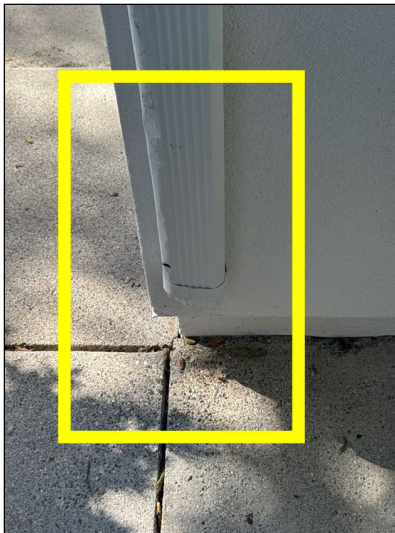
One downspout discharged roof drainage next to the foundation. This condition can effect the ability of the soil to support the weight of the structure above and can cause damage related to soil/foundation movement. The Inspector recommends the installation of downspout extensions to discharge roof drainage a minimum of 6 feet from the foundation.

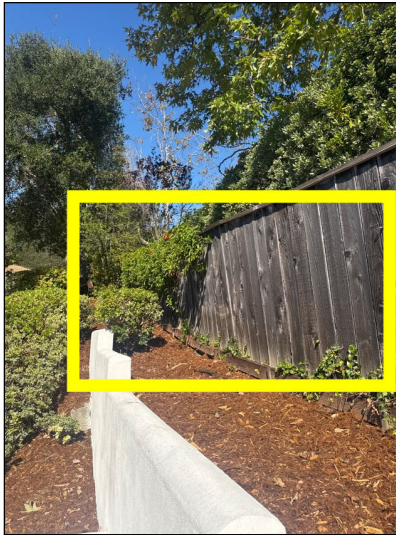
**Monitor:** The fence(s) showed signs of failure such as leaning outward in sections. This is usually caused by unstable or wood rotted supports posts. Before the expiration of your Inspection Objection Deadline consider consulting with a qualified contractor to discuss options and costs for repairs or replacement as needed.

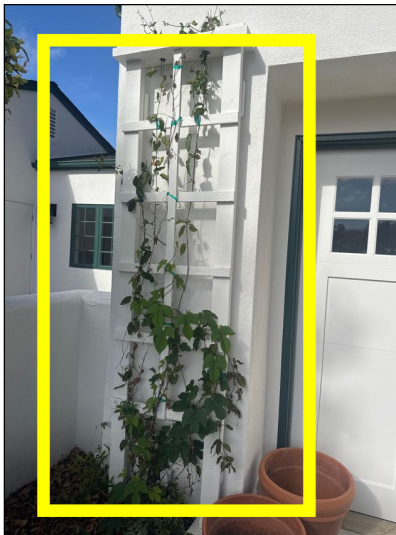
- **Monitor:** Vines growing on the exterior walls may introduce insects, pests and/or accelerate deterioration of the exterior wall covering by retaining moisture. Over time, vine tendrils may damage wall covering materials. The Inspector recommends removal of the vegetation from exterior walls.

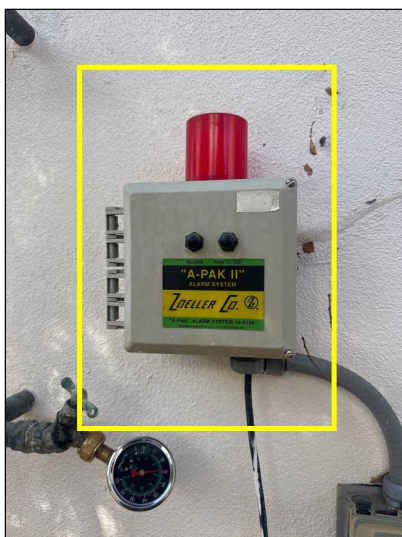
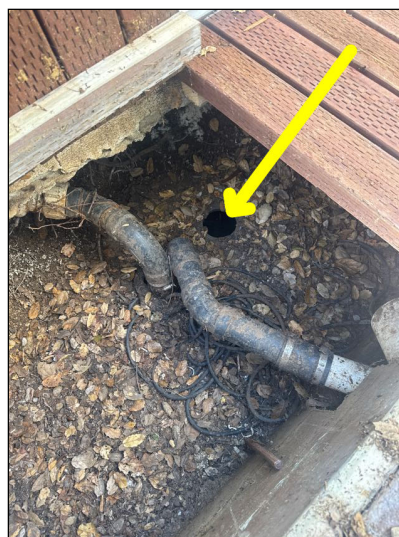
The lid to the sewage ejector pump should not have an open hole and should be replaced to prevent sewer gases from escaping the catch basin. All work should be performed by a qualified plumbing contractor.

The lid to the sewage ejector pump should not have an open hole

| | Page 23 Item: 16 | Sewer Ejection / Sump Pump | The lid to the sewage ejector pump should not have an open hole and should be replaced to prevent sewer gases from escaping the catch basin. All work should be performed by a qualified plumbing contractor. |

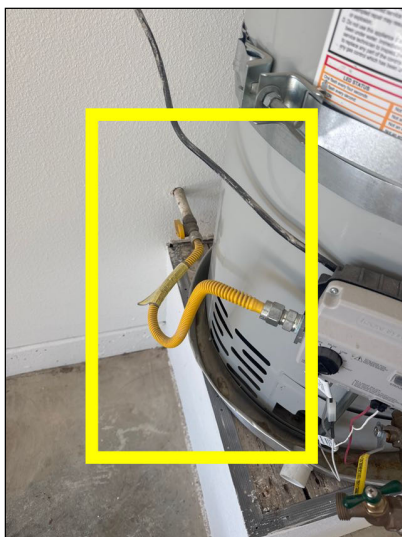
**Recommended Improvement:** The gas supply pipe contained no sediment trap. The purpose of a sediment trap is to prevent sediment or debris particulates from entering and clogging the water heater gas valve, which can cause the water heater to shut down. You may wish to consult with local contractor concerning the advisability of installing a sediment trap in the gas line.

**Improvement:** The gas supply pipe contained no sediment trap.

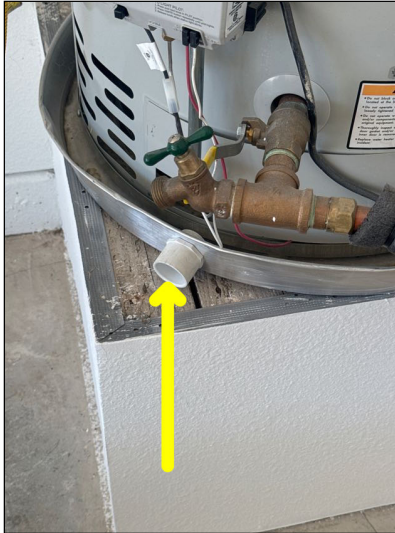
**Monitor:** The drain pipe serving this water heater drain pan had no overflow extension. To reduce the potential for damage from a leaking tank or pipe fittings, the drip pan should have an overflow pipe installed that discharges to the home exterior or just above the floor. The Inspector recommends correction by a qualified plumbing contractor.

**Monitor:** The drain pipe serving this water heater drain pan had no overflow extension.

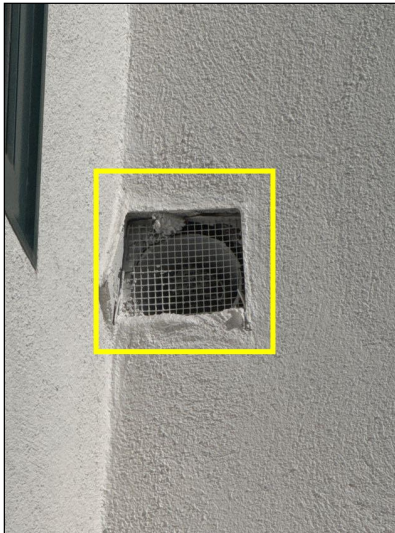
- **Maintenance Needed:** The vent termination was missing an eyebrow cap this may allow wind driven rain into the interior wall. The inspector recommends that the termination is reinstalled and sealed to keep unwanted moisture out.
