INSPECTION REPORT BY PACIFIC CREST INSPECTIONS

645 Front St 2102
San Diego, CA 92101

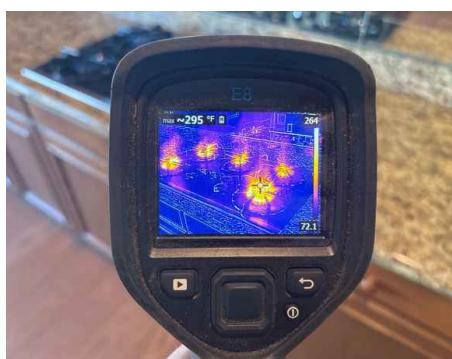
Ranges and Cooktops: Thermal Image Showing Operation

Infrared picture of range/cooktop in operation. This image shows function of the operable range burners.

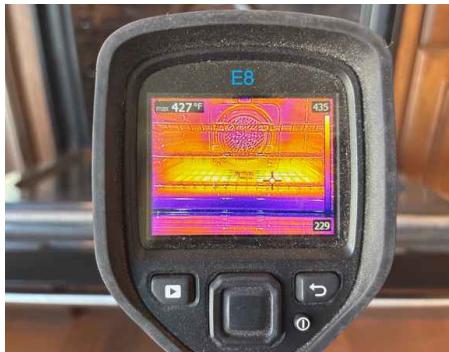
Wall Oven: Thermal Image Showing Operation

Infrared picture of oven in operation. This image shows function of the operable oven heat source.

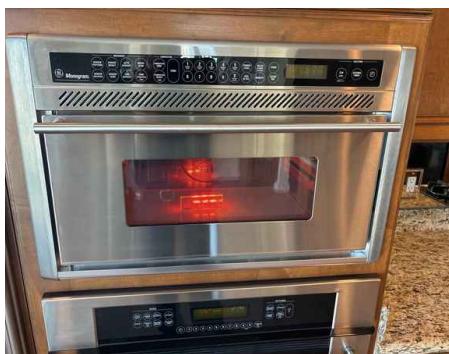
Built-In Microwave : Picture of Microwave During Operation

The operation of the microwave was tested using a microwave tester. This unit appeared functional at the time of inspection.

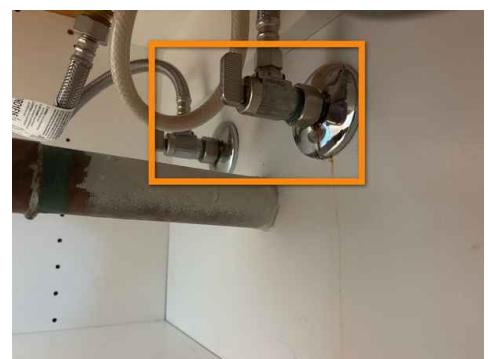
Master Bathroom Right

ANGLE STOP CORRODED

Some of the angle stops/shut off valves and/or supply lines under the sinks or behind the toilets are corroding, have mineral deposits or are rusted. This may be indicative of previous possible leaks. The valve appeared dry at the time of the inspection. The valves are not operated as part of the home inspection process in order to prevent possible damage. These valves are typically recommended for replacement every 10 years. Recommend consulting a licensed plumbing contractor to verify proper operation and determine if corrections are needed at this time.

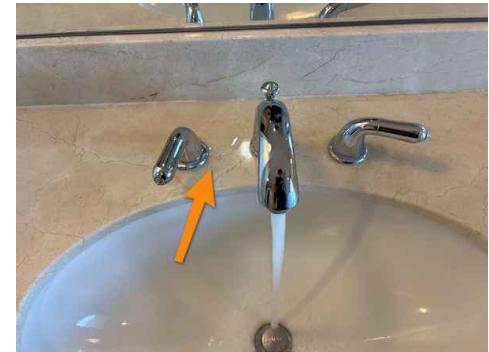
Master Bathroom Left

FAUCET LEAKS-IN USE

The faucet was noted leaking from the valve or stem during operation. Recommend further evaluation and repair by a licensed plumbing contractor.

Contact a qualified plumbing contractor.

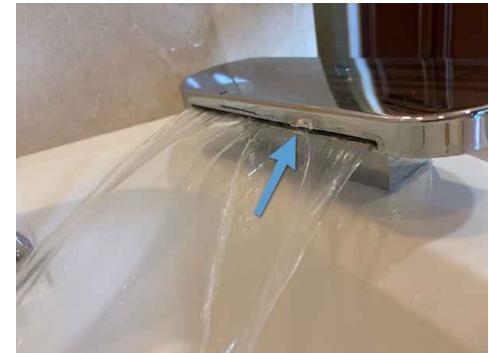
Master Bathroom tub spout

CORROSION AT FIXTURE

Corrosion was noted at one or more fixture locations. You may wish to view this for yourself and have repaired/replaced as desired.

Contact a qualified plumbing contractor.

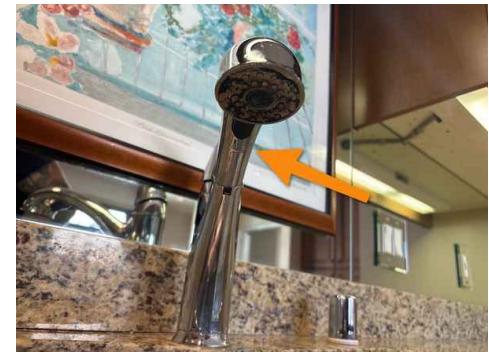
Kitchen

The faucet diverter did not function properly at the time of the inspection. Advise repair by a licensed plumbing contractor.

Contact a qualified plumbing contractor.

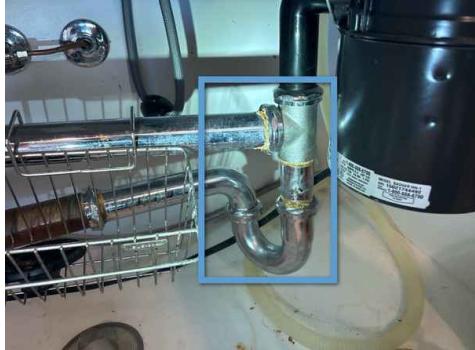
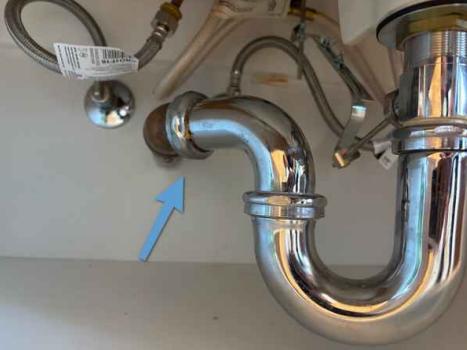
Kitchen

PREVIOUS LEAK

Contact a qualified plumbing contractor.

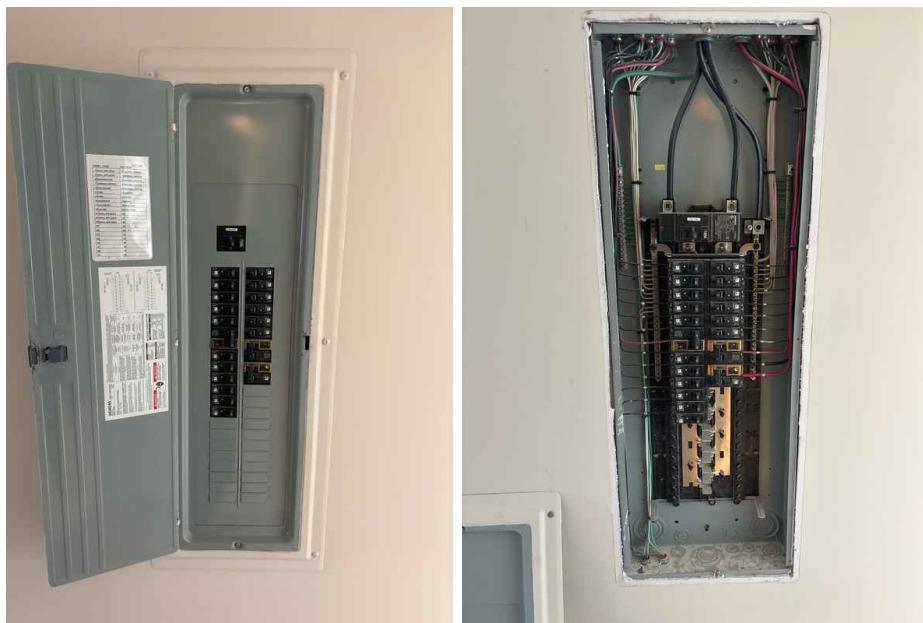
Main and Distribution Panels: Picture of Panels

Pictures of electrical panel(s).

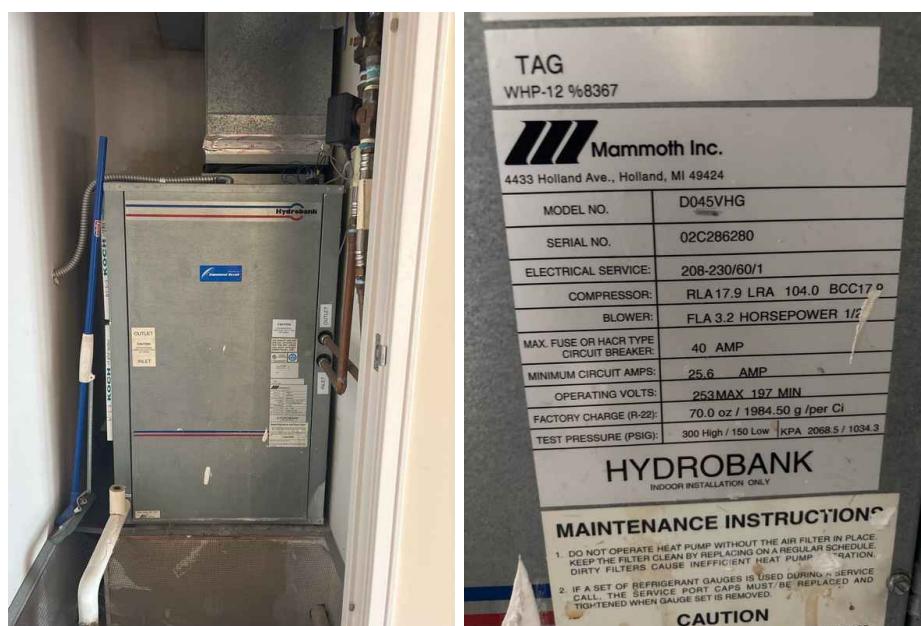
Heating Equipment : Picture of Heating Equipment

Picture of heating equipment.

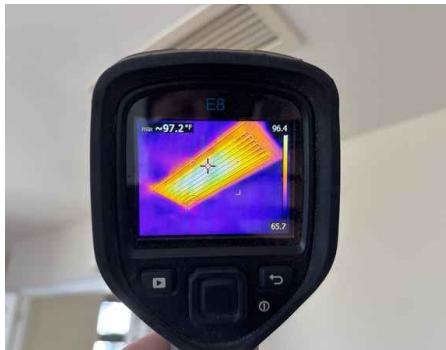
Heating Equipment : Thermal Image Showing Operation

The furnace turned on and produced heat at the time of the inspection.

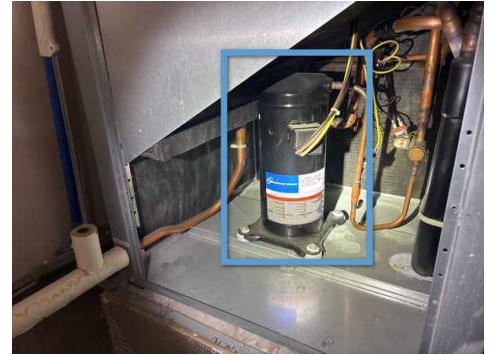
11.1.3 Heating Equipment

PREVIOUS REPAIRS

Contact a qualified professional.

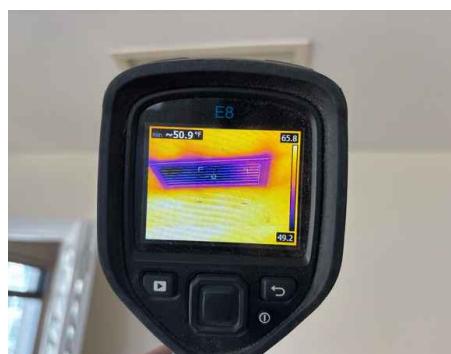
Cooling and Air Handler Equipment: Thermal Image Showing Operation

The AC appeared to turn on and produce cold air at the time of the inspection.
