### CONFIDENTIAL INSPECTION REPORT

9810 Guisante Terrace, San Diego, CA 92124

2/10/2026 1:00 pm to 3:00 pm

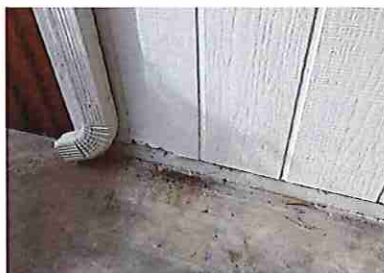
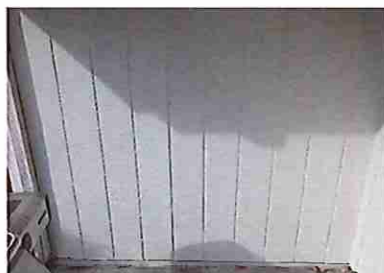
2.9 - The wood siding is in functional condition, with some minor deterioration noted at various locations.

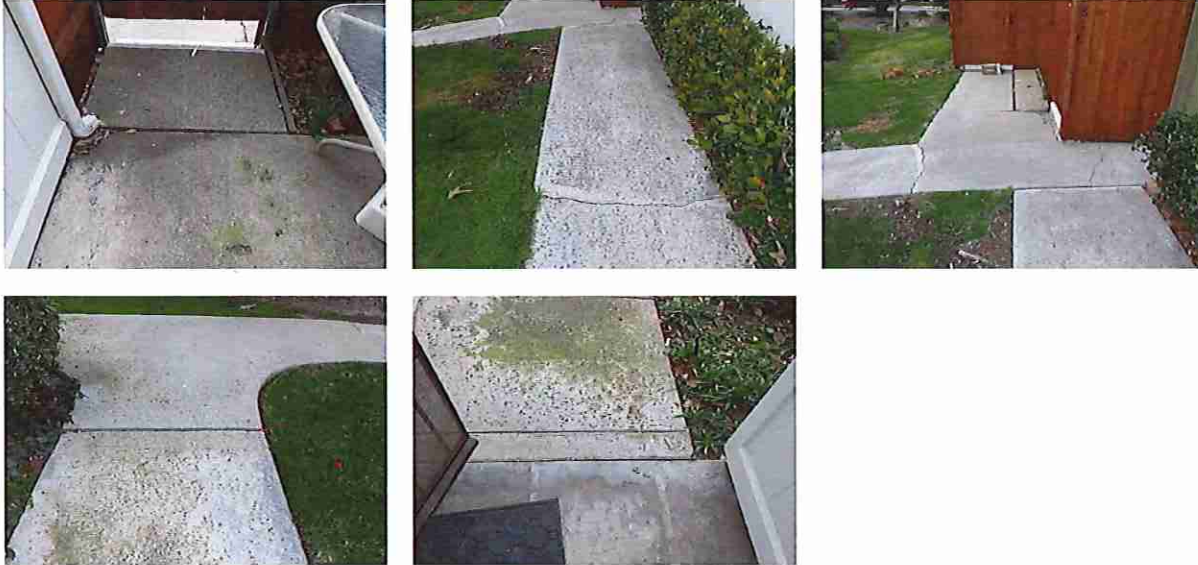
2.12 - There are several cracks and or offsets in the walkways that could prove to be trip-hazards.

2.13 - One or more sections of the walkways have been displaced by root and or soil movement, which could present a trip-hazard. Further evaluation and repair by a licensed contractors advised.

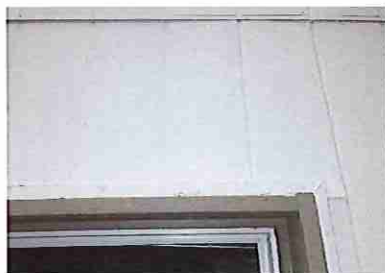
2.17 - There is possible moisture and or termite damage noted in the wood trim, fascia boards, and eaves at various locations throughout the building. (Above the overhead garage door) Further evaluation and repair by a licensed Pest Control Operator is advised.

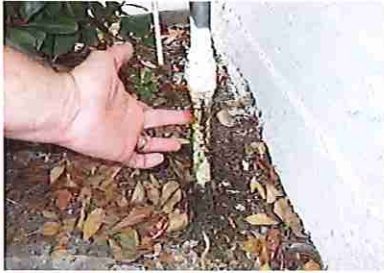
4.2 - There appears to be a leak in the main water supply line at the rear of the home. Further evaluation and repair by a licensed plumber is advised.

SOLD TO		JOB	SAME	
ADDRESS		ADDRESS		
CITY, STATE, ZIP		CITY, STATE, ZIP		
CUSTOMER PHONE		TERMS	DATE	2/17/26
ORDERED	SHIPPED	DESCRIPTION	PRICE	UNIT
		REPLACED MAIN WATER SHUT OFF AND REGULATOR. SET PRESSURE AT 60 PSI.		
		TOTAL LABOR & MATERIAL		525.00
		TAX		
		LABOR		
		TOTAL		525.00

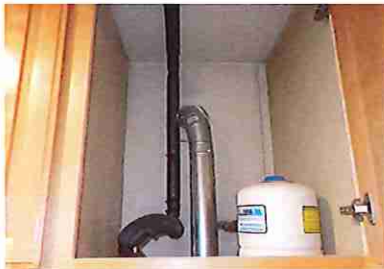
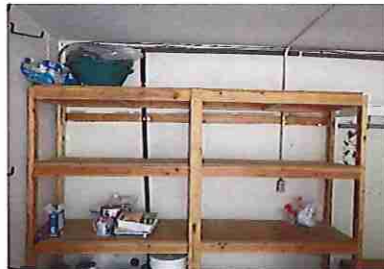
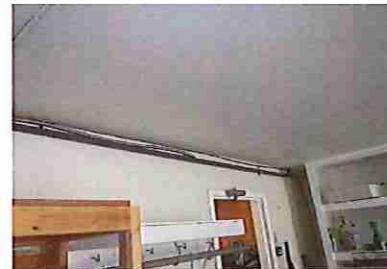
4.6 - A small section of the home has been re-piped from galvanized pipes to copper pipes, which are functional. Visible in the garage and water heater closet.

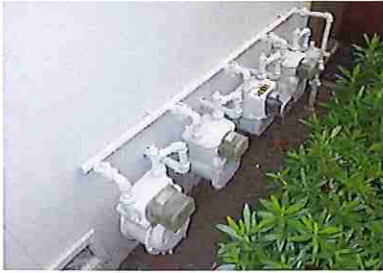
4.7 - The gas main shut-off is located on the East side of the building. You should be aware that gas leaks are not uncommon, particularly underground ones, and that they can be difficult to detect without the use of sophisticated instruments, which is why natural gas is odorized in the manufacturing process. Therefore, we recommend that you request a recent gas bill from the sellers, so that you can establish a norm and thereby be alerted to any potential leak.

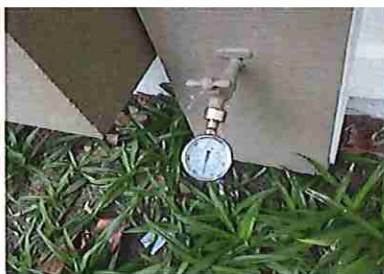
4.24 - One or more hose bibs are leaking and should be repaired by a licensed plumber. (Front hose bib)

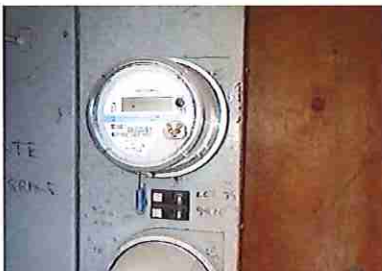
5.5 - The 70 amp main panel is small by current standards, and you may wish to have it further evaluated by a licensed electrician with a view to upgrading the service.

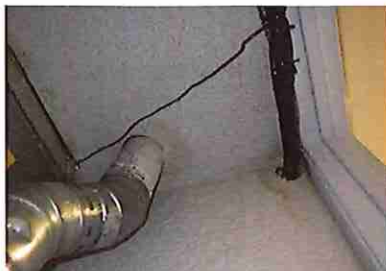
7.5 - There are stains around the vent pipe and refrigerant line on the wall and ceiling of the furnace closet. Further evaluation by a licensed roofer is advised.

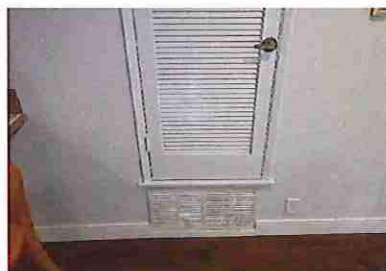
7.10 - The louvered door, which is the combustion air ventilation for the gas furnace, and the return air grill, are too close, which may cause mixing of combustion air and return air, which could mean that combustion air may be redistributed into the home through the supply ducts. Further evaluation and repair by a licensed HVAC contractor is advised.

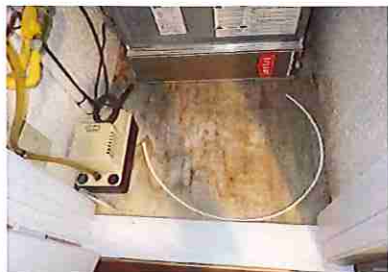
7.15 - There are stains on the platform below the condensate drain lines that indicate previous leaks have occurred. Consult the Seller and or a licensed HVAC contractor for further information regarding this condition.

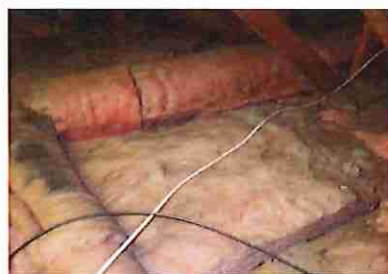
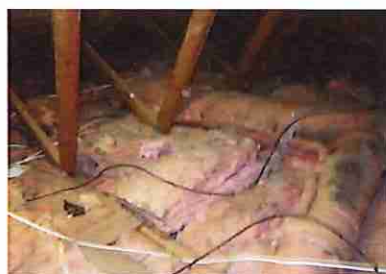
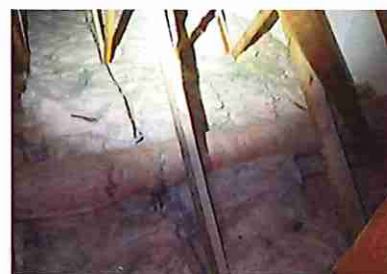
7.23 - This is the original ductwork to the home and is inefficient by today standards.

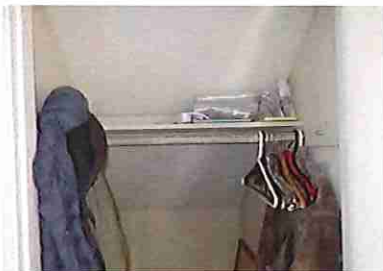
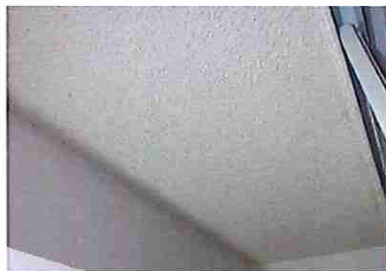
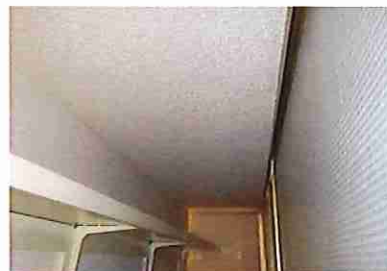
9.3 - The acoustic sprayed ceilings may contain asbestos. (Acoustic spray was left on the ceilings in the closets) We do not have the expertise or the authority to detect the presence of environmental contaminants. If this is a concern, you should consult with a licensed environmental hygienist, particularly if you intend to remodel any area of the residence.

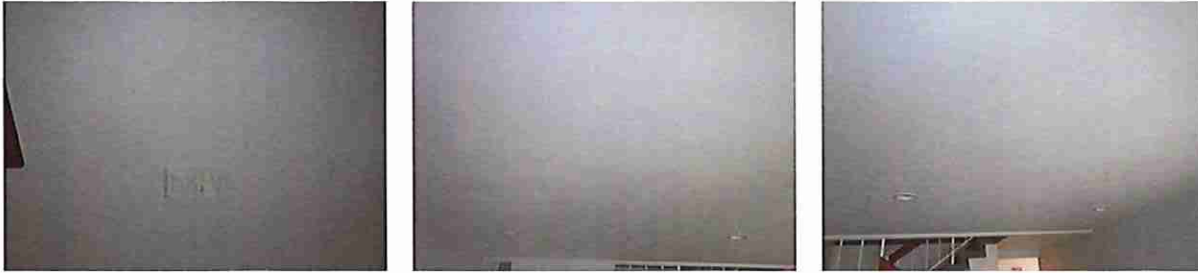
9.7 - There are patched areas in the walls and or ceiling, which you should question the seller about, or have further evaluated by a licensed contractor.

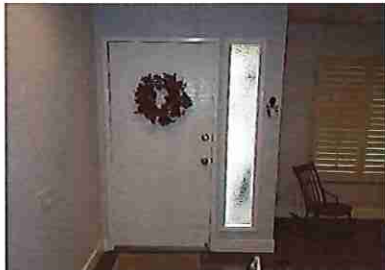
9.9 - The glass in the window does not appear to be tempered safety glass, as required by current building standards.

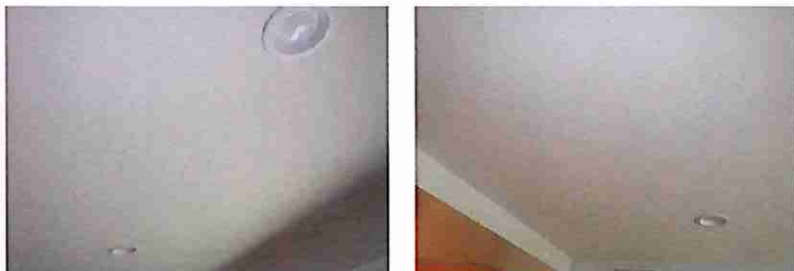
9.19 - There are patched areas in the walls and or ceiling, which you should question the seller about, or have further evaluated by a licensed contractor.

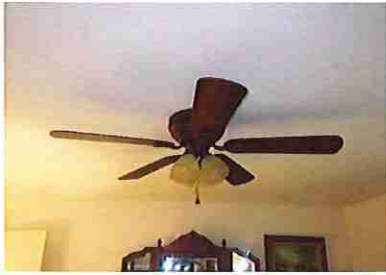
10.7 - The combination ceiling fan and light is functional, however, is hard wired without a wall switch to turn the power off and on to the fan. Building standards require a switch to power the fan off and on, which you may wish to have a licensed electrician properly repair.

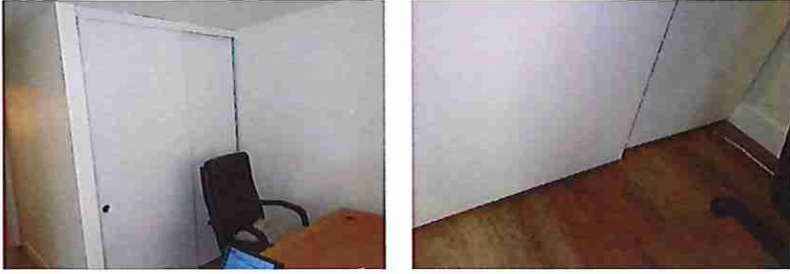
10.34 - The closet doors are the wrong size for the opening and the door guide is missing on the floor.

The closet doors are the wrong size for the opening - *Continued*

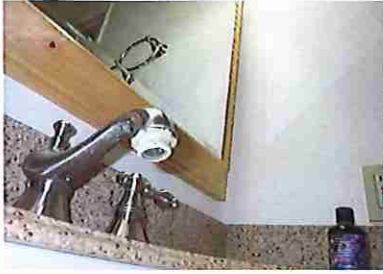
11.9 - There is corrosion noted on the sink faucet aerator, which should be serviced.

There is corrosion noted on the sink faucet aerator - *Continued*

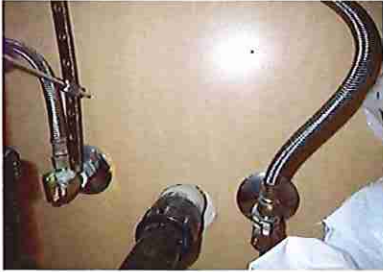
11.23 - Corrosion was noted on the water lines and or connectors below the sink, which should be serviced by a licensed plumber.

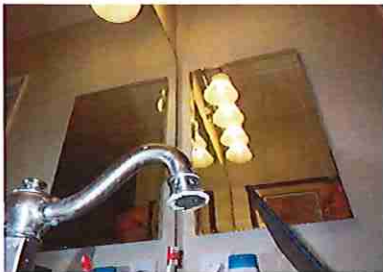
11.24 - There is corrosion noted on the sink faucet aerator, which should be serviced.

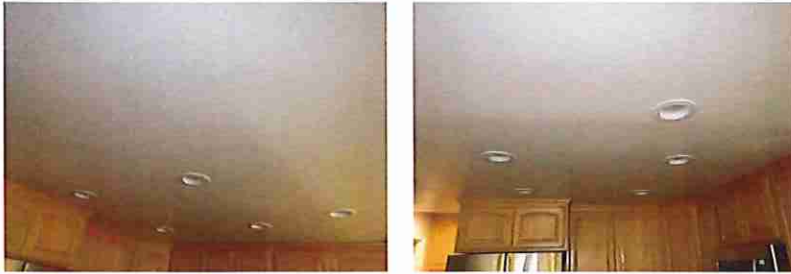
12.4 - There are patched areas in the walls and or ceiling, which you should question the seller about, or have further evaluated by a licensed contractor.

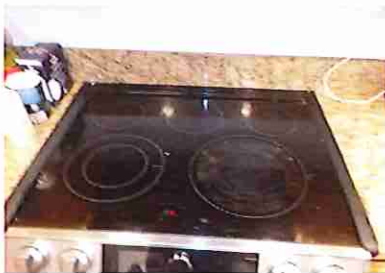
12.13 - Surface scratching was noted on the cook top surface, which you may wish to view for yourself.

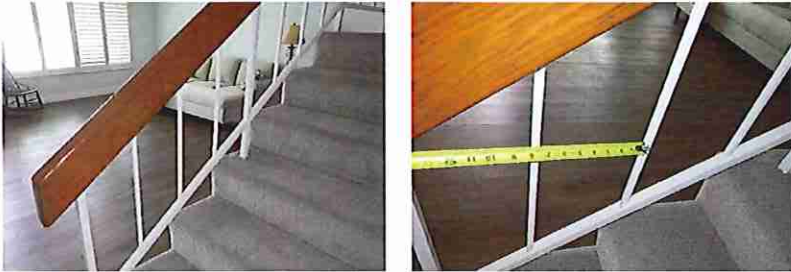
15.5 - The balusters in the stair rails are more than four-inches apart and are not child safe. Therefore, you may wish to add a protective barrier.

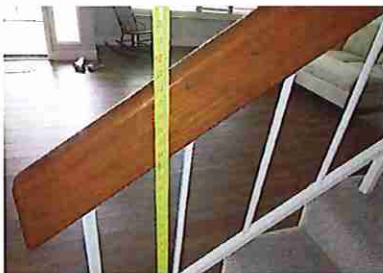
15.7 - The handrail for the staircase is too low and does not meet current building requirements. For safety reasons, upgrading the handrail is advised.

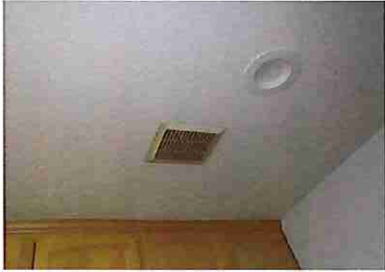
16.6 - There is no exhaust fan, which you may want to install for better ventilation of the room. (The fan appears to have been removed)

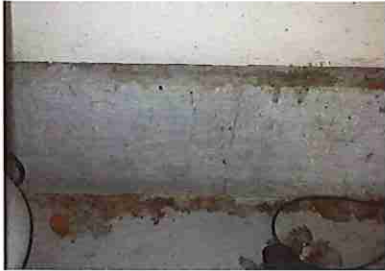
17.2 - There are small cracks in the stem walls of the garage footing that we do not regard as being structurally significant, which you may wish to view for yourself and decide whether or not you want a second opinion.

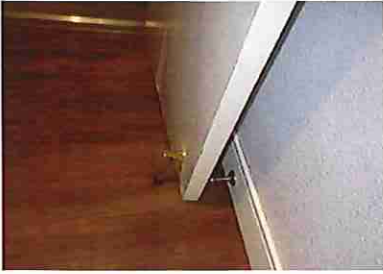
17.8 - There is a door stopper that has been added to the door to keep it in the opened position, this is not allowed for fire separation requirements. Removal of the door stopper is advised.

There is a door stopper that has been added to the door to keep it in the opened position - *Continued*

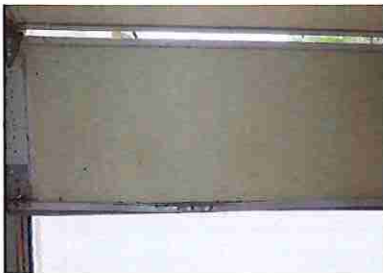
17.10 - There are one or more panels of the roll-up garage door that are bent and damaged. Proper repairs are recommended by a licensed contractor.

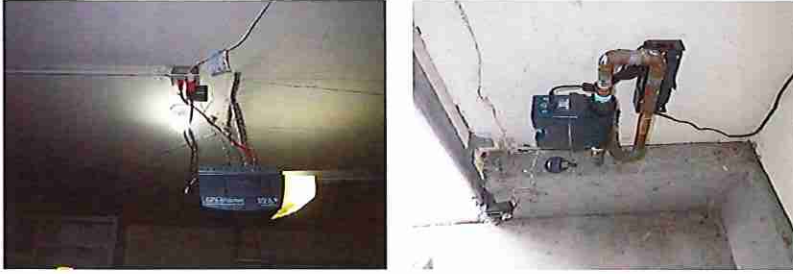
17.14 - There is extension cord wiring being used to operate permanently installed fixtures. (The extension cord is run from the garage door outlet in the ceiling to the added leak detector at the front of the garage) Further evaluation and repair by a licensed electrician is advised.

There is extension cord wiring being used to operate permanently installed fixtures - *Continued*

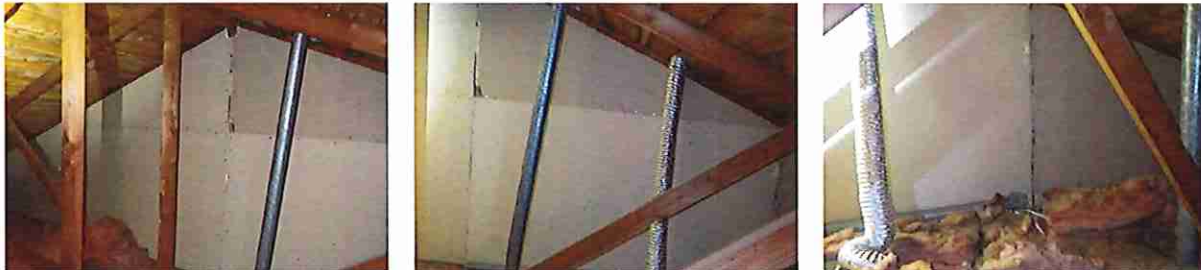
18.3 - The fire separation wall between the units was not properly sealed. Further evaluation and repairs by a licensed contractor is advised before the close of escrow.

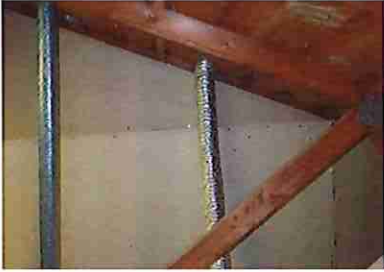
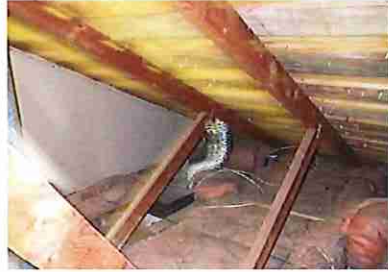
18.10 - The bathroom and kitchen exhaust ducts are improperly ducted using flexible dryer duct material. Further evaluation and repair by a licensed contractor is advised.
