## RESIDENTIAL INSPECTION

3887 Pell Pl 314  
San Diego, CA 92130

Joy Yoo  
03/27/2026

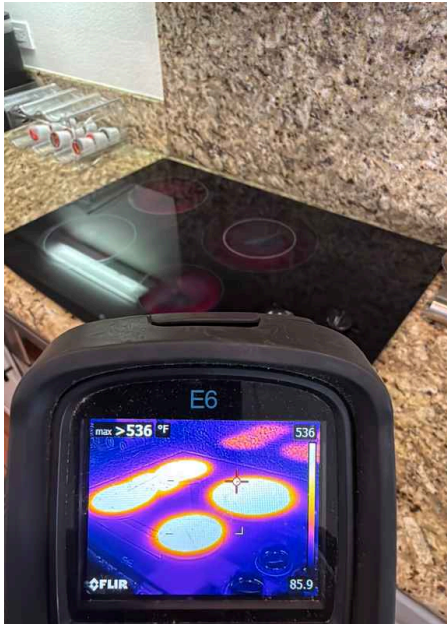
## RANGES AND COOKTOPS: Thermal Image Showing Range Working

Infrared picture of range/cooktop in operation. This unit appeared to be functional at the time of the inspection.

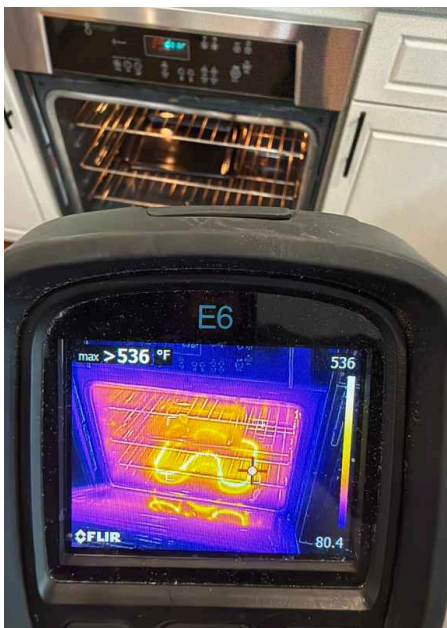
## OVEN: Thermal Image Showing Oven Working

Infrared picture of the oven(s) in operation. The unit(s) appeared to be functional at the time of the inspection.

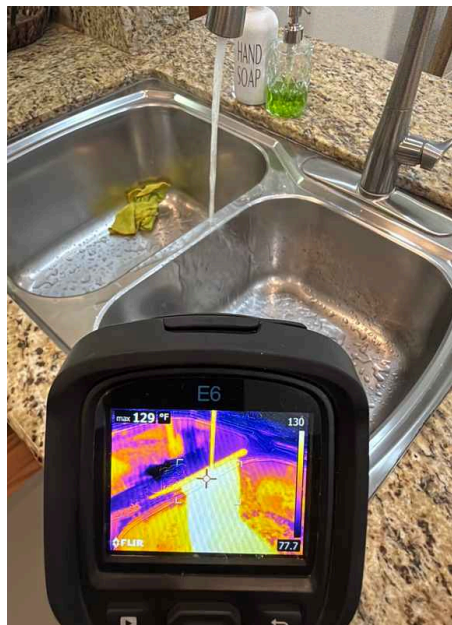
## WATER HEATERS, CONTROLS, FLUES AND VENTS: Thermal Image of Hot Water

Infrared image(s) showing the water heater(s) producing hot water at the time of the inspection.

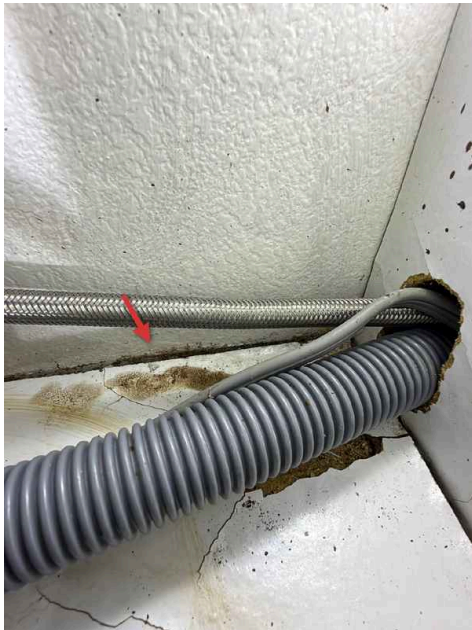
Example Noted Below the Kitchen Sink

### 5.5.3 COUNTERS AND A REPRESENTATIVE NUMBER OF CABINETS

#### **POSSIBLE ORGANIC GROWTH (DRY)**

#### Recommendation

Contact a qualified environmental contractor

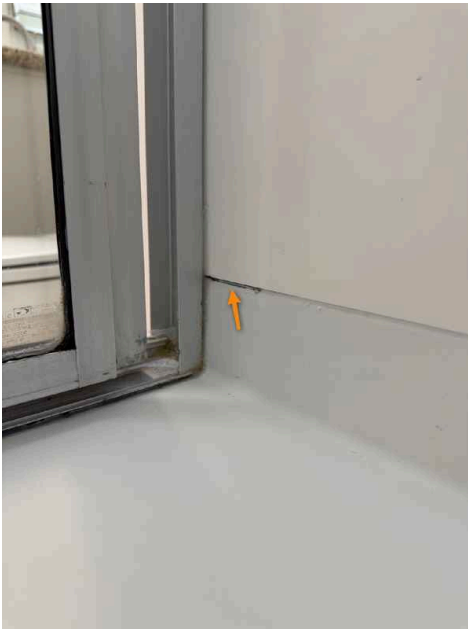
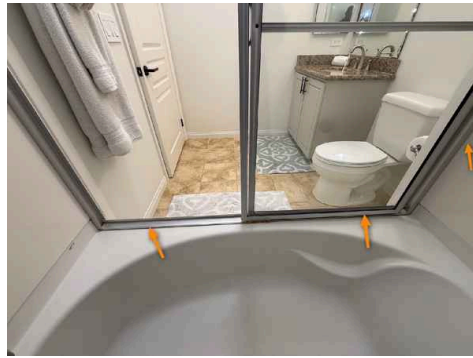
Example Noted at Master Bathroom

#### 5.6.1 TUB/SHOWER ENCLOSURES

#### Recommendation

Contact a handyman or DIY project

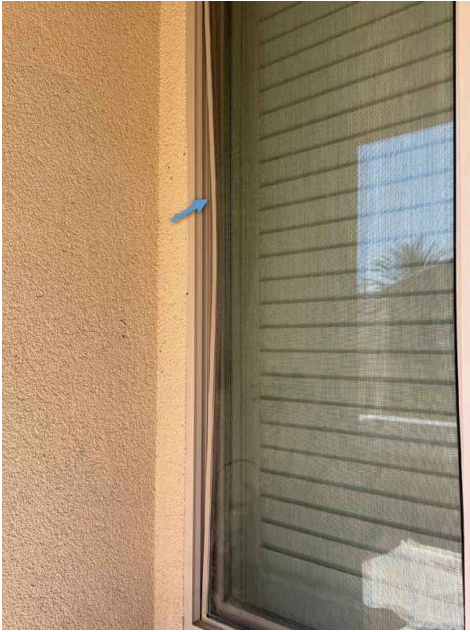
Example Noted Balcony

## 5.8.1 WINDOWS (REPRESENTATIVE NUMBER)

## Recommendation

Contact a qualified professional.
