Inspection Report

Property Address:
1641 Pentecost Way
unit 10
San Diego CA 92105

Champion Properties Home Inspections

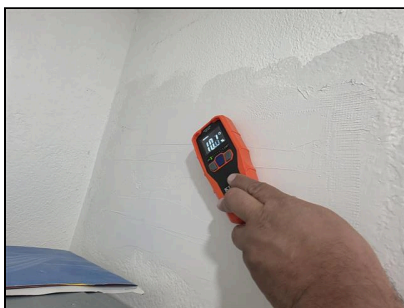
1.1 Item 1(Picture)

1.1 The sheetrock on the wall reveals minor repairs and mismatch in paint touch up at the home. This damage is considered cosmetic The moisture meter was used and it did not indicate an active leak. A qualified person should repair or replace as needed.

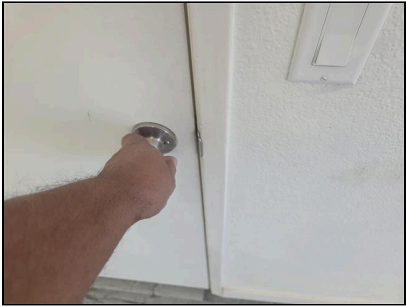
1.4 Item 1(Picture)

1.4 (1) The Entry door does not catch strike-plate on jamb at the Bedroom. Door does not lock. This is a maintenance issue and is for your information. A qualified person should repair or replace as needed.

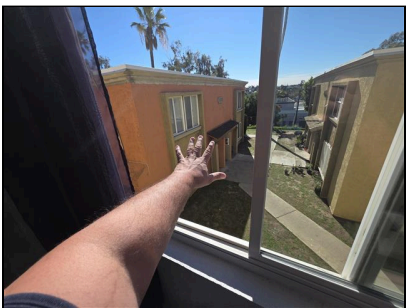
1.5 Item 1(Picture)

1.5 (1) Most window missing screens at the home. This is a maintenance issue and is for your information. A qualified person should repair or replace as needed.

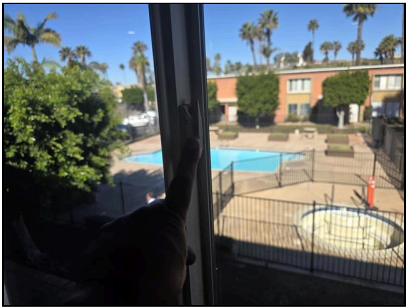
1.5 Item 4(Picture)

1.5 (2) One window handle or lock hardware need adjustment at the Living Room. Window does not lock. Further deterioration may occur if not repaired. A qualified person should repair or replace as needed.

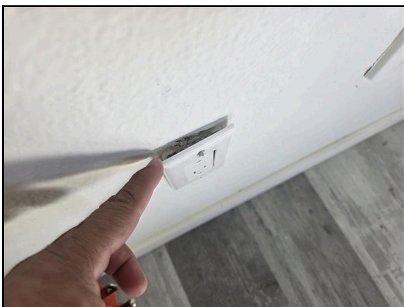
1.6 Item 1(Picture)

1.6 (1) One cover plate is loose off the wall in the Bedroom. Electrical issues are considered a hazard until repaired. This is a safety issue that needs to be corrected. A qualified licensed electrical contractor should correct as needed.

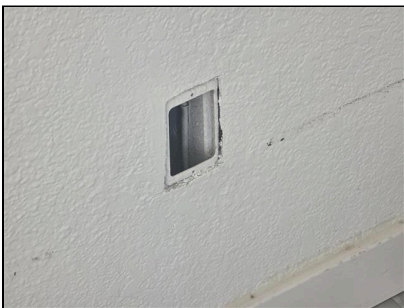
1.6 Item 3(Picture)

1.6 (2) One CATV outlet is missing a cover-plate at the Bedroom. Electrical issues are considered a hazard until repaired. This is a safety issue that needs to be corrected. A qualified licensed electrical contractor should perform repairs that involve wiring.

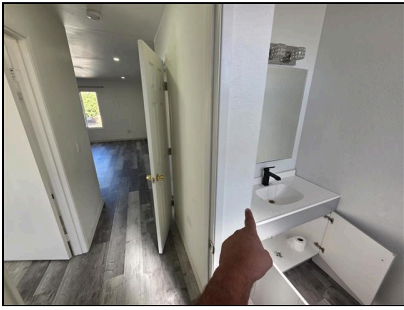
1.6 Item 5(Picture)

1.6 (3) The laundry room wall switch for light fixture is installed at a different room (at the Hall Bath). This is not adequate. Electrical issues are considered a hazard until repaired. This is a safety issue that needs to be corrected. A qualified licensed electrical contractor should correct as needed.

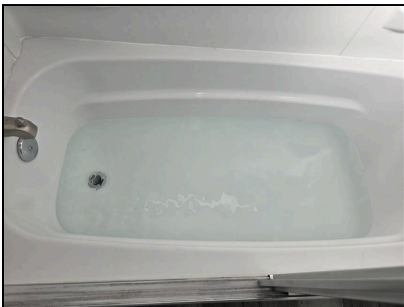
2.3 Item 1(Picture)

2.3 The plumbing waste line drains slowly at the Hall Bath tub. Repairs are needed. A qualified licensed plumber should repair or correct as needed.

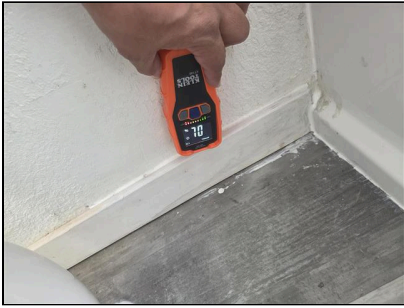
2.8 Item 1(Picture)

2.8 The sheetrock on the wall shows moisture or water intrusion did or still may occur. Water is entering behind covering and needs correcting at the Hall Bath. The moisture meter was used and it recorded 19% or higher, which indicates the leak has not been corrected. This is a safety issue. A qualified person should repair or replace as needed.

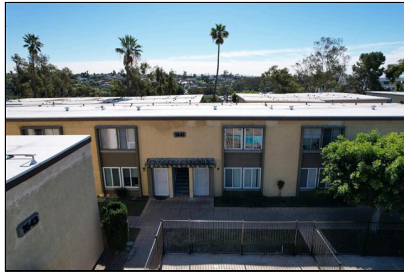
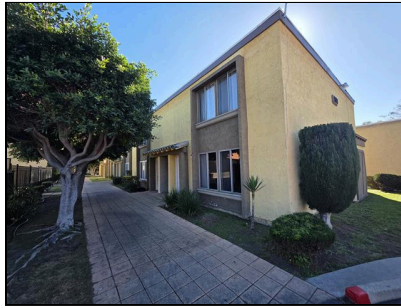
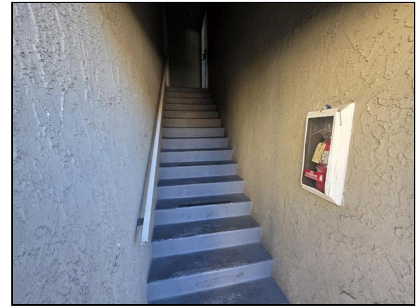
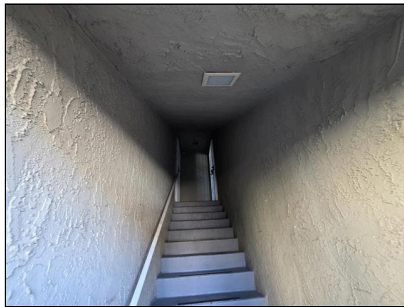
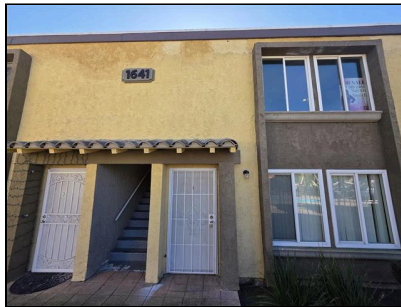
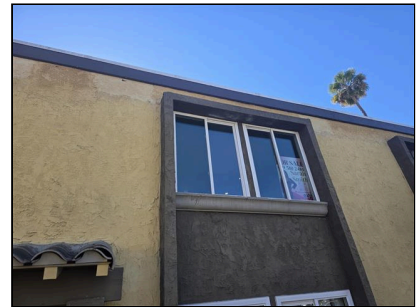
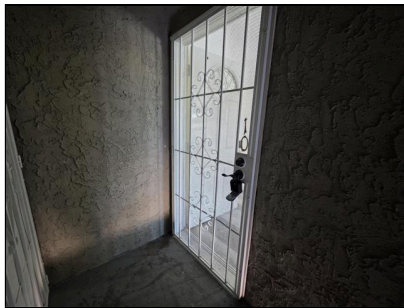
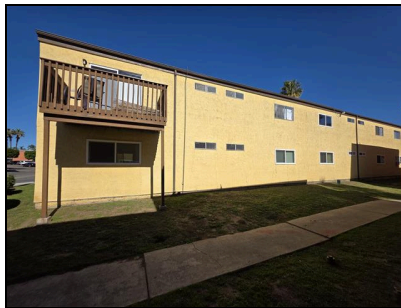
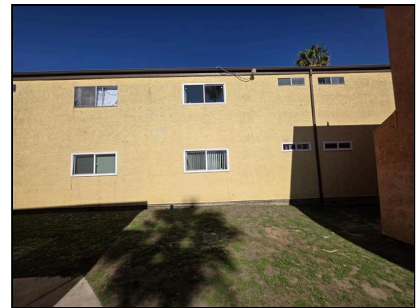
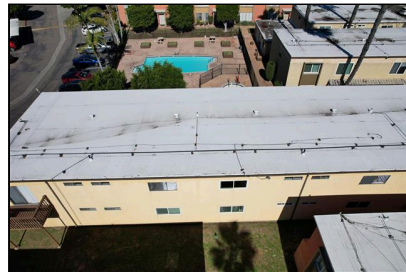
5.0 The Stucco coating at the exterior in areas damaged or has hairline cracks. The moisture meter was used and it did not indicate an active leak. This is a cosmetic issue due to ground settlement. Further deterioration can occur if not corrected. A qualified person should repair or replace as needed.

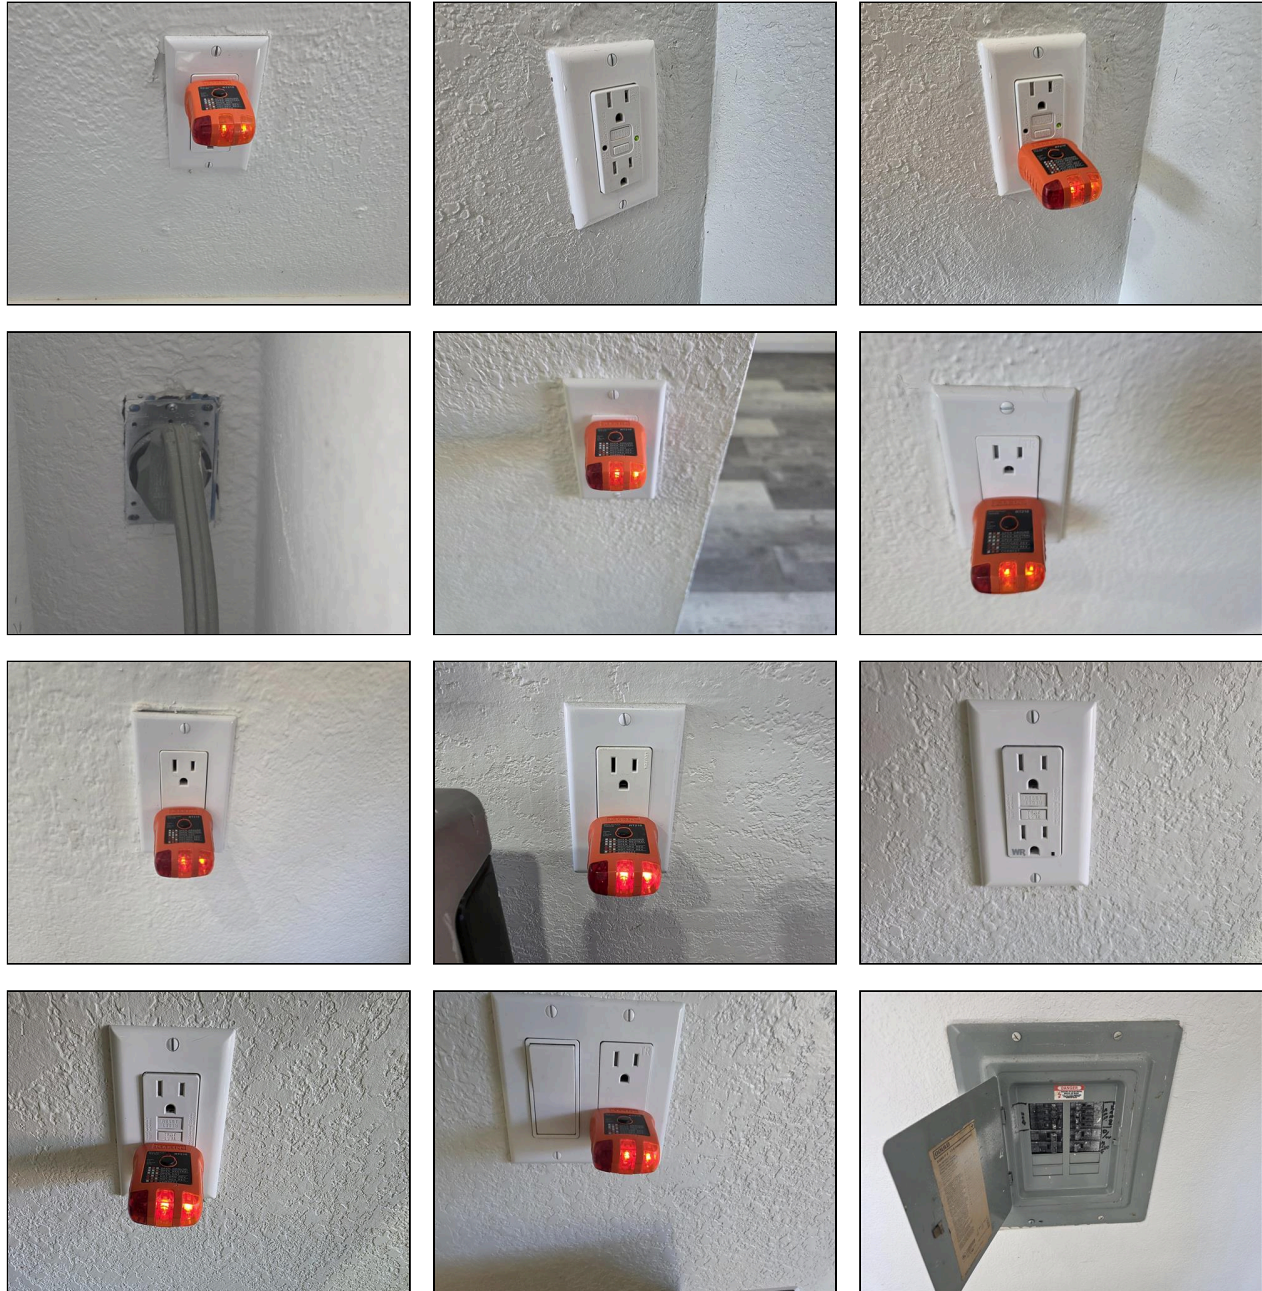
8.1 (2) The main electrical panel screws are loose. This is a maintenance issue that needs to be corrected. A qualified licensed electrical contractor should correct as needed.

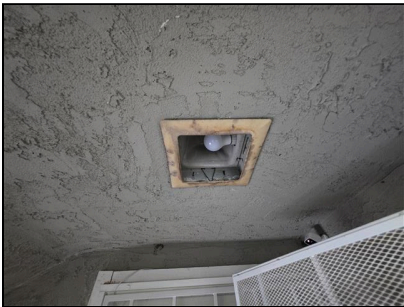
8.3 Item 1(Picture)

8.3 The light fixture does not work (try bulb first) at the exterior main entry. Electrical issues are considered a hazard until repaired. This is a safety issue that needs to be corrected. I recommend repair as needed. A qualified licensed electrical contractor should perform repairs that involve wiring.

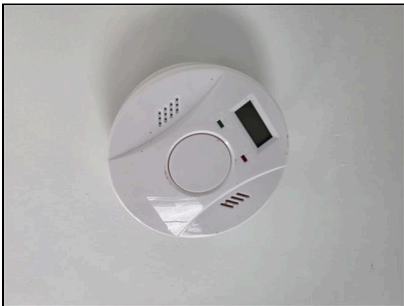
8.7 Item 1(Picture)

8.7 (1) The smoke detector did not work when tested and are in need of a back up battery at the Bedroom. Without a working smoke detector in your home you have no first alert to a possible fire. A qualified person should repair or replace as needed.

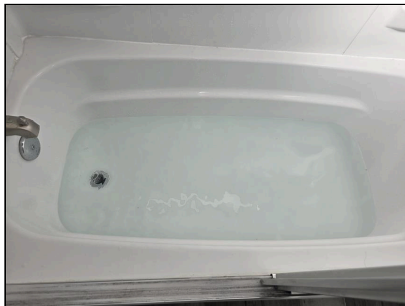
2.3 Item 1(Picture)

The plumbing waste line drains slowly at the Hall Bath tub. Repairs are needed. A qualified licensed plumber should repair or correct as needed.

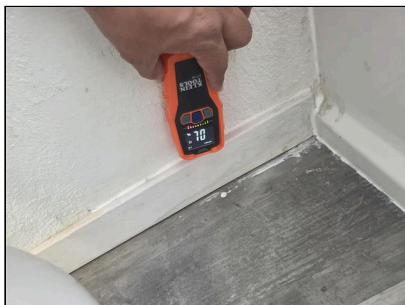
2.8 Item 1(Picture)

The sheetrock on the wall shows moisture or water intrusion did or still may occur. Water is entering behind covering and needs correcting at the Hall Bath. The moisture meter was used and it recorded 19% or higher, which indicates the leak has not been corrected. This is a safety issue. A qualified person should repair or replace as needed.

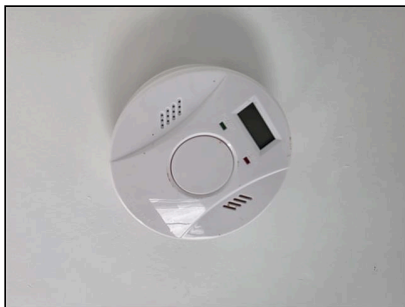
8.7 Item 1(Picture)

(1) The smoke detector did not work when tested and are in need of a back up battery at the Bedroom. Without a working smoke detector in your home you have no first alert to a possible fire. A qualified person should repair or replace as needed.

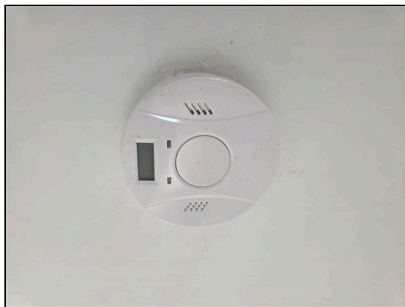
8.7 Item 2(Picture)

(2) The smoke detector did not work when tested and are in need of a back up battery at the common hallway to bedrooms. Without a working smoke detector in your home you have no first alert to a possible fire. A qualified person should repair or replace as needed.
