# Inspection Report

450 E Bradley Ave

**BHI San Diego / Bailey's Home Inspections**

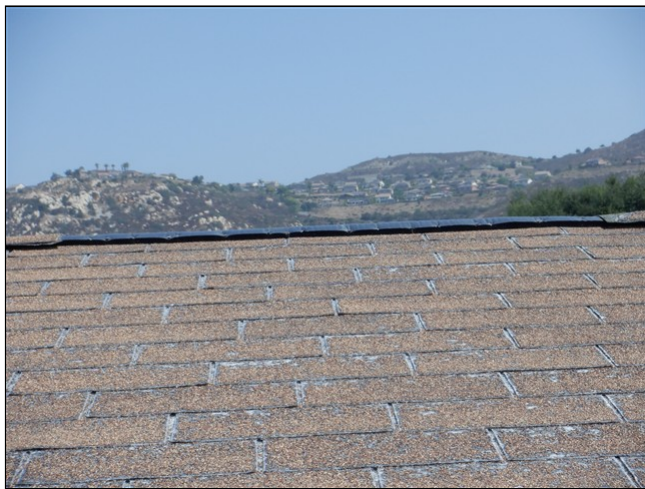
1.0 The roof is a 3-tab fiberglass shingled roof that can last upwards of 20-25 years. The ridge line is straight with no evidence of sagging. There are missing ridge line shingles and wear and tear at the shingles. Recommend evaluation by a licensed roofer and repair/replace.

1.0 Item 14(Picture) Missing ridge line shingles

The roof is a 3-tab fiberglass shingled roof that can last upwards of 20-25 years. The ridge line is straight with no evidence of sagging. There are missing ridge line shingles and wear and tear at the shingles. Recommend evaluation by a licensed roofer and repair/replace.

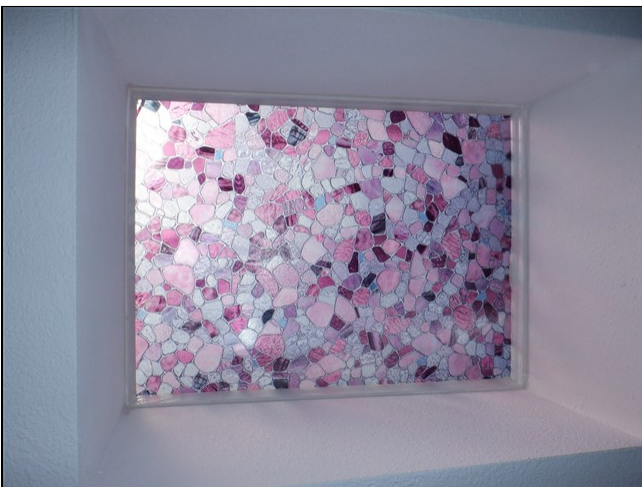
1.1 No evidence of leaks from skylight.

1.1 Item 1(Picture) No evidence of leaks from skylight

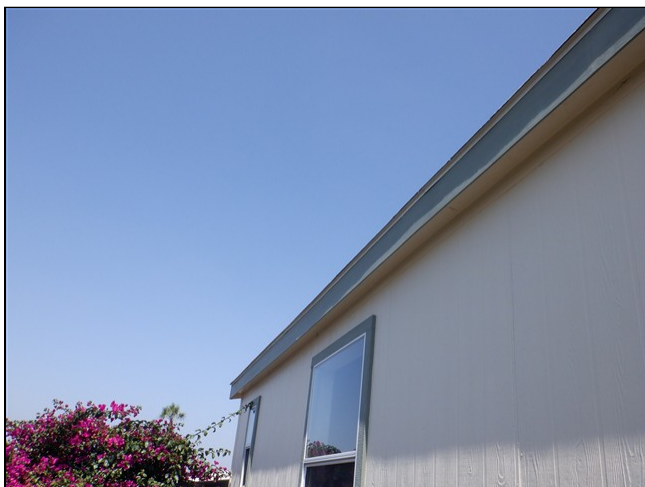
1.2 Item 1(Picture) No gutters

**1.2** Recommend installing gutters on entire home.

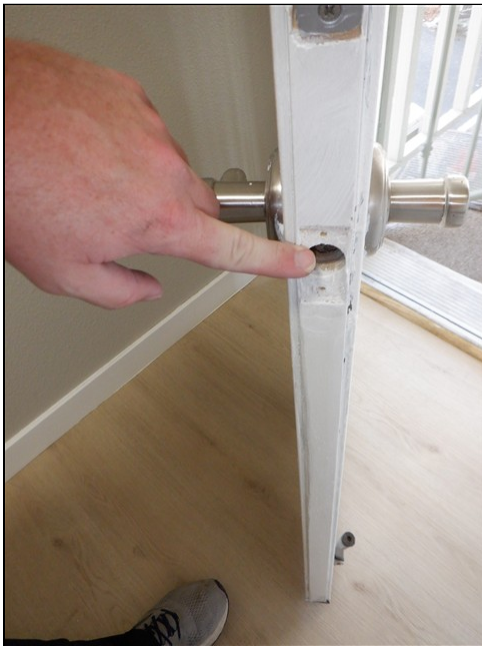
2.1 Laundry room exterior door is missing the latch.

2.1 Item 1(Picture) Missing latch on laundry room exterior door

Laundry room exterior door is missing the latch.

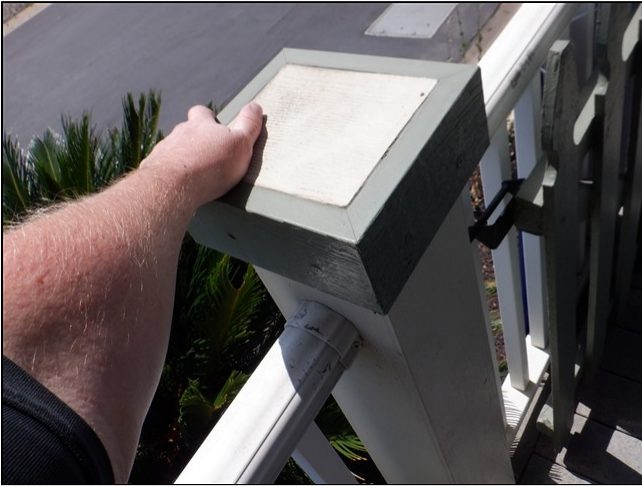
**2.3** Loose railing on front deck.

2.3 Item 1(Picture) Loose railing on front porch

Loose railing on front deck.

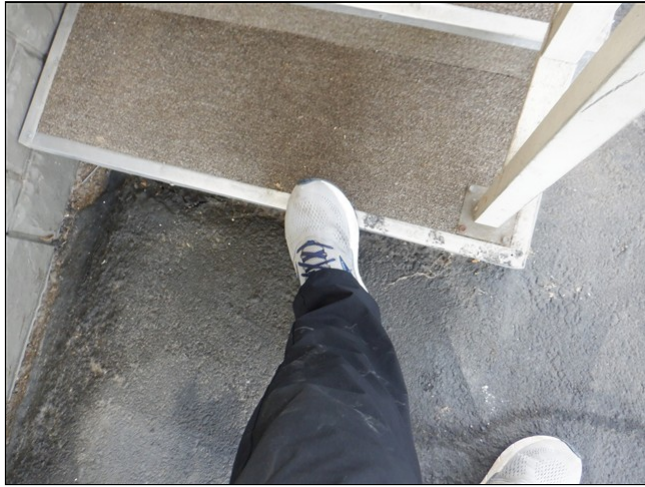
2.3 Item 2(Picture) Loose trim on steps

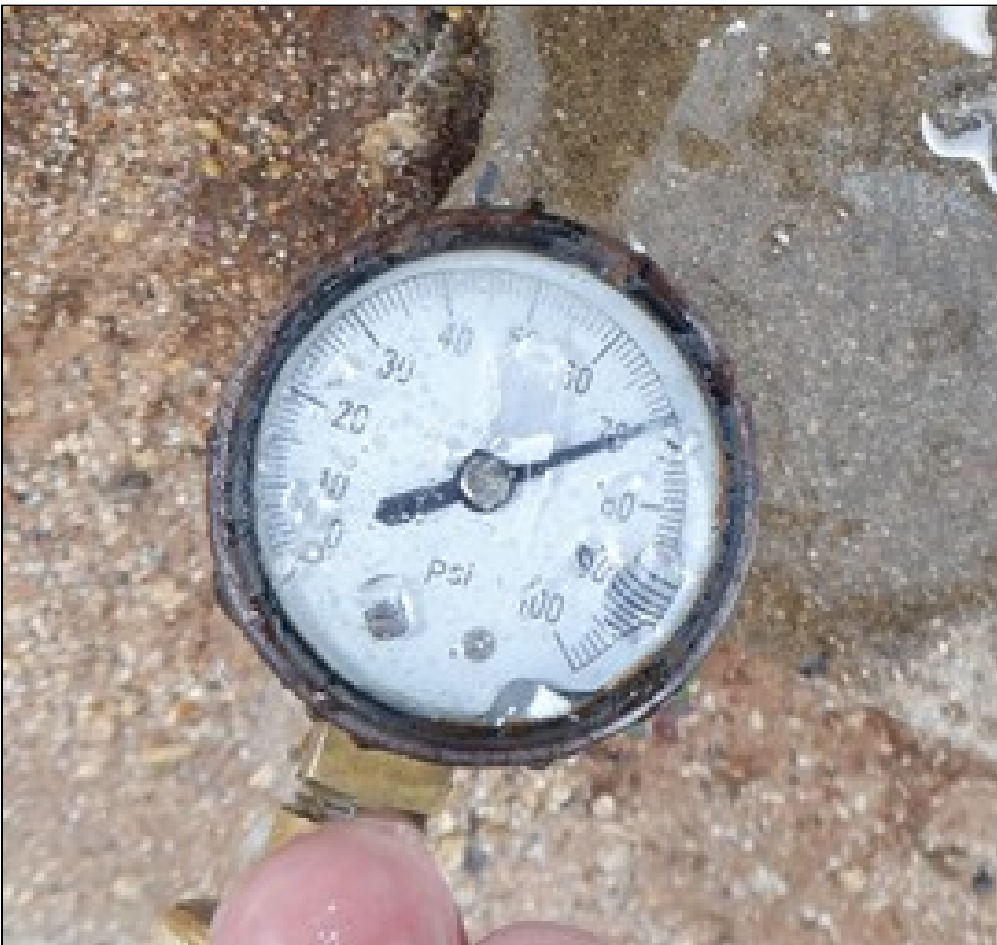
**2.6** Water pressure should read between 40 and 80 PSI. On day of inspection pressure was reading 70-74 PSI.

2.6 Item 1(Picture) Water pressure

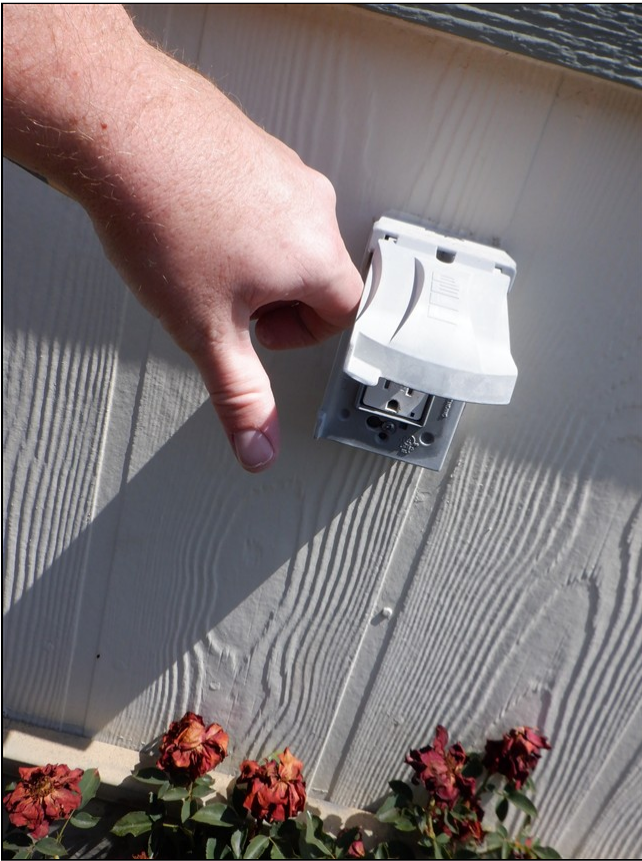
**2.7** Bad GFCI on left side of home. Recommend repair by a licensed electrician.

**2.7** Item 1(Picture) Bad GFCI on left side of home

Bad GFCI on left side of home. Recommend repair by a licensed electrician.

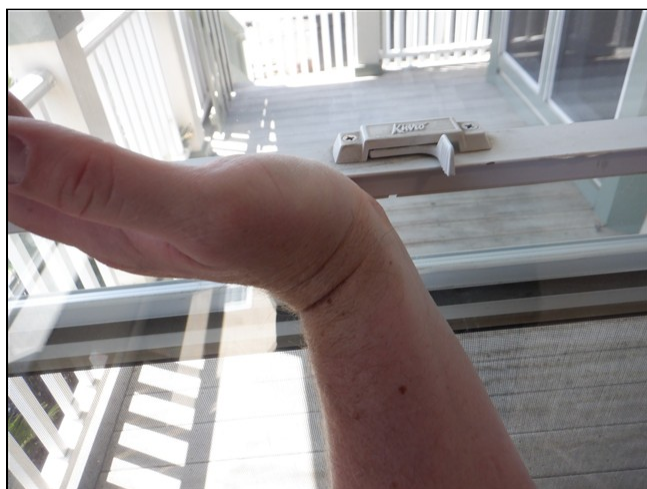
**3.3** The windows throughout the home are original and they are very difficult to open and close and most do not lock properly. Recommend repair.

3.3 Item 1(Picture) Tight window

The windows throughout the home are original and they are very difficult to open and close and most do not lock properly. Recommend repair.

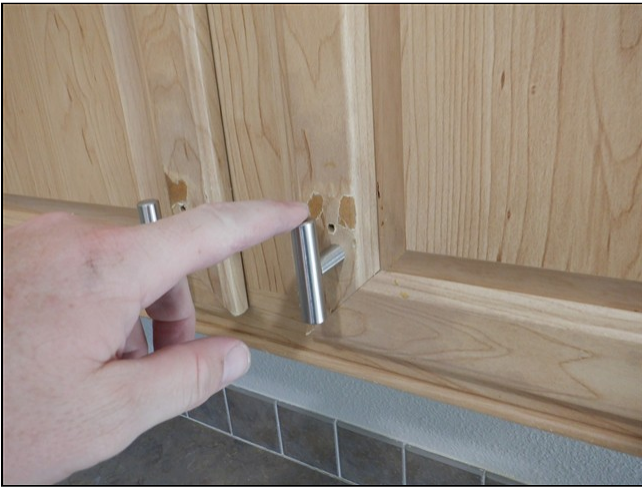
3.4 Wear and tear on some cabinets.

3.4 Item 1(Picture) Wear and tear on cabinets

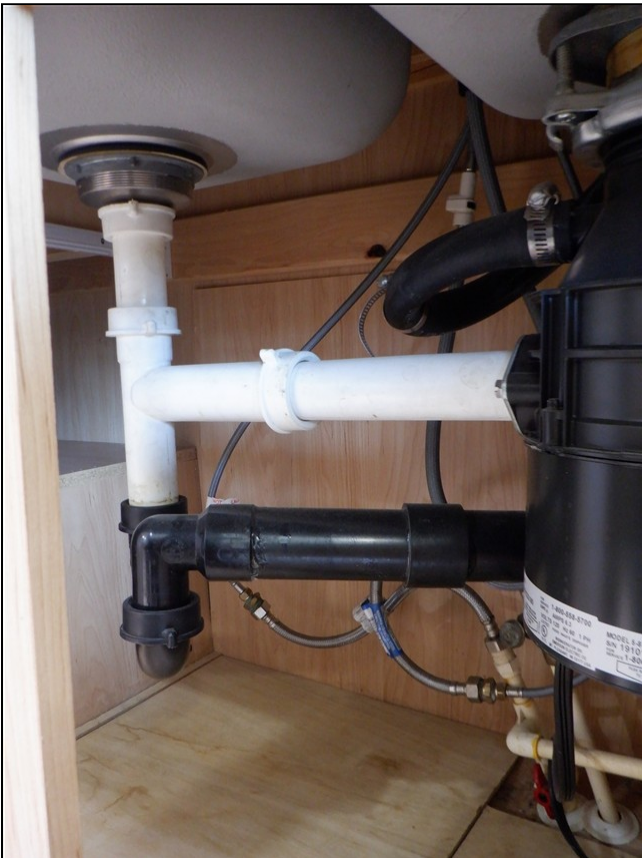
3.5 No leaks under kitchen sink on day of inspection.

3.5 Item 1(Picture) Kitchen sink plumbing / no leaks

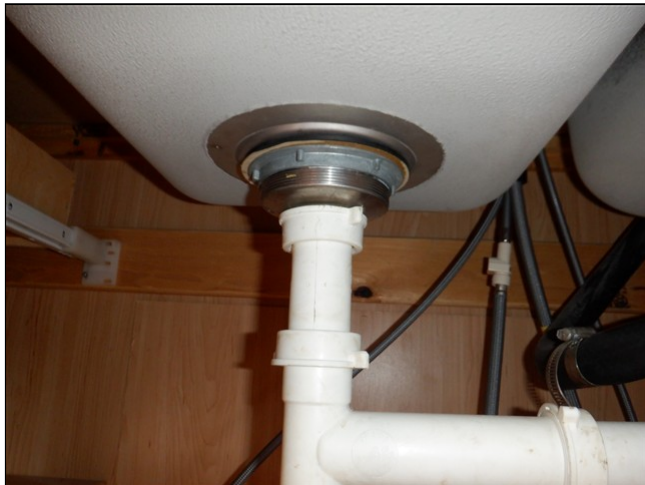
3.5 Item 2(Picture) Kitchen sink plumbing / no leaks

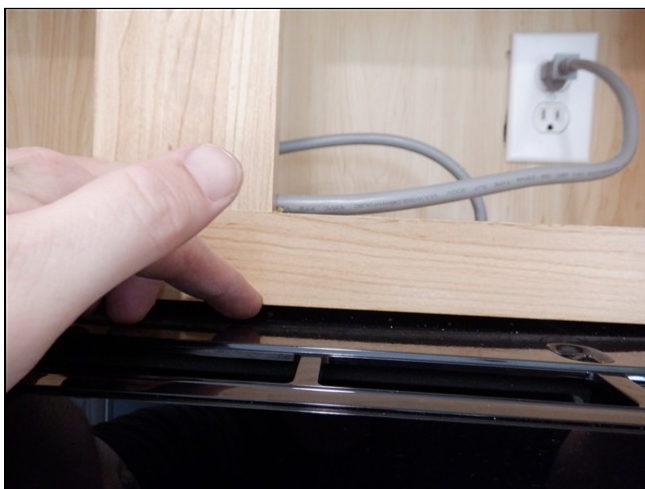
**3.10** The fan is venting under cabinet. Recommend repair.

3.10 Item 1(Picture) Fan venting under cabinet

The fan is venting under cabinet. Recommend repair.

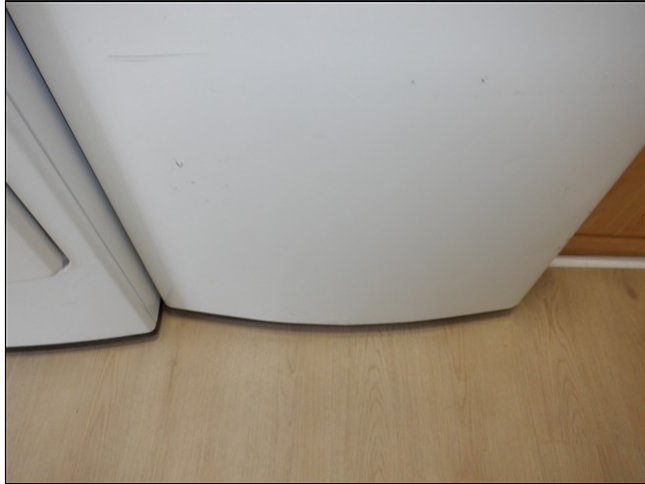
**3.13** The dryer is not connected to dryer vent. It is a gas connection for the dryer. Recommend installing a drip pan under washer in case of leaks.

3.13 Item 2(Picture) Missing drip pan under washer

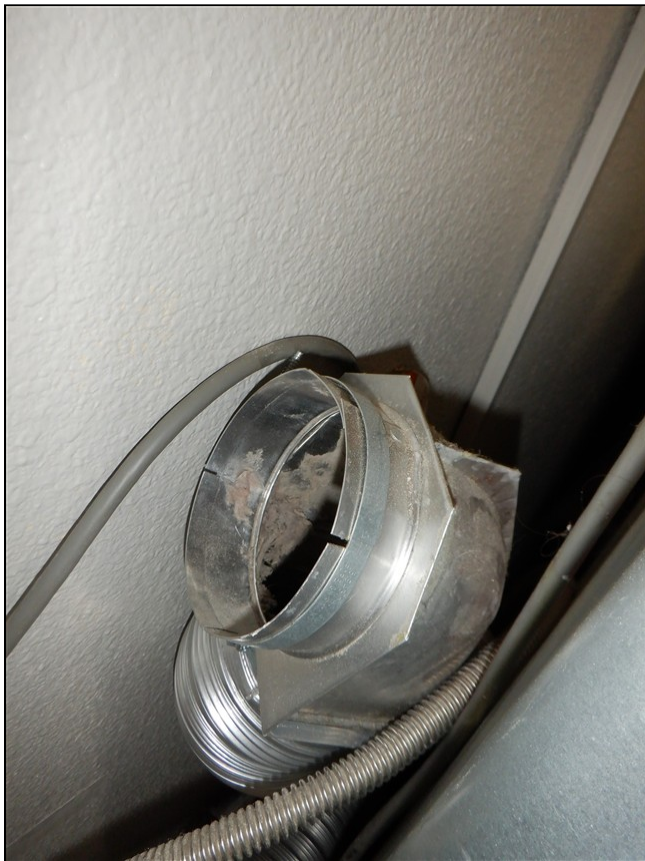
3.13 Item 5(Picture) Dryer vent not connected

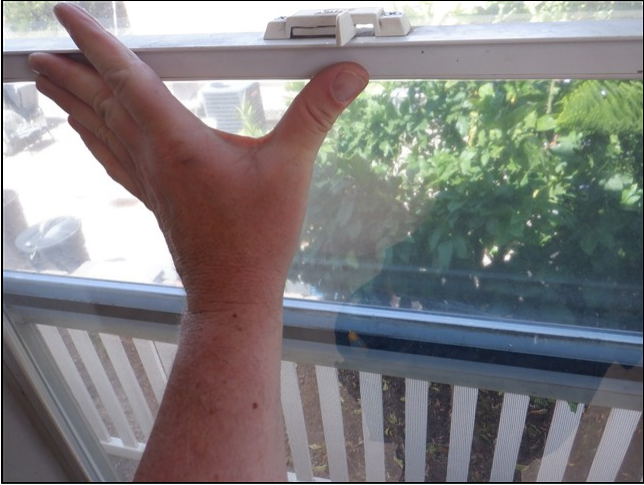
4.4 The windows throughout the home are original and they are very difficult to open and close and most do not lock properly. Recommend repair.

4.4 Item 1(Picture) Windows are difficult to open and close

The windows throughout the home are original and they are very difficult to open and close and most do not lock properly. Recommend repair.

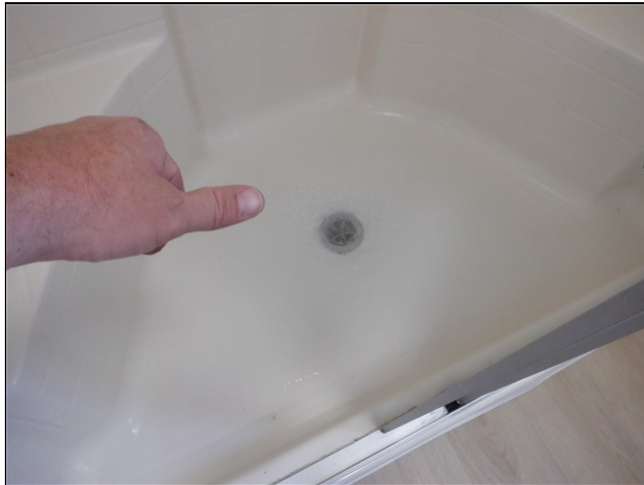
**5.6** No leaks noted under any of the bathroom sinks on day of inspection. The primary bath shower drains slowly, recommend repair.

5.6 Item 2(Picture) Primary bath shower drained slowly

No leaks noted under any of the bathroom sinks on day of inspection. The primary bath shower drains slowly, recommend repair.

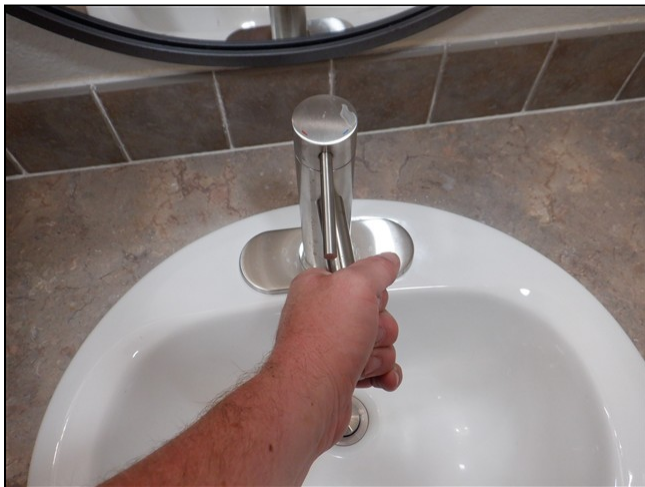
**5.7** Loose sink faucet, shower/tub fixtures not sealed, loose plastic trim at base of shower / tub, old CPVC plastic supply lines, and loose toilet. The older CPVC plumbing does have plastic connectors that do have a history of leaks. No active leaks noted on day of inspection. Recommend upgrading to PEX or copper by a licensed plumber.

5.7 Item 1(Picture) Loose faucet in hallway bath

Loose sink faucet, shower/tub fixtures not sealed, loose plastic trim at base of shower / tub, old CPVC plastic supply lines, and loose toilet. The older CPVC plumbing does have plastic connectors that do have a history of leaks. No active leaks noted on day of inspection. Recommend upgrading to PEX or copper by a licensed plumber.

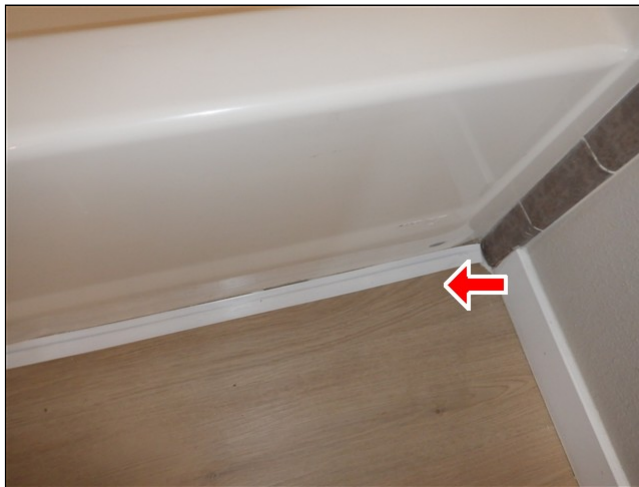
5.7 Item 2(Picture) Loose trim at base of tub

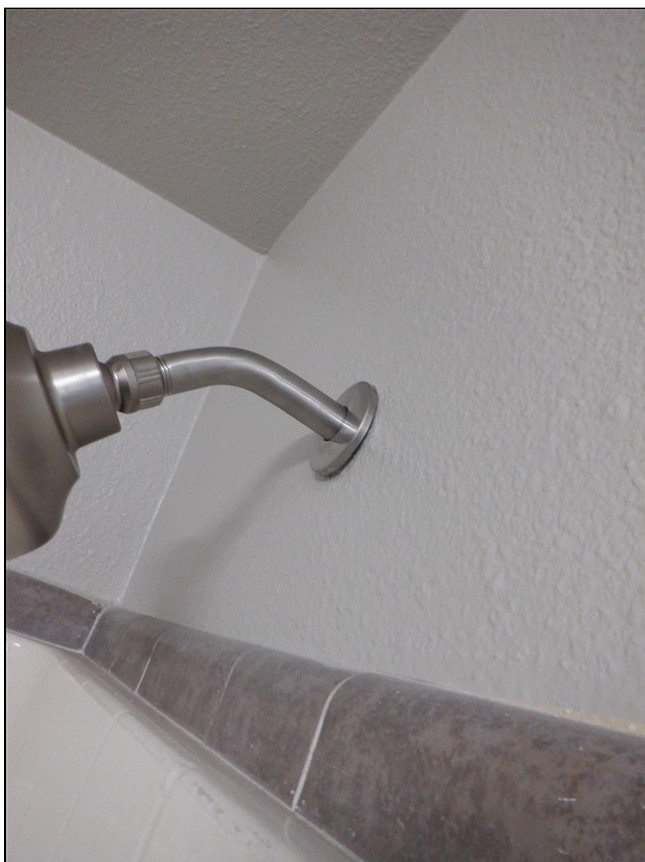
5.7 Item 3(Picture) Hallway bath showerhead not sealed

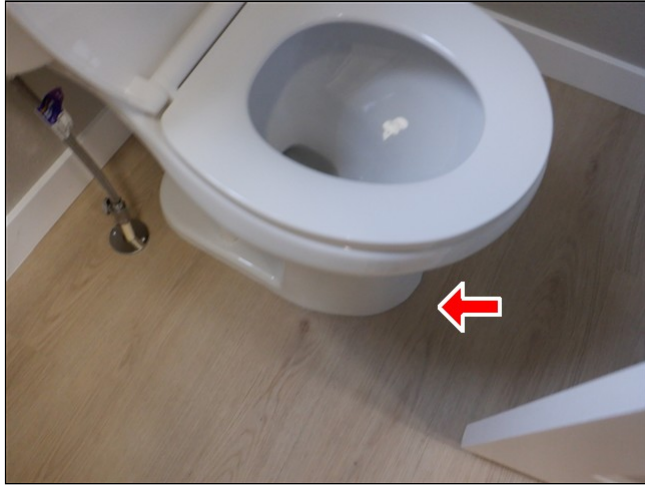
5.7 Item 6(Picture) Loose primary bath toilet

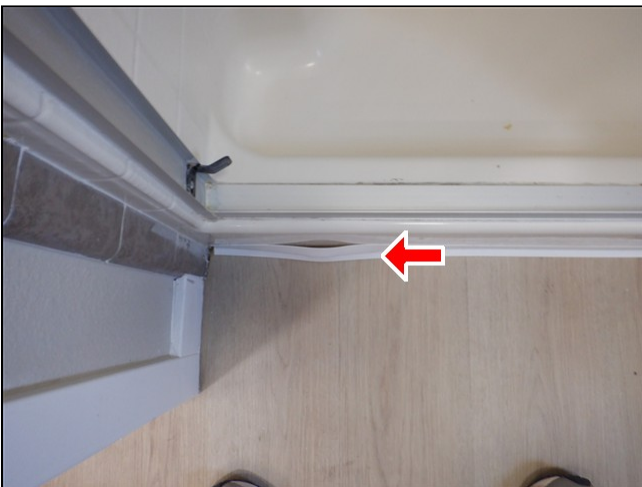
5.7 Item 7(Picture) Loose plastic stripping on primary bath shower

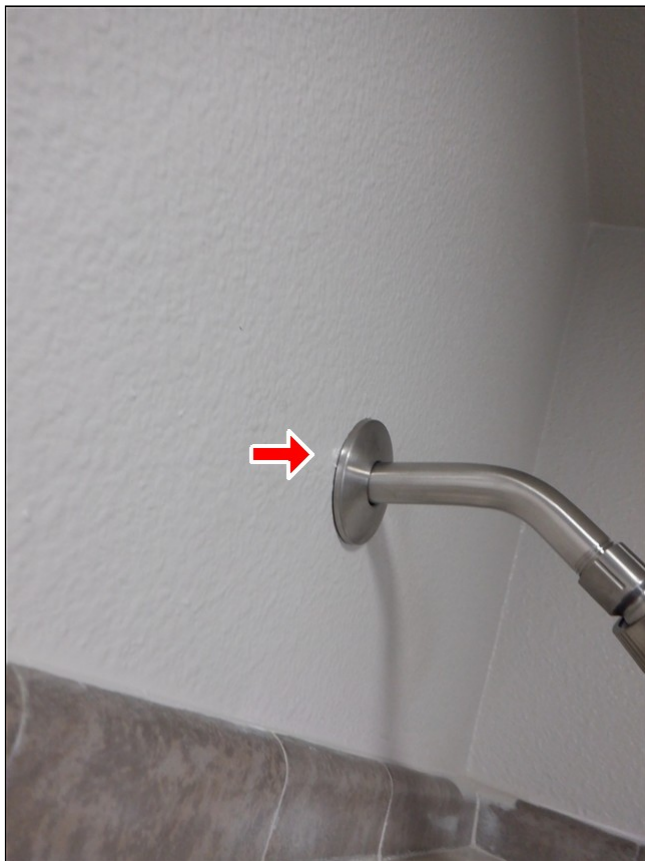
5.7 Item 8(Picture) Primary bath showerhead not sealed

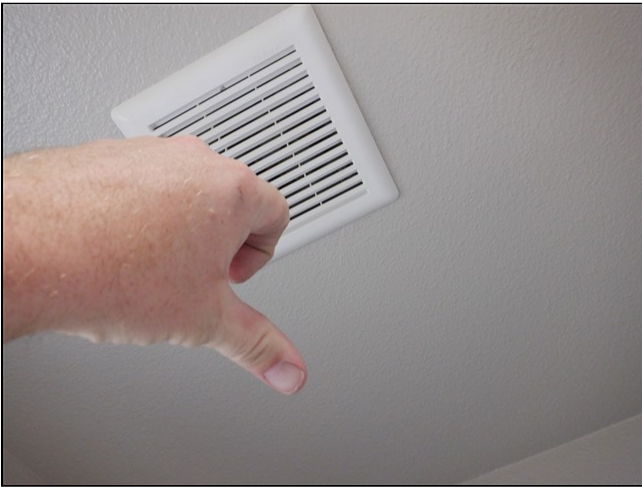
**5.9** The primary bath exhaust fan did not work. Recommend repair.

5.9 Item 1(Picture) Primary bath exhaust fan did not work

The primary bath exhaust fan did not work. Recommend repair.

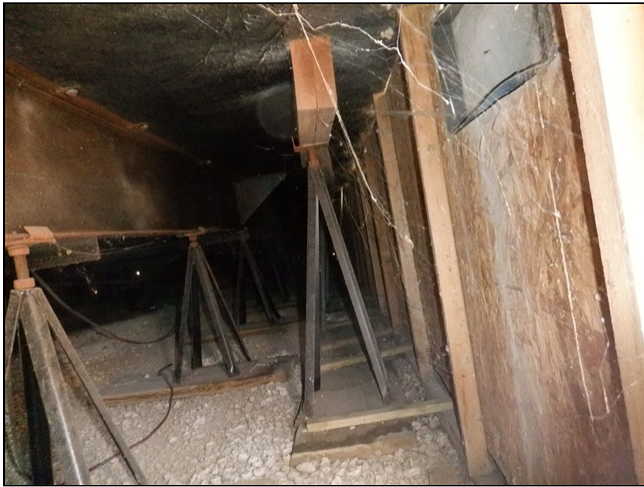
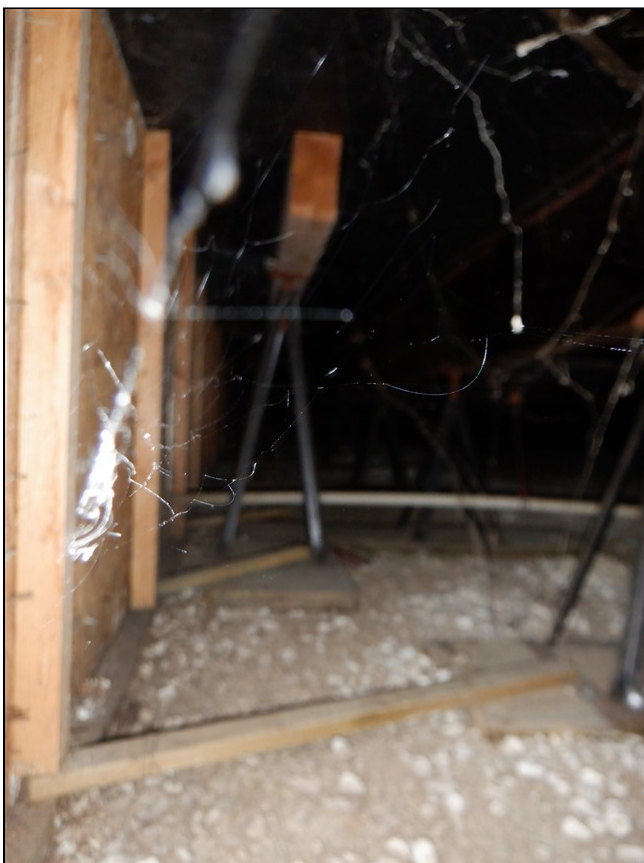
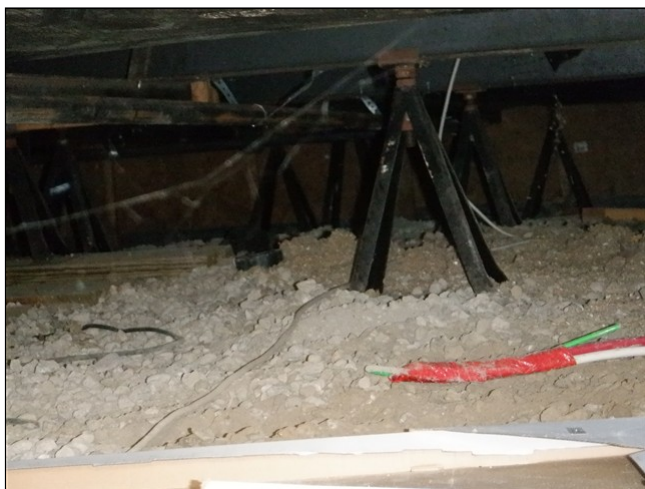
**6.0** Recommend sealing gaps in skirting to avoid critter intrusion. No evidence of excessive critter or moisture intrusion under home on day of inspection.

6.0 Item 3(Picture) Crawlspace

Recommend sealing gaps in skirting to avoid critter intrusion. No evidence of excessive critter or moisture intrusion under home on day of inspection.

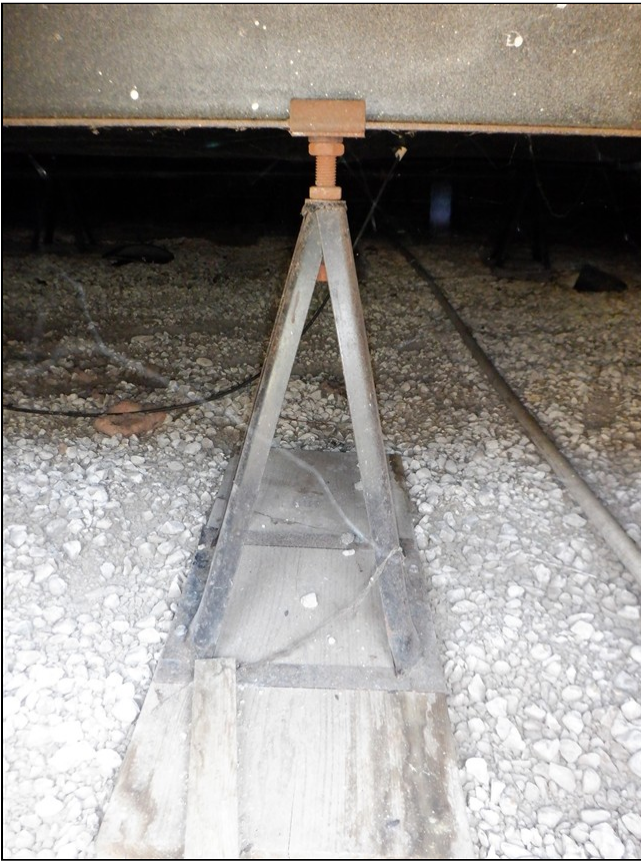
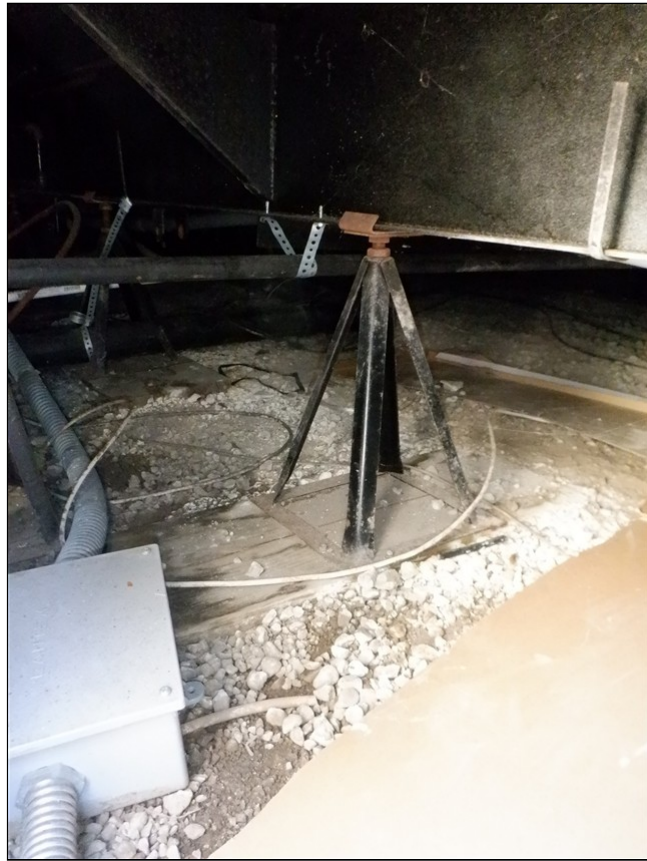
6.2 The steel jacks are in good condition.

6.2 Item 1(Picture) Steel jacks

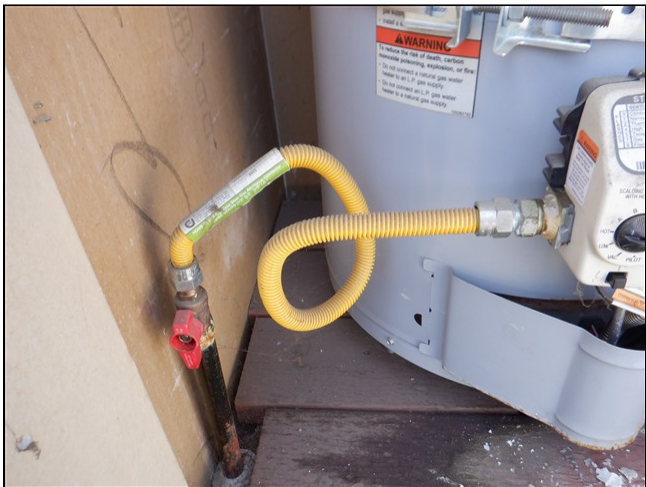
7.1 The water heater is a 30 gallon / 2016 model. Typical life span for a water heater is 8-12 years. The system worked on day of inspection. The gas line is missing the required sediment trap, there is no drip pan installed, flue venting is in tact, corrosion but no leaks at the water lines, and loose belly straps. The T&P plumbing is in tact. Recommend repair by a licensed plumber.

7.1 Item 3(Picture) Missing sediment trap

The water heater is a 30 gallon / 2016 model. Typical life span for a water heater is 8-12 years. The system worked on day of inspection. The gas line is missing the required sediment trap, there is no drip pan installed, flue venting is in tact, corrosion but no leaks at the water lines, and loose belly straps. The T&P plumbing is in tact. Recommend repair by a licensed plumber.

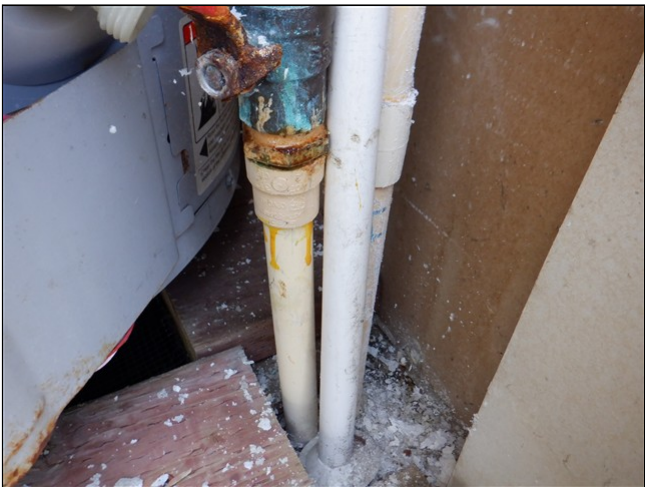
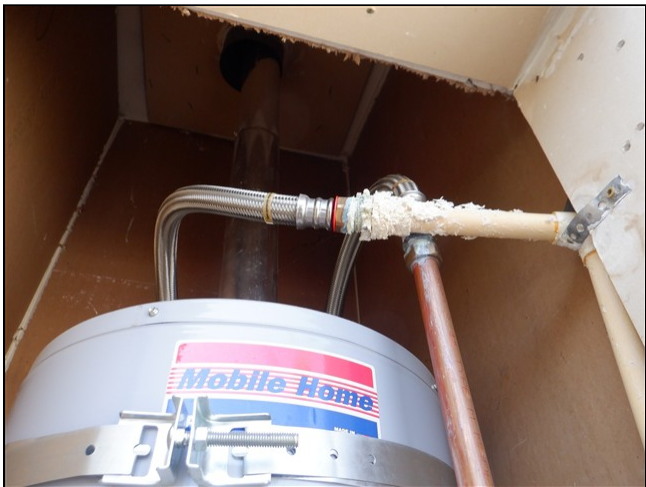
7.1 Item 4(Picture) Corrosion

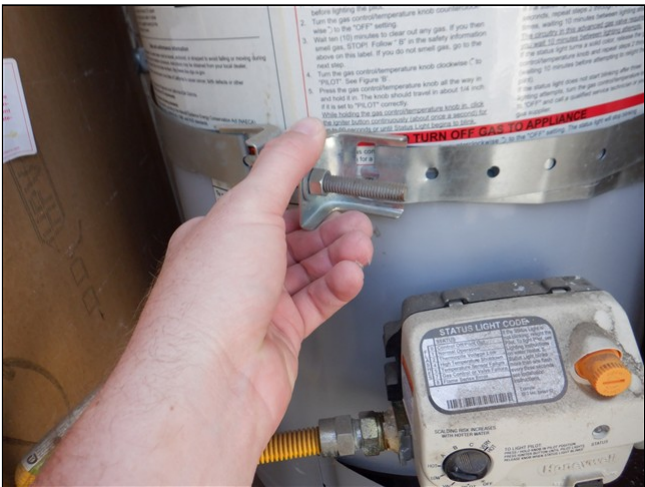
7.1 Item 6(Picture) Loose belly strap

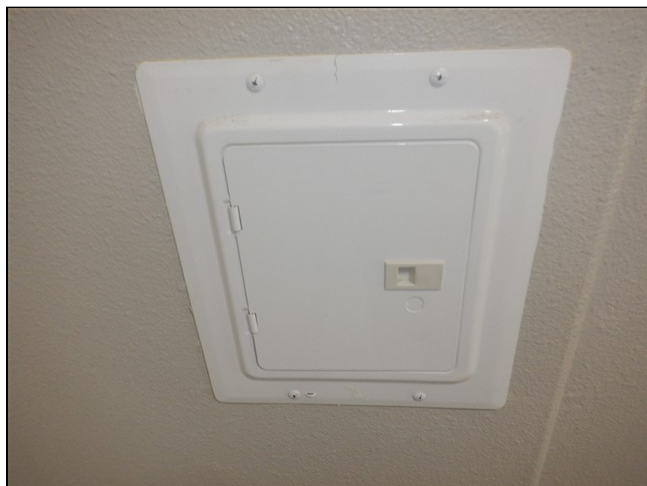
**8.0** The electrical panel is a 100 amp Siemens panel. The panel is labelled, clean on the inside, no corrosion found at grounding/neutral boards, none of the circuit breakers are double tapped with wires, and all connections were in tact.

8.0 Item 1(Picture) Electrical panel

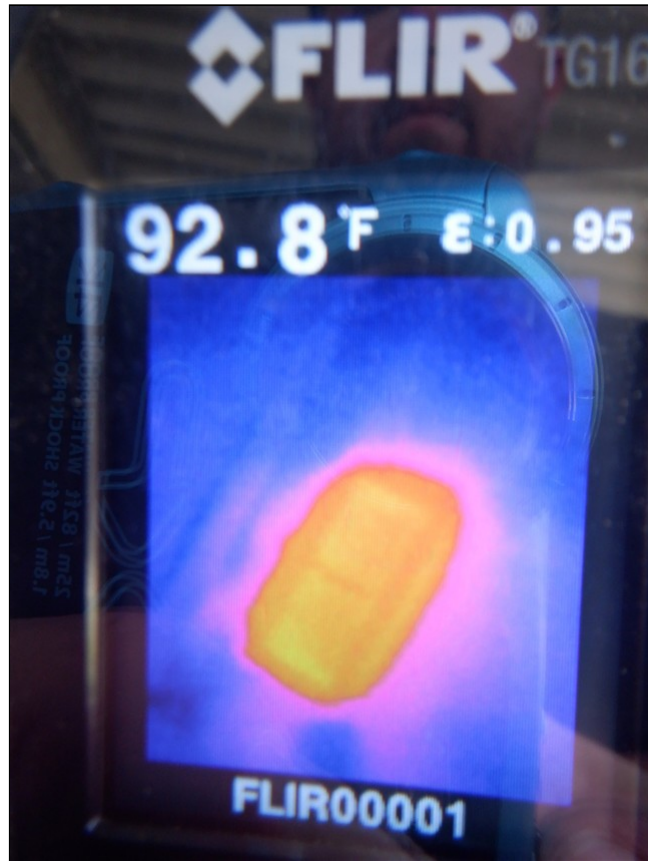
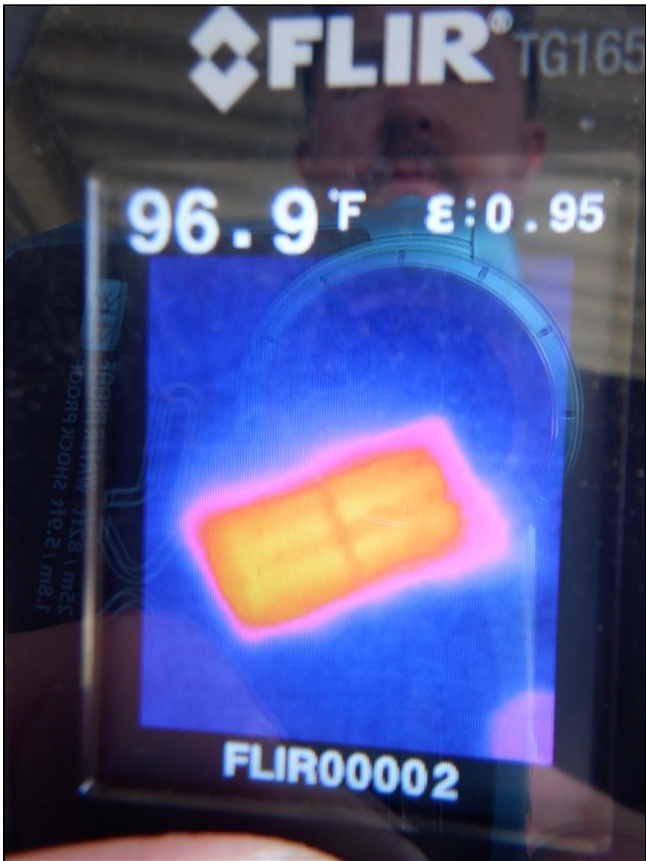
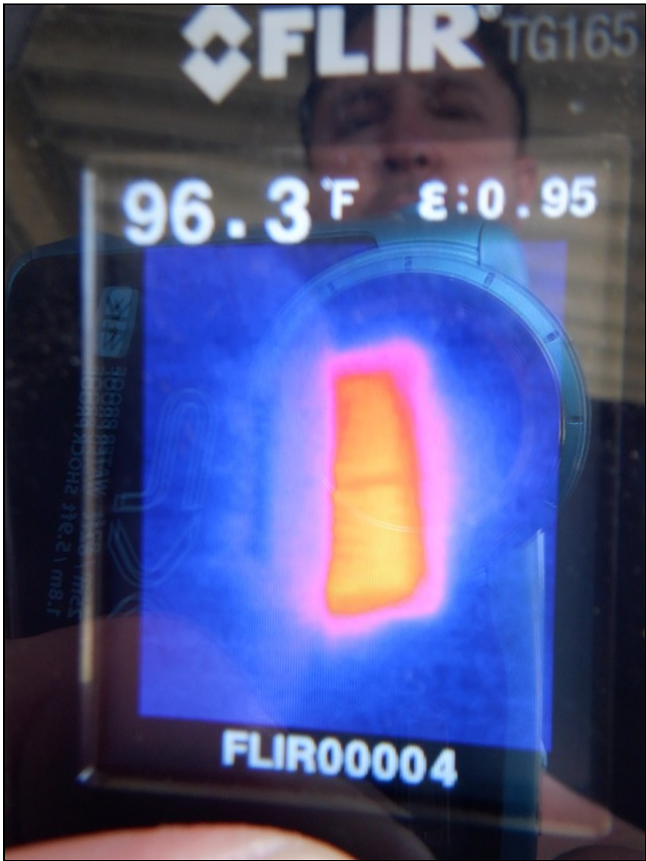
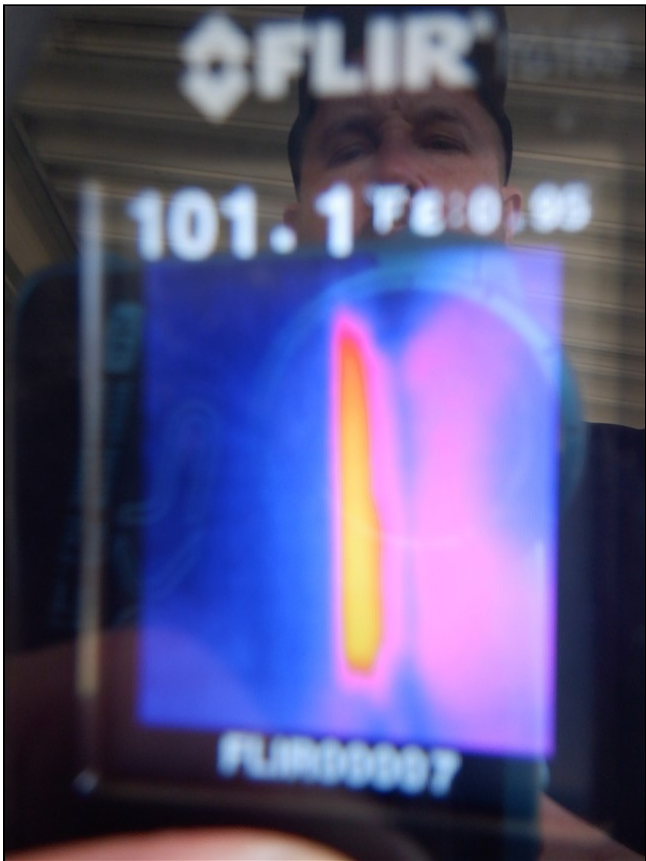
**9.0** The furnace is located in the laundry room. Typical life span for a furnace is 20-25 years. The system did work on day of inspection. The flue venting is in tact. The system was tested using a thermal imager. The temperature was set to 78 degrees. The air coming out of each vent should be, at minimum, 90 degrees (+12 degree jump in temperature). The air was reading in the low 90 to low 100 degree range. This system does require periodic servicing/maintenance. Recommend replacing filter upon move in.

9.0 Item 2(Picture) Thermal imager test
