## RESIDENTIAL INSPECTION REPORT

930 Via Mil Cumbres 116  
Solana Beach, CA 92075

JUNE 19, 2026

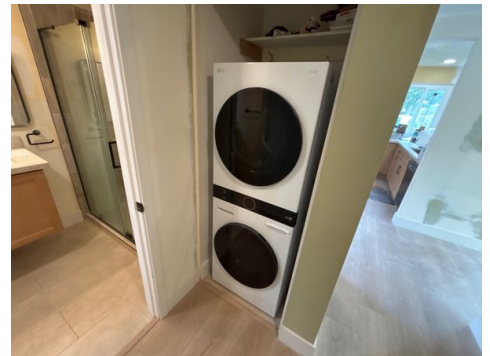
### **LAUNDRY: WASHER/DRYER NOT TESTED**

The washer and dryer appliances were not tested. Recommend having the seller demonstrate these appliances, if staying with the home, are operating.

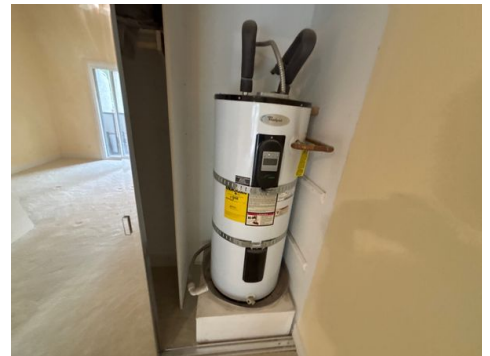
No visible service or maintenance records were observed on or around the water heater.

Routine maintenance is recommended to help ensure efficient operation and extend the service life of the unit. Both tank and tankless water heaters should be serviced annually or in accordance with manufacturer recommendations. Recommend a qualified professional to service the water heater.

Recommendation

Contact a qualified professional.

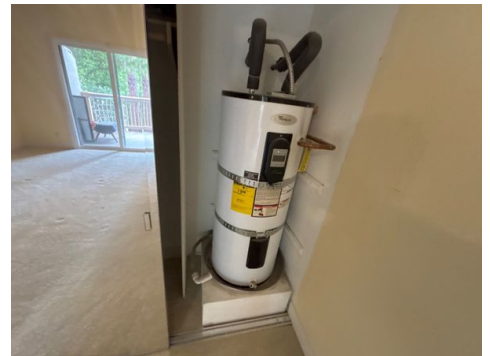
### 5.3.1 Supply Pipes

#### **WATER HEATER: CORROSION AT WATER SUPPLY LINE**

Corrosion at water supply pipes for the water heater. Rust and corrosion can cause water leaks to develop. Recommend a qualified professional to evaluate and repair.

Contact a qualified professional.

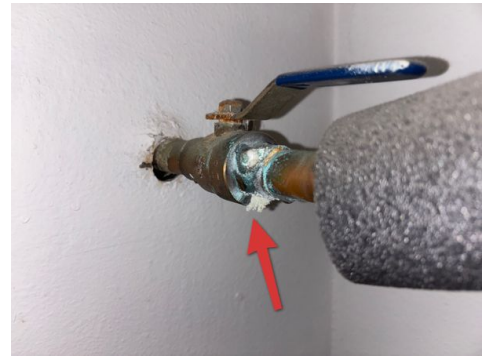
## 5.4.1 Tank/Straps/Catch Pan

### WATER HEATER: EXPANSION TANK MISSING

No expansion tank was visible around the water heater. Expansion tanks help with thermal expansion when water is heating and help minimize the risk of pressure damage to the plumbing system. Recommend a qualified professional to evaluate and repair.

Contact a qualified professional.

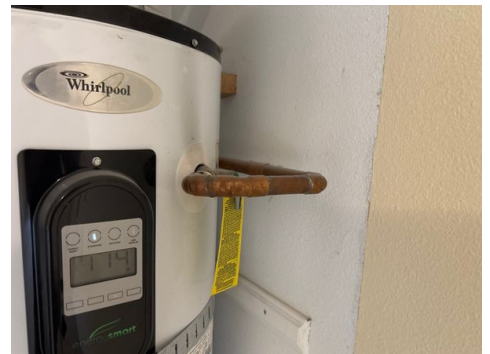
## 5.8.1 Closet/Area Around Tank

### WATER HEATER: ELECTRICAL DISCONNECT NOT OBSERVED

An electrical disconnect was not observed within sight of the electric water heater. A disconnecting means within sight of the appliance is intended to allow the unit to be safely serviced or shut off in an emergency. The absence of a nearby disconnect may create a safety concern. Recommend evaluation and installation of an approved disconnecting means within sight of the water heater by a qualified professional, as needed.

Contact a qualified professional.

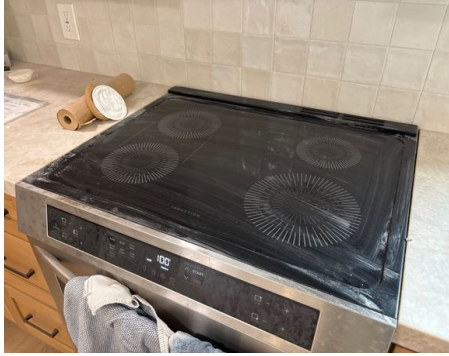
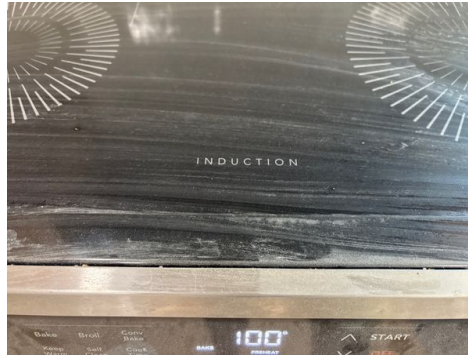
**General: Range**

Not Tested, Induction Top

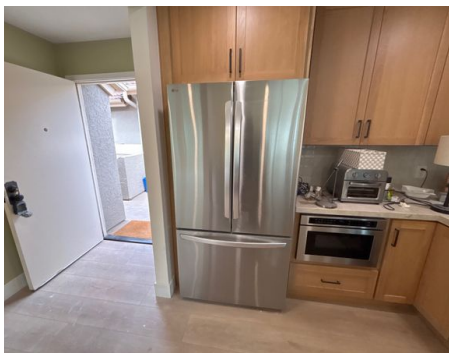
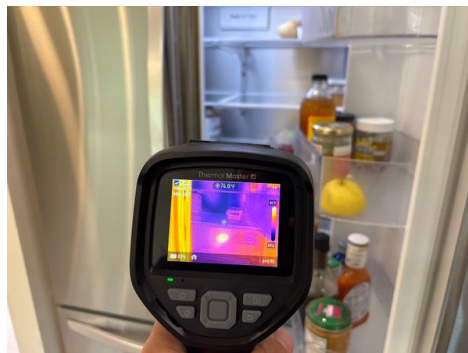
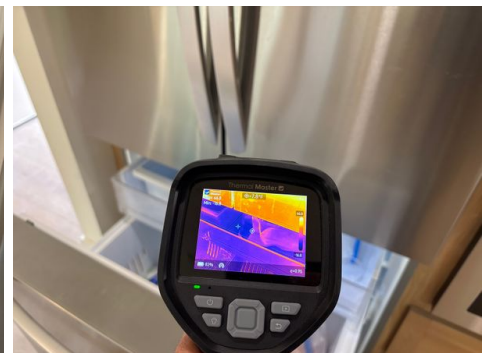
**General: Refrigerator**

Operable

Refrigerators/Freezers need to be serviced annually or per manufacturer recommendations. Refrigerators need service according to manufacturer recommendations.

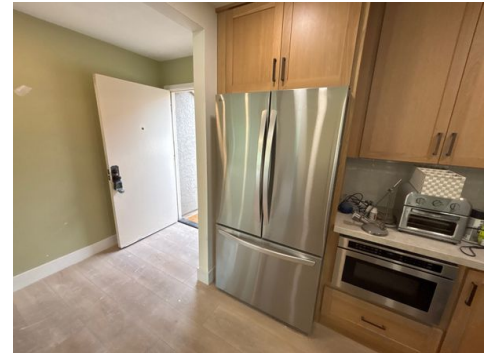
#### AREA BEHIND REFRIGERATOR NOT VISIBLE

The areas behind and under the refrigerator were not visible during the inspection. Pulling out the refrigerator can damage the plumbing components (valves, hose connections) which could cause a water leak. Pulling the refrigerator out can sometimes damage the flooring.

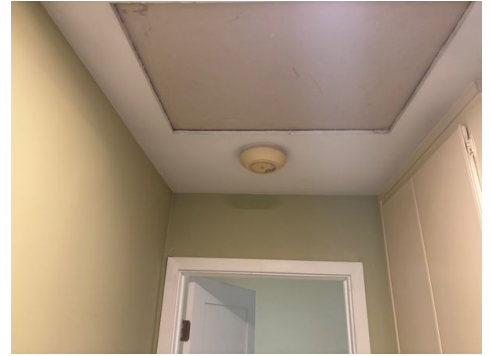
Hallway

Some areas of the home are missing smoke detectors. Recommend a qualified professional to install additional smoke detectors in proper locations.

Contact a qualified professional.

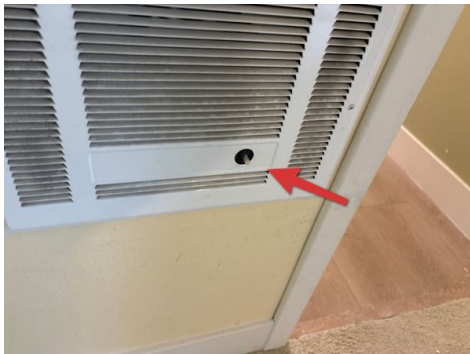
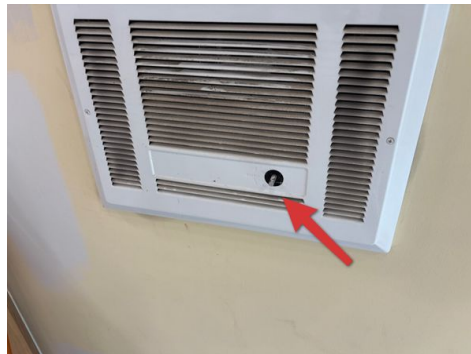
Bedroom

#### **ELECTRIC HEATER: CONTROL KNOB MISSING**

One or more electric heater control knobs were missing. Recommend a qualified professional to repair.

Contact a qualified professional.

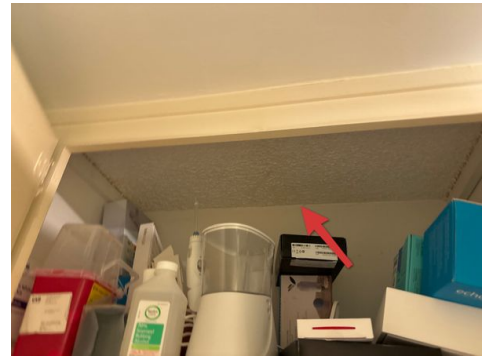
Hallway Closet

**CEILING: POPCORN TEXTURE  
(POSSIBLE ASBESTOS-CONTAINING MATERIAL)**

Popcorn-style ceiling texture is present in some areas of the home. This type of material was commonly used in homes constructed prior to the early 1980s. Some materials from this era may contain asbestos; however, the presence of asbestos cannot be determined through a visual, non-invasive inspection. At the time of inspection, the ceiling materials appeared intact with no visible signs of damage or deterioration. Materials of this type are generally considered low risk when in good condition and left undisturbed. Concerns typically arise if the material is damaged, deteriorated, or disturbed during renovation or removal. If desired, a qualified professional can collect and test a sample to determine whether asbestos is present. Testing is the only way to confirm the presence or absence of asbestos-containing materials.

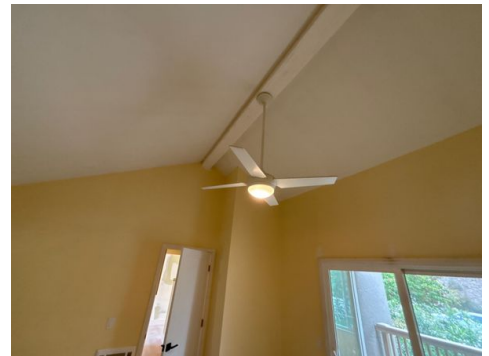
Bedroom

**CEILING FAN: REMOTE NOT  
OBSERVED**

A remote control was not observed for one or more ceiling fans. Without the remote, full operation of the fan (including speed settings and lighting, if applicable) may be limited or cannot be verified. Recommend that the seller demonstrate proper operation of the ceiling fan(s). If the operation cannot be confirmed, recommend evaluation and repair, as needed, by a qualified professional.

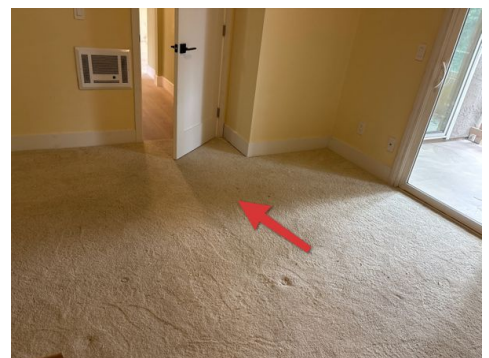
Bedroom

One or more slopes or low spots were observed on the floor. This can be caused by settling, installation of flooring, and/or structural movement. Recommend a qualified professional to evaluate.

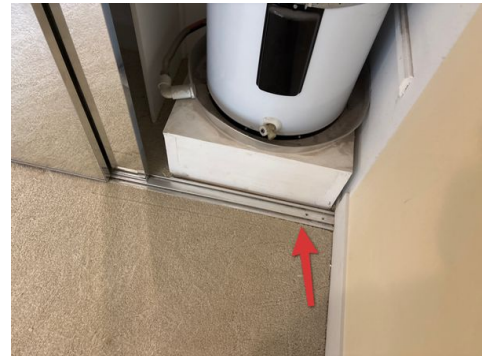
Bedroom

##### **CLOSET SLIDING DOOR: BOTTOM TRACK LOOSE**

One or more areas of the bottom track for the closet sliding doors are loose. Recommend a qualified professional to repair.

Contact a qualified professional.

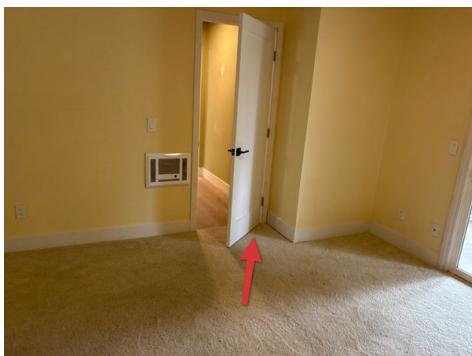
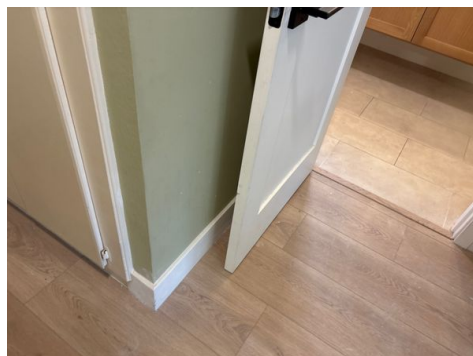
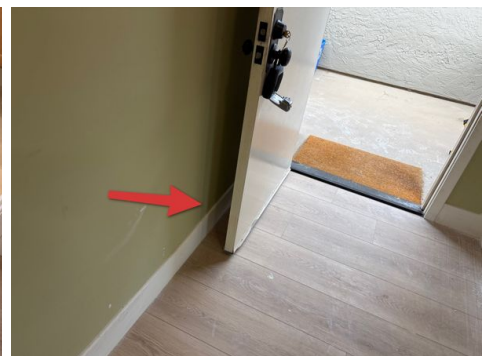
Bedroom

##### **INTERIOR DOOR(S): DOOR STOPS MISSING / NOT OPERATING PROPERLY**

One or more door stops are missing and/ or not operating properly. Doorstops help protect drywall from the doorknob when the door is opened. Recommend a qualified professional to repair.

Contact a qualified professional.
