## Inspection Report

**Property Address:**  
4085 Crystal Dawn Ln #201  
San Diego CA 92122

<b>Date:</b> 4/23/2026	<b>Time:</b> 01:00 PM	<b>Report ID:</b> 20260422-4085-Crystal-Dawn-Ln-201
<b>Property:</b> 4085 Crystal Dawn Ln #201 San Diego CA 92122	<b>Customer:</b> Eileen Ponce	<b>Real Estate Professional:</b> Ixie Weber Redfin

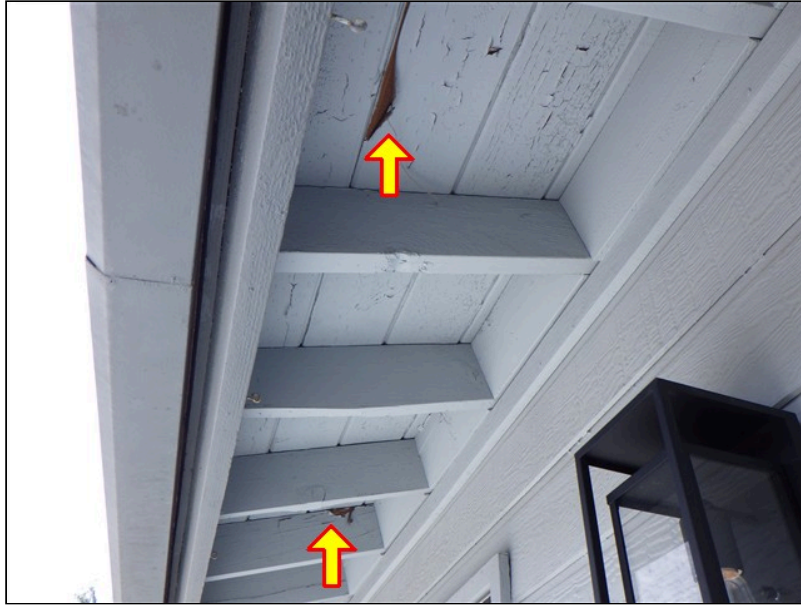
2.1 Item 1(Picture)

Paint is failing at the eaves at several areas and needs prep and paint. **We recommend inquiring with the HOA for any necessary repairs needed at this time.**

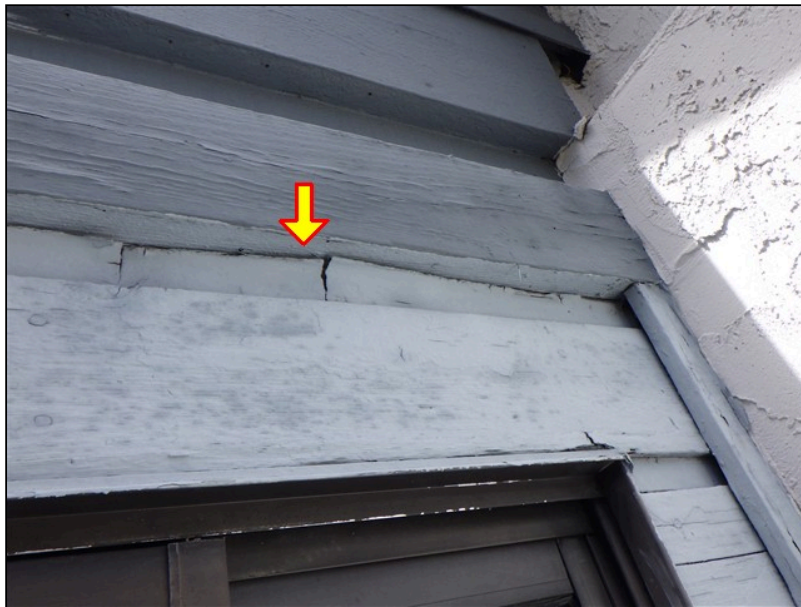
2.2 Item 1(Picture)

(1) Flashing is damaged at the rear balcony door flashing. **We recommend inquiring with the HOA for any necessary repairs needed at this time.**

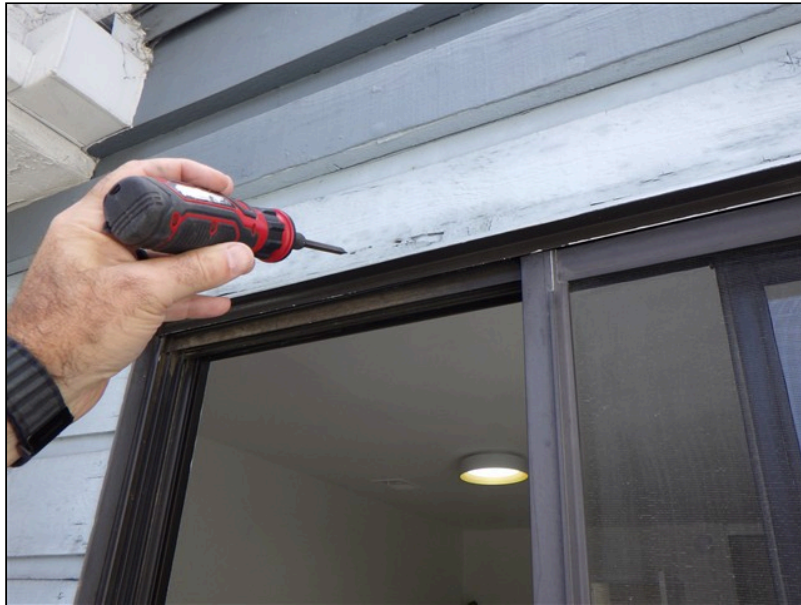
2.2 Item 2(Picture)

(2) Some damaged wood trim is observed at several areas. We recommend referring to the pest inspection report for a detailed evaluation of the wood. **We also recommend inquiring with the HOA for any necessary repairs needed at this time.**

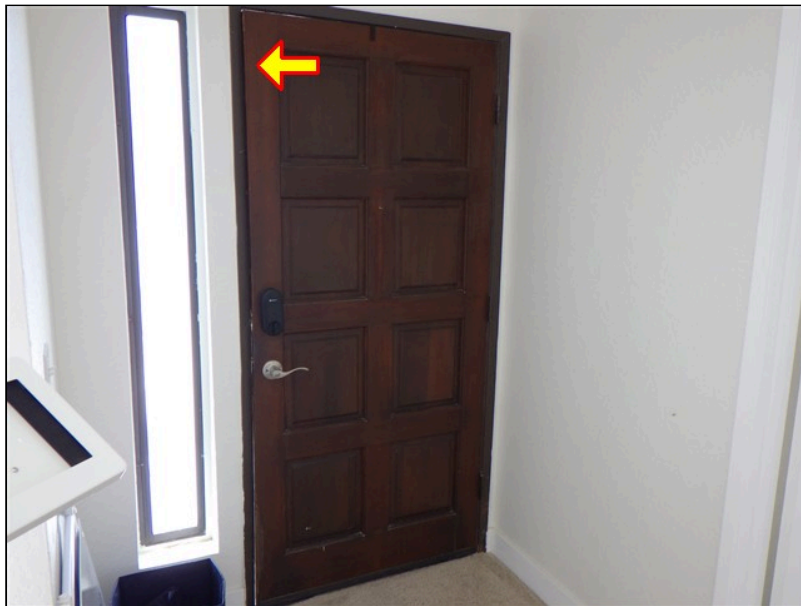
2.3 Item 1(Picture)

(1) The entry door does not fit squarely in the door frame and rubs. This can be caused by several factors including poor installation or settlement of the house. We recommend necessary repairs by a qualified licensed door contractor.

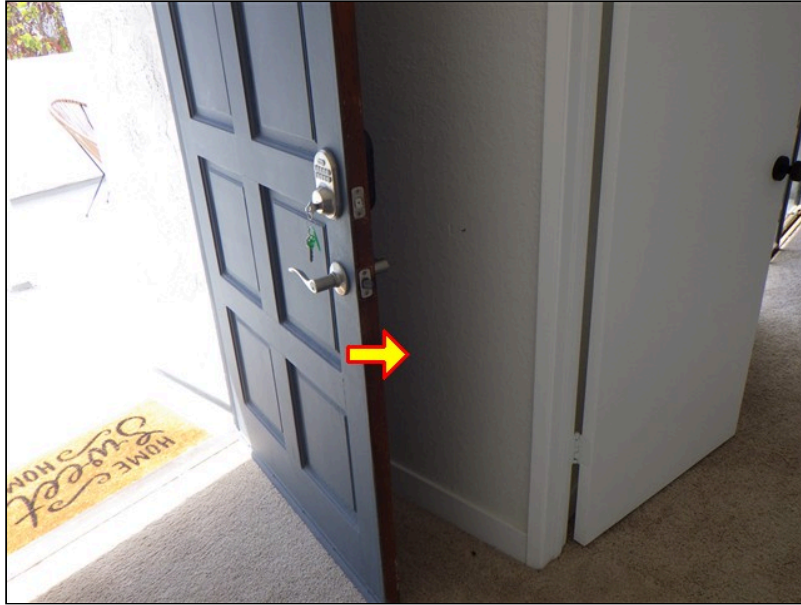
2.3 Item 2(Picture)

(2) Door stopper missing at the main entry door. Door stoppers are recommended where

door handles contact walls. We recommend adding a door stop and repair the wall as needed by a qualified person.

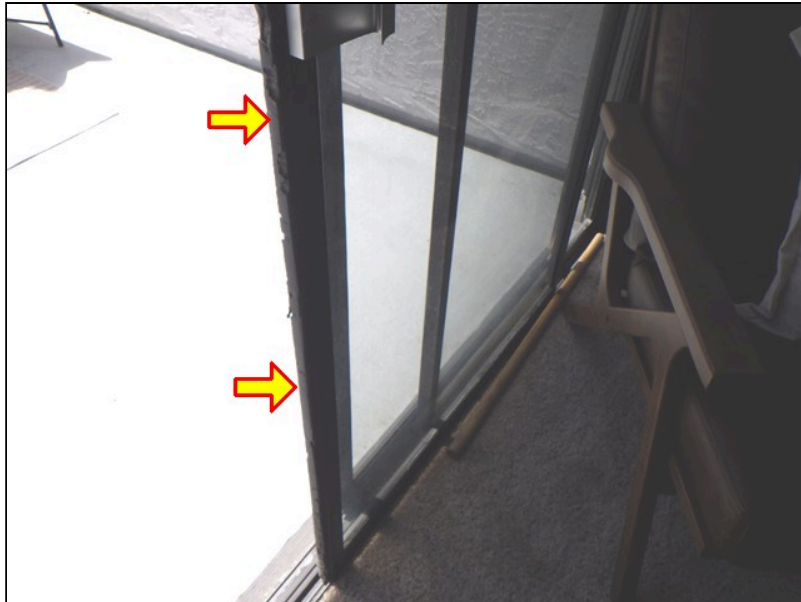
2.3 Item 3(Picture)

(3) The master bedroom sliding glass door weather-stripping is damaged. We recommend replacement by a qualified person.

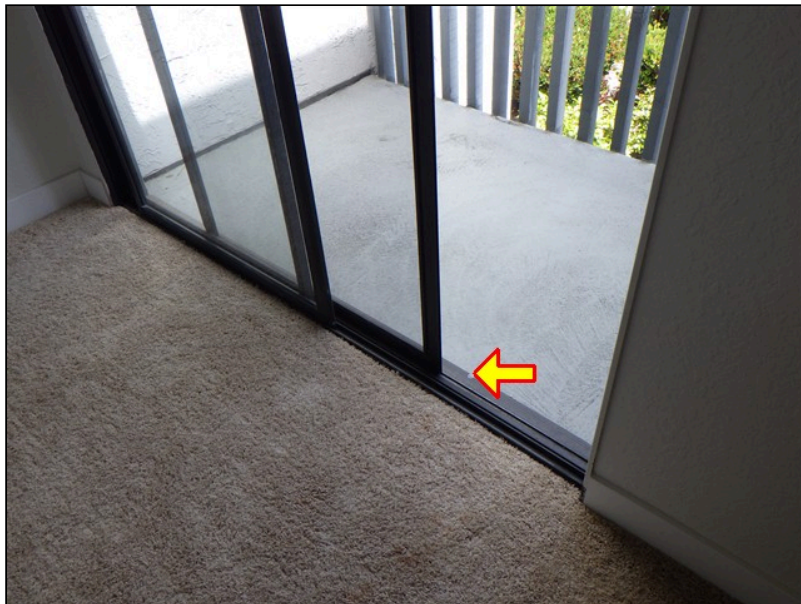
2.3 Item 4(Picture)

(4) Bedroom #2 sliding screen door sticks and is difficult to slide. We recommend necessary repairs or replacement by a qualified person.

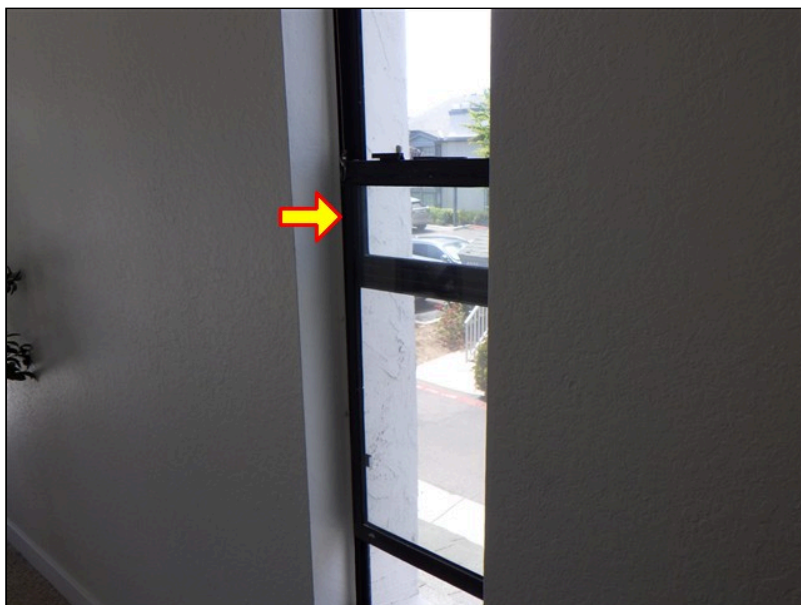
2.4 Item 1(Picture)

(1) Damaged/loose counter-balance cord noted at a single hung window in the master bedroom. This makes the window difficult to open/close. We recommend necessary repairs by a qualified licensed window contractor.

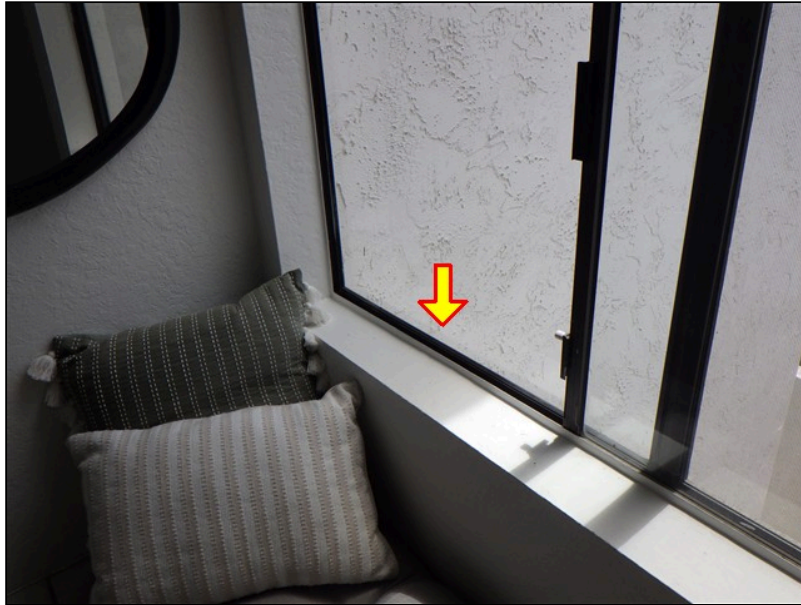
2.4 Item 2(Picture)

(2) The window glides for several sliding windows are worn. This causes metal-on-metal friction. The added force required to open and close the windows can lead to breakage.

We recommend replacing all of the window glides by a qualified person.

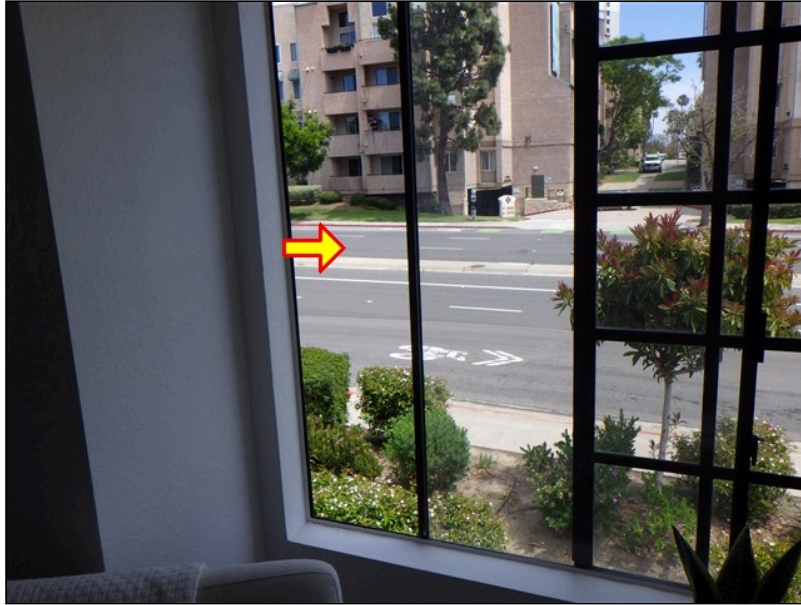
2.4 Item 4(Picture)

(3) A window screen is missing in the family room. We recommend replacing by a qualified person.

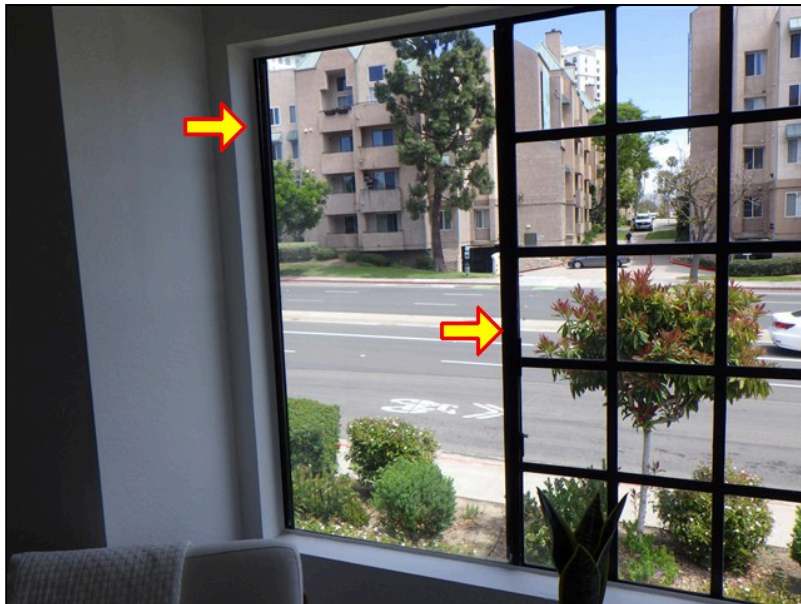
2.4 Item 5(Picture)

(4) Family room window is difficult to shut and latch. We recommend necessary repairs by a qualified licensed window contractor.

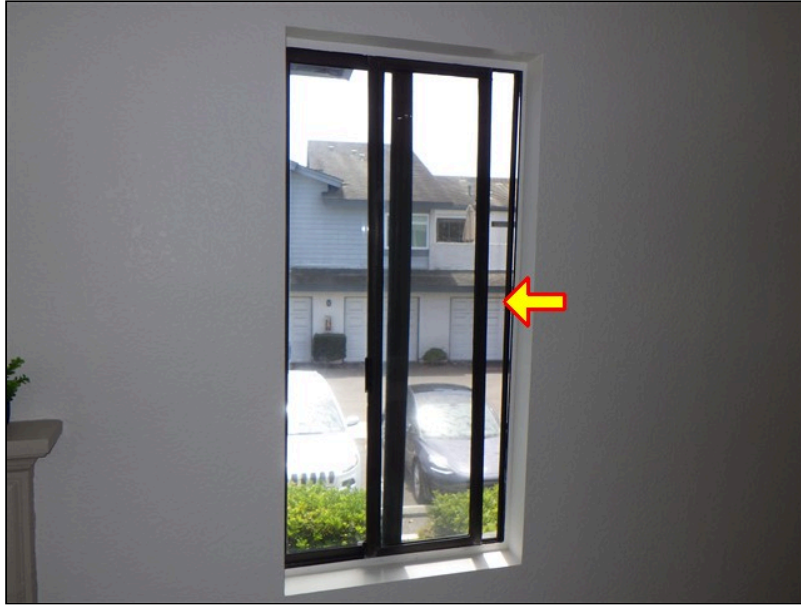
2.4 Item 6(Picture)

(5) A window screen is bent/damaged in the family room. We recommend replacing by a qualified person.

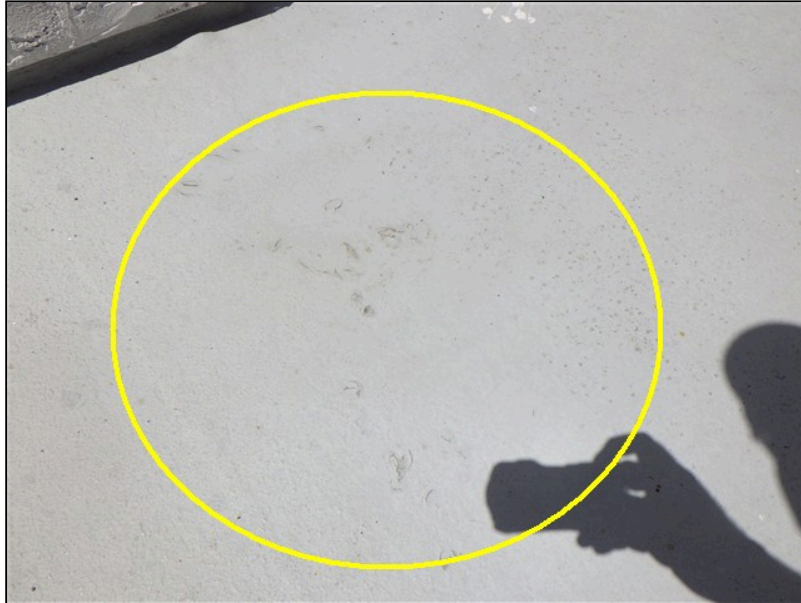
2.6 Item 1(Picture)

(1) The decking material/water proof membrane is worn and cracked at the front deck surface. The effectiveness of the material may be compromised. **We recommend inquiring with the HOA for any necessary repairs needed at this time.**

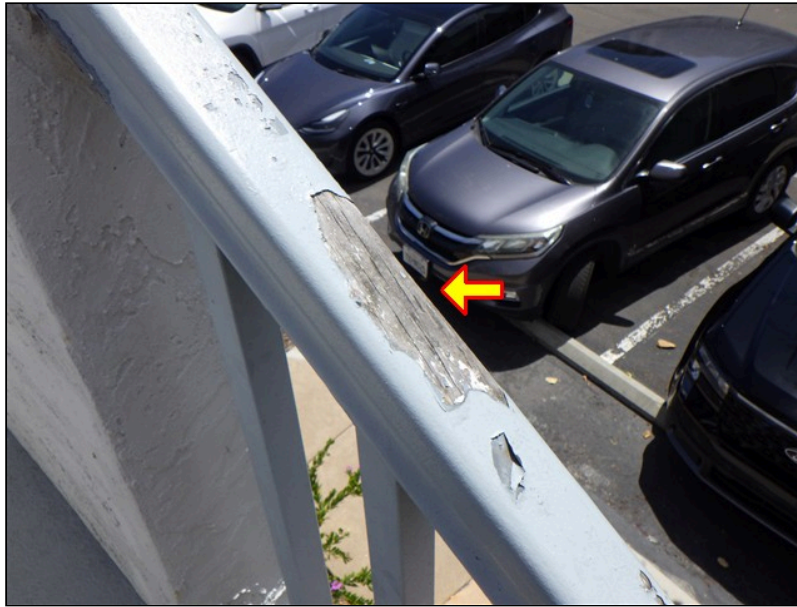
2.6 Item 3(Picture)

(3) The deck stairway guardrail paint is worn/ damaged. We recommend inquiring with the HOA for any necessary repairs needed at this time.

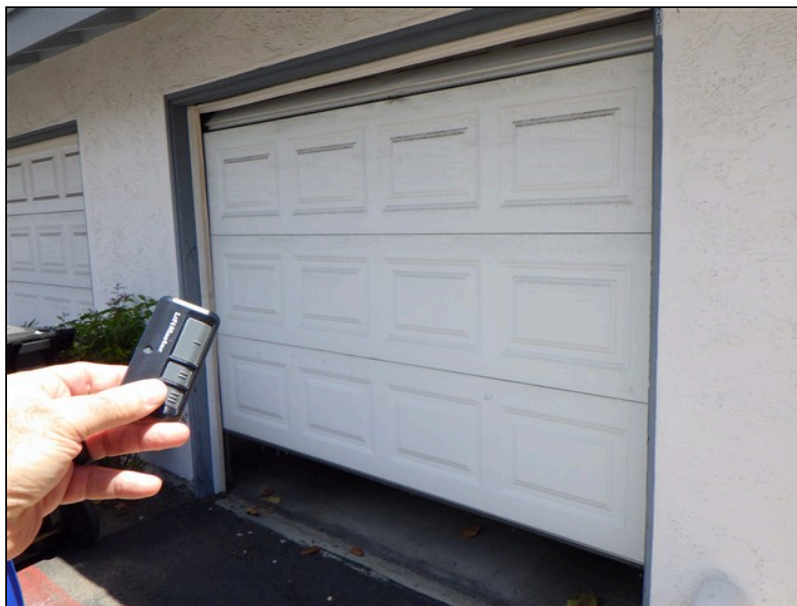
3.0 Item 1(Picture)

The garage vehicle door hardware including the door, track, and springs appear to be functioning as intended.

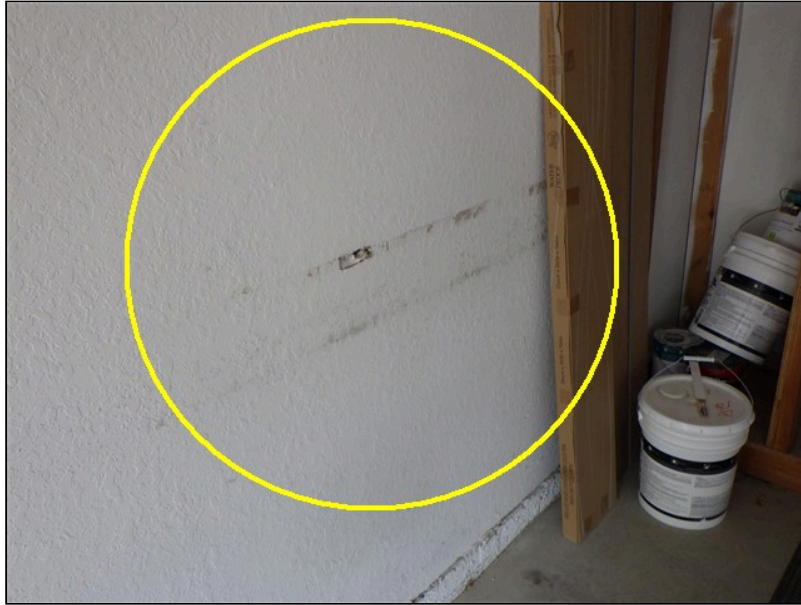
3.3 Item 1(Picture)

The walls have cosmetic damage in one or more locations. We recommend prep and paint and/or repairs as needed by a qualified licensed drywall contractor.

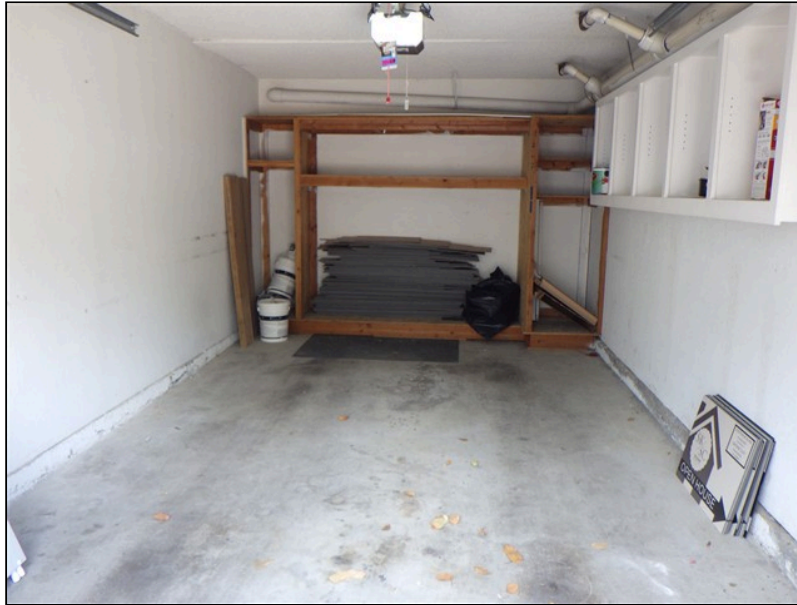
3.5 Item 1(Picture)

Garage vents are not present in the garage. Garage vents are needed to allow chemical and gas vapors to dissipate, and allow fresh combustion air into the garage for gas burning appliances. We recommend having vents installed by a qualified licensed contractor.

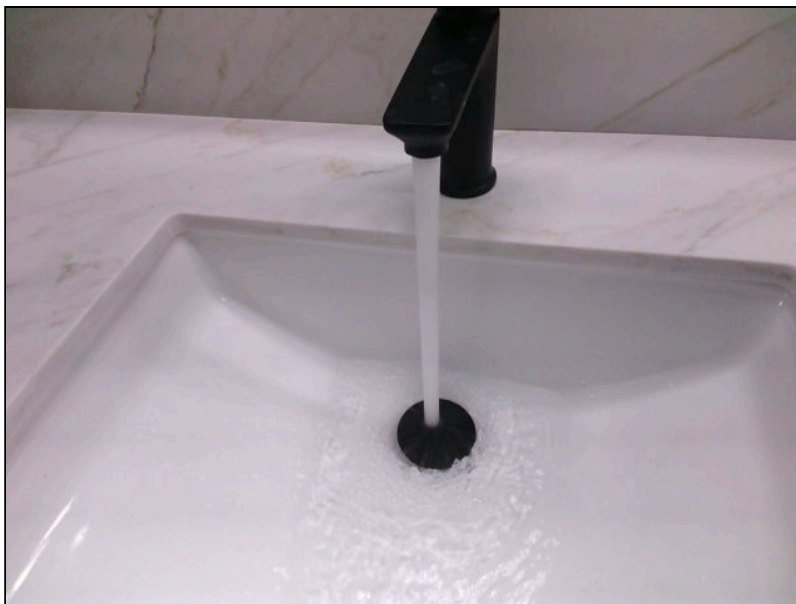
4.0 Item 1(Picture)

The temperature of the water was tested using a thermal camera during the inspection and was found to be operating within normal range.

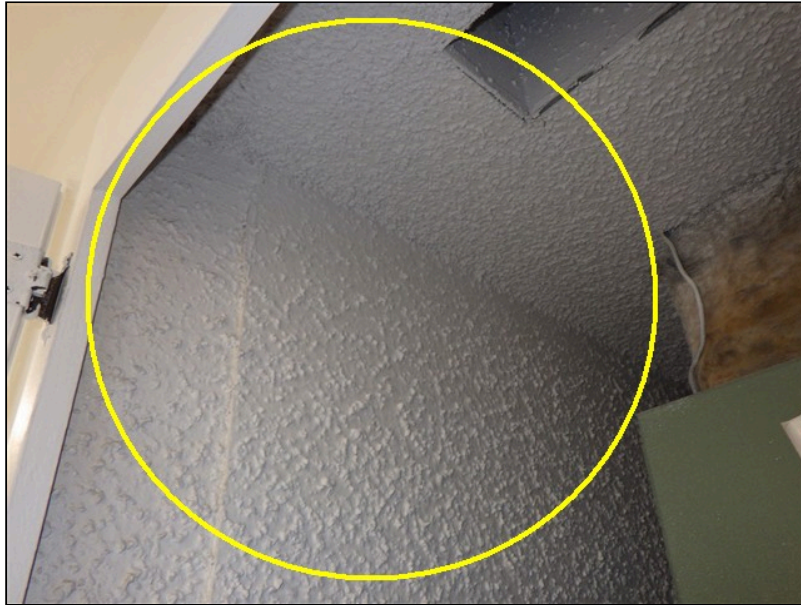
5.0 Item 1(Picture)

(1) There is acoustic texture present at the ceiling. Some of this acoustic texture installed before the 1980's has been known to contain asbestos. It is beyond the scope of this general home inspection for us to test for asbestos. The only way to confirm the presence or absence of asbestos is by having it tested by a qualified person.

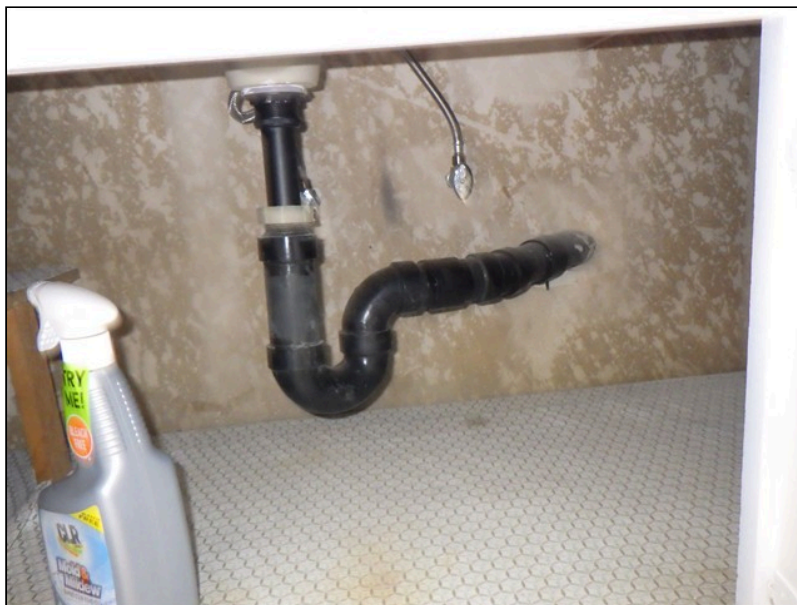
5.4 Item 1(Picture)

There are typical stains noted at the bathroom(s) sink cabinet base(s). These stains were dry at the time of inspection. We recommend necessary corrections/ repairs by a qualified licensed contractor.

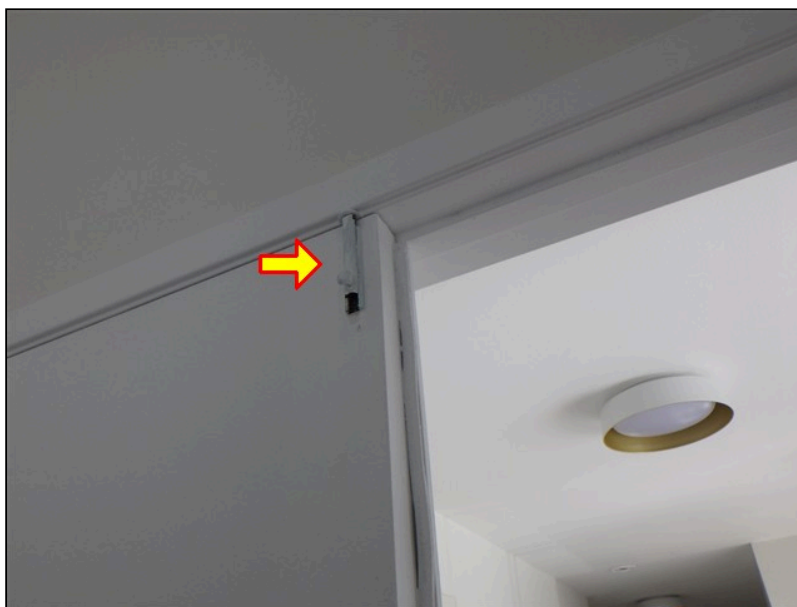
5.5 Item 1(Picture)

(1) Master bedroom door upper locking latch does not latch and needs adjustment or repair. We recommend corrections by a qualified person.

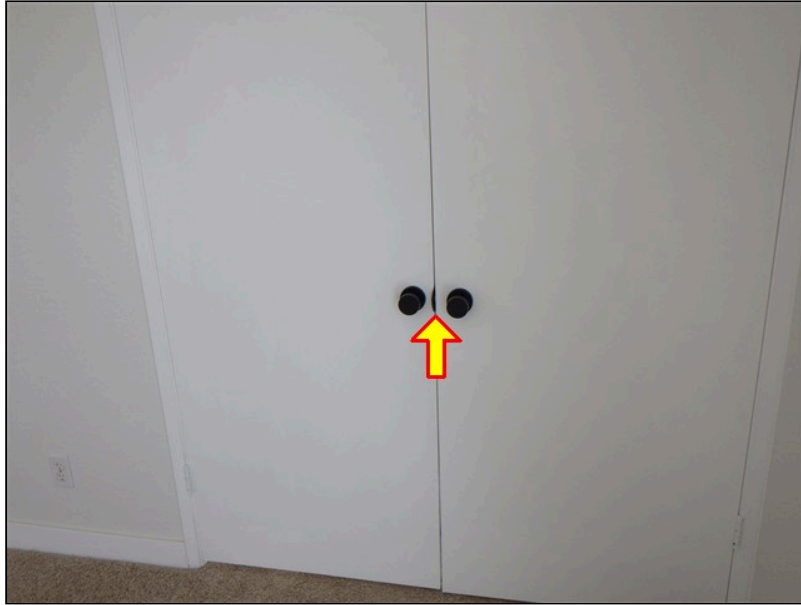
5.5 Item 2(Picture)

(2) Master bedroom door hardware is misaligned; the door does not latch. We recommend adjusting the strike plate or necessary corrections made by a qualified person.

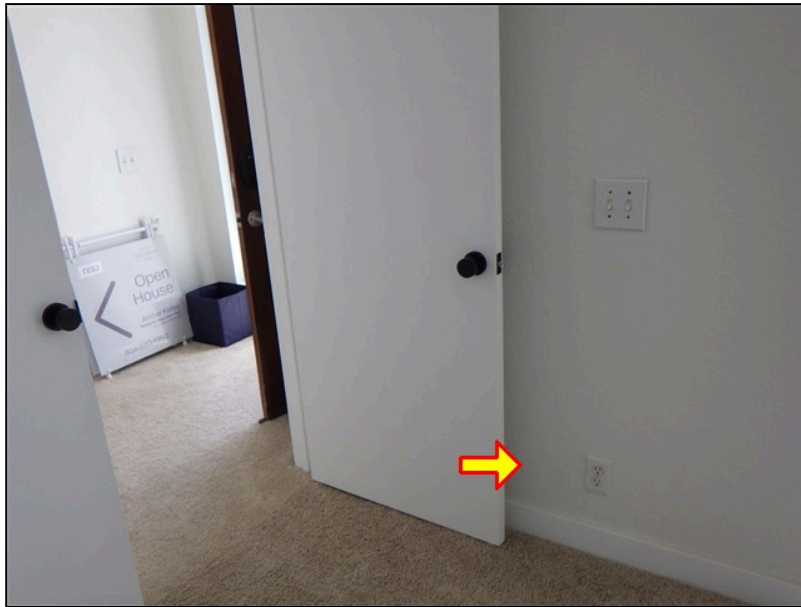
5.5 Item 3(Picture)

(3) Door stoppers are missing at several doors. Door stoppers are recommended where door handles contact walls. We recommend adding door stops and repair of any walls by a qualified person.

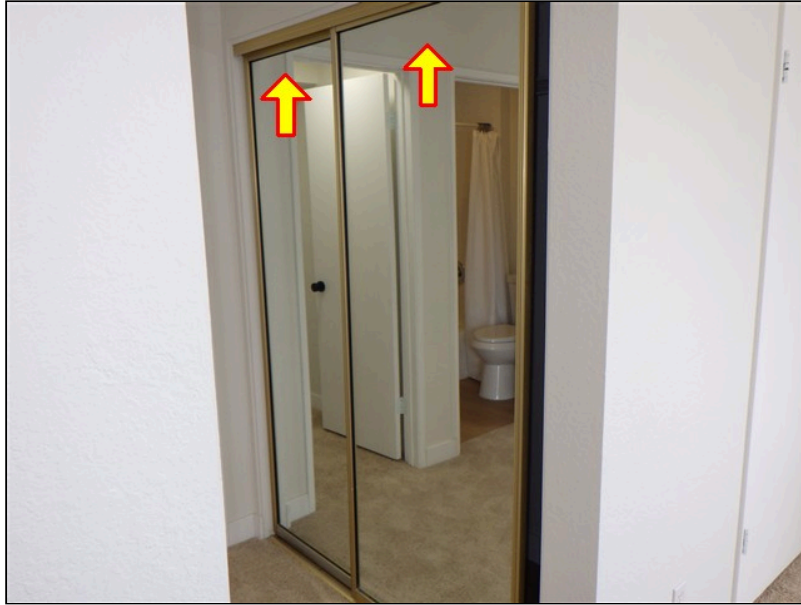
5.5 Item 4(Picture)

(4) Closet door rollers are damaged at the master bedroom closet doors. We recommend repair or replacement where needed by a qualified person.

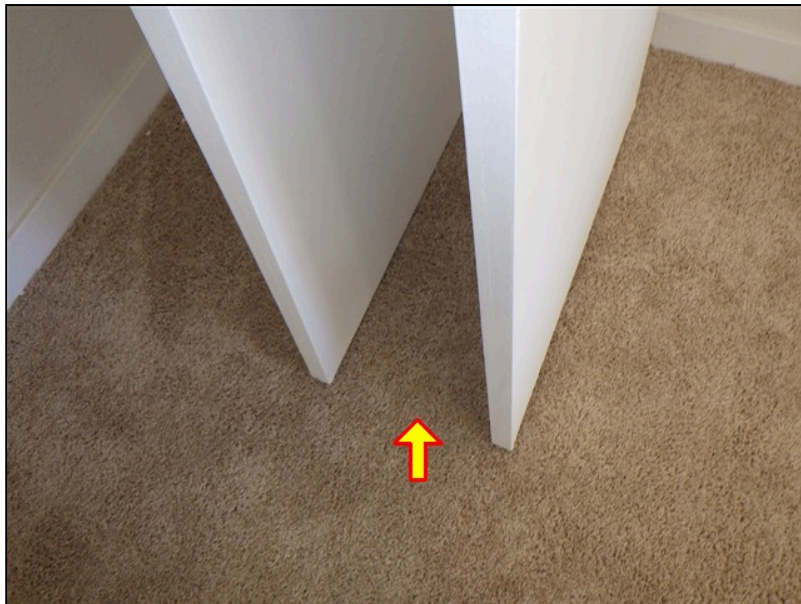
5.5 Item 5(Picture)

(5) Closet door floor guides are missing at bedroom #2 closet doors. This is a pinching hazard. We recommend installing where needed by a qualified person.

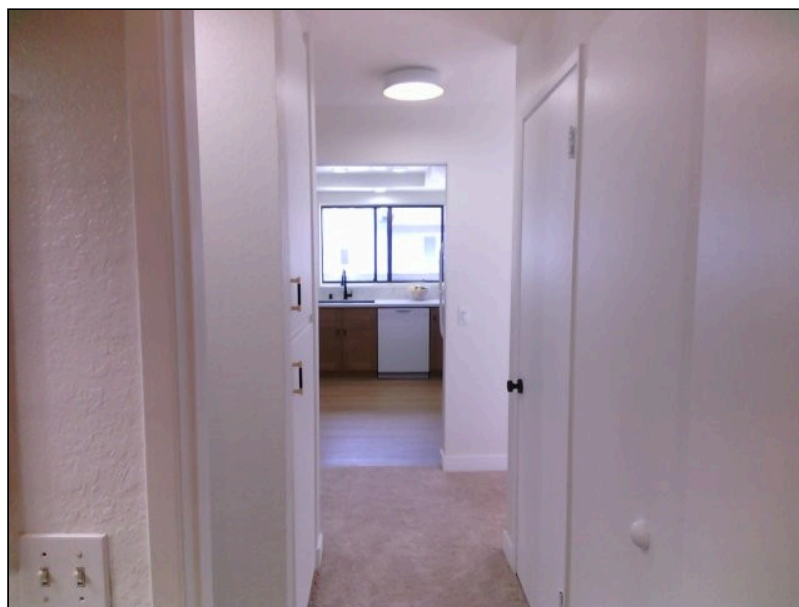
5.6 Item 1(Picture)

An infrared (thermal imaging) scan was performed throughout the house and garage at the time of the inspection using a hand held infrared (thermal imaging) inspection camera. No anomalies were found at the time of the inspection using this camera.

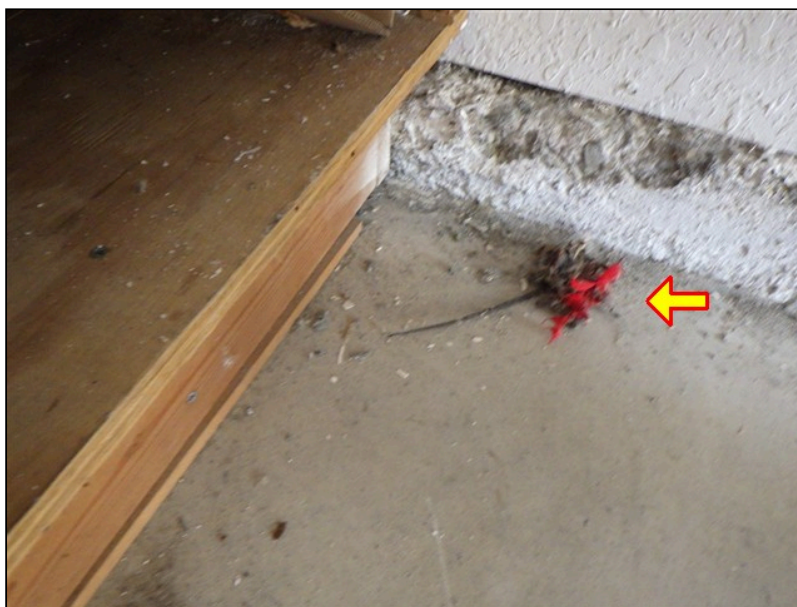
5.8 Item 1(Picture)

hygienist prior to the end of your contingency if you are concerned .  
(2) Rodent activity noted in the garage. We recommend removal by a qualified licensed pest control company.

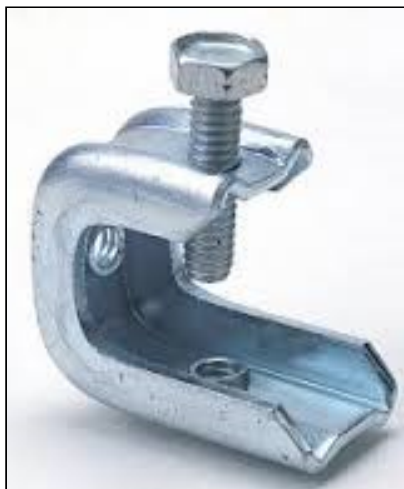
6.1 Item 1(Picture)

A damper clamp is not installed at the family room fireplace damper door. A damper clamp is required to be installed at a damper door when there is a gas supply to the fireplace(s). This damper clamp help prevents the damper from closing all the way as a safety precaution. If the damper is closed, Carbon Monoxide gas could enter the living space easier which is undetectable. SDG&E now requires damper clamps at all fireplaces damper doors. We recommend installation of a damper clamp by a qualified person.

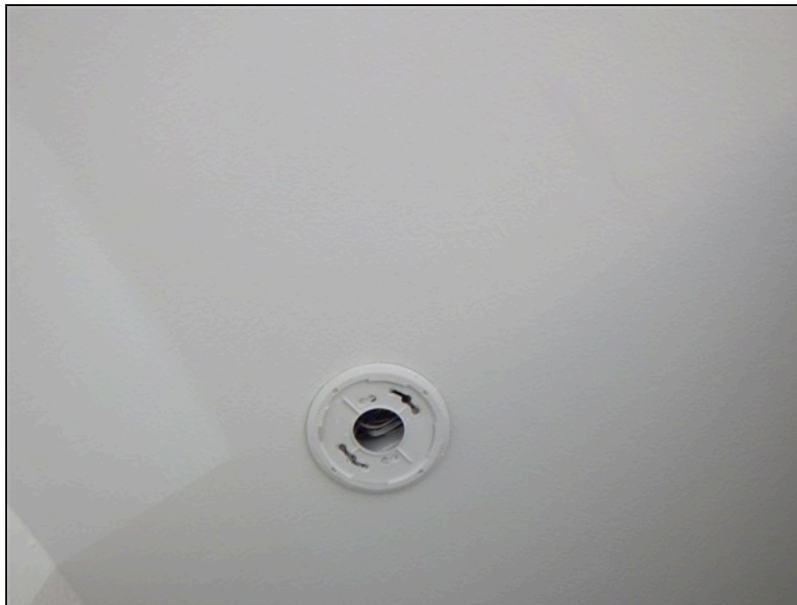
7.0 Item 1(Picture)

(1) A 110-volt hard-wired smoke alarm has been removed from the hallway. We recommend replacement/ installing a 110-volt smoke alarm prior to occupancy for safety.

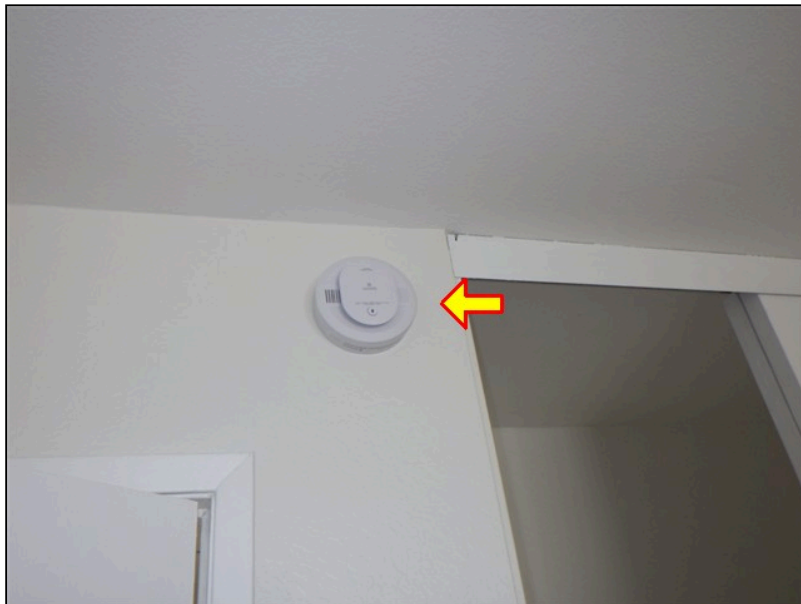
7.0 Item 2(Picture)

(2) Note: There were smoke detectors installed in the hallway and in each bedroom and were tested and were found to be operable at the time of the inspection.

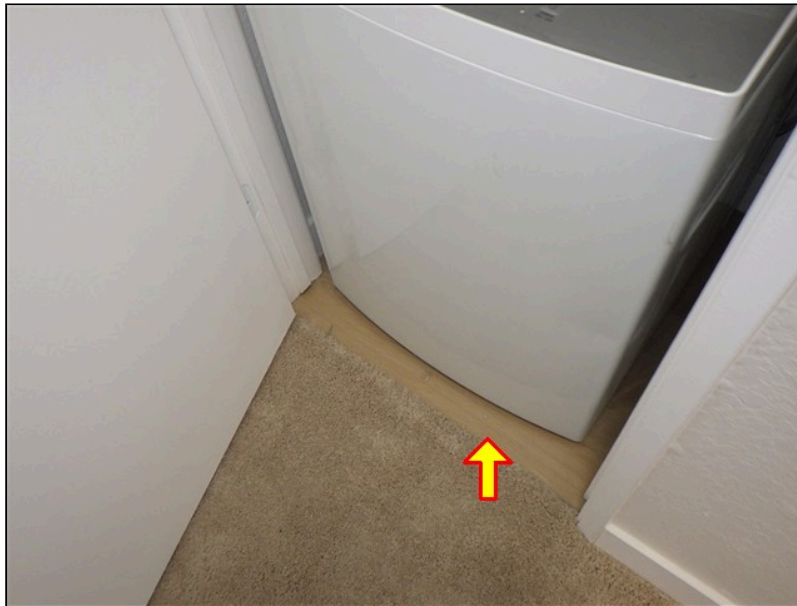
8.0 Item 1(Picture)

(1) A washer pan and drain line is not installed under the washing machine. When a washing machine is installed on a floor level above another finished floor a washer pan and drain line should be installed to help prevent damage from an overflowing washer or a leak. We recommend installing a drain pan and a drain line if possible by a qualified licensed plumber.

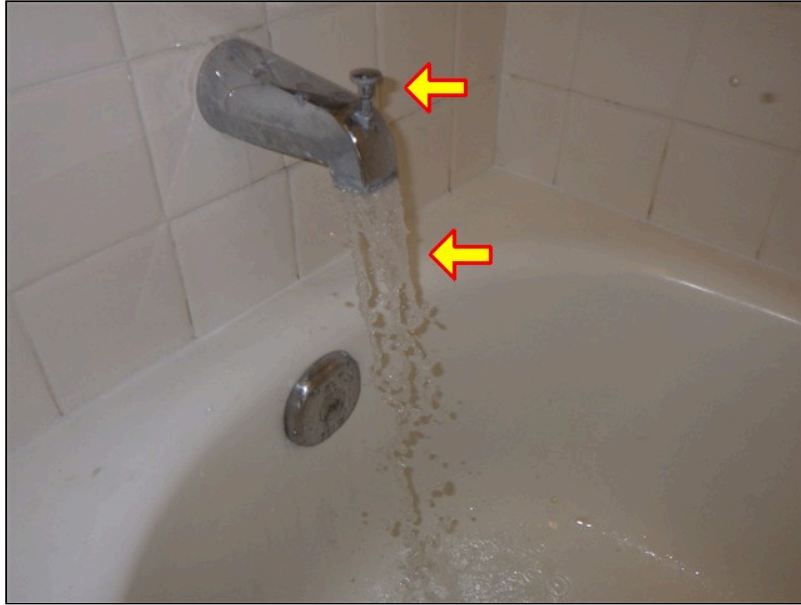
8.3 Item 1(Picture)

(1) The master bathroom tub diverter is defective. Possibly due to hard water deposits. We recommend necessary repairs or replacement as needed.

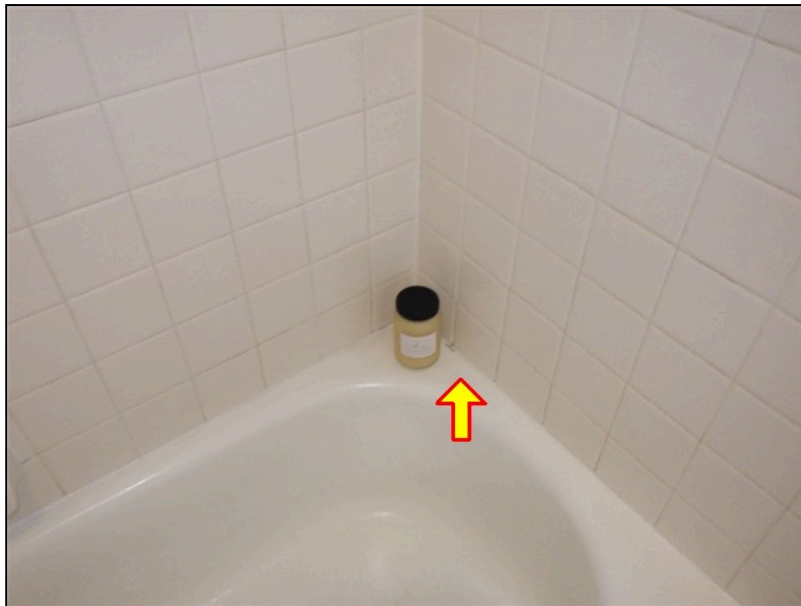
8.3 Item 2(Picture)

(2) Mildew is noted in the grout at the master bath tub/shower. We recommend properly cleaning by a qualified person and/or repairs made by a qualified licensed tile contractor.

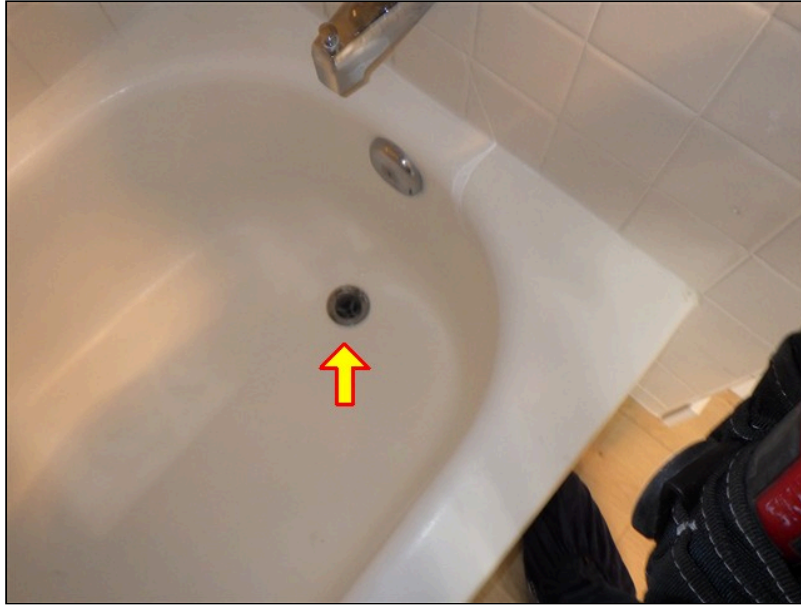
8.3 Item 3(Picture)

(3) The hall bathroom tub stopper is missing. We recommend replacement by a qualified person.

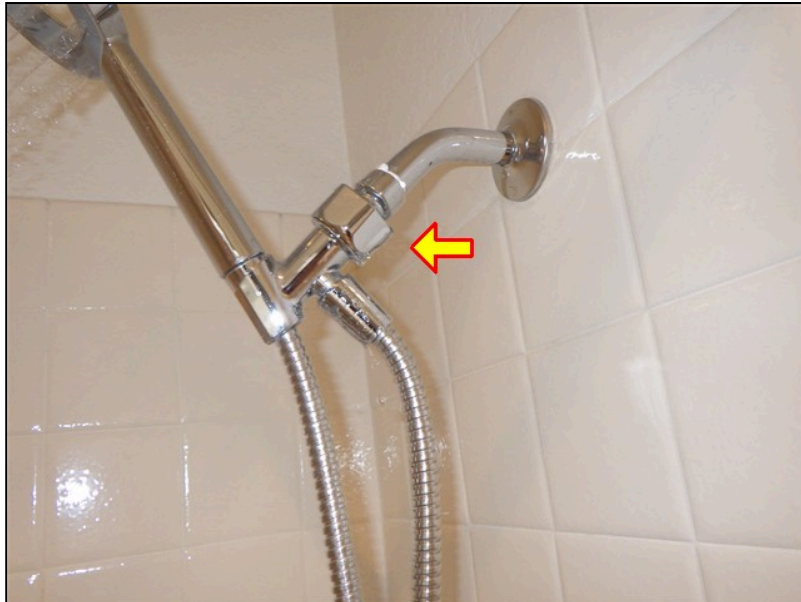
8.3 Item 4(Picture)

(4) The hall bathroom shower head leaks at the fitting. We recommend replacement by a qualified person.

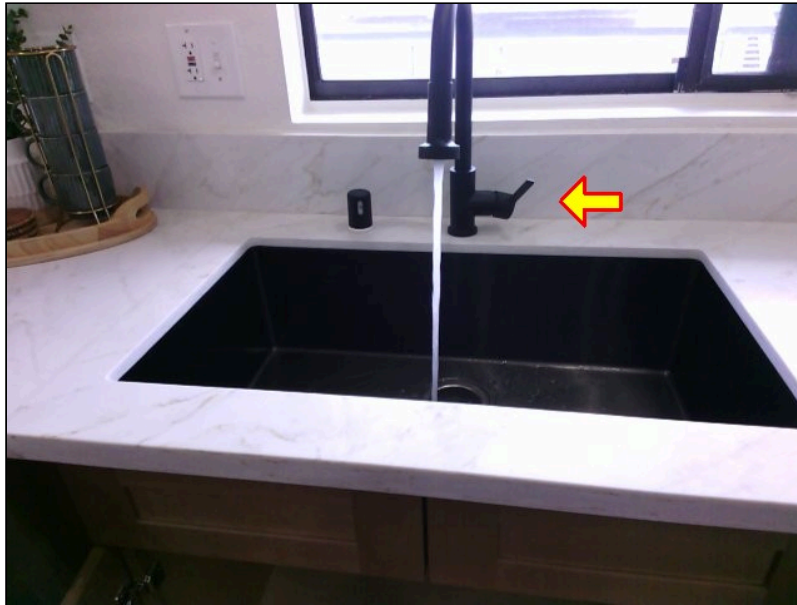
8.4 Item 1(Picture)

The hot and cold water supply is reversed at the kitchen sink. This is considered a scalding and safety hazard. We recommend necessary corrections by a qualified licensed plumber safety.

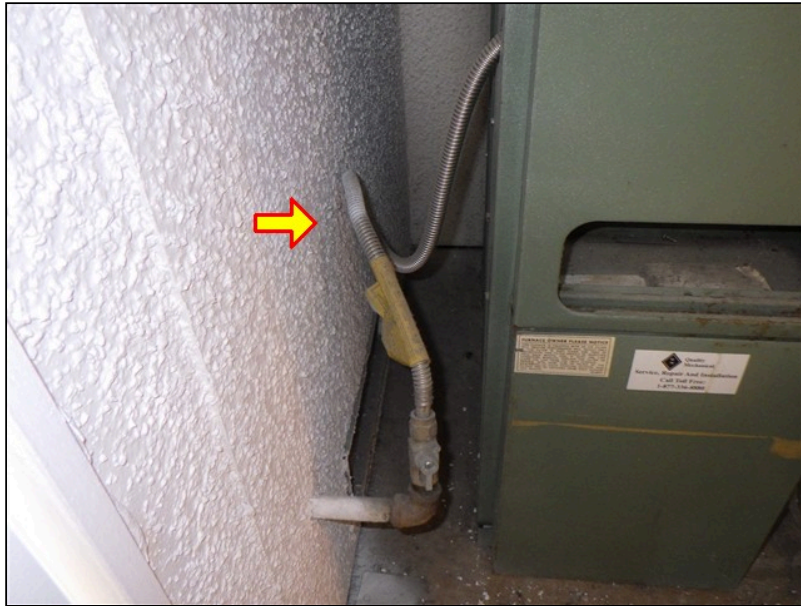
8.6 Item 1(Picture)

(1) The gas supply pipe at the furnace did not contained a drip leg/ sediment trap. This may have been standard at the time of installation but now is highly recommended. The purpose of a drip leg is to help prevent sediment/ debris from entering and clogging the furnace gas valve which could cause the furnace to shut down. We recommend having a drip leg installed by a qualified licensed HVAC contractor.

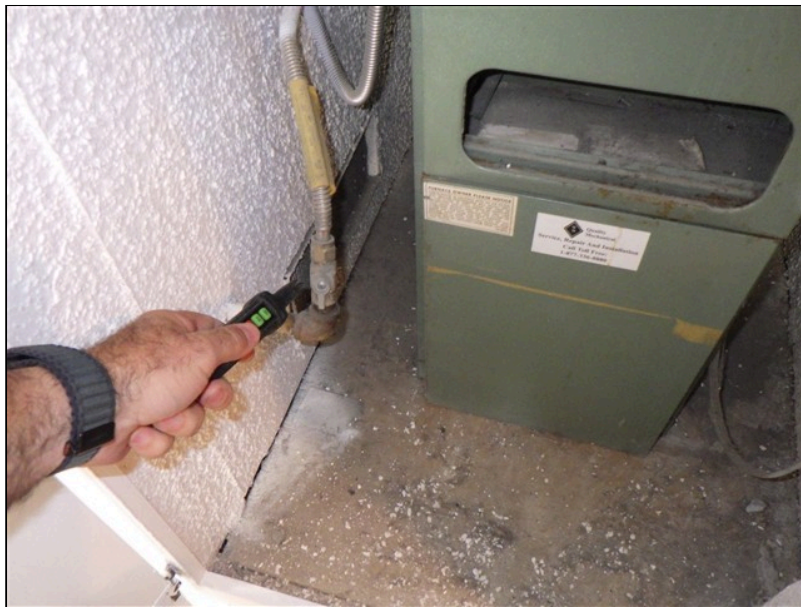
8.6 Item 3(Picture)

(2) Note: A gas and carbon monoxide leak test was conducted at accessible gas fittings and appliances using gas and CO leak detectors. There were no gas or CO leaks detected at the time of the inspection.

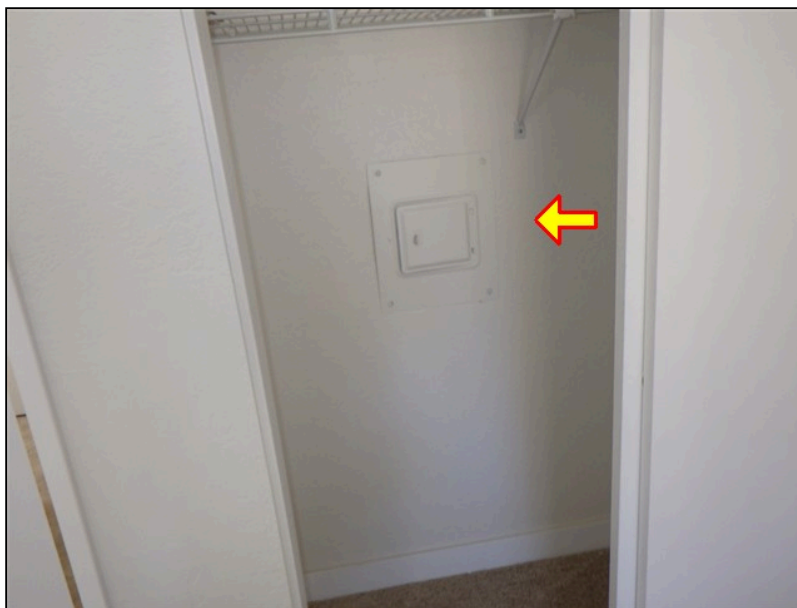
9.0 Item 1(Picture)

(1) There is a sub electrical panel located in a closet. Sub electrical panels are no longer allowed to be installed in closets due to the combustible nature of clothing and inadequate clearances. We recommend having the sub-panel relocated to an approved location by a qualified licensed electrician.

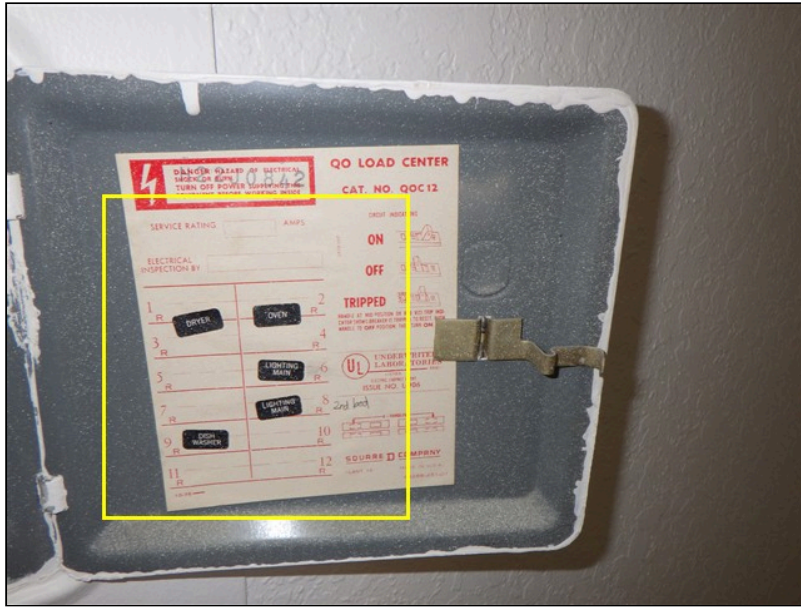
9.0 Item 2(Picture)

(2) The sub panel breaker labels are confusing. We recommend having the breakers properly labeled for safety by a qualified person.

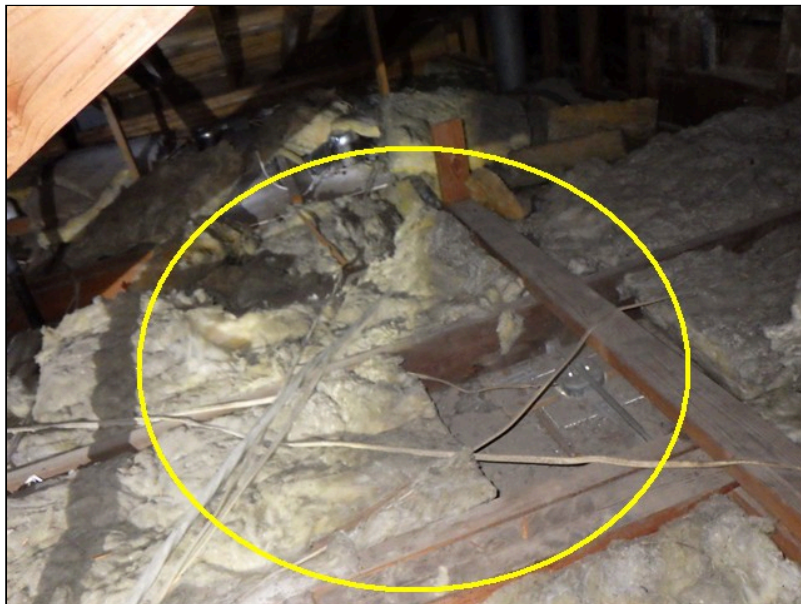
9.1 Item 1(Picture)

(1) Wires for some lighting fixtures in the attic space were observed to be unsecured. We recommend necessary corrections by a qualified licensed electrician.

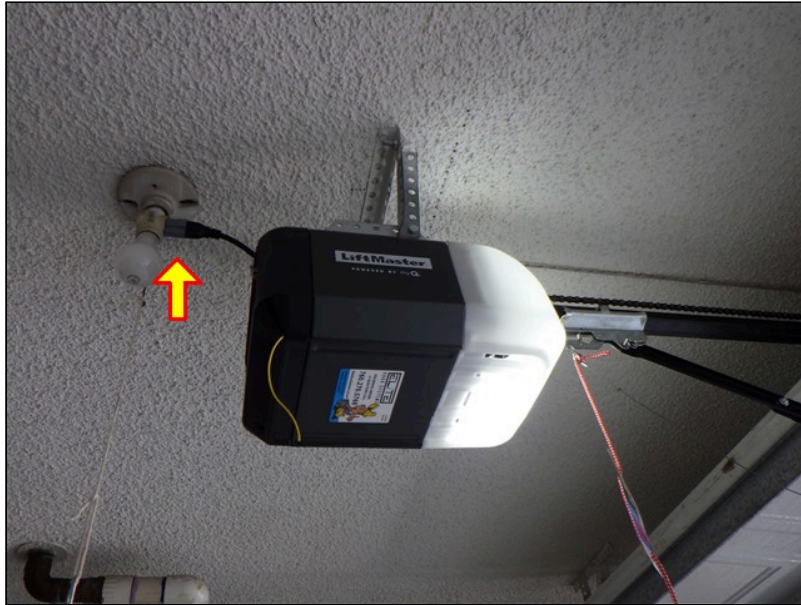
9.3 Item 1(Picture)

(1) The garage door operator is plugged into the garage light fixture which is nonstandard. The garage door operator should be plugged into a designated receptacle independent of the garage light fixture. We recommend corrections by a qualified licensed electrician.
