## Inspection Report

**Property Address:**  
4085 Crystal Dawn Ln #201  
San Diego CA 92122

<b>Date:</b> 4/23/2026	<b>Time:</b> 01:00 PM	<b>Report ID:</b> 20260422-4085-Crystal-Dawn-Ln-201
<b>Property:</b> 4085 Crystal Dawn Ln #201 San Diego CA 92122	<b>Customer:</b> Eileen Ponce	<b>Real Estate Professional:</b> Ixie Weber Redfin

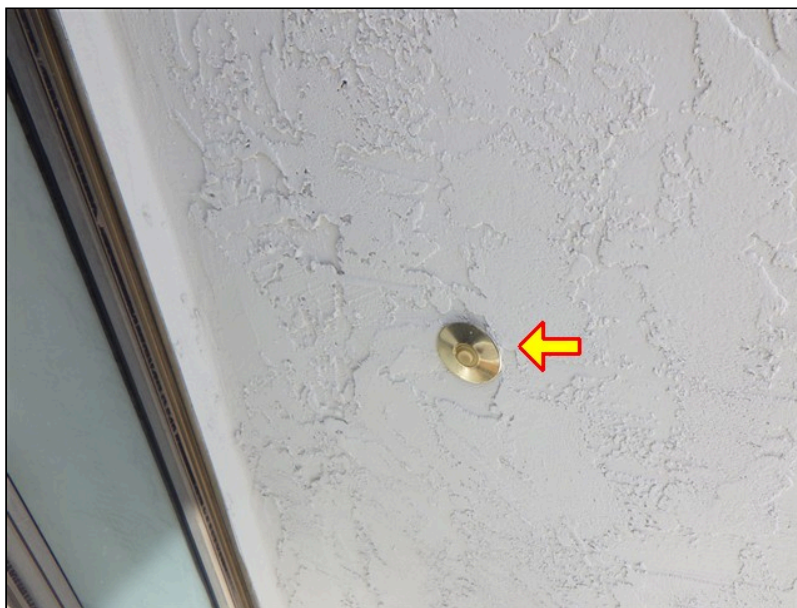
9.3 Item 3(Picture)

(3) The door bell is inoperable. We recommend necessary repair or replacement by a qualified person.

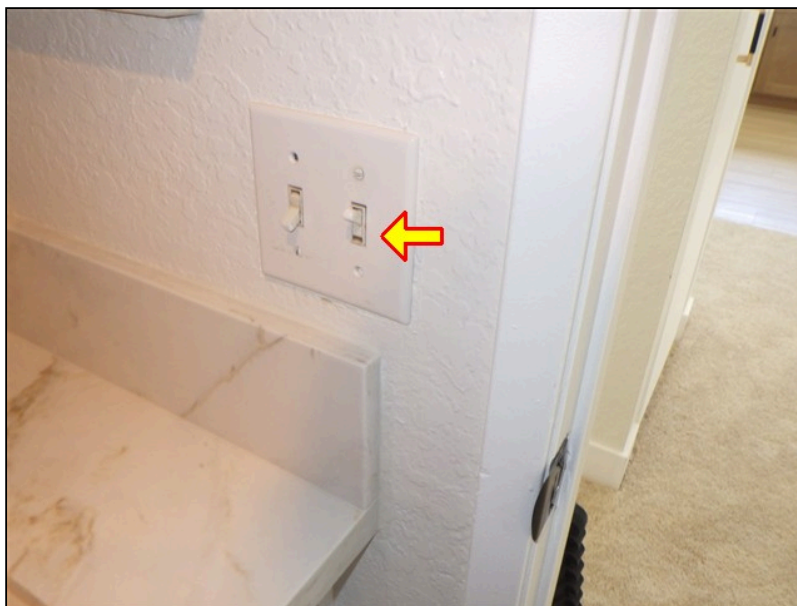
9.3 Item 4(Picture)

(4) The wall switches and receptacles (outlets) throughout the home are worn due to use and age. We recommend upgrading the wall switches and receptacles (outlets) as needed by a qualified licensed electrician.

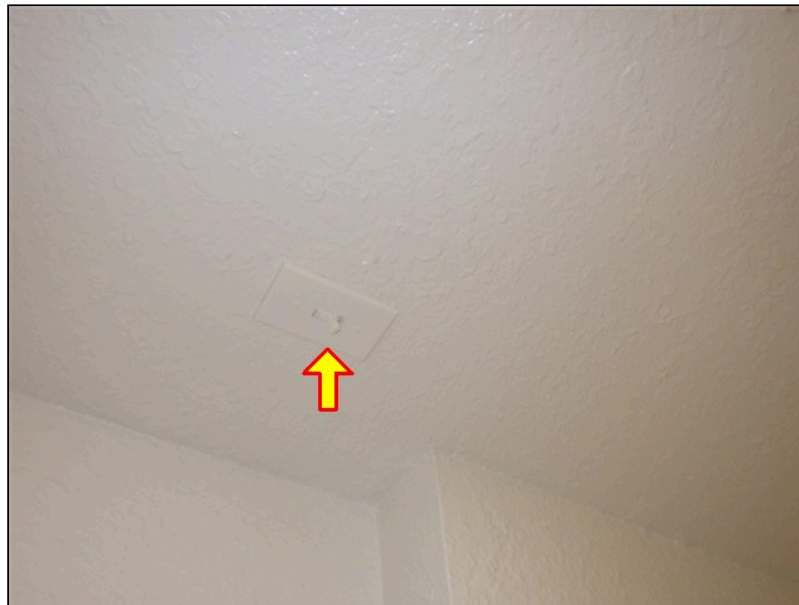
9.3 Item 5(Picture)

(5) I was unable to determine the function of the ceiling switch in the master bathroom. We recommend further evaluation by a qualified licensed electrician and repairs made as needed.

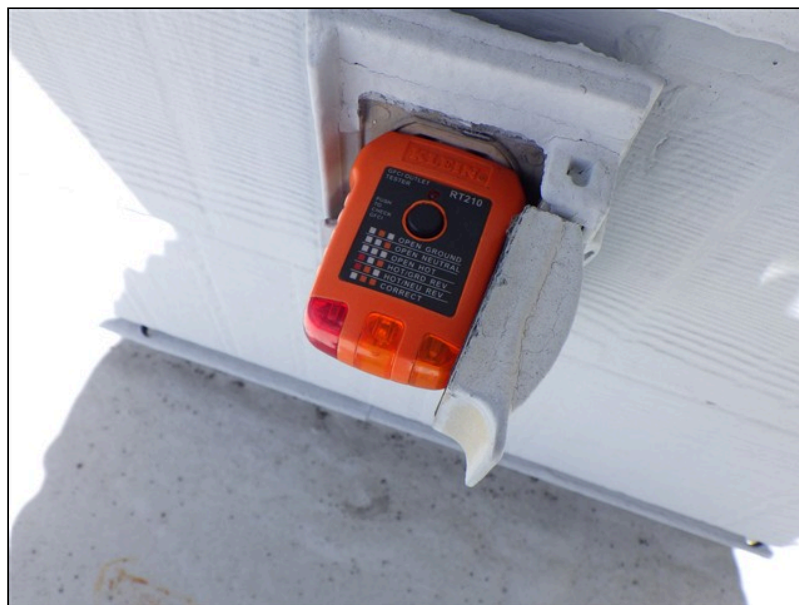
9.4 Item 1(Picture)

(1) A 3-prong receptacle at the front deck was found to be mis-wired with no ground. We recommend necessary corrections by a qualified licensed electrician.

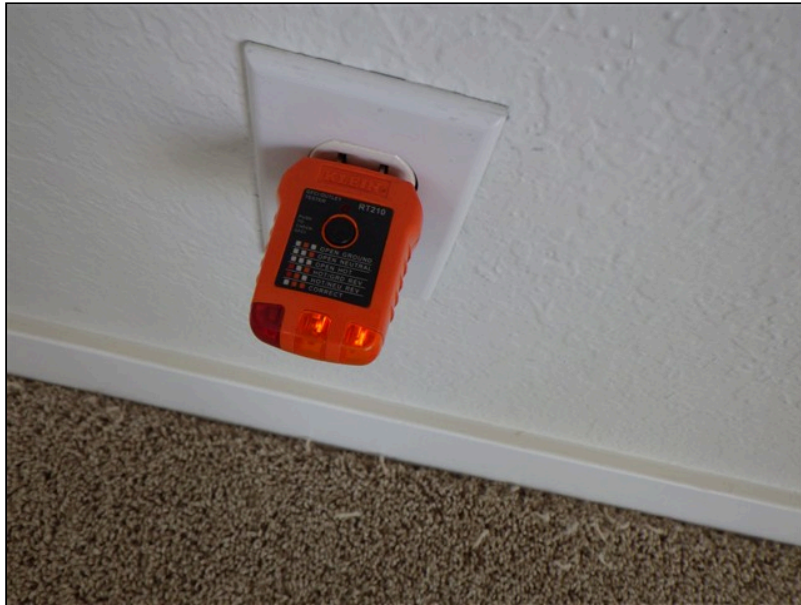
9.4 Item 2(Picture)

receptacles were observed to be functioning properly at the time of the inspection, **unless otherwise noted.** Note: Receptacles that are blocked/ covered and otherwise inaccessible were not inspected.

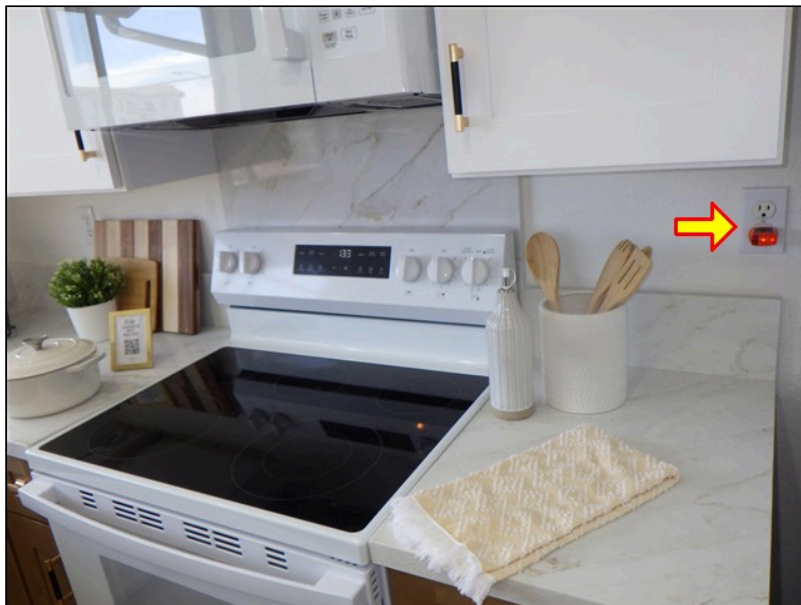
9.5 Item 1(Picture)

(1) One or more receptacles in the kitchen are not GFCI protected. We recommend upgrading all non-fixed appliance receptacles in the kitchen to GFCI protected receptacles by a qualified licensed electrician for safety.

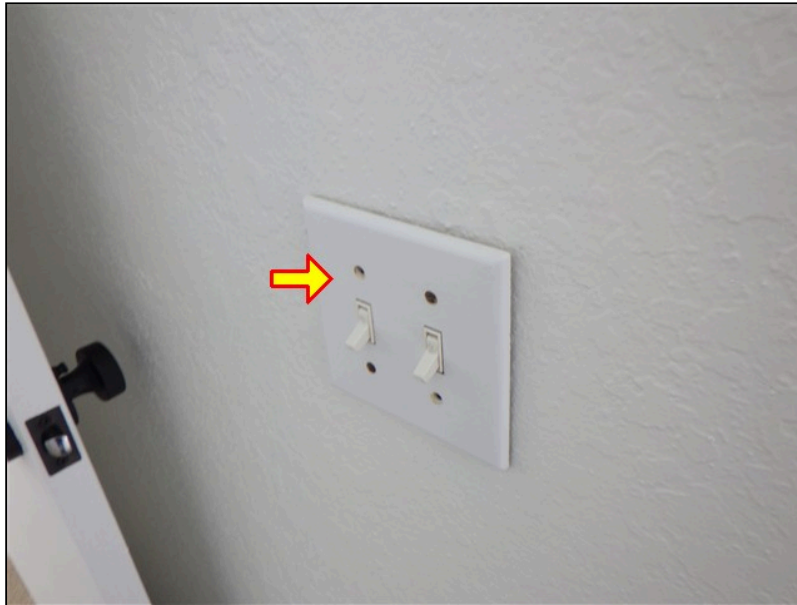
9.7 Item 1(Picture)

There are several loose switchplate and receptacle covers. This is nonstandard and a potential shock hazard. We recommend corrections by a qualified person where needed for safety.

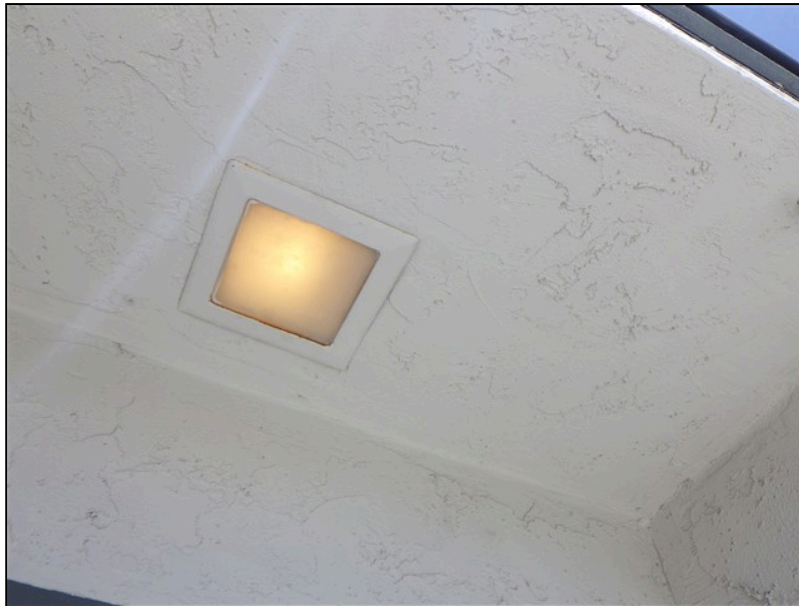
9.8 Item 1(Picture)

A representative number of exterior lights were tested and were found to be functional at the time of the inspection.

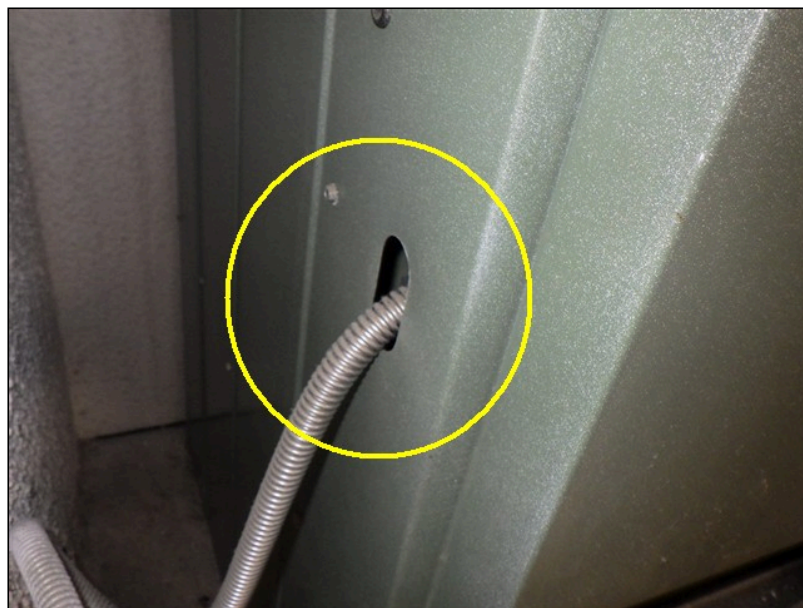
10.0 Item 4(Picture)

(2) The flexible gas supply pipe passes through furnace housing. Vibration from the furnace can wear through flexible gas pipe which could cause a gas leak. SDG&E is "Red Tagging" this condition as they considered it to be unsafe. Due to this condition we recommend a rigid cast pipe be installed from the gas regulator through furnace housing, to the exterior of furnace housing by a qualified licensed HVAC contractor.

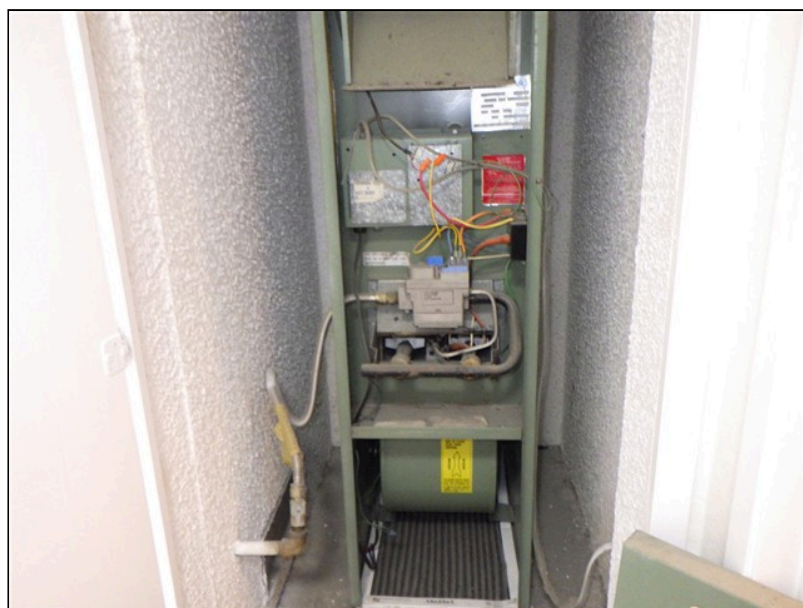
10.0 Item 5(Picture)

(3) There is excessive dust and debris observed in the furnace. We recommend having the furnace serviced and cleaned by a qualified licensed HVAC contractor.

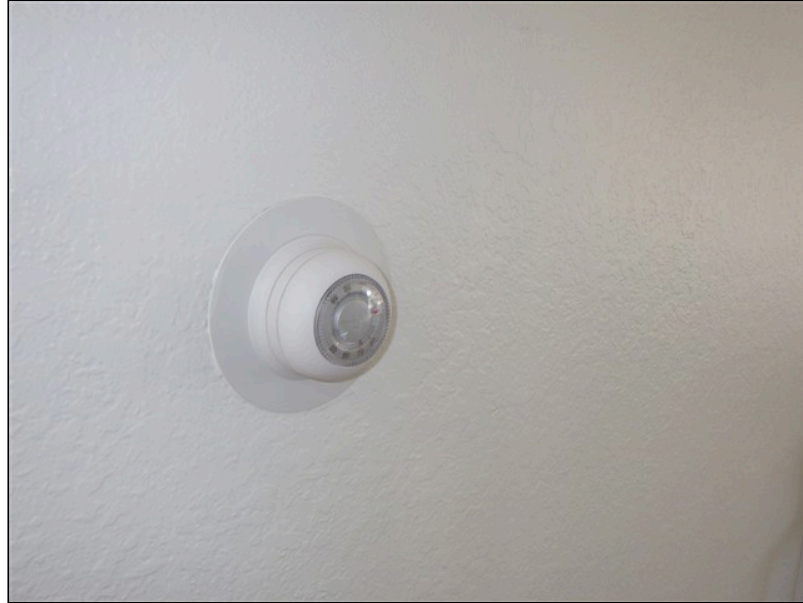
10.1 Item 1(Picture)

a programmable electronic model.

Note: The thermostat was operational when used to operate the HVAC system at the time of the inspection.

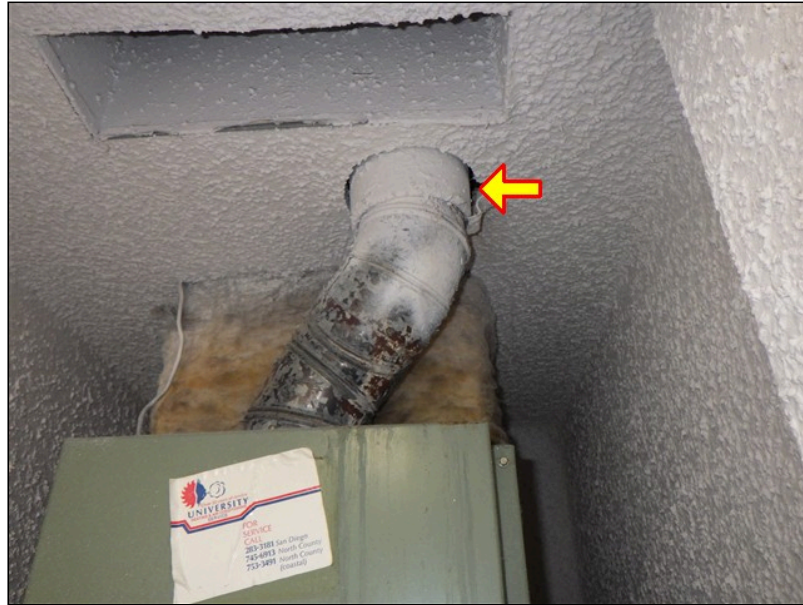
10.2 Item 1(Picture)

A section of the furnace flue may contain asbestos. It is beyond the scope of a home inspection to test for the presence or absence of asbestos. If the flue contains asbestos, there may be additional costs to remove the flue if you upgrade the Transite flue to metal. Inspecting the Transite flue should be part of an annual furnace servicing until it is replaced. We recommend replacement of the Transite flue upon replacement of the furnace, replacement of the roof, or if you are concerned about asbestos by a qualified licensed HVAC contractor.

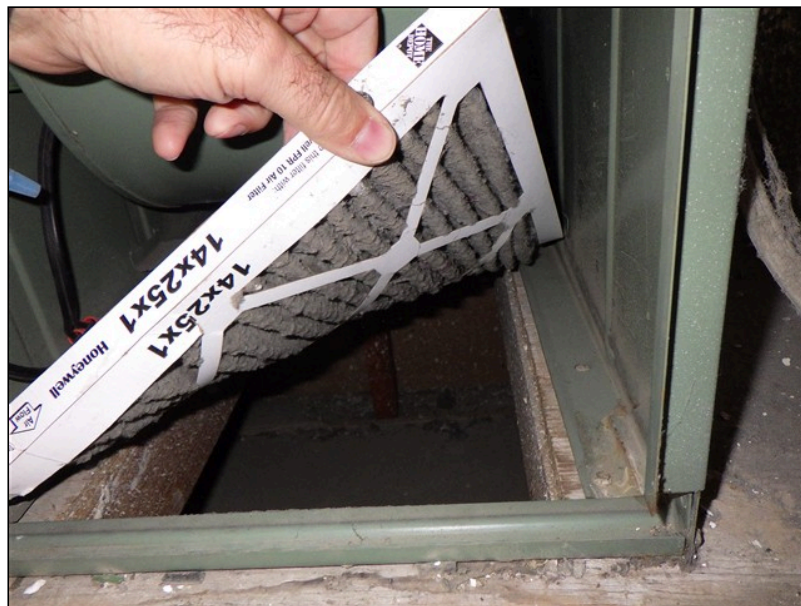
10.3 Item 1(Picture)

The air filter for the HVAC system is dirty. We recommend replacing by a qualified person.

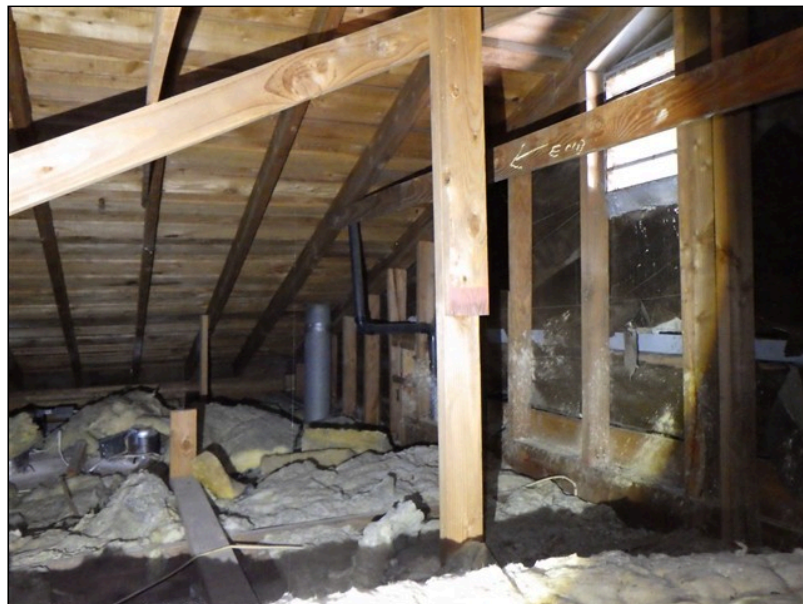
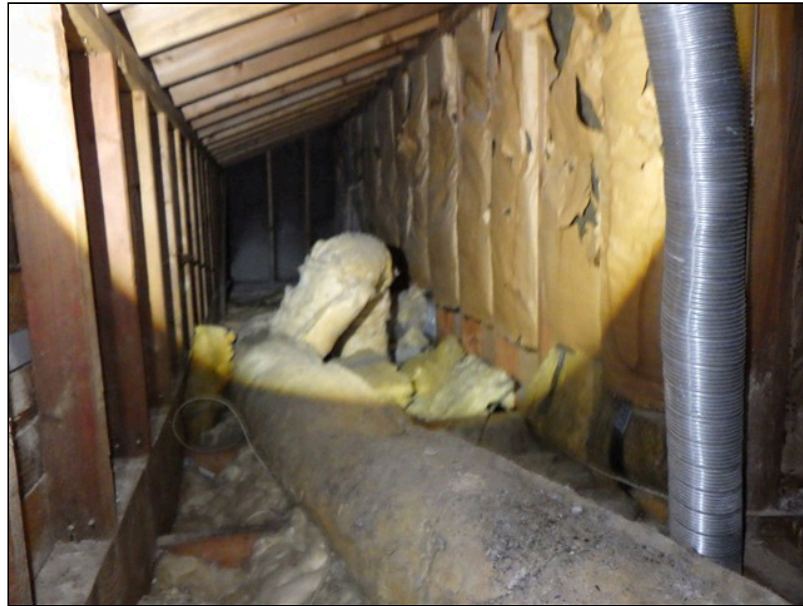
12.1 Item 1(Picture)

Due to the structure of the roof/ framing and forced air handling components, some areas of the attic space could not be inspected.

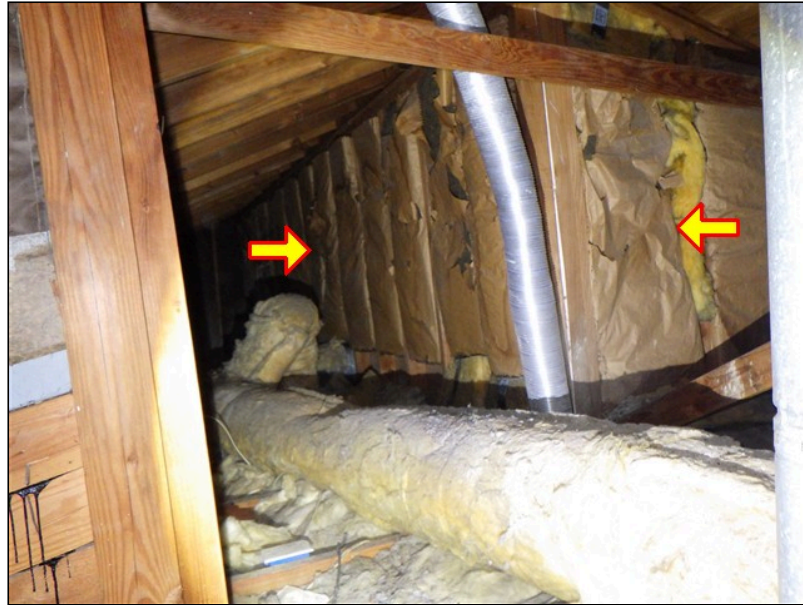
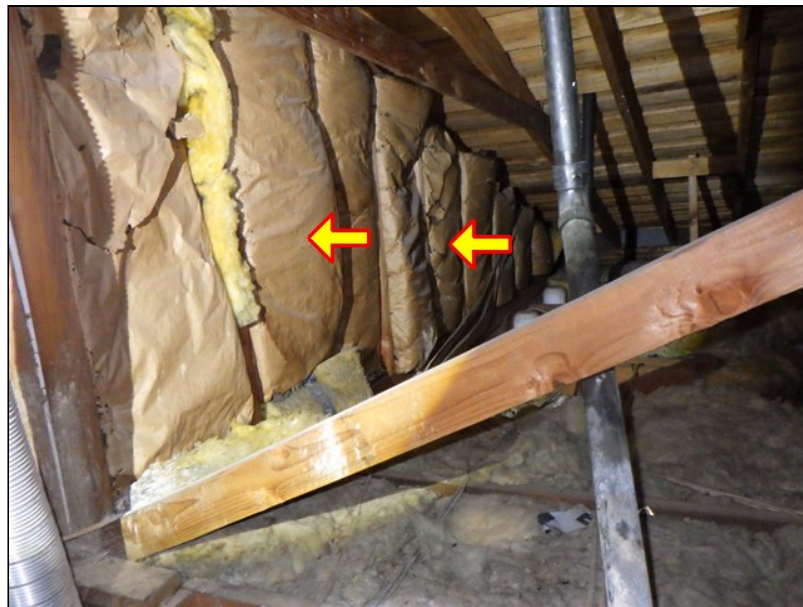
13.0 Item 1(Picture)

(1) The attic wall insulation is installed with the vapor barrier or paper side out. This is a non-standard installation. Per manufacturer's specifications, the paper should not be exposed due to fire risk. We recommend necessary corrections by a qualified licensed contractor.

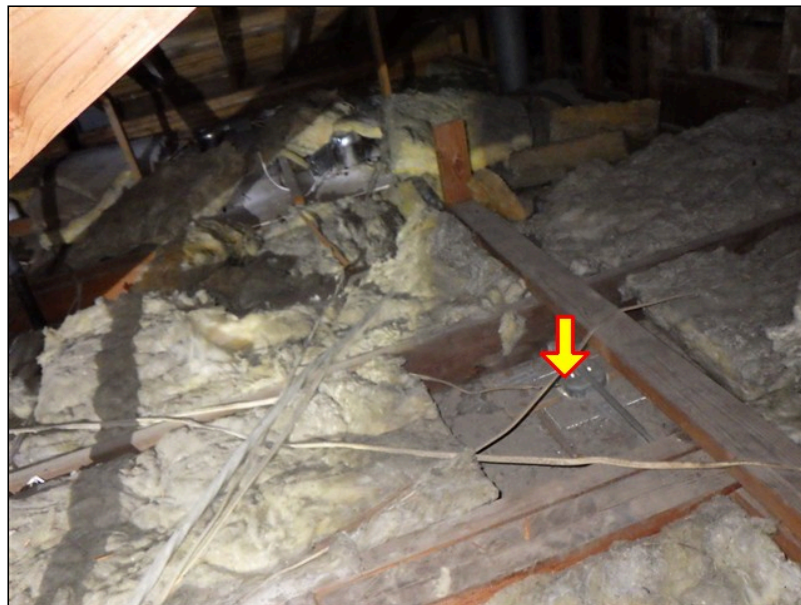
13.0 Item 3(Picture)

(2) Some of the batt insulation has been moved in the attic space for installation of recessed lights or other reasons. This insulation was not put back into position where needed. We recommend having the insulation distributed properly/ put back into place to improve the thermal efficiency of the house by a qualified person.

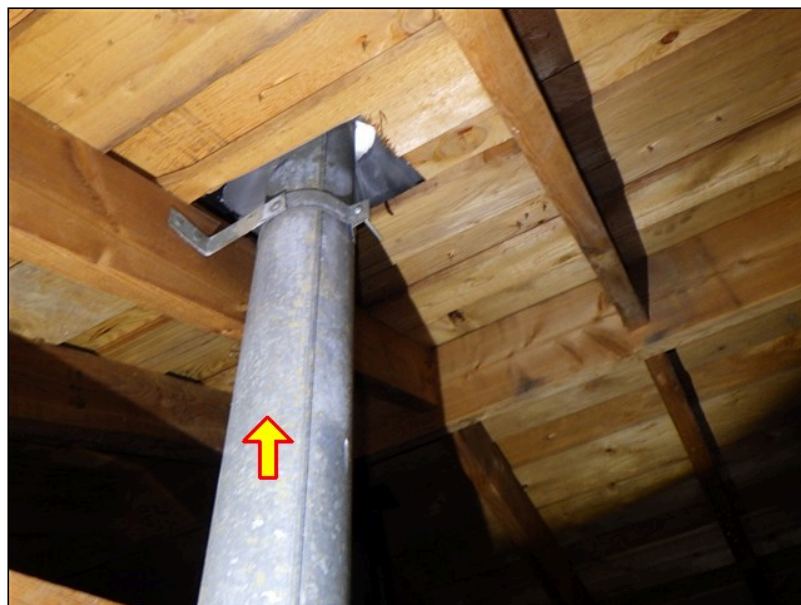
13.1 Item 1(Picture)

Vertical dryer vent noted which extends dry time and could lead to lint build up. We recommend corrections as needed by a qualified contractor.

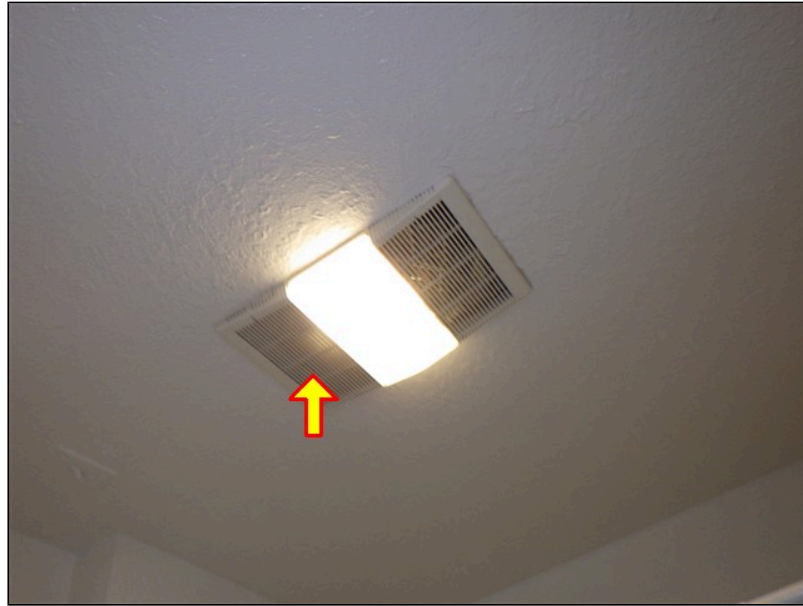
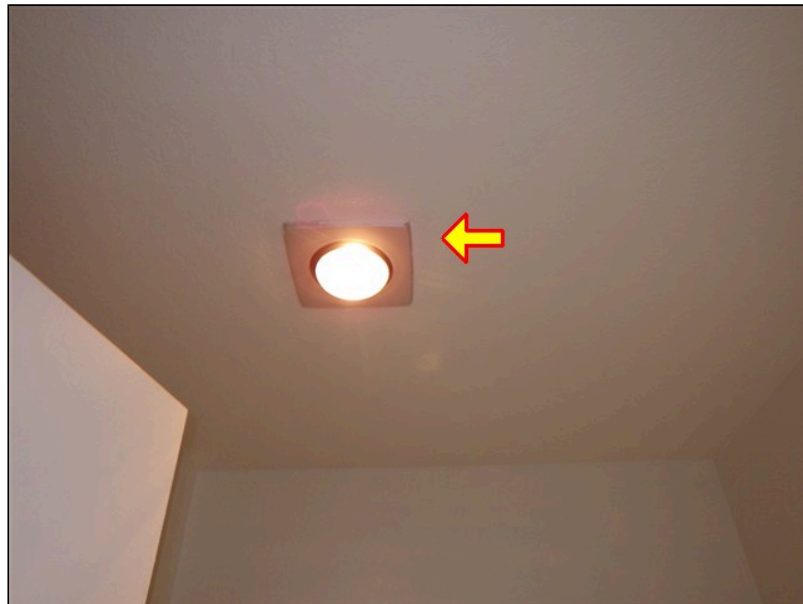
13.2 Item 1(Picture)

Both bathroom exhaust vents made excessive noise during operation. This typically indicates that the unit is at or near the end of its service life. We recommend replacing all bathroom exhaust vents by a qualified licensed contractor.

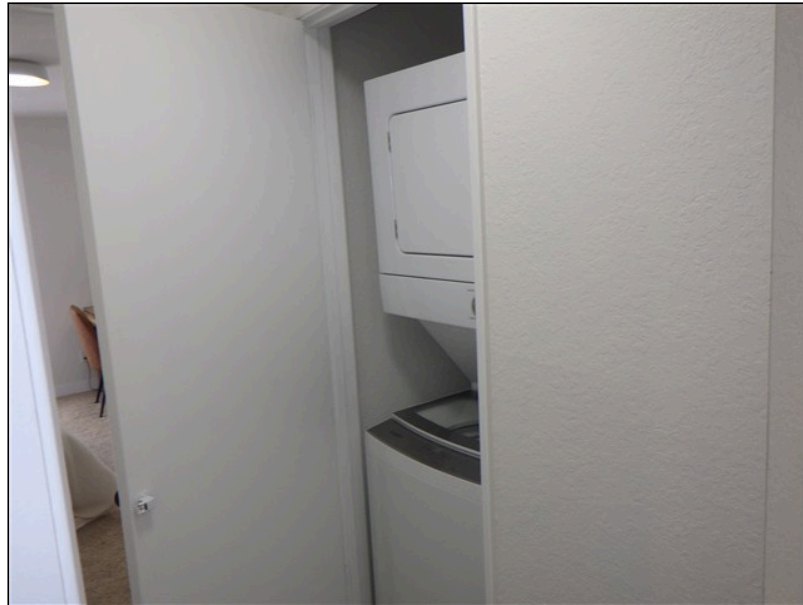
13.3 Item 1(Picture)

The clothes dryer closet does not have adequate ventilation. A louvered or vented door is required by most clothes dryer manufacturers to allow for fresh air exchange. We recommend necessary corrections by a qualified licensed contractor.

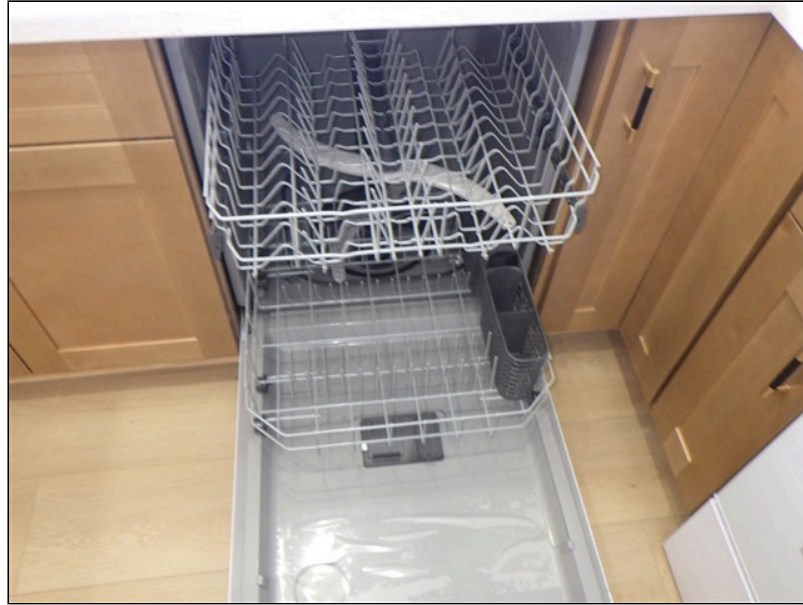
14.0 Item 1(Picture)

The dishwasher was tested and functioned properly at the time of the inspection. This is not an exhaustive test and does not verify the cleaning efficiency of the dishwasher.

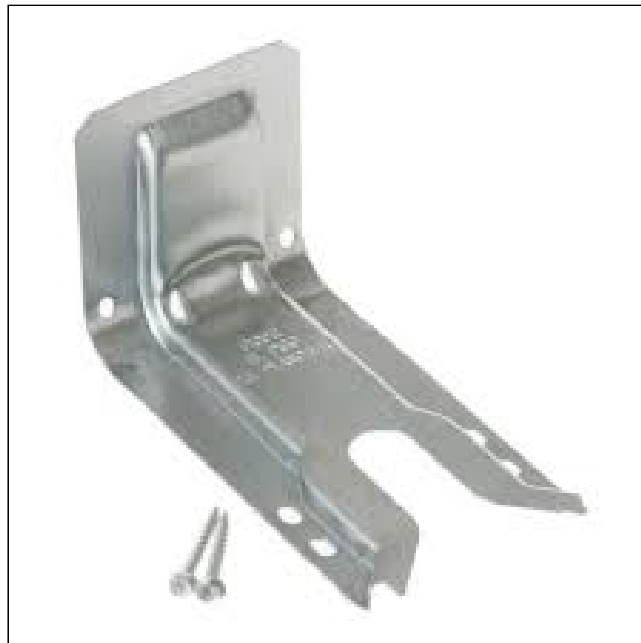
14.1 Item 1(Picture)

(1) An anti tip bracket was not installed at the range. This bracket prevents the range from tipping forward which could cause the range to fall over. We recommend installation of an anti tip bracket by a qualified person for safety and to help prevent injury.

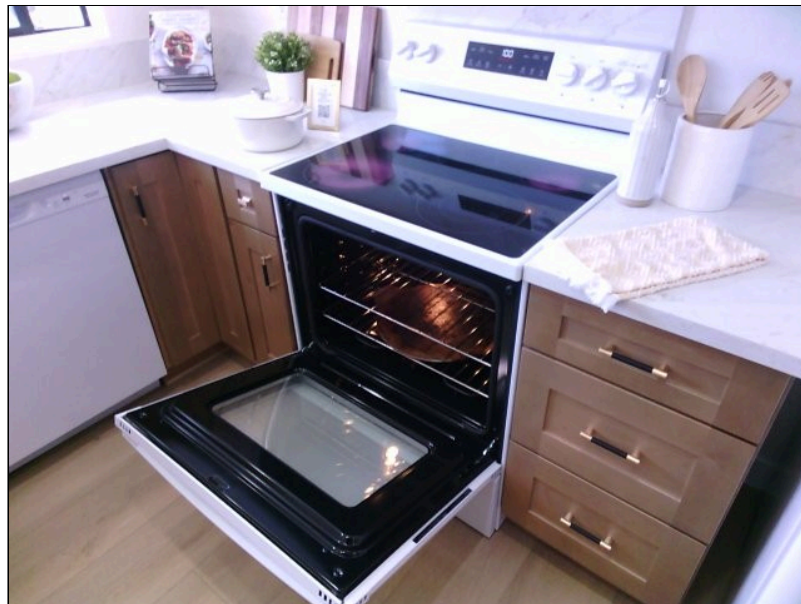
14.1 Item 3(Picture)

(2) Note: The range/oven was tested and was functional at the time of the inspection. This test is not exhaustive and does not confirm the performance, accuracy, or effectiveness of the oven.

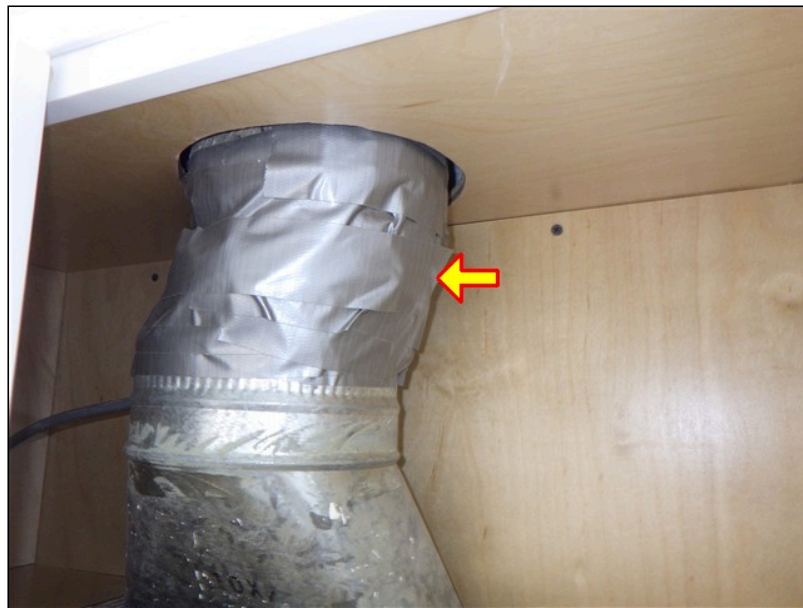
14.2 Item 1(Picture)

(1) The vent duct was taped with duct tape. Duct tape is no longer used at vent ducts. We recommend re-taping the duct with a flexible metal tape by a qualified person.

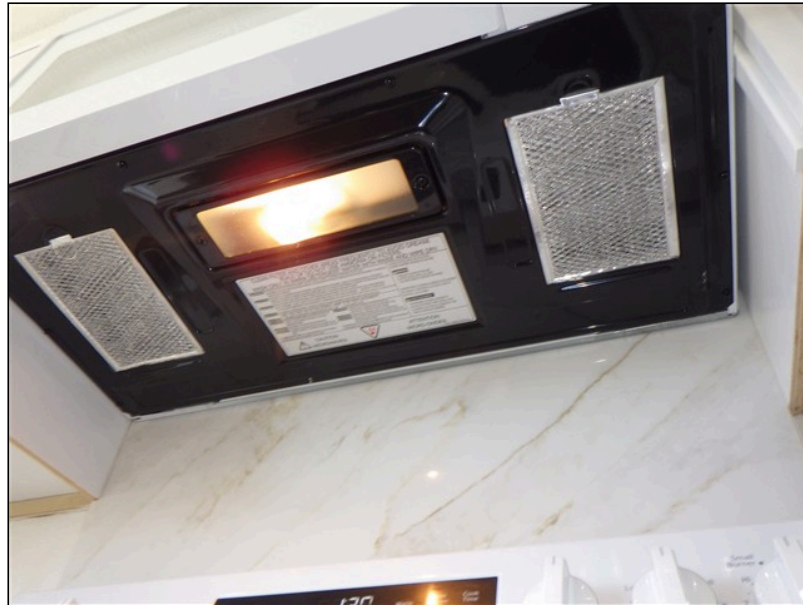
14.2 Item 2(Picture)

(2) Note: The range exhaust vent was tested and was functional at the time of the the inspection. This is not an exhaustive test, and does not evaluate the performance or effectiveness of the unit.

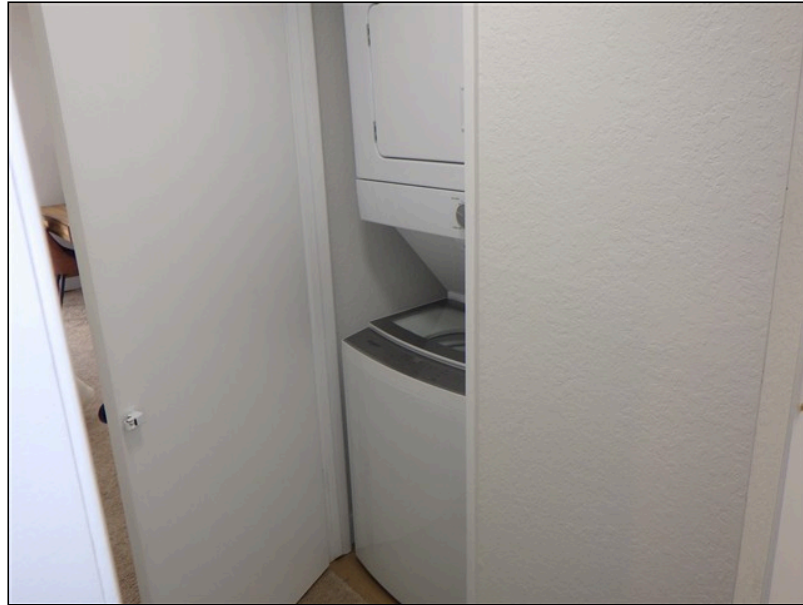
14.5 Item 1(Picture)

The clothes washer and dryer are not part of our general inspection and were not inspected or commented on. If concerned about there serviceability and functionality we recommend further evaluation by a qualified licensed appliance contractor prior to the end of your contingency period.

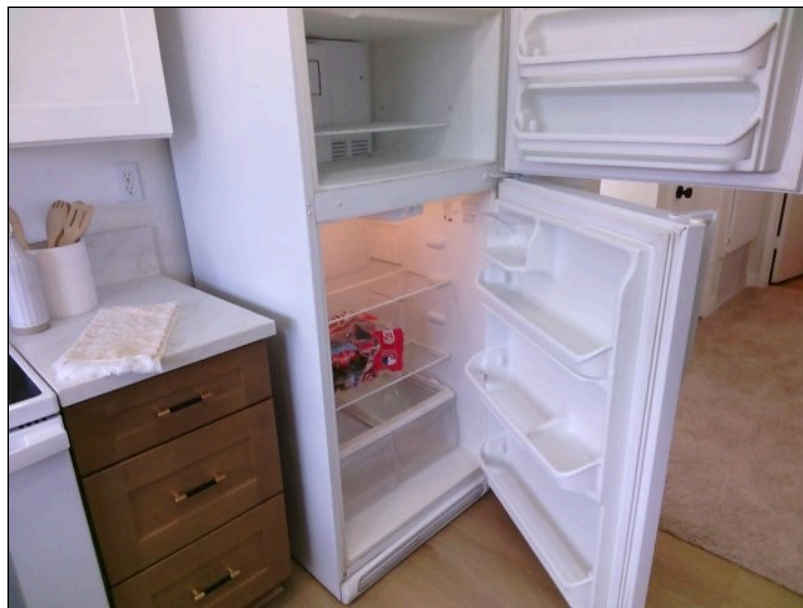
14.6 Item 1(Picture)

(1) Refrigerators built in or not are not part of our general home inspection and are not inspected or commented on. If concerned about its serviceability and functionality we recommend further evaluation by a qualified licensed appliance contractor prior to the end of your contingency period.

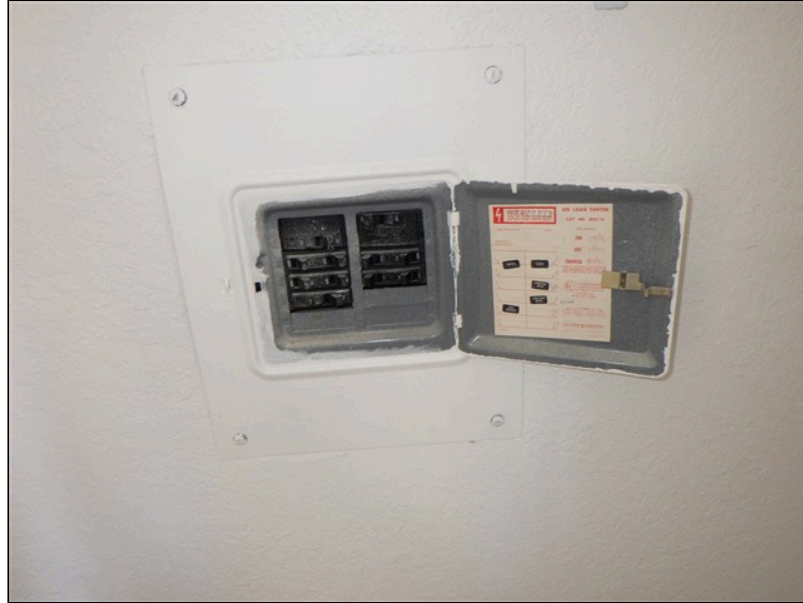
15.3 Item 1(Picture)

The sub-panel is located in a bedroom closet.
