PROPERTY INSPECTION REPORT

1904 Via Casa Alta
San Diego, CA 92037

07/01/2025

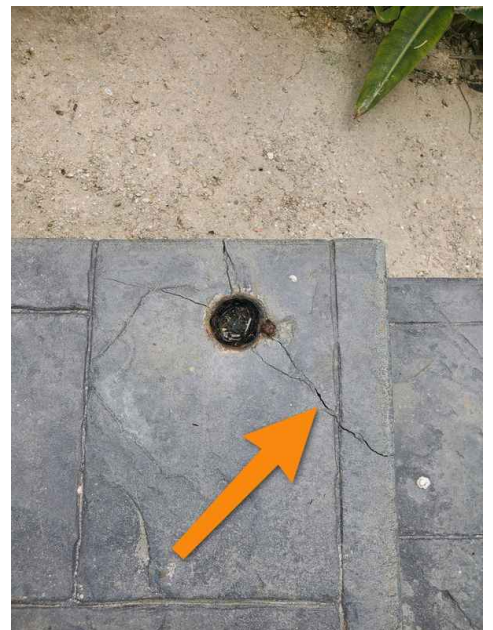
4.1.1 Driveways, Sidewalks, Patios

Contact a qualified concrete contractor.

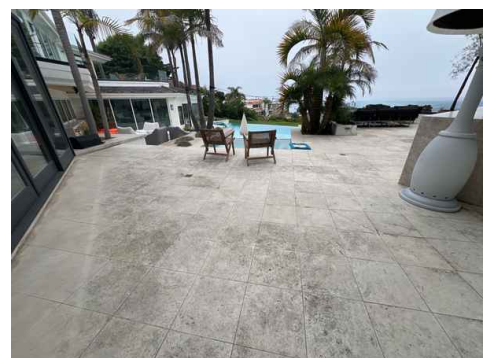
4.1.2 Driveways, Sidewalks, Patios

POTENTIALLY SLIPPERY SURFACE

Contact a qualified professional.

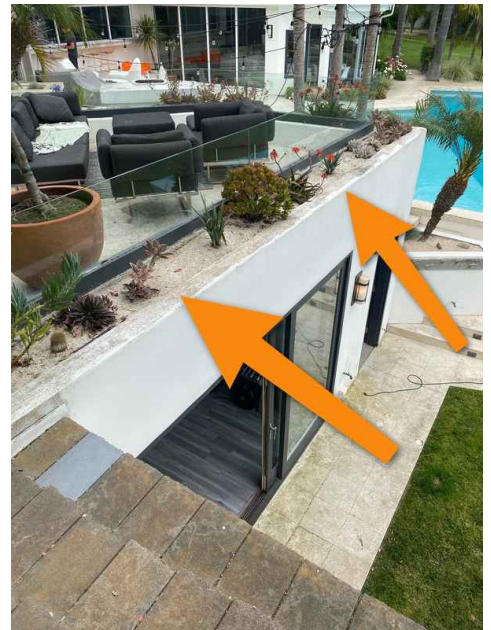
4.2.1 Drainage or Grading

Recommend monitoring.

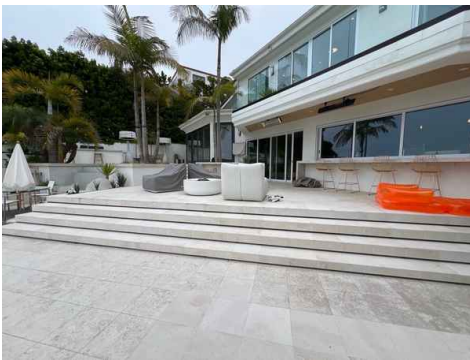
4.8.1 Decks / Balconies / Stairs

Contact a qualified professional.

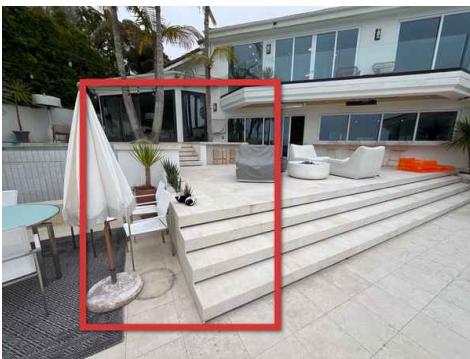
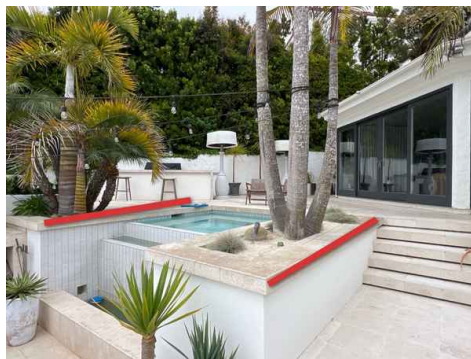
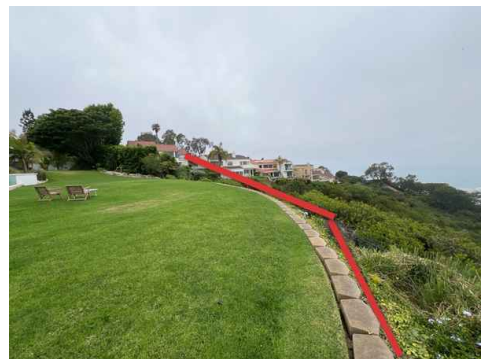
4.8.2 Decks / Balconies / Stairs

WALK OFF HAZARD(S) NOTED

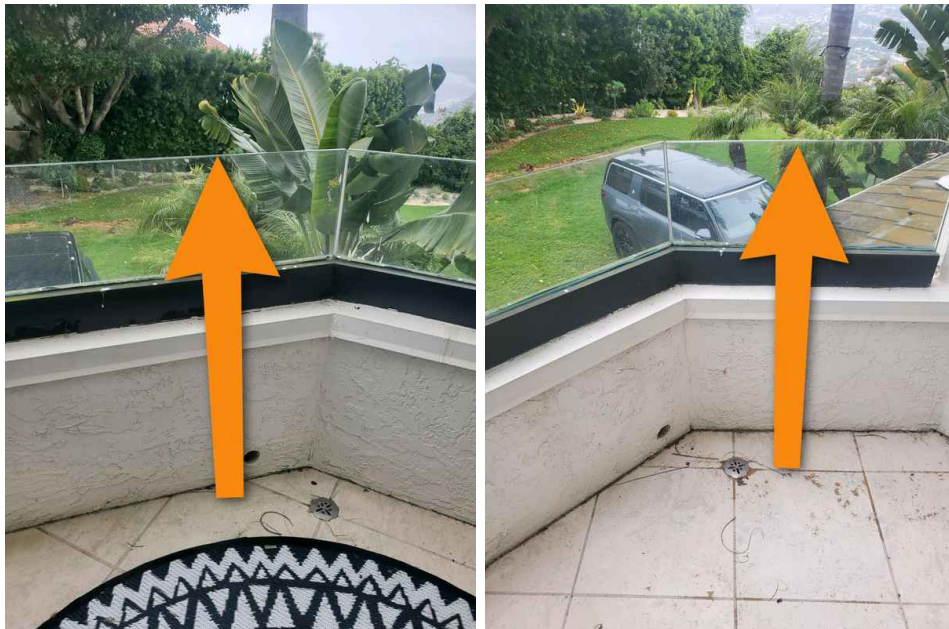
4.8.3 Decks / Balconies / Stairs

Contact a qualified professional.

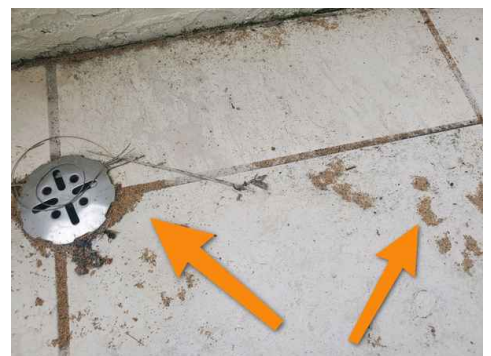
4.8.4 Decks / Balconies / Stairs

Contact a qualified pest control specialist.

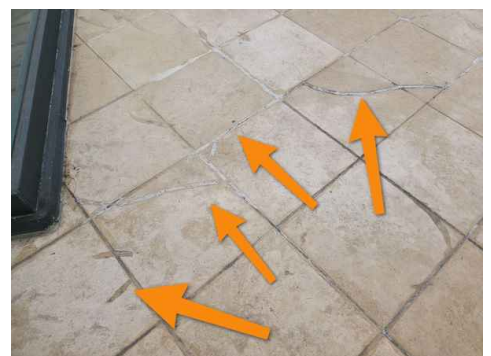
4.8.5 Decks / Balconies / Stairs

Contact a qualified flooring contractor

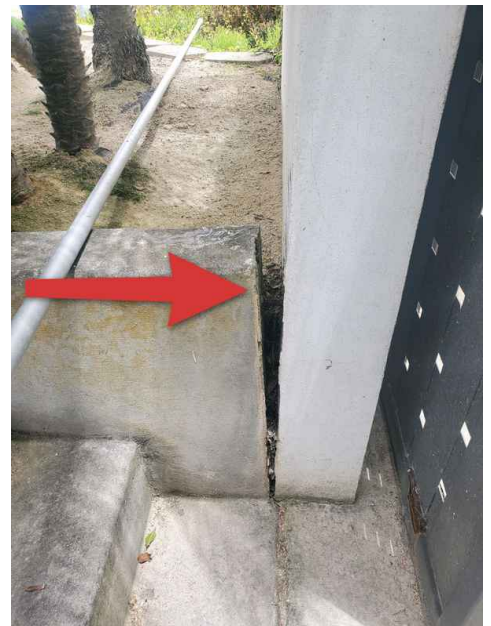
4.8.6 Decks / Balconies / Stairs

DECK / BALCONY CONSTRUCTED OVER LIVING SPACE

Contact a qualified professional engineer

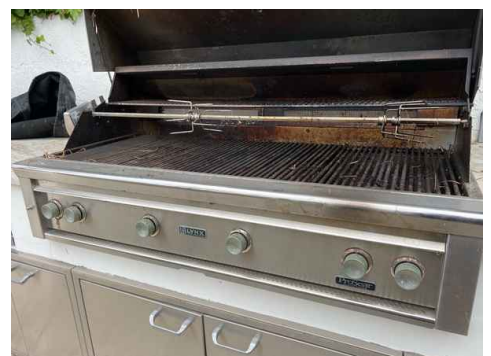
4.10.1 BBQ Area

IGNITER NOT OPERATIONAL

Contact a qualified professional.

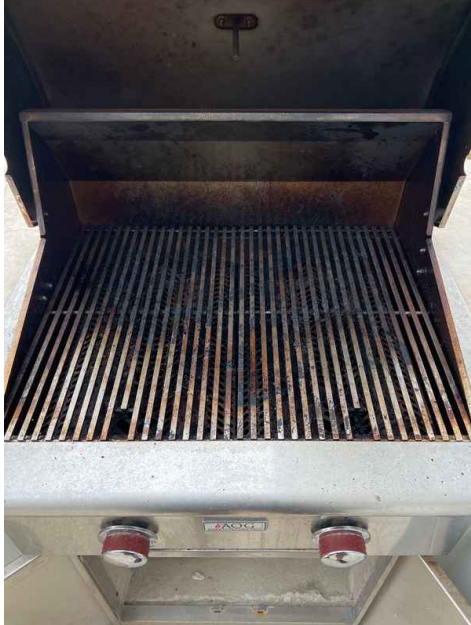
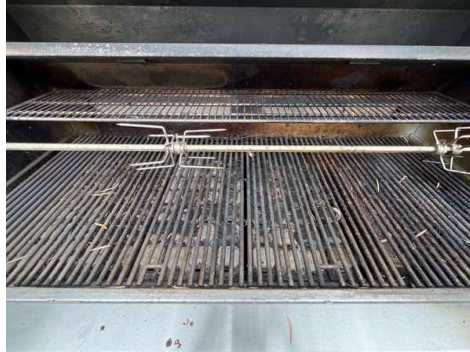
4.10.2 BBQ Area

DIRTY GRILL

Contact a qualified professional.

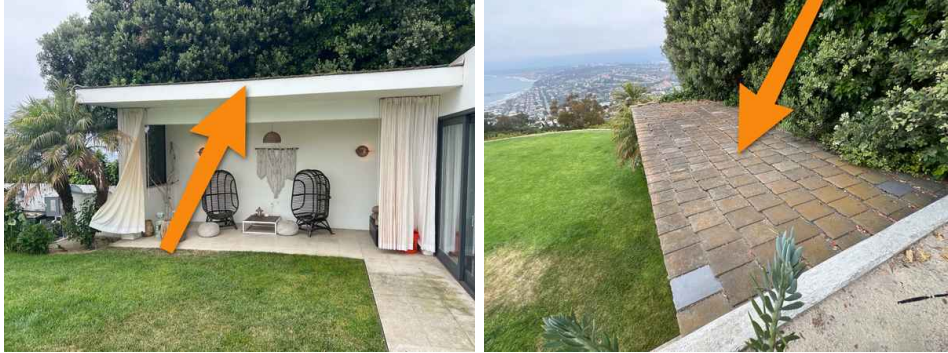
6.2.2 Coverings

Attention Required**TILE INSTALLED ON A FLAT / LOW PITCH ROOF**

Contact a qualified roofing professional.

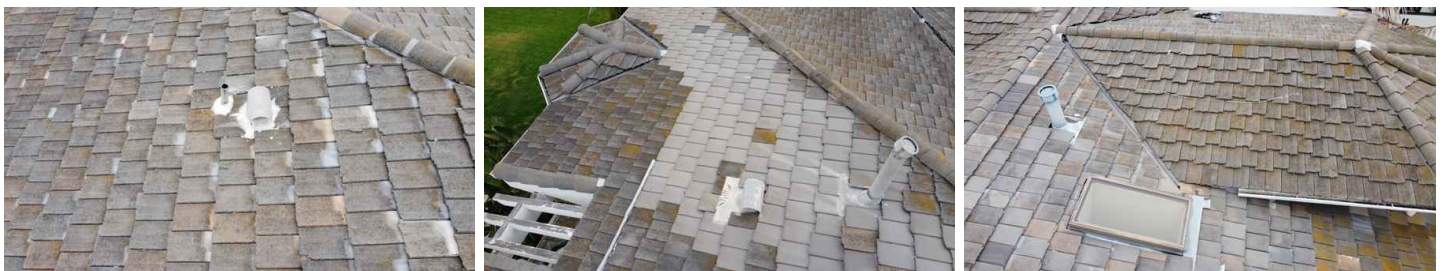
6.2.3 Coverings

Contact the seller for more info

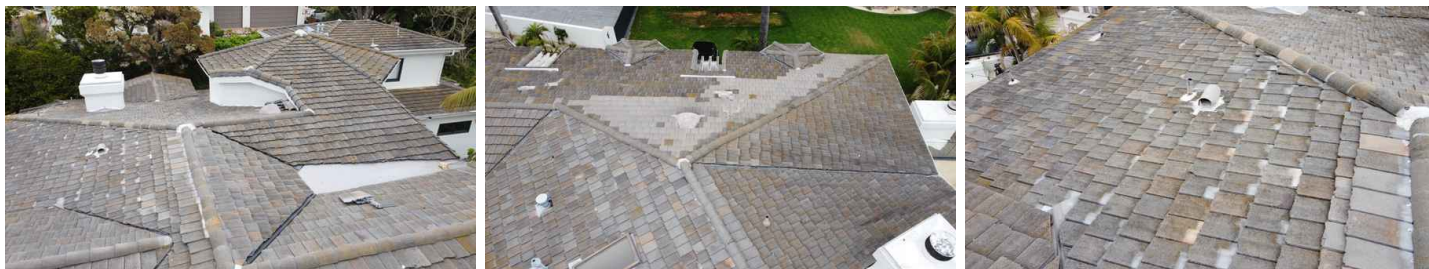
6.2.4 Coverings

Contact a qualified professional.

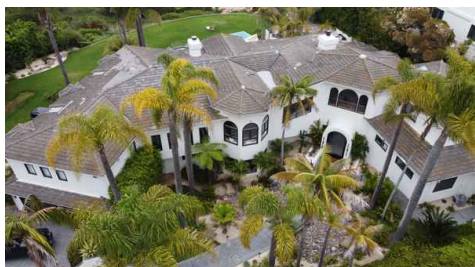
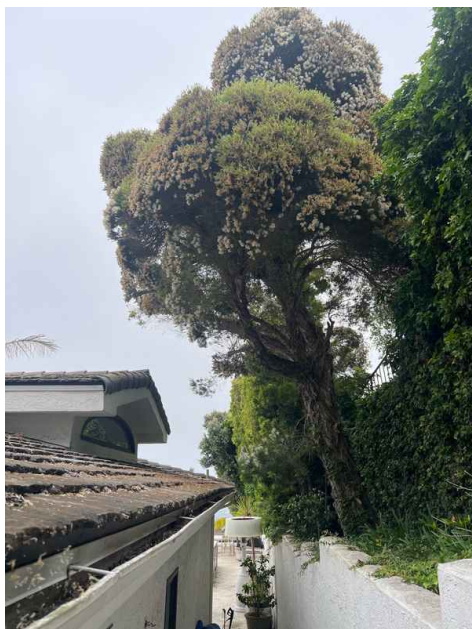
6.2.5 Coverings

Contact a qualified landscaping contractor

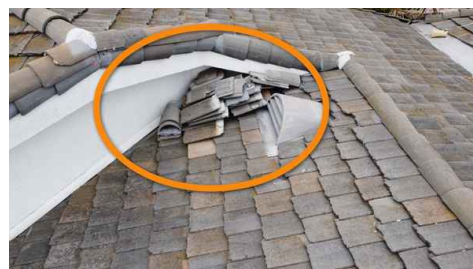
6.2.6 Coverings

Contact a qualified professional.

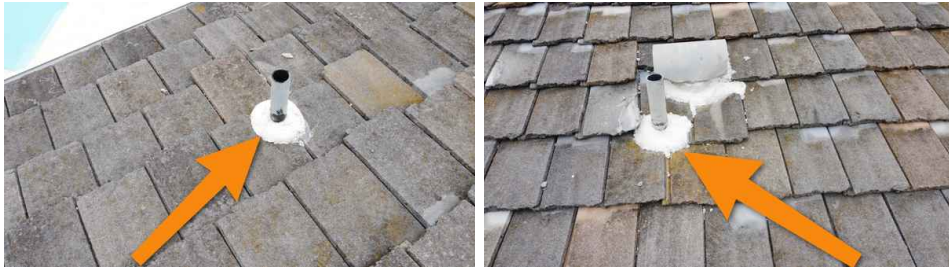
6.3.1 Flashings

Contact a qualified roofing professional.

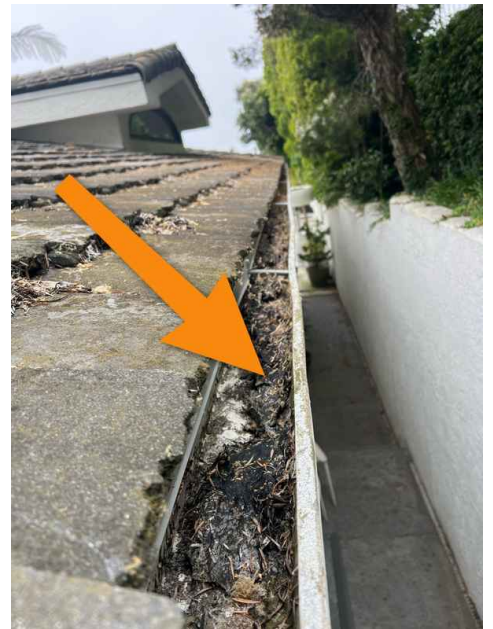
6.5.1 Roof Drainage Systems

DEBRIS IN GUTTER(S) AND/OR DOWNSPOUT(S)

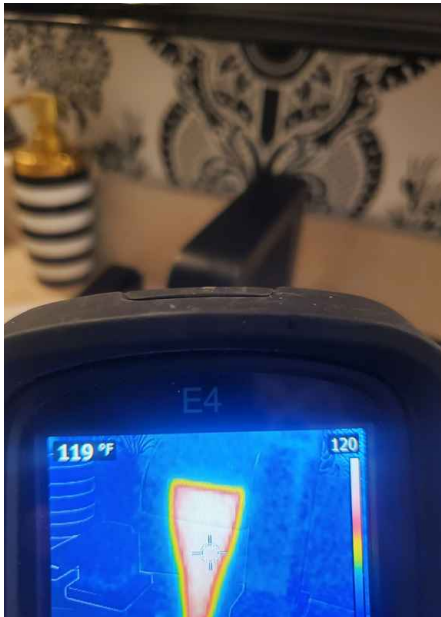
Thermal image of the water heater producing hot water.

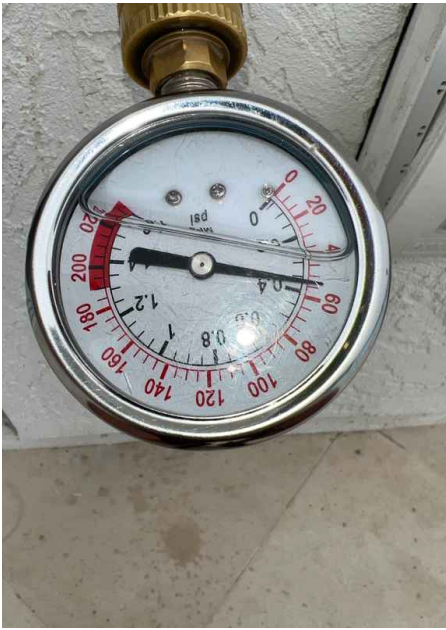
View of water pressure at the time of the inspection. 50 to 80 PSI is acceptable 60 to 75 PSI is ideal.

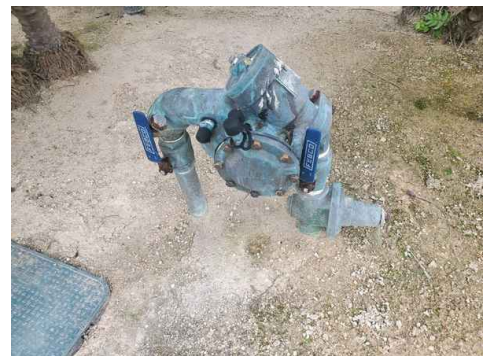
BACKFLOW PROTECTION NOT TESTED

Backflow prevention device was present but not tested at the time inspection.

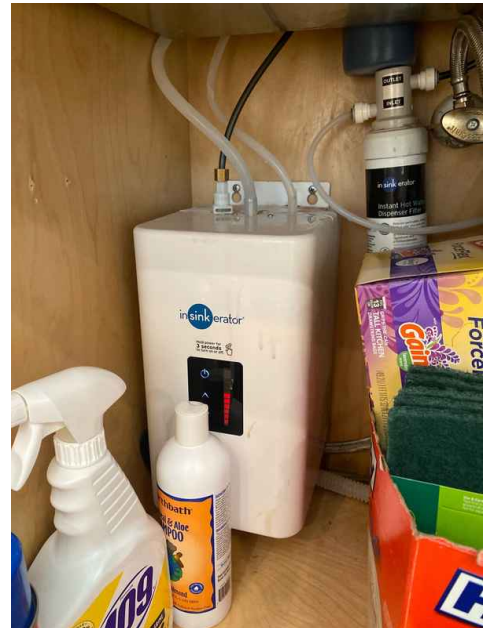
Note: An instant hot water system was noted. These are specialty systems and are excluded from this inspection. Comments in this report related to this system are made as a courtesy only and are not meant to be a substitute for a full evaluation by a qualified specialist. Recommend consulting with the property owner about this system.

Recommendation

Contact a qualified professional.

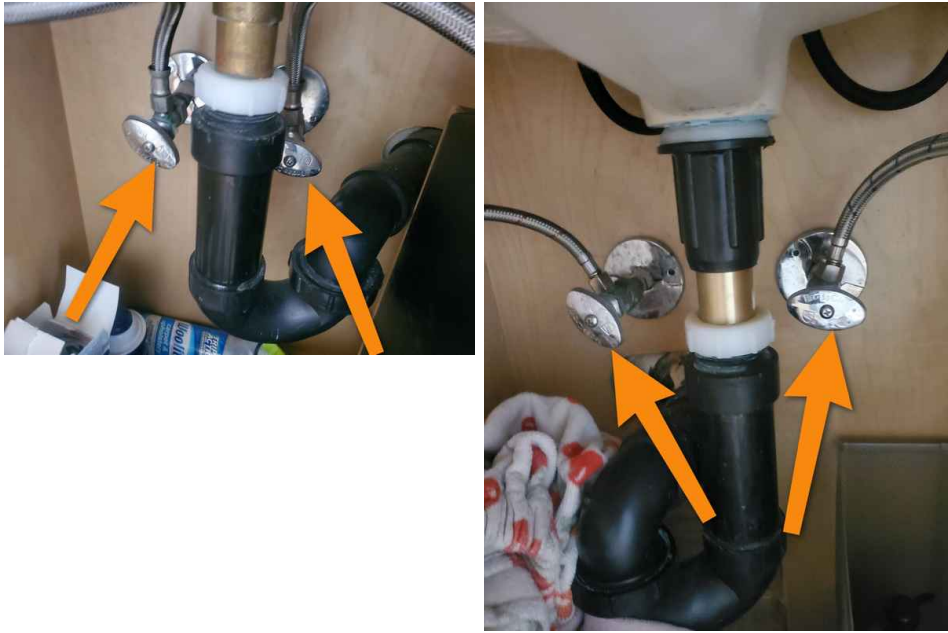
Old water lines and or angle stops were noted in one or more areas. These are prone to leaking and replacement is recommended.

Recommendation

Contact a qualified professional.

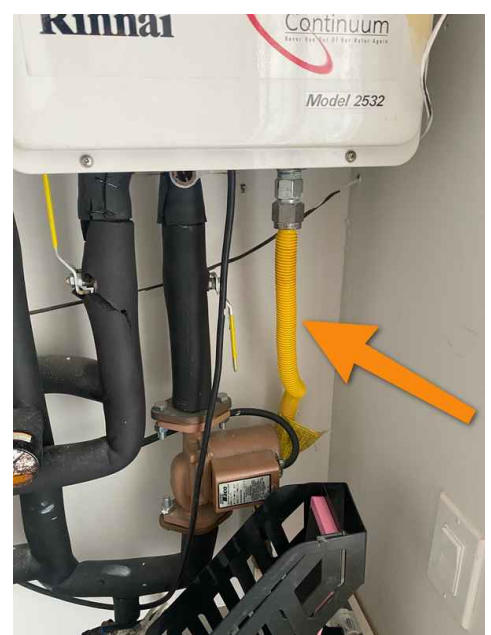
SEDIMENT TRAP MISSING

The gas line for the water heater is missing a sediment trap. Recommend further evaluation and repair by a licensed plumber.

Recommendation

Contact a qualified professional.

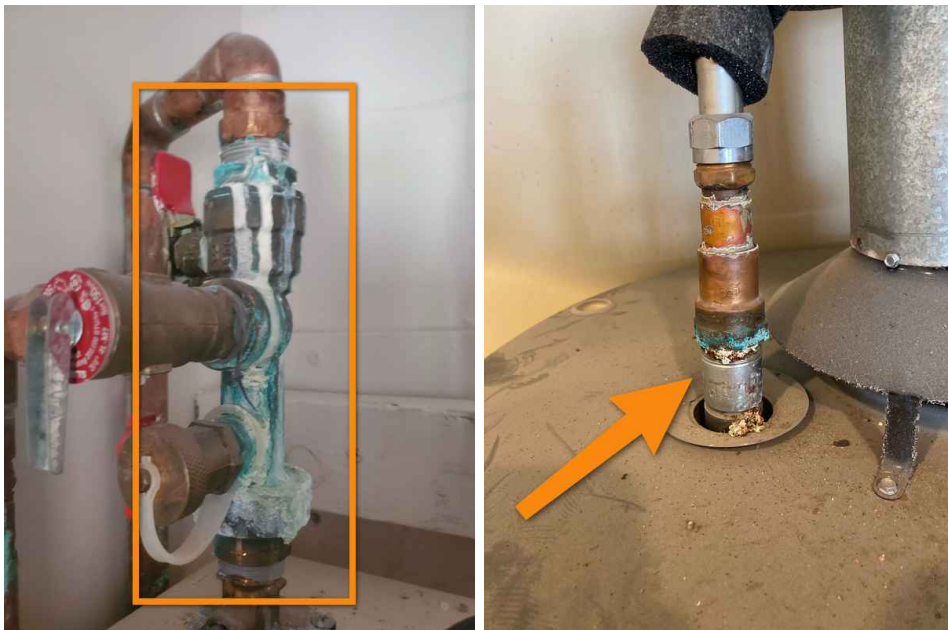
Attention Required**FITTING CORROSION**

Recommendation

Contact a qualified plumbing contractor.

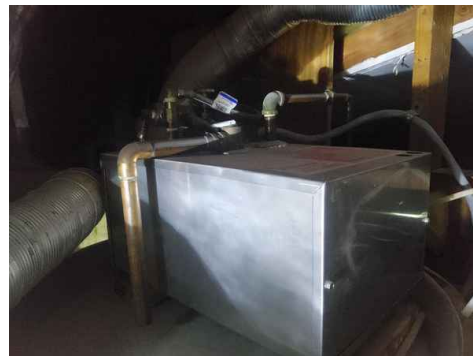
STEAM SHOWER

Recommendation

Contact a qualified professional.

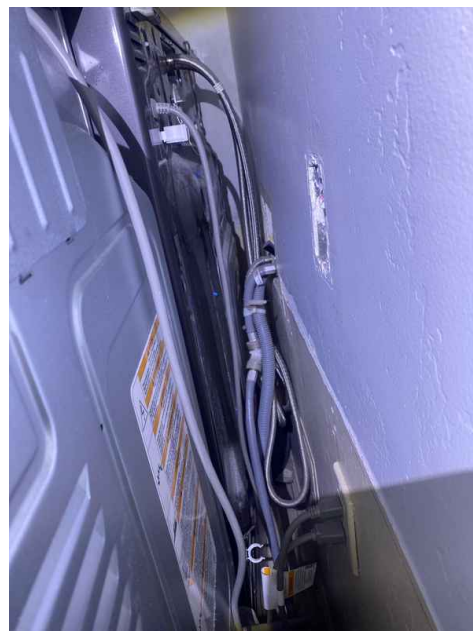
WATER LINES NOT BRAIDED METAL

Recommendation

Contact a handyman or DIY project

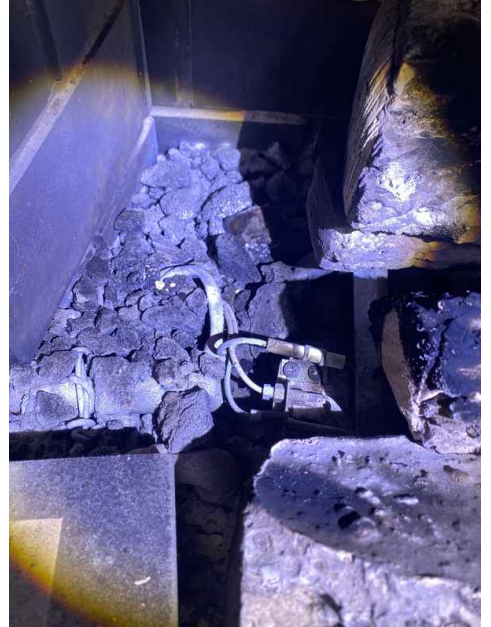
RIGID ALUMINUM GAS LINE

Recommendation

Contact a qualified professional.

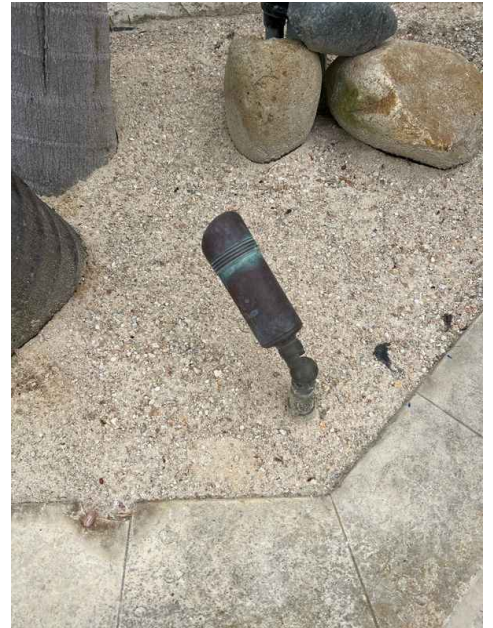
LOW VOLTAGE LIGHTING NOT INSPECTED

Low voltage lighting is beyond the scope of the inspection.
Correction is recommended.

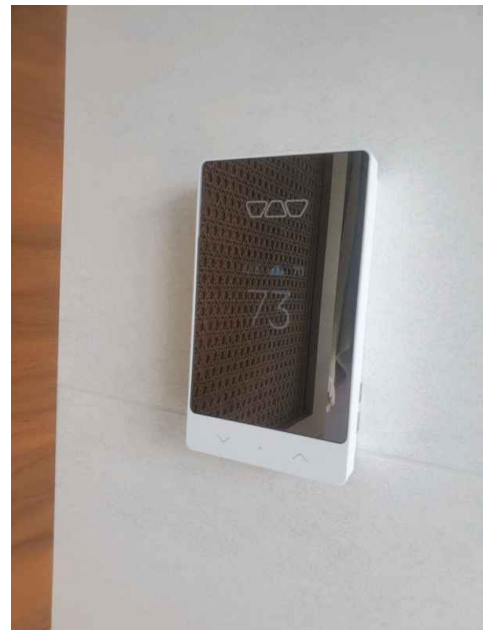
FLOOR HEATING BEYOND SCOPE

Floor heating is beyond the scope of this inspection.
Further evaluation maybe desired.

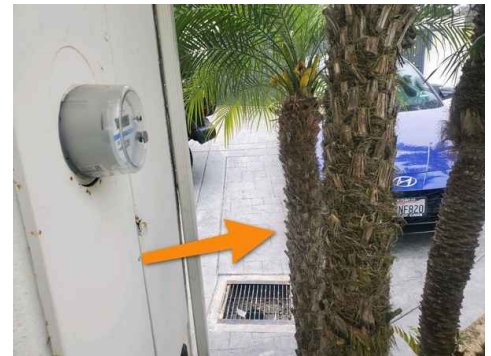
CHALLENGER PANEL

Recommendation

Contact a handyman or DIY project

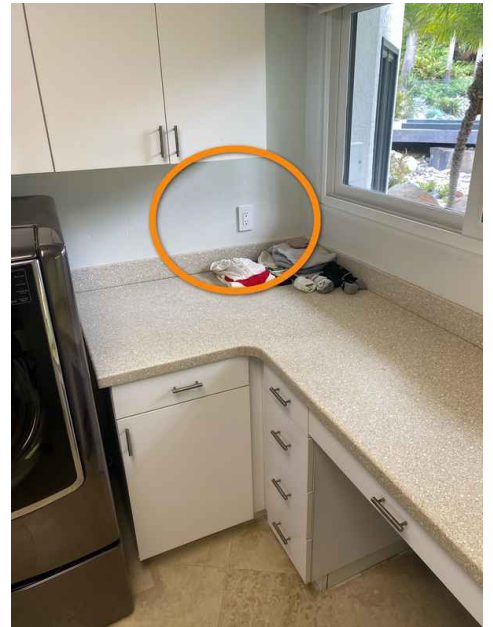
9.6.1 Electrical Wiring

JUNCTION BOX COVER PLATES LOOSE, MISSING, BROKEN

A junction box cover plate was loose, missing and/or broken at one or more areas. This is a potential safety hazard. A qualified professional is recommended to install or replace cover plates as needed.

Recommendation

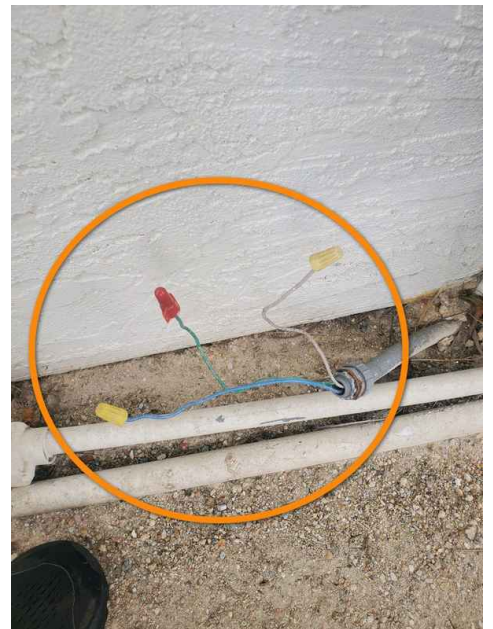
9.6.3 Electrical Wiring

Open wire splices were observed at one or more location. All Romex connections must be enclosed in a covered junction box that is secured to a framing member of the house. Recommend further evaluation by a licensed electrical contractor before the end of your contingency period to determine repairs possible at this time.

Recommendation

Contact a qualified professional.

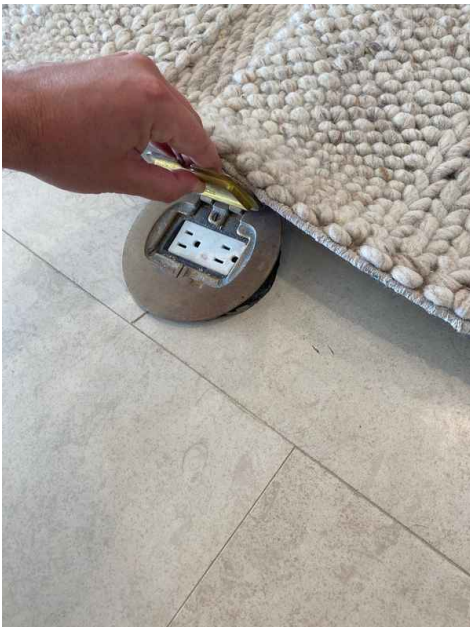
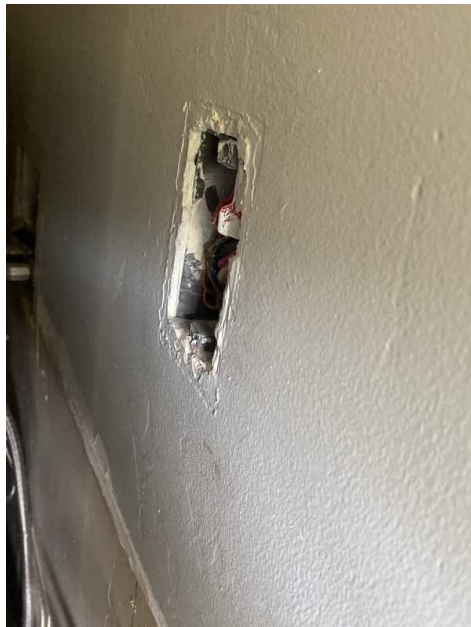
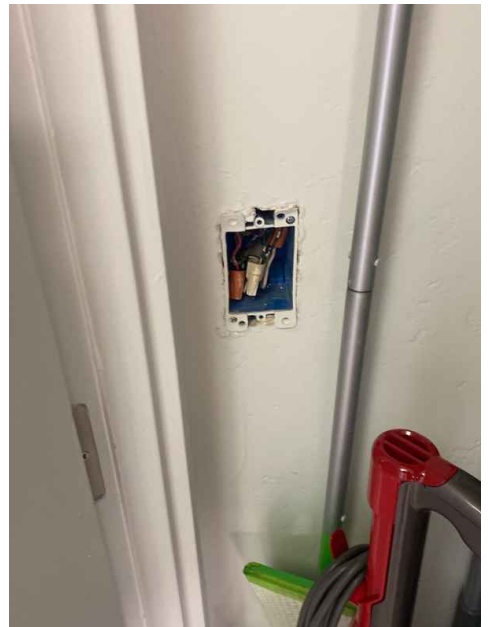
9.7.1 Outlets / Switches / Lighting / Fans

COVER PLATE(S) MISSING, LOOSE OR DAMAGED

Cover plate(s) were missing, loose and/or damaged in one or more areas. These plates are intended to contain fire and prevent electric shock from occurring due to exposed wires. We recommend that a qualified person install cover plates where necessary.

Breakfast Area

Laundry

Recommendation

Contact a qualified electrical contractor.

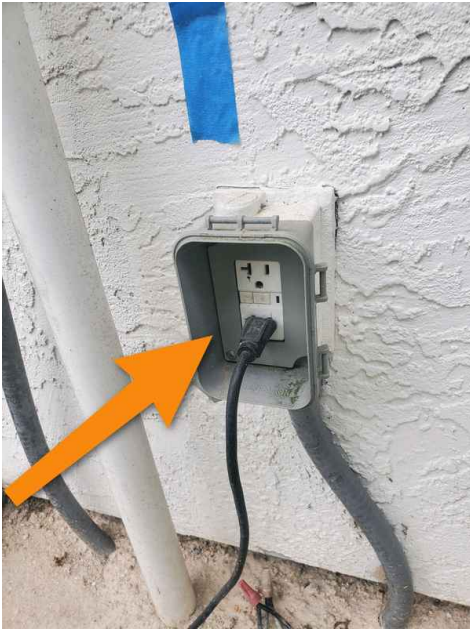
9.7.5 Outlets / Switches / Lighting / Fans

Unable to determine function of one or more switches. Recommend inquiring with the seller or further evaluation by a licensed electrical contractor.

Recommendation

Contact a qualified electrical contractor.

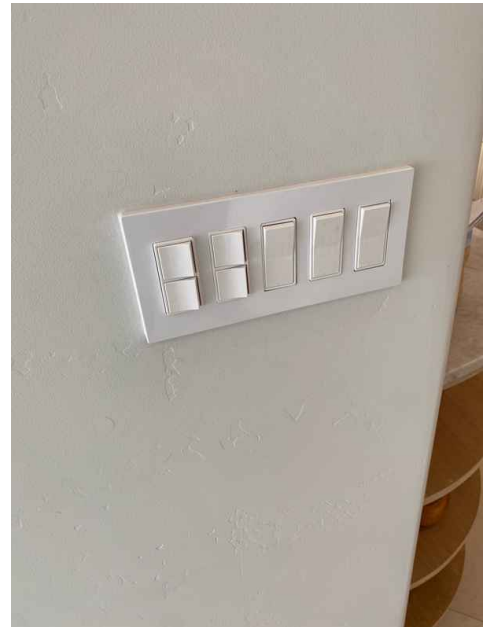
9.7.6 Outlets / Switches / Lighting / Fans

SWITCH DAMAGED

An electric switch was damaged at one or more areas. A qualified electrician is recommended to replace damaged switches where needed.

Recommendation

Contact a qualified electrical contractor.

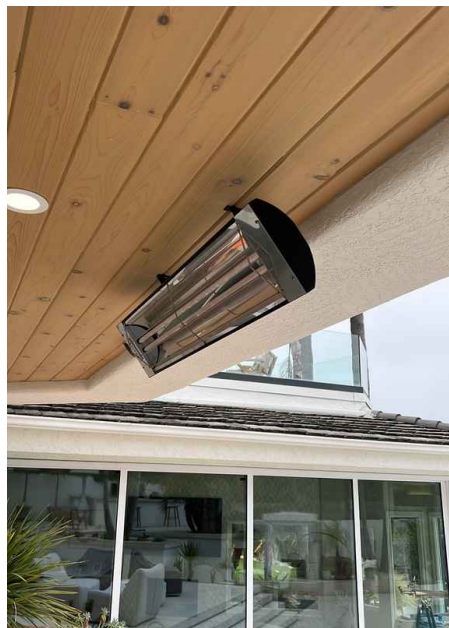
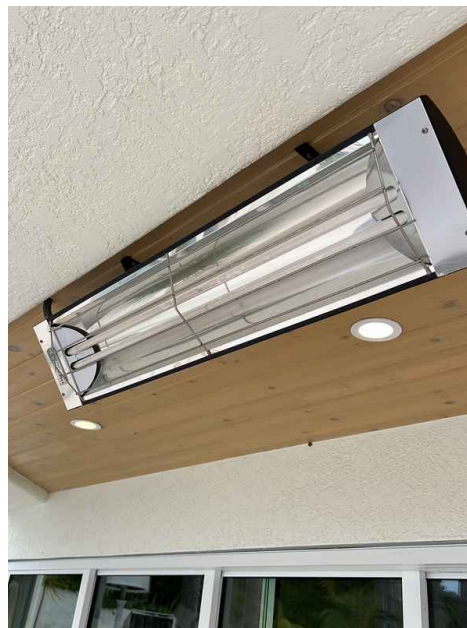
Heat Lamp(s): Individual Heater(s) Appear Functional

Note: Individual gas and/or electric heating system(s) appear to be functioning as intended. Below are thermal images of the heating systems during operation.

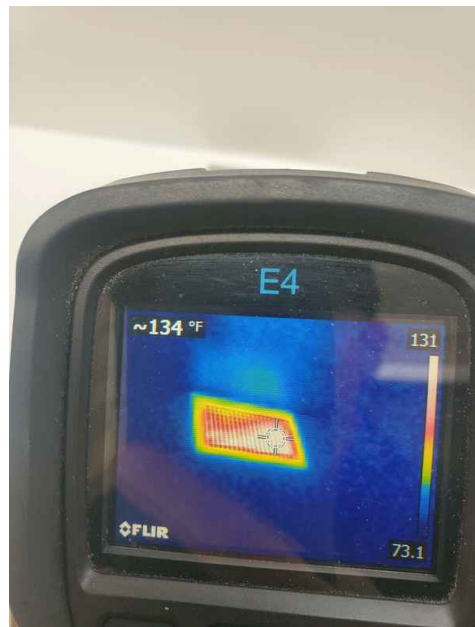
10.2.2 Heating (Forced Air)

DRIP LEG (SEDIMENT TRAP) MISSING

The furnace is not equipped with a sediment trap (drip leg). We recommend further evaluation by a licensed HVAC contractor and correction as needed.

Recommendation

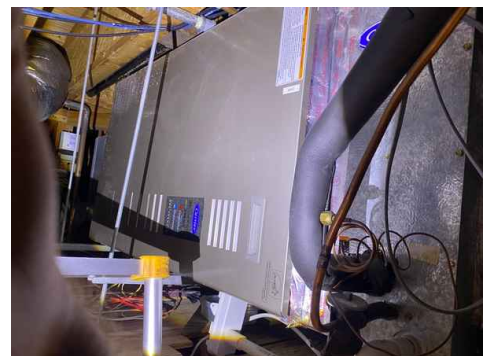
10.2.6 Heating (Forced Air)

BEYOND LIFESPAN (NOT OPERATIONAL)

The forced air system was not operational at the time of this inspection, which could be due to a thermostat issue. The unit was unplugged at time of inspection. The unit is beyond its designed lifespan. A qualified licensed contractor is recommended to evaluate and estimate repairs/replacement.

Recommendation

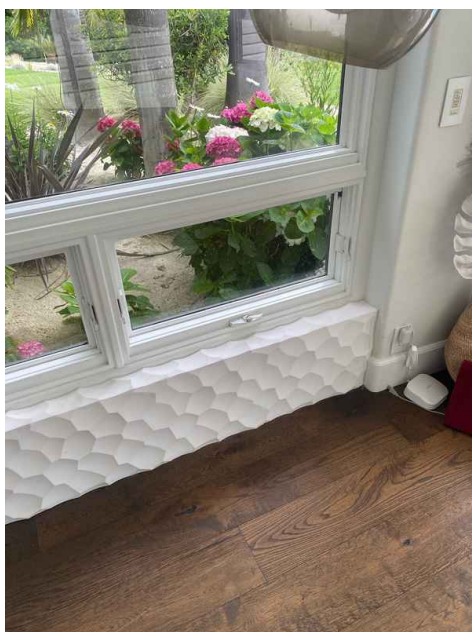
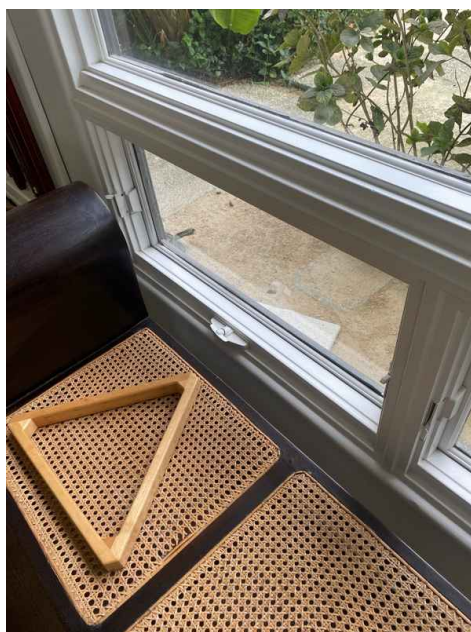
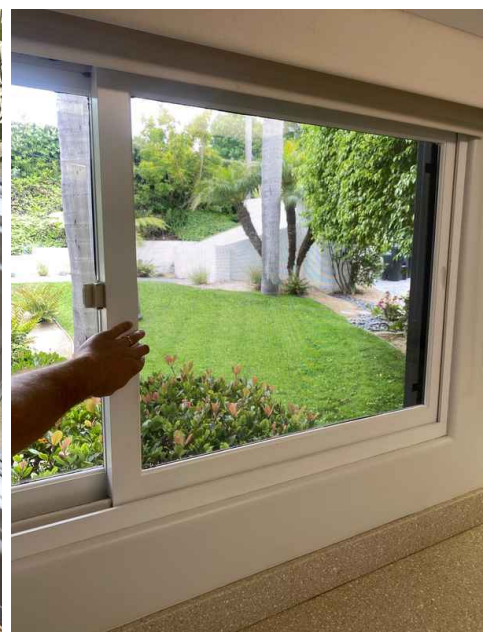
Family Room

Laundry

Contact a qualified window repair/installation contractor.

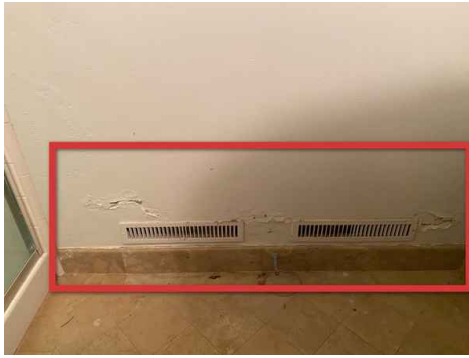
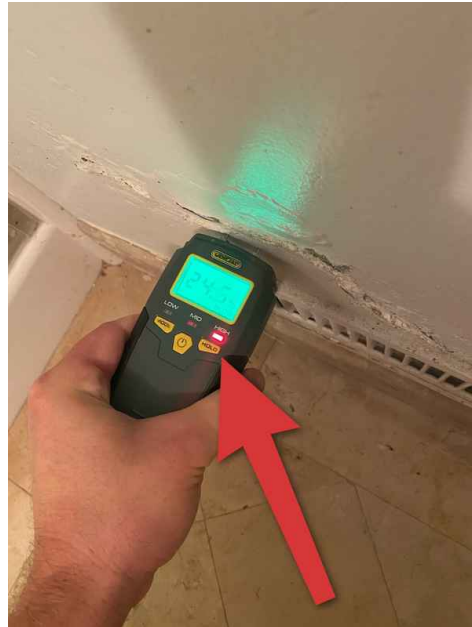
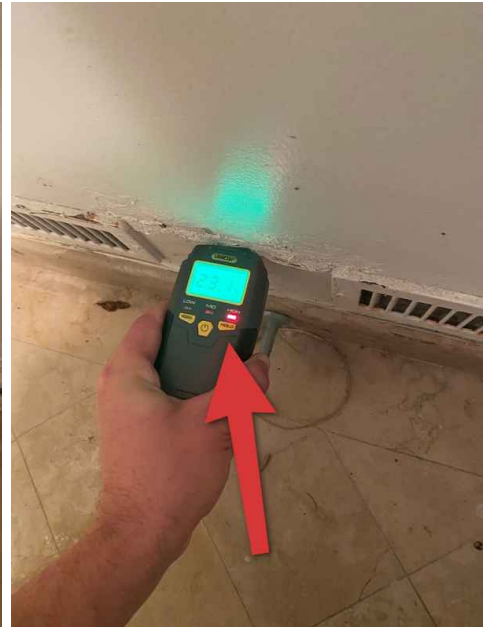
11.6.2 Walls

COMMON CRACKS / NAIL POPS / DETERIORATION NOTED

Nail pops, common cracks, loose corner bead(s) and/or blemishes were found in one or more areas. These can be caused by lumber shrinkage or minor settlement and or seismic activity. They did not appear to be a structural concern but repairs or further evaluation may be desired.

Contact a handyman or DIY project

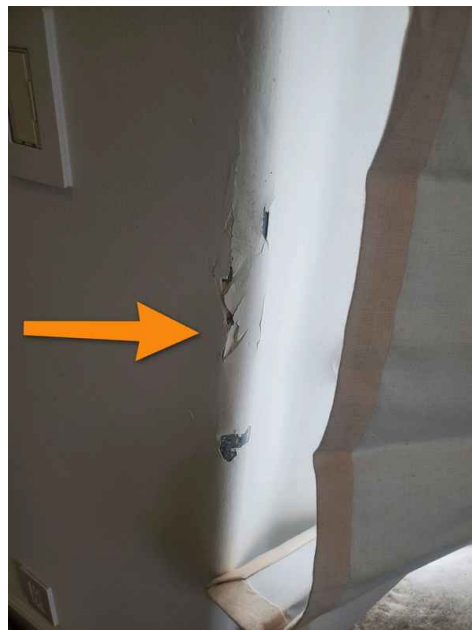
11.6.3 Walls

DAMAGE NOTED

Damage and or deterioration was present at one or more areas. Correction is recommended.

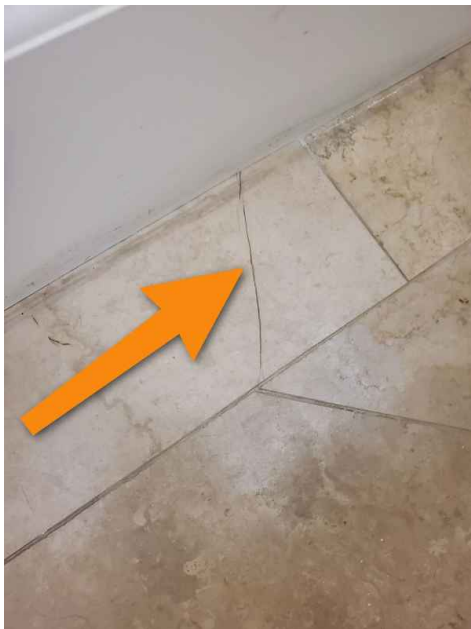
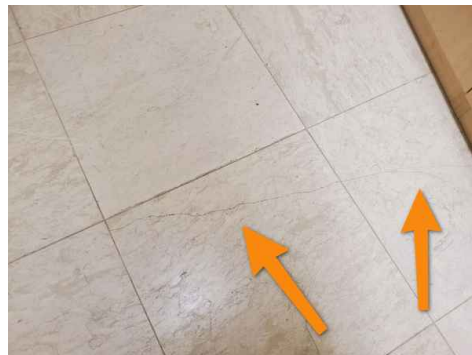
11.7.2 Floors

WOOD FLOOR DAMAGED

Wood flooring in one or more areas was deteriorated, worn and or damaged. A qualified professional maybe desired for further evaluation and/or repairs.

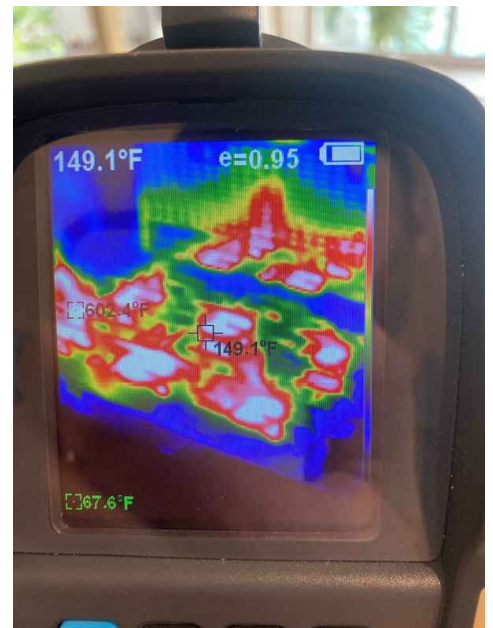
12.2.2 Range/Oven/Cooktop

THERMAL IMAGE OF OVEN WORKING

Thermal image of the oven working. This unit appeared functional.

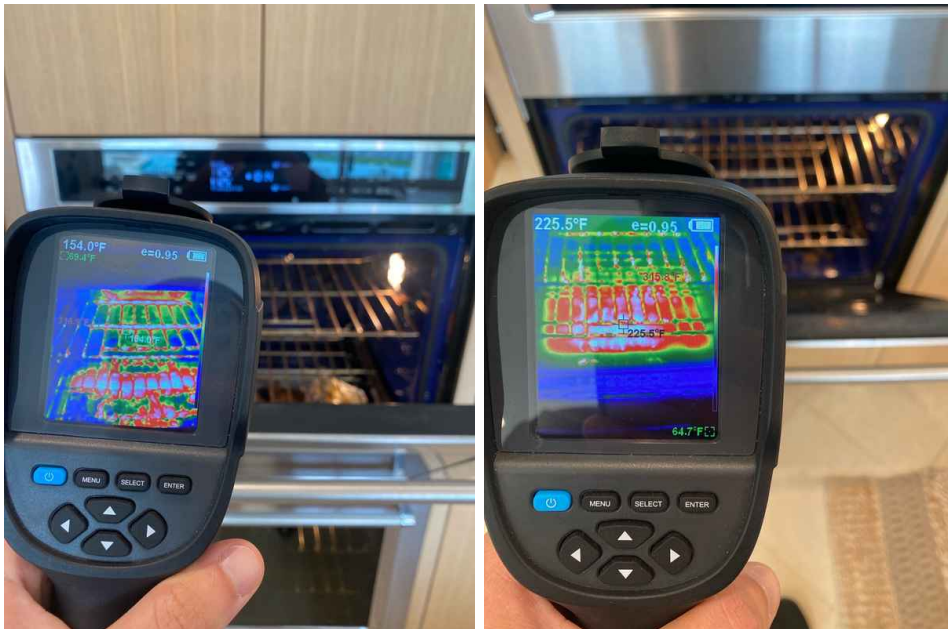
12.2.3 Range/Oven/Cooktop

GAS FLAME UNSUALLY HIGH

The gas flame was unusually high at one or more burners. Adjustment is highly recommended for improved safety.

Contact a qualified professional.

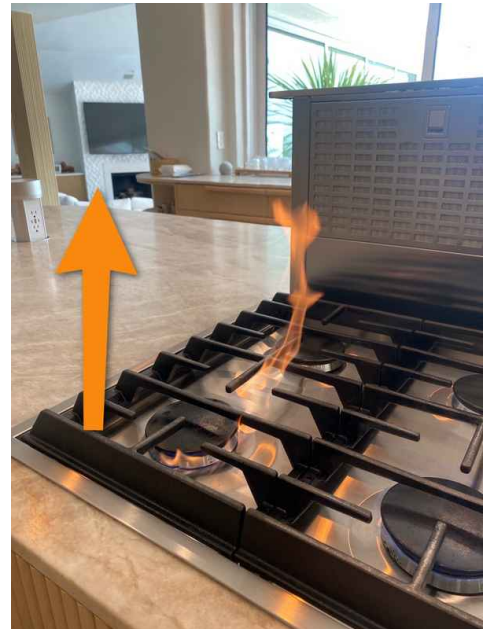
12.3.1 Exhaust / Ventilation

DOWNDRAFT NOT TO EXTERIOR

The cooktop vent has not been routed to the exterior and instead blows air inside the cabinets. It is highly recommended to vent the exhaust to the exterior when using gas appliances for health and safety reasons. A qualified contractor is recommended to repair as necessary.

Contact a qualified professional.

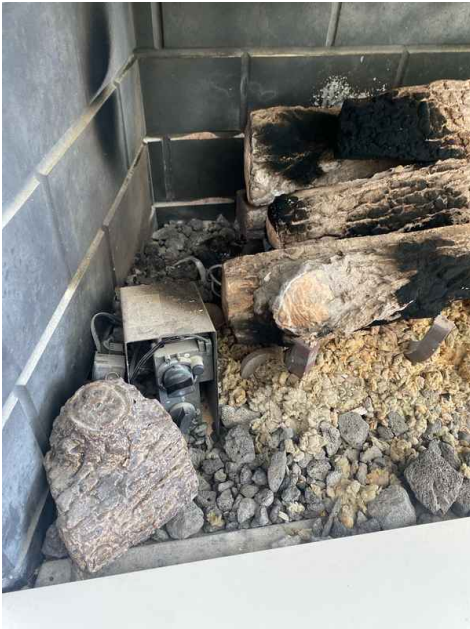
13.1.4 Fireplaces, Stoves & Inserts

GLASS DOORS AND OR SCREENS MISSING

The spark screen and/or glass doors for the fireplace were missing or not installed. Correction is recommended.

Contact a qualified professional.

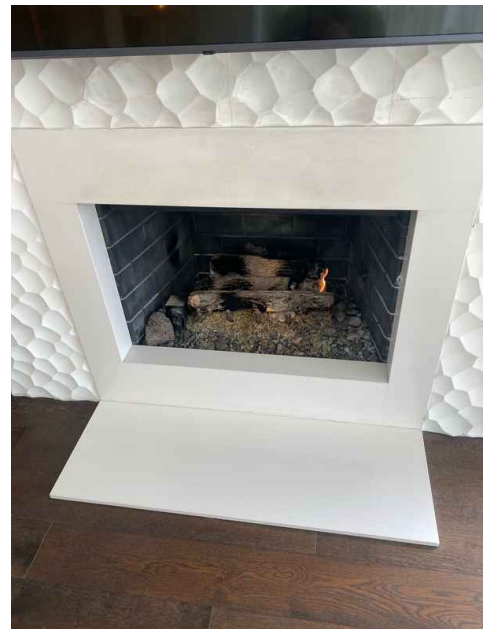
13.1.5 Fireplaces, Stoves & Inserts

EFFLORESCENCE

Efflorescence was observed inside the fireplace. Efflorescence is the dissolved salts deposited on the surface of a material (such as concrete or brick) that are visible after the evaporation of the water in which it was transported. The moisture that creates efflorescence often comes from groundwater, but rain water can also be the source. Efflorescence alone does not pose a major problem, but it can be an indication of moisture intrusion.

Contact a qualified professional.

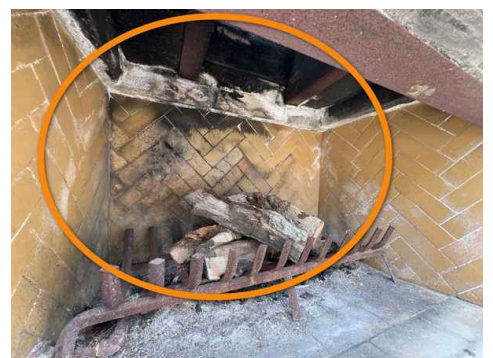
13.1.6 Fireplaces, Stoves & Inserts

COMMON CRACKING

Common/moderate cracks were noted at the fireplace surround. Recommend monitoring this condition and corrections may be desired.

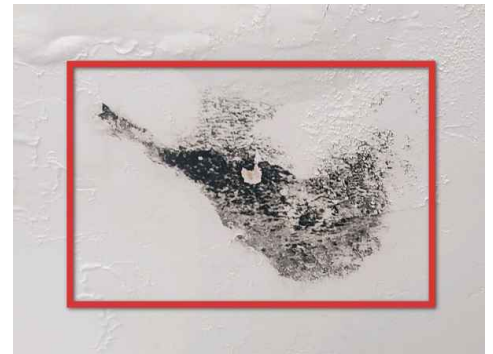
UNIDENTIFIABLE BIOLOGICAL GROWTH

Unidentifiable biological growth was present and is a potential health concern (probably a mold or mildew). We recommend repair by a qualified specialist. Our company can provide mold testing if desired.

Contact a qualified professional.

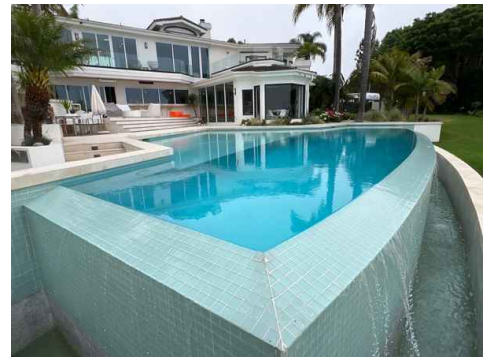
15.4.1 Spa Condition

SPA JETS - FUNCTIONED

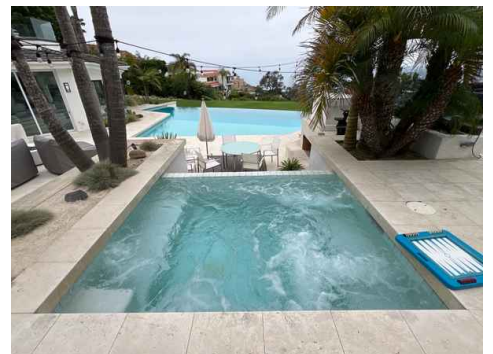
15.4.2 Spa Condition

SPA JETS - POOR

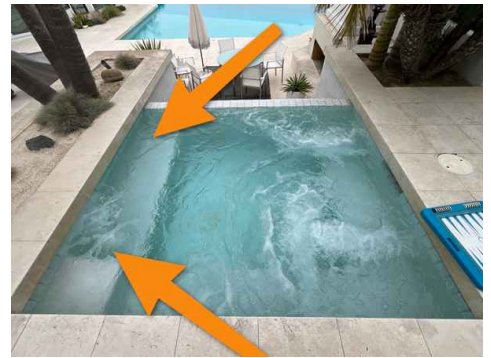
Spa jets did not appear to be functioning as intended. One or more of the jets had low or no flow during testing. This can be caused by an obstruction or problems with concealed plumbing. We advise further review with qualified pool technician.

Contact a qualified swimming pool contractor

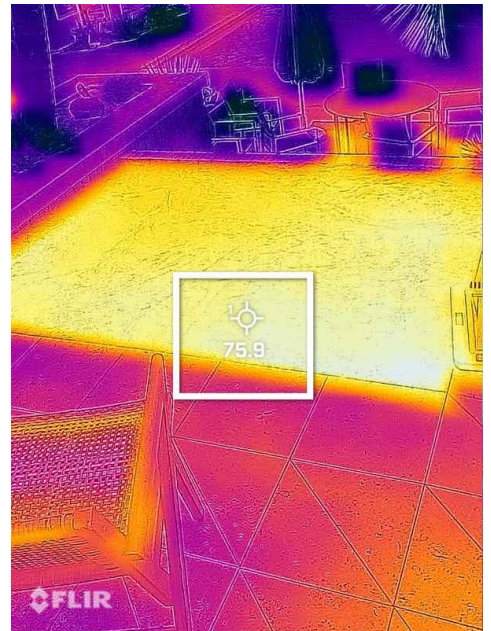
During the testing of the spa, the spa did not appear to heat properly during the time of inspection. The spa heat change/temperature differential was 10 degrees per hour. This unit does not appear to be functioning properly. Recommend correcting and advise further review and repair by a qualified pool specialist.

10 Degrees per hour

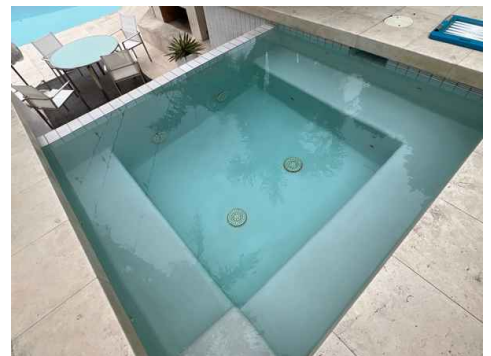
15.4.3 Spa Condition

SPA - NOT HEATING PROPERLY

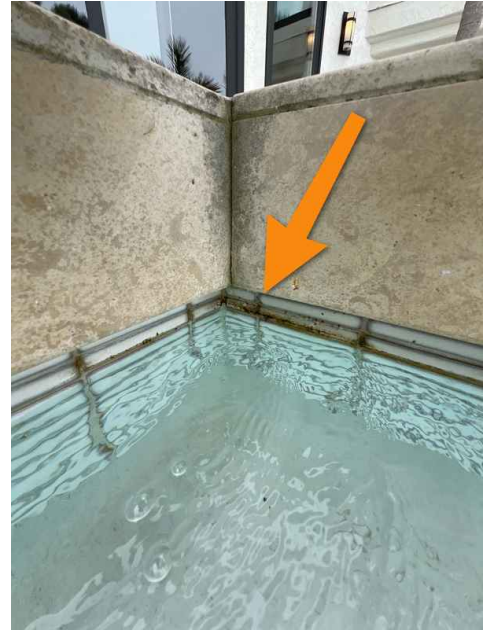
TILES - DAMAGED

Tiles are missing or damaged at the pool or spa walls. We recommend having the tiles repaired/replaced by a qualified pool contractor.

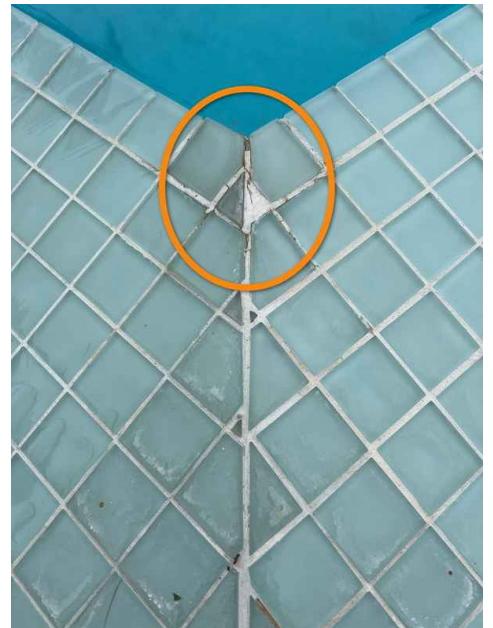
15.5.4 Pool/Spa Surface

TILES- LOOSE OR MISSING GROUT

The tile had areas of missing/loose grout. We recommend maintenance be performed by a qualified swimming pool contractor.

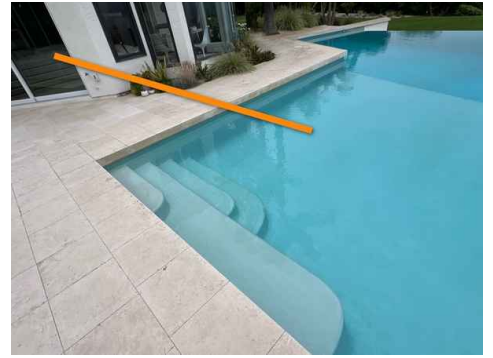
15.6.1 Ladders, Steps, Rails and Diving board

No handrail was present at the step(s). We recommend installation for safety.

Contact a qualified swimming pool contractor

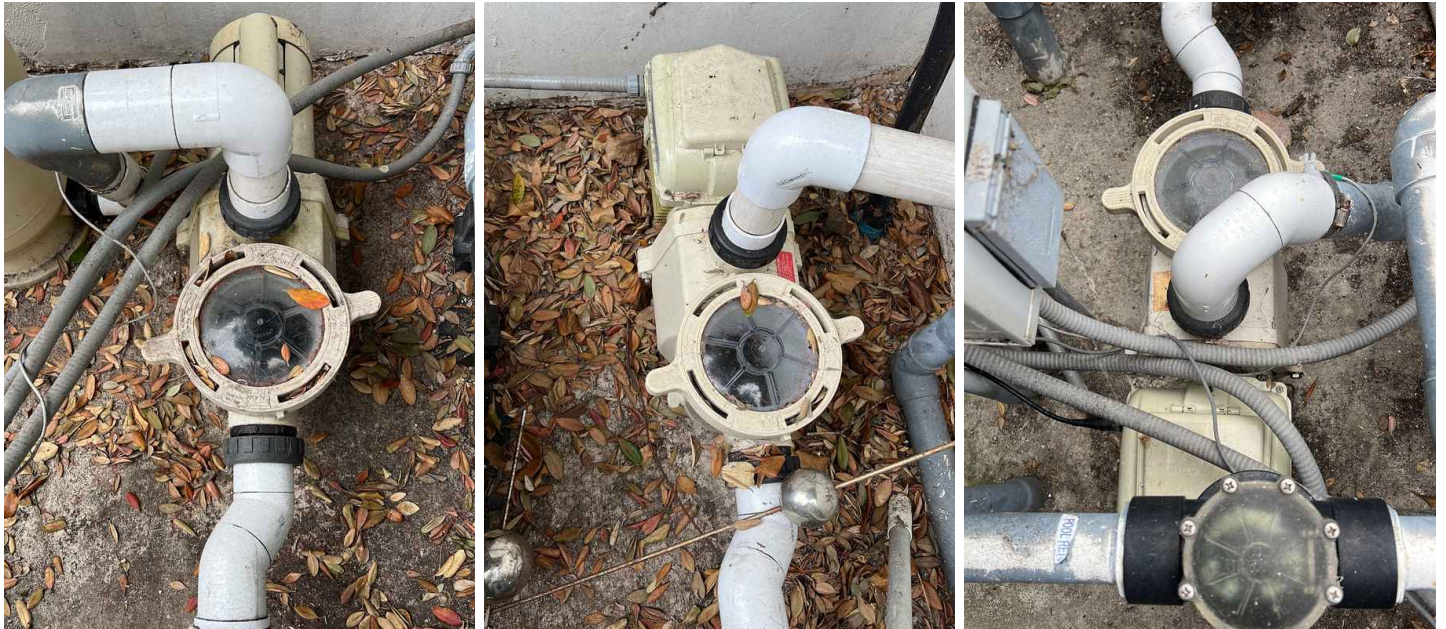
15.7.3 Pumps And Plumbing

PUMP(S) - AGED

Recommendation

Contact a qualified professional.
