PROPERTY INSPECTION REPORT

1904 Via Casa Alta
San Diego, CA 92037

07/01/2025

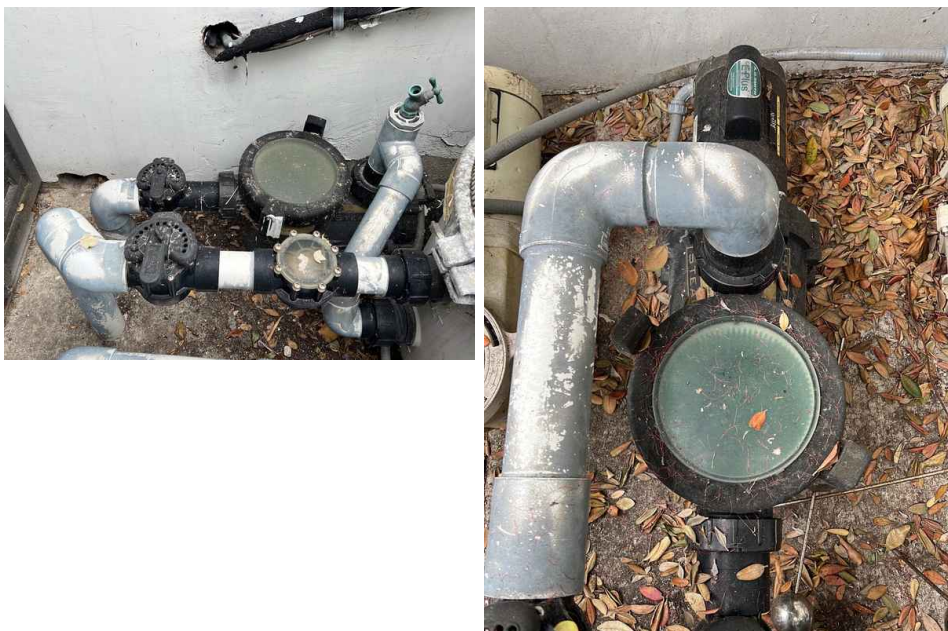
Note: The pool pump(s) is/are older. According to InterNACHI pool pumps have an average life span of 10 years. Pump(s) appears to be 10+ years old. We recommend having a good home warranty in place which covers the pool equipment or replacement may be desired.

Contact a qualified professional.

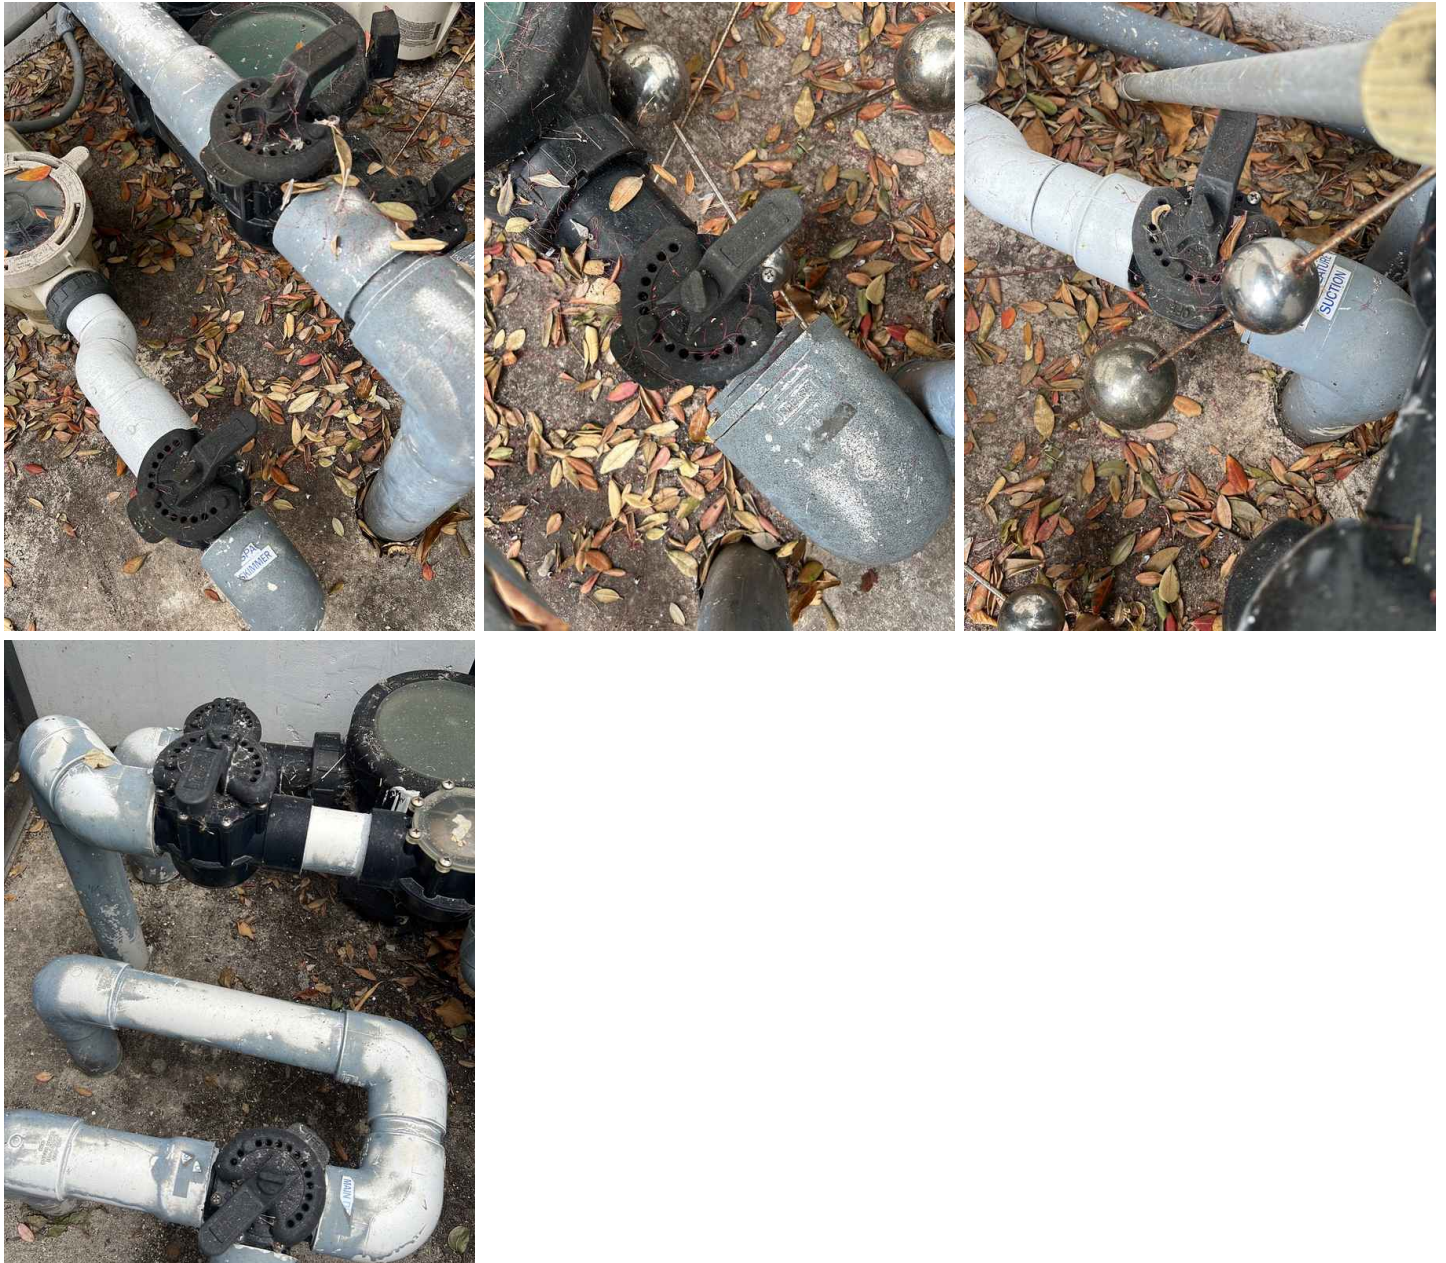
15.8.1 Valves

POOL VALVES - NOT MOVED

The valves were not moved due to lack of labeling. If moving valves could adversely affect pool operation, home inspectors are not required to turn them. We recommend having seller demonstrate that valves are in good working order, and identify each valve.

Contact a qualified professional.

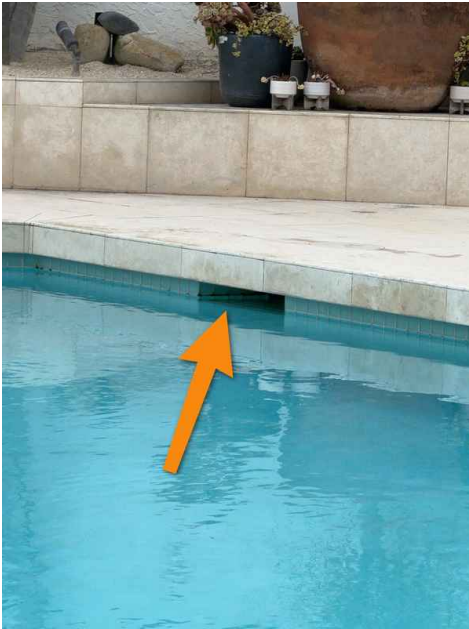
15.9.1 Skimmer

SKIMMER - WEIR DOOR MISSING

The weir door in the skimmer is missing and should be replaced to prevent objects from entering into the skimmer. We recommend replacing by a licensed pool contractor.

Contact a qualified swimming pool contractor

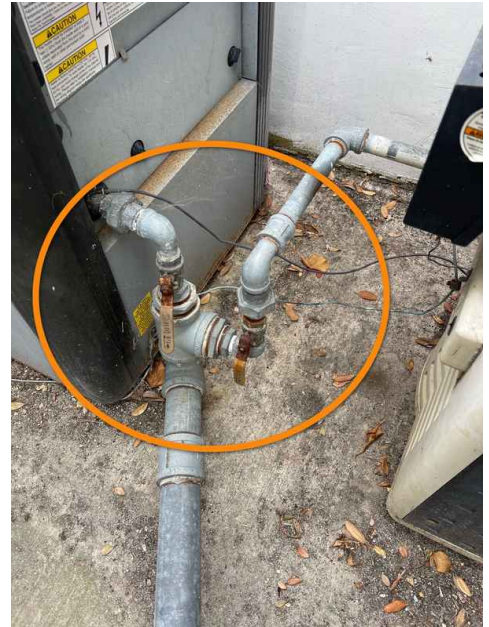
15.10.2 Pool/Spa Furnace

The gas supply pipe to furnace contained no drip leg/sediment trap. A drip leg is generally recommended but not typically required in San Diego. The purpose of a drip leg is to prevent particulates or moisture from condensation from entering and clogging the water heater gas valve, which can cause the heater to malfunction. You may wish to consult with a plumber concerning the advisability of installing a drip leg/sediment trap in the gas line.

Contact a qualified professional.

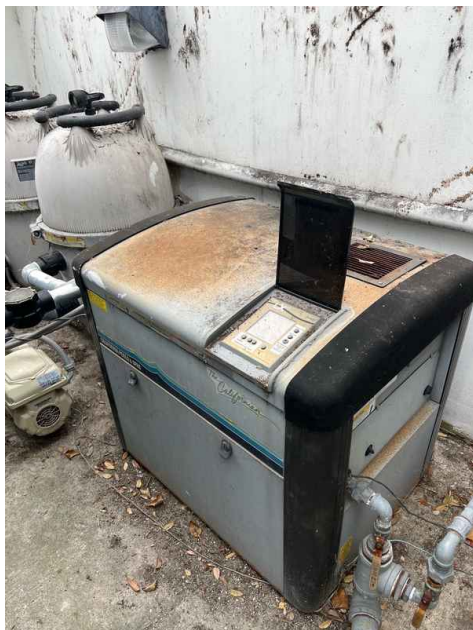
15.10.3 Pool/Spa Furnace

Furnace service light was on during testing. This indicates a fault in the furnace. We recommend further evaluation by a qualified pool service technician.

Contact a qualified swimming pool contractor

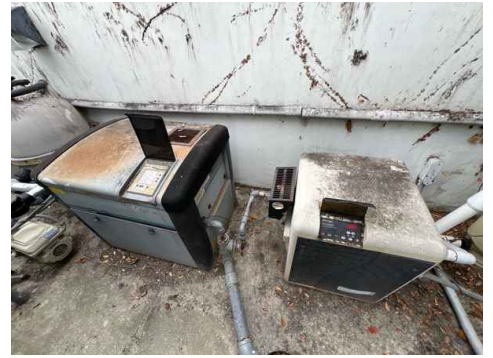
15.10.4 Pool/Spa Furnace

Note: The pool heater is older and its life remaining is unknown. According to InterNACHI the average life span of a pool heater is 8-10 years. This heater appears to be 10+ years old. We recommend that keep a good home warranty in place which covers the pool equipment.

Contact a qualified swimming pool contractor

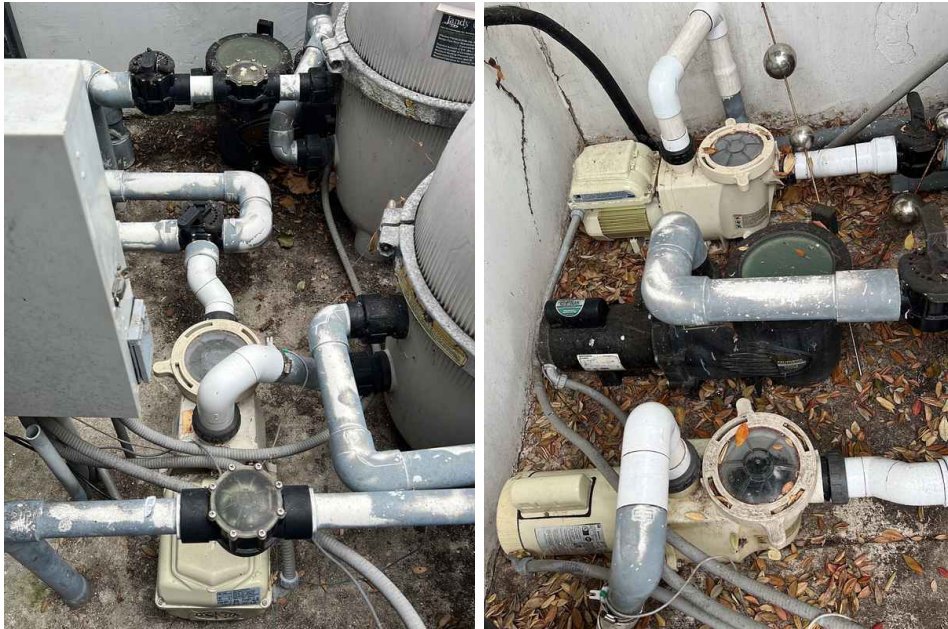
15.12.1 GFCI Protection

PUMP NOT GFCI PROTECTED

GFCI protection was not visible for one or more pumps. Pumps are now required to have GFCI protection. It is recommended GFCI protection be installed for overall safety. A qualified electrician should evaluate and repair as necessary.

Contact a qualified electrical contractor.

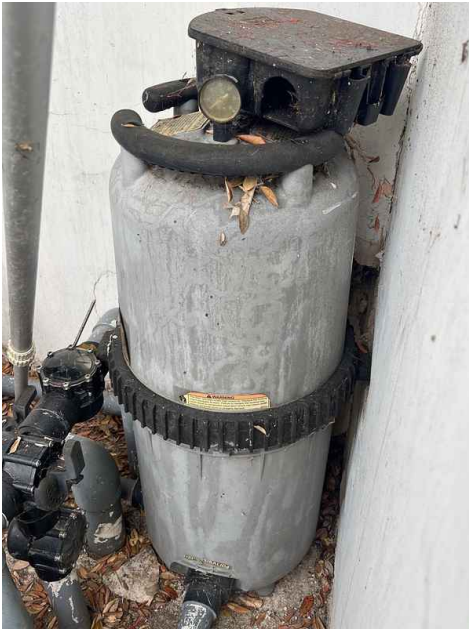
15.15.2 Filter

POOL FILTER - AGED*

Note: The pool filter is older. Life remaining may be limited. According to InterNACHI the average life span of a pool filter is 10 years. This filter appears to be 10+ years old. We recommend that keep a good home warranty in place which covers the pool equipment.

Contact a qualified professional.
