**ELITE GROUP**  
INSPECTION PROFESSIONALS

PROPERTY LOCATION: 23728 President Ave Harbor City, CA 90710

# INSPECTIONREPORT

Date of Inspection: 6/24/2026 at 2:00 PM

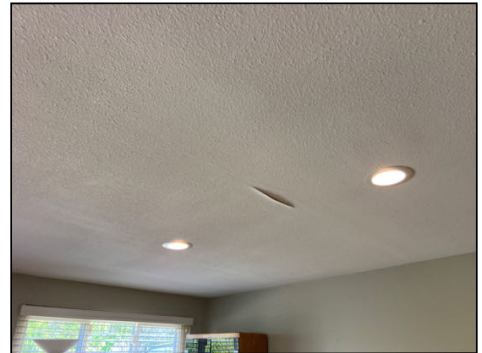
- No major visible defects observed at the time of inspection
- Small cracks/holes/chipped/dirty areas/cosmetic blemishes observed - typical for age of structure
- Spotty areas or signs of moisture accumulation on ceiling in areas - recommend improving ventilation in the bathroom
- Loose material observed - needs to be serviced

Loose material observed - needs to be serviced

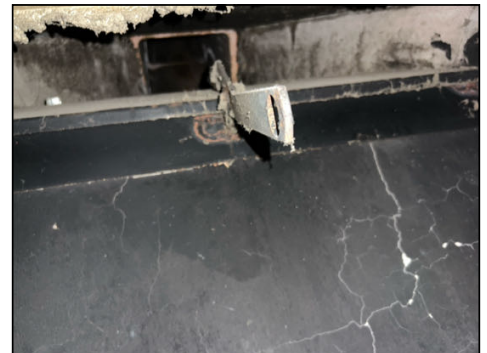
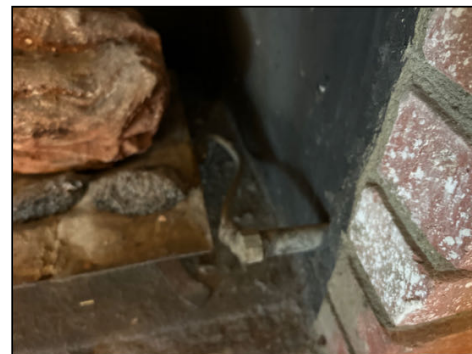
- The fireplace is visually inspected only, the fireplace is not lit to test flame color or condition. The internal cavity of the fireplace is not inspected. It is recommended that you have an internal inspection of the chimney and a Gas Company evaluation of the fireplace prior to operating the fireplace.
- Recommend fire caulk/sealing any holes/gaps/cracks
- Damper was tested and operated at the time of the inspection
- Damper was worn/rusted/dirty - recommend cleaning
- Aluminum gas line present - okay with cosmetic logset
- **Pre-Fab concrete Rampart General fireplace present; known to be problematic suggest further review by CSIA certified chimney sweep**

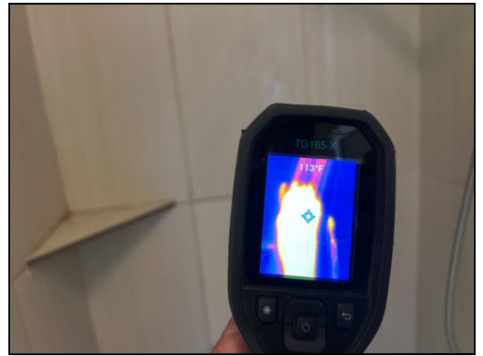
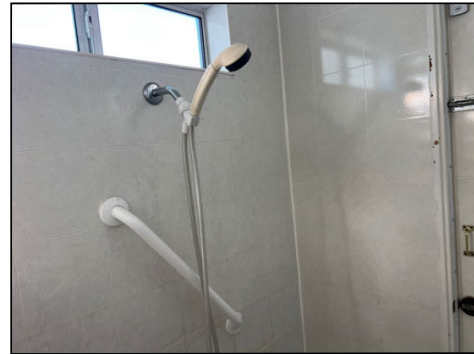
- Tub/Shower combo present - see tub notes for additional information
- Fixture was tested and operating at time of inspection via normal fixture controls
- Fixture had normal wear for age of material - no major visible defects
- Shower arm faceplate is loose at the wall - recommend securing and sealing this area
- Plumbing loose in wall - needs to be serviced - upstairs hall
- Shower fixture does not operate - needs to be serviced - downstairs
- Hot and cold reversed at faucet - needs to be serviced - master

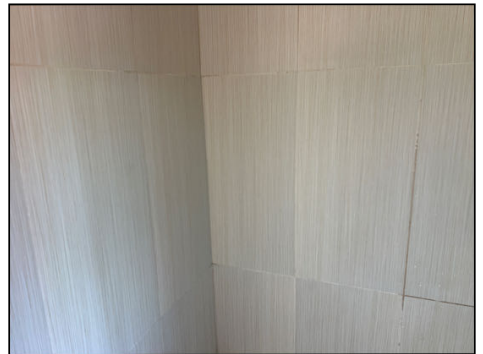
- Solid surface (fiberglass/plastic/etc.) shower pan present
- Tile and grout present
- Shower walls have normal wear for age at the time of the inspection - no major visible defects - recommend routine grout and sealer maintenance
- Shower pan is in a worn/stained/older condition - typical for the age - recommend routine grout and sealer maintenance
- Recommend grout and sealer maintenance
- Caulking needed around perimeter

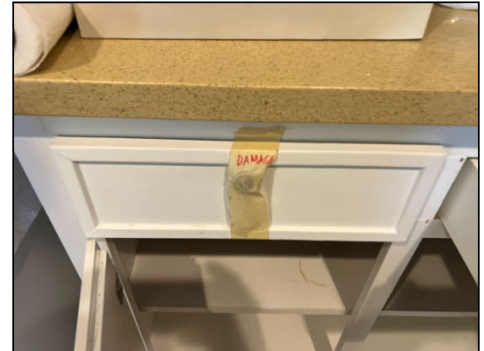
- Interior cabinet areas have been painted - paint or patching may cover known past defects - consult the seller/disclosures for all past repairs
- Worn cabinets with loose/worn hardware - typical for age
- Damaged drawer/front - needs to be serviced

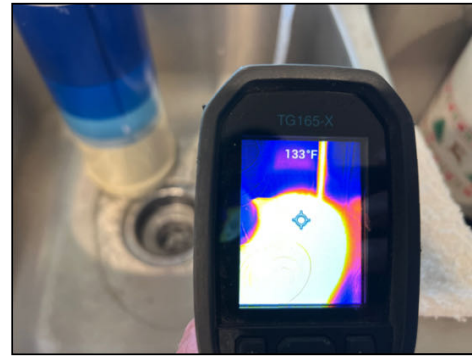
- Fixture operated at the time of the inspection
- Loose/worn fixture - needs minor maintenance

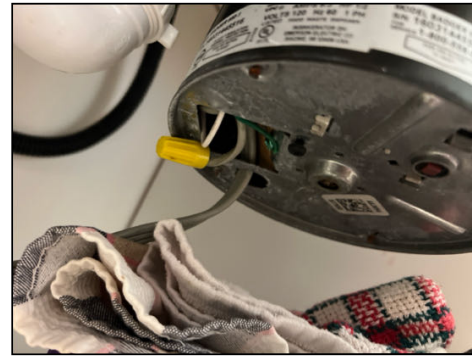
- The garbage disposal has a limited inspection, the Inspector cannot predict the remaining life of the garbage disposal nor determine how well the garbage disposal disposes of food or other items. The sharpness or adequacies of the internal blades is not determined during the home inspection.
- Not operating properly - needs to be serviced
- Normal wear for age - no major visible defects
- No visible leaks at the time of the inspection
- Unit stuck (hums) - needs to be serviced
- Exposed wire connections - needs to be serviced

**Exposed wire connections - needs to be serviced**

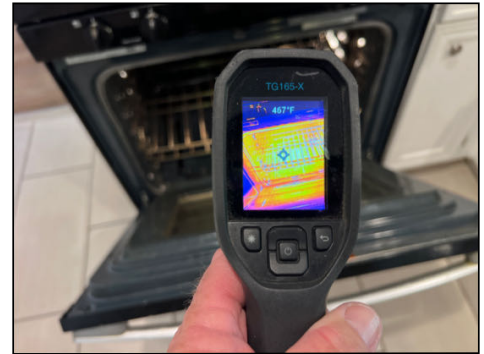
- Gas supplied unit
- Tested and operational at time of inspection via normal controls
- Worn/older unit - typical wear for age and use
- Stained/dirty - needs to be serviced and cleaned

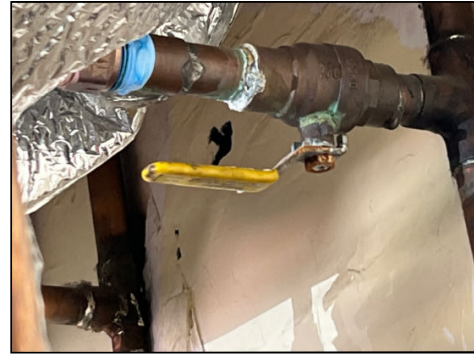
- Worn valve/piping/connections - typical for age - no visible leaks found at the time of the inspection
- Corrosion present - signs of wear - monitor for moisture

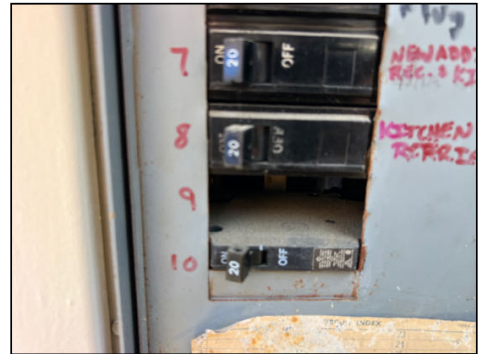
- Worn/weathered panel - typical for age and weather exposure
- Recommend upgrading services due to age of electrical system
- Panel cover screw(s) missing - recommend installing appropriate screws
- ***Panels are visually inspected only, the inspector does not perform a load calculation to determine service capacity adequacy***
- ***Electrical fires due to poor installation of wiring cannot be determined by inspector***
- ***Open breaker panel slot(s) at panel box cover - needs to be serviced***

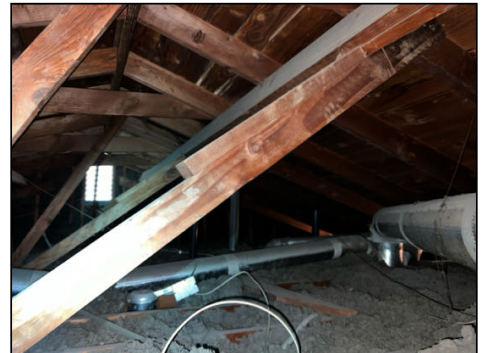
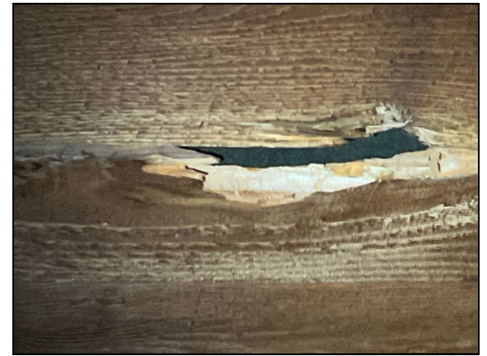
- Conventional framing present, normal wear at time of inspection - no major visible defects
- No major visible staining found at the time of the inspection
- **Cracking large- needs to be serviced**

Cracking large- needs to be serviced

| Page 39 Item: 2 | Structure | <ul style="list-style-type: none"> <li>• Cracking large- needs to be serviced</li> </ul> |

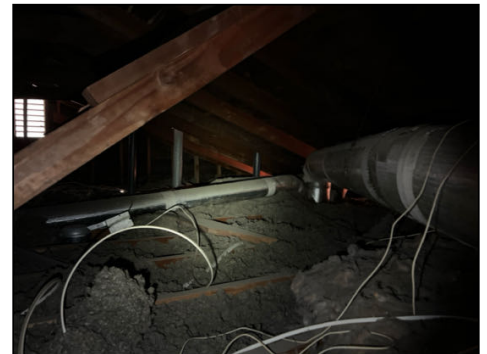
- *The inspector cannot determine efficiency or effectiveness of the duct layout - check all installation permits*
- *Some areas not visible due to access hindrances or limitations*
- *Limited inspection/access due to structure and duct layout*
- Older ducts present, possibly original to the structure - recommend further evaluation and pressure/leak test due to the age of the ducts

| Page 41 Item: 7 | Duct Work | <ul style="list-style-type: none"> <li>• Older ducts present, possibly original to the structure - recommend further evaluation and pressure/leak test due to the age of the ducts</li> </ul> |

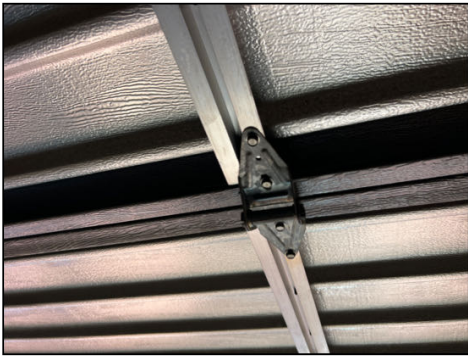
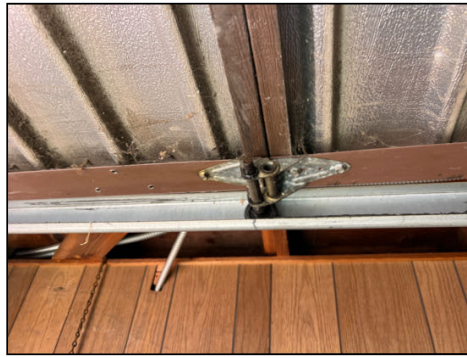
- ***Garage doors require periodic maintenance and is recommended to ensure that all hardware is properly lubricated and secured***
- Door hardware is in a worn or loose condition - recommend standard service/lubrication

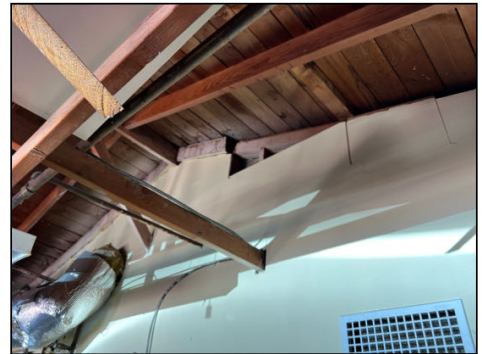
- Normal wear at the time of inspection - no major visible defects
- Holes present - needs to be serviced to retain integrity of fire separation
- Heat/cool register present - needs to be serviced - recommend HVAC contractor to evaluate

| Page 45 Item: 9 | Firewalls | <ul style="list-style-type: none"> <li>• Holes present - needs to be serviced to retain integrity of fire separation</li> <li>• Heat/cool register present - needs to be serviced - recommend HVAC contractor to evaluate</li> </ul> |

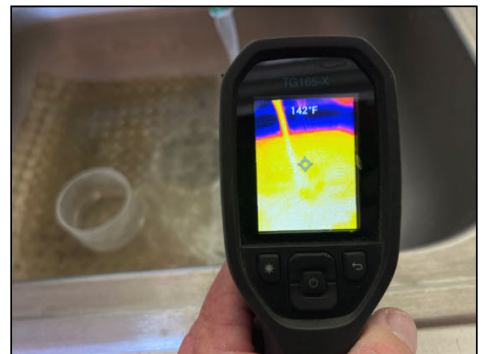
- Operated with worn fixtures at time of inspection
- There were no visible leaks at the time of the inspection
- **Drains slow - needs to be serviced**

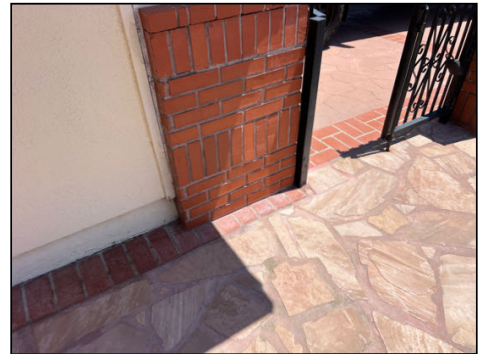
- **Consult termite report for all exterior wood**
- Worn/weathered/cracked materials where visible – recommend siding **maintenance**
- Recommend **maintenance** to seal all gaps, cracks and openings
- **Cracking/chipping/holes more than typical - needs to be serviced**

| Page 48 Item: 2 | Siding | <ul style="list-style-type: none"> <li>• Cracking/chipping/holes more than typical - needs to be serviced</li> </ul> |

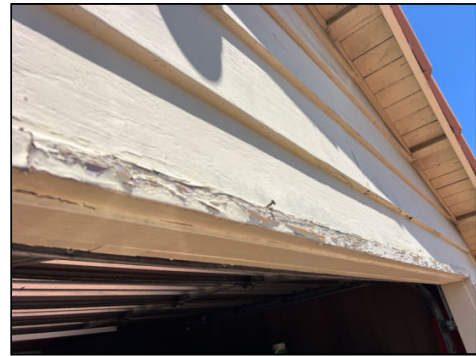
- **Consult termite report for all exterior wood**
- Recommend general trim **maintenance** and sealing any holes/gaps
- **Deteriorated - recommend servicing**

| Page 49 Item: 4 | Wood Trim | <ul style="list-style-type: none"> <li>• Deteriorated - recommend servicing</li> </ul> |

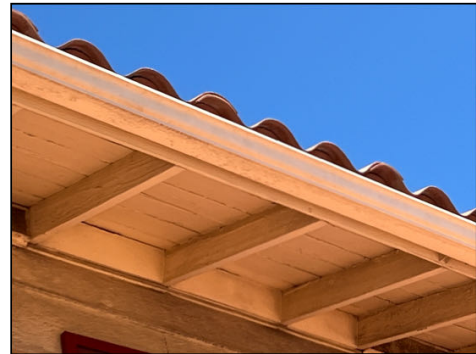
- **Consult termite report for all wood areas at the structure**
- Weathering and staining present in areas
- Recommend paint and **maintenance** repair

| Page 50 Item: 8 | Exterior Paint | <ul style="list-style-type: none"> <li>• Weathered and worn more than normal - needs to be serviced</li> </ul> |

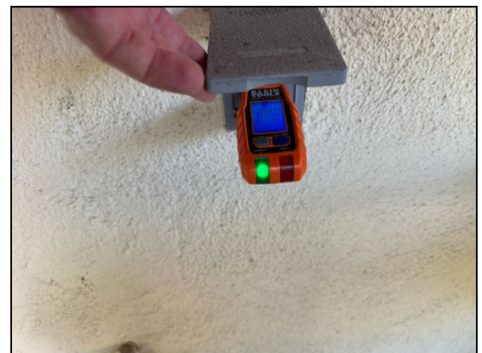
Loose fixture(s) - needs to be serviced

Three prong outlets not grounded - needs to be serviced - west side

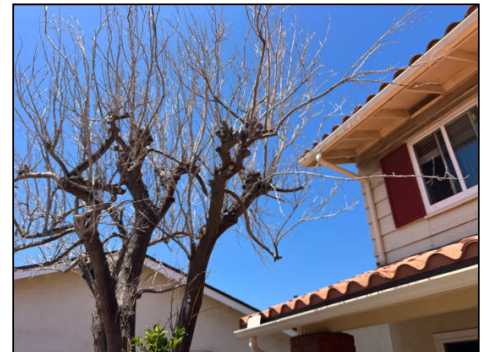
- Normal wear on the day of the inspection - no major visible defects
- Recommend pruning or remove any plants or trees that are in contact or proximity to structure to eliminate pathways of wood destroying insects and moisture
- ***Loose/cracked materials present - needs to be serviced***

| Page 57 Item: 14 | Planters | <ul style="list-style-type: none"> <li>• Loose/cracked materials present - needs to be serviced</li> </ul> |

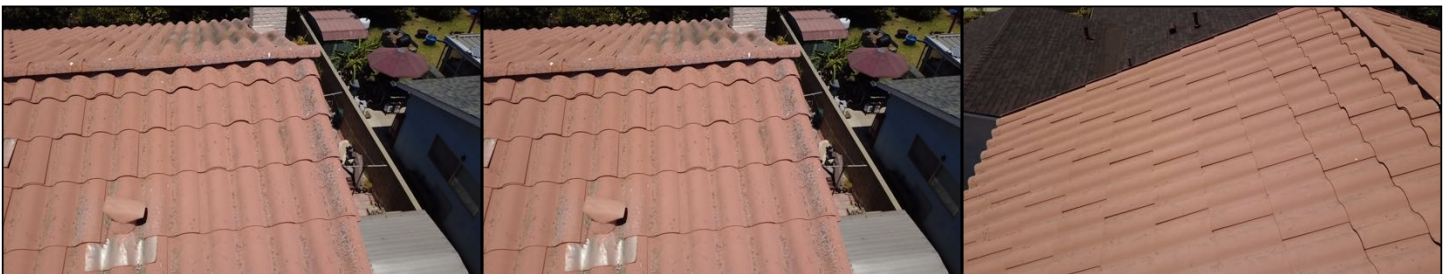
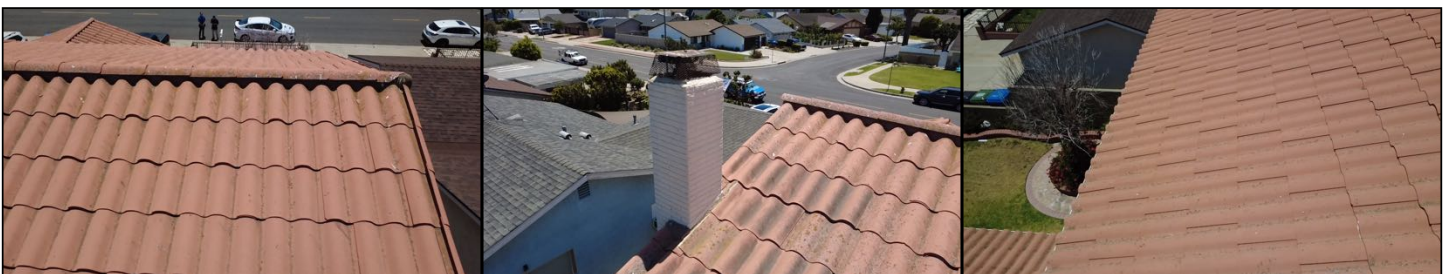
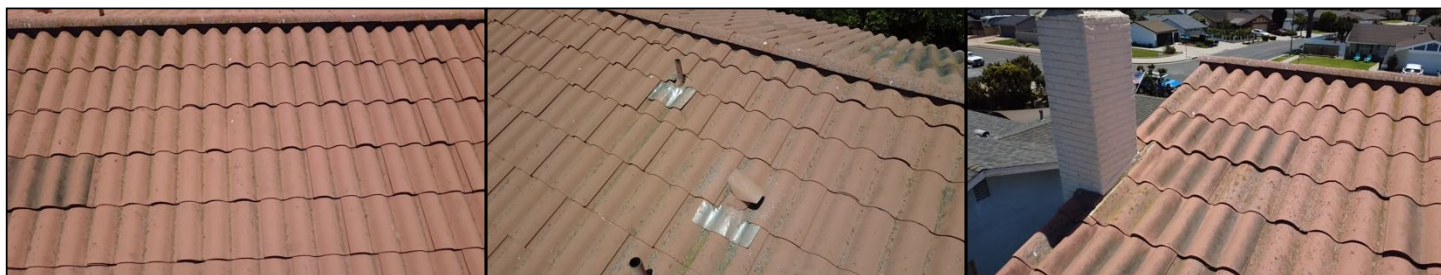
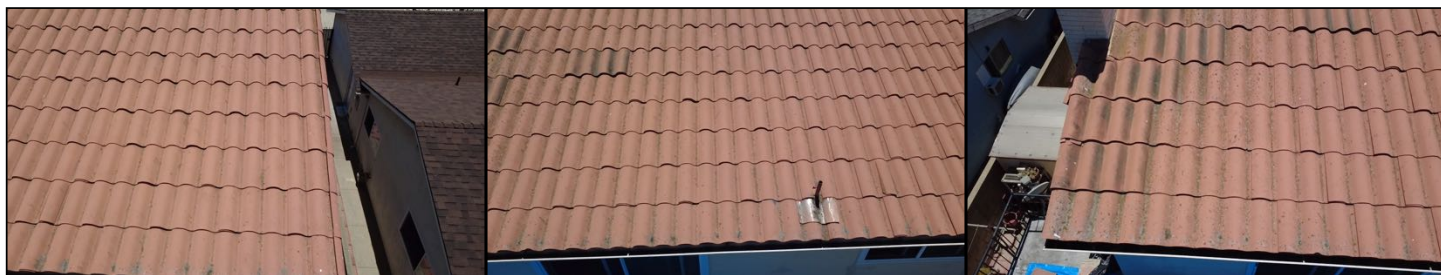
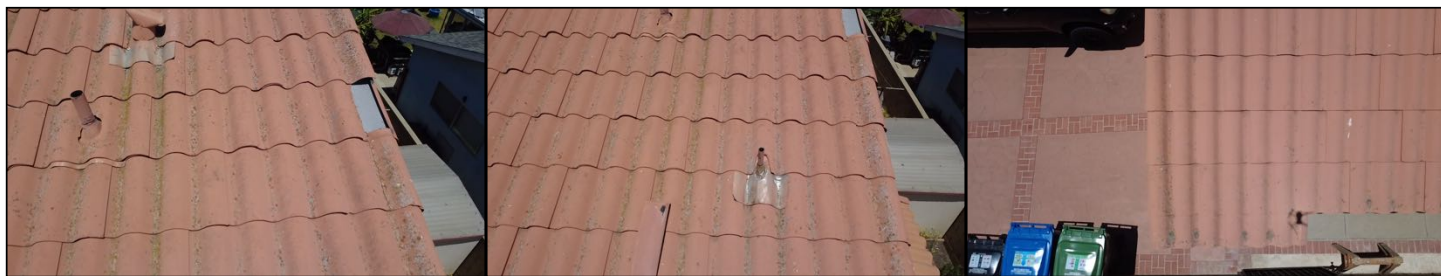
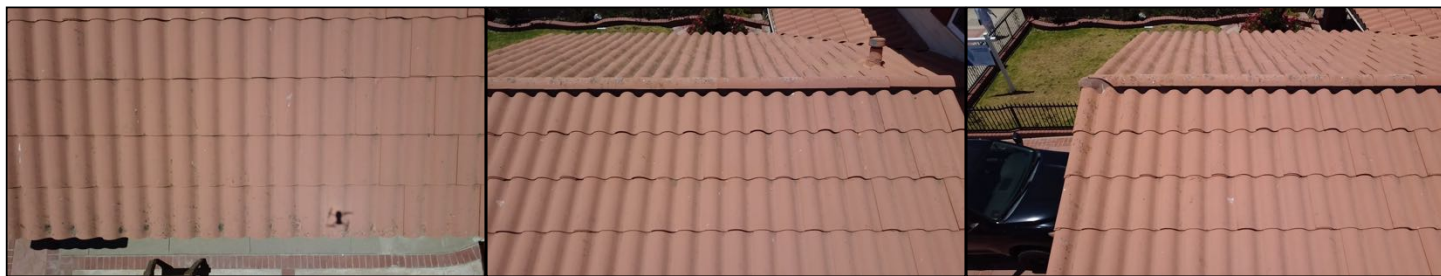
- Visible materials show signs of normal wear for the age of the materials at time of inspection - no major visible defects - Regular seasonal maintenance is recommended to extend the life of the roof
- Recommend roofing contractor to further evaluate
- **Cracked/chipped tiles/mortar - typical for age/materials - recommend seasonal roof maintenance**
- **Missing/damaged shingles/tiles in areas - needs to be serviced**

| Page 59 Item: 1 | Condition | <ul style="list-style-type: none"> <li>• Cracked/chipped tiles/mortar - typical for age/materials - recommend seasonal roof maintenance</li> <li>• Missing/damaged shingles/tiles in areas - needs to be serviced</li> </ul> |
