ALLIANCE HOME INSPECTIONS

3 Harbor View Dr  
Stockton Springs, ME 04981

09/03/2026

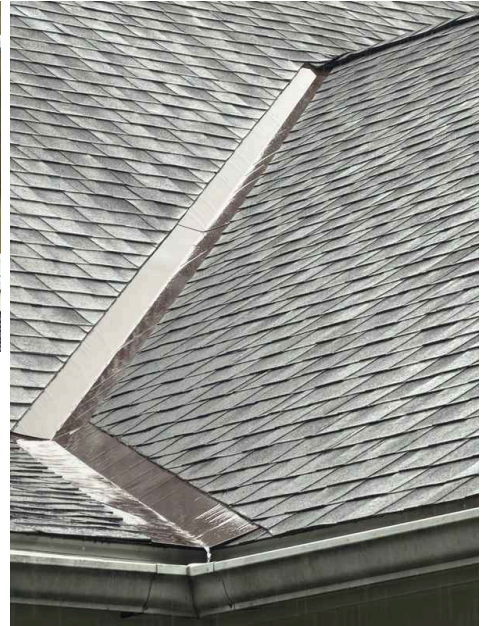
All visible areas of flashing inspected with no major concerns observed at time of inspection.

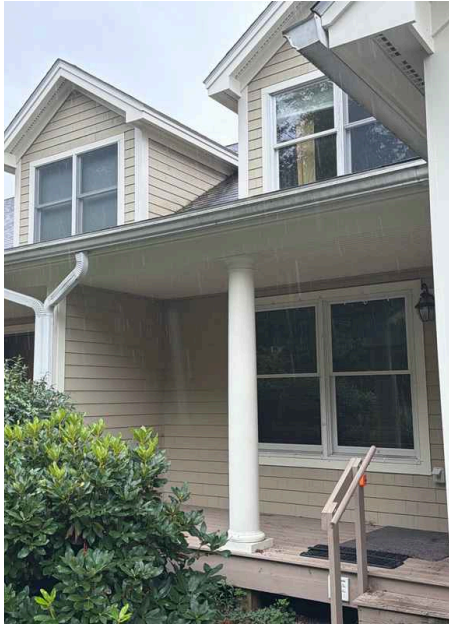
Gutter systems in place.

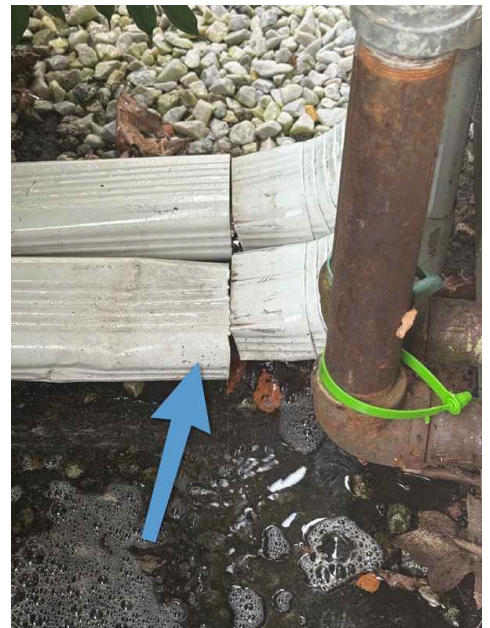
Downspout extensions at the front of the home have come loose. Recommend securing. It should be noted that this is a very minor concern.

Recommend extending the bottom of the downspouts to carry the water away from the home.

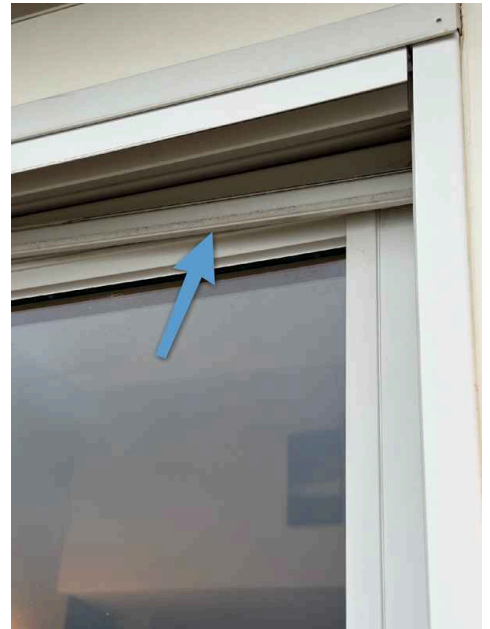
## 2.2.2 Doors (Exterior)

Loose weatherstripping observed at the main level rear deck entrance. Recommend securing.

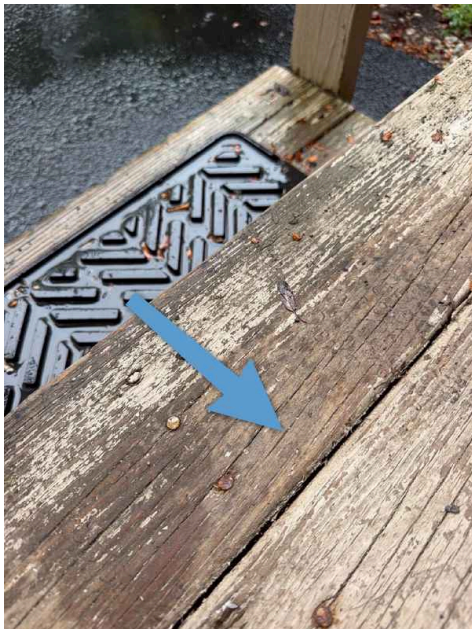
## 2.3.1 Decks, Balconies, Stoops, Steps, Areaways, Porches, Patio/Cover and Applicable Railings

**PEELING PAINT/LIGHT DETERIORATION**

All deck areas could use a new coat of paint or stain.

Various areas of peeling paint and deterioration were observed at deck areas around the home, recommend making repairs where necessary as well as scraping and applying a coat of paint or stain.

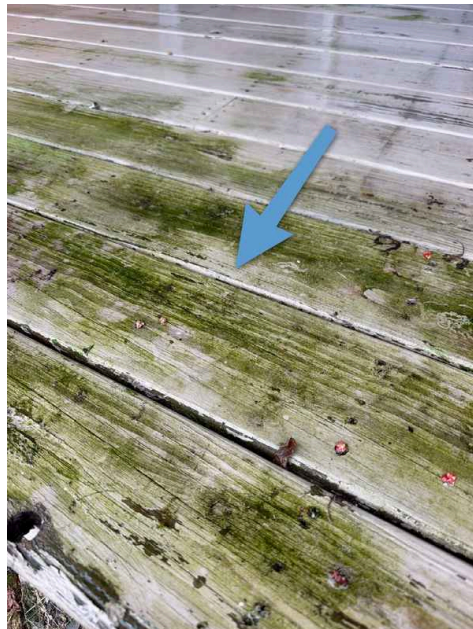
Additionally, the first level rear deck could use cleaning. It should be noted that these are very minor concerns.

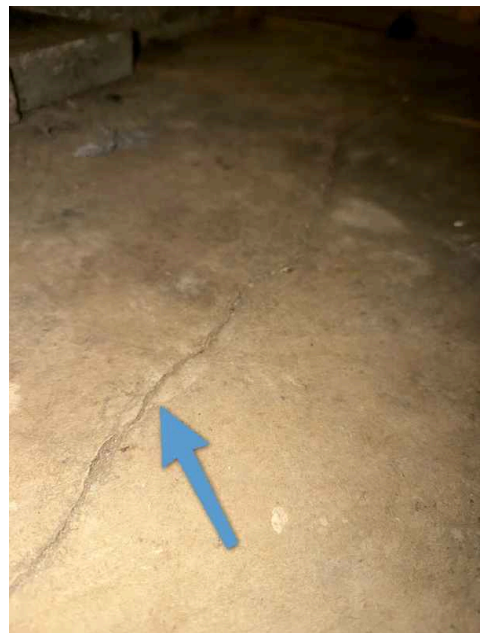
Areas of settlement cracks observed on basement floor. This does not have an impact on structural integrity of slab.

Settling cracks found in the basement floor do not appear to be structurally concerning at this time.

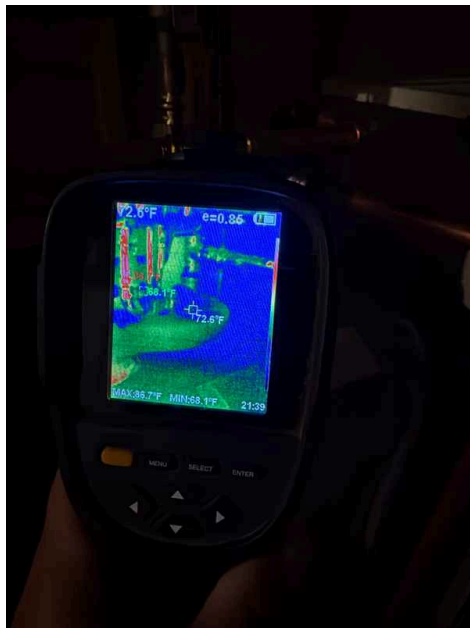
Unit installed as of 2022.

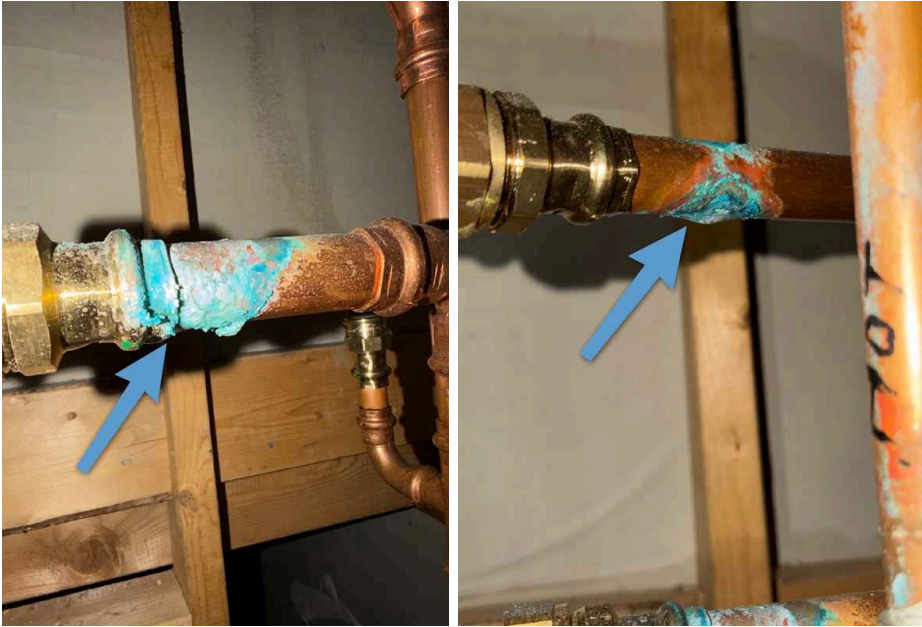
The indirect water heater was found to have been turned off due to leaks found in the plumbing connected to the unit.

Recommend consulting a plumber for repairs.

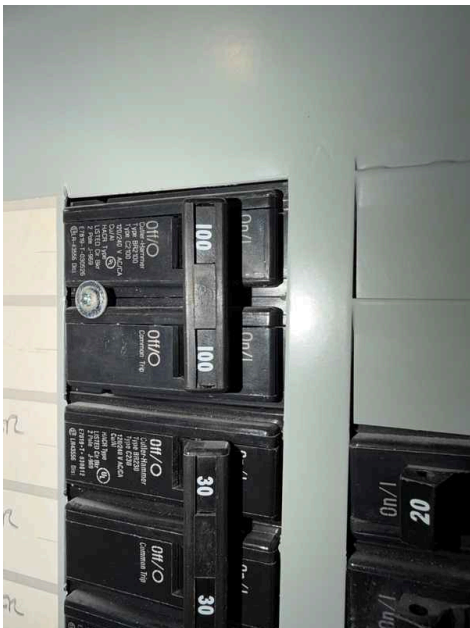
Main panel inspected by the boiler with no major concerns observed.

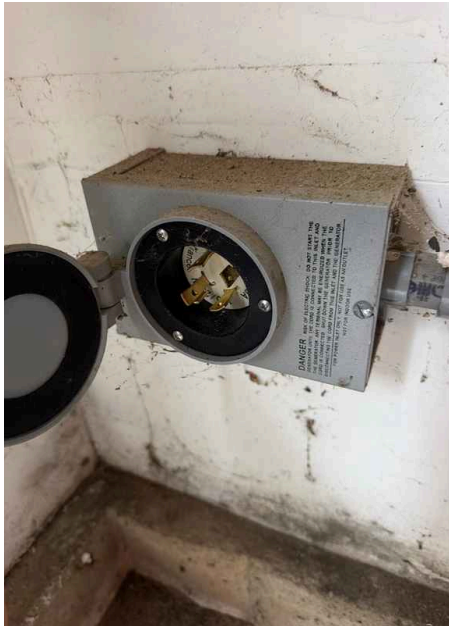
Generator connection present in the garage.

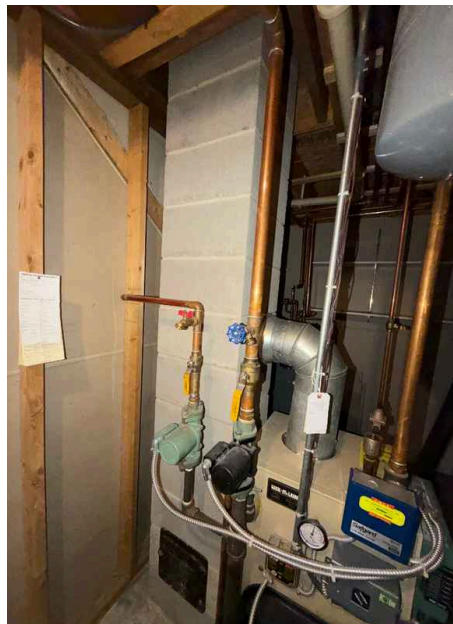
Chimney structure in the basement found to be in good condition.

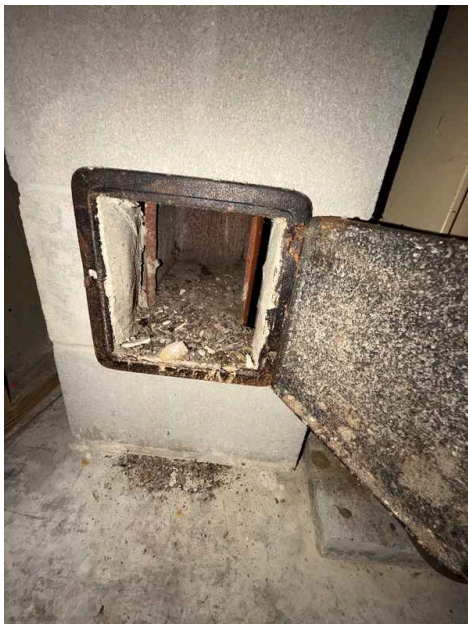
Partial view up chimney flue

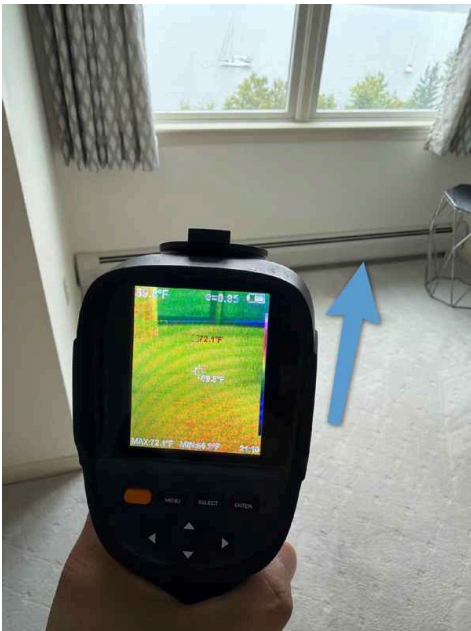
The thermostat on the second level was turned up to the maximum temperature and allowed approximately 20 minutes for the system to heat up.

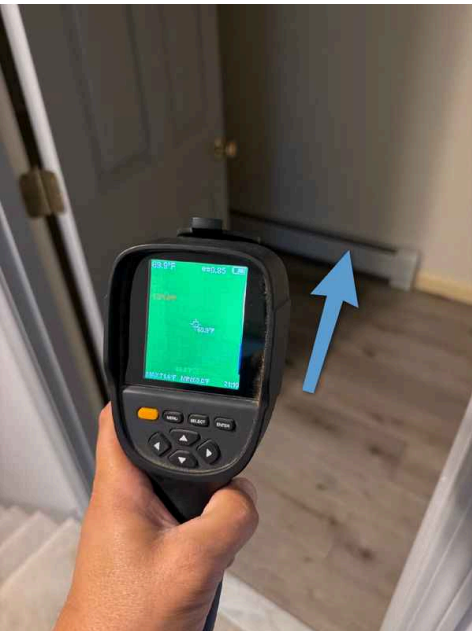
No noticeable difference in temperature was observed through the course of the inspection. Recommend consulting a heating professional for further inspection and possible solutions if necessary.

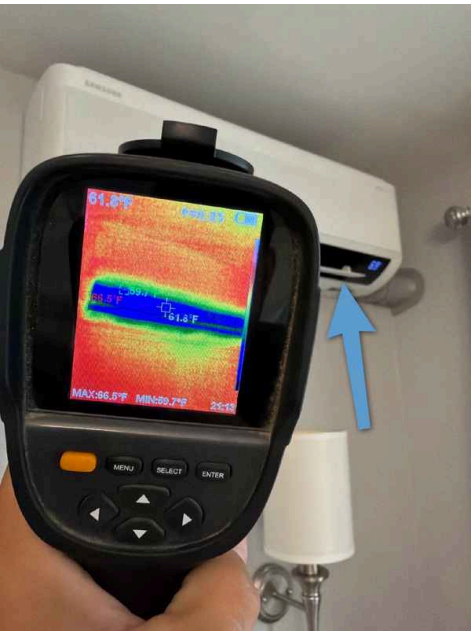
Heat pumps in the living room and master bedroom were set to the highest heat setting and allowed approximately 45 minutes to an hour to heat up with no noticeable increase in temperature observed. Recommend consulting a heat pump professional for possible solutions.

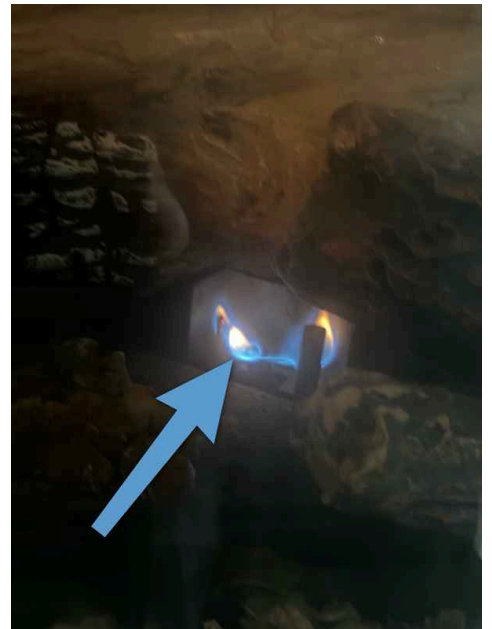
#### 8.6.1 Gas/LP Firelogs and Fireplaces

Pilot for the ignition system would not light or stay lit. Recommend having unit serviced.

The burner pilot on the propane fireplace would ignite, but would not stay lit after holding for the recommended minute and a half. Recommend consulting a heating professional for further inspection and repair if necessary.

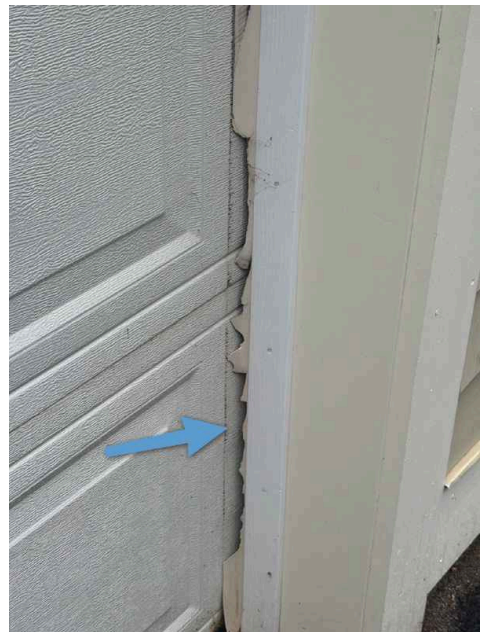
Damaged weatherstripping observed around the garage bay door. It should be noted that this is a very minor concern. Recommend necessary repairs.
