WOOD DESTROYING PESTS AND ORGANISMS INSPECTION REPORT

Building No. 5720	Street Huasna Townsite	City Arroyo Grande	ZIP 93420	Date of Inspection 06/25/2024	Number of Pages 4
----------------------	---------------------------	-----------------------	--------------	----------------------------------	----------------------

GENERAL DESCRIPTION: FURNISHED AND OCCUPIED TWO STORY SIDED RESIDENCE WITH ATTACHED THREE CAR GARAGE ON A CONCRETE SLAB FOUNDATION AND COMP ROOF	Inspection Tag Posted: Meter Box Other Tags Posted:
--	---

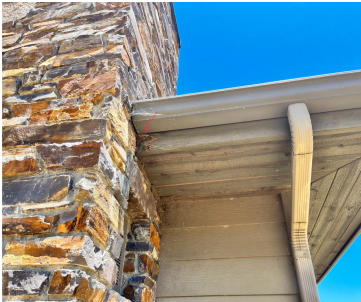
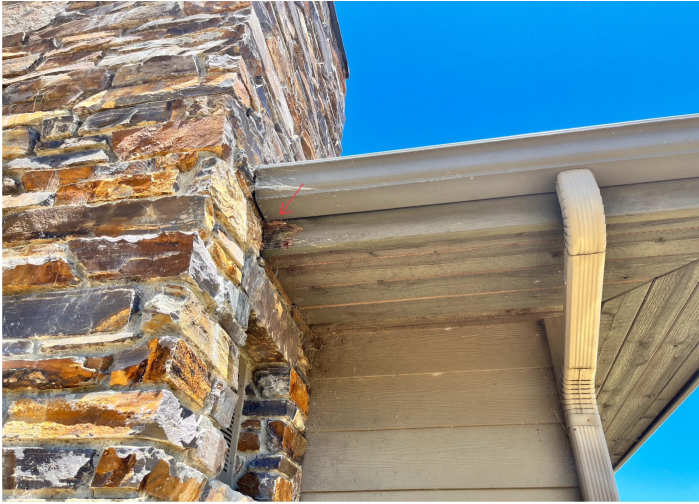
3A - Damage to the fascia board

3A - Fungus / Dryrot

FINDING-Fungus infection and damage noted at the fascia boards of the eave framing.

RECOMMENDATION-Remove and replace damaged wood members as necessary. Paint areas to a reasonable match. (Estimate is for the visible damage) (Substitute materials may be used)

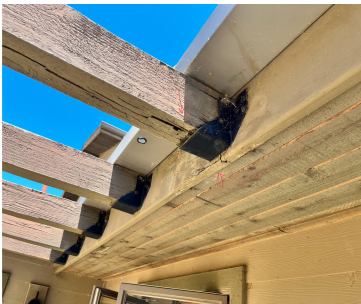
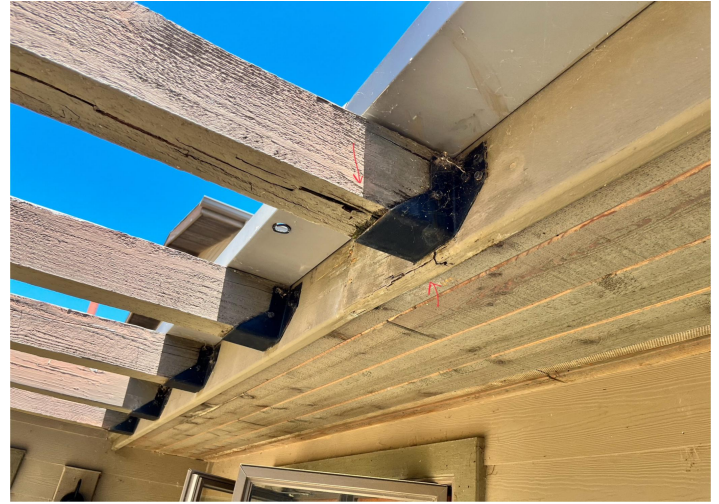
3A & 3B Example of damage to the fascia and patio framing.

3B - Fungus / Dryrot

FINDING-Fungus infection and damage noted at the 4x6 beams and 6x10 header beam of the attached patio cover.

RECOMMENDATION-Remove and replace damaged wood members as necessary. Repair header beam as necessary. Paint areas to a reasonable match. (Estimate is for the visible damage) (Substitute materials may be used)

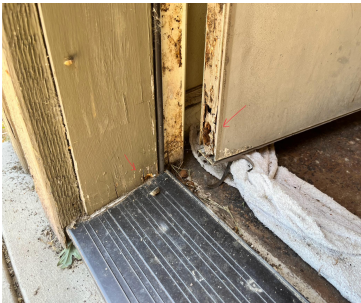
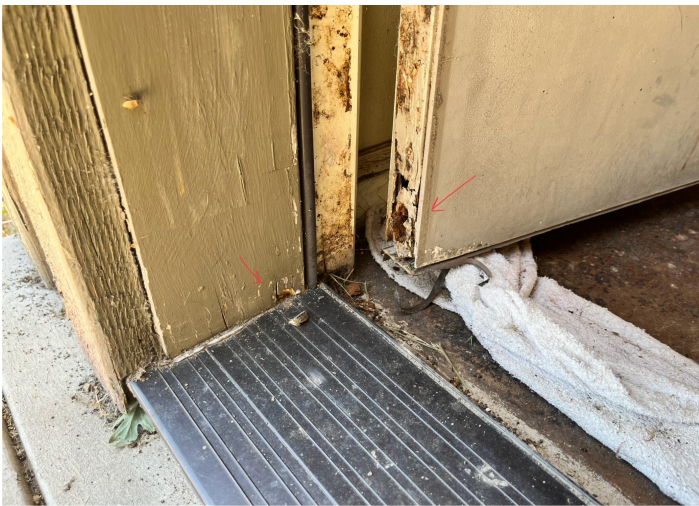
3C - Damage to laundry room door

3C - Fungus / Dryrot

FINDING-Fungus infection and damage noted at the jamb and door framing of the laundry room door.

RECOMMENDATION- Remove and replace door and door jambs with a new pre-hung door unit.

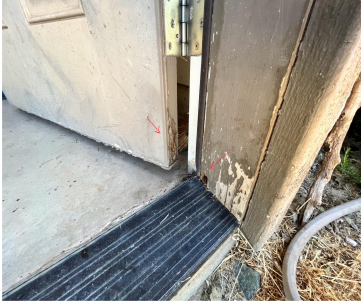
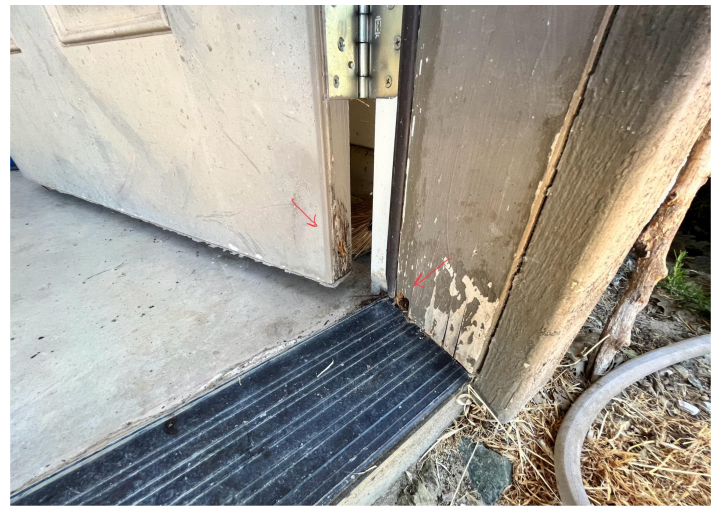
3D - Fungus / Dryrot

FINDING- Fungus infection and damage noted at the pedestrian garage door and jambs.

3D - Damage to pedestrian garage door

RECOMMENDATION- Remove and replace door and door jambs with a new pre-hung door unit.

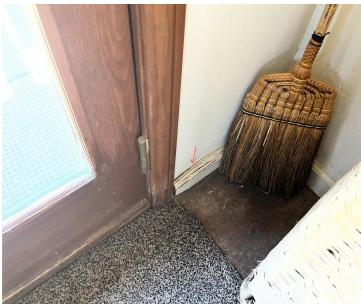
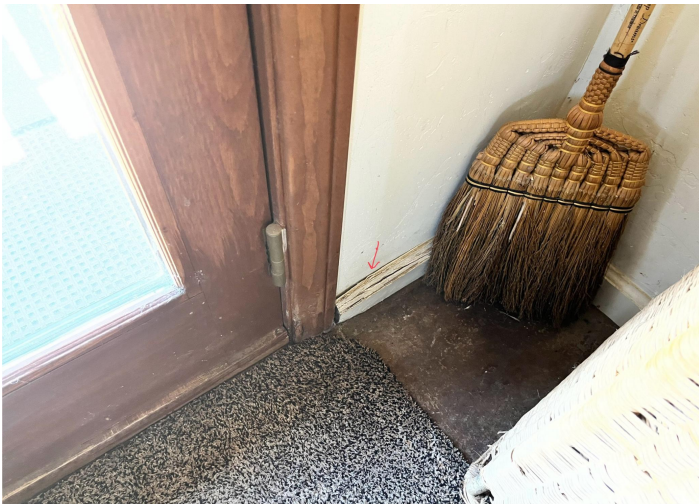
3E - Fungus / Dryrot

FINDING-Fungus infection and damage noted at the baseboards adjacent to the living room door.

3E - Damage to baseboards

RECOMMENDATION-Remove and replace damaged wood members as necessary. Paint areas to a reasonable match. (Estimate is for the visible damage) (Substitute materials may be used)

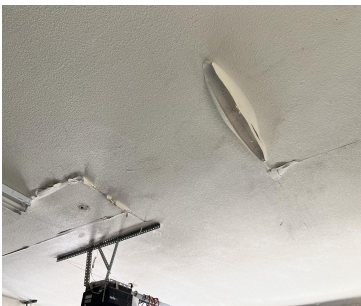
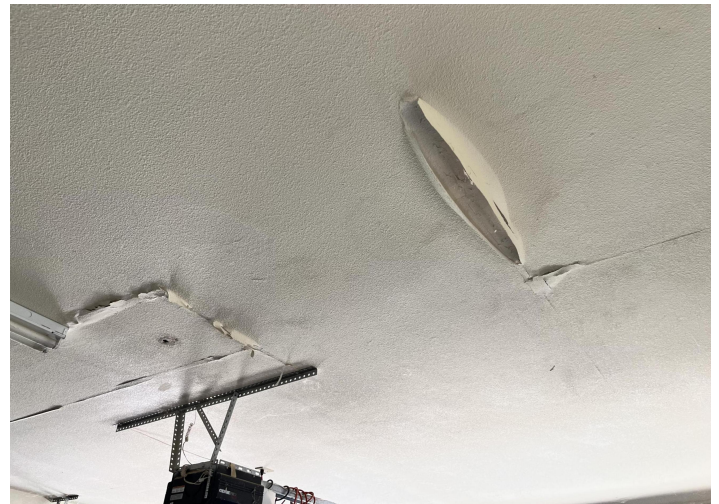
4A - Other Findings

FINDING- Excessive moisture noted to have caused damage to the garage ceiling. Moisture appears to be caused from an old roof leak. Owner states that the roof has been repaired. If any questions arise regarding the condition of the roof, contact the owner and/or a licensed roofer.

RECOMMENDATION- Repair garage ceiling as necessary.
