SB 326

EXTERIOR ELEVATED ELEMENTS INSPECTION REPORT

Examination Date	November 3, 2023	Order: 01606
Property Owner	The Regency at Veteran HOA	
Requested by	c/o Pacific Edge Management	
Address	303 N. Glenoaks Blvd. Suite 200 Burbank CA 91502	
Site Name	The Regency at Veteran HOA	
Site Address	1861 Veteran Ave., Los Angeles, CA, 90025

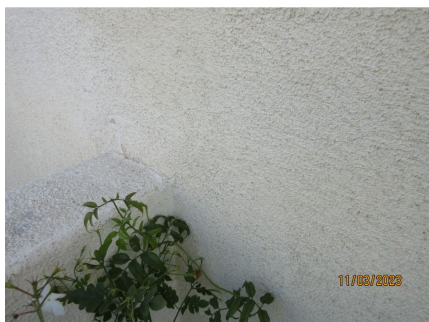
1606 - 123.JPG

The staining surrounding the scuppers on several of the units suggest that the scuppers are not long enough. Scuppers should be modified or replace to prevent eventual water penetration. The staining in the soffit on the second deck at unit 303 suggests that water has penetrated the deck surface.

303	Balcony Deck 2nd Deck	<input type="checkbox"/> Yes <input checked="" type="checkbox"/> No	Suggested Maintenance: See General Discussion for more information; Repair or replace scupper	<div style="display: flex; justify-content: space-around;"> ■ <input type="checkbox"/> <input type="checkbox"/></div> <div style="display: flex; justify-content: space-around;"> ● <input type="checkbox"/> <input type="checkbox"/> </div>	116 - 126
303	Balcony Deck 3rd Deck	<input type="checkbox"/> Yes <input checked="" type="checkbox"/> No	Suggested Maintenance: Repair or replace scupper	<div style="display: flex; justify-content: space-around;"> ■ <input type="checkbox"/> <input type="checkbox"/></div> <div style="display: flex; justify-content: space-around;"> ● <input type="checkbox"/> <input type="checkbox"/> </div>	127 - 139
201	Balcony Deck	<input type="checkbox"/> Yes <input checked="" type="checkbox"/> No	None	<div style="display: flex; justify-content: space-around;"> ■ <input type="checkbox"/> <input type="checkbox"/></div> <div style="display: flex; justify-content: space-around;"> ● <input type="checkbox"/> <input type="checkbox"/> </div>	140 - 152

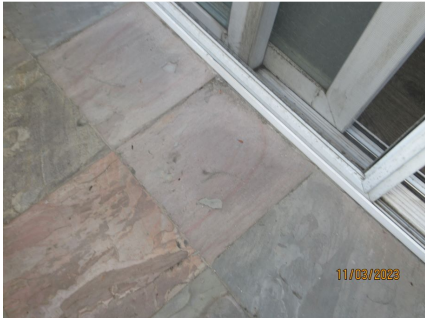
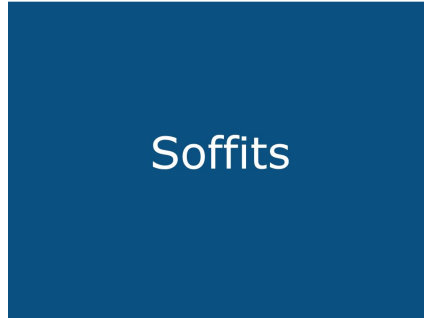
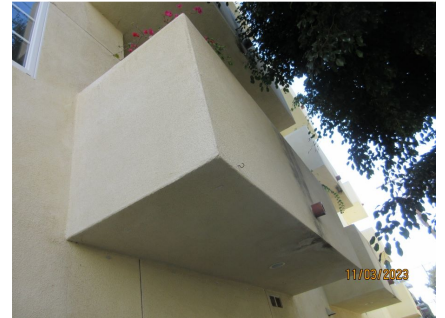
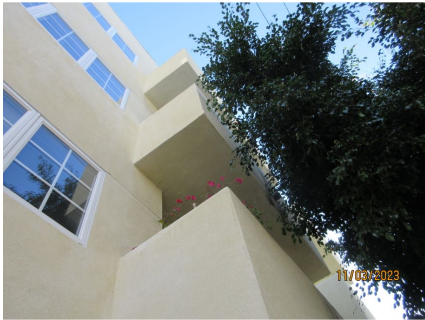
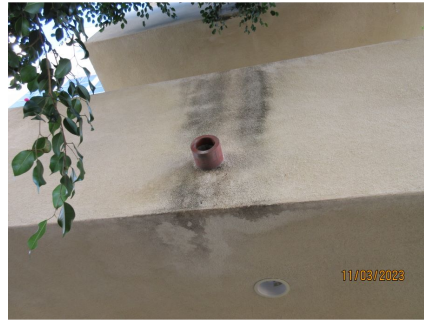
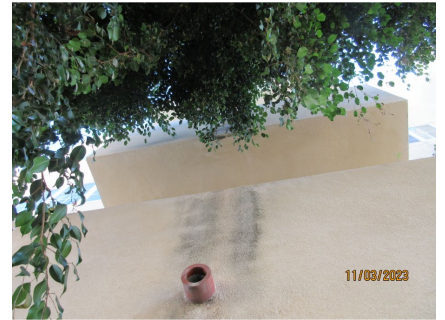
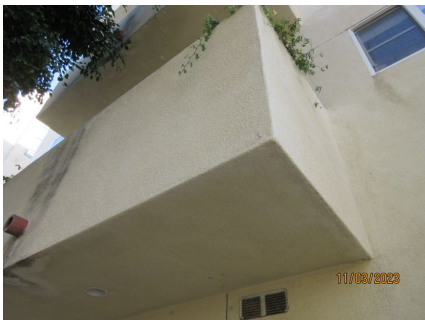
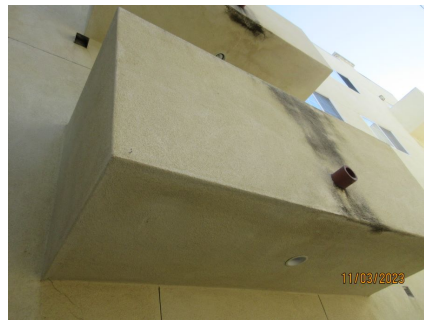
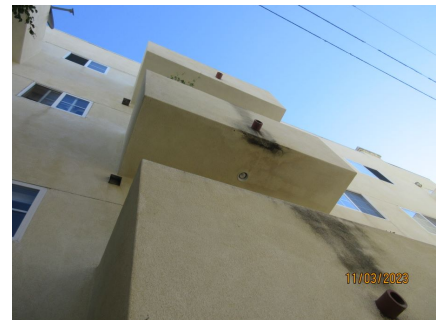
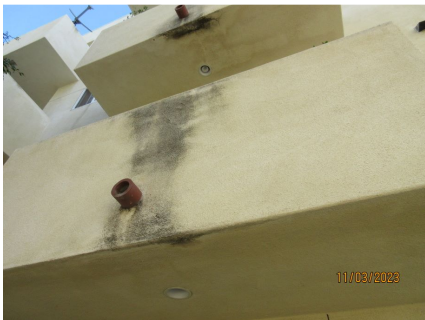
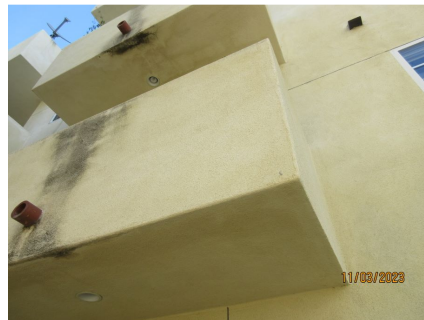
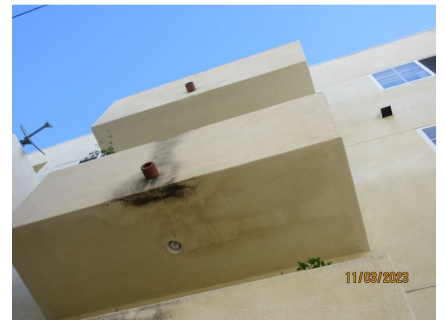
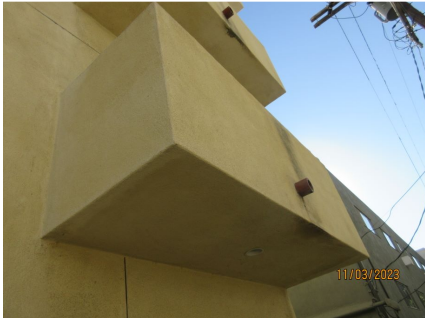
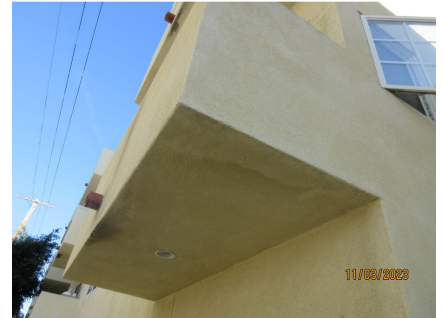
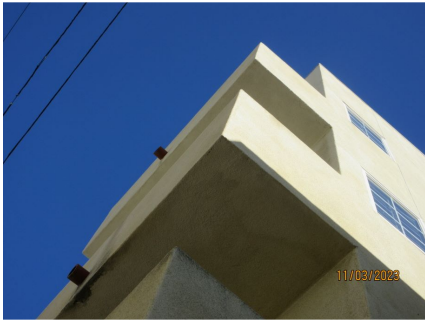
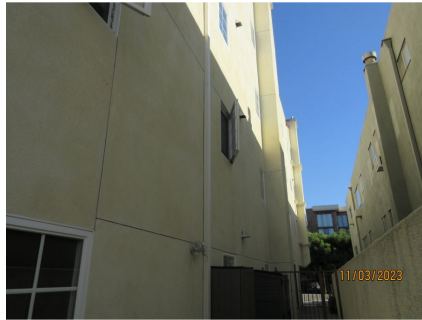
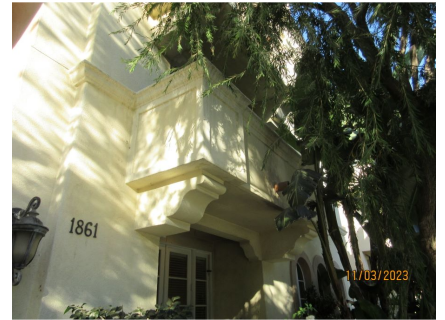
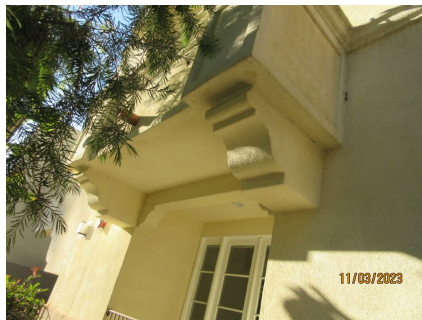
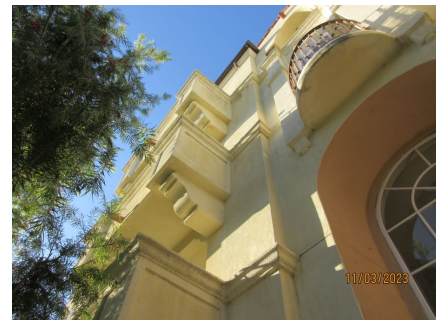
Site Name: The Regency at Veteran HOA		Examination Date: 11/3/2023		Site Overview Photos: 1 - 6		
Location	Description	Immediate Hazard Yes No		Recommendations /Comments	<input type="checkbox"/> Structural Condition <input type="checkbox"/> Service Photo #s	
203	Balcony Deck 3rd Deck	<input type="checkbox"/>	<input checked="" type="checkbox"/>	None	<input checked="" type="checkbox"/> <input type="checkbox"/> <input type="checkbox"/> <input checked="" type="checkbox"/> <input type="checkbox"/> <input type="checkbox"/>	183 - 193
Soffits	Soffits	<input type="checkbox"/>	<input type="checkbox"/>		<input type="checkbox"/> <input type="checkbox"/> <input type="checkbox"/> <input type="checkbox"/> <input type="checkbox"/> <input type="checkbox"/>	194 - 213
