HomeTech Inspections

CONFIDENTIAL INSPECTION REPORT

558 Rose Ln, Twin Peaks, Ca 92391

2/3/2026 9:00 am to 12:00 pm

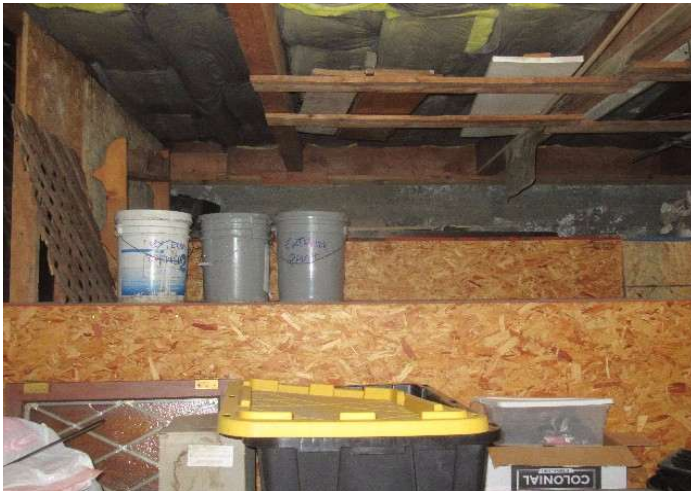
1.10 - There is earth to wood contact in the crawlspace that should be referenced on the termite report

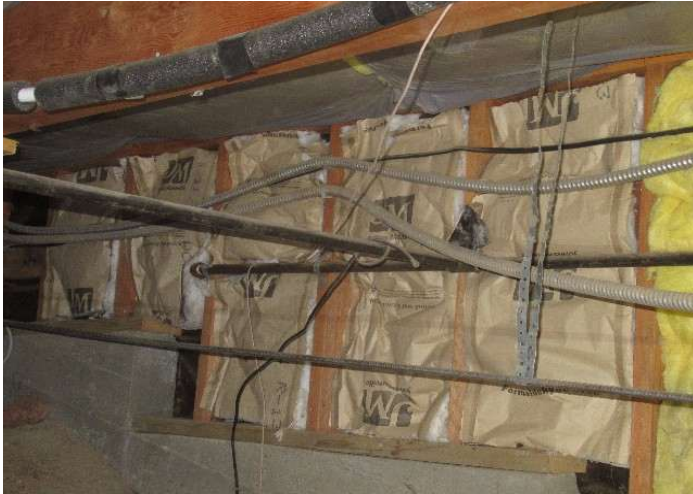
1.15 - Fiberglas batt insulation is installed upside down. so its vapor barrier is exposed. The facing on this insulation is flammable, as indicated by the warning statements printed on the facing. Flammable facing should be covered to prevent the spread of fire.

A qualified licensed contractor should reinstall this insulation or install new insulation as per the manufacturer's recommendations to eliminate the fire hazard and conducive conditions for wood destroying insects. When the old insulation is removed, the exposed structure should be evaluated for damage by wood destroying insects and/or organisms, and repairs should be made if necessary.

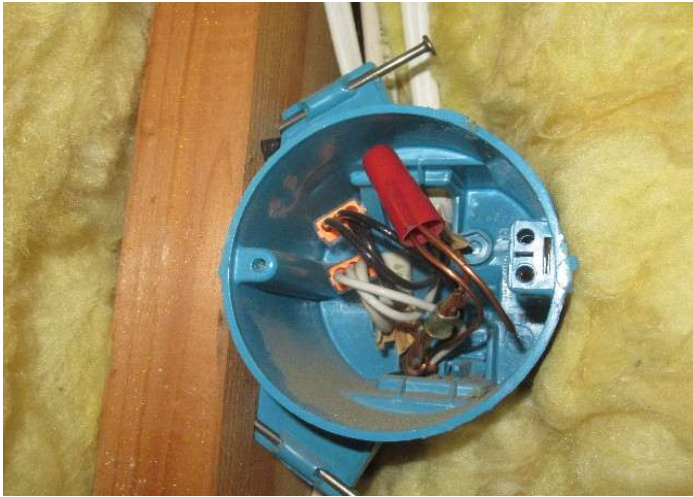
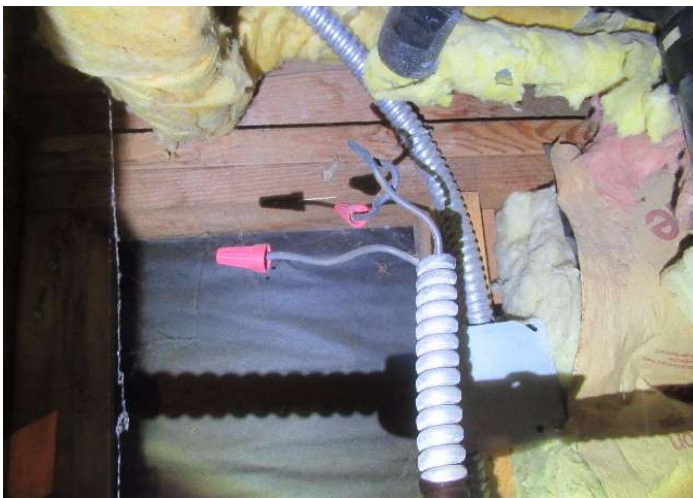
Open electrical junction box - *Continued*

1.17 - There are one or more open electrical junction box within the crawlspace, which should be sealed so that any arching or sparking would be contained within the box.

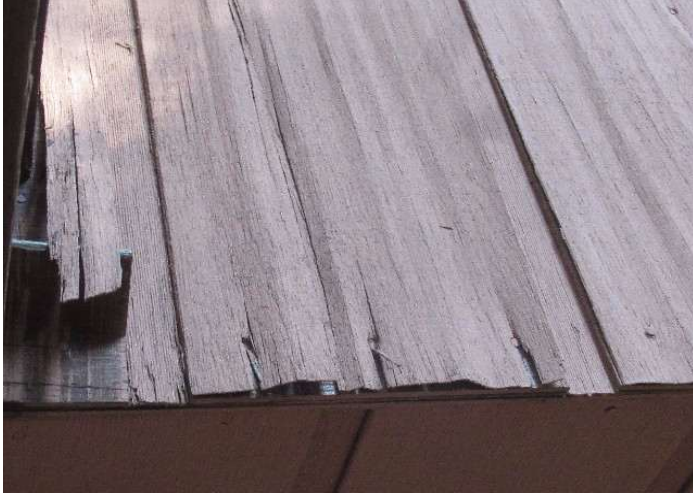
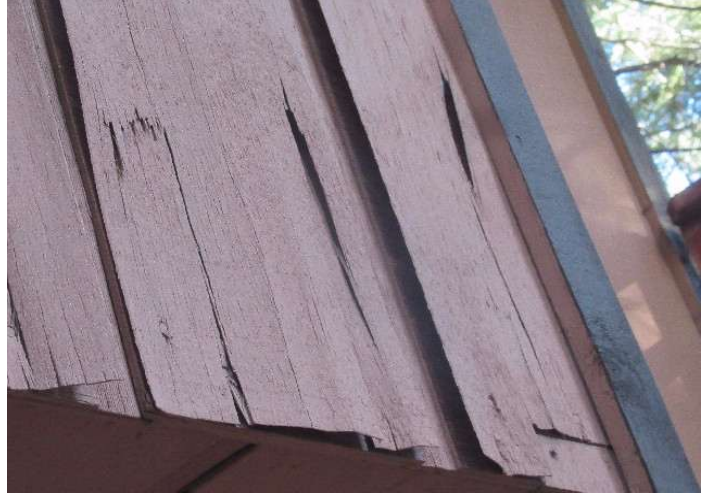
2.12 - Exterior plywood siding was observed to be delaminating in areas. This condition indicates moisture intrusion and material deterioration, which can reduce the siding's durability and weather resistance. Repair or replacement by a qualified contractor is recommended to prevent further damage.

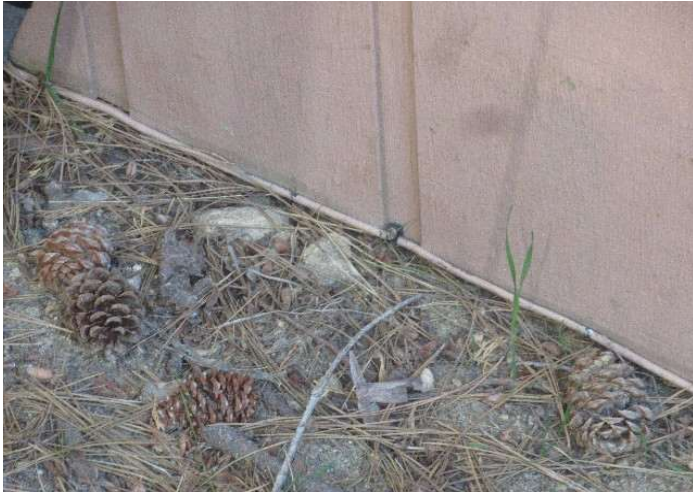
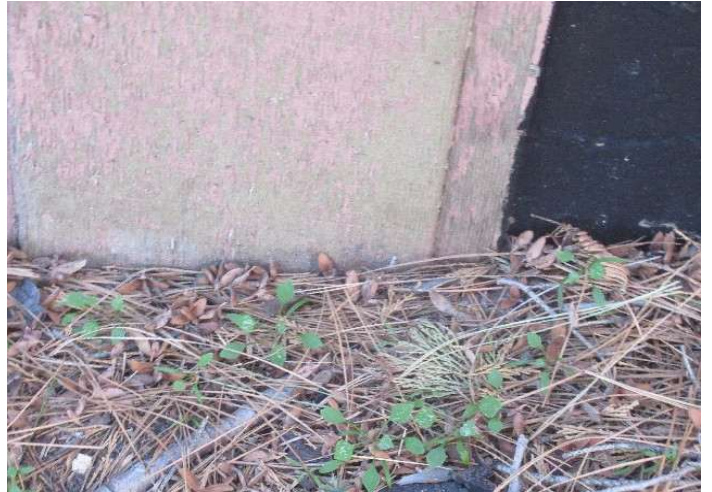
2.13 - There is earth to wood contact that should be referenced on the termite report and serviced as deemed necessary.

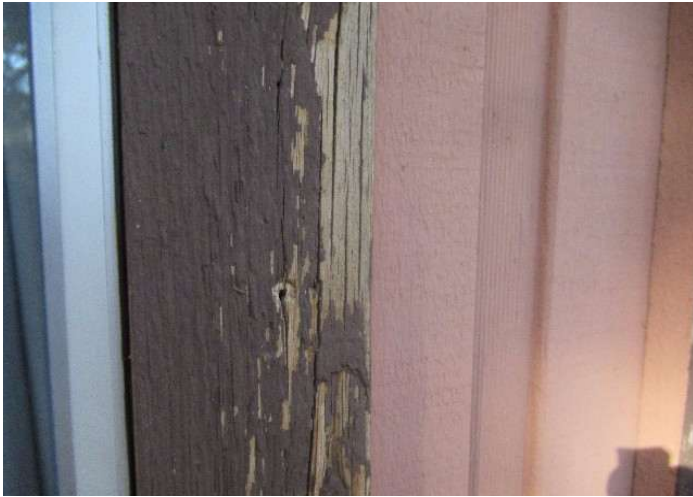
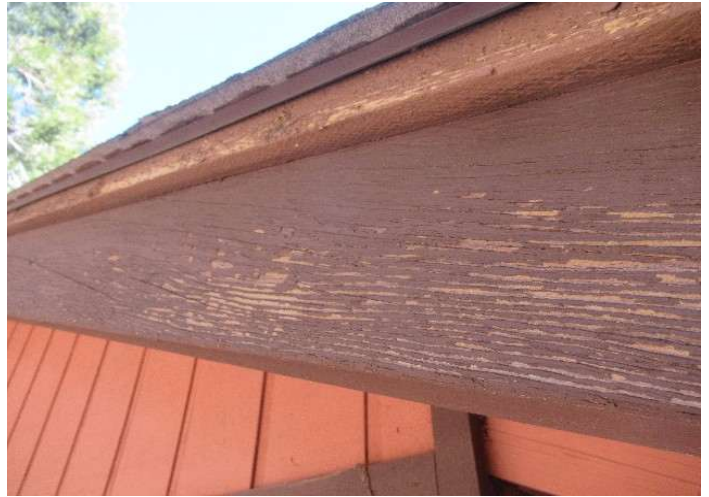
Fascia and trim - maintenance-type - *Continued*

2.14 - The fascia and trim need maintenance-type service to prevent further deterioration.

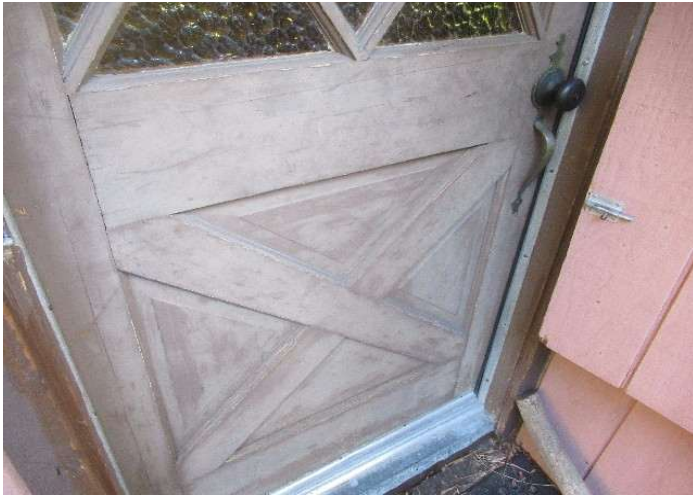
2.21 - The exterior doors needs maintenance-type service such as, sanding, sealing, and paint or staining, all of which will prolong the life of the doors.

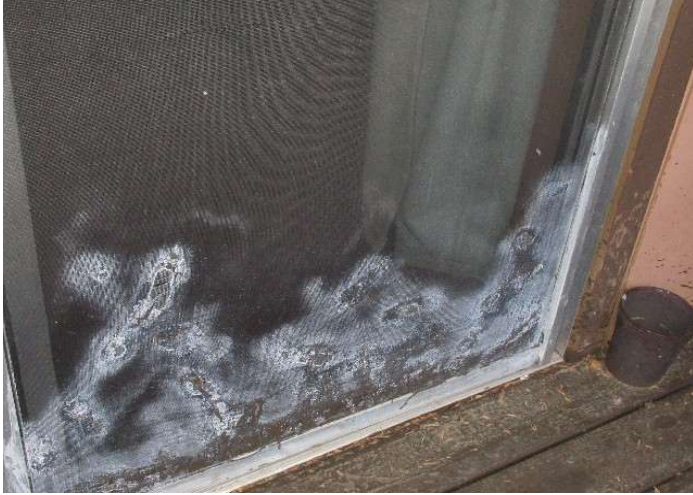
2.28 - The slider screen is damaged, and you may wish to have it repaired.

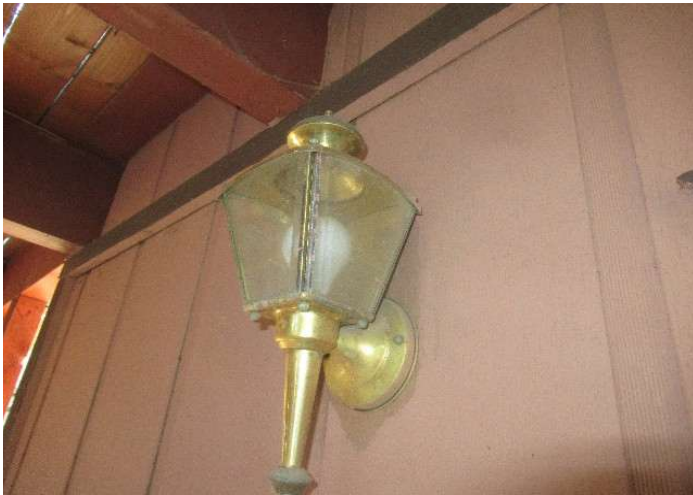
2.29 - One or more light fixtures appear to be inoperable. Recommend further evaluation by replacing bulb(s) and/or consulting with the property owner(s) if possible. Repairs or replacement of the light fixture(s) by a qualified licensed electrician may be necessary.

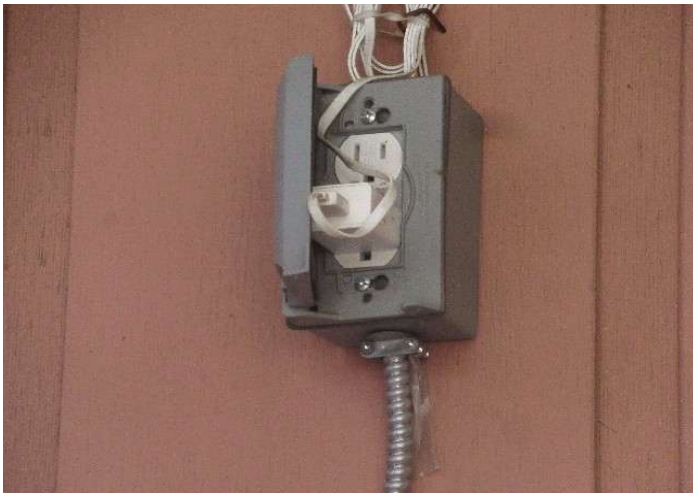
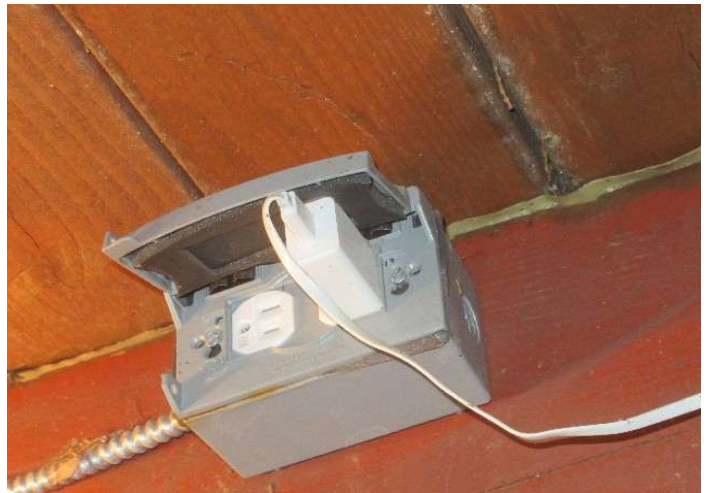
2.31 - Waterproof cover(s) over one or more electric receptacles are damaged, missing, or broken. This is a safety hazard due to the risk of shock and fire. Damaged covers should be replaced where necessary.

2.32 - One or more exterior electric receptacles are being used for appliances or systems that are constantly in use, and are not equipped with "in-use" receptacle covers for wet locations. "In use" covers should be installed where necessary.

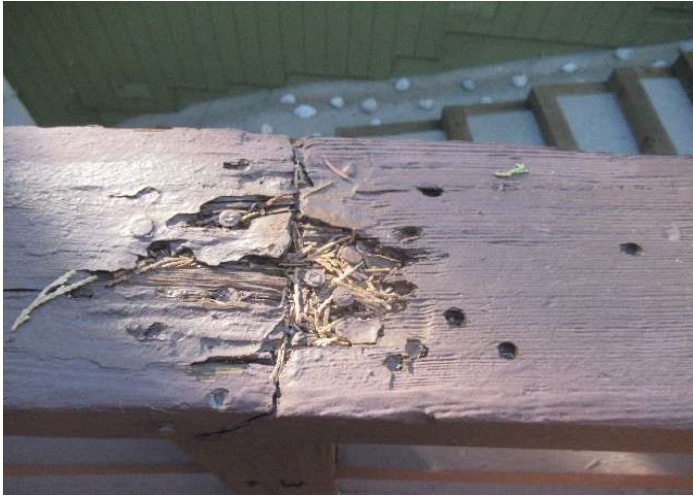
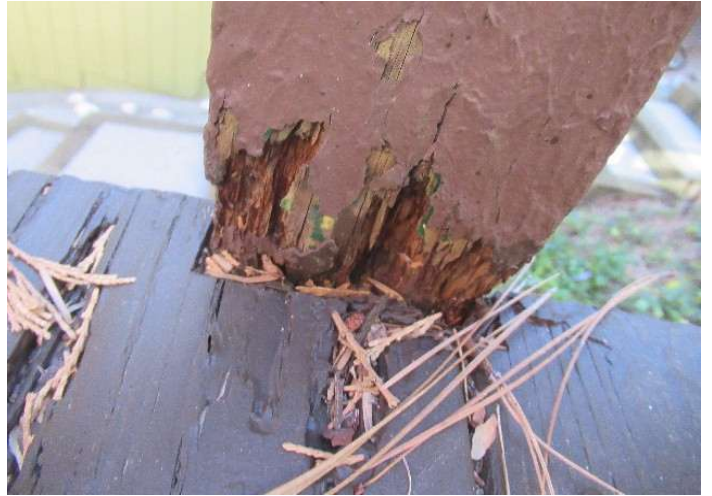
2.34 - There is damage to the wood deck that should be evaluated by the termite inspector.

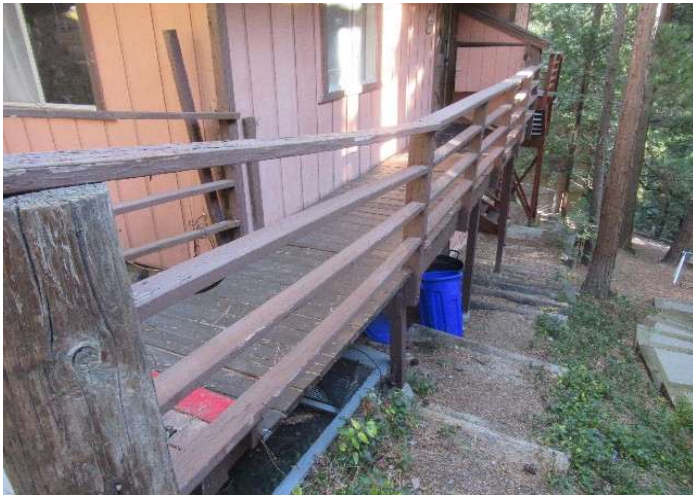
2.36 - One or more deck guardrails are constructed in such a way that children could climb them like a ladder. This is a potential safety hazard. At the time this home was built these were built to standard building specifications for that time period, but does not meet today's standard building practices. Client(s) may want modifications to be made as necessary by a qualified licensed contractor so guardrails cannot be climbed by children.

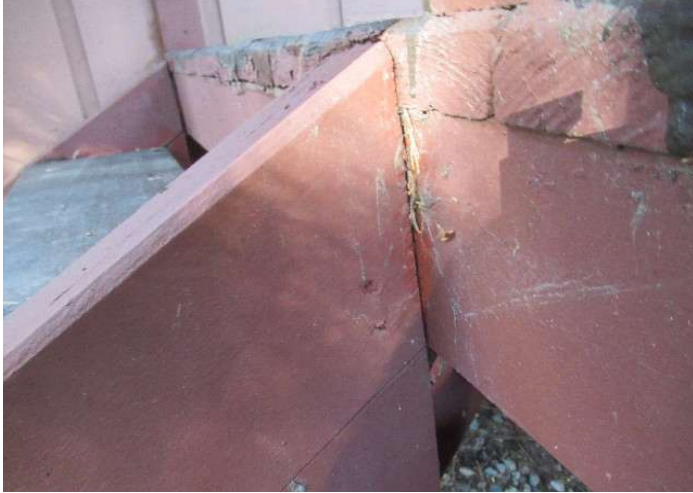
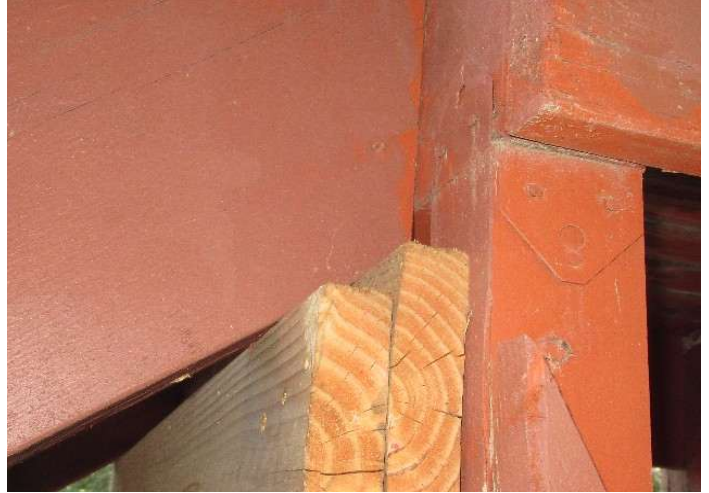
2.38 - The stringers have no straps and are separating from the deck landing and should be evaluated by a licensed contractor and repaired or replaced as needed.

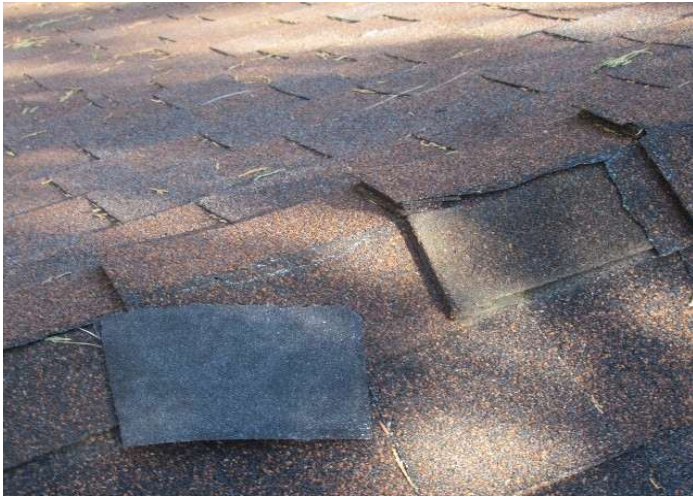
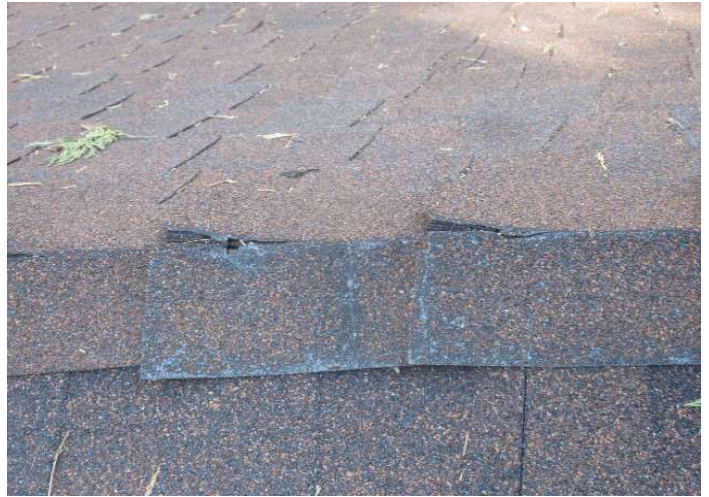
Ridge shingles - significantly deteriorated - *Continued*

3.5 - The ridge shingles are deteriorated and should be repaired or replaced as needed.

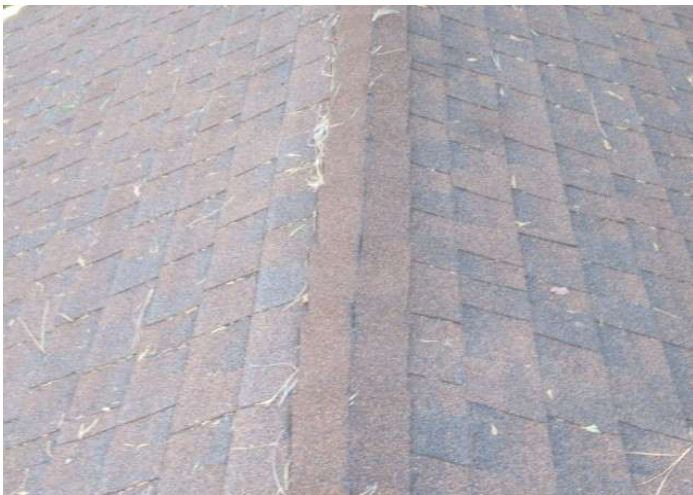
3.7 - When a composition roof is losing granules, it typically indicates that the shingles are aging or deteriorating. These granules help protect the shingles from the sun's UV rays and provide fire resistance. Loss of granules can lead to premature aging, curling, or cracking of the shingles, making the roof more susceptible to leaks and damage. It's often a sign that the roof may need repair or replacement in the near future. Recommend evaluation by a licensed roofing contractor.

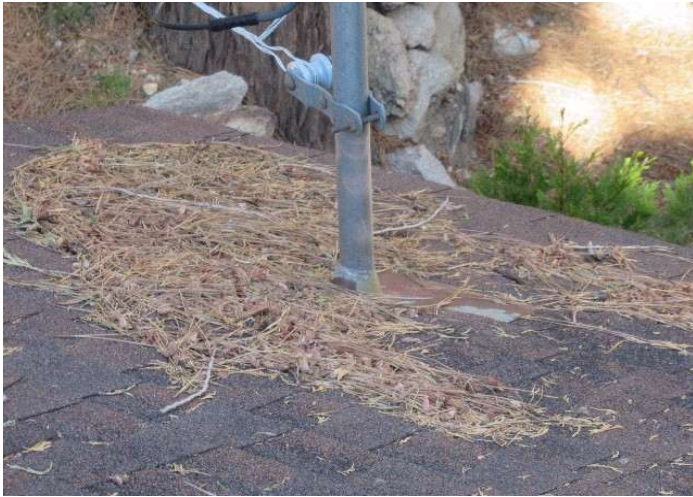
Roof needs to be cleaned - *Continued*

3.8 - The roof was partially obscured by accumulated debris and couldn't be fully evaluated. The client(s) may want to have a qualified licensed roofing contractor evaluate later when the roof has been cleaned.

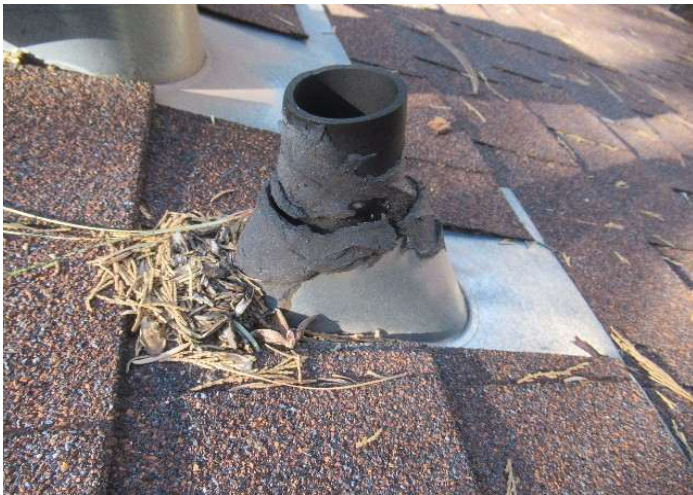
3.10 - One or more plumbing vent pipes were observed terminating too close to the roof surface. Current standards typically require vent pipes to extend a minimum of 12 inches above the roof covering in snow-prone areas to reduce the risk of blockage or freezing. A qualified plumber should evaluate and extend the vent(s) as needed to meet current requirements.

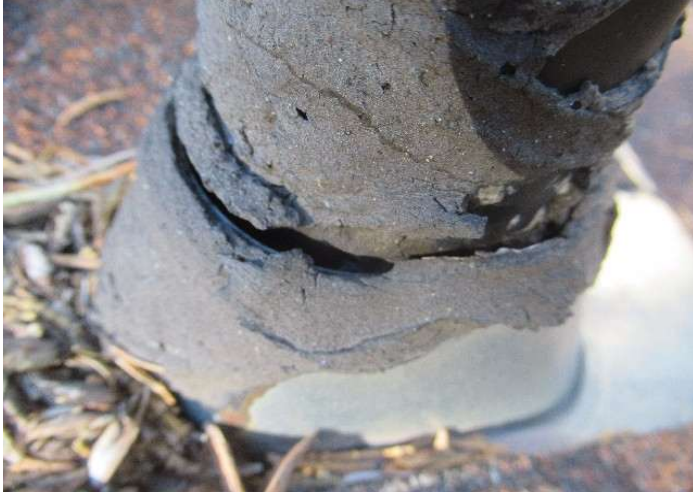
3.11 - Flashings at one or more plumbing vent pipes or exhaust pipes have gaps due to deteriorated or missing sealant. Rain water or snow melt may flow between the pipe and the flashing, resulting in leaks. A qualified licensed roofing contractor should make repairs as necessary so Flashings are sealed as per standard building practices.

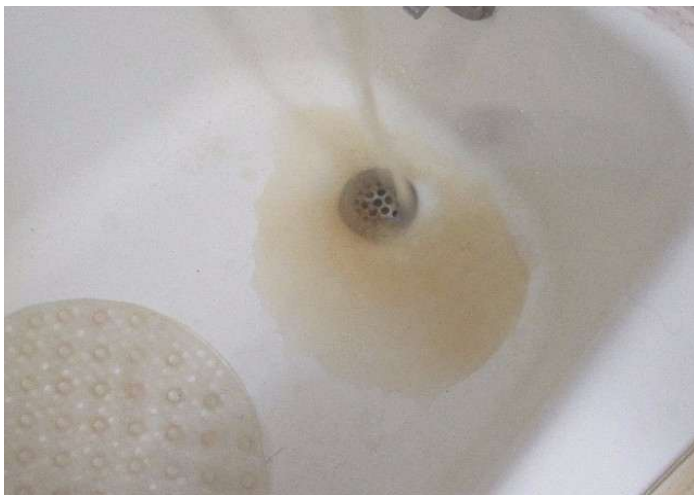
4.10 - The home contains galvanized steel water supply piping. Galvanized pipes are prone to internal corrosion and were observed to be producing rusty or discolored water, indicating deterioration. This condition can restrict water flow and affect water quality. Replacement of the galvanized piping with modern materials is recommended, and further evaluation by a licensed plumber is advised.

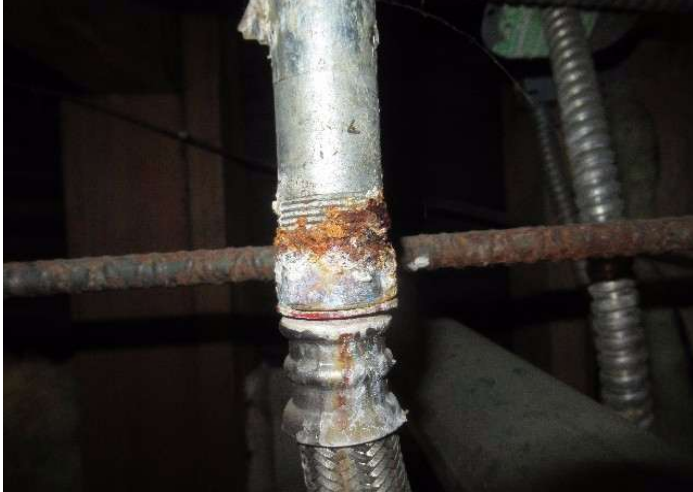
4.11 - The home contains original galvanized steel plumbing. Corrosion was observed at several pipe fittings, which is common with aging galvanized systems and can restrict water flow or lead to leaks. Evaluation and repair or replacement by a qualified plumber is recommended.

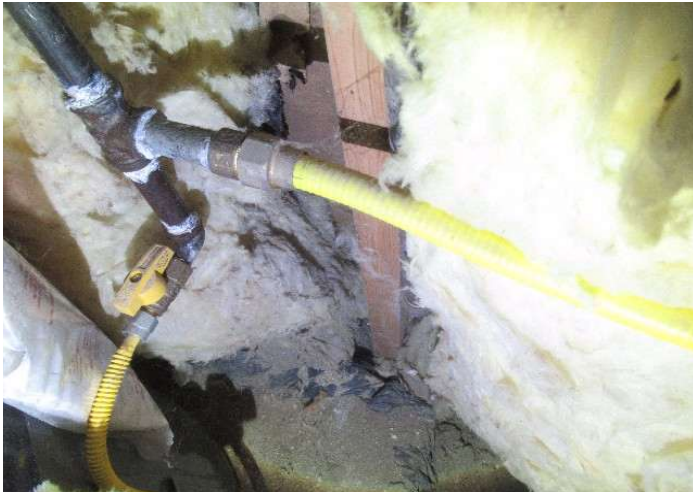
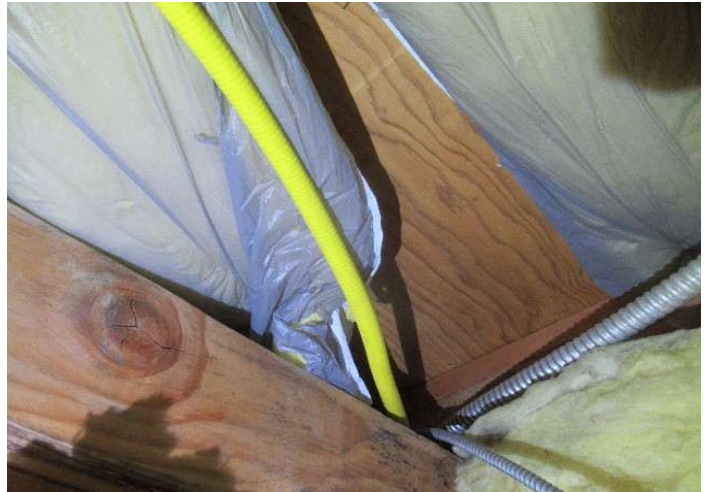
4.20 - Manufacturers of yellow corrugated stainless steel tubing believe that yellow corrugated stainless steel tubing is safer if properly bonded and grounded as required by the manufacturer's installation instructions. Proper bonding and grounding of this product can only be determined by a licensed electrical contractor.

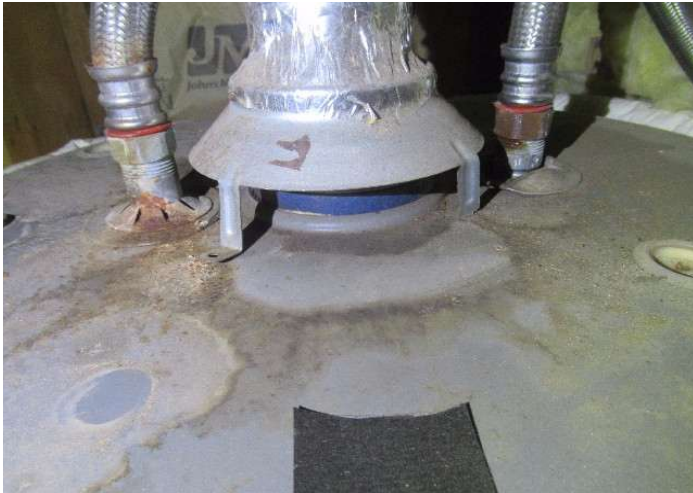
4.33 - The vent pipe does not extend past the roof line and is not drafting correctly and should be serviced.

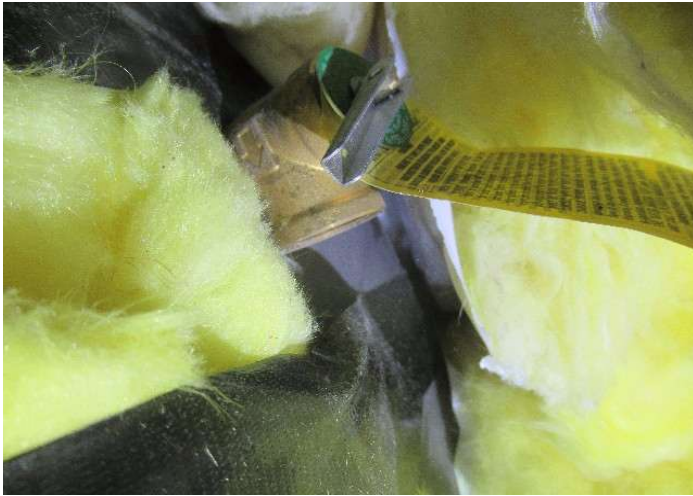
4.36 - The pressure relief valve on the water heater does not have a discharge pipe. One should be installed that terminates approximately six inches above grade.

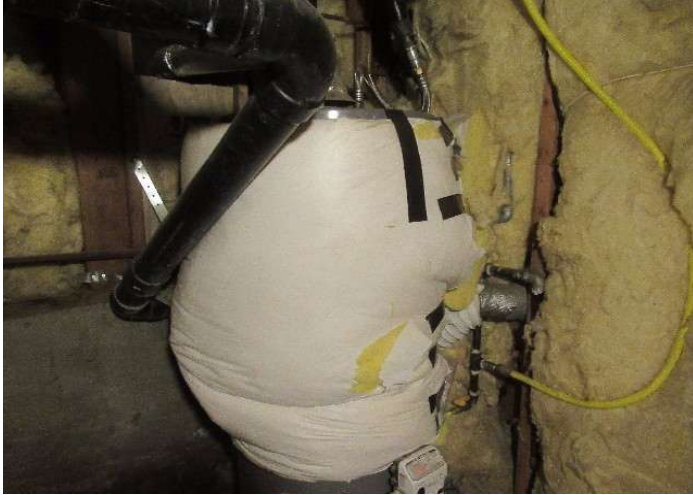
WATER HEATER SEISMIC BRACING: Water heaters must be braced, anchored or strapped to resist toppling or horizontal displacement due to earthquake motion. As per the Department of the State Architect (DSA): Minimum requirements for water heaters to 50 gallons capacity are two approved straps (not on top of the insulation blanket) properly located (top 1/3 & bottom 1/3 but 4" above the controls) and anchored with minimum 1/4" X 3" lag bolts into the studs (or the structural equivalent where stud attachment is not an option. The DSA also recommends one additional strap for each 25 gallons of capacity over 50, 51-75 = 3 straps and 76-100 = four straps.

The water heater is not correctly secured and needs to be strapped in accordance with local standards - *Continued*

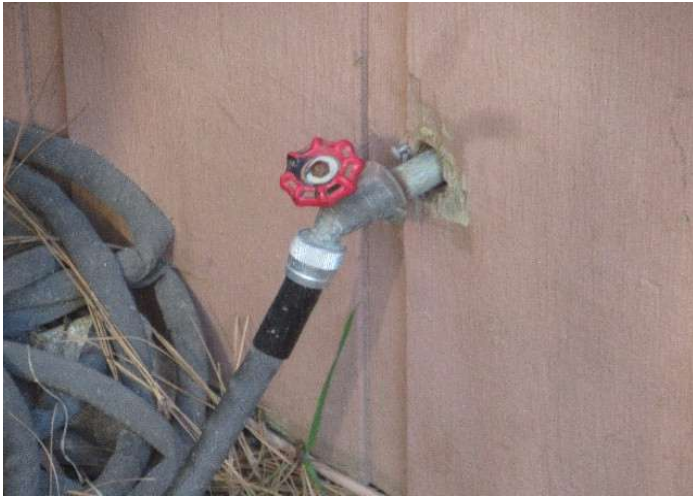
Not attached to the house - *Continued*

4.43 - One or more of the hose bibs is not attached to the house correctly should be serviced.

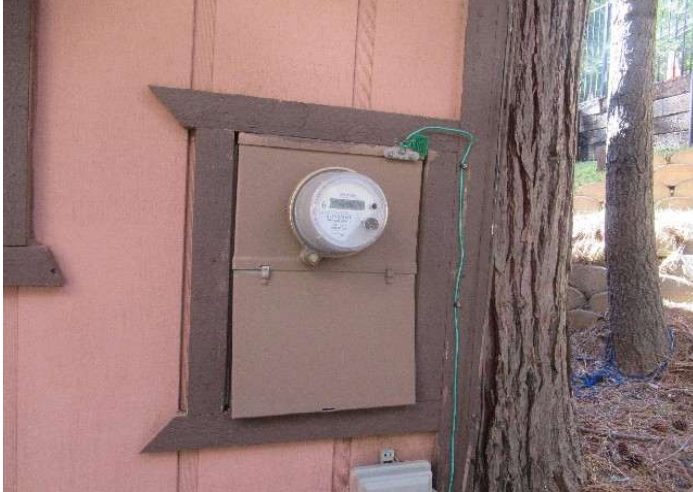
These panels are very common in the mountain areas and with the mountains dry climate corrosion is very rare. At time of inspection this panel appears to be clean and free of corrosion. Buyer may want to have panel evaluated in future years to see if any corrosion is apparent.

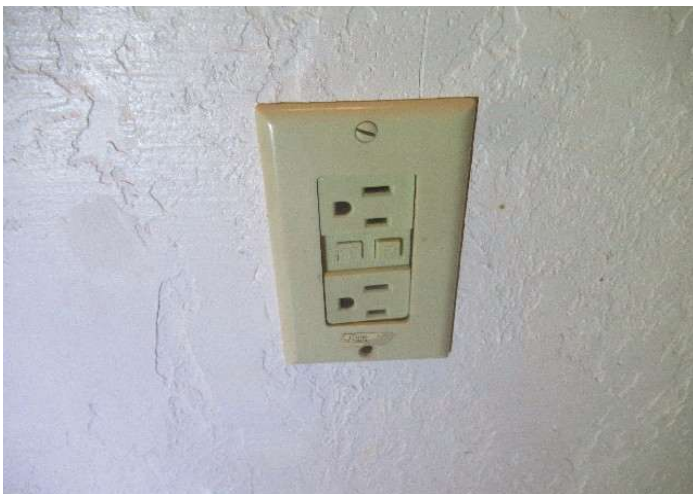
5.19 - One or more ground fault circuit interrupter (GFCI) electric receptacles did not trip when tested. This is a safety hazard due to the risk of shock. A qualified licensed electrician should evaluate and repair as necessary.

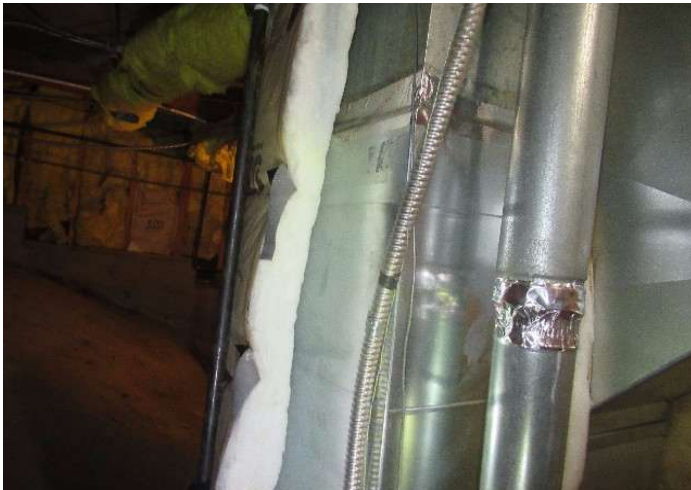
6.3 - The plenum is not correctly insulated, and should be evaluated by a licensed HVAC contractor and served as needed.

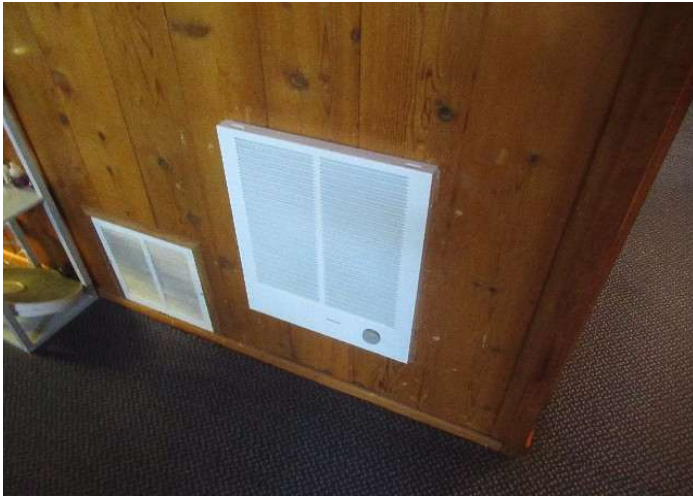
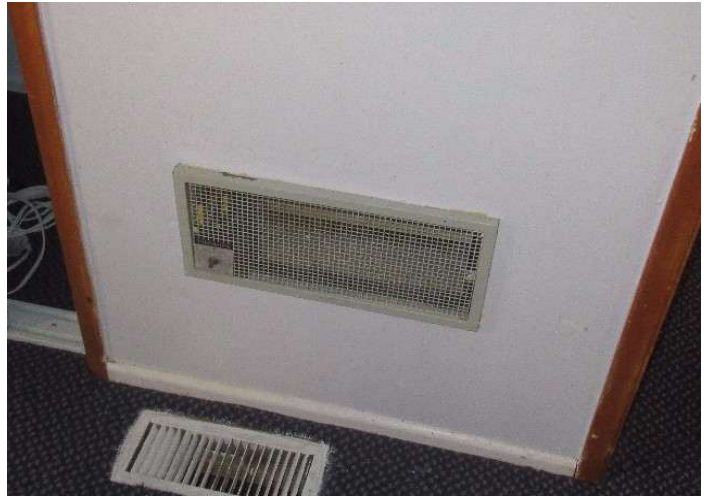
Electric wall heater does not respond - *Continued*

6.14 - One or more of the electric wall heater(s) does not respond, and should be serviced.

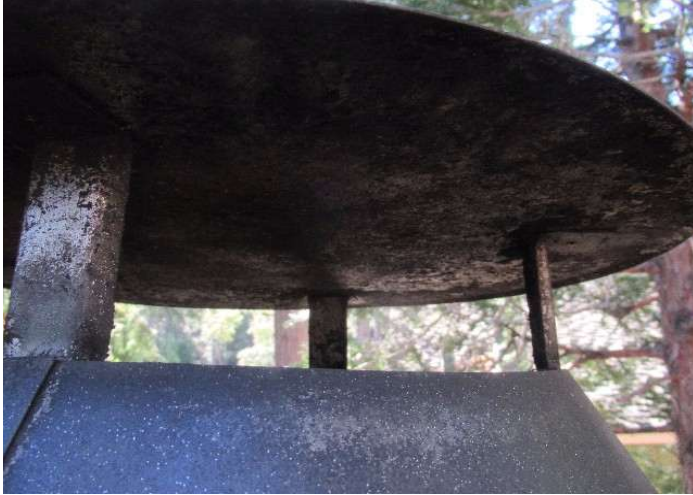
The chimney does not have a spark arrestor which is mandated in most jurisdictions - *Continued*

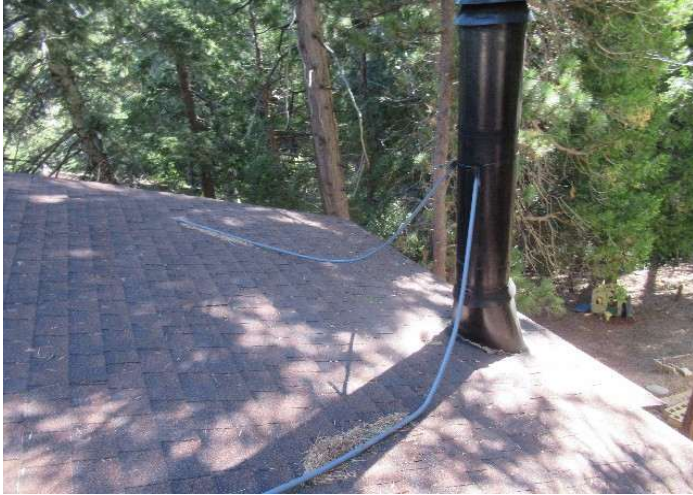
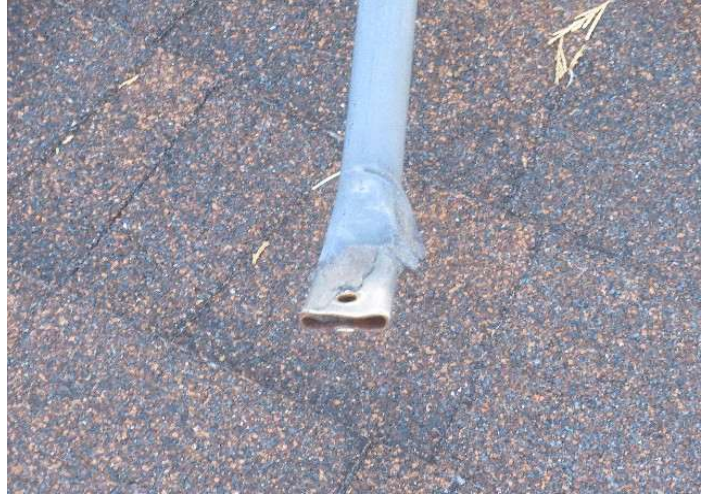
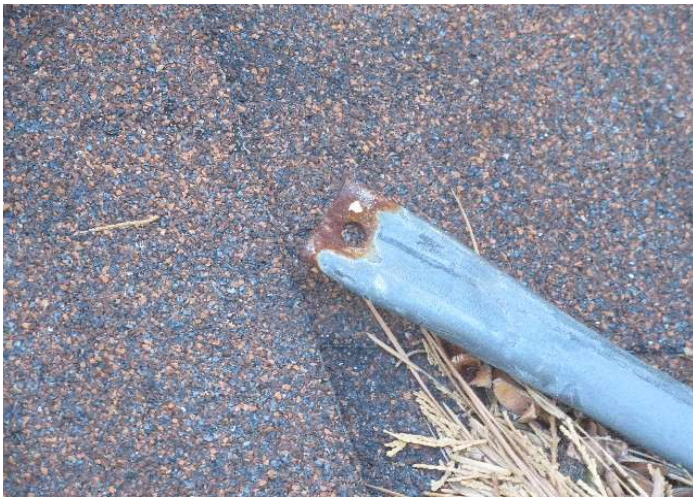
Missing or damaged Tie backs - *Continued*

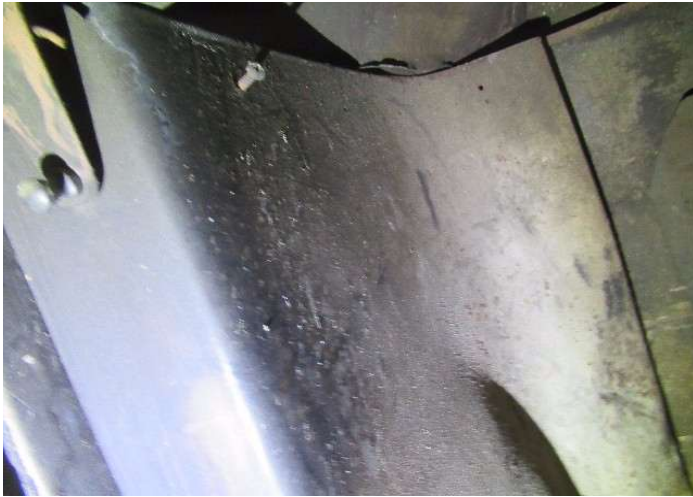
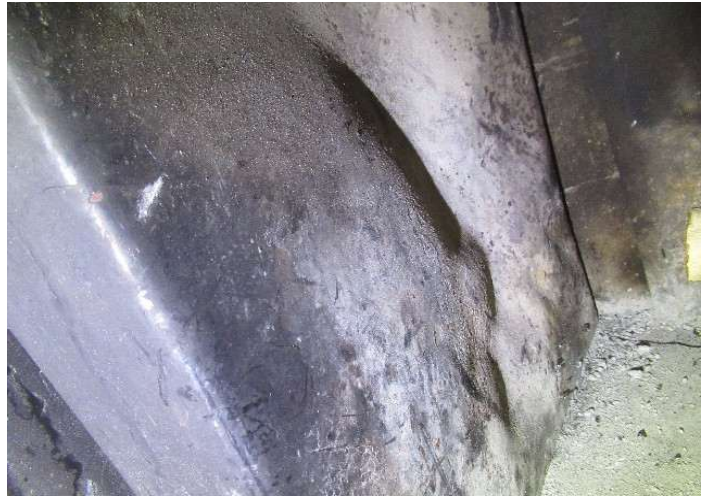
Thermal Warping Noted - Continued

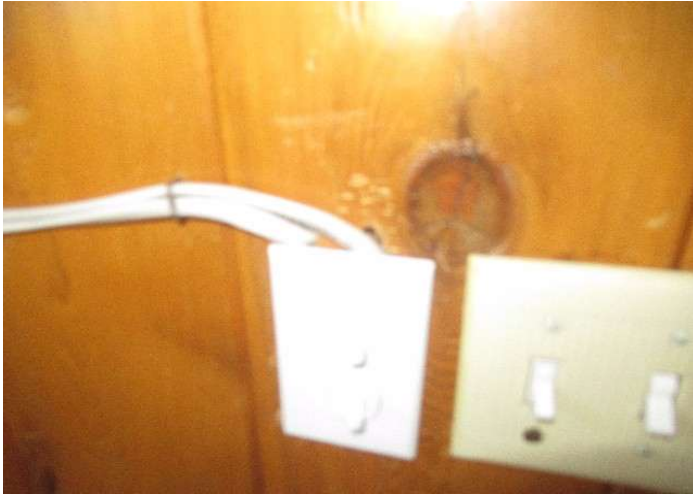
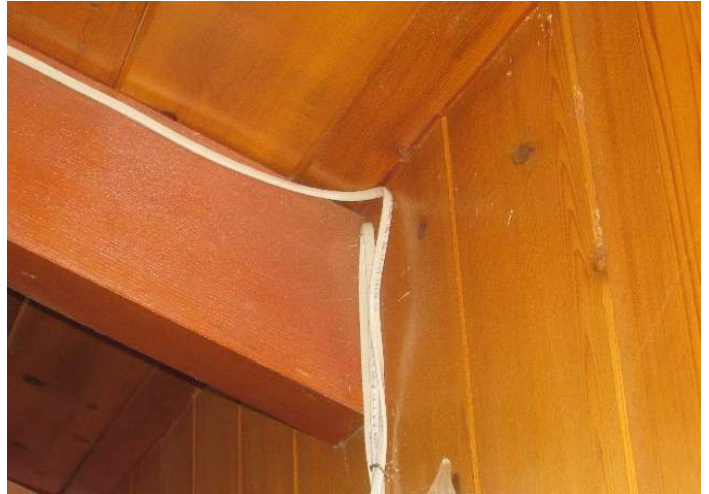
9.12 - One or more ceiling-mounted lights and/or fans were observed to be wired with exposed Romex (non-metallic sheathed cable). Romex wiring is not designed to be left exposed and should be properly protected within an approved electrical box and/or conduit, depending on location. Exposed wiring is subject to physical damage and presents an increased risk of electrical shock or fire. It is recommended that a qualified, licensed electrician evaluate the installation and make any necessary corrections to bring it into compliance with current safety standards.

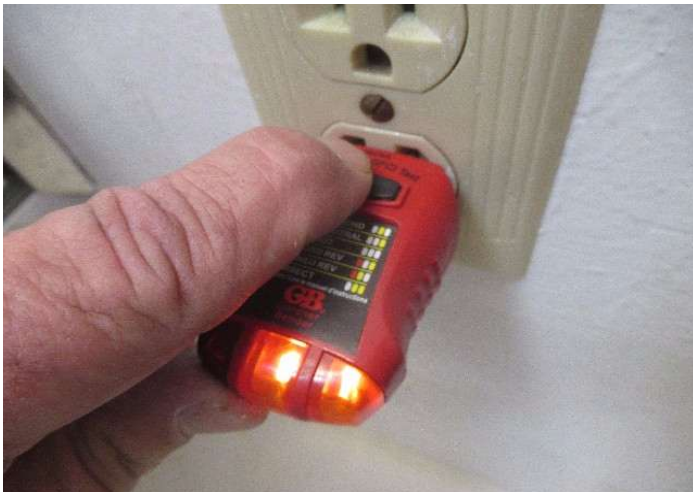
11.12 - One electric receptacle that serves counter-top surfaces within six feet of the sink appears to have no ground fault circuit interrupter (GFCI) protection. Also this receptacle is a two pronged ungrounded receptacle. This was not a requirement on homes built or remodeled prior to 1975 for bathrooms. This poses a safety hazard due to the risk of shock. Buyer may want a qualified licensed electrician to install a grounded GFCI receptacle that serves counter-top surfaces within six feet of the sink.

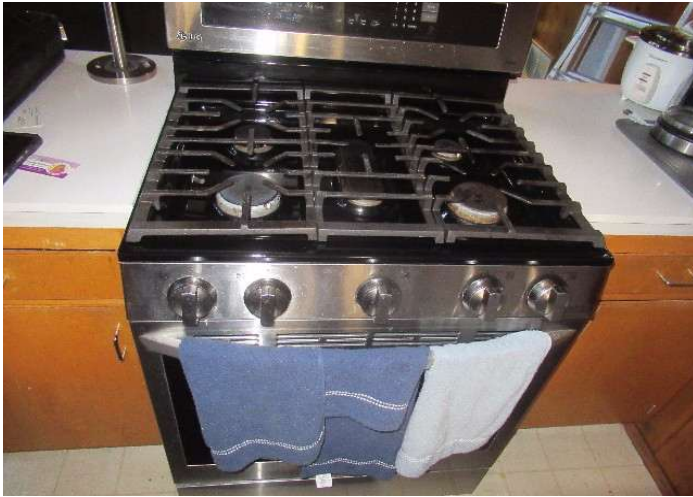
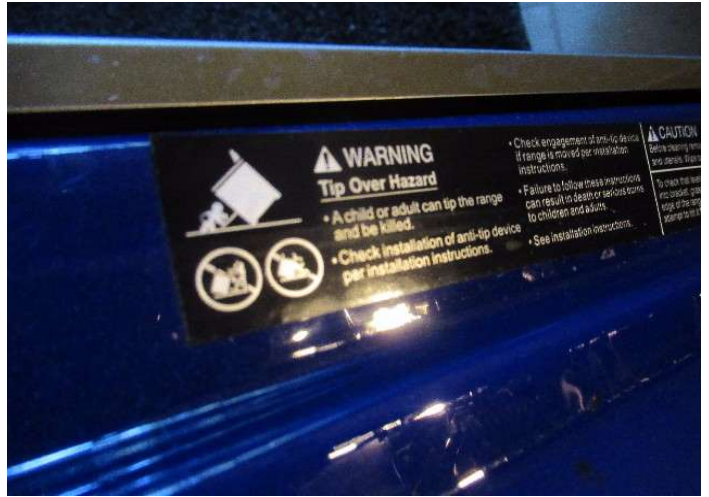
No anti-tilting brackets - *Continued*

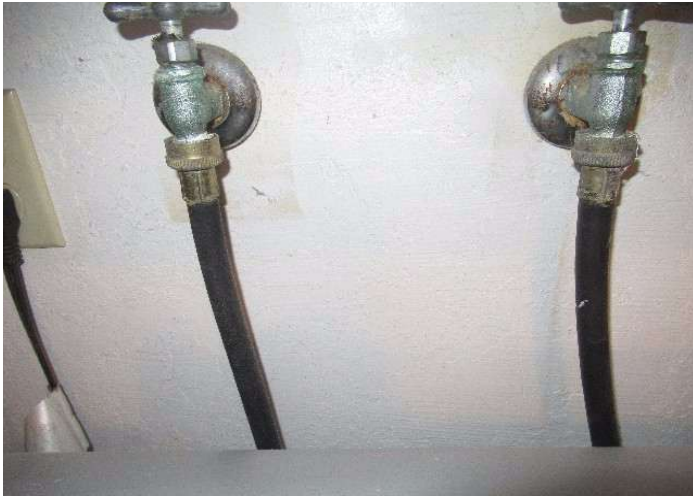
Replacing the rubber supply hoses - *Continued*
