We have enclosed the report for the property inspection we conducted for you on Tuesday, March 31, 2026 at:

2537 Fulton Rd
La Verne, CA 91750

Inspector, Eric Bergeron
BellHamm Inspection Group

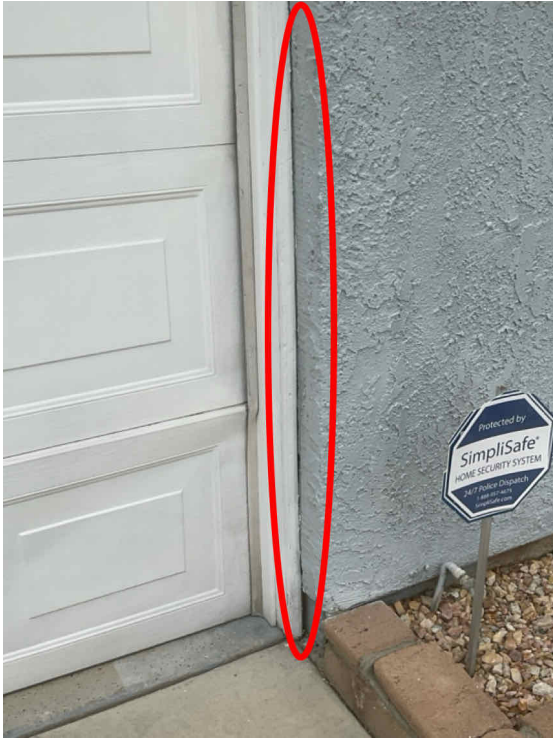
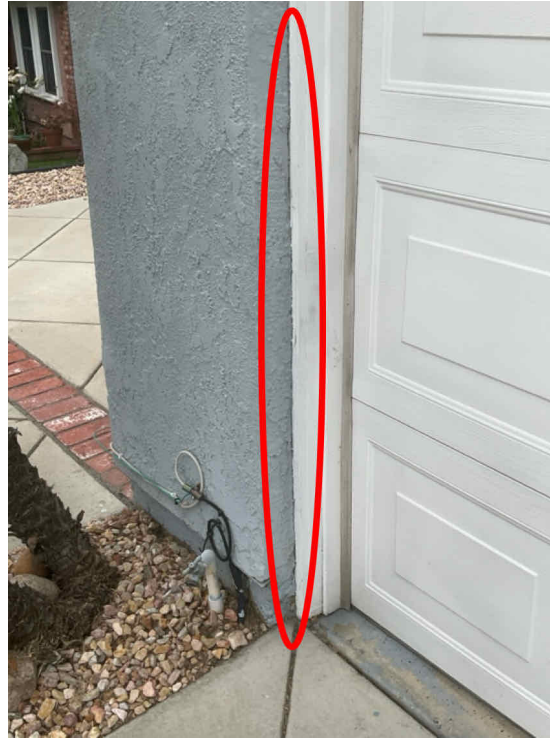
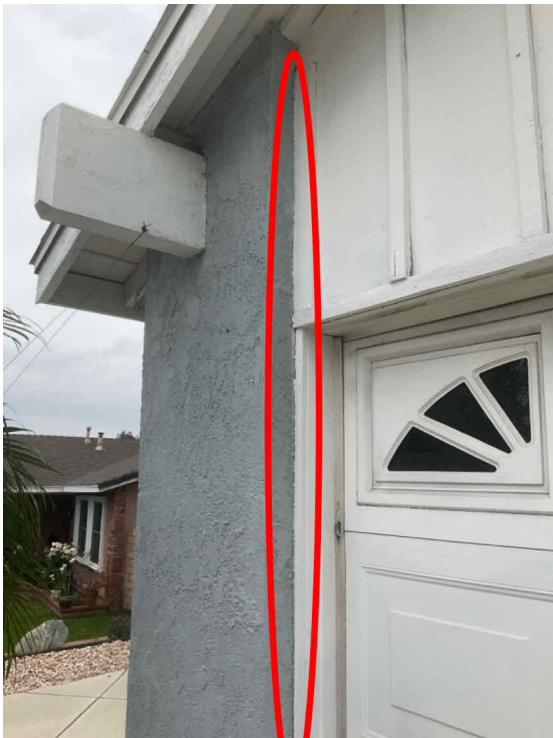
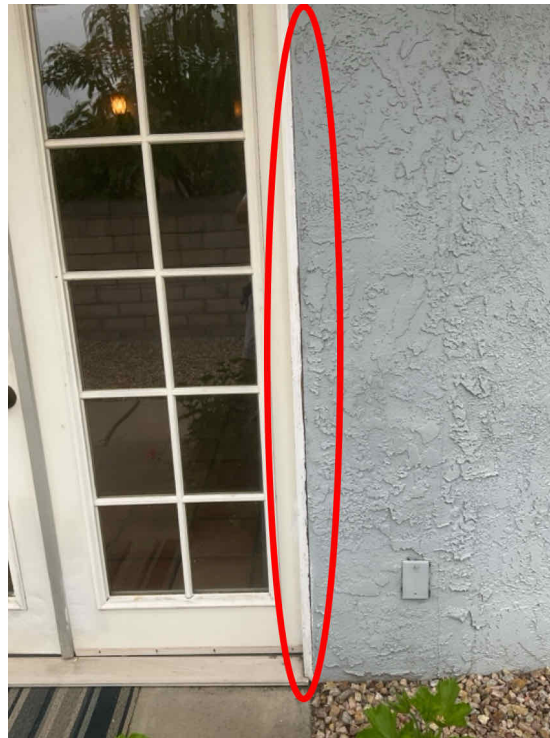
CR There were gaps between the stucco siding and adjacent materials. These conditions are conducive to moisture intrusion/deterioration. All similar areas should be inspected as part of an annual maintenance item. We recommend correcting the condition(s) noted.

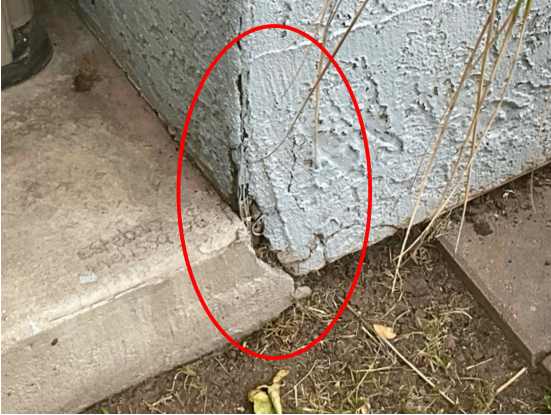
CR The stucco siding was loose/damaged. These conditions are conducive to moisture intrusion/deterioration. We recommend correcting the condition(s) noted.

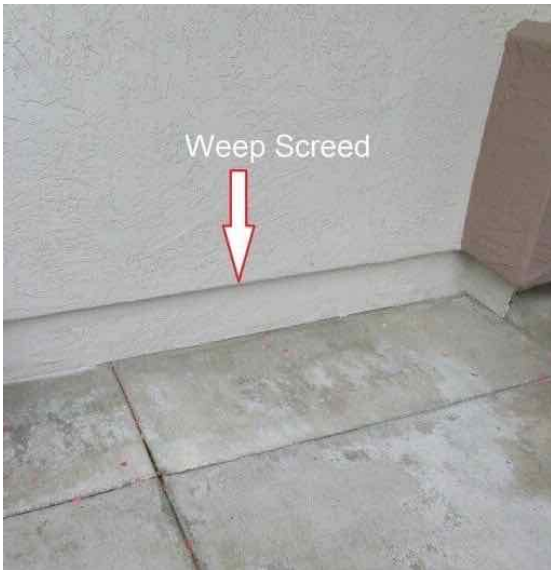
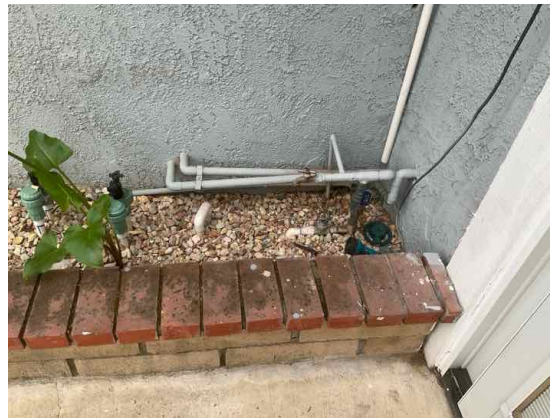
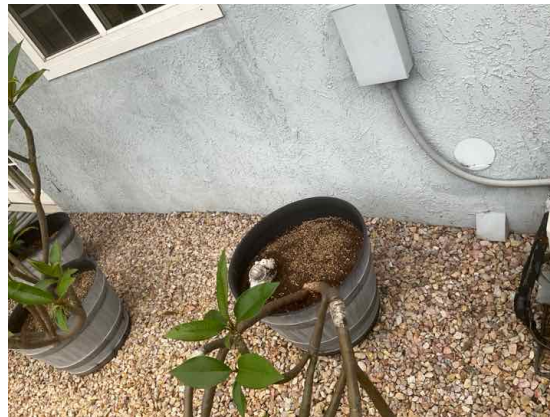
CR Portions of the metal stucco weep screed along the bottom edge of the stucco siding lacked adequate clearance from or were buried in the ground. These conditions are conducive to moisture intrusion/deterioration. We recommend further evaluation and corrections by a specialist in the appropriate trade.

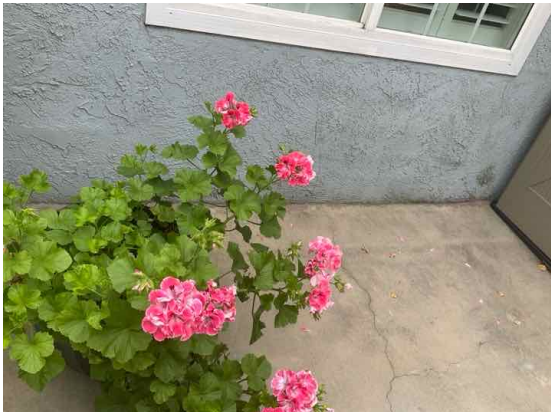
CR The patio/walkway surface had been installed above the metal stucco weep screed along the bottom edge of the stucco siding. This condition is conducive to moisture intrusion/deterioration. We recommend further evaluation and corrections by a specialist in the appropriate trade.

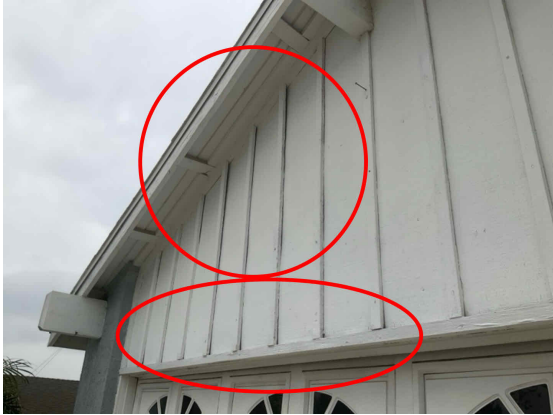
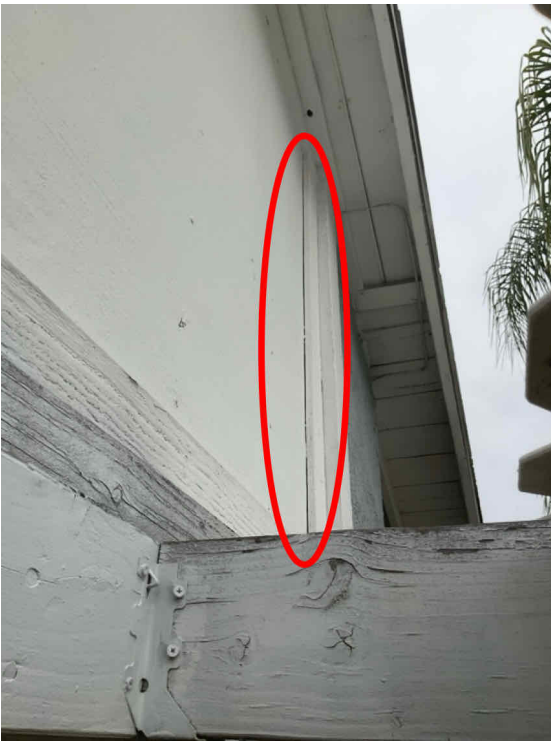
CR There were gaps between the wood siding and or adjacent materials. (Note) Not all gaps were photographed. All similar areas will need annual inspections. These conditions are conducive to moisture intrusion/deterioration. We recommend correcting the condition(s) noted.

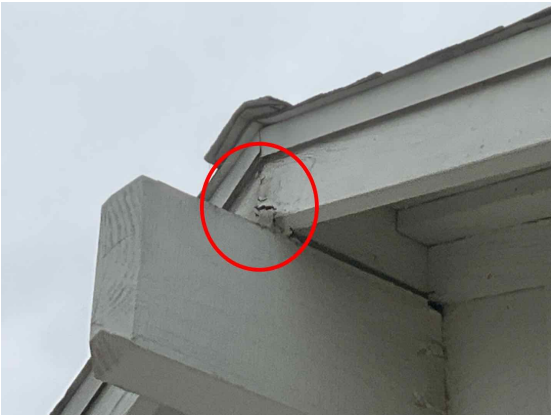
There were damaged/deteriorated trim surfaces noted at the fascia boards

CR The finish on the exterior trim was worn. We recommend they be refinished for better appearance and to maximize their service life. We recommend correcting the condition(s) noted.

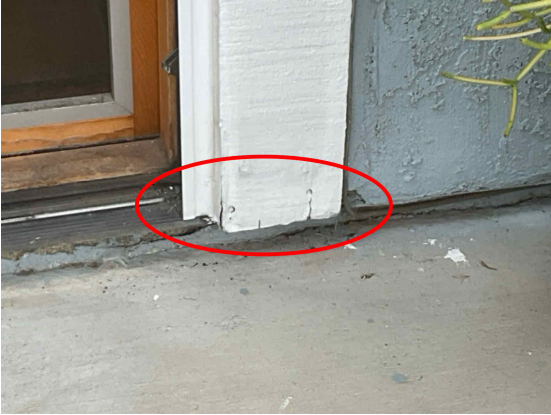
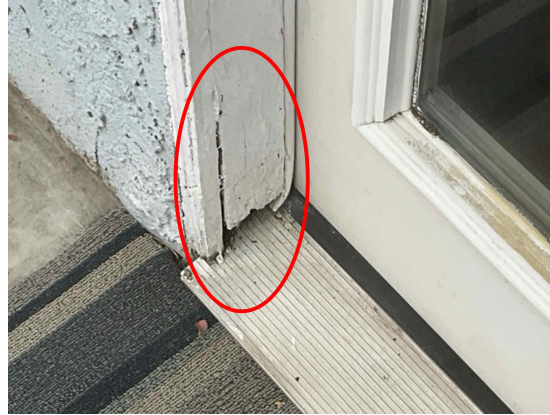
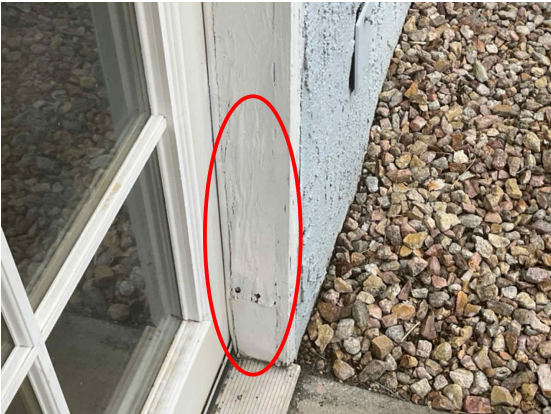
door and/or window trim.

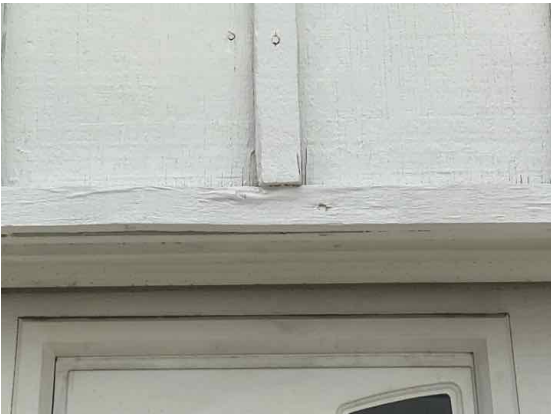
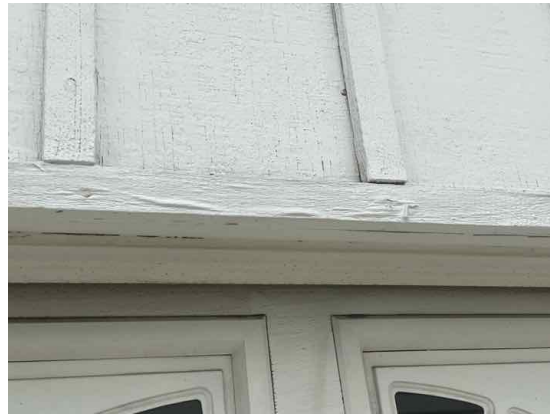
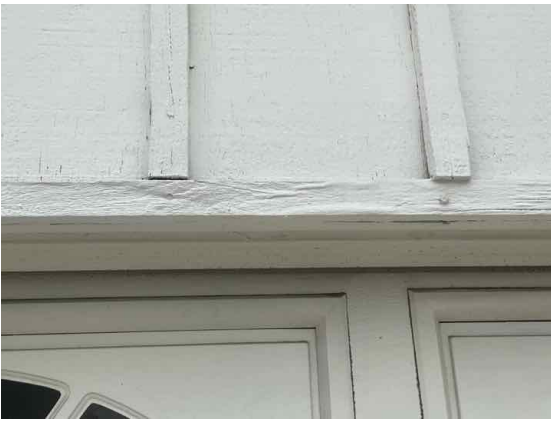
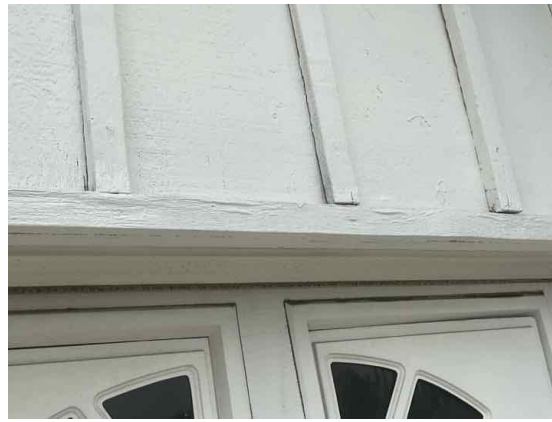
garage door trim.

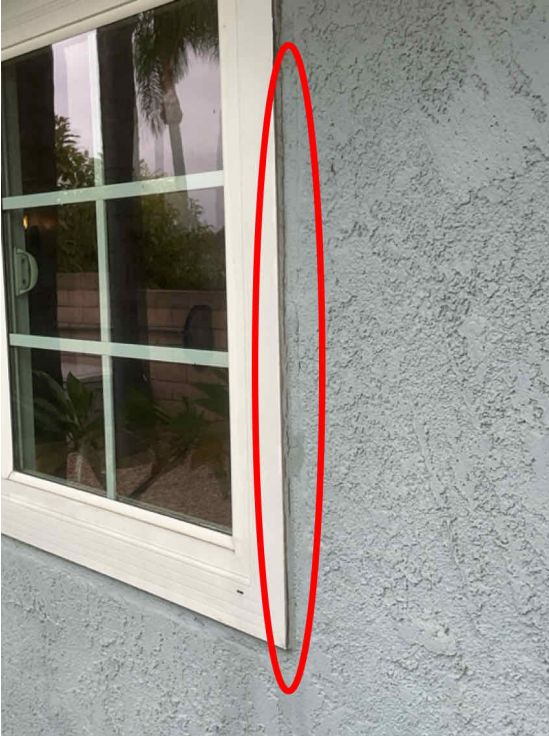
CR Some of the windows are retro-fit type windows and require the sealant at the trim to be sealed at all times, these areas will require future or current maintenance. We recommend correcting the condition(s) noted.

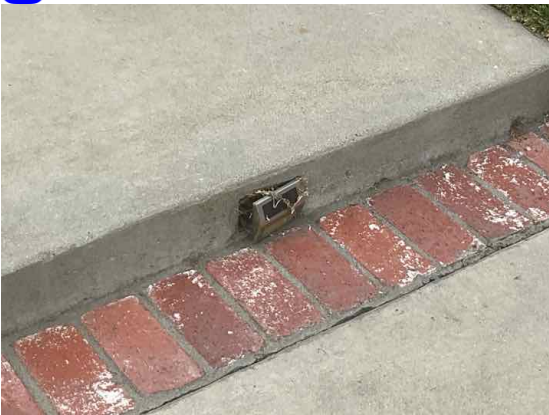
CR Light fixtures were loose/damaged. We recommend correcting the condition(s) noted.

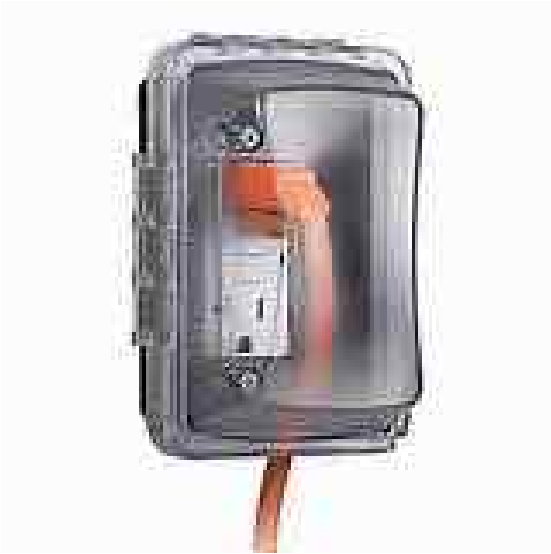
RU There were outdoor receptacles without an in-use weather tight cover. We recommend installing the in-use weather tight type cover(s) where needed

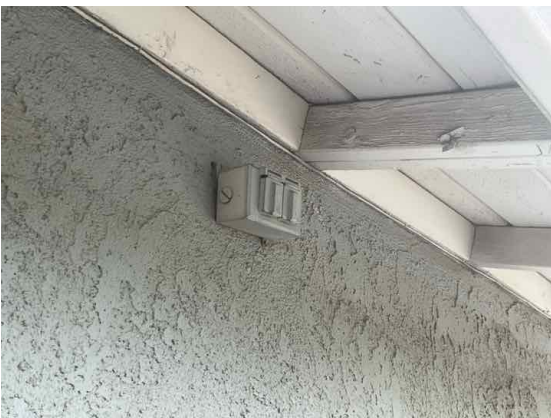
SC CR There were loose/unsecured receptacles noted. We recommend correcting the condition(s) noted.

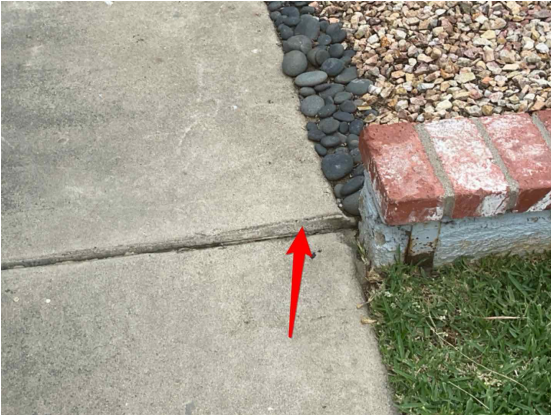
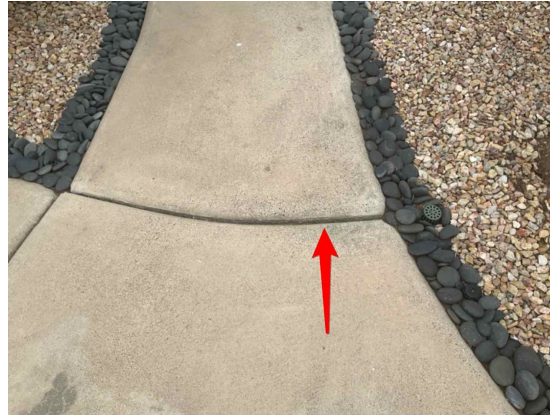
SC CR Uneven sections were noted in the walkway surface. This condition is a trip hazard. We recommend correcting the condition(s) noted.

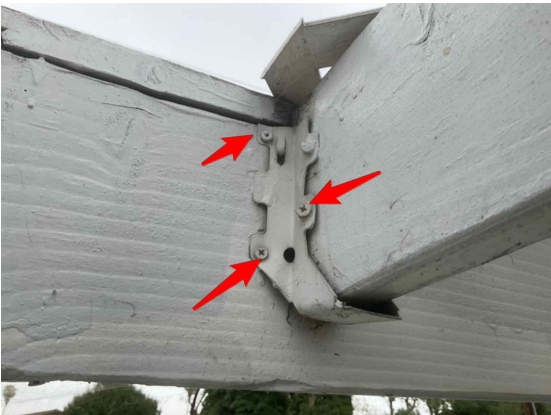
CR The wood patio cover was attached to the building using screws. We recommend using nails for their superior shear strength. We recommend correcting the condition(s) noted.

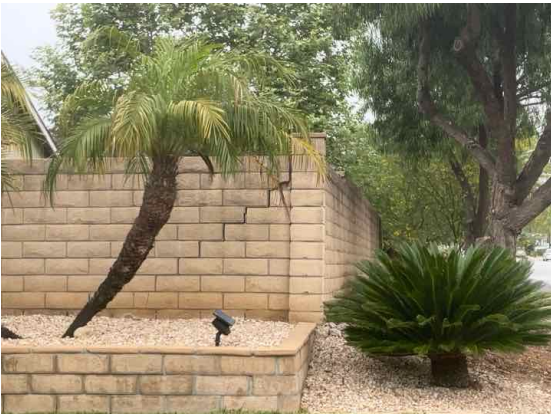
[NOTE] The concrete block fencing had common settlement or movement cracks. We recommend monitoring the condition(s) noted.

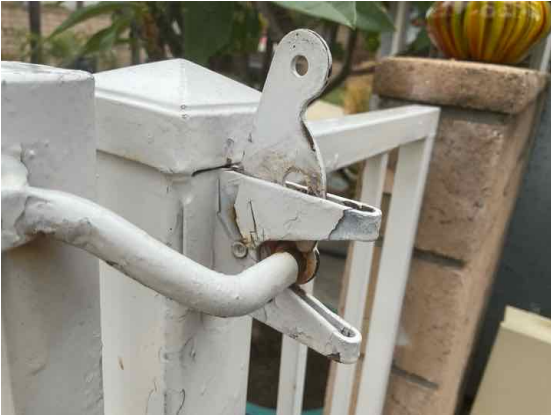
CR The gate(s) needed adjustment or repairs to restore proper operation. We recommend correcting the condition(s) noted.

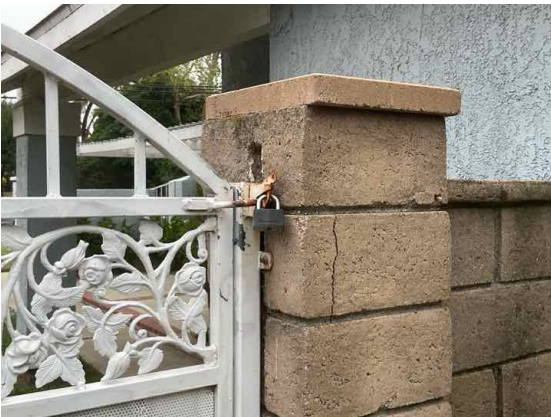
FE The gate was locked and operation could not be verified. We recommend correcting the condition(s) noted.

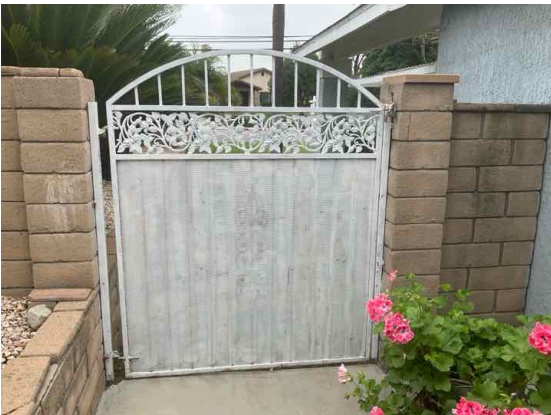
SC FE CR DH The gates/fencing do not meet the present pool safety standards. We recommend they be upgraded to the present standards. A copy of which may be obtained at the local building department.

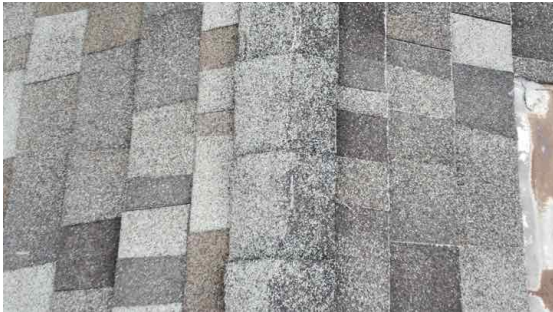
FE The ridge cap shingles for these roofs are deteriorating in 6-8 years after installation. They are a different material than the roof shingles and require periodic replacement. The ridge caps are worn/deteriorated and should be replaced. We recommend further evaluation and corrections by a professional in the appropriate trade.

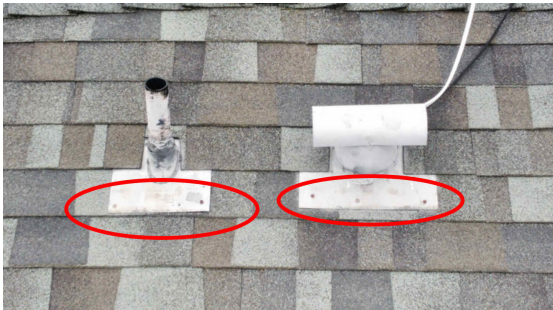
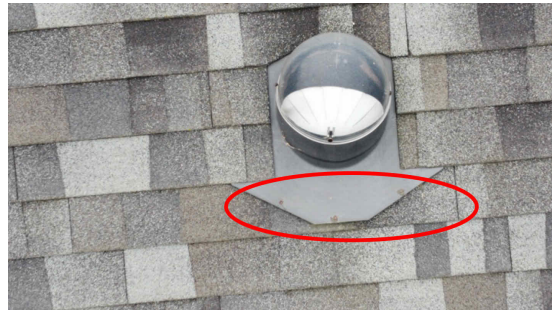
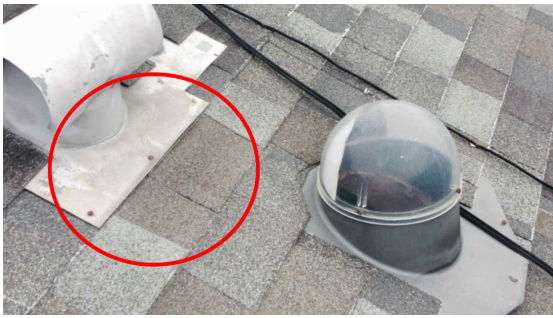
CR There are unsealed exposed nails on the shingles/flashings. We recommend correcting the condition(s) noted.

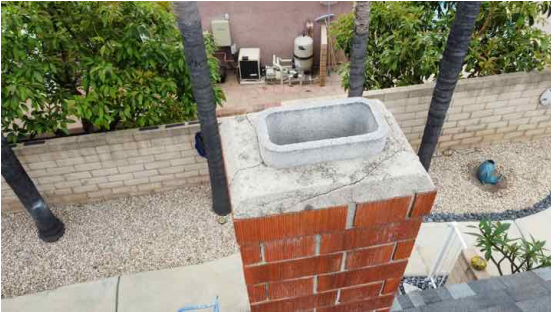
CR The mortar cap on top of the chimney was cracked. We recommend the cracks be sealed to prevent water intrusion into the brick structure.

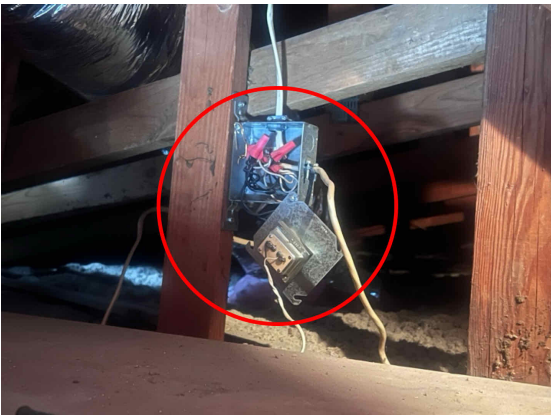
SC **CR** There was improper wiring in the attic in the form of open junction boxes with exposed wire connections. We recommend correcting the condition(s) noted.

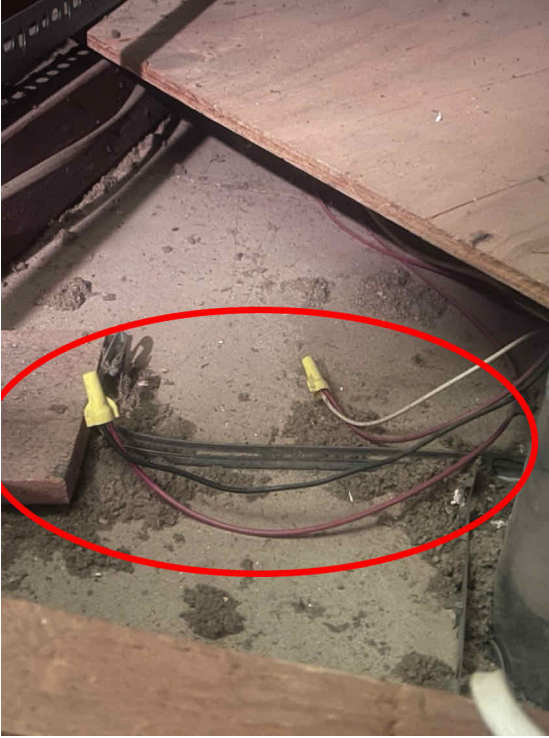
SC CR There was improper wiring in the attic in the form of splices in wiring that were not contained in approved/covered boxes

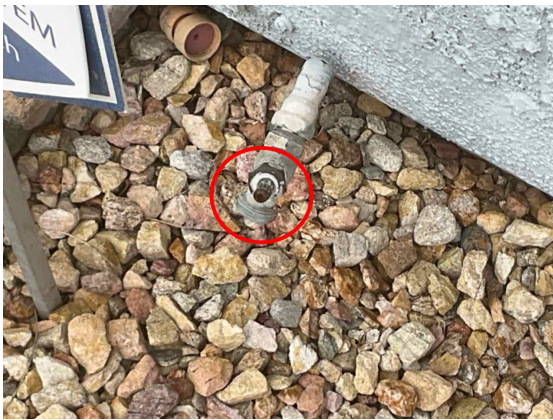
CR There were damaged or missing hose faucet handles. We recommend correcting the condition(s) noted.

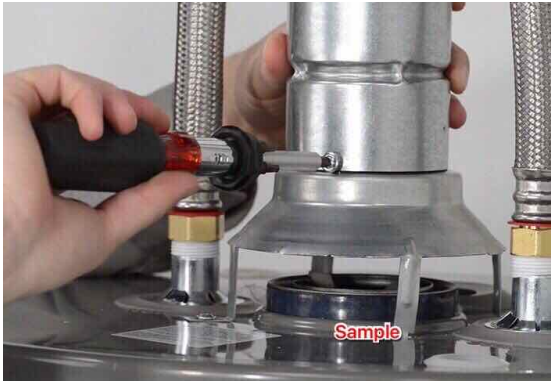
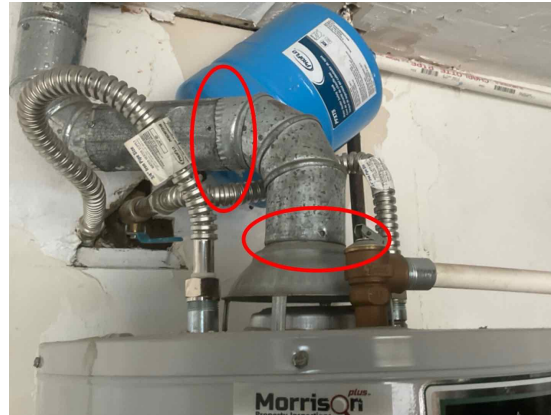
SC CR The flue vent pipe was not secured as required. We recommend correcting the condition(s) noted.

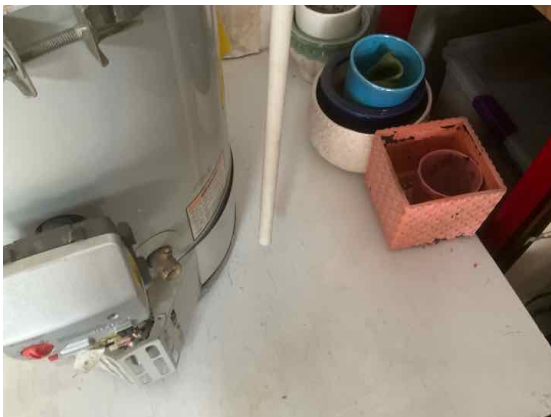
SC CR The temperature & pressure relief valve's discharge line was too short. We recommend installing an approved discharge line that extends to the exterior or terminates close to the ground facing downward.

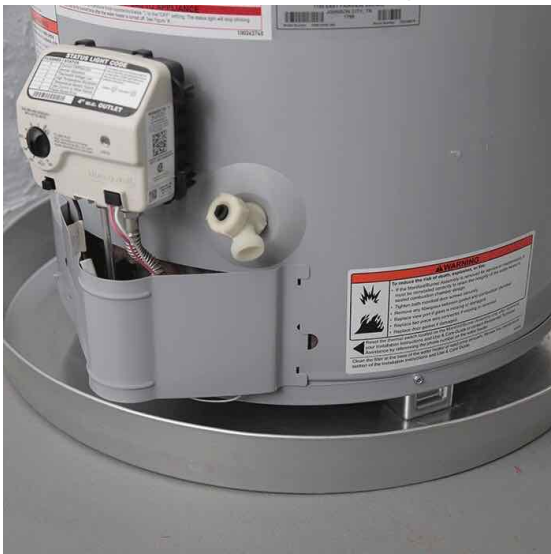
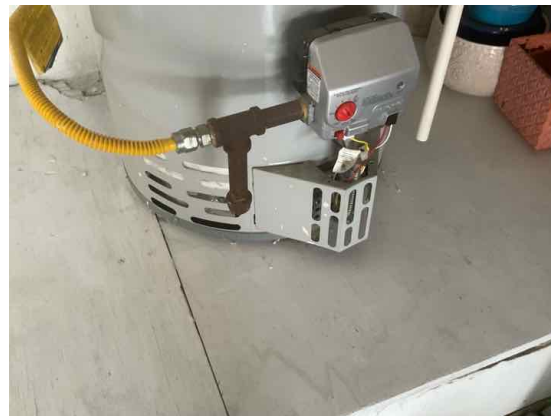
RU There was no drip pan and drain line under the water heater to catch and divert any dripping water to the exterior. We recommend a pan and drain line be installed for water heaters located in interior spaces.

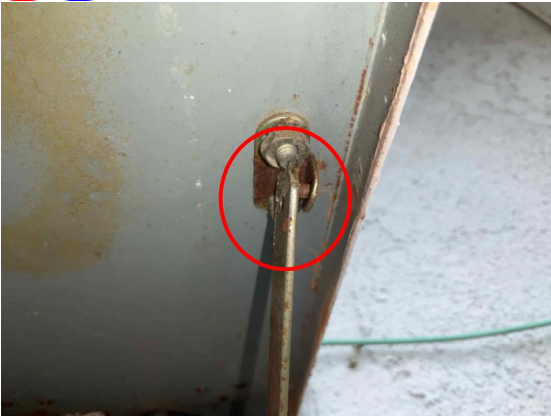
SC CR The cover hinges were missing/damaged. We recommend correcting the condition(s) noted.

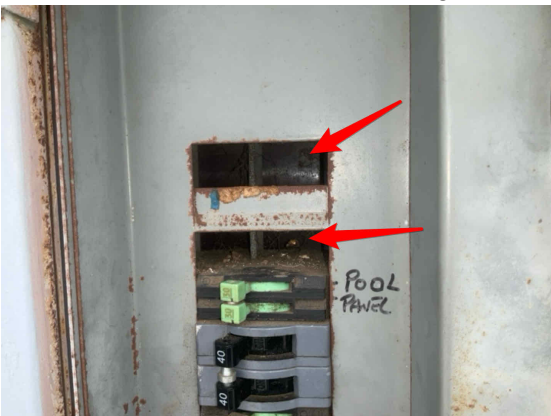
SC CR There were missing twist-outs/unused breaker slots in the panel. This condition is a safety hazard. We recommend correcting the condition(s) noted.

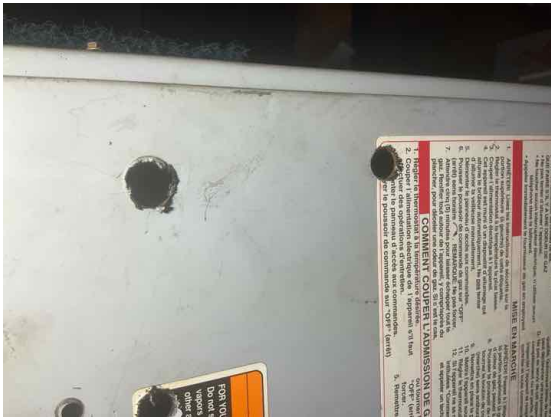
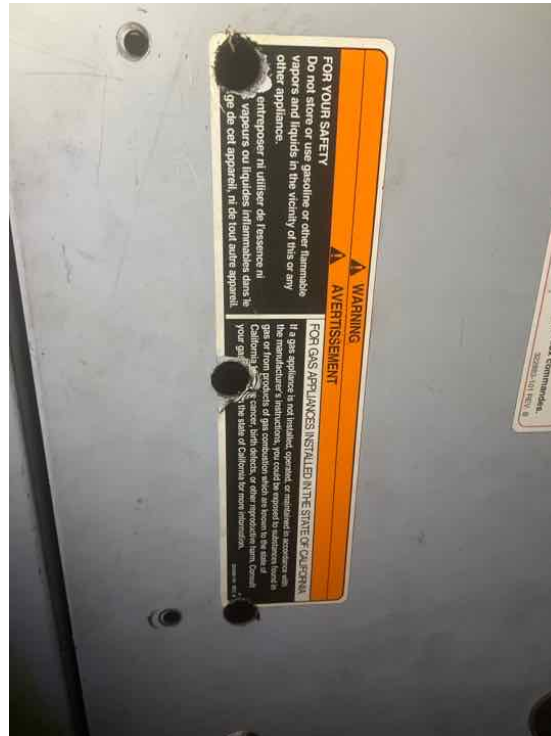
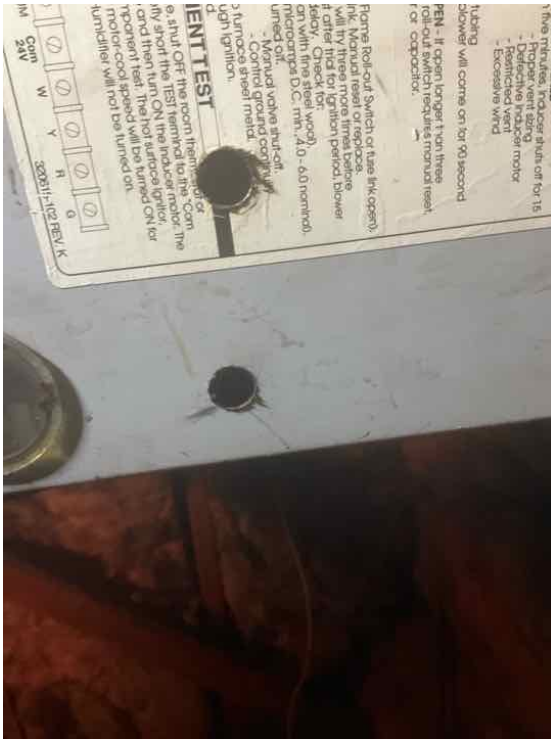
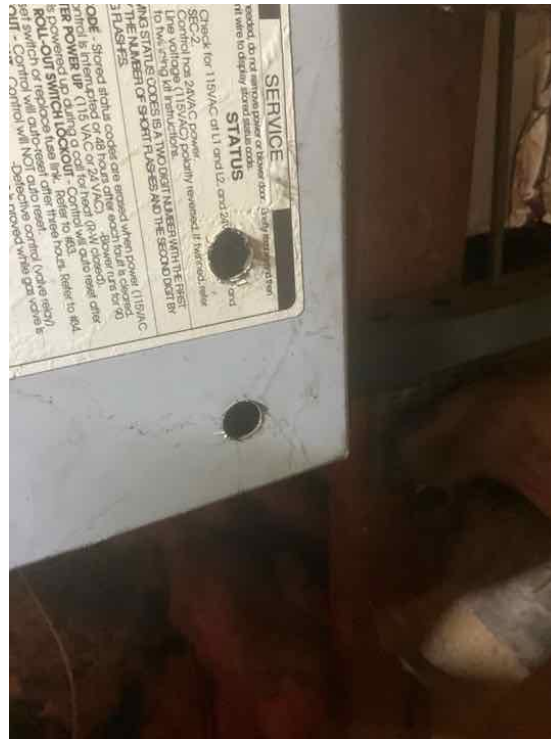
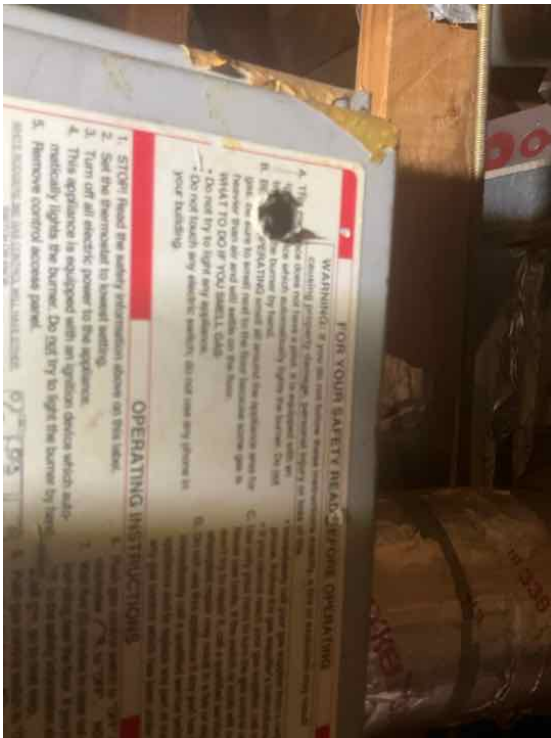
CR The blower meter cover has several holes drilled into it. This allows attic air to enter the system. We recommend correcting the condition(s) noted.

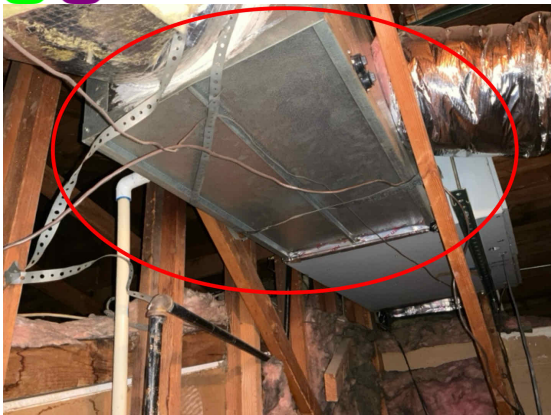
RU FE There is no drain pan present under the attic installed furnace

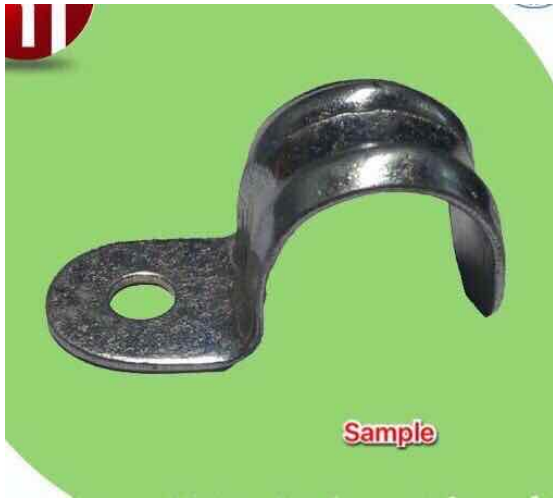
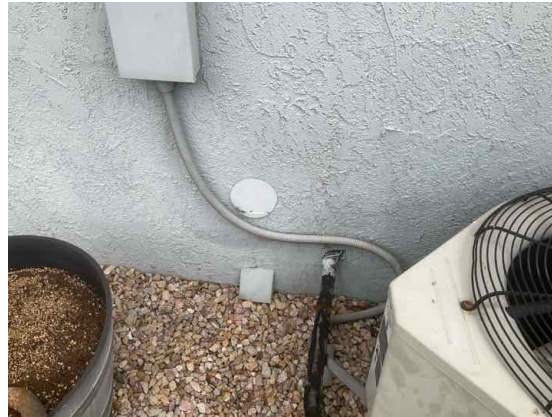
CR The flex connector/conduit was not fastened to the wall after exiting the electrical disconnect panel. We recommend correcting the condition(s) noted.

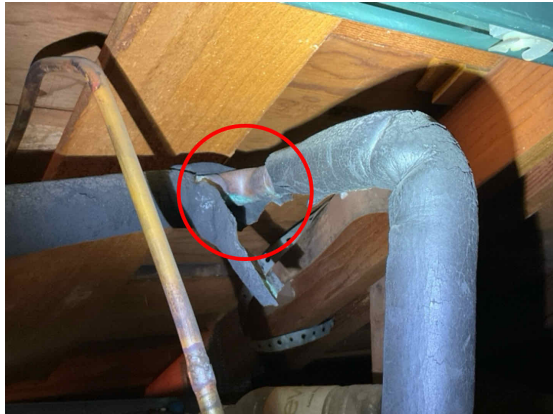
FE CR The refrigerant line is bent beyond 90°. This could effecting the flow of refrigerant in the system. We recommend further evaluation and corrections by a professional/specialist in the appropriate trade.

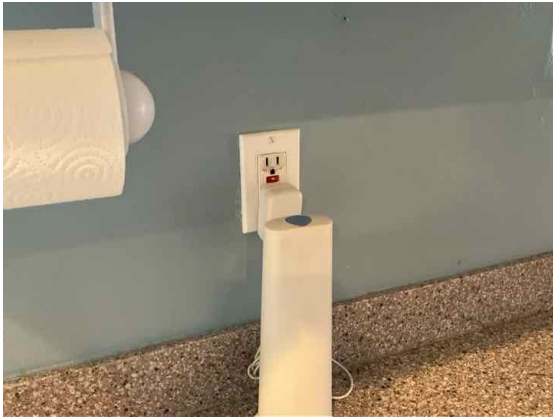
SC **FE** **CR** The GFCI receptacle was providing power, but failed to trip when tested with a GFCI tester. this condition is safety hazard. We recommend correcting the condition(s) noted.

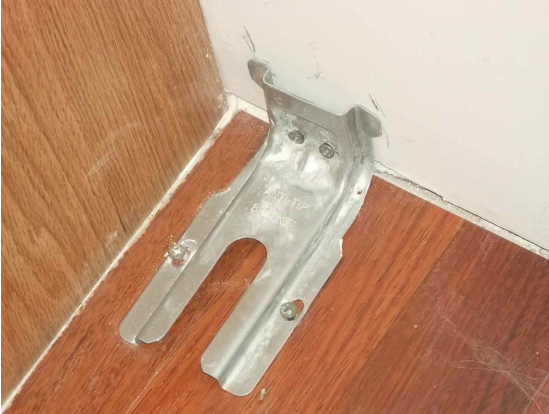
SC CR The range/oven lacked an anti-tip device at the rear as required. This condition is a topple hazard. We recommend correcting the condition(s) noted.

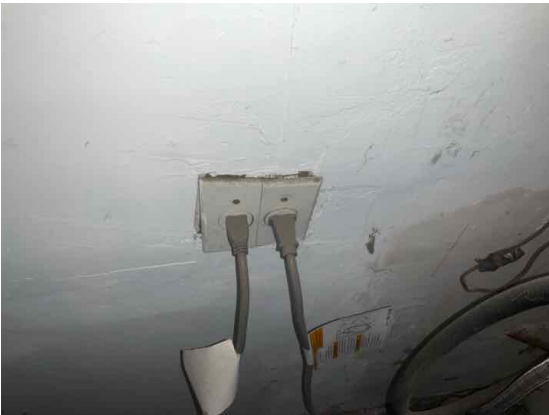
SC CR The accessible receptacles were serviceable, they were not GFCI protected. We recommend upgrading to provide GFCI protection for the receptacles for safety reasons.

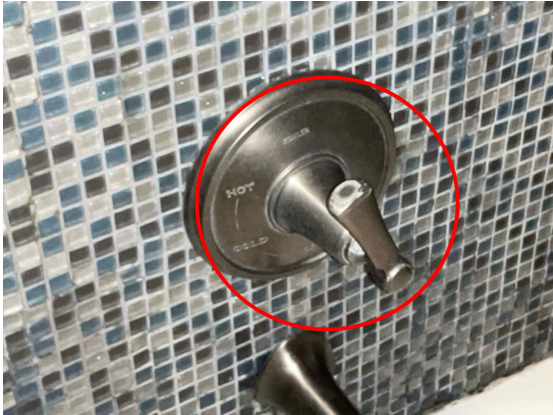
SC CR The hot and cold water were reversed at the faucet, this condition is a scald hazard. We recommend correcting the condition(s) noted.

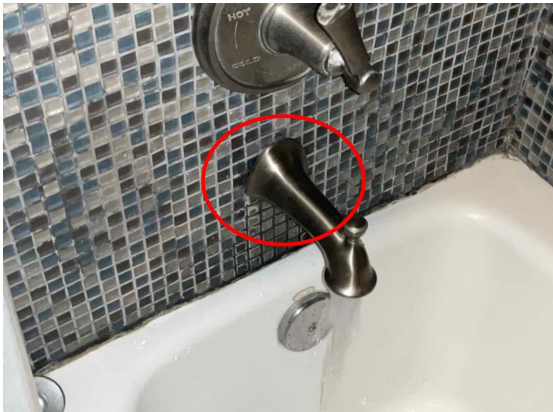
CR The faucet(s)/spout were not sealed to the wall/deck, this is a potential leak source. We recommend correcting this condition to prevent moisture intrusion into concealed spaces.

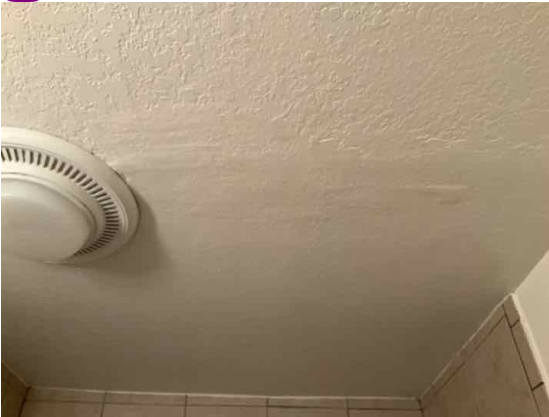
FE Past repairs were noted on the wall(s)/ceiling. We recommend inquiring about the condition(s) noted.

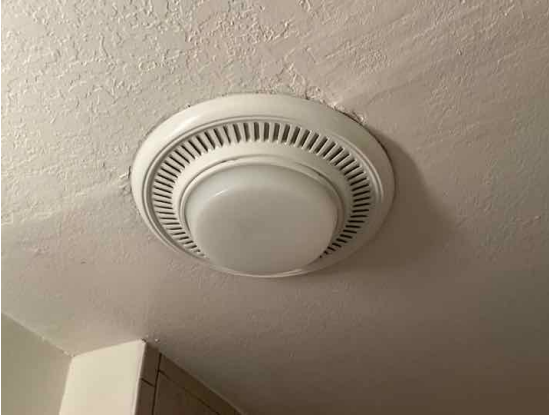
CR Some of the lights failed to function or were burned out. We recommend correcting the condition(s) noted.

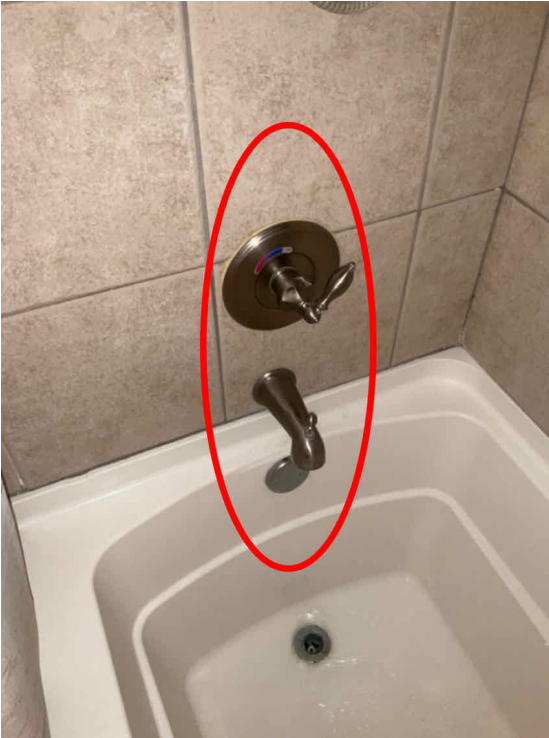
CR The faucet(s)/spout/handles were loose on the wall/deck. We recommend correcting this condition to prevent moisture intrusion into concealed spaces.

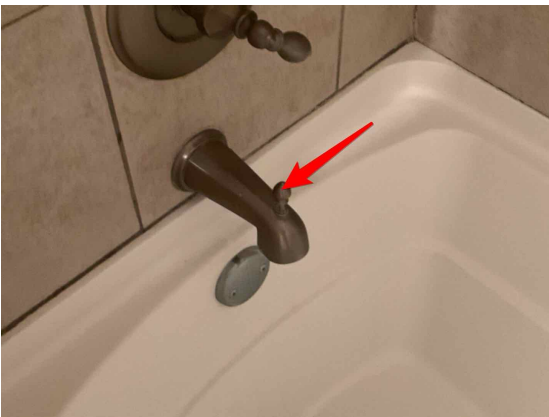
CR The diverter was deteriorated/damaged. (Leaks while shower is running) We recommend correcting the condition(s) noted.

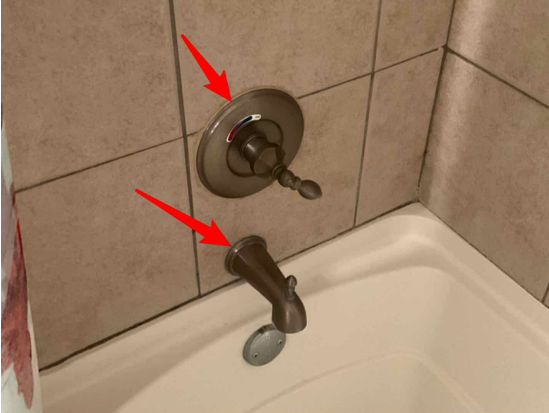
CR The faucet(s)/spout were not sealed to the wall/deck, this is a potential leak source. We recommend correcting this condition to prevent moisture intrusion into concealed spaces.

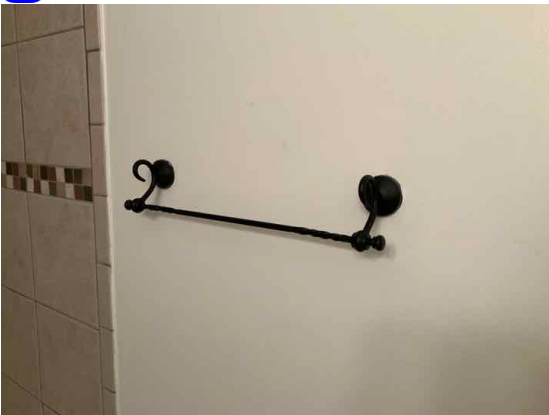
CR The towel bar(s) were loose/damaged. We recommend correcting the condition(s) noted.

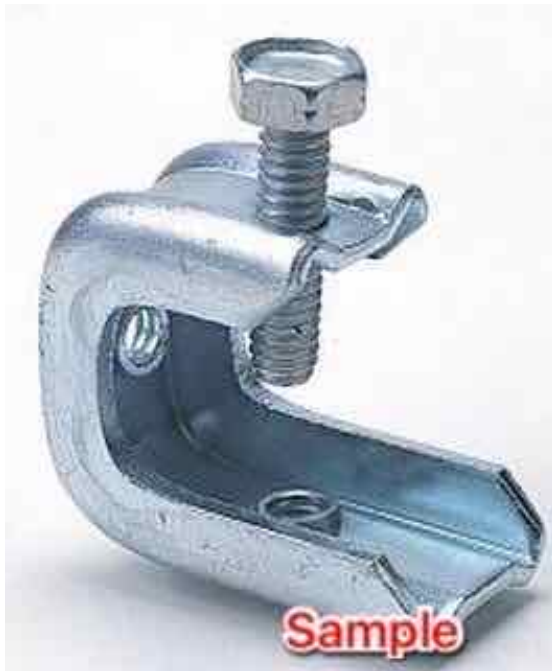
SC CR We recommend that the flue damper be permanently blocked/clamped in the open position to prevent products of combustion from spilling out into the room.

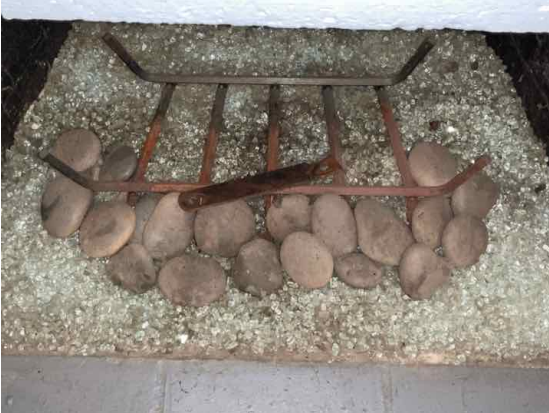
CR The handle for the flu dampener disconnected during operation. We recommend correcting the condition(s) noted.

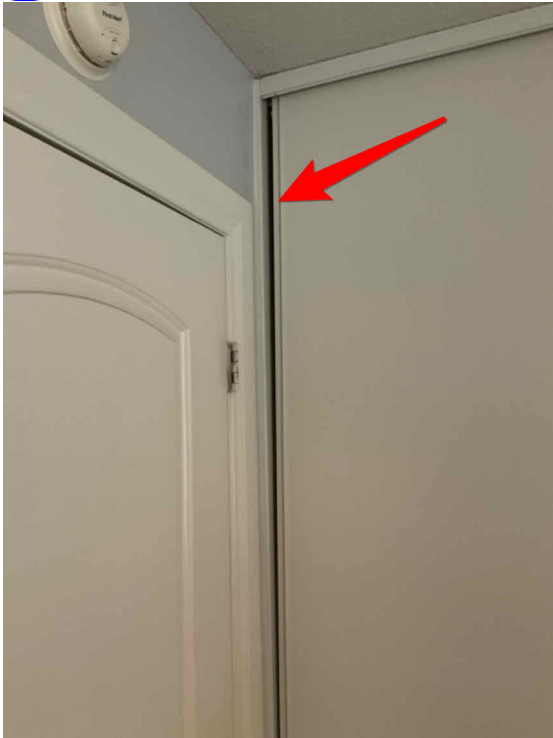
CR The door(s) did not close squarely or seal tightly. We recommend correcting the condition(s) noted.

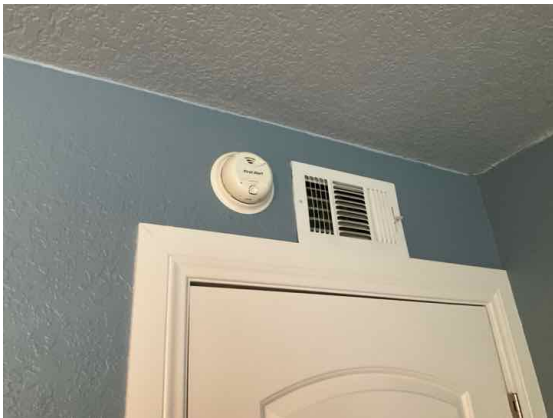
SC CR The smoke detector is within 3 feet of the supply register of the HVAC system. The forced air flow from a register that is too close to a smoke detector will disturb the natural upward flow of smoke to the detector, and slow its response time. We recommend correcting the condition(s) noted.

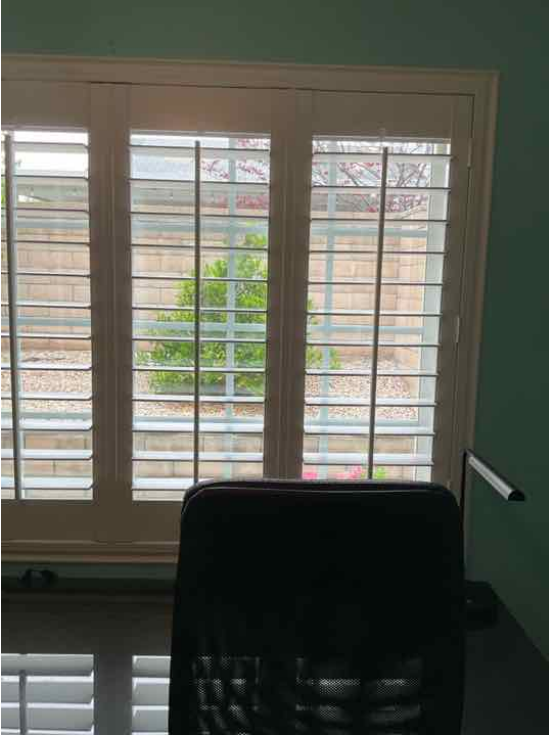
CR The window screen(s) had damaged mesh/frames/latches or were missing. We recommend correcting the condition(s) noted.

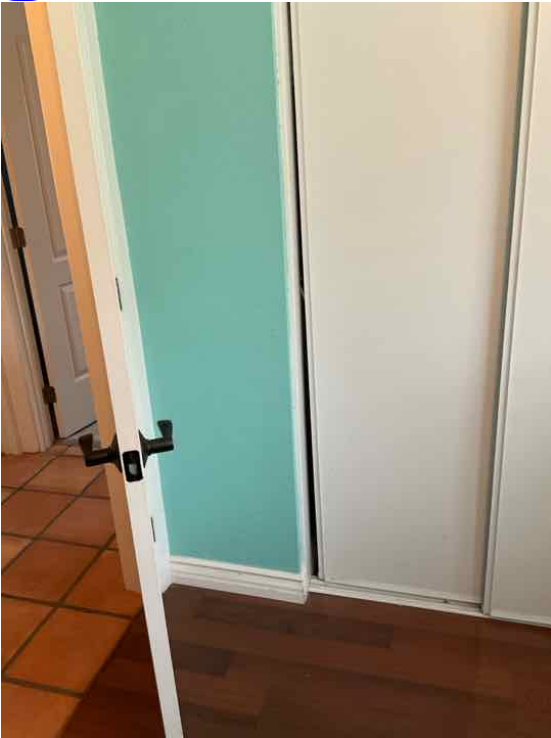
CR The door(s) did not close squarely or seal tightly. We recommend correcting the condition(s) noted.

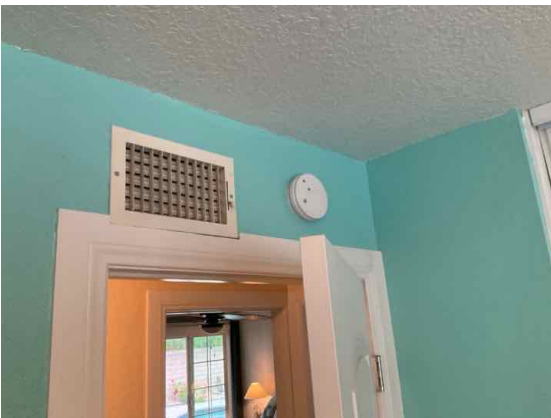
SC CR The smoke detector is within 3 feet of the supply register of the HVAC system. The forced air flow from a register that is too close to a smoke detector will disturb the natural upward flow of smoke to the detector, and slow its response time. We recommend correcting the condition(s) noted.

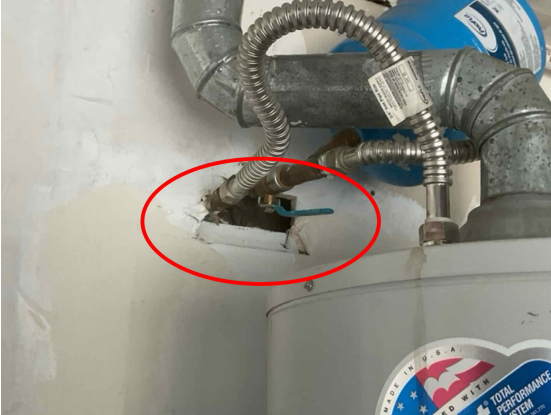
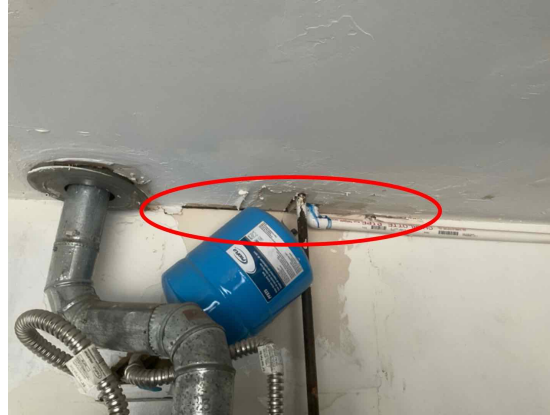
SC CR There were holes in the fire resistive wall between the garage and living space. We recommend correcting the condition(s) noted with approved methods and materials.

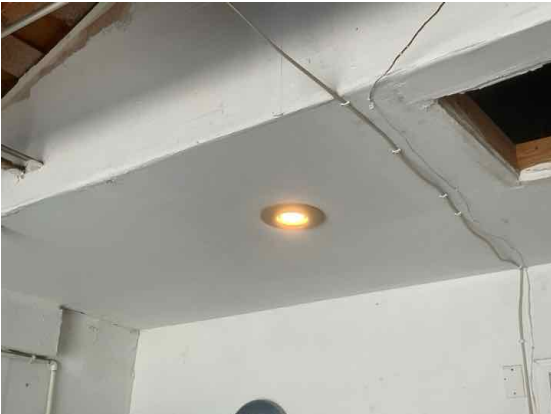
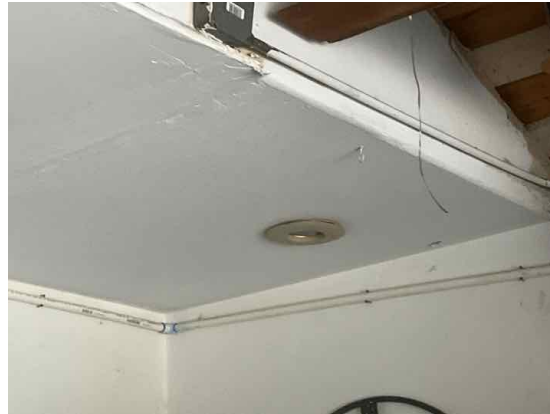
SC CR The recessed lights in the ceiling are a breach in the fire separation wall. We recommend correcting the condition(s) noted.

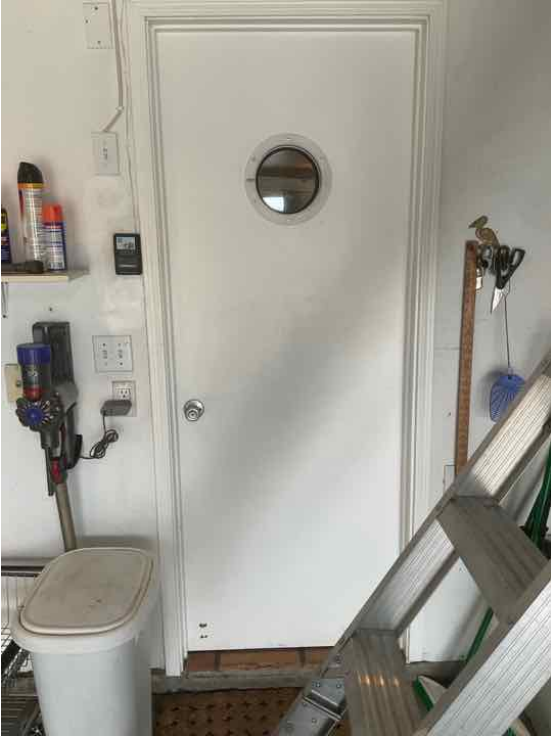
SC **CR** The present standards require the door between the garage and living space to be of fire resistive construction and have an automatic closer. We recommend correcting the condition(s) noted.
