We have enclosed the report for the property inspection we conducted for you on Tuesday, March 31, 2026 at:

2537 Fulton Rd
La Verne, CA 91750

Inspector, Eric Bergeron
BellHamm Inspection Group

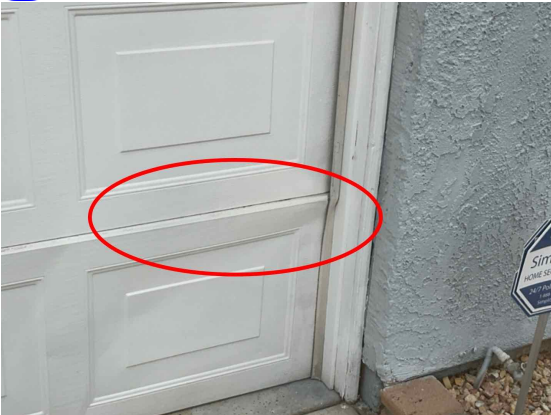
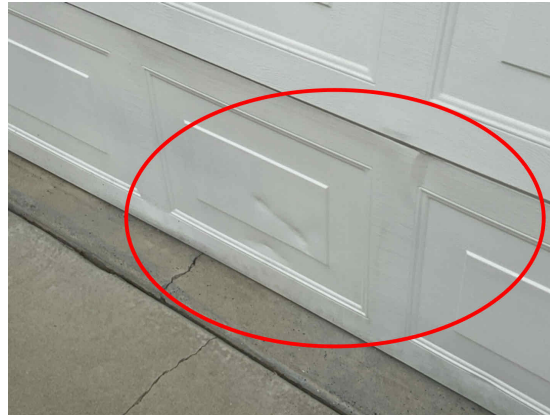
CR The car door(s) were damaged. We recommend correcting the condition(s) noted.

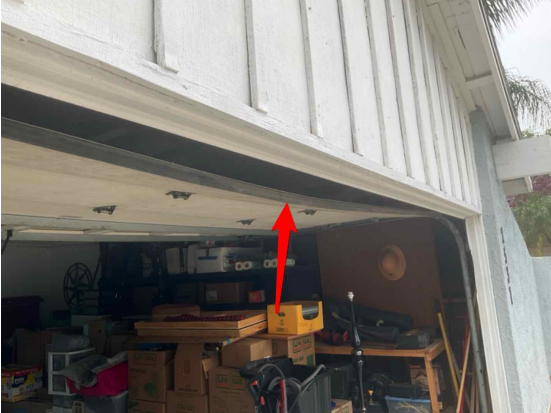
SC FE CR The car door sagged when reaching its open position. We recommend further evaluation and corrections by a specialist in the appropriate trade.

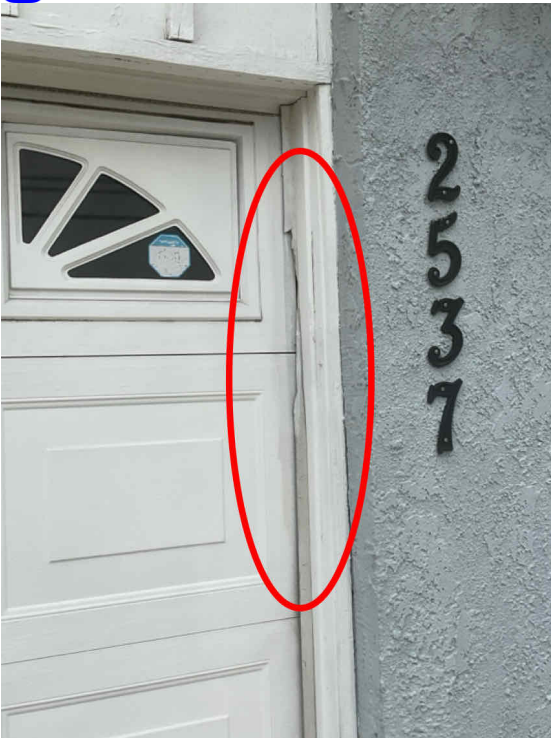
CR The weather stripping/molding was loose. We recommend correcting the condition(s) noted.

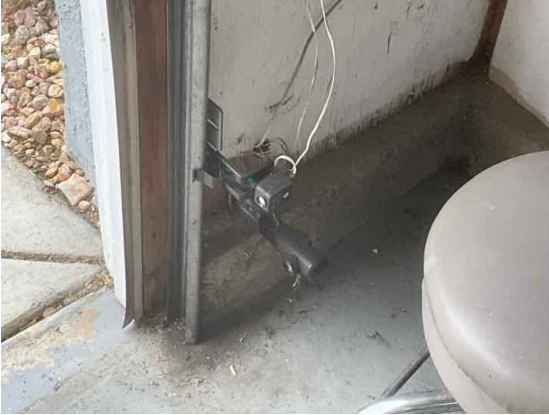
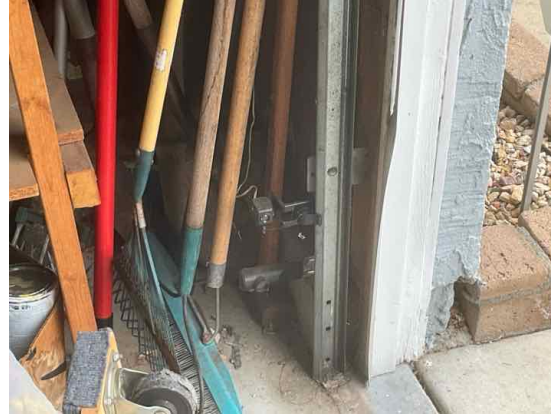
SC CR The secondary safety system (electric eyes) were mounted higher than the manufacturer's recommendation of 4" to 6" above the floor. We recommend correcting the condition(s) noted.

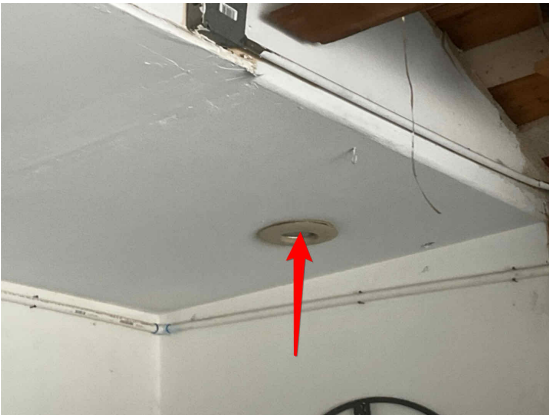
1524 LIGHTS/FIXTURES

CR Some of the lights failed to function or were burned out/missing bulbs. We recommend correcting the condition(s) noted.

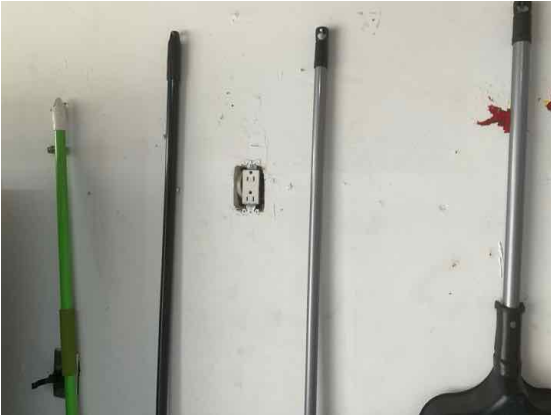
CR There was no power at a number of the receptacles. We recommend correcting the condition(s) noted.

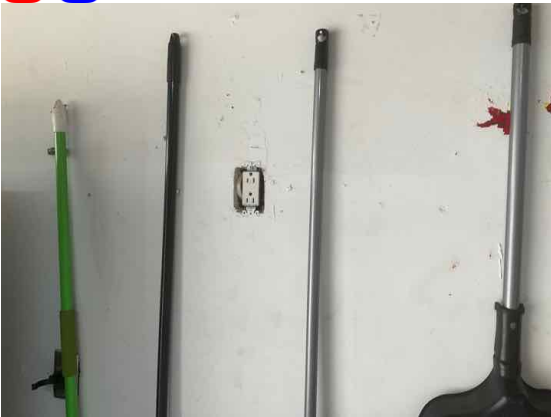
SC CR Receptacle cover plates were missing. We recommend correcting the condition(s) noted.

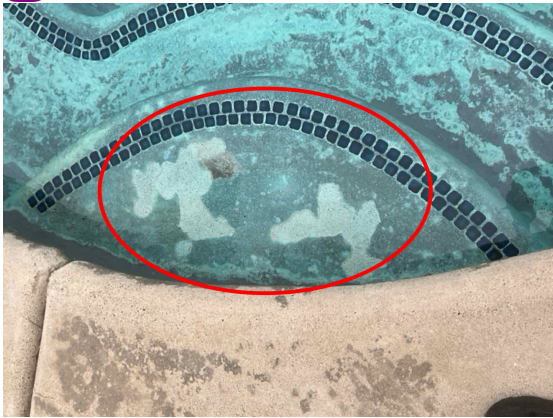
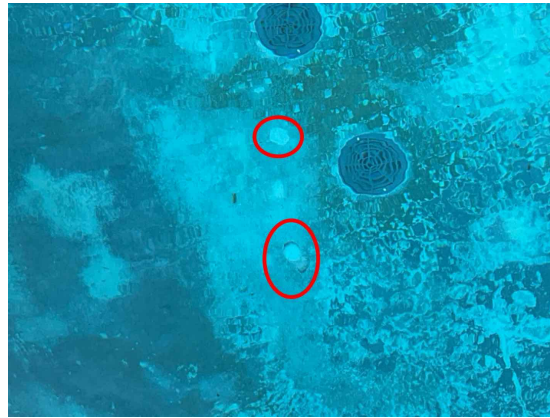
FE areas of chipped plaster were noted.

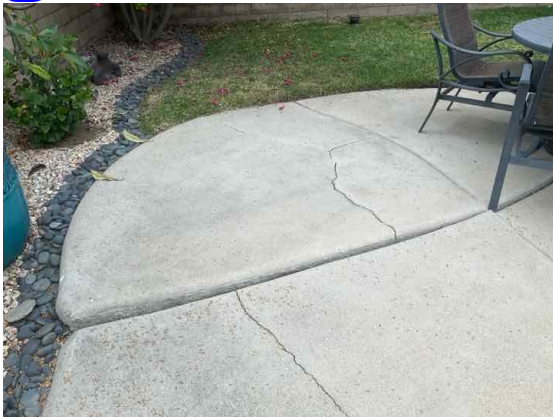
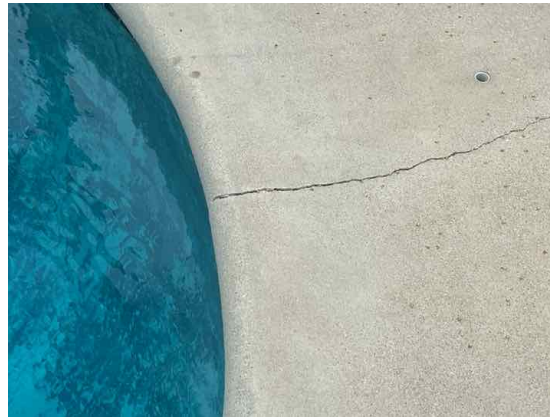
CR There were cracks noted in the pool decking. We recommend correcting the condition(s) noted.

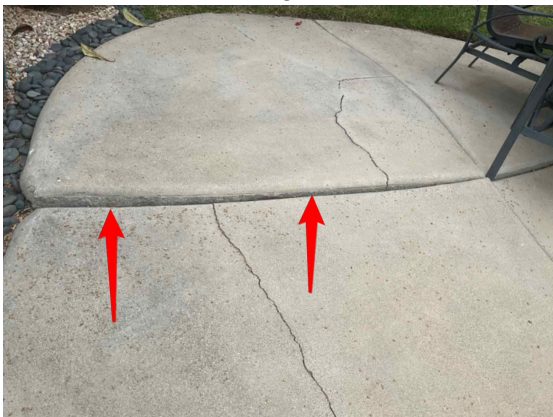
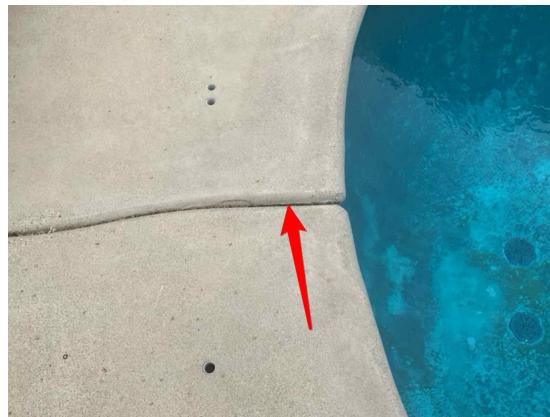
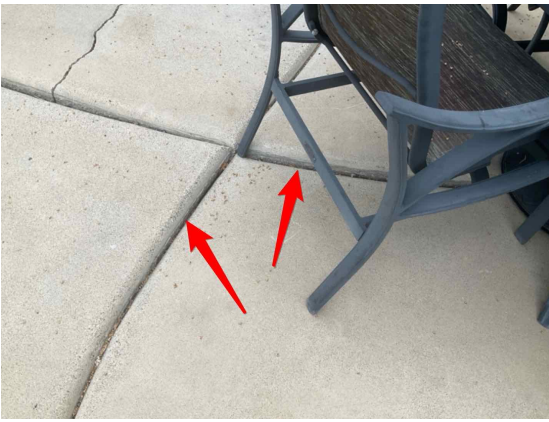
SC **CR** Uneven sections were noted in the decking surface. This condition is a trip hazard. We recommend correcting the condition(s) noted.

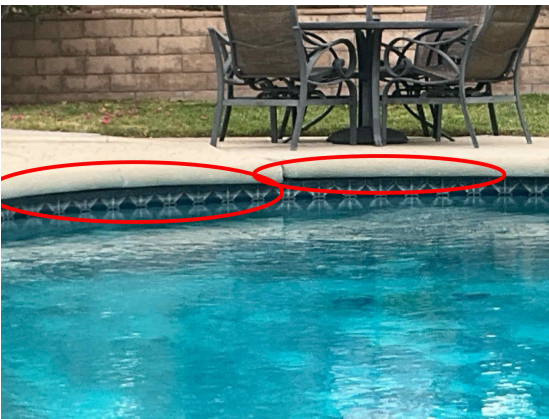
CR Caulking between the deck/tile surfaces was missing. We recommend correcting the condition(s) noted.

Lifting concrete

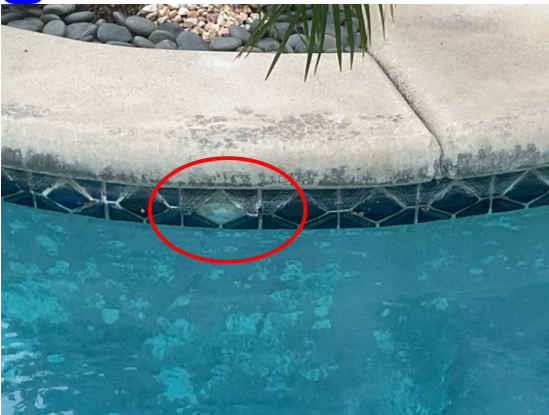
1609 WATERLINE TILES

CR There were loose/damaged/missing water line tiles. We recommend correcting the condition(s) noted.

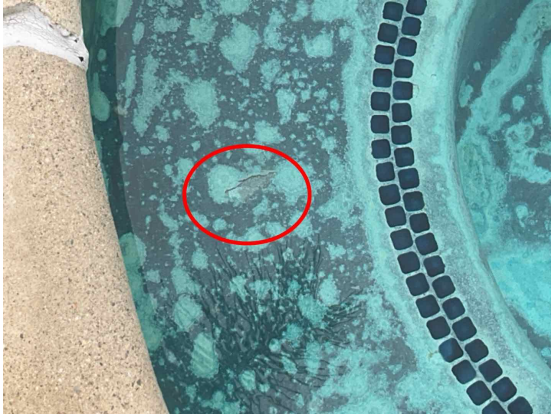
The following vessel condition(s) were noted:
the plaster surface was rough to the touch.

FE areas of chipped plaster were noted.

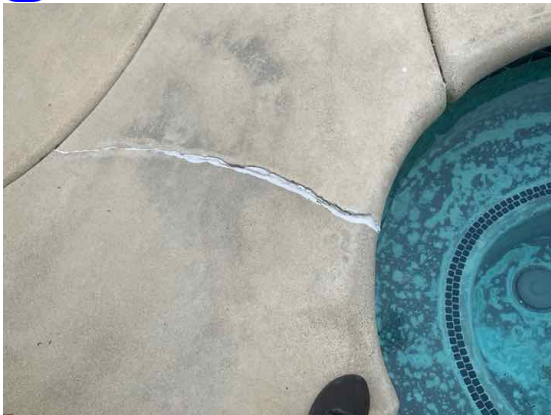
1623 DECKING

CR There were cracks noted in the spa decking. We recommend correcting the condition(s) noted.

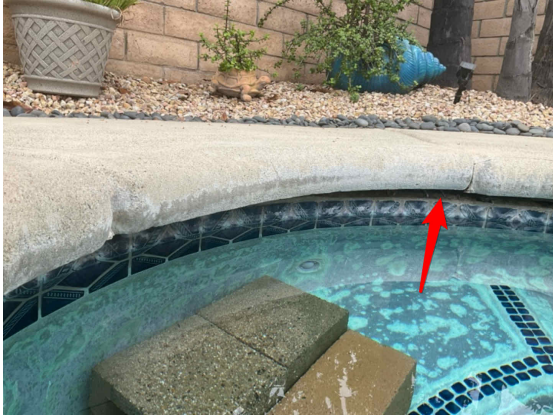
CR The caulking between the coping and deck/tile surface was cracked/damaged/deteriorated/missing. We recommend correcting the condition(s) noted.

Lifting concrete

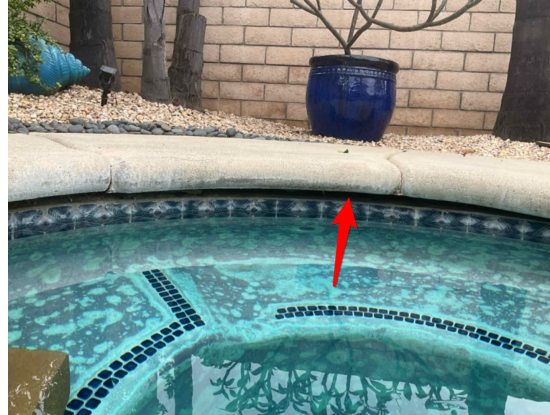
Lifting concrete

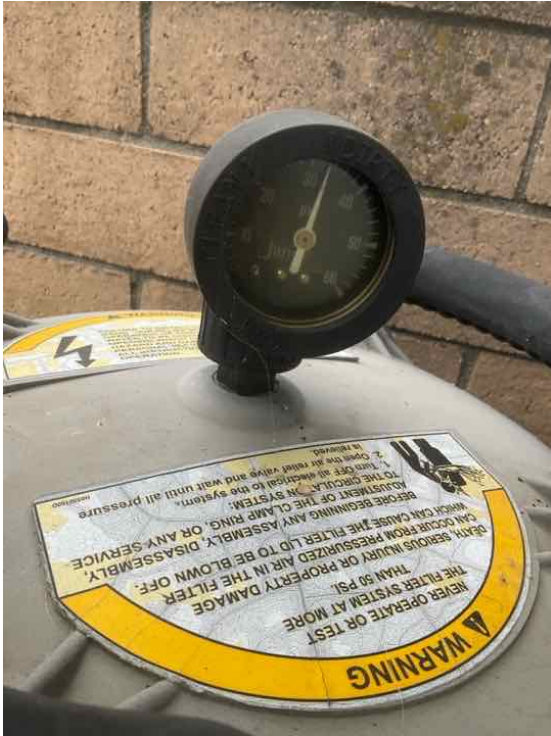
FE CR The gauge indicated a high pressure situation, this condition may indicate that the filter needs to be cleaned. We recommend cleaning/replacing the filter and operating the system to determine what the clean system pressure is. This pressure reading can be used to determine when the filter needs to be cleaned.

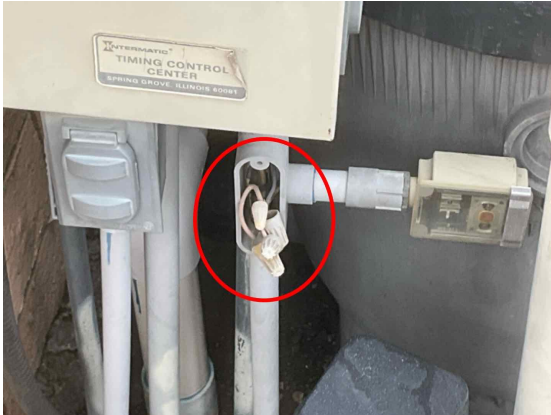
SC CR The conduit is missing a cap and there are exposed wires. We recommend correcting the condition(s) noted.
