Accurate Inspection Team LLC
Property Inspection Report

1110 Arno Dr, Sierra Madre, CA 91024
Inspection prepared for: Harry Wurmsdobler & Mary Ann Shinnick
Real Estate Agent: Pete Whan - Pete Whan & Associates

Date of Inspection: 1/6/2026 Time: 10:00 am
Age of Home: 1967 Size: 2,166 sqft
Weather: Cool & Sunny

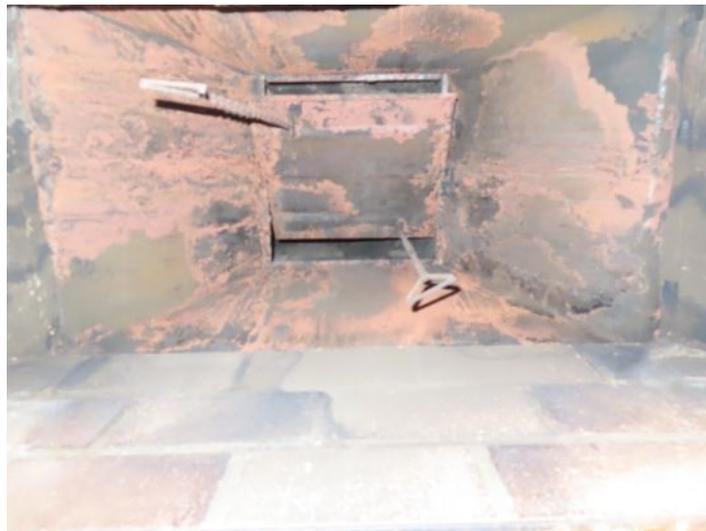
Observations: limited inspection, gas only, **recommend installing a damper door clamp**

recommend installing a damper door clamp

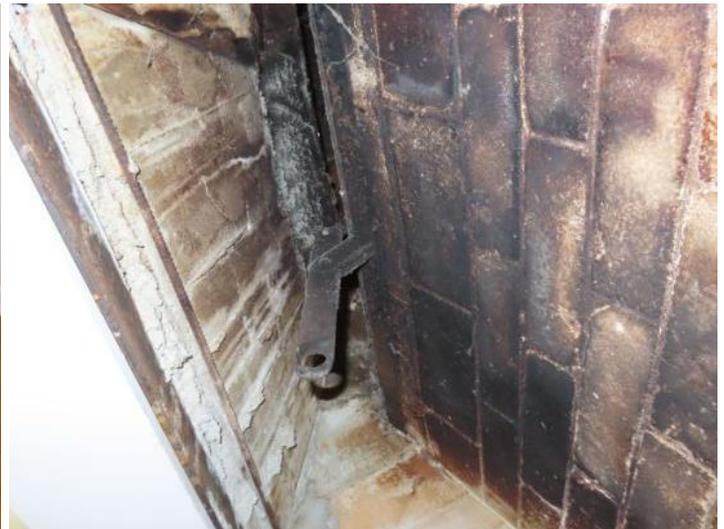
Observations: gas log lighter, **recommend cleaning, recommend a damper door clamp, recommend screen**

recommend screen

recommend a damper door clamp

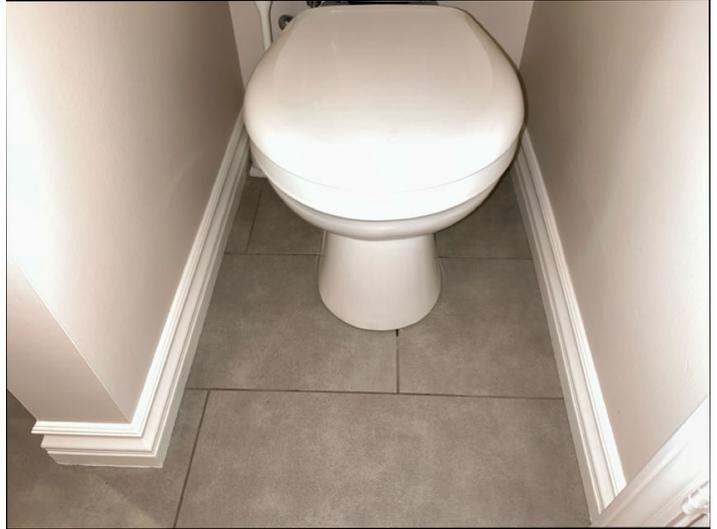
Observations: functional, worn hardware, bidet present, not tested by inspector, **toilet is loose on the floor**

toilet is loose on the floor

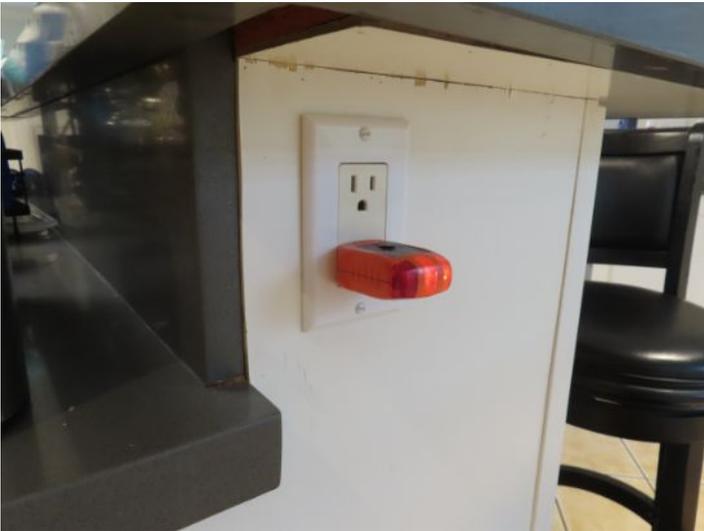
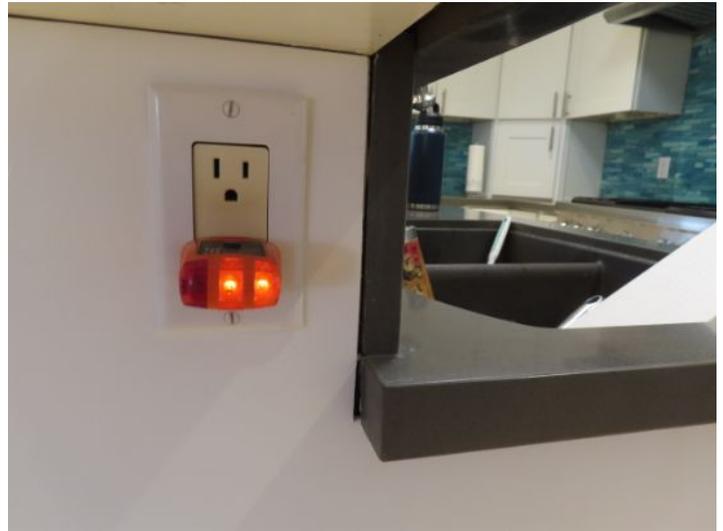
Observations: **recommend all outlets by the sink area are GFCI protected**

recommend all outlets by the sink area are GFCI protected

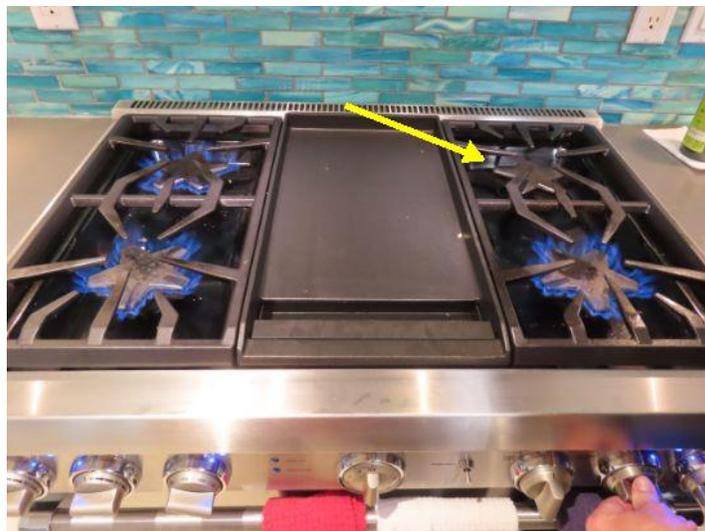
Observations: operated, gas, **back right burner did not self light**

back right burner did not self light

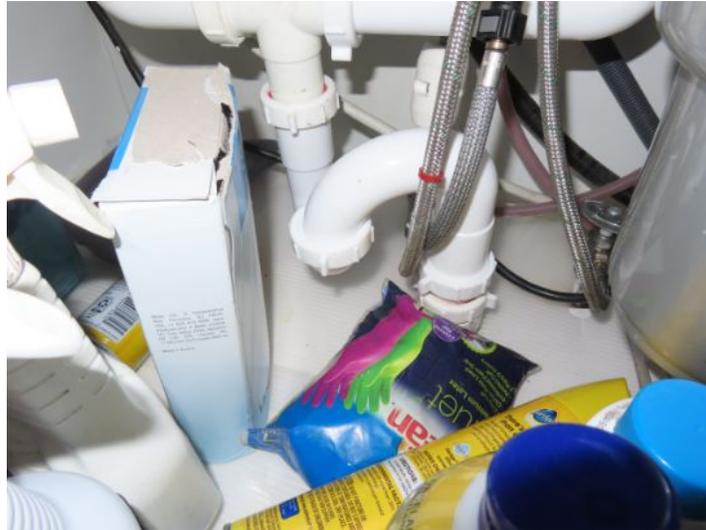
Observations: some not accessible due to personal items, worn fixtures, **S trap present, recommend a P trap, no plumbing vent pipe present at the sink area, recommend further evaluation by a plumber**

S trap present, recommend a P trap

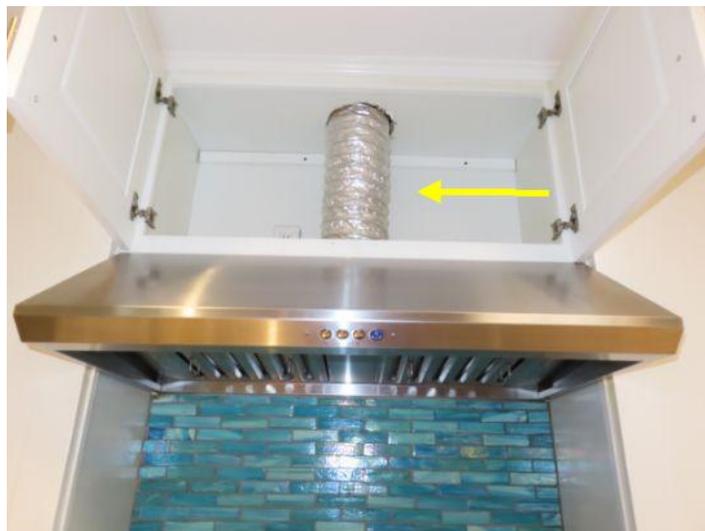
Observations: operated, could not fully inspect, **flex vent pipe present, recommend a ridged exhaust vent pipe**

flex vent pipe present, recommend a ridged exhaust vent pipe

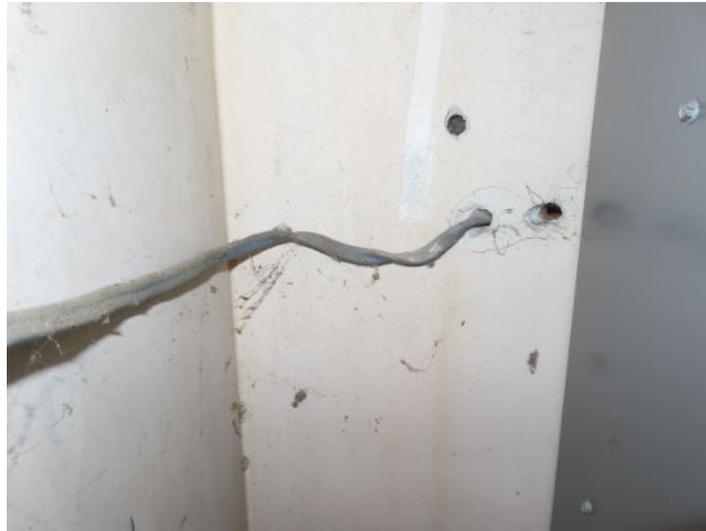
Observations: functional, worn hardware, **romex wire running through the wall**

romex wire running through the wall

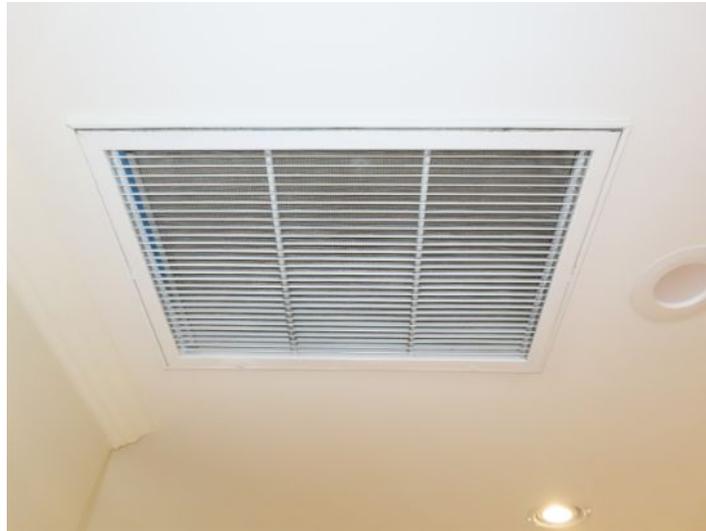
Observations: dirty filter, recommend cleaning

dirty filter, recommend cleaning

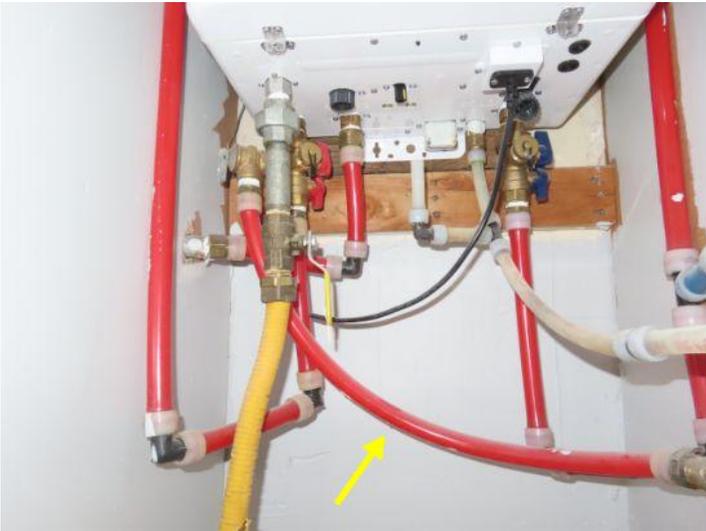
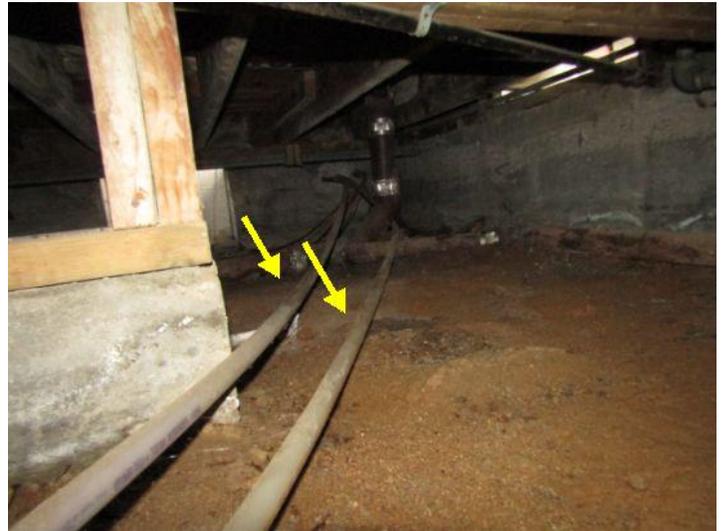
Observations: **overflow drain line runs uphill underneath the structure, Pex plumbing at the overflow line may not be hot water rated, recommend further evaluation**

Pex plumbing at the overflow line may not be hot water rated, recommend further evaluation

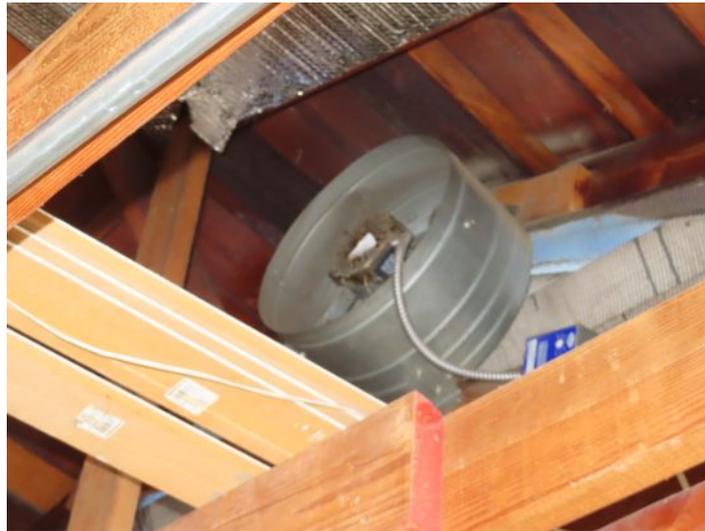
Observations: none visible, recommend vents, vent fan present, not tested by the inspector

vent fan present, not tested by the inspector

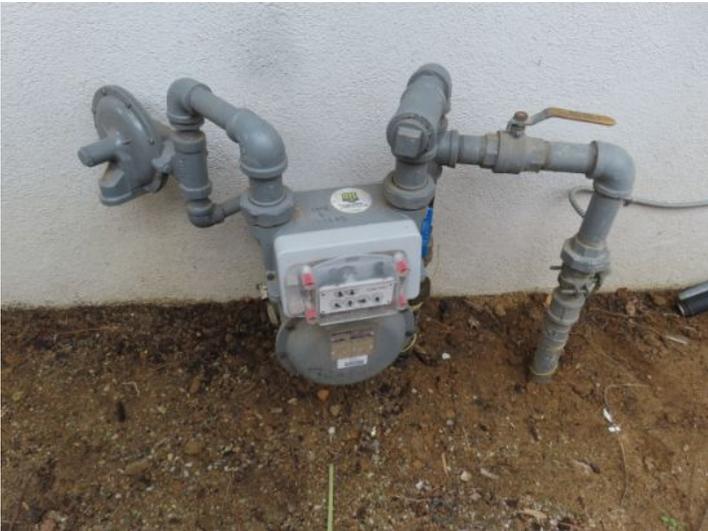
Location: east side exterior of structure
Observations: natural gas, no seismic shut off present, recommend a seismic shut off, can not determine if gas pipe is protected in the ground

natural gas

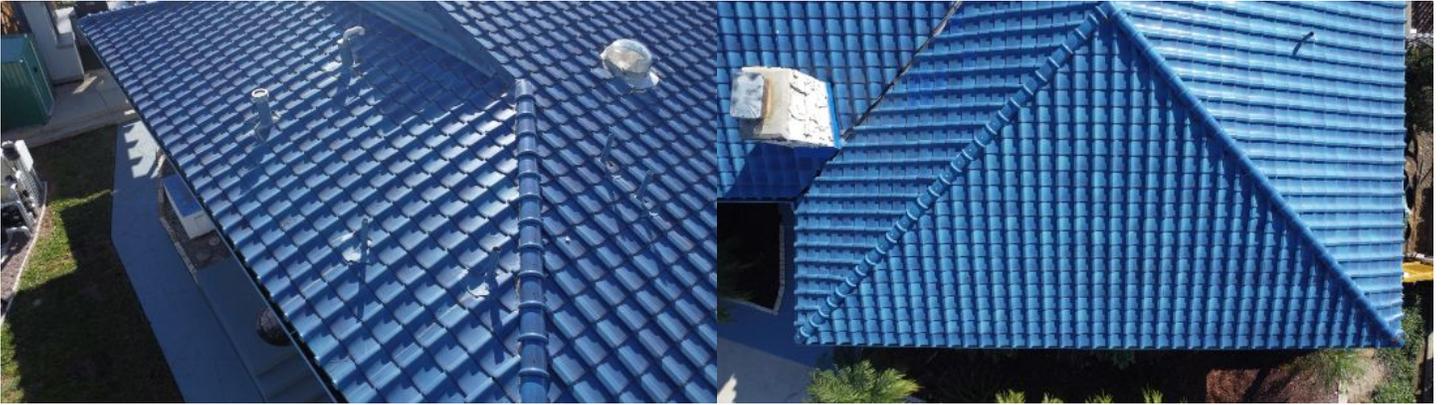
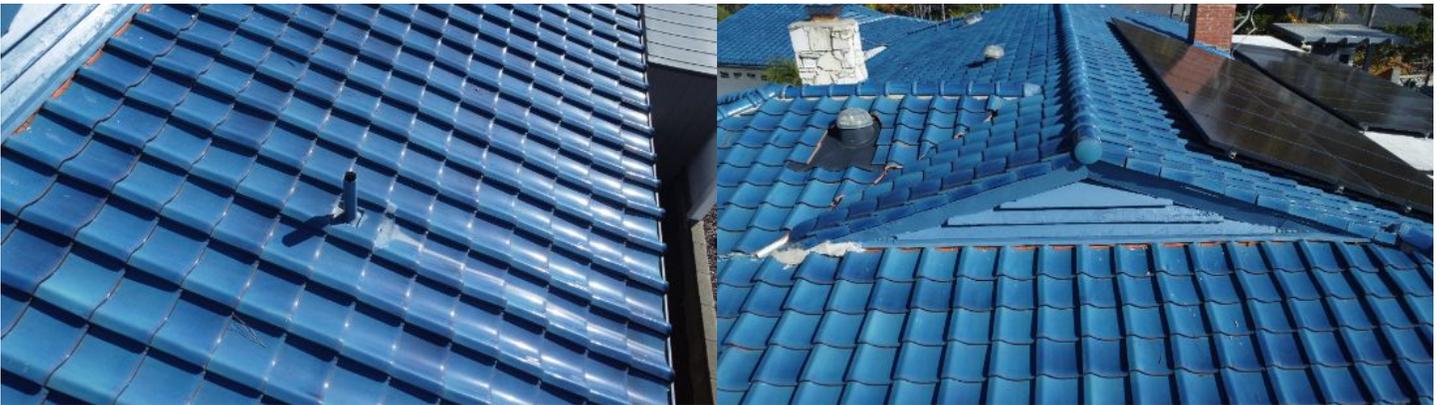
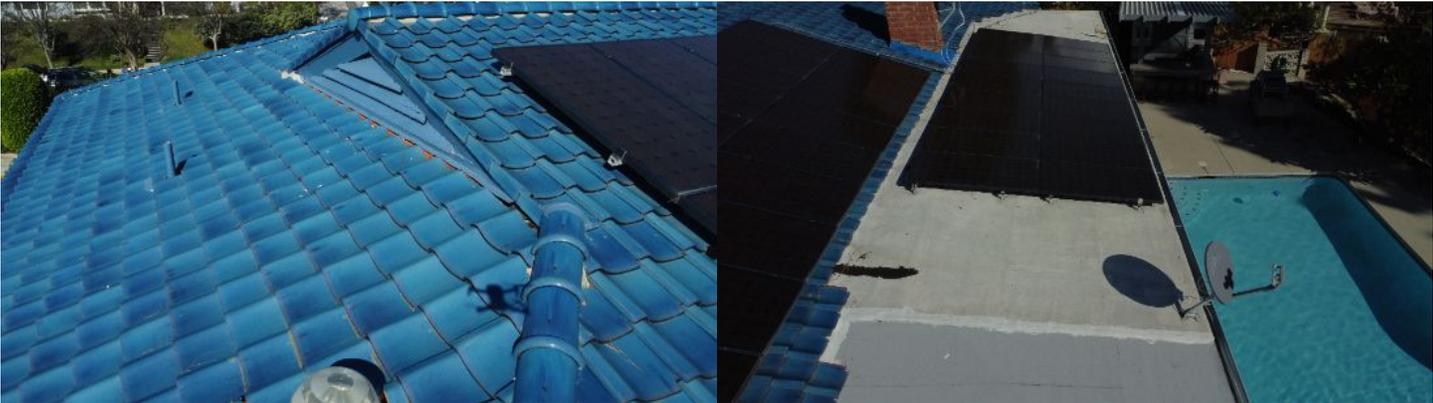
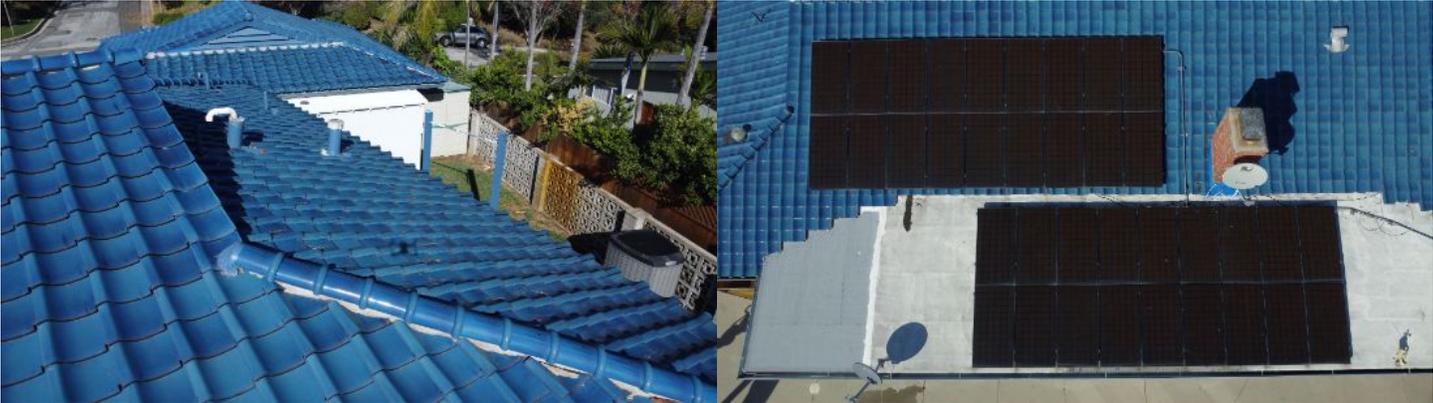
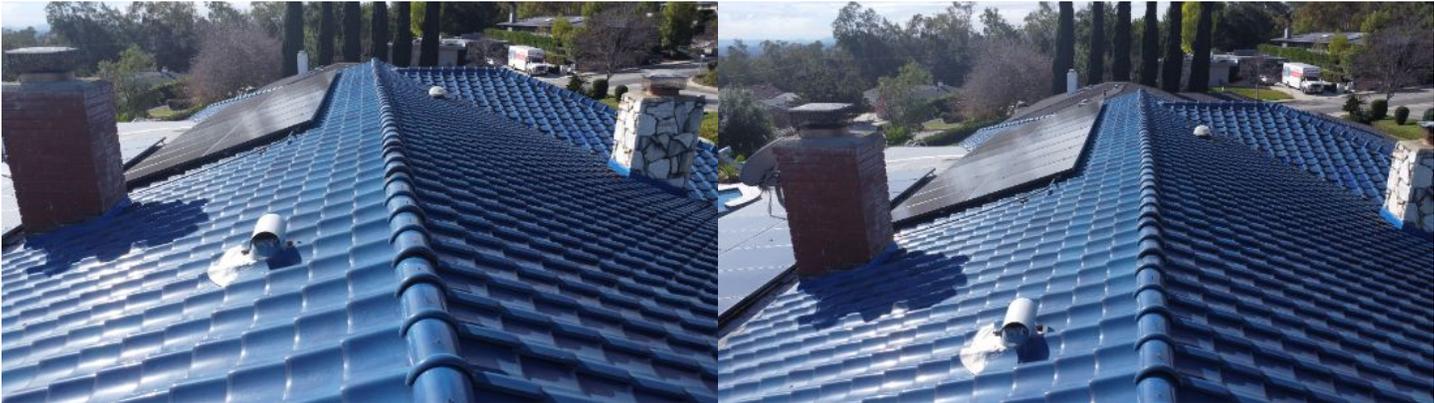
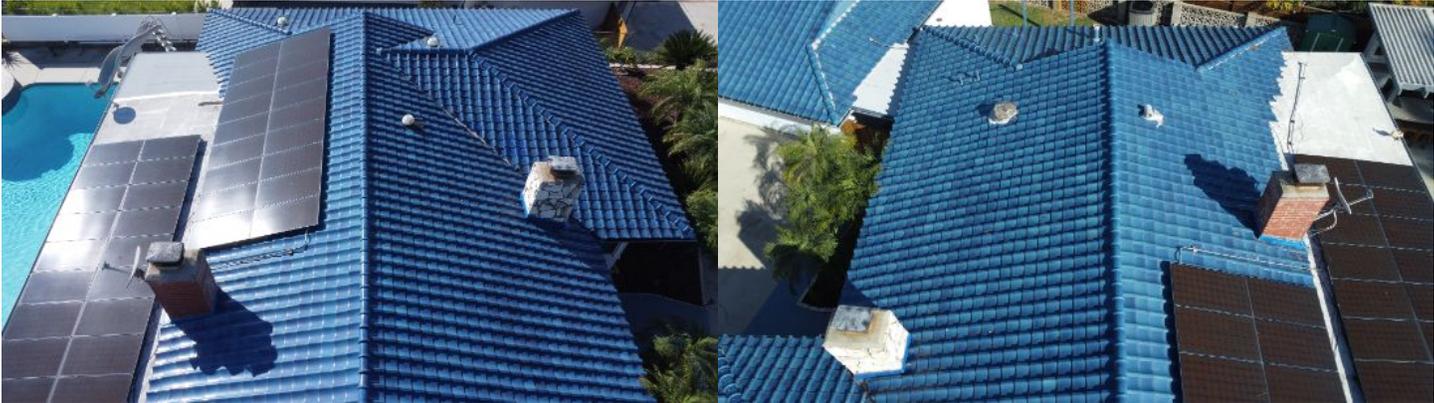
Observations: could not access due to type of roofing materials, inspected from the ground and drone, solar panels present, not inspected by the inspector, Solar panels present, could not fully check all areas under the panels, **loose tiles, patched areas, tree touching the roof, recommend trimming, exposed nails at the ridge, recommend a licensed roofer for servicing**

Solar panels present, could not fully check all areas under the panels

patched areas

loose tiles

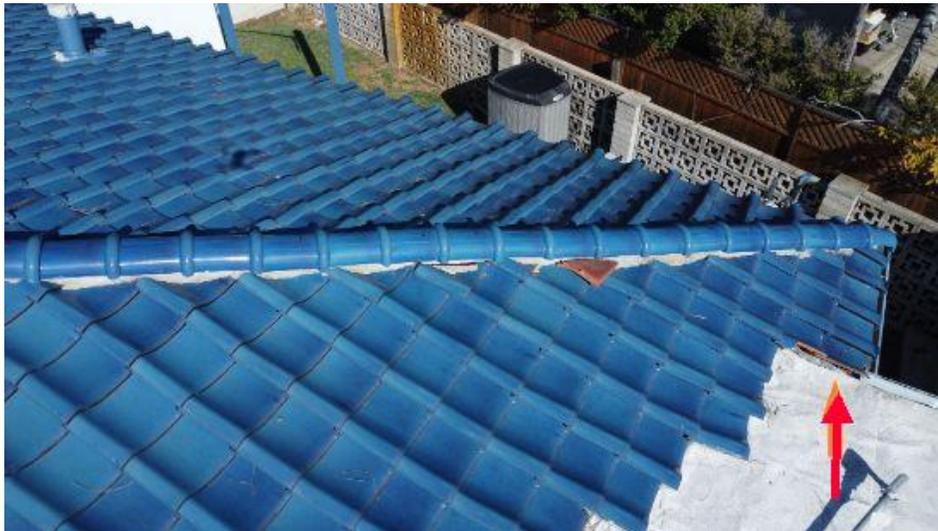
Observations: could not access due to type of roofing material, inspected from the ground and drone, recommend mastic at the flashings, **missing flashing**

missing flashing

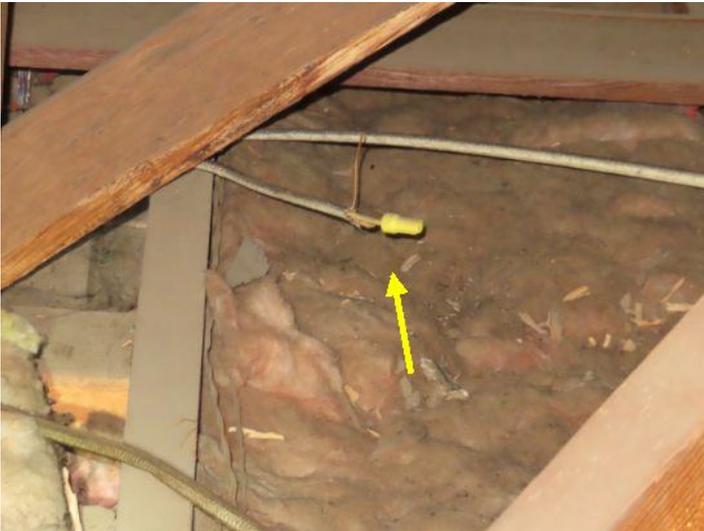
Observations: functional, unsecured electrical, **missing junction box cover above kitchen area, exposed wire above #2 bedroom**

exposed wire above #2 bedroom

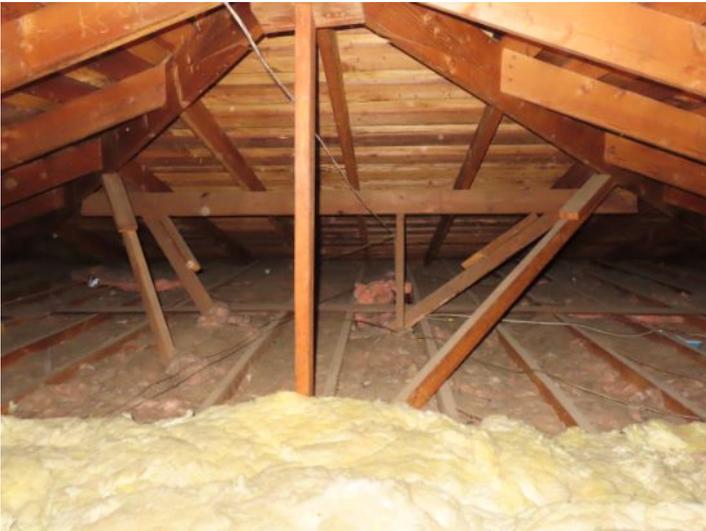
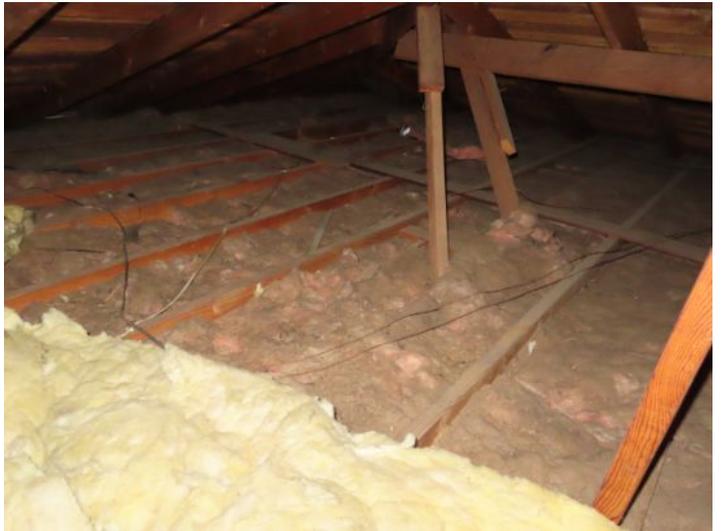
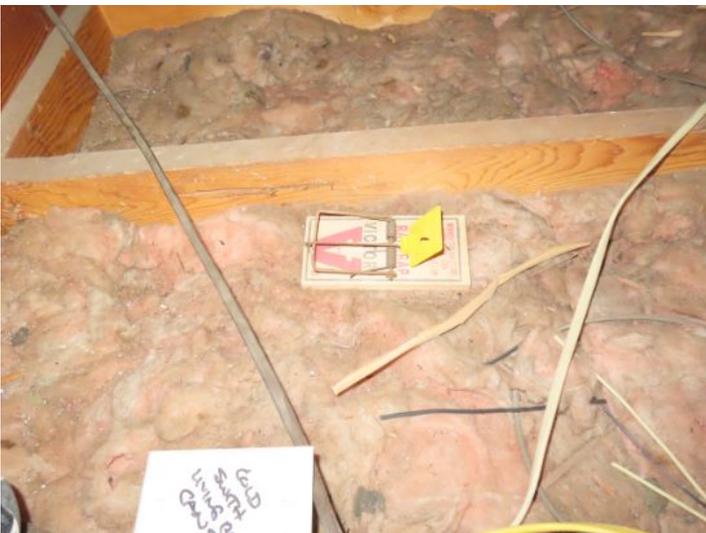
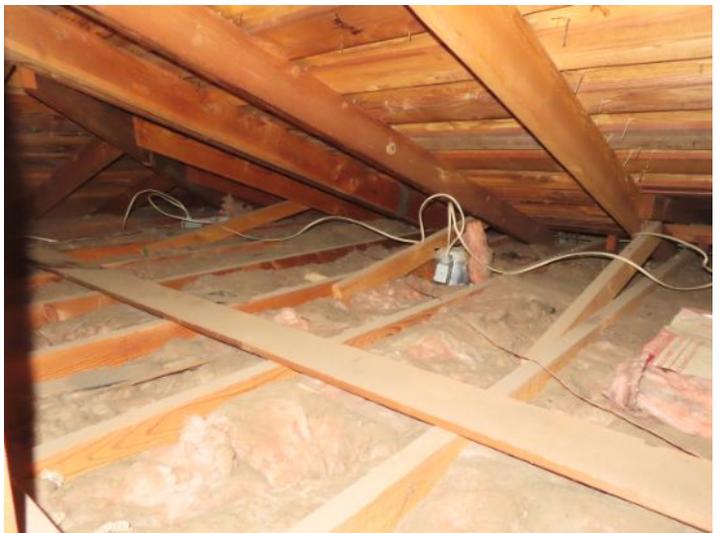
Observations: recommend additional insulation, rodent traps present

rodent traps present

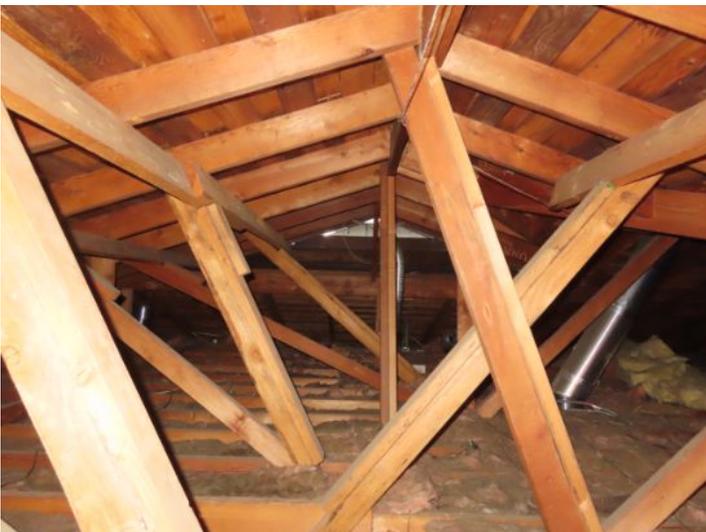
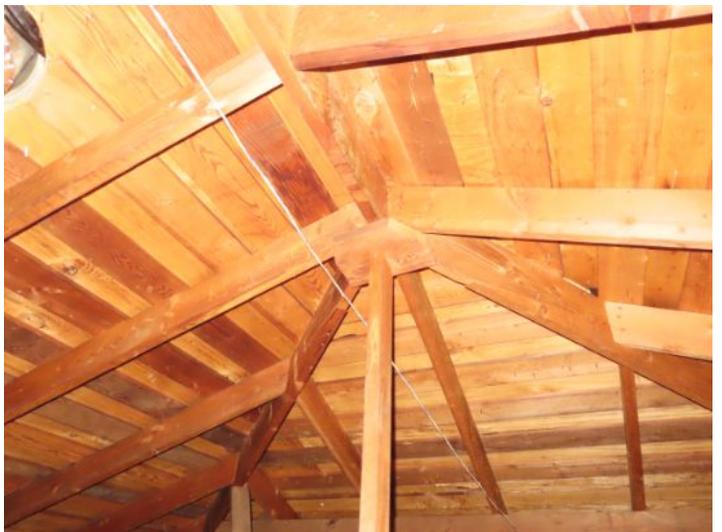
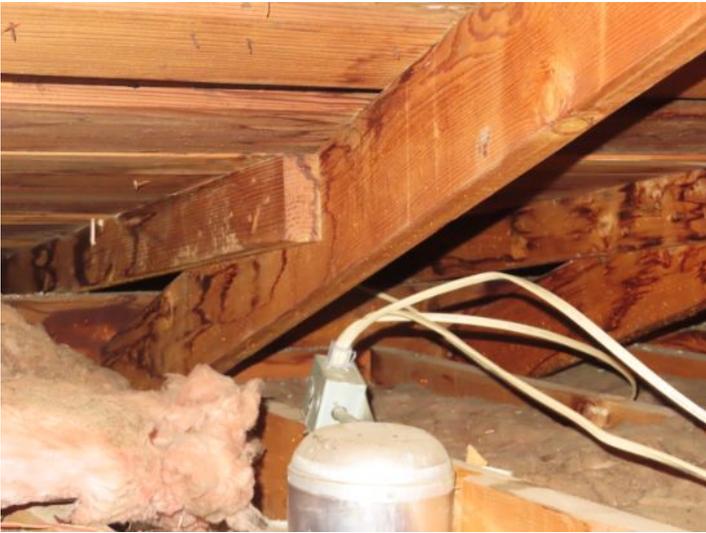
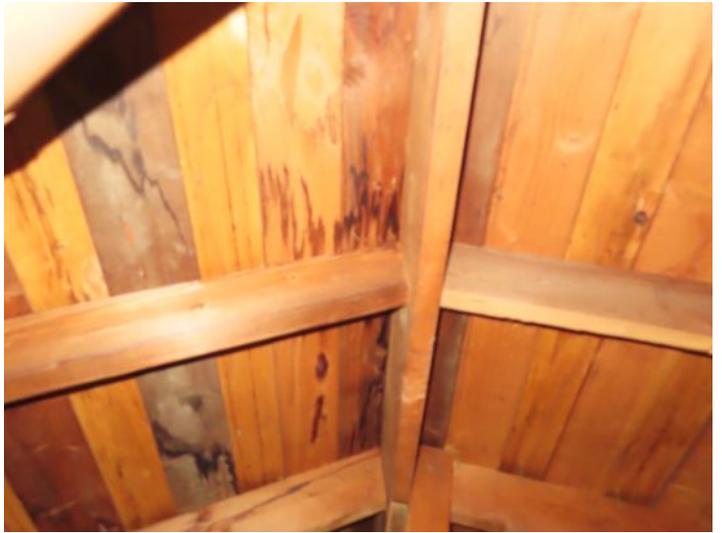
Observations: good, could not access all areas, stains in areas, evidence of past leaking

stains in areas, evidence of past leaking

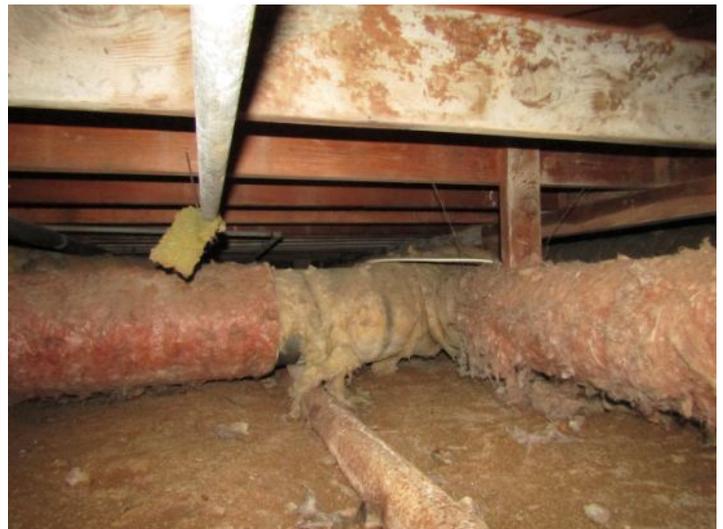
Observations: functional, moisture present, **excessive moisture present, recommend further evaluation by a contractor**

excessive moisture present, recommend further evaluation by a contractor

excessive moisture present

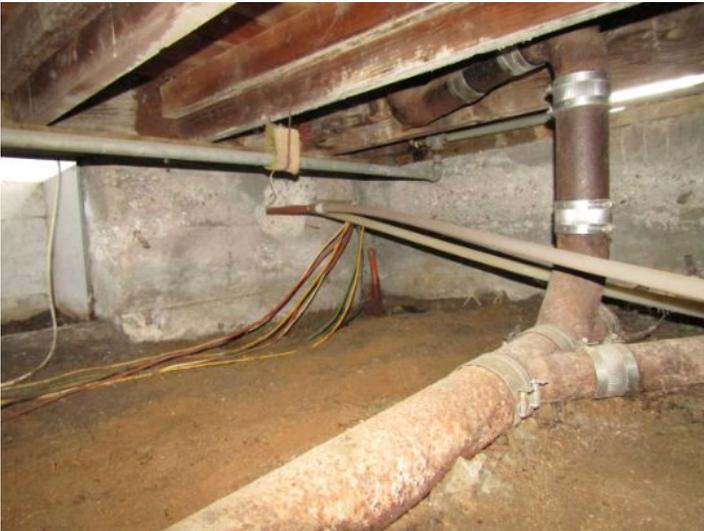
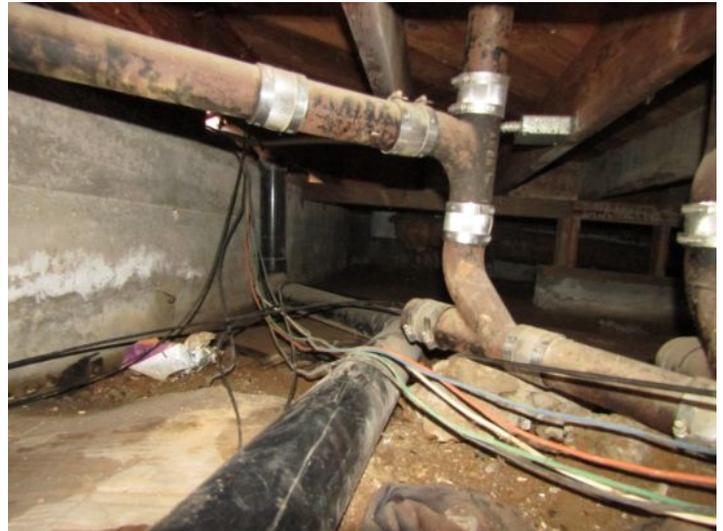
Observations: functional, some electrical not accessible, could not access all areas, **unsecured wiring laying on the ground**

unsecured wiring laying on the ground

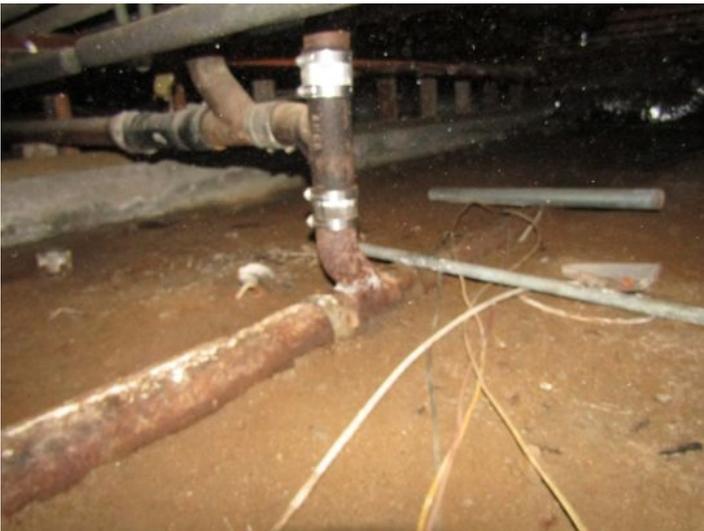
rusted and corroded drain lines

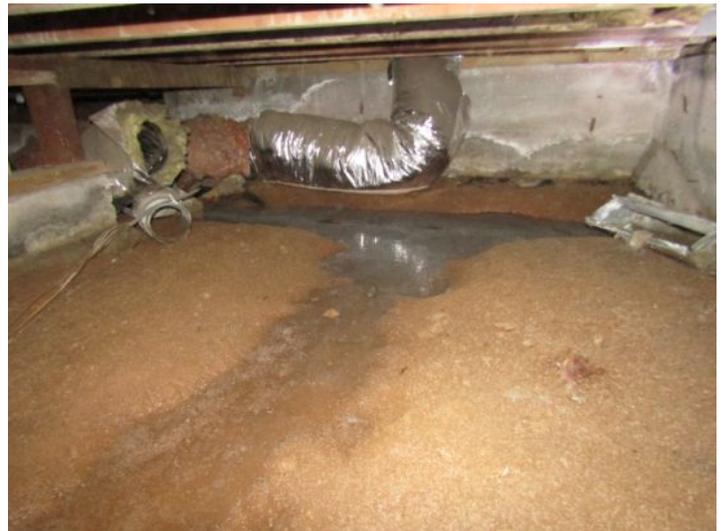
sewer line leaking, recommend that a licensed plumber evaluate

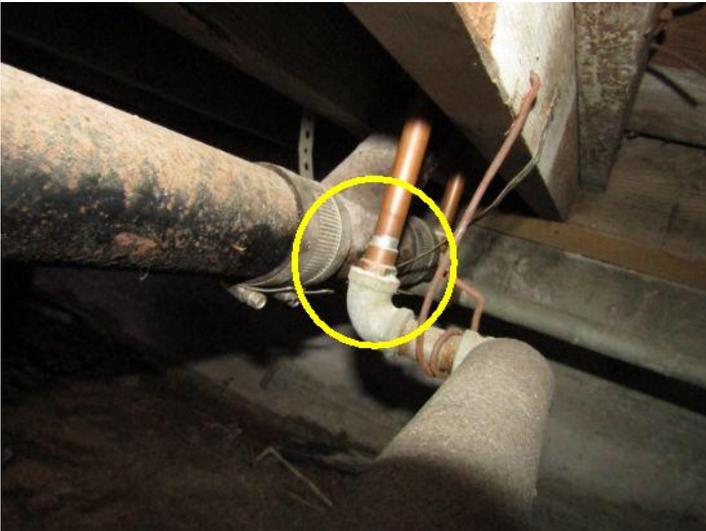
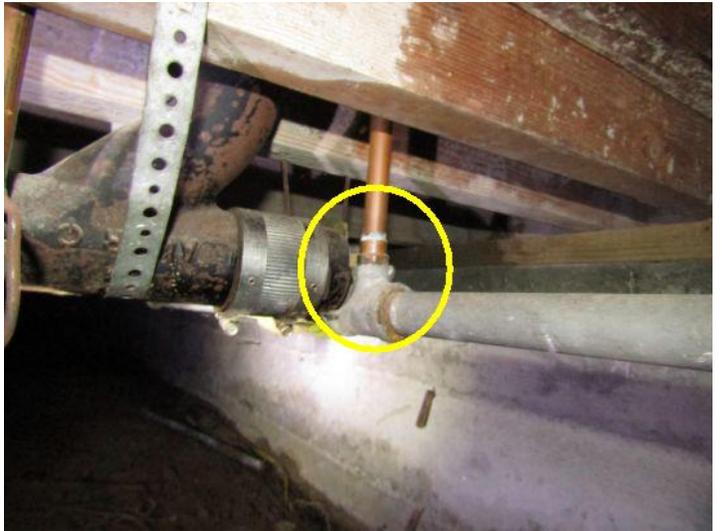
copper to galvanized missing proper connections

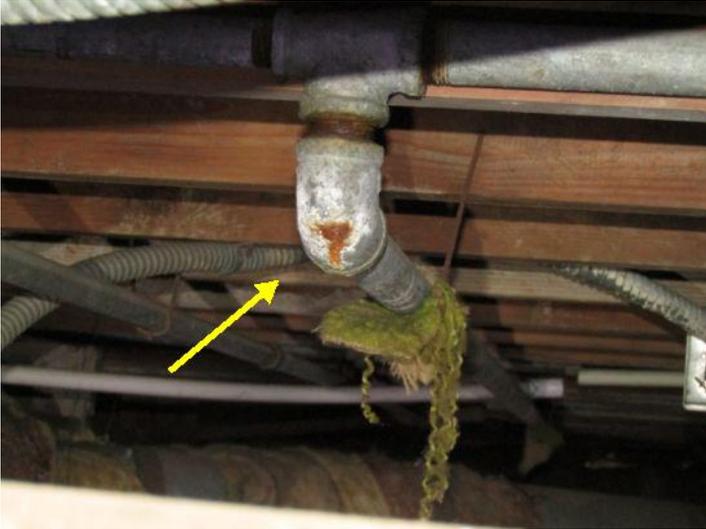
pin hole leaking

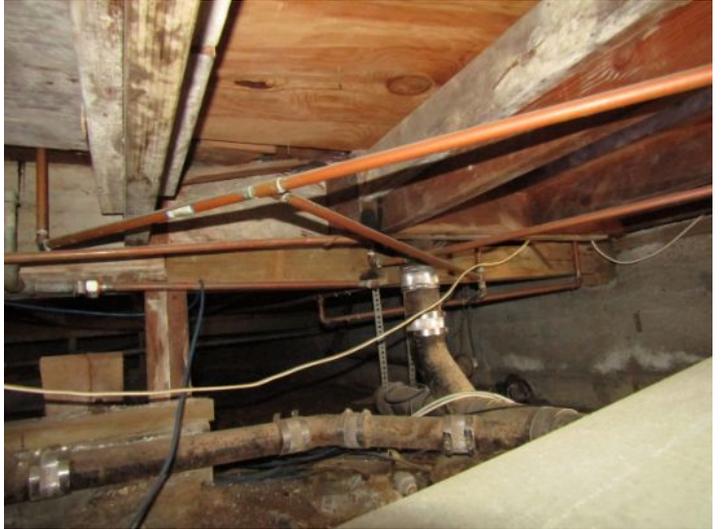
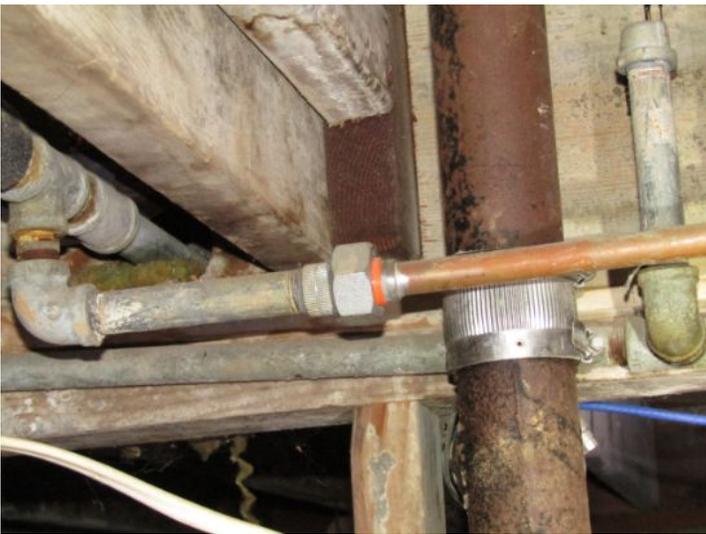
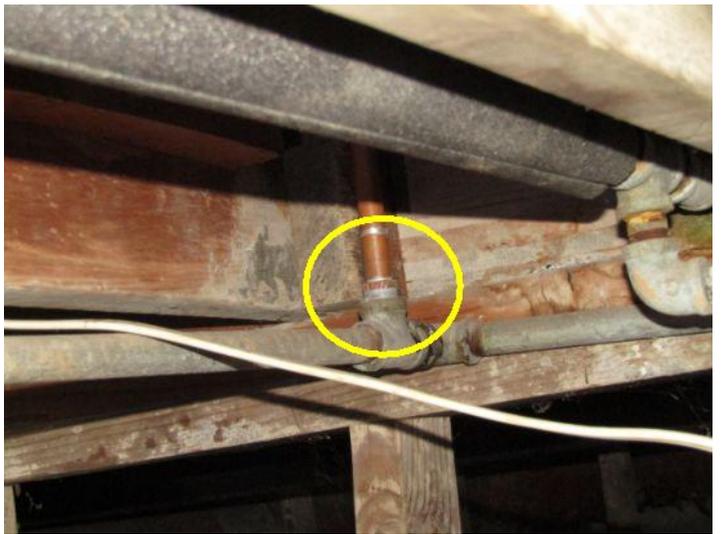
copper to galvanized missing proper connections

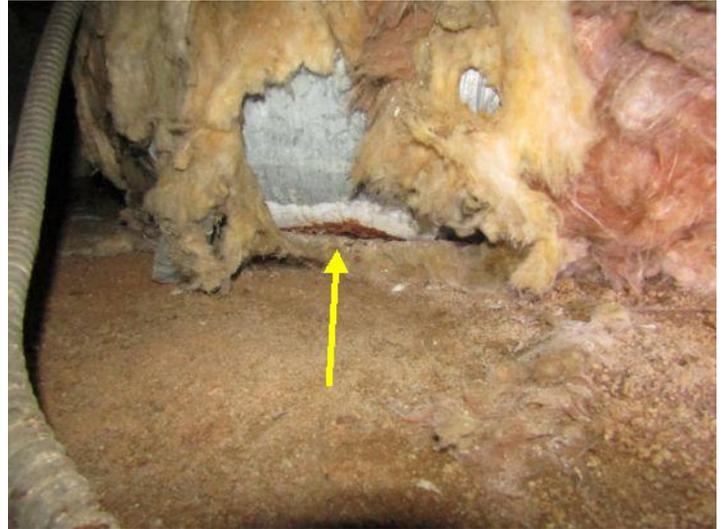
rusted ducting

Observations: crushed ducting, insulation missing in areas, ducting laying on the ground, rusted ducting, recommend a licensed heating and **AVC** contractor to evaluate

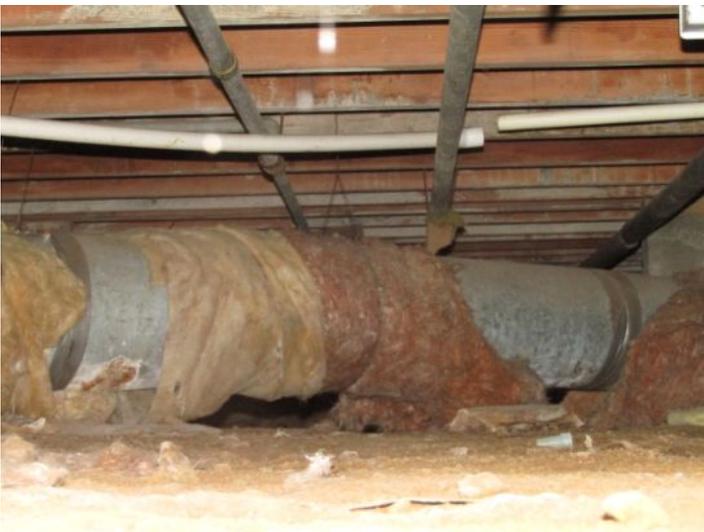
insulation missing in areas

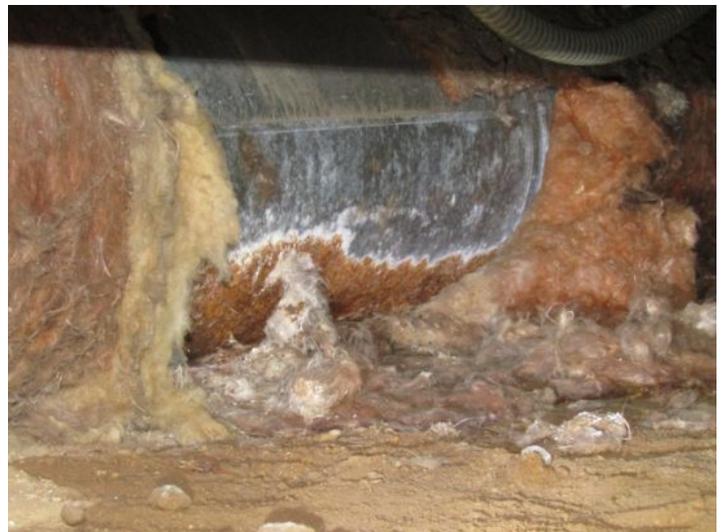
rusted ducting

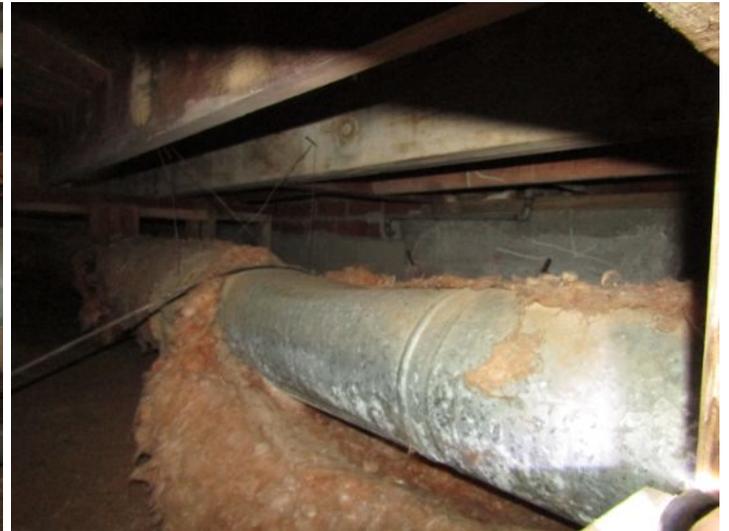
insulation missing in areas

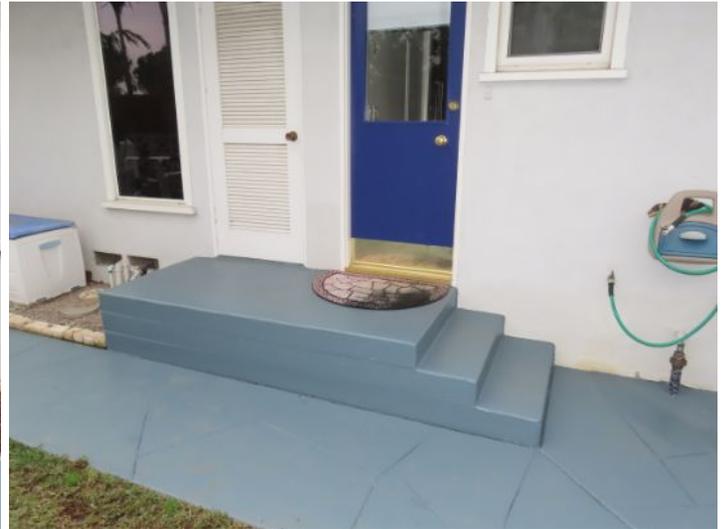
Observations: **recommend hand rails**

recommend hand rails

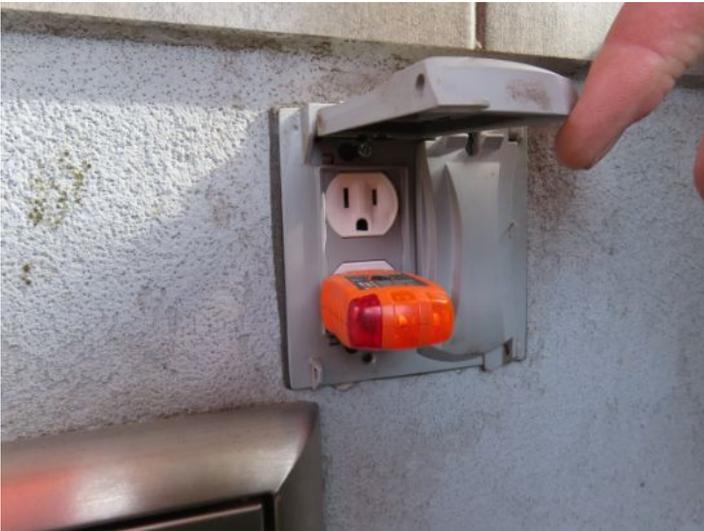
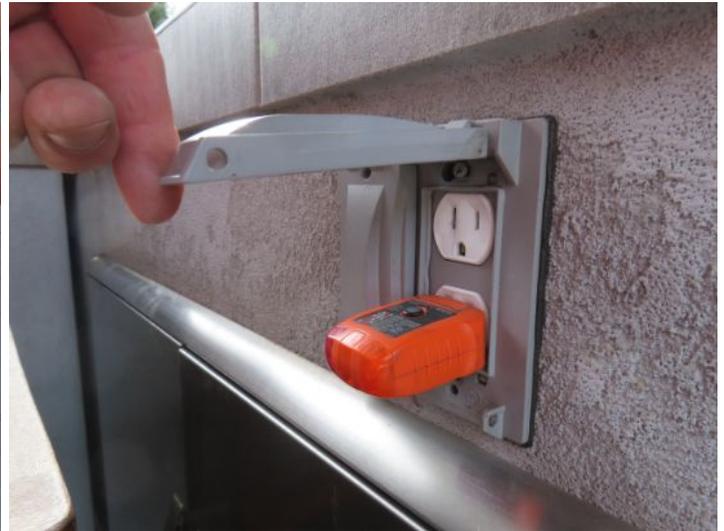
Observations: **recommend -GFCI on all exterior outlets including the BBQ area, GFCI is reversed, test did not operate**

recommend -GFCI on all exterior outlets including the BBQ area

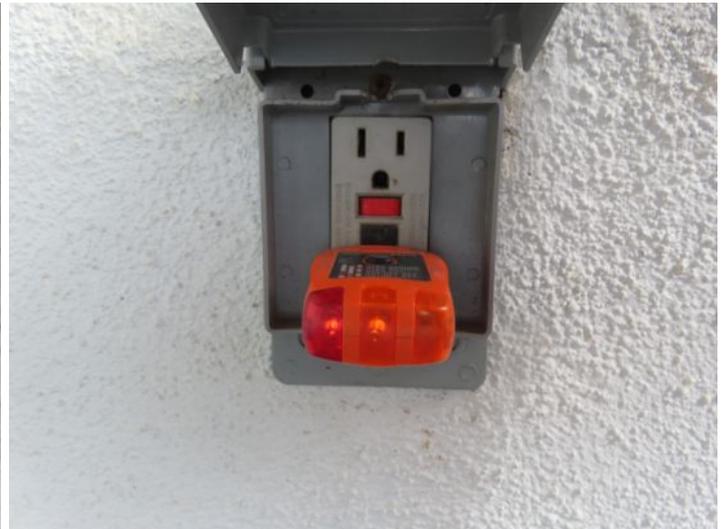
GFCI is reversed, test did not operate

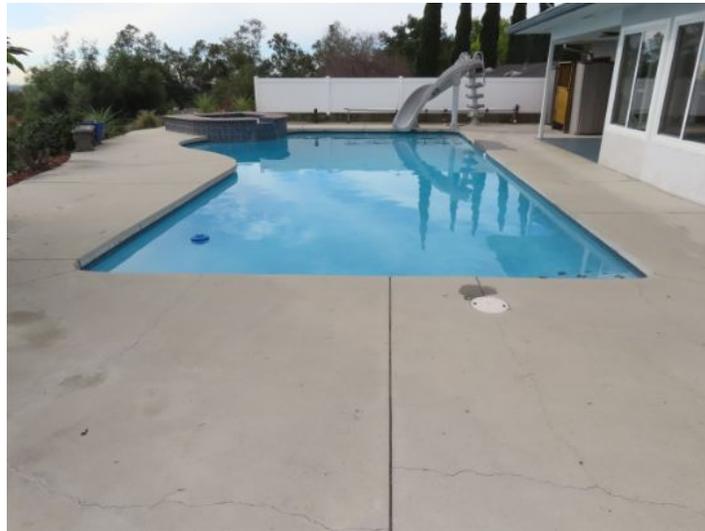
Observations: recommend safety alarms at all doors and windows leading to the pool area, recommend a 5 foot fence or better at the pool area, gate to the pool should open outward away from the pool, recommend pool safety features comply with current city code

recommend a 5 foot fence or better at the pool area, gate to the pool should open outward away from the pool
