# Property Inspection Report

**584 NORTH PLYMOUTH BLVD  
LOS ANGELES, CA 90004**

**JOHN FREEMAN  
Inspector**

**Date  
01/26/26**

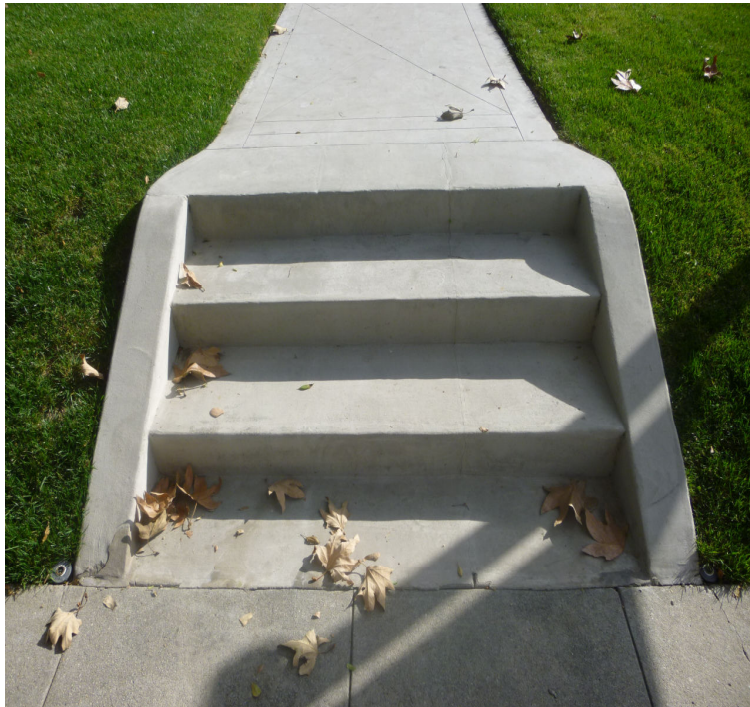
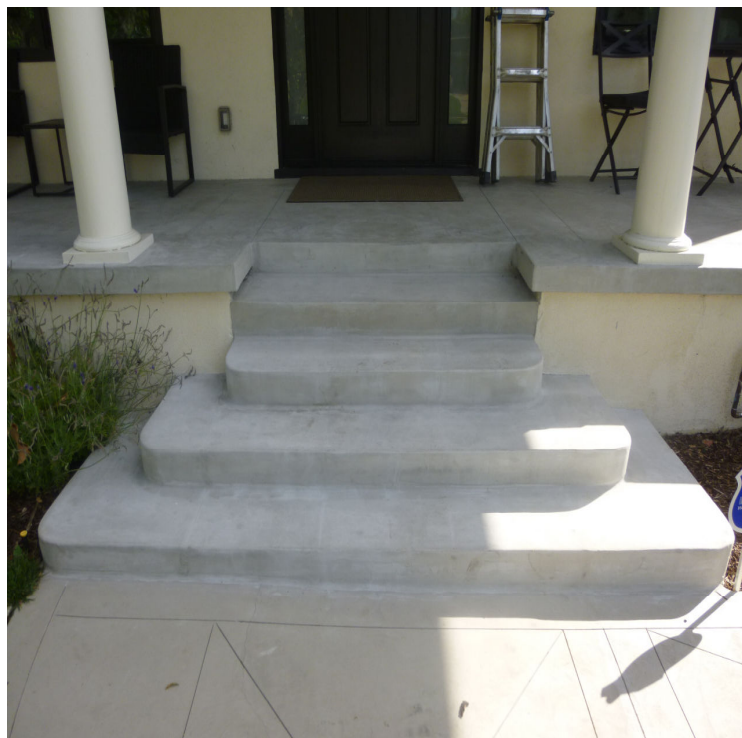
Comments: See picture 2A-Several exterior steps front of house missing at least one handrail installment needed

**SEVERAL EXTERIOR STEPS FRONT OF HOUSE MISSING AT LEAST ONE HANDRAIL INSTALLMENT NEEDED**

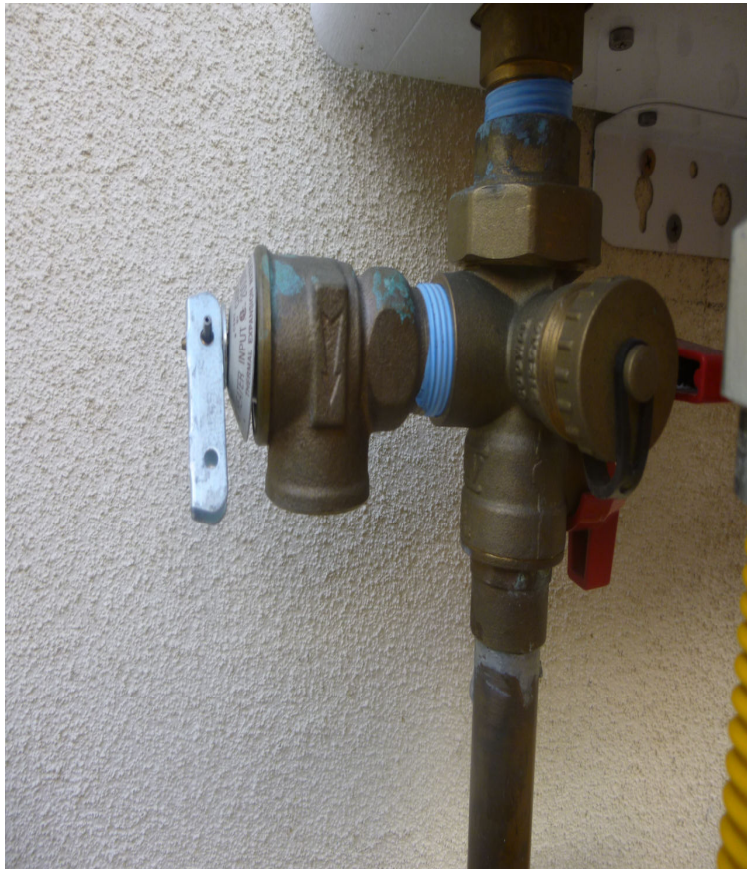
See picture 4A-Missing t.p.r pipe on water heater pipe needs to be copper are galvanized installment needed

MISSING T.P.R PIPE ON WATER HEATER PIPE NEEDS TO BE  
COPPER ARE GALVANIZED INSTALLMENT NEEDED

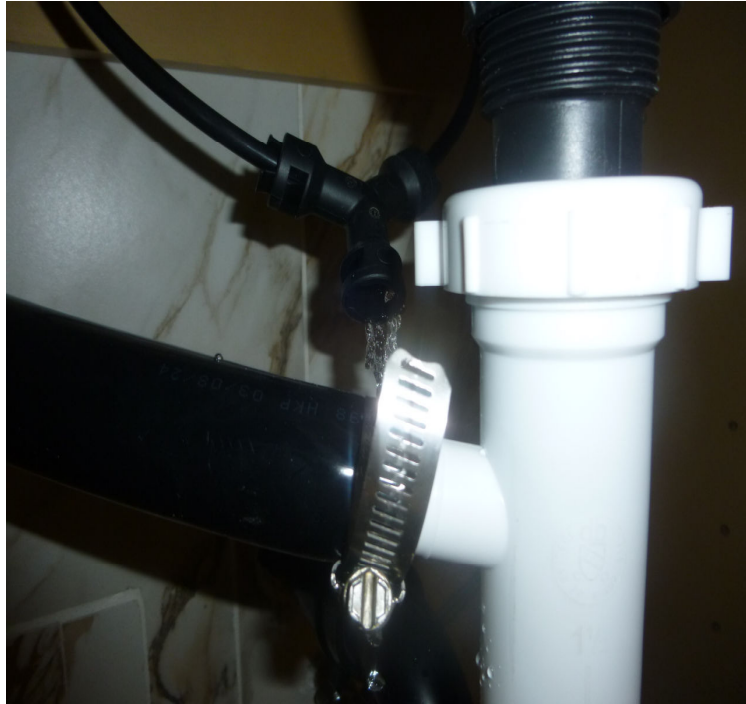
**Comments:** See picture 11A-Hot and cold water supply lines under hall bathroom sink leaks repair needed  
Recommend further evaluation

HOT AND COLD WATER SUPPLY LINES UNDER HALL BATHROOM  
LEAKS REPAIR NEEDED RECOMMEND FURTHER EVALUATION

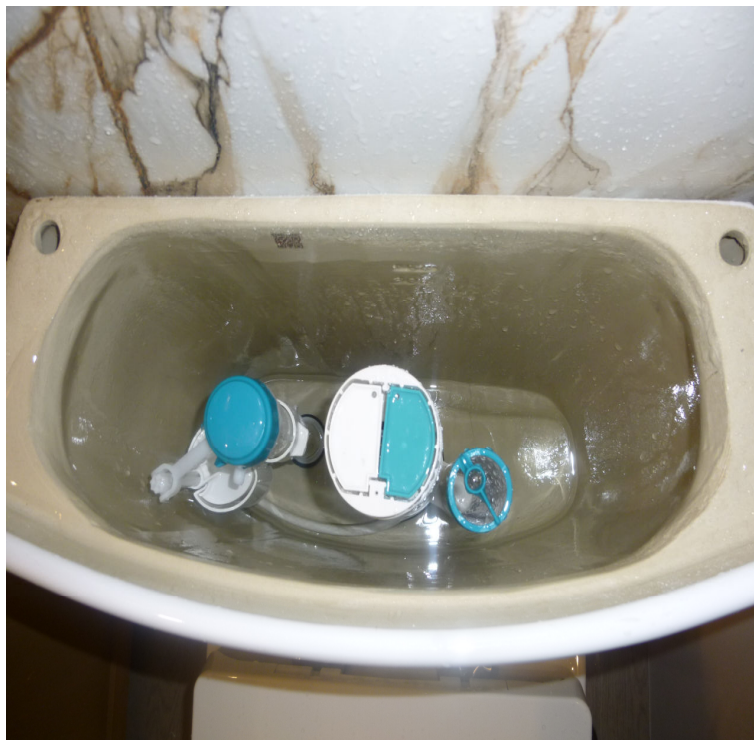
**Comments:** See picture 11A-Toilet in hall bathroom runs continually Recommend replacing floater in tank

TOILET IN HALL BATHROOM RUNS CONSTANTLY RECOMMENDS  
REPLACING FLOATER IN TANK
