# WOOD DESTROYING PESTS AND ORGANISMS INSPECTION REPORT

Building No. 8505	Street Santa Cruz	City Atascadero	ZIP 93422	Date of Inspection 01/23/2026	Number of Pages 4
----------------------	----------------------	--------------------	--------------	----------------------------------	----------------------

Report # : 17381  
Registration # : PR 9988  
Escrow # :  
 CORRECTED REPORT

GENERAL DESCRIPTION: FURNISHED AND OCCUPIED TWO STORY STUCCO FRAMED RESIDENCE ON A RAISED FOUNDATION AND DETACHED TWO CAR GARAGE	Inspection Tag Posted: Meter Box
	Other Tags Posted:

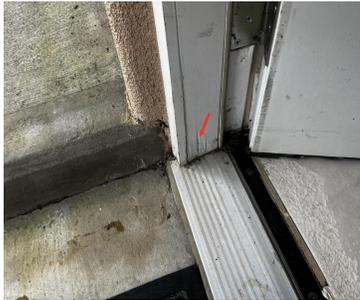
Finding 3A

FINDING-Fungus infection and damage noted at the door jamb of the side door.

RECOMMENDATION- Remove and replace approximately 6 to 8 inches of damaged door jamb as necessary.

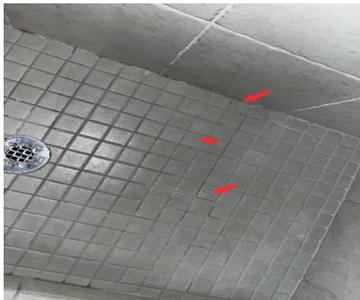
Finding 4A

FINDING- Cracked or missing grout noted at the stall shower.

RECOMMENDATION- Owner to contact the proper trades for recommendation and repair.

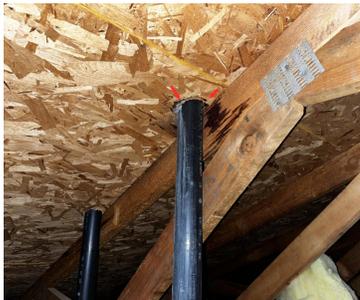
Finding 4B

FINDING- Water stains noted at the attic framing around the roof jacks. It could not be determined if stains are caused from previous or current leakage.

RECOMMENDATION- Owner to contact the proper trades for recommendation and repair.
