PROPERTY INSPECTION REPORT

8523 Lindley Avenue

Date of Inspection: 3/21/2026

Age of House: 72 years old Size: 1753 sqft

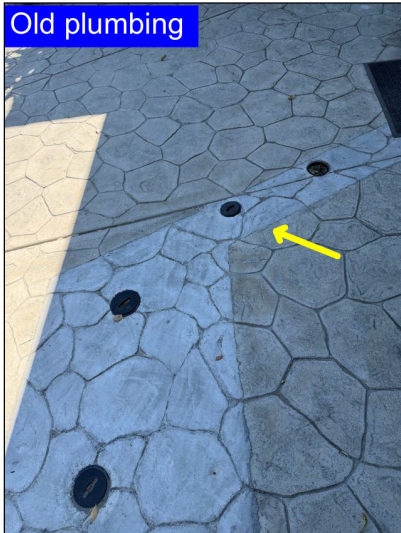
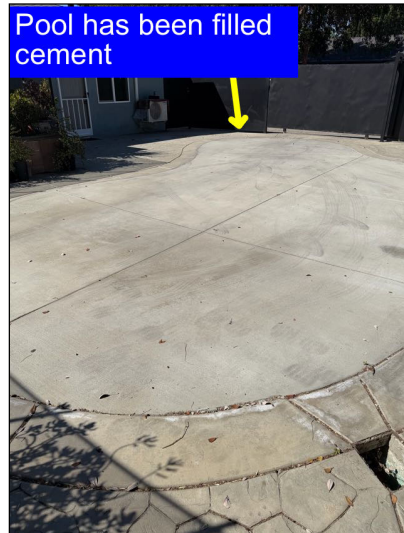
Materials: Concrete driveway noted.

Observations: Driveway is in good shape for age and wear at the time of inspection. , Pool was filled with cement at the driveway. Existing plumbing and electrical components were noted. Buyer to obtain invoice and/or warranty documentation for the pool fill.

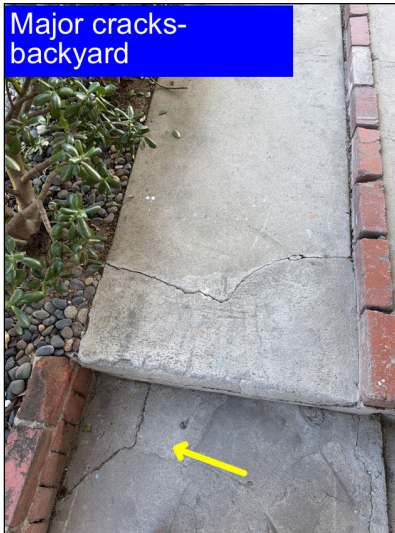
2. Sidewalk and Walkway Condition

Observations: **The sidewalk has major cracks at the time of inspection. Recommend further evaluation and repairs by a licensed contractor.**

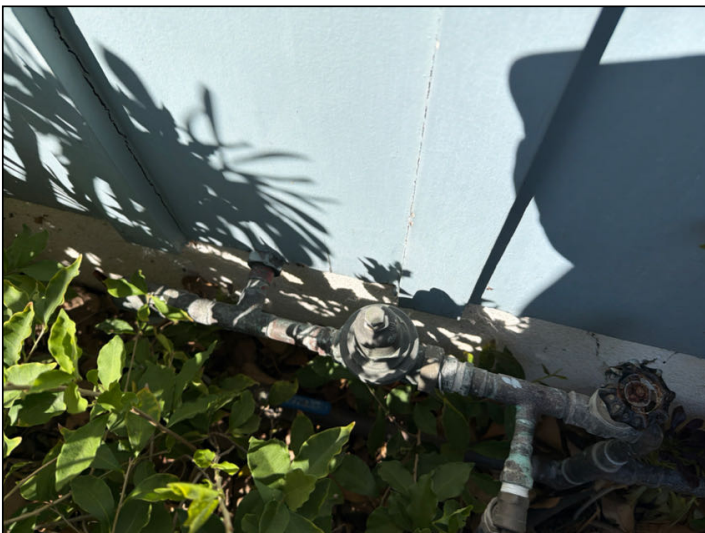
• Inspector noted moisture at the water meter.

Recommend further evaluation to determine the condition and source of a possible leak by a licensed plumber.

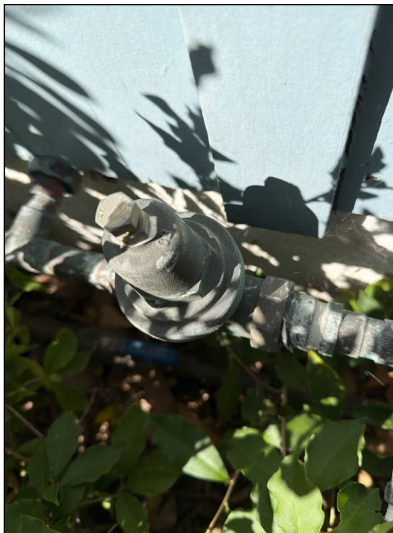
- Pressure regulator noted at the time of inspection. Note: Pressure regulators are not tested.

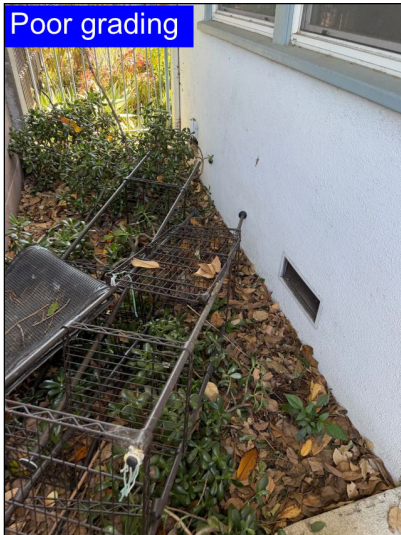
10. Grading

Poor grading and drainage was noted to the property. Recommend further evaluation and/or repairs by a licensed contractor.

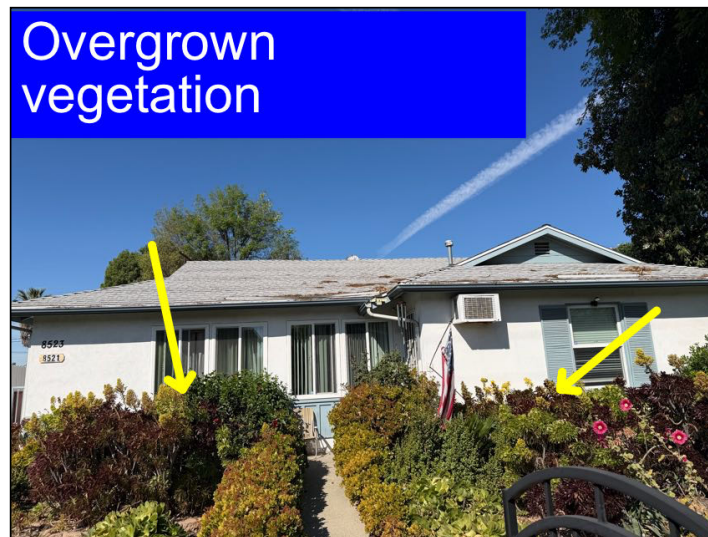
11. Vegetation Observations

- Trees that grow too close, or overhang property, should be trimmed back. This will help reduce the frequency of having to clean out the gutters, which should be done on a regular basis.
- Vegetation was in contact with the exterior walls. The vegetation should be trimmed away to prevent damage to the building.
- The property has overgrown vegetation that needs to be landscaped.

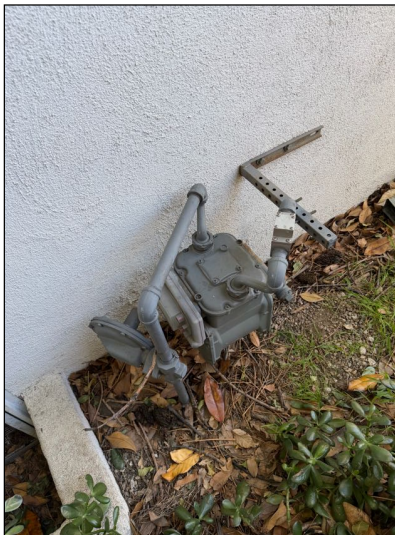
13. Main Gas Valve Condition

- Meter located at exterior and appears to be in serviceable condition. All gas appliances have cut-off valves in line at each unit. No gas odors detected.
- The gas meter did have a seismic shut off valve installed. Note: The seismic valve was not tested.

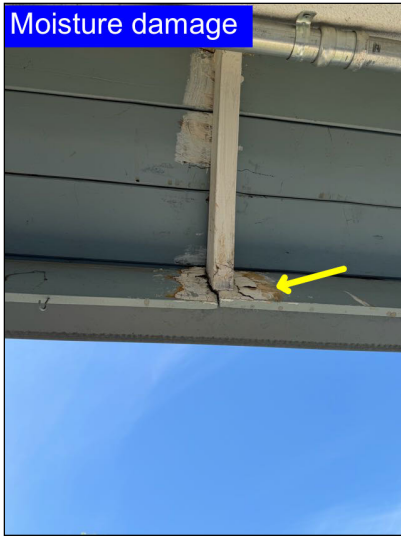
- Peeling/chipping paint observed, suggest scraping and painting as necessary.
 - Moisture damage, wood rot, observed.
- Recommend review for repair as necessary. Recommend termite inspection.

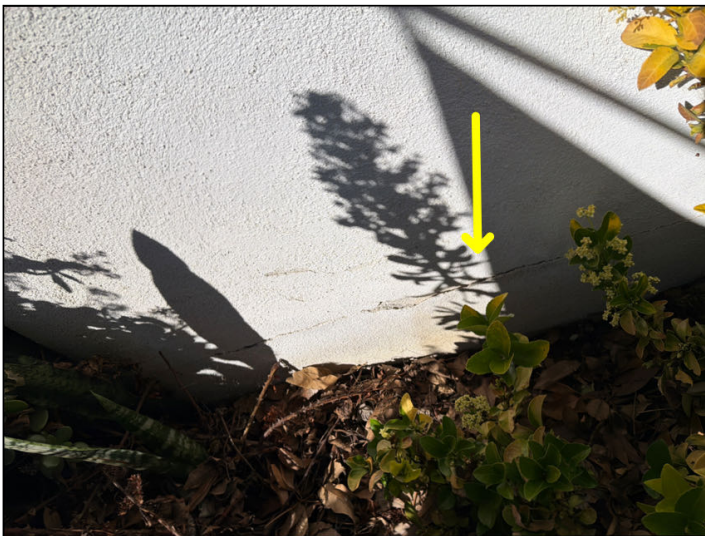
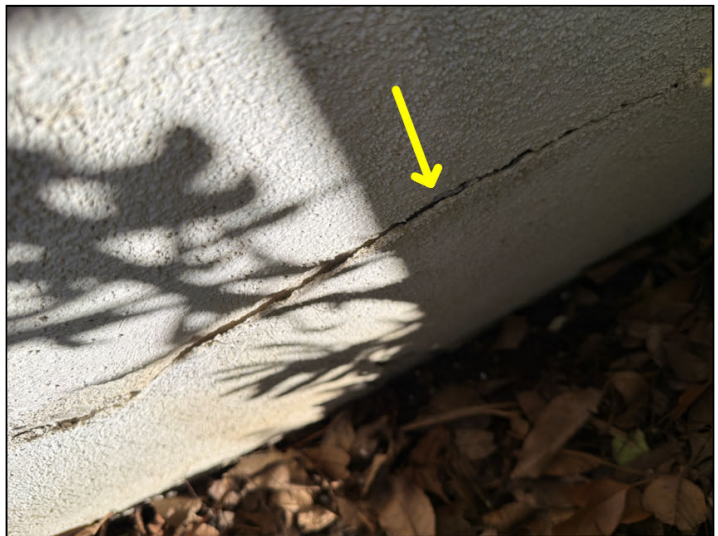
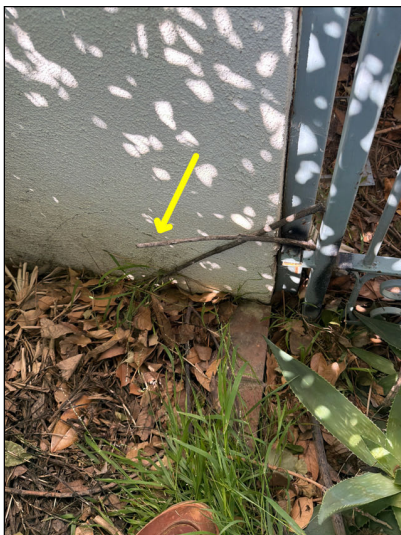
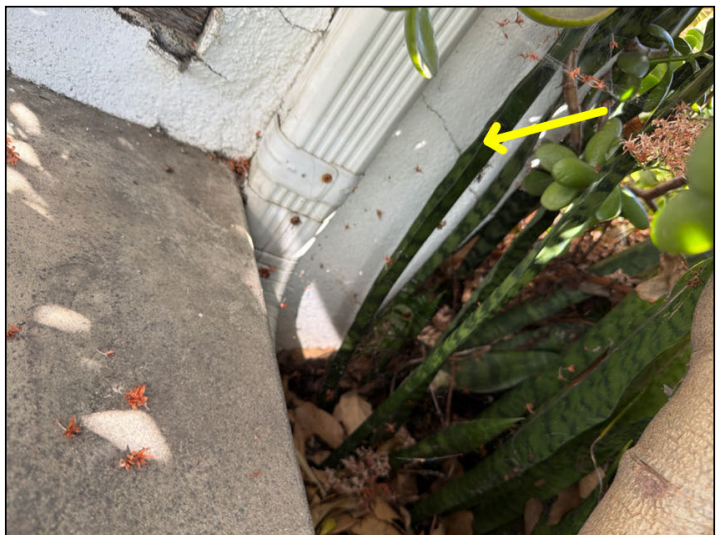
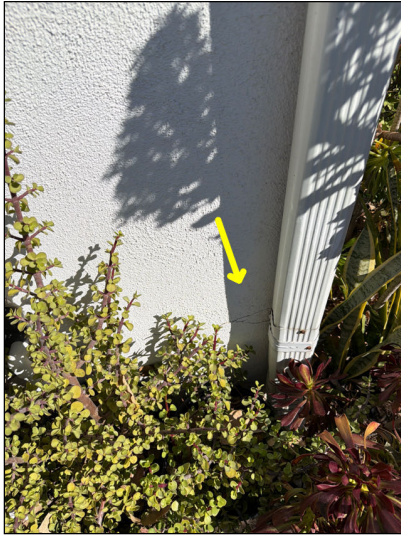
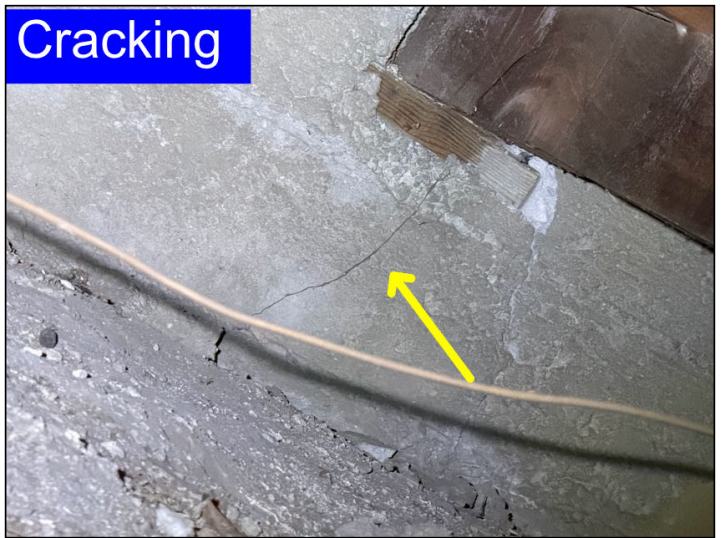
3. Foundation Walls

- The foundation appeared to be in serviceable condition at the time of inspection.
- Recommend further evaluation and or repairs by a licensed contractor.
- **Vertical crack(s) noted to the foundation wall.**
- **Efflorescence observed to the foundation walls. This is a mineral deposit left behind from exterior water infiltration.**
- **Recommend further evaluation and repairs by a licensed contractor.**

Efflorescence

Crack

Cracking

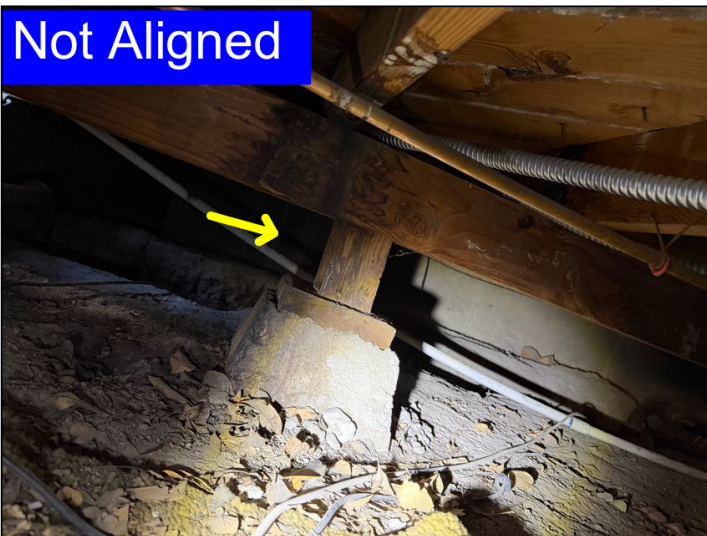
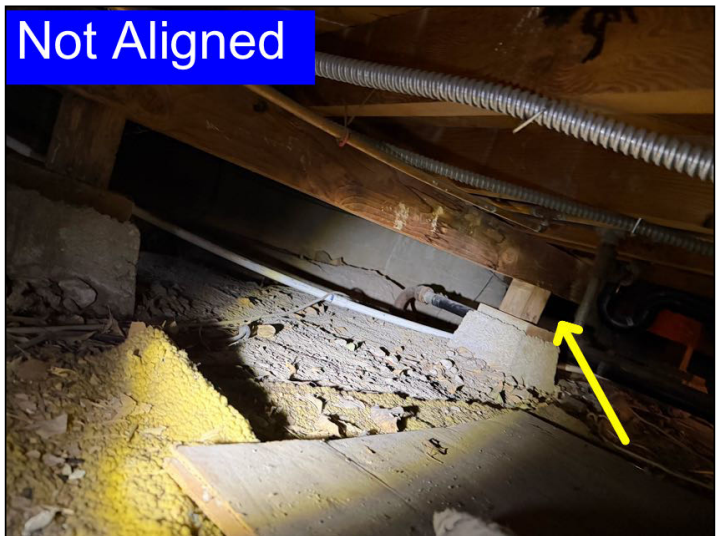
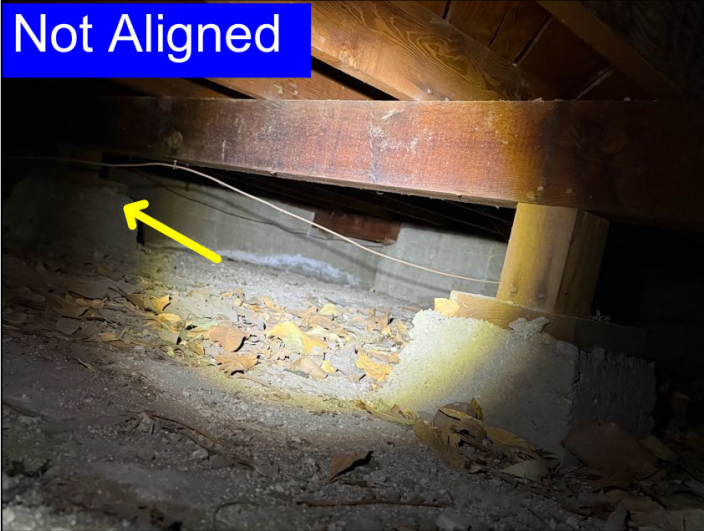
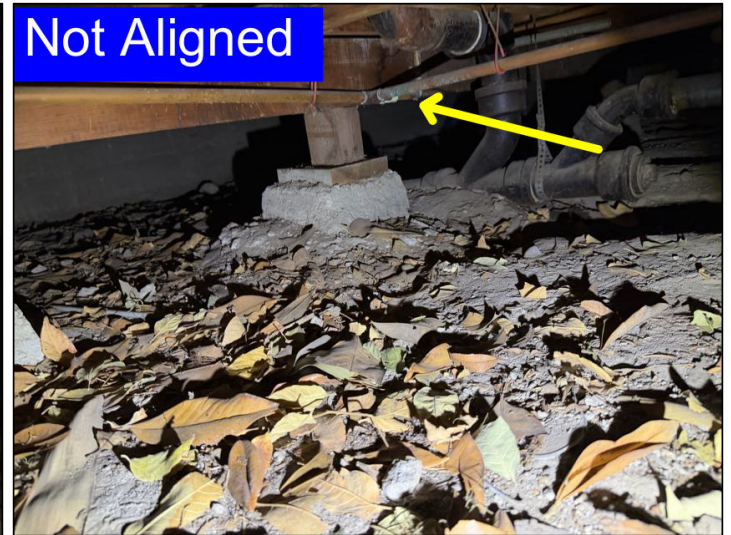
- The footing/post/beams/girders appeared to be in serviceable condition at the time of inspection.
- Inspector noted support post is not properly aligned and/or centered with the support beam. Recommend correction by a licensed contractor.

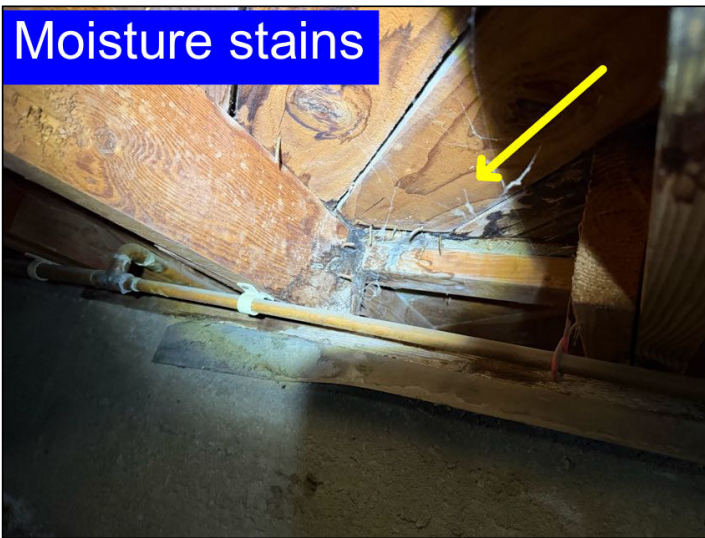
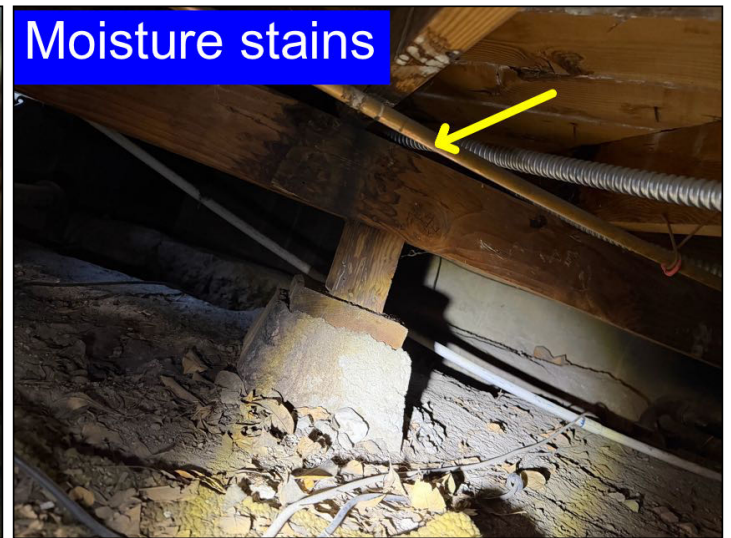
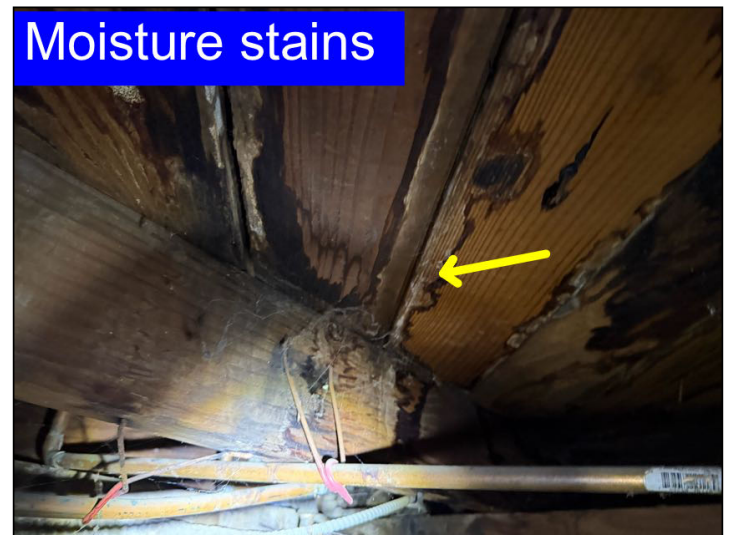
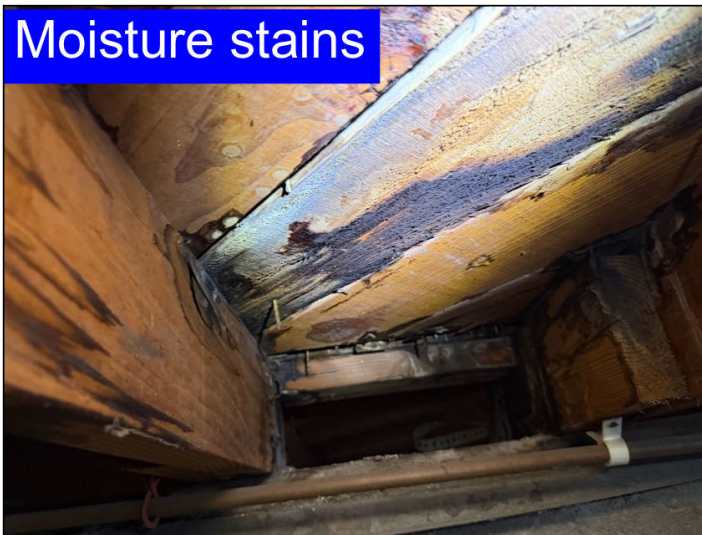
6. Sub Flooring & Crawlspace

- Surface fungus was noted at the subfloor in areas with moisture staining. Recommend further evaluation and necessary repairs by a licensed contractor for areas with moisture damage.

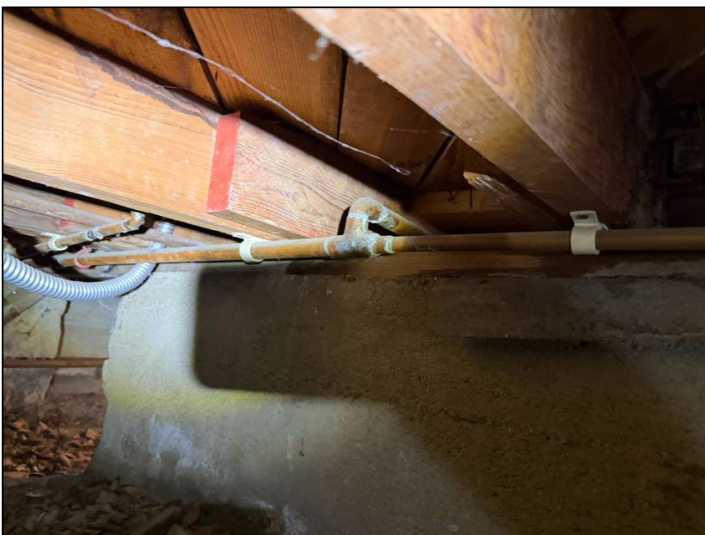
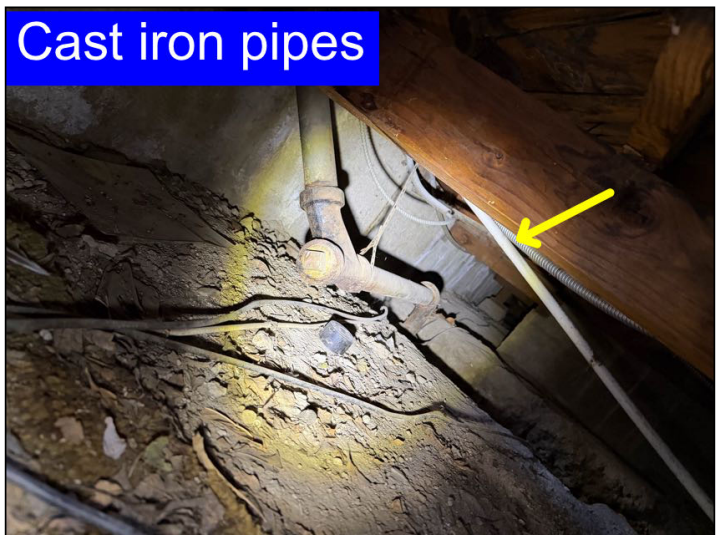
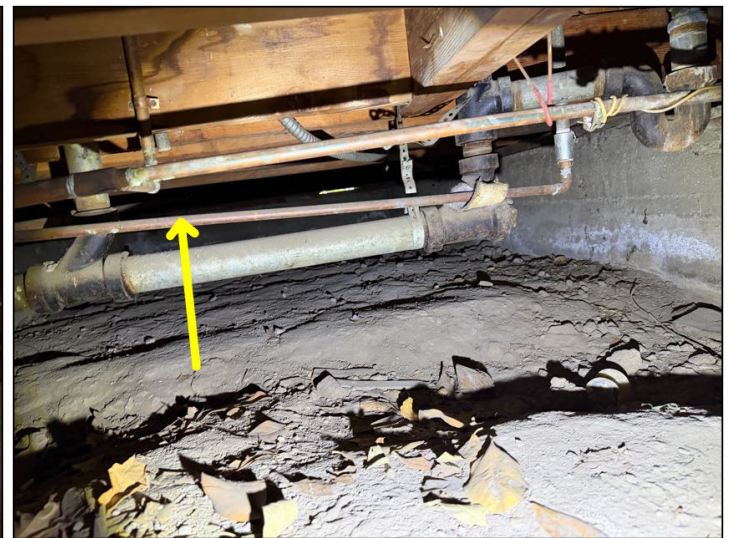
9. Foundation Plumbing

- The copper plumbing appeared to be in serviceable condition at the time of inspection.
- **Cast iron waste and/or vent pipe appeared in worn condition with rust and or corrosion. Recommend further evaluation and/or repairs, including upgrading cast-iron plumbing, by a licensed plumber.**

Corrosion

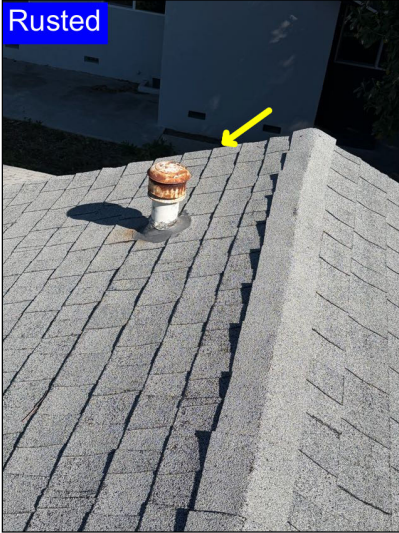
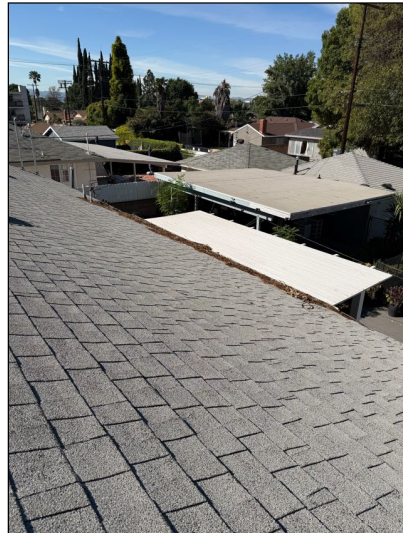
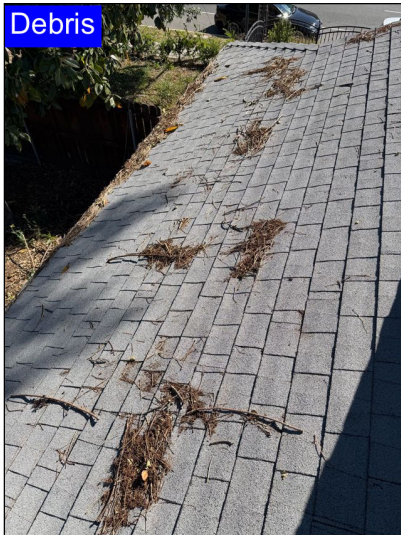
1. Roof Condition

- The main roof appeared to be in worn condition with signs of weathering and aging.
- **Roof appears to be in worn condition with signs of weathering and aging. Moderate wear noted in areas of the composition shingles with granule loss. Recommend further evaluation and repairs by a licensed roofer.**

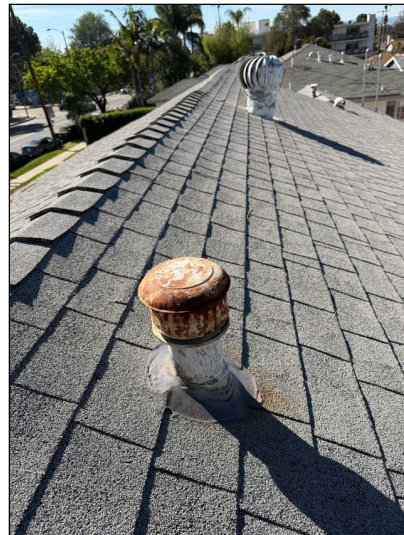
2. Flashing

- The exposed flashing is on worn condition at the time of inspection. Recommend further evaluation and repairs of flashing by a licensed roofer.

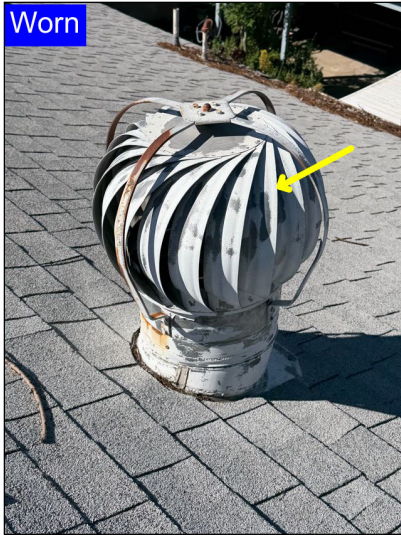
- The vent cap is rusted and appears to be failing. We recommend replacing the vent cap.

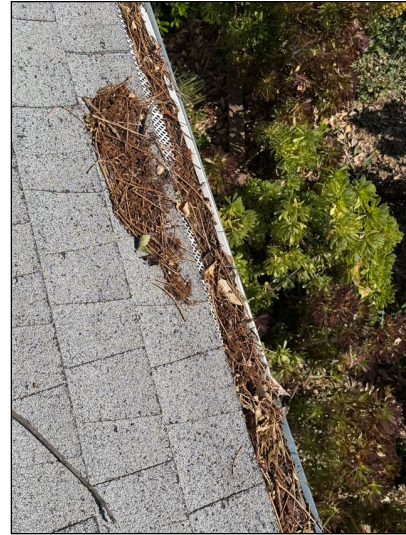
4. Gutter

- Partial gutters - Full installation recommended to keep water away from structure. Water can weaken the foundation and deteriorate the siding.
- Clean gutters: Significant amounts of debris evident at the gutter. Recommend cleaning gutters.

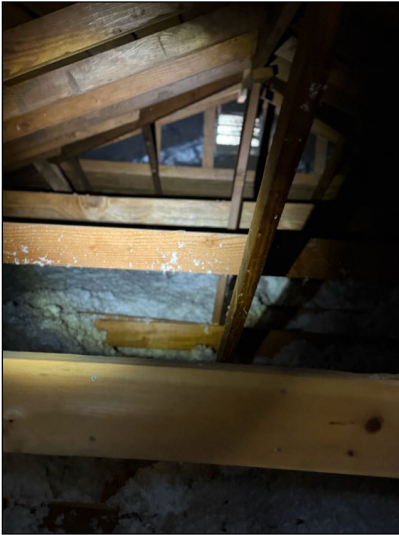
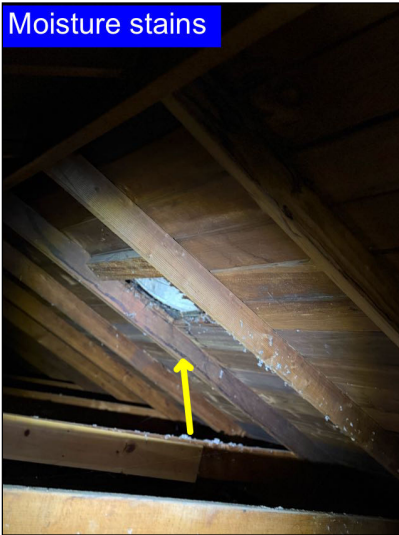
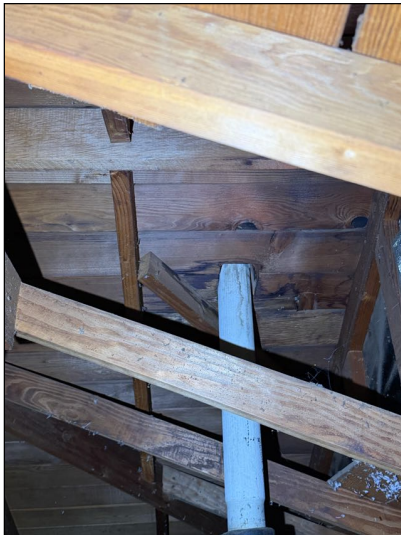
- The attic area appeared to be in serviceable condition at the time of inspection.
- **Moderate water stains visible. Unable to determine if there are active leaks. Recommend further evaluation.**

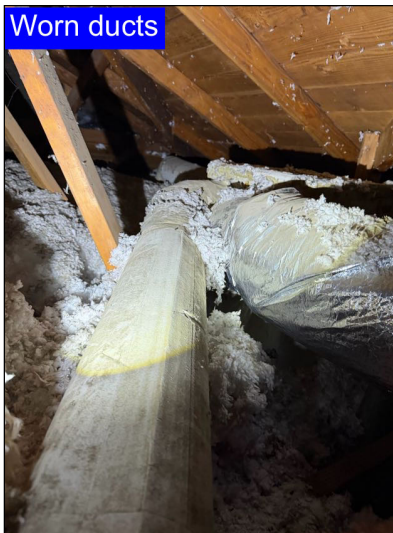
- **The ducting system is in worn condition at the time of inspection.**

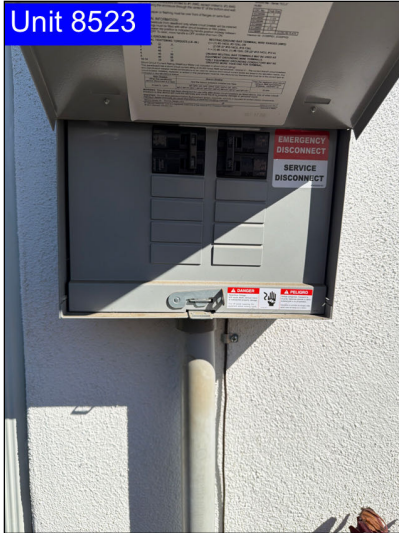
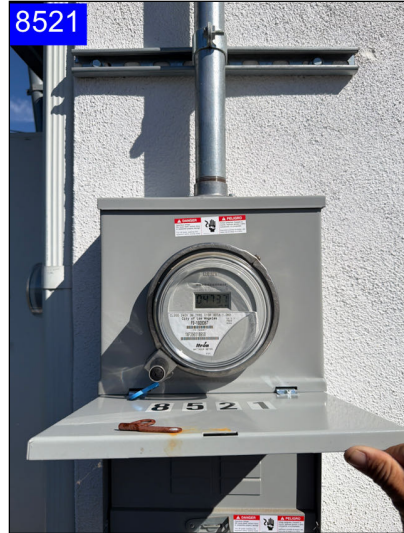
- The main panel appeared to be in serviceable condition at the time of inspection.

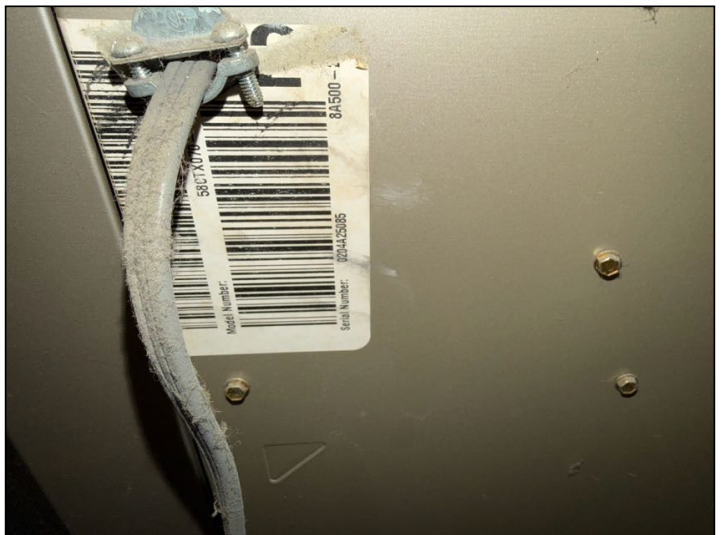
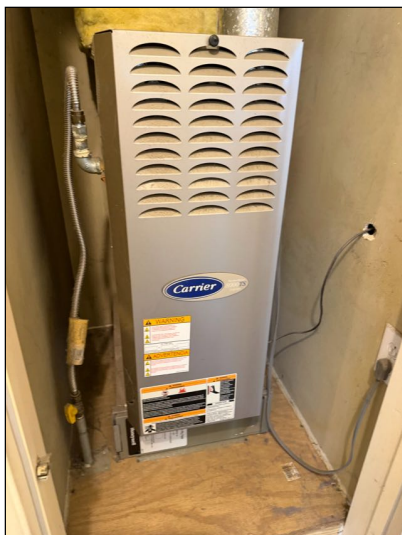
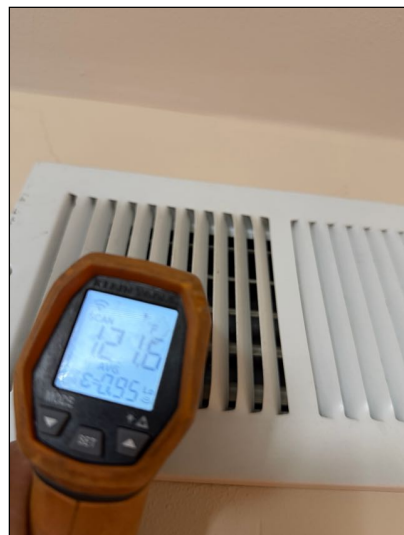
- The heating furnace is in serviceable condition at the time of inspection.
- Heating furnace appeared to have been manufactured 2004

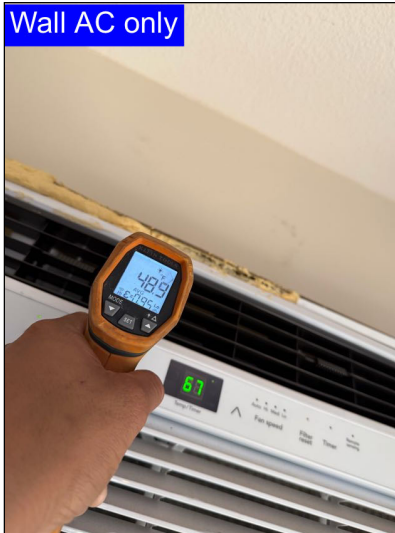
3. AC system - AC Compress Condition

- The wall AC was tested using normal operating controls and was functional at the time of inspection.

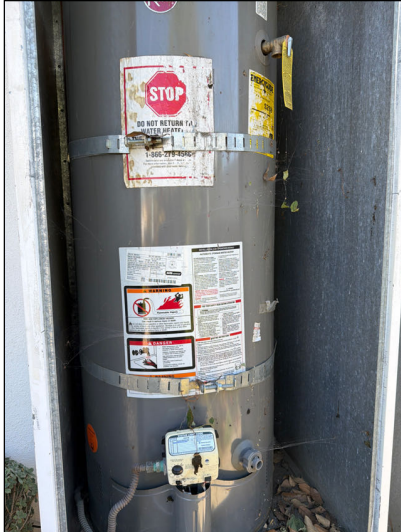
- The water heater appears to be in satisfactory condition at the time of inspection.
- Water heater manufactured date: October 8, 2021

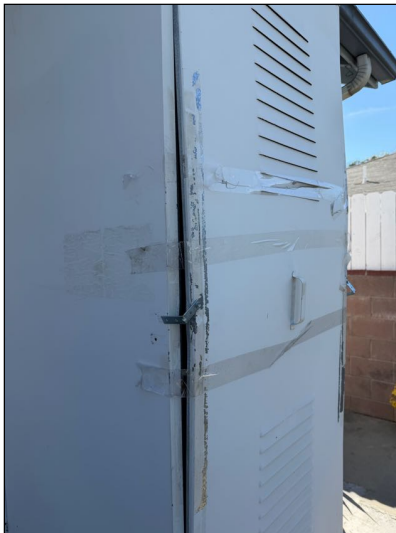
- **The water heater enclosure is showing signs of prior damage.**

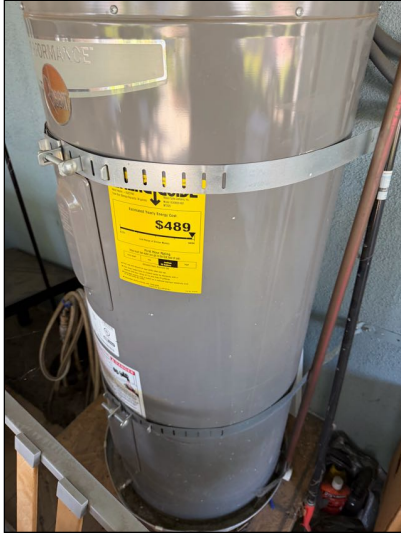
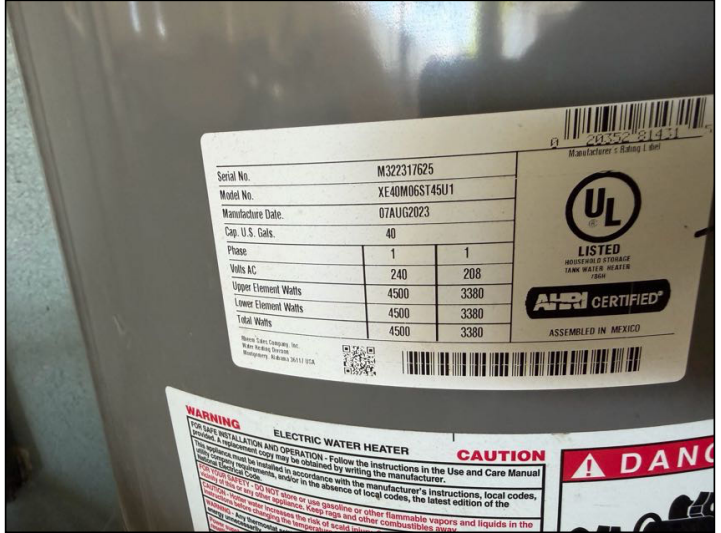
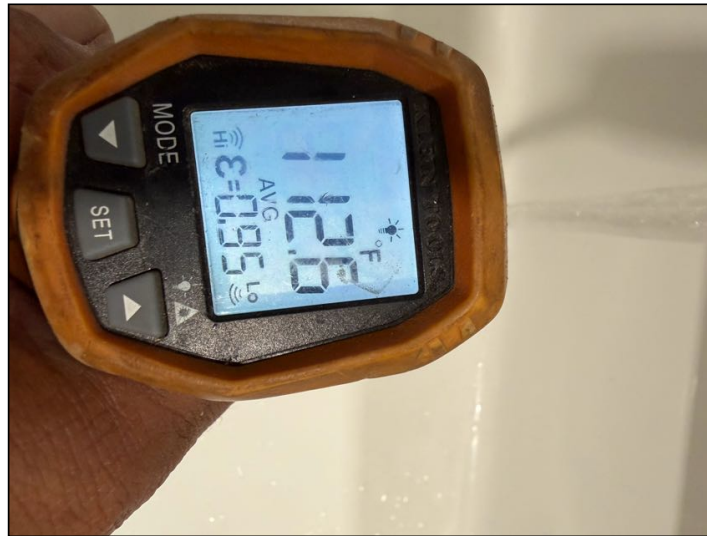
1. Water Heater Condition

- The water heater appears to be in satisfactory condition at the time of inspection.

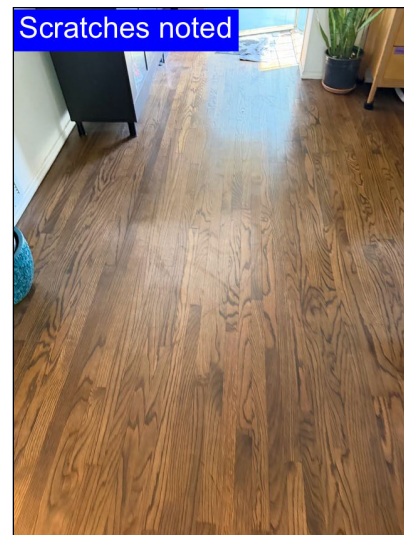
4. Floor Condition

- The floors appeared to be in serviceable condition at the time of inspection.
- **The wood floors are in worn condition at the time of inspection. Recommend upgrade of the wood flooring.**

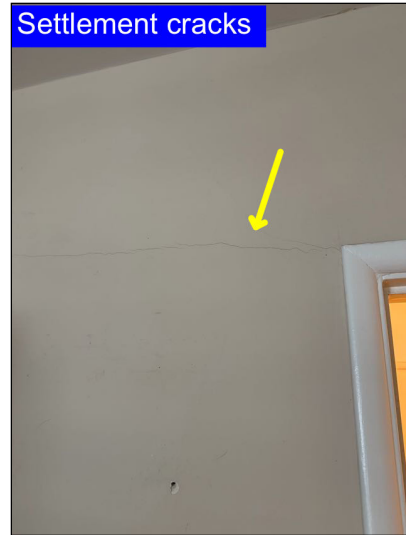
6. Wall Condition

- Settlement cracks were noted to interior walls.

Settlement crack are usually superficial. All houses settle over time, and this may cause a series of hairline cracks to appear in drywall.

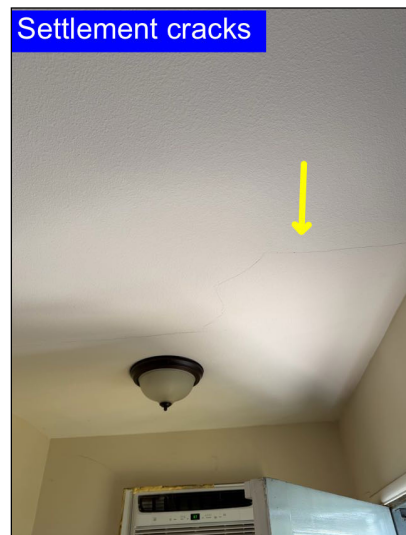
7. Ceiling Condition

• Settlement type cracks were noted to the ceiling.

Settlement cracks are usually superficial. All houses settle overtime and may cause a series of hairline cracks. Recommend repair of cracks and or monitoring.

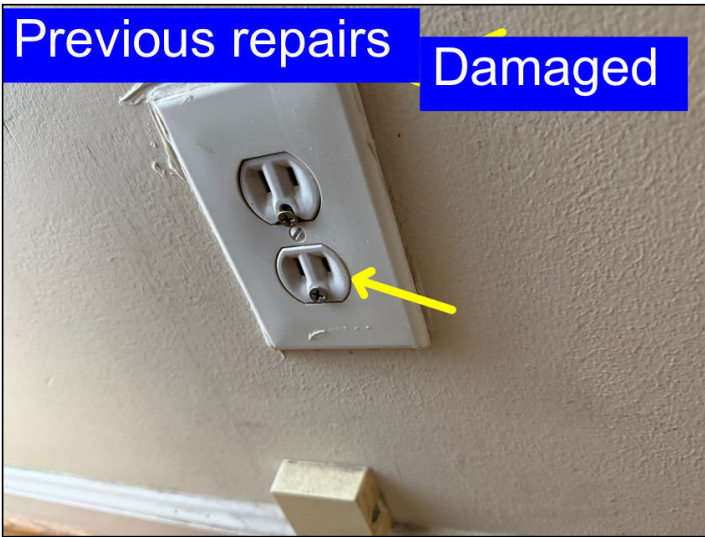
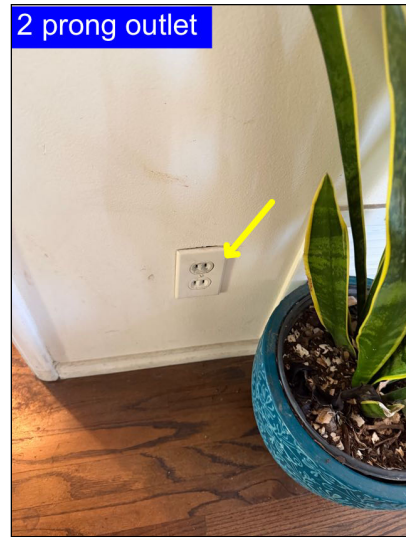
- The tested outlets were operational at the time of inspection.
- 2-prong outlets - The home contained outdated, ungrounded 2-prong electrical outlets. Although this condition may have been commonly considered safe or acceptable at the time the home was originally constructed, as general knowledge of safe building practices has improved with the passage of time, building standards have changed to reflect current understanding. Consider updating the existing condition to meet generally-accepted current standards.
- Damaged electrical outlet noted with signs of prior repair. Recommend further evaluation and repairs by a licensed electrician.

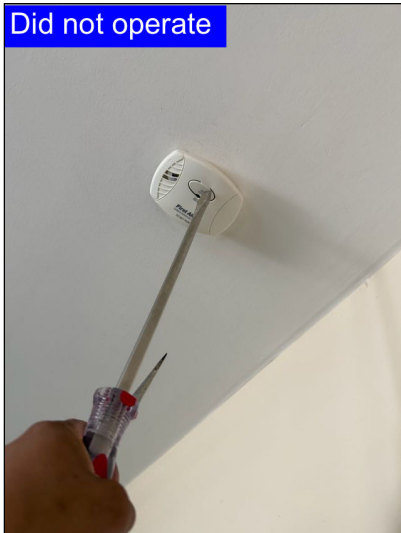
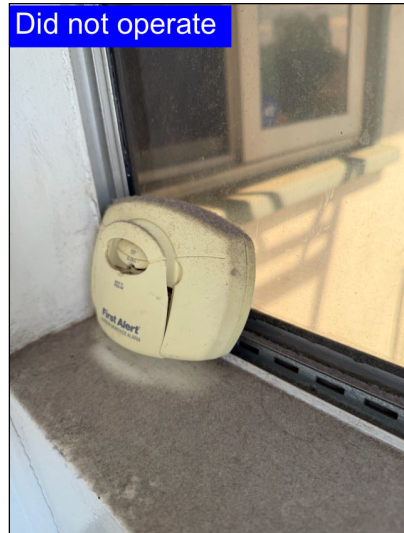
- Smoke detector missing at bedrooms. All bedrooms should have a operational smoke detector.
- The carbon monoxide detector did sound off the alarm when tested. Install a new battery and test monthly.

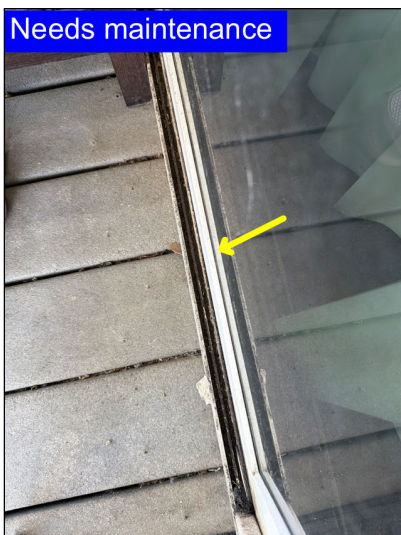
- The sliding patio door was functional during the inspection.
- The sliding door tracks appeared dirty at the time of inspection, making the door difficult to operate. Recommend servicing the door, including cleaning the tracks and lubricating the rollers.
- The patio door did not lock. Recommend further evaluation and repairs by a licensed contractor if needed.

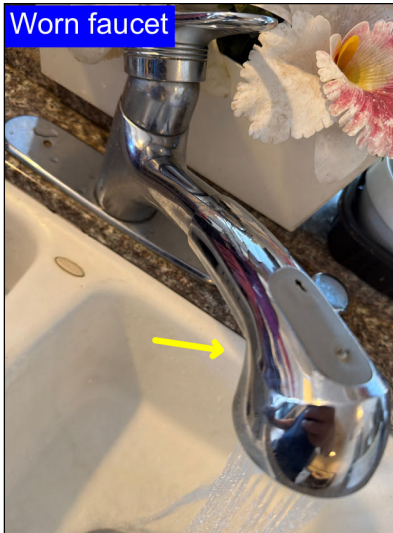
- The sink and faucets were operational at the time of inspection.
- The kitchen sink faucet is in worn condition, recommend upgrade.

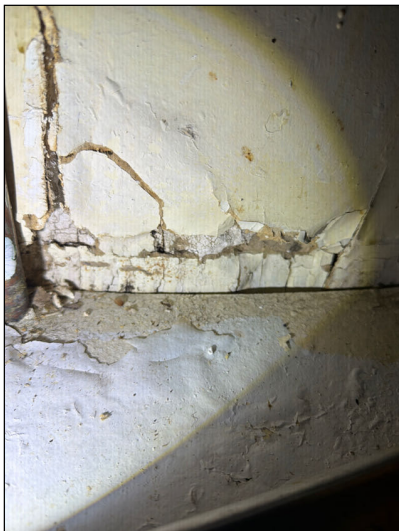
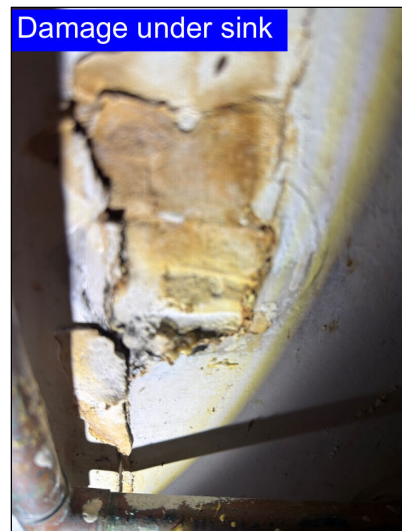
Damage under sink

- **DEFERRED COST:** The cabinets are in worn condition. Consider upgrade.
- Moisture damage and possible mold were noted on the walls beneath the kitchen cabinet/sink. Recommend further evaluation and repairs by a licensed contractor.

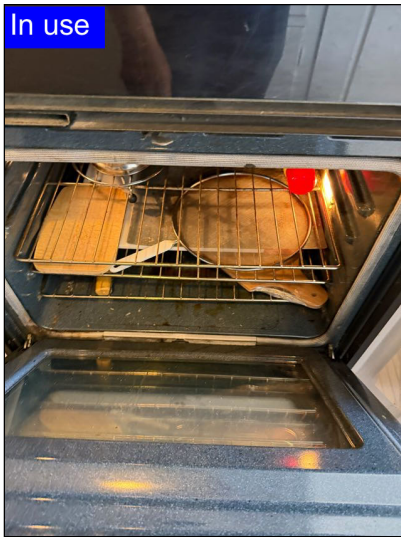
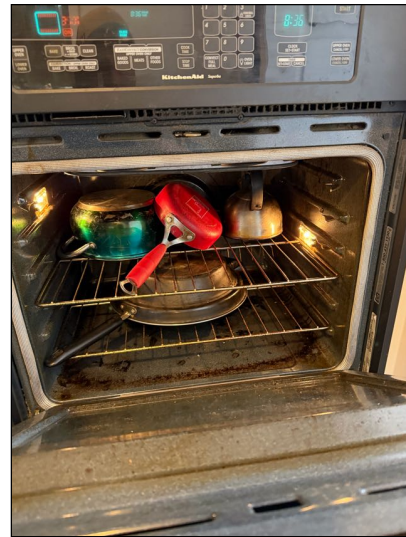
7. Cook top / Range condition

Observations:
 • **DEFERRED COST:** The stove/range is in worn condition at the time of inspection. Recommend service and or upgrade of the stove/range.
 • The burners did not operate properly when tested.

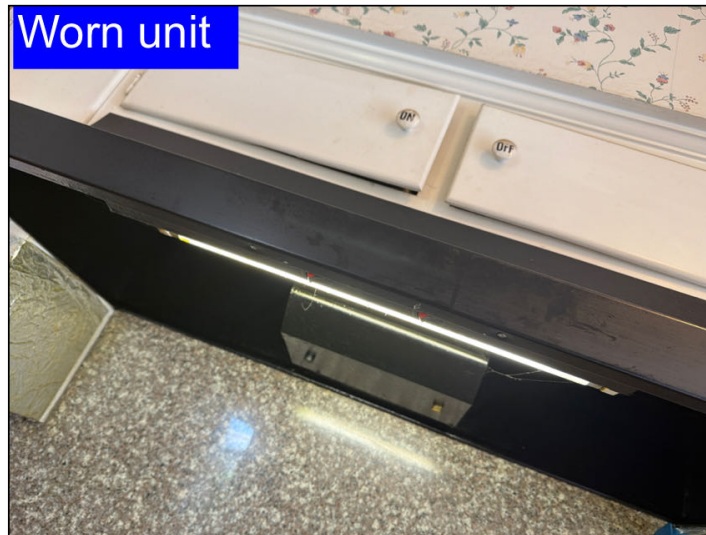
8. Vent Condition

Observations:
 • The exhaust fan was operational at the time of inspection.
 • The kitchen exhaust fan filter was dirty at the time of inspection. Recommend cleaning and or replacing the exhaust filter.

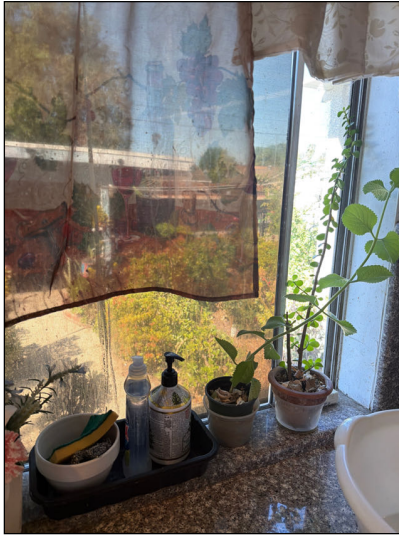
- In the inspectors opinion the windows/frames are near the end of their useful life.

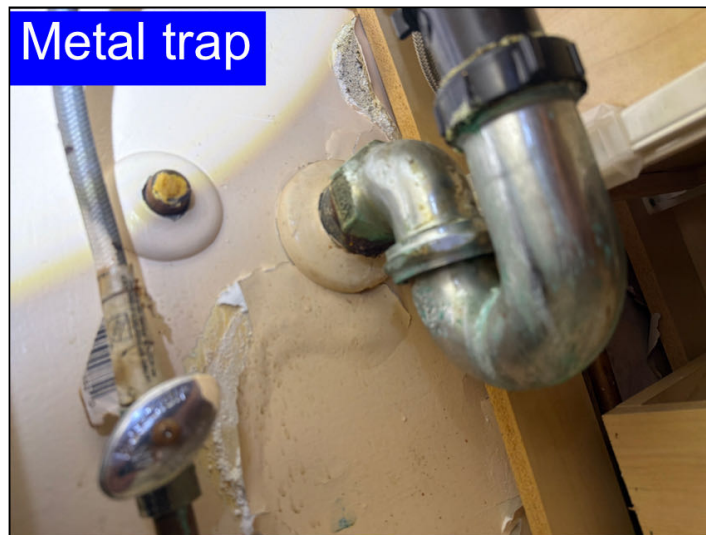
- The bath plumbing was in serviceable condition at the time of inspection.
- Older style metal traps noted. Buyer is cautioned that these traps can leak at any time due to corrosion.

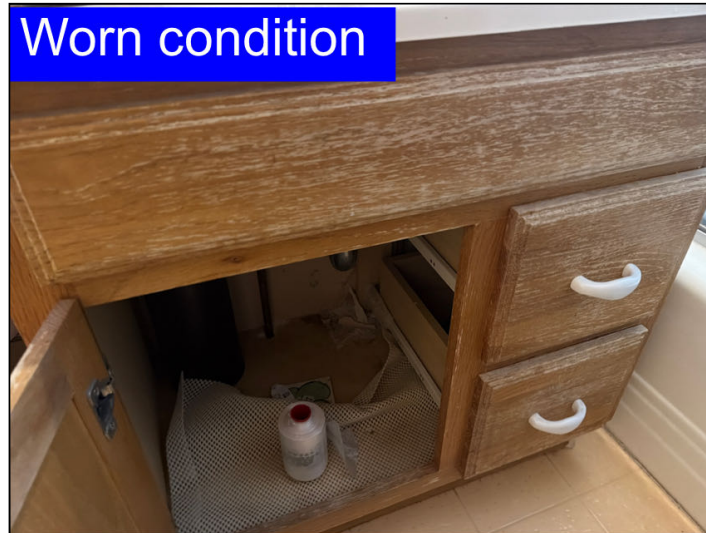
4. Cabinets

- **DEFERRED COST:** The cabinets are in worn condition. Consider upgrade..
- Moisture damage was noted between the bathtub and adjacent cabinet. Recommend further evaluation and repairs by a licensed contractor.

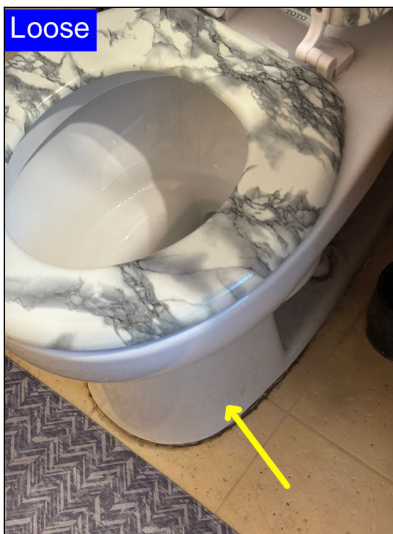
- The toilets were serviceable at the time of inspection.
- A loose toilet and/or loose/soft sub-flooring was observed. This can indicate damage to the sub-flooring beneath the fixture and floor covering. This condition is not visible or fully accessible to the inspector without destructive investigation. Client is advised to seek further review by a licensed plumbing contractor prior to closing for repairs/replacement as required.

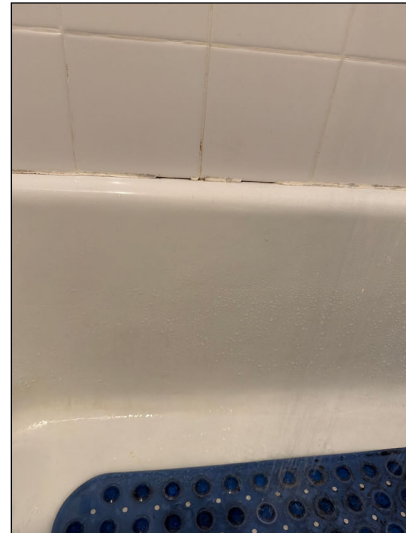
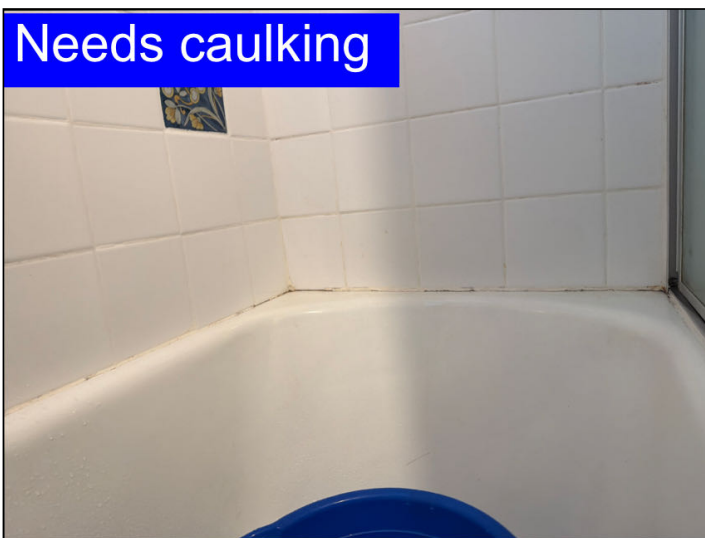
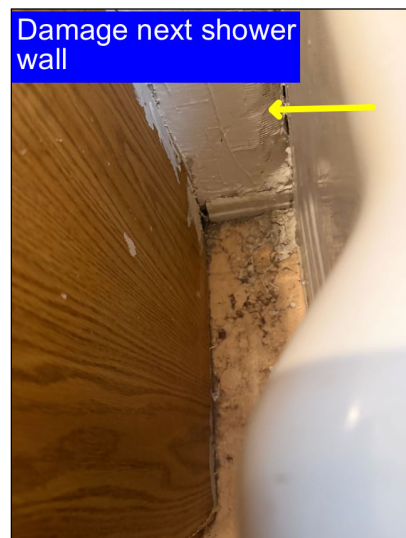
- The shower walls are in serviceable condition at the time of inspection.
- Recommend caulking as required.

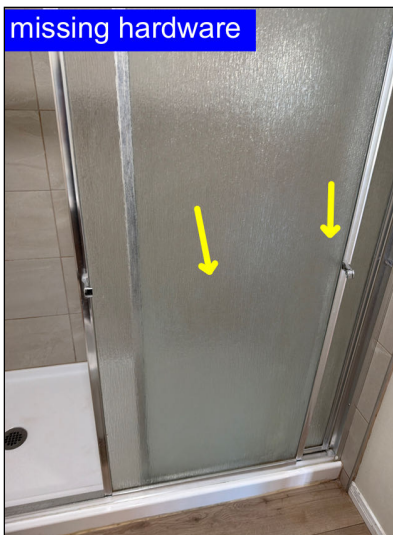
- The shower enclosure was functional at the time of the inspection.
- **Missing hardware on the shower door.**

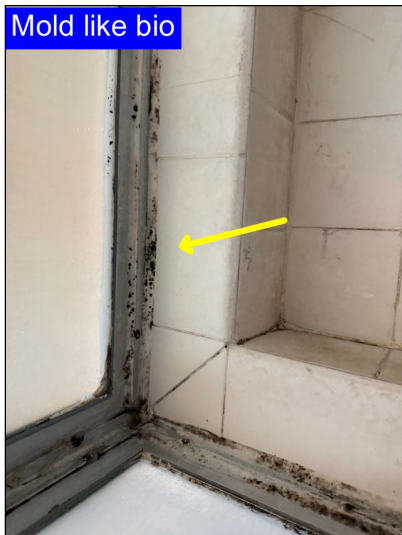
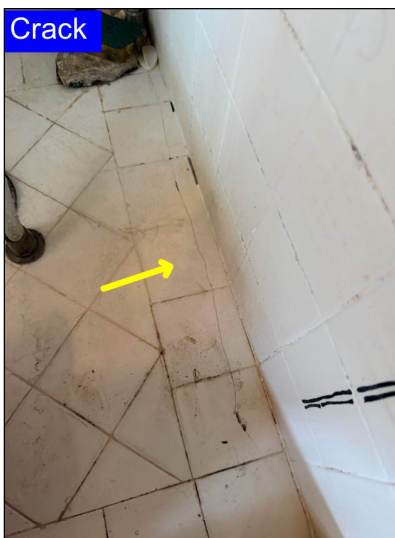
- The shower walls are in serviceable condition at the time of inspection.
- Suggest all tile edges and tub/shower walls be caulked and sealed to prevent moisture penetration.

All missing/damaged grouting should be replaced. Failure to keep walls sealed can cause deterioration and extensive moisture damage to the interior walls and surrounding sub-flooring. This damage is not always visible or accessible to the inspector at the time of inspection.

- Cracked/Broken tile observed at the shower at the time of inspection. Recommend repair.

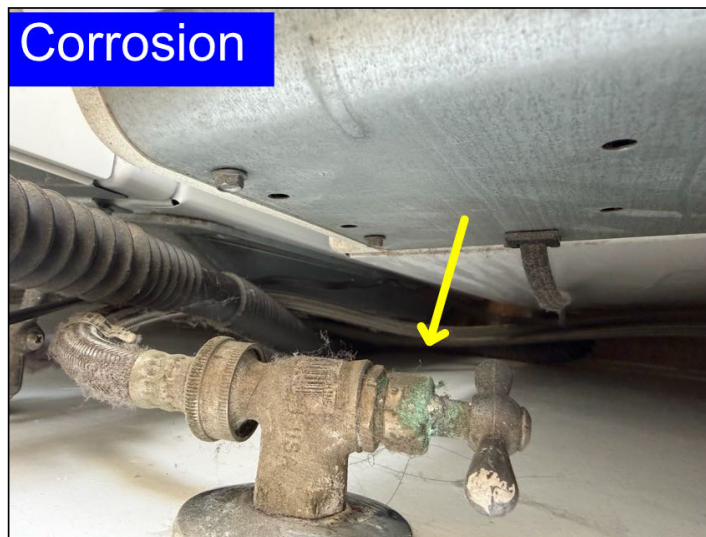
- The laundry area plumbing appeared to be serviceable condition at the time of inspection.
- **Corrosion was noted to the supply lines at the time of inspection.**
