CROSSWIND HOME INSPECTION

HOME INSPECTION

645 Elm Ave
Long Beach, CA 90802

04/11/2025

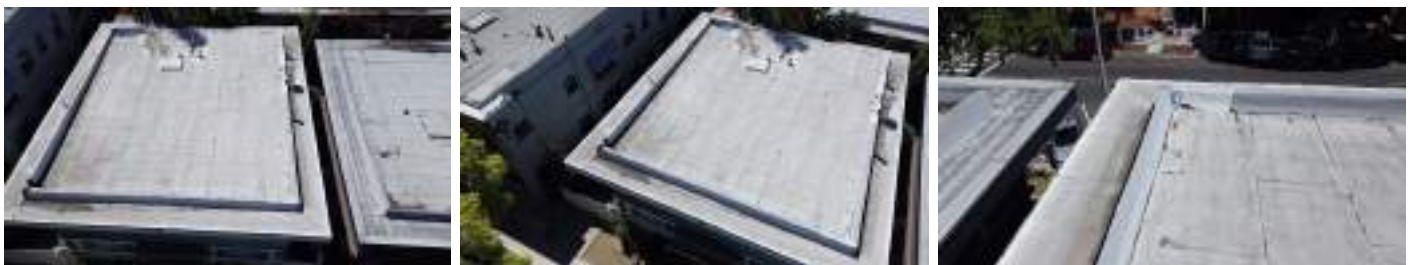
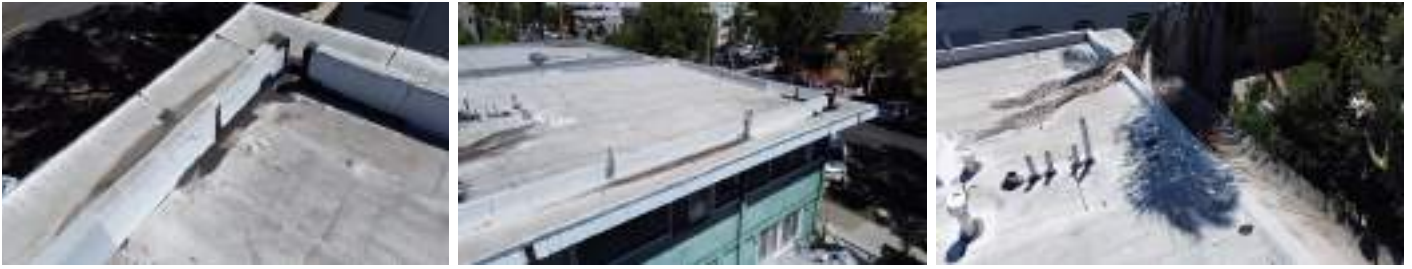
I observed the roof-covering material and attempted to identify its type.

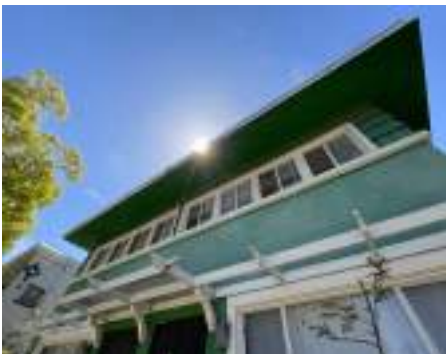
Flashing: Eaves and Gables

I looked for flashing installed at the eaves (near the gutter edge) and at the gables (the diagonal edge of the roof). There should be metal drip flashing material installed in these locations. The flashing helps the surface water on the roof to discharge into the gutter. Flashing also helps to prevent water intrusion under the roof-covering.

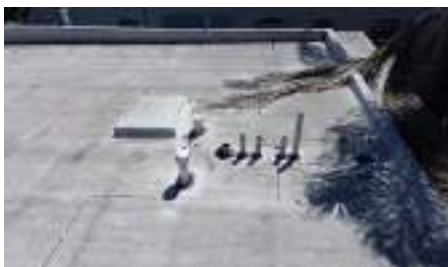
Plumbing Vent Pipes: Plumbing Vent Pipes Inspected

I looked at DWV (drain, waste and vent) pipes that pass through the roof covering. There should be watertight flashing (often black rubber material) installed around the vent pipes. These plumbing vent pipes should extend far enough above the roof surface.

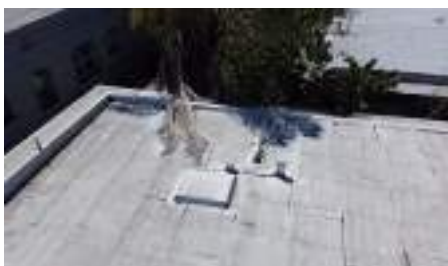
I looked at flue gas vent pipes that pass through the roof covering.

All gas-fired appliances must be connected to venting systems. There should be watertight metal flashing installed around the flue gas vent pipes. The vent pipes should extend far enough above the roof surface.

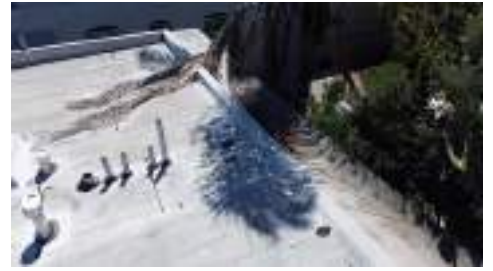
I observed indications that a tree and or tree branch were overhanging the roof and maybe in contact with it.

Contact a qualified tree service company.

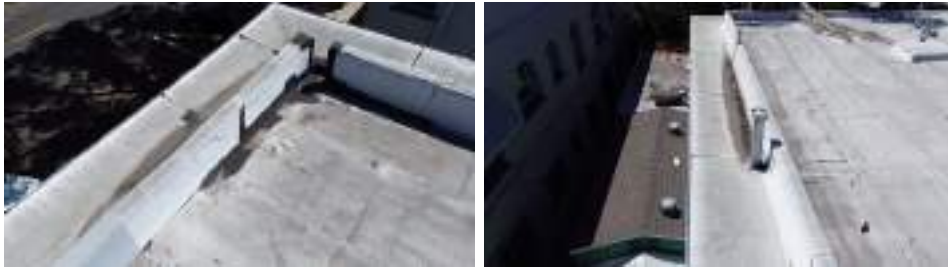
I observed indications of ponding in one or more areas of roof. Ponding or puddling of water concentrated in a particular area of the roof can lead to the deterioration and the roof leaking water. Recommend a qualified roofing contractor evaluate further and make any repairs deemed necessary.

Contact a qualified roofing professional.

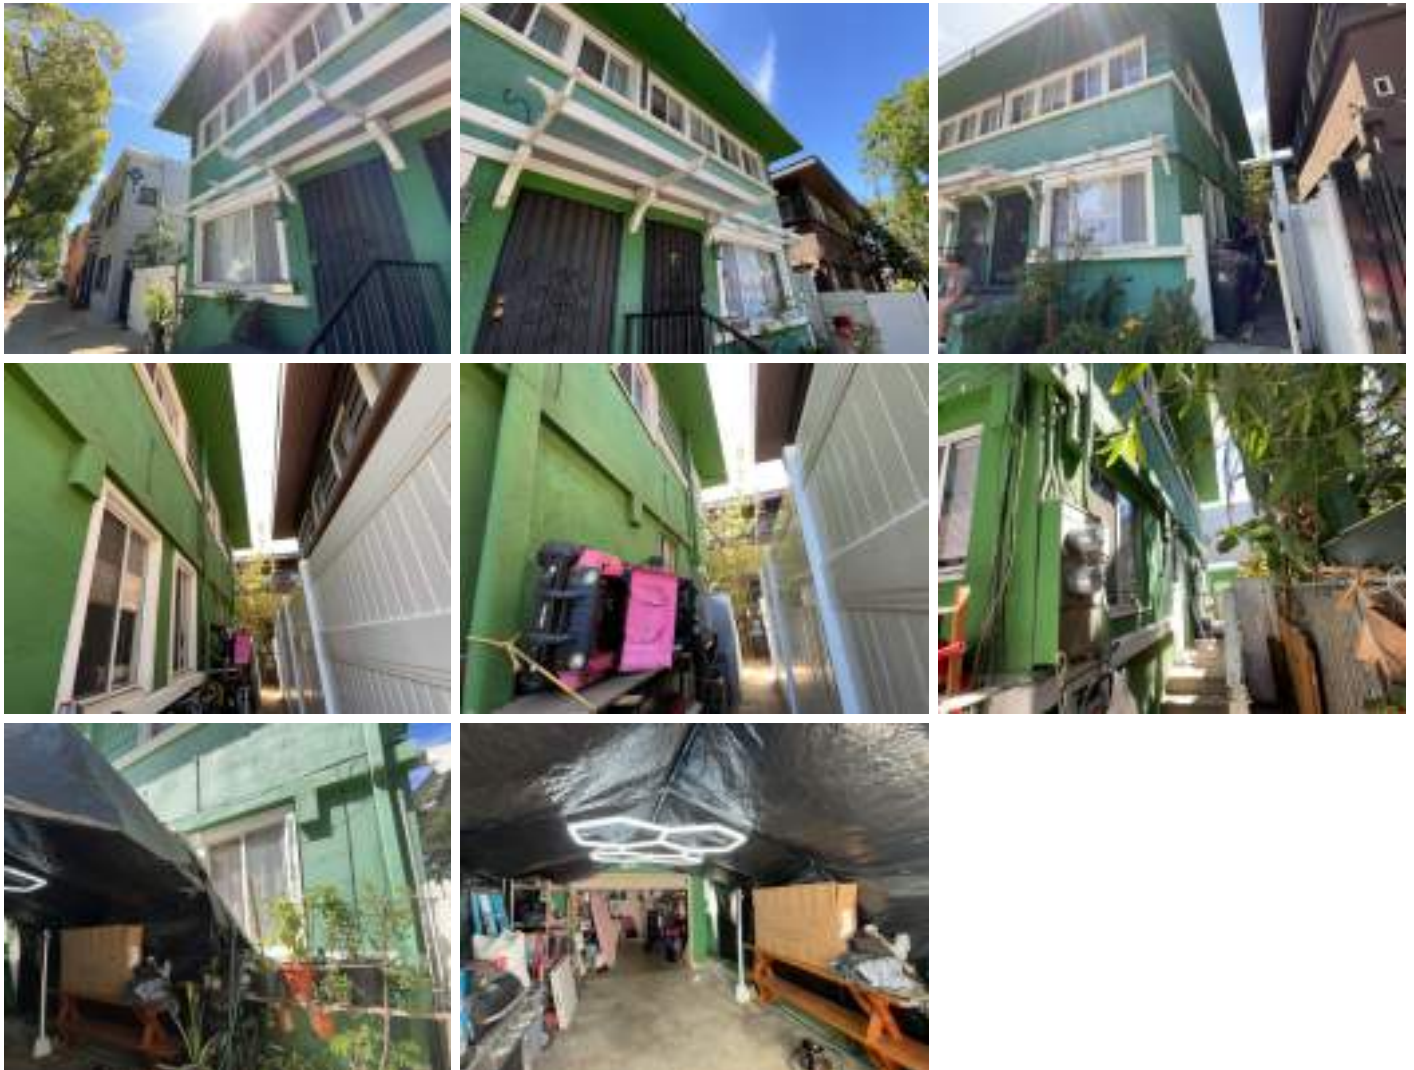
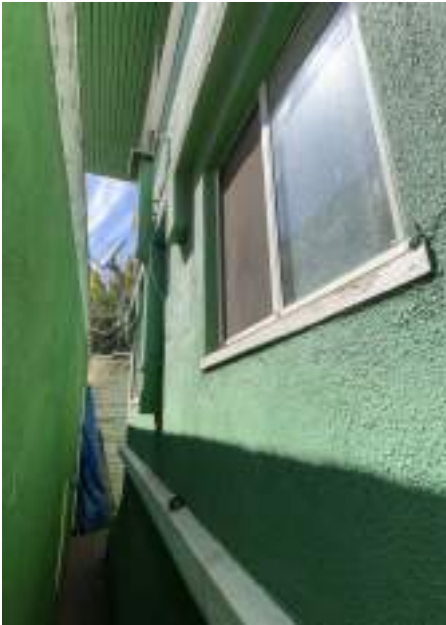
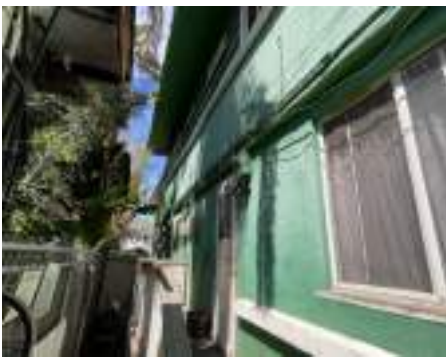
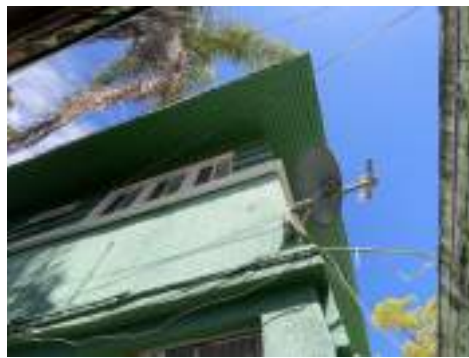
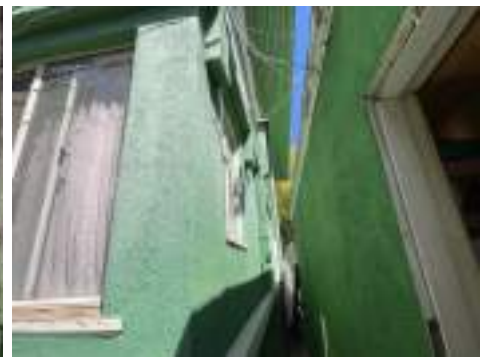
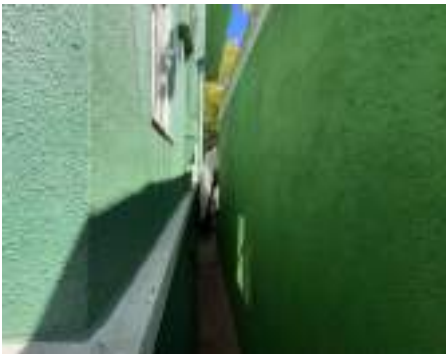
General: Exterior Was Inspected

I inspected the exterior of the house.

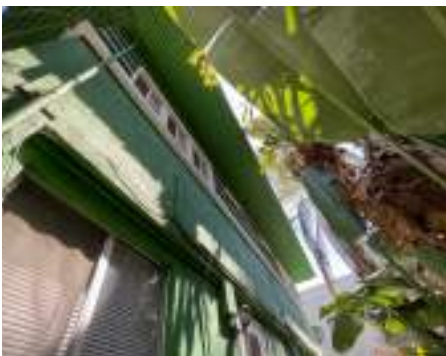
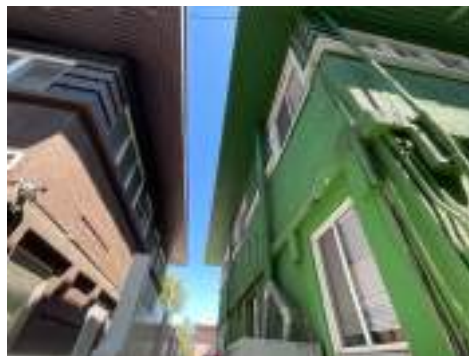
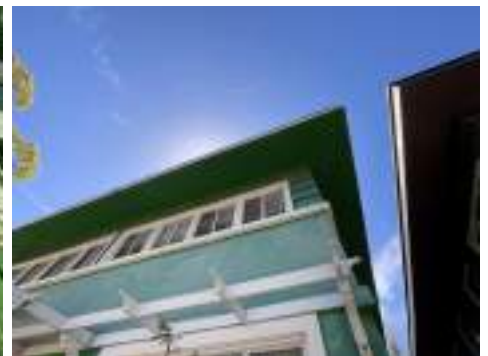
Eaves, Soffits & Fascia: Eaves, Soffits and Fascia Were Inspected

I inspected the eaves, soffits and fascia. I was not able to inspect every detail, since a home inspection is limited in its scope.

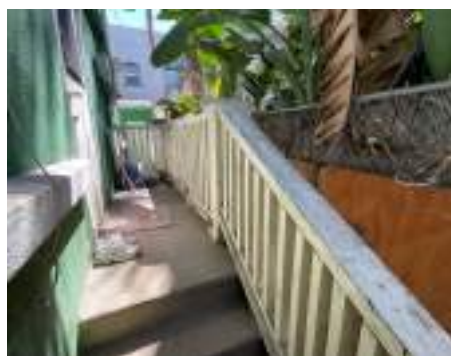
Windows: Windows Inspected

A representative number of windows from the ground surface were inspected.

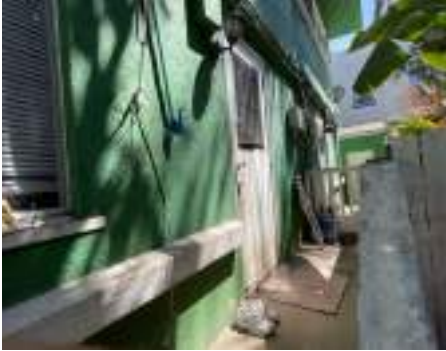
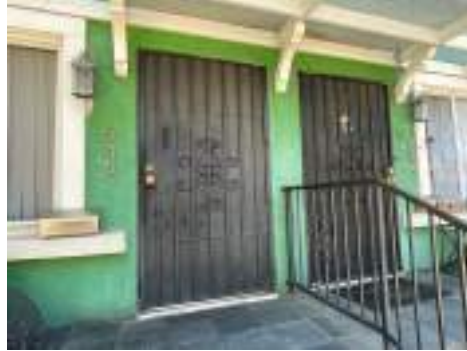
Exterior Doors: Exterior Doors Inspected

I inspected the exterior doors.

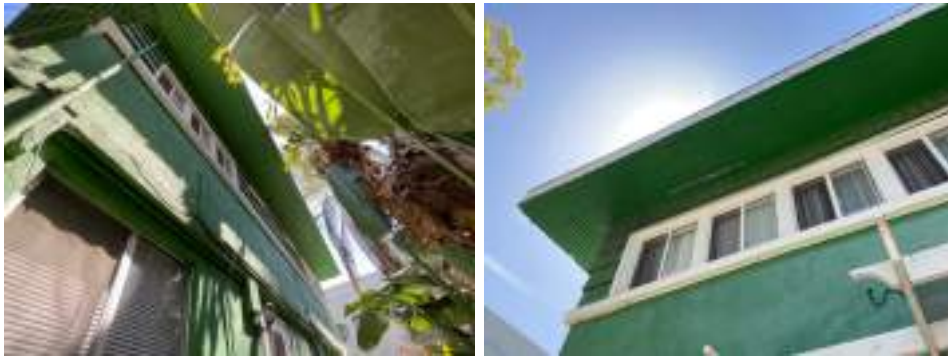
**PAINT SURFACE IN POOR CONDITION**

I observed indications of paint or staining in poor condition. Flaking, cracking, and worn areas.

Correction and further evaluation is recommended.

Contact a qualified painting contractor.

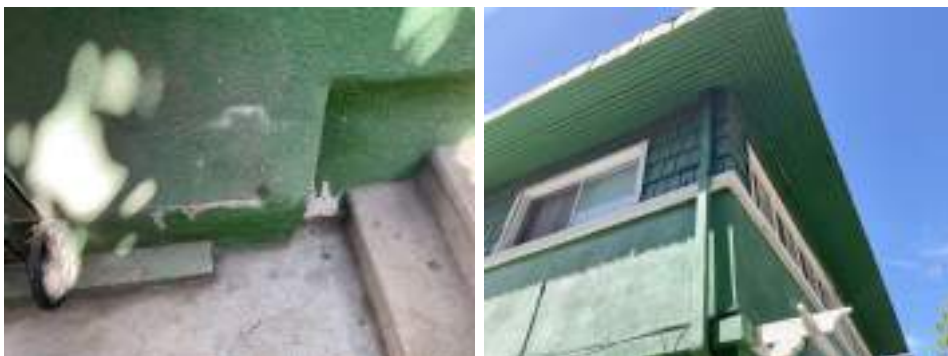
3.3.1 Wall-Covering, Flashing & Trim

**DAMAGED WALL-COVERING MATERIAL**

I observed indications of a defect at the exterior wall-covering material.

Correction and further evaluation is recommended.

Contact a qualified professional.

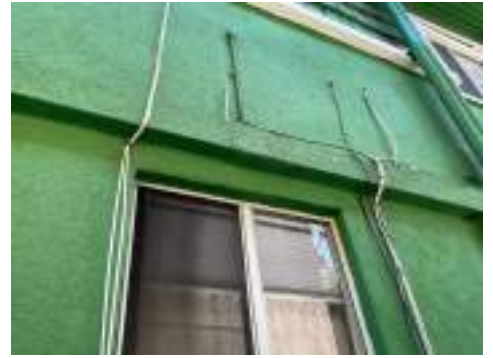
3.3.2 Wall-Covering, Flashing & Trim

CRACKING

Siding showed cracking in one or more places. Recommend monitoring.

Recommended DIY Project

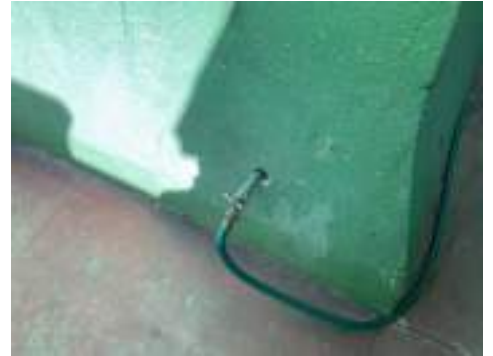
3.3.3 Wall-Covering, Flashing & Trim

INADEQUATE SEALING

I noted in one or more locations there were gaps in the siding, I recommend sealing all gaps to prevent moisture and pest intrusion.

Contact a qualified professional.

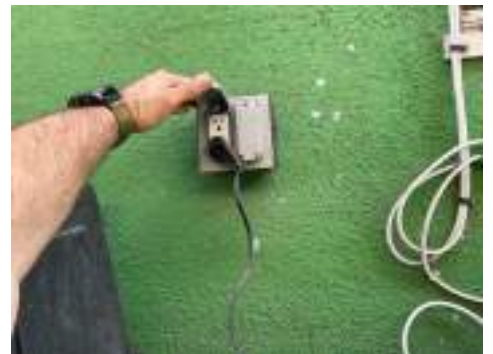
3.5.1 GFCIs & Electrical

MISSING GFCI

I observed indications that a GFCI is missing in an area that is required to keep people safe.

Contact a qualified electrical contractor.

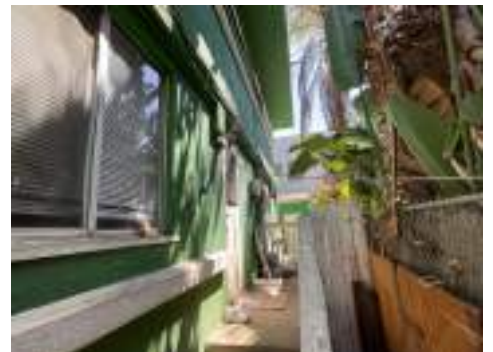
3.5.2 GFCIs & Electrical

LOOSE WIRES

I noted loose wires on the exterior, recommend securing.

Contact a qualified professional.

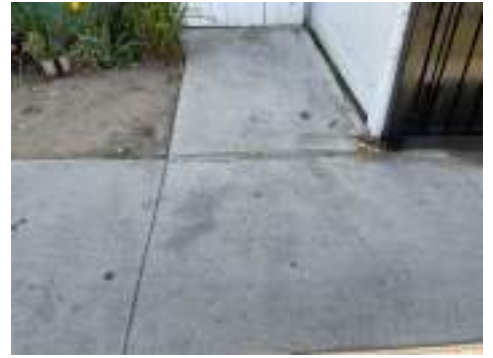
3.6.1 Walkways & Driveways

TRIP HAZARD

I observed a trip hazard. This condition is a safety concern.

Correction and further evaluation is recommended.

Contact a handyman or DIY project

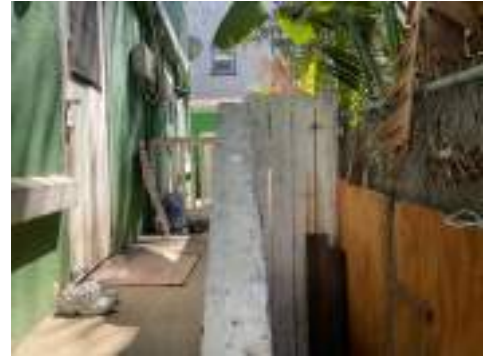
3.9.1 Railings, Guards & Handrails

I observed a handrail that is not grippable or graspable. This condition is a safety hazard.

Correction and further evaluation is recommended.

Contact a qualified handyman.

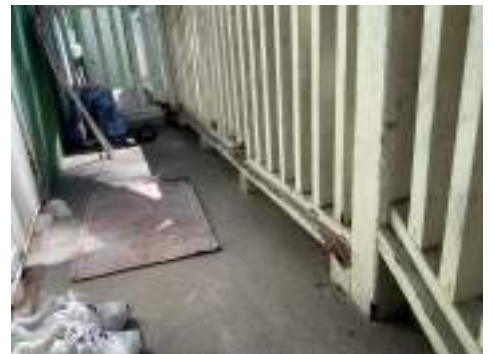
3.9.2 Railings, Guards & Handrails

WDO DAMAGE NOTED

I was able to see some damage possibly caused by WDO. I recommend having the damage repaired.

Contact a qualified professional.

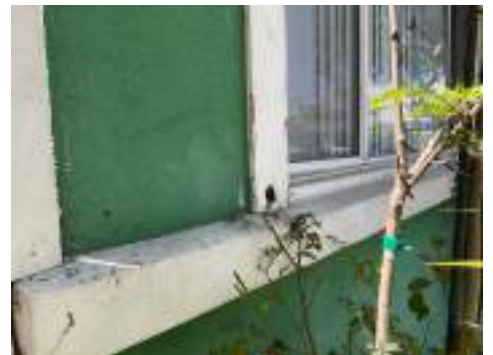
3.10.1 Windows

WOOD ROT AT WINDOW

I observed indications of wood rot at the window.

Correction and further evaluation is recommended.

Contact a qualified handyman.

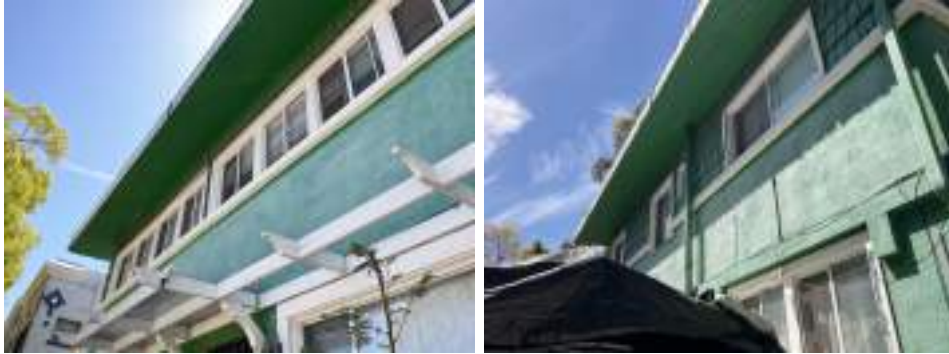
3.10.2 Windows

**WINDOW TRIM DAMAGED**

I noted some damage to the trim around one or more windows, recommend repair to prevent progression and further deterioration of the trim piece.

Contact a qualified professional.

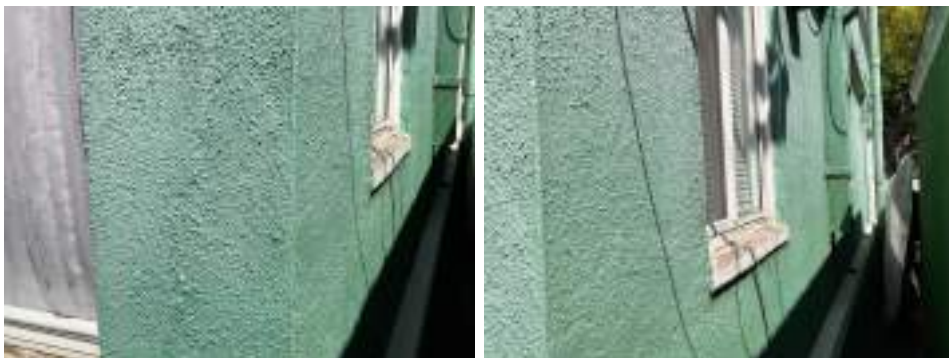
3.10.3 Windows

**WORN FINISH AT WINDOW SIL**

I noted the finish was worn an one or more window sills. Recommend refinishing to extend t he life of the substrate.

Contact a qualified professional.

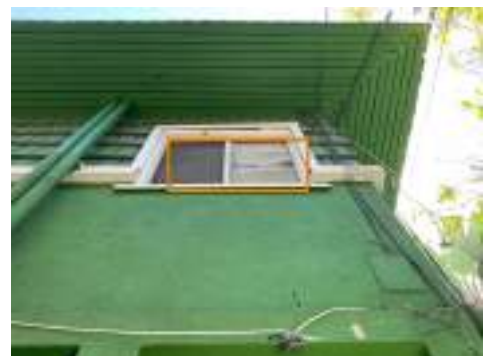
3.10.4 Windows

I noted possible microbial growth at one or more windows, recommend further testing and evaluation.

Contact a qualified professional.

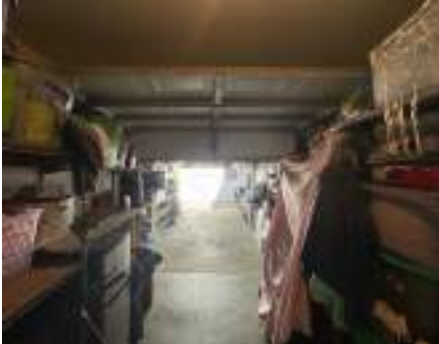
Garage Vehicle Door: Type of Door Operation

Manual

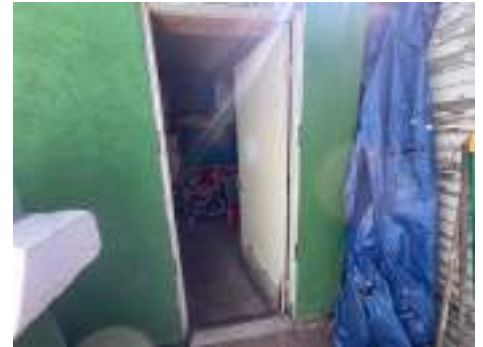
Exterior Door: Exterior Doors Inspected

I inspected the exterior doors of the detached garage.

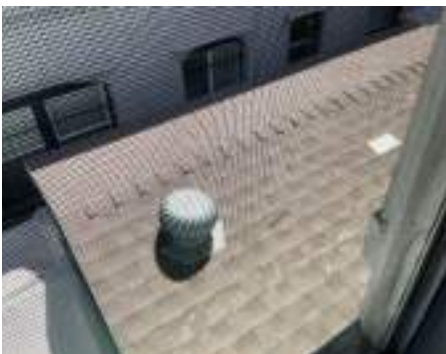
I observed the roof-covering material and attempted to identify its type.

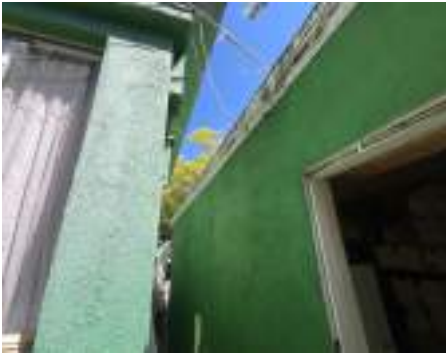
Roof Flashing: Eaves and Gables

I looked for flashing installed at the eaves (near the gutter edge) and at the gables (the diagonal edge of the roof).

There should be metal drip flashing material installed in these locations. The flashing helps the surface water on the roof to discharge into the gutter. Flashing also helps to prevent water intrusion under the roof-covering.

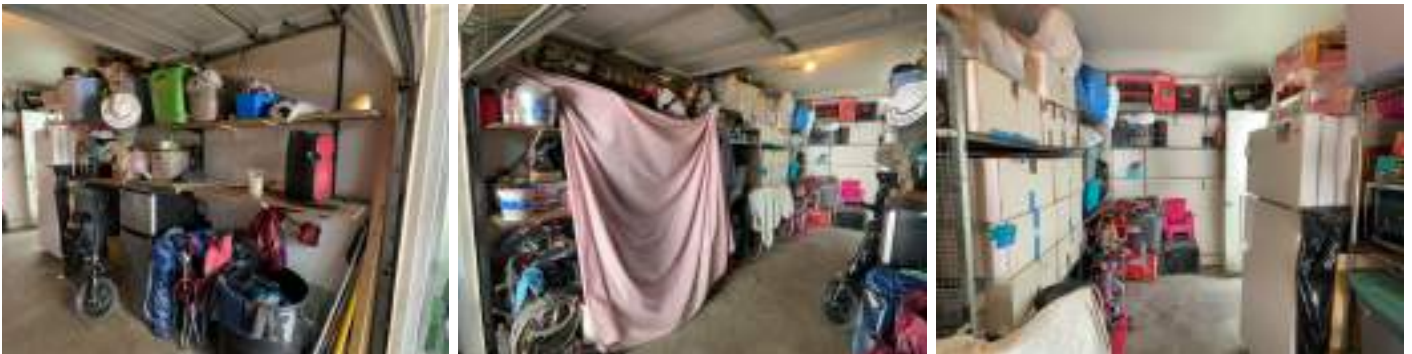
Ceiling & Walls in Garage: Garage Ceiling & Walls Were Inspected

I inspected the ceiling and walls of the detached garage according to the Home Inspection Standards of Practice.

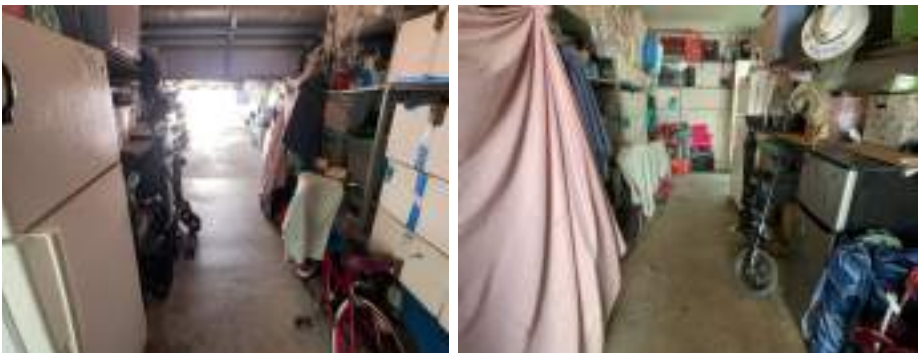
Garage Floor: Garage Floor Inspected

I inspected the floor of the garage.

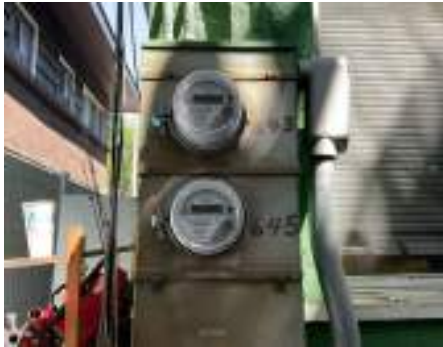
Electric Meter & Base: Inspected the Electric Meter & Base

I inspected the electrical electric meter and base.

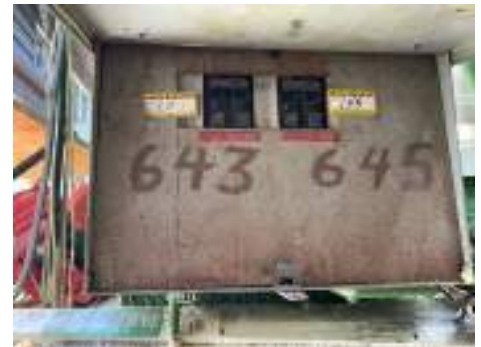
Main Service Disconnect: Inspected Main Service Disconnect

I inspected the electrical main service disconnect.

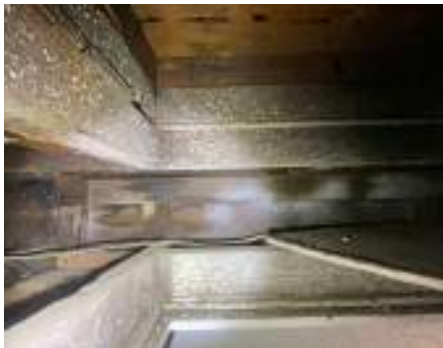
Electrical Wiring: Type of Wiring, If Visible

NM-B (Romex)

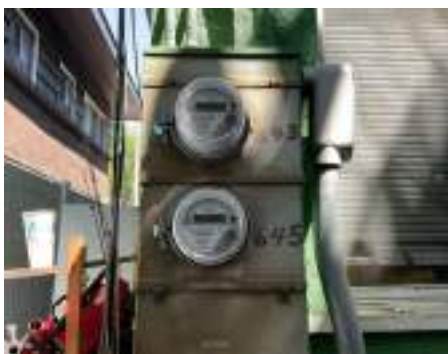
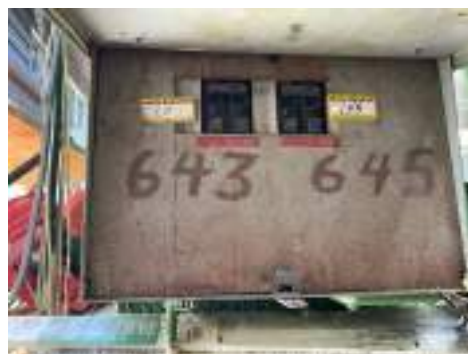
Panelboards & Breakers: Inspected Main Panelboard & Breakers

I inspected the electrical panelboards and over-current protection devices (circuit breakers and fuses).

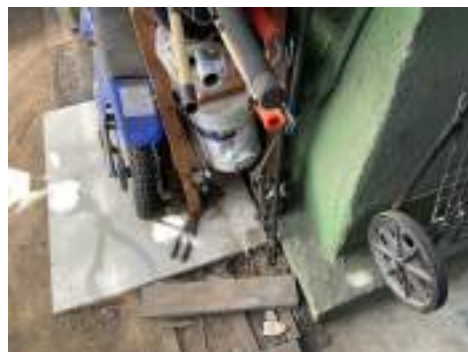
Service Grounding & Bonding: Inspected the Service Grounding & Bonding

I inspected the electrical service grounding and bonding.

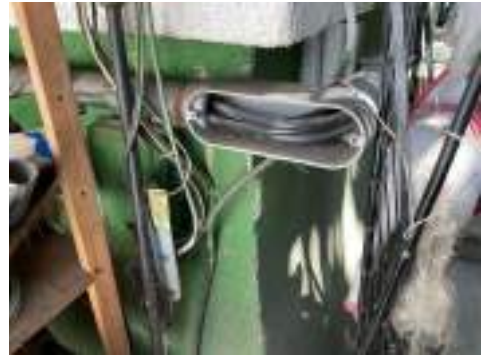
5.8.1 Electrical Defects

MISSING JUNCTION BOX COVER

I observed one or more missing junction box covers, this is a shock hazard, recommend correction by a licensed electrician

Recommendation

Contact a qualified electrical contractor.

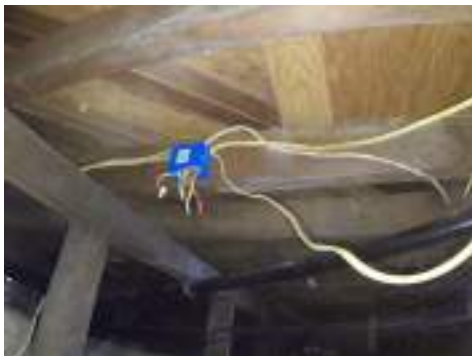
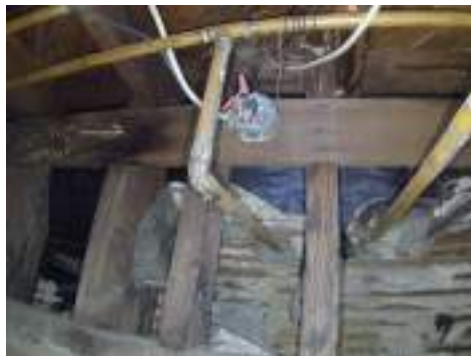
5.8.2 Electrical Defects

I noted exposed wires, recommend further evaluation and correction by a licensed electrician.

Recommendation

Contact a qualified professional.

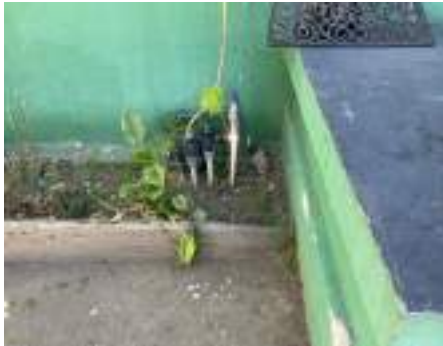
Main Water Shut-Off Valve:
Location of Main Shut-Off Valve
 Outside of House

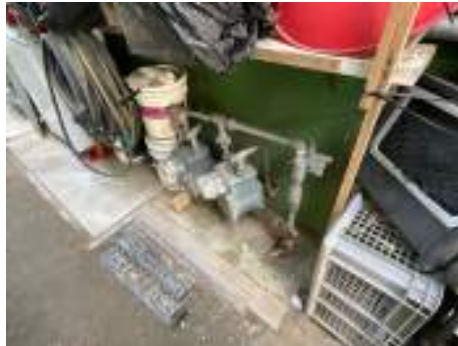
Main Fuel Supply Shut-Off Valve:
Location of Main Shut-Off Valve
 Side of House

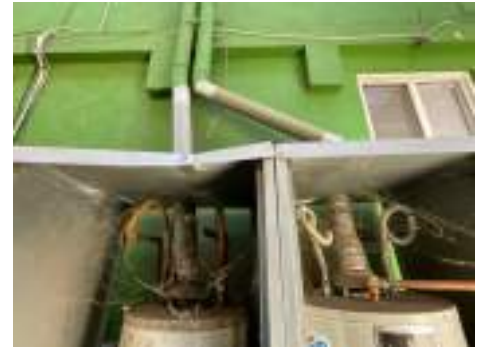
Hot Water Source: Inspected Venting Connections

I inspected the venting connections.

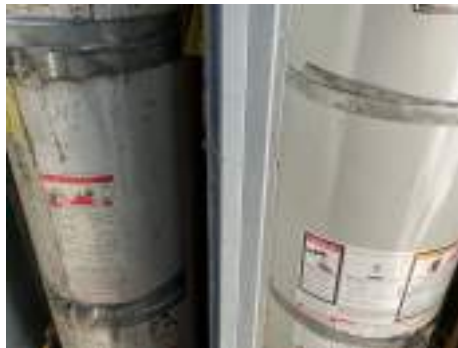
Hot Water Source: Inspected Seismic Bracing

I inspected the seismic bracing for the hot water tank.

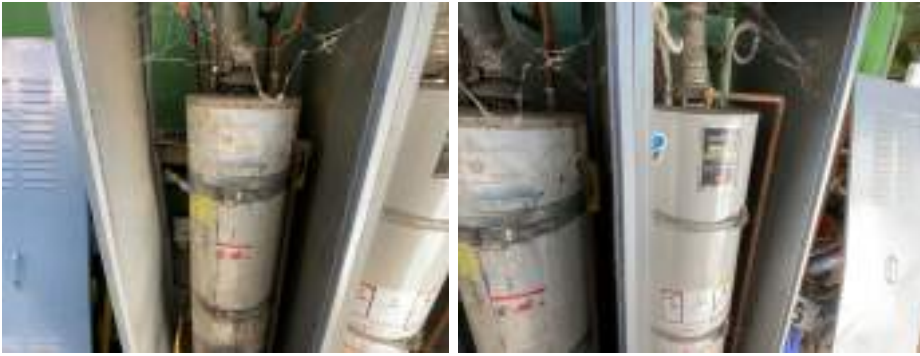
Gas-Fired Hot Water Tank

I inspected for the main source of the distributed hot water to the plumbing fixtures (sinks, tubs, showers). I recommend asking the homeowner for details about the hot water equipment and past performance.

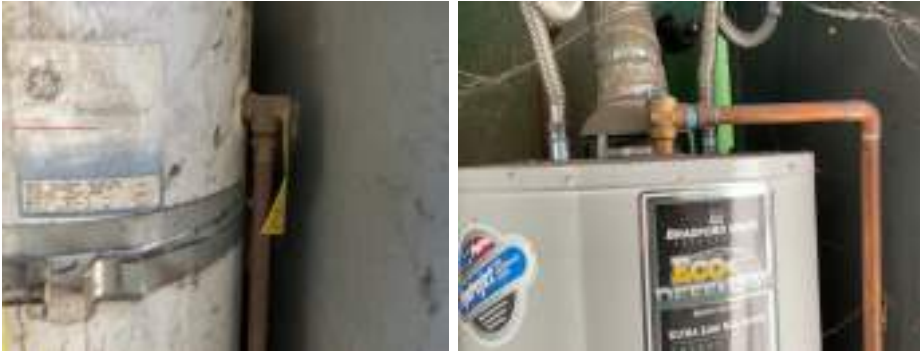
Hot Water Source: Inspected TPR Valve

I inspected the temperature and pressure relief valve.

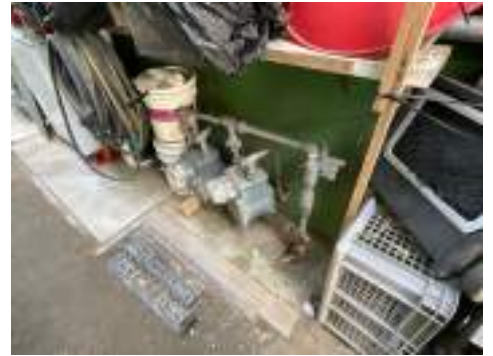
CORROSION AT RIGID GAS LINE

I noted corrosion at one or more gas lines ,recommend repair to prevent future gas leaks.

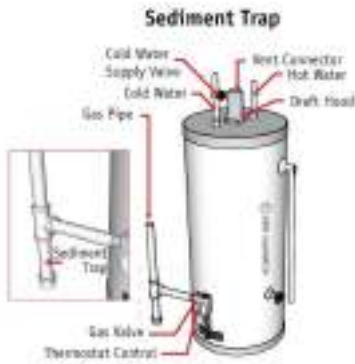
MISSING SEDEMENT TRAP

The gas feed line should have a sediment trap before the shutoff valve, recommend correction by a licensed plumber.

Recommendation
Contact a qualified professional.

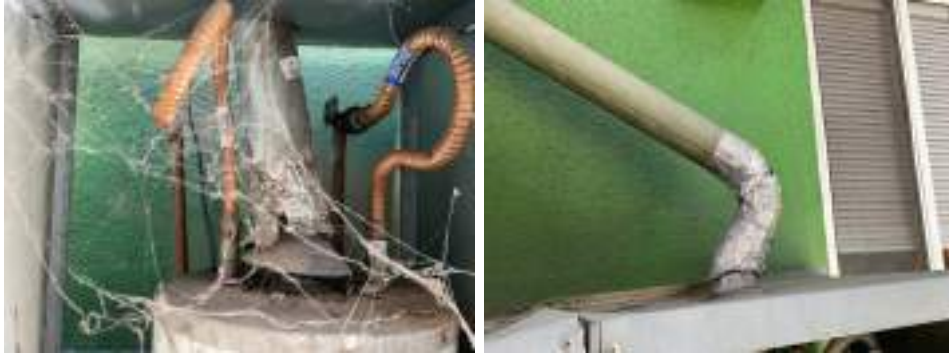
6.4.2 Hot Water Source

WATER HEATER FLUE IMPROPER

The water heater flue was not installed correctly, recommend further review and correction by a licensed plumber.

Recommendation

Contact a qualified professional.

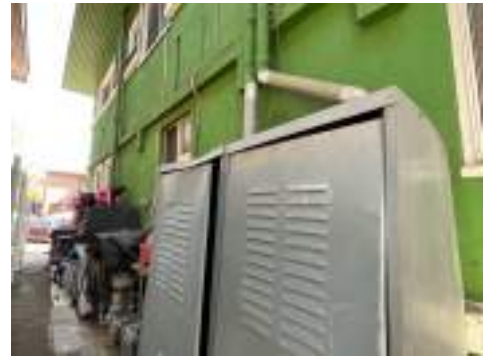
6.4.3 Hot Water Source

WATER HEATER ENCLOSURE DAMAGED

I noted some damage to the water heater enclosure, recommend correction.

Recommendation

Contact a qualified professional.

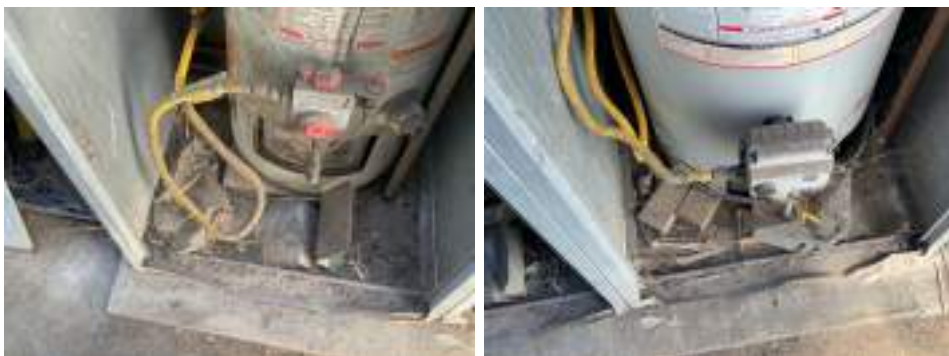
6.4.4 Hot Water Source

I noted a cover does not fit on the water heater, recommend further review by a licensed plumber

Recommendation

Contact a qualified professional.

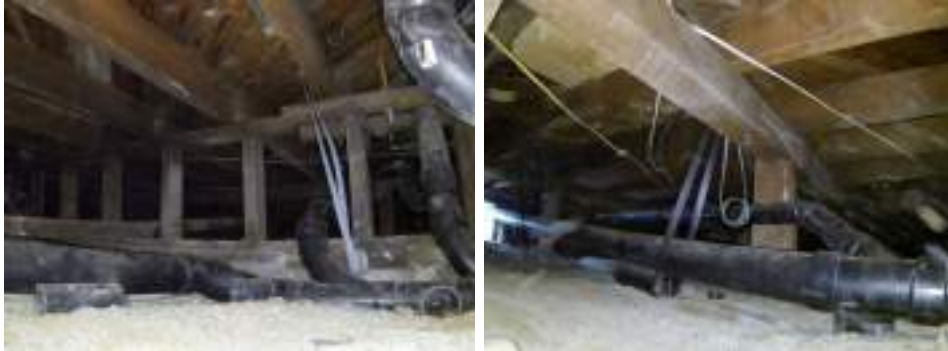
6.5.1 Drain, Waste, & Vent Systems

POSSIBLE ABANDONED PIPE

Contact a qualified professional.

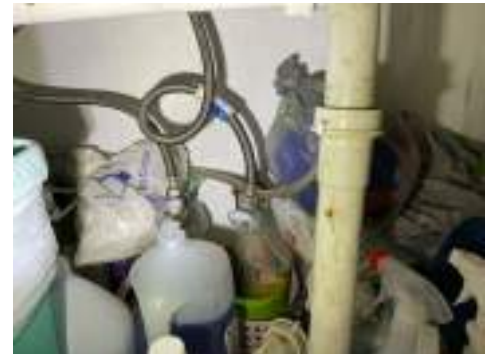
6.6.1 Water Supply & Distribution Systems

SUPPLY LINE CORROSION

Contact a qualified professional.

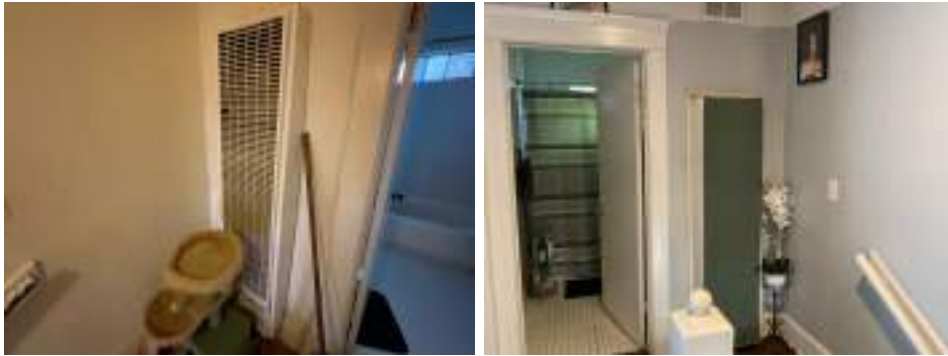
UNABLE TO OPERATE THE HEATING SYSTEM

I was unable to operate the heating system due to the gas being turned off.

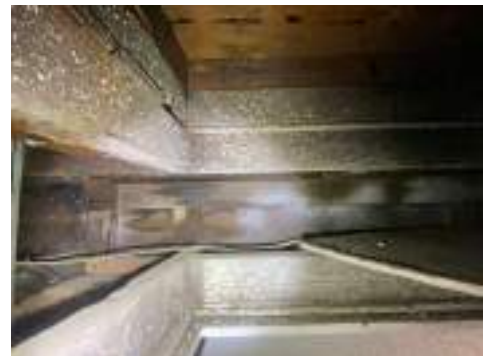
PRIOR WATER PENETRATION OBSERVED

I observed indications that sometime in the past there was water penetration or intrusion into the attic. Water marks were observed. Correction and further evaluation is recommended.

Recommendation

Recommend monitoring.

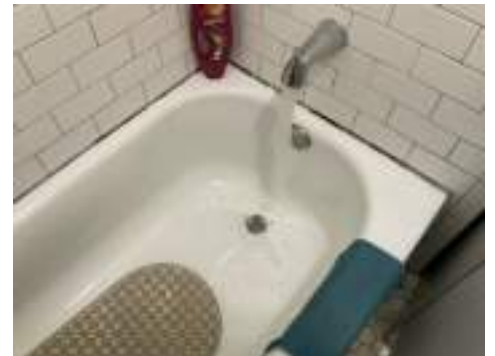
9.2.1 Sinks, Tubs & Showers

MISSING TUB STOPPER

I noted a missing tub stopper, I recommend installing one.

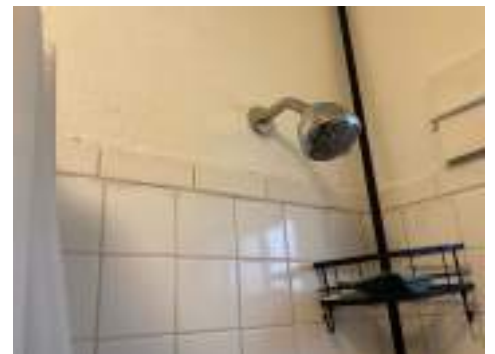
9.2.2 Sinks, Tubs & Showers

LOOSE FIXTURE

I observed indications that the fixture is loose. Not secure. Not installed properly. Loose.

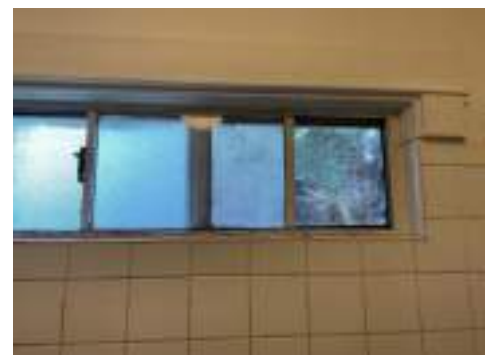
9.2.3 Sinks, Tubs & Showers

APPARENT MICROBIAL GROWTH

I noted some apparent microbial growth in the shower, recommend removing the growth with the appropriate cleaning solution.

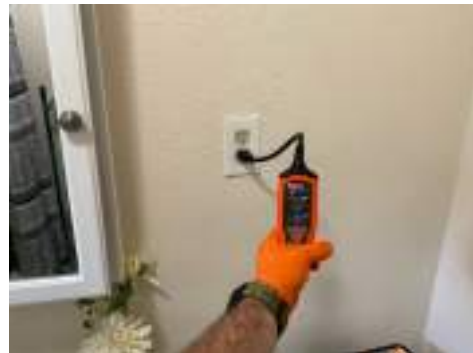
9.3.1 GFCI & Electric in Bathroom

MISSING GFCI PROTECTION

The bathrooms did not have GFCI protection installed. I recommend having GFCI outlets installed for safety

Contact a qualified professional.

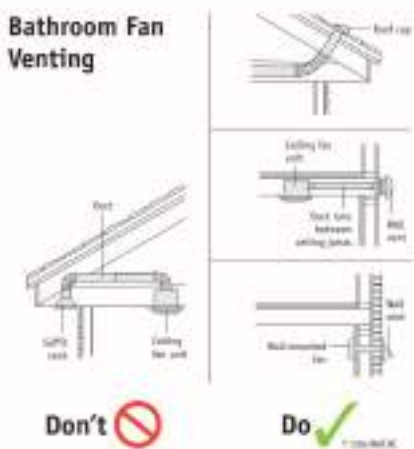
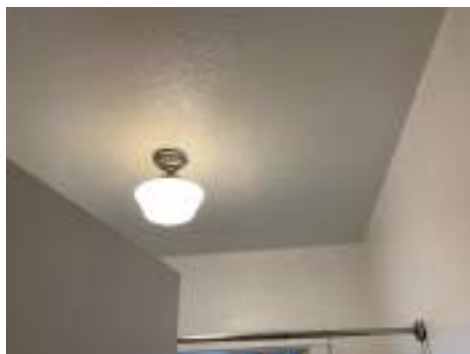
9.4.1 Bathroom Exhaust Fan / Window

MISSING FAN

I observed that the bathroom does not have a mechanical exhaust fan installed.

Regardless of what kind of ventilation system may be installed for the rest of the house, exhaust fans are recommended in the bathrooms to remove excess moisture, cleaning chemical fumes, etc. The fan should be ducted to exhaust outside of the home.

Contact a qualified general contractor.

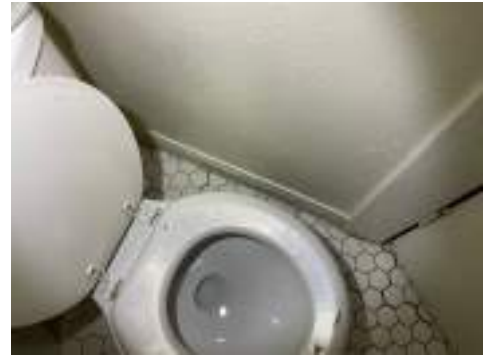
MOISTURE DAMAGE-BATHROOM WALL

I noted an area of moisture damage in the bathroom wall, I recommend correction to prevent further degradation of the material.

Contact a qualified professional.

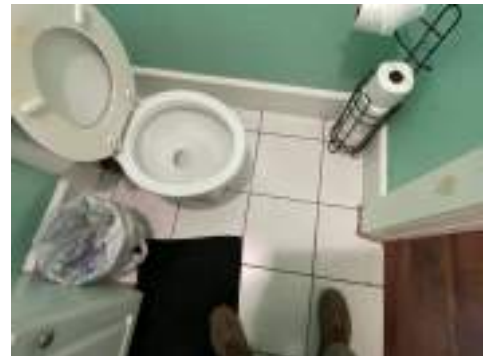
9.5.2 Cabinetry, Ceiling, Walls & Floor

CRACKED TILE

I noted one or more cracked tiles in the bathroom, I recommend repair to prevent moisture intrusion past the tile and into the wall/floor.

Contact a qualified professional.

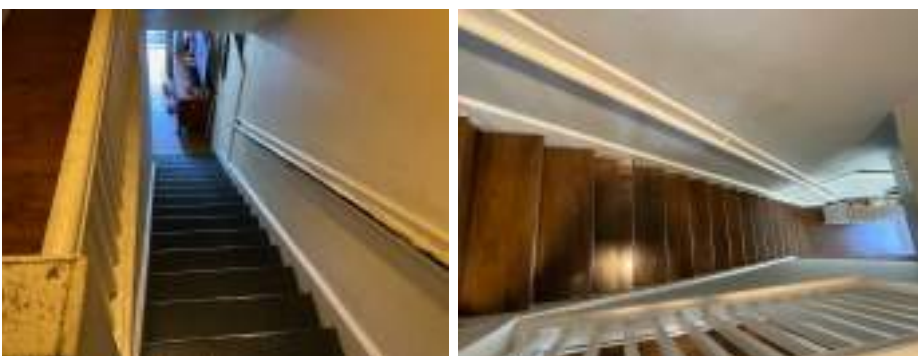
Stairs, Steps, Stoops, Stairways & Ramps: Stairs, Steps, Stoops, Stairways & Ramps Were Inspected

I inspected the stairs, steps, stoops, stairways and ramps that were within the scope of my home inspection.

All treads should be level and secure. Riser heights and tread depths should be as uniform as possible. As a guide, stairs must have a maximum riser of 7-3/4 inches and a minimum tread of 10 inches.

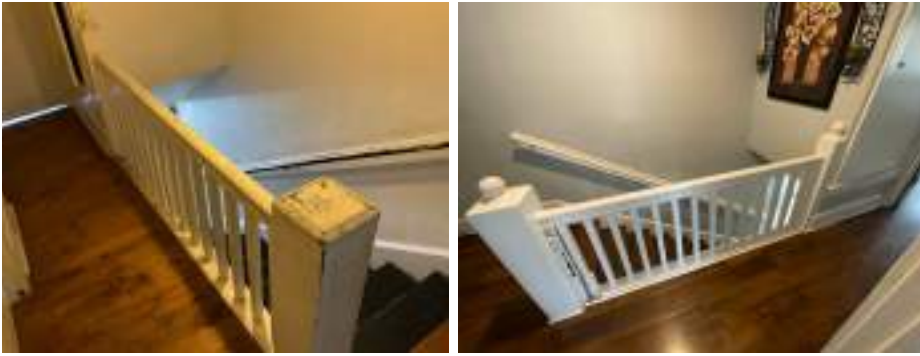
Railings, Guards & Handrails: Railings, Guards & Handrails Were Inspected

I inspected a representative number railings, guards and handrails that were within the scope of the home inspection.

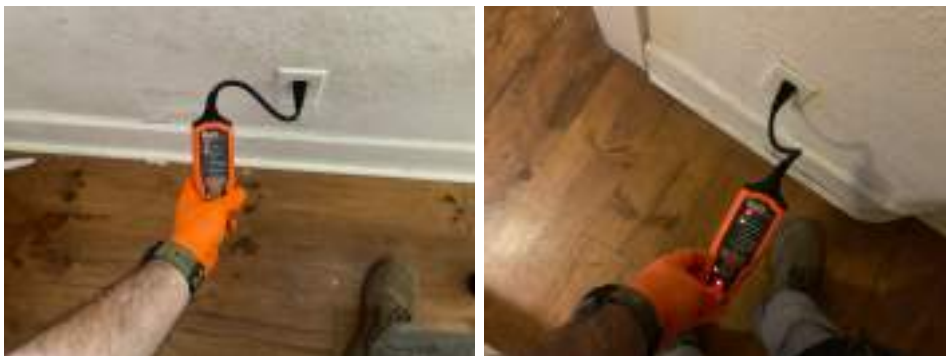
10.3.2 Switches, Fixtures & Receptacles

LOOSE RECEPTACLE

I observed indications of a loosely connected receptacle. Not secured to the wall. Defect.

Contact a qualified electrical contractor.

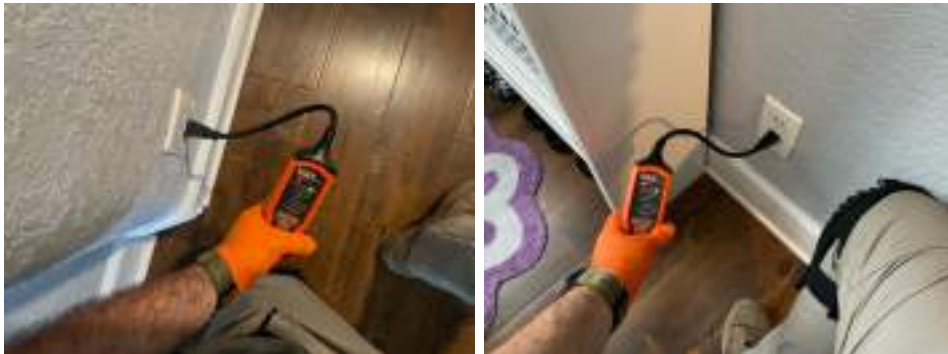
10.4.1 Floors, Walls, Ceilings

MINOR INTERIOR DAMAGE

Minor damage or deterioration to the interior was visible at the time of the inspection. Recommend repair.

Contact a qualified general contractor.

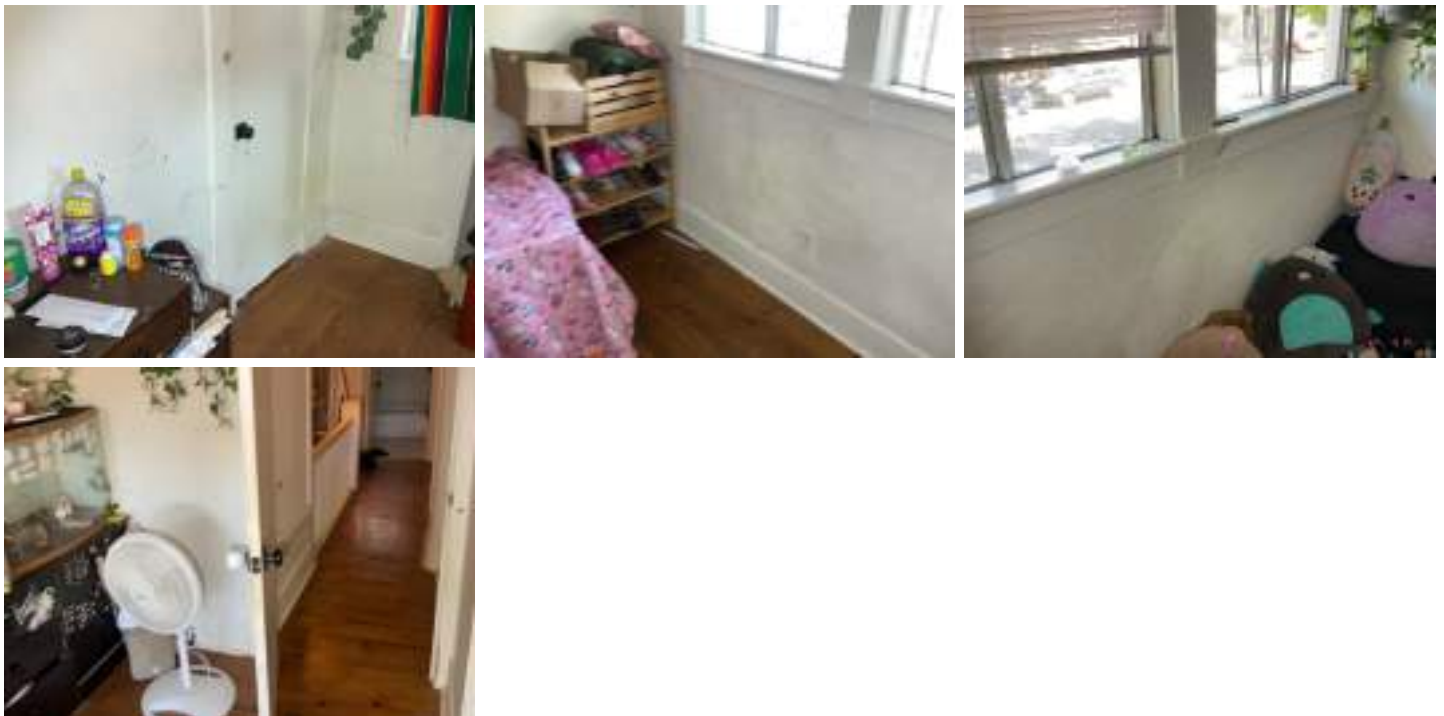
10.4.2 Floors, Walls, Ceilings

DAMAGED FLOORING

I noted some damage to the flooring material, recommend correction.

Contact a qualified professional.

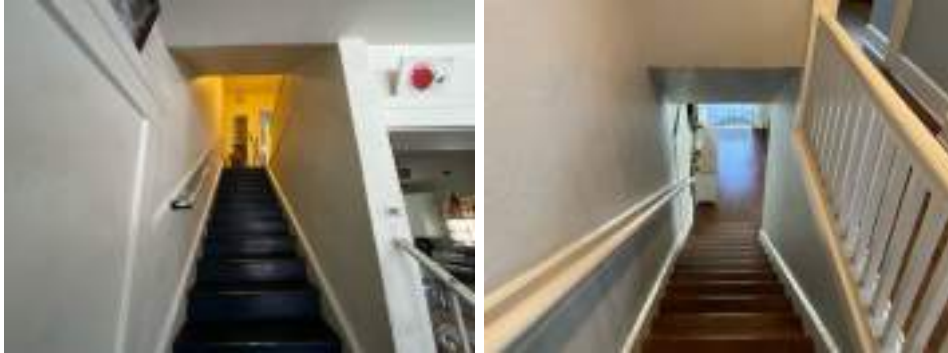
10.6.1 Railings, Guards & Handrails

**IMPROPER GUARDRAIL HEIGHT (NOT 36")**

I observed indications of a defect related to the height of a guardrail.

Correction and further evaluation is recommended.

Contact a qualified carpenter.

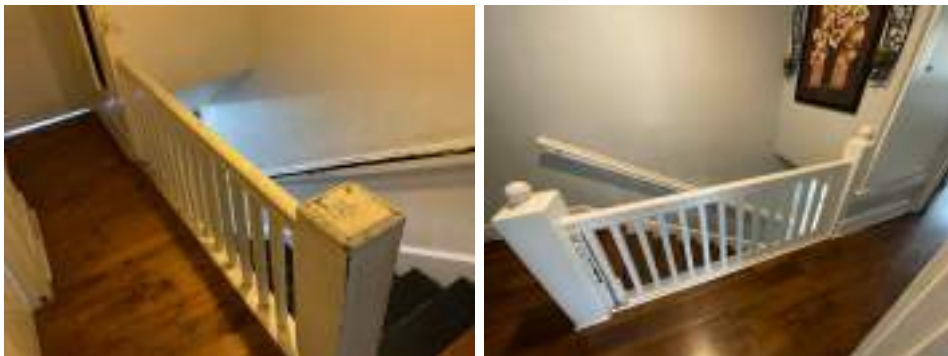
10.7.1 Presence of Smoke and CO Detectors

**MISSING SMOKE DETECTOR**

I observed indications of a missing smoke detector in an area required to keep people safe. Smoke detectors should be in every sleeping area, outside each sleeping area, and on every level of the home.

Contact a qualified professional.

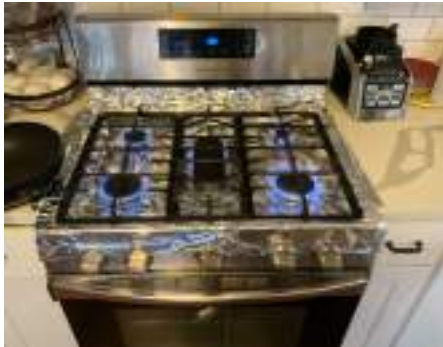
Range/Oven/Cooktop: Turned On
cooking appliance.

I turned on the kitchen's stove
and or oven

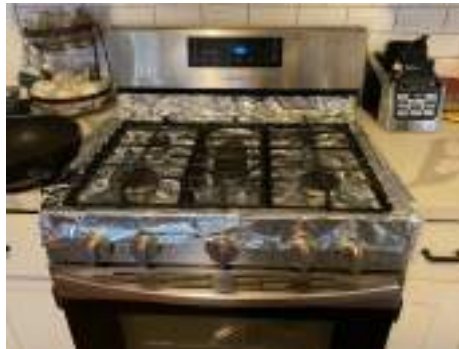
Range/Oven/Cooktop: Verified
Stove and Oven are OFF

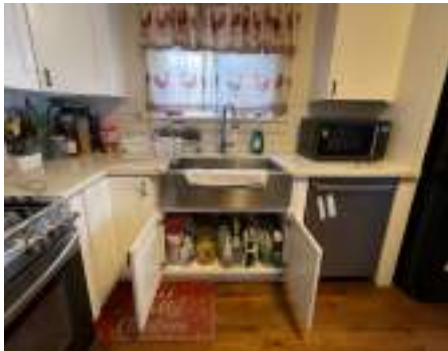
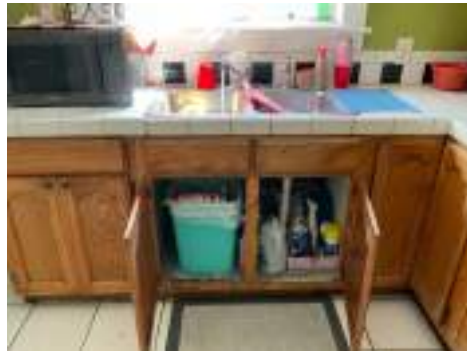
Kitchen Sink: Ran Water at Kitchen Sink

I ran water at the kitchen sink.
