CROSSWIND HOME INSPECTION

HOME INSPECTION

645 Elm Ave
Long Beach, CA 90802

04/11/2025

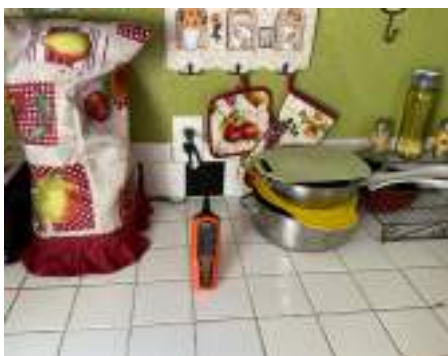
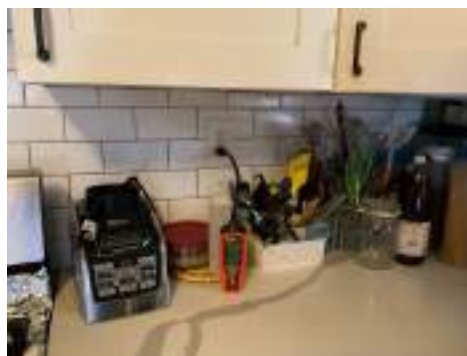
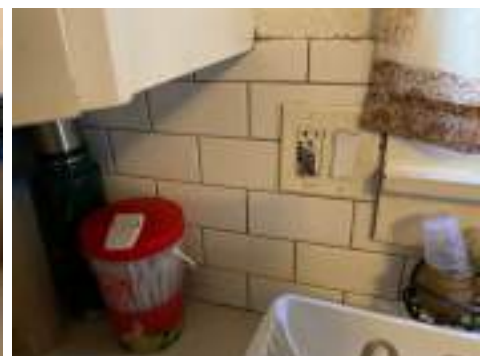
GFCI: GFCI Tested

I inspected and tested for GFCI protection in the kitchen.

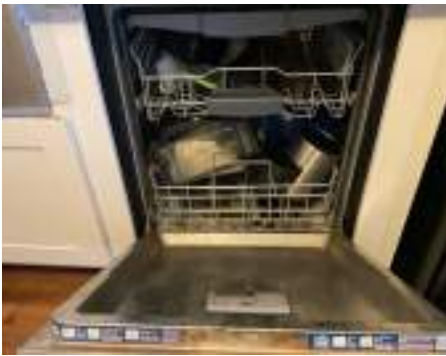
Dishwasher: Inspected Dishwasher

I inspected the dishwasher visually. If there were no belongings inside, I operated the dishwasher to check for leaks. A full functional check is beyond the scope of a home inspection.

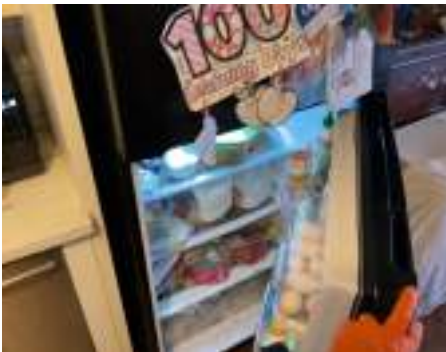
Refrigerator: Refrigerator Was On

I checked to see if the refrigerator was on. It was. That's all I inspected in relation to a refrigerator. Refrigerators are beyond the scope of a home inspection.

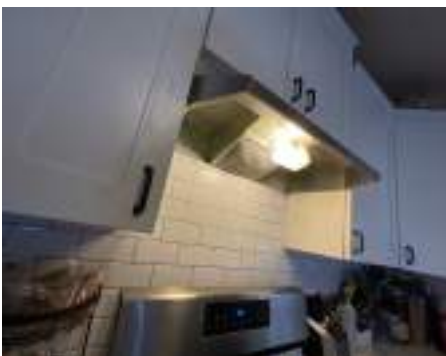
Exhaust Fan: Inspected Exhaust Fan

I inspected the exhaust fan in the kitchen. All mechanical exhaust fans should terminate outside. Confirming that the fan exhausts outside is beyond the scope of a home inspection.

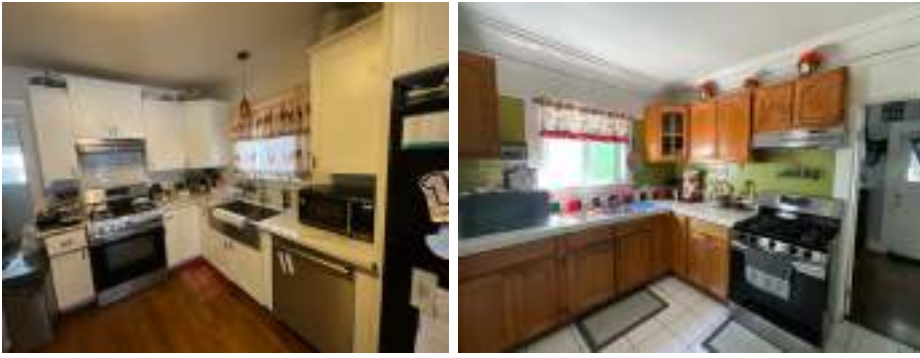
Countertops & Cabinets: Inspected Cabinets & Countertops

I inspected a representative number of cabinets and countertop surfaces.

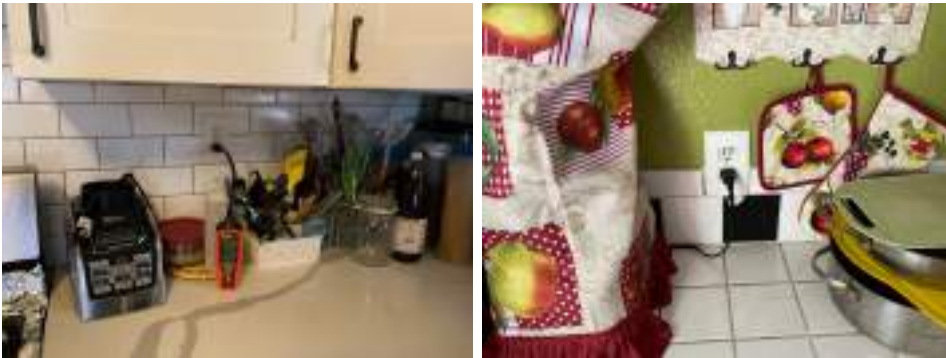
11.2.1 GFCI

MISSING GFCI PROTECTION

I observed indications of missing GFCI protection in the kitchen. All kitchen counter/ island receptacles are required to be GFCI protected. I recommend contacting a licensed electrician to install GFCI receptacles.

Contact a qualified electrical contractor.

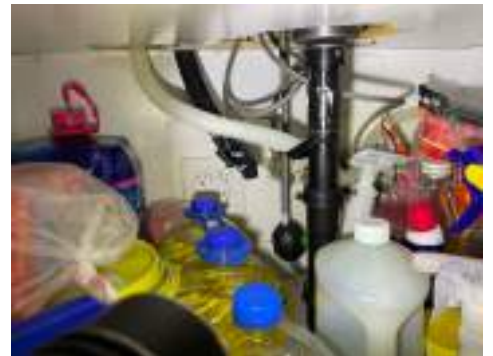
11.2.2 GFCI

MISSING GFCI UNDER SINK

Contact a qualified electrical contractor.

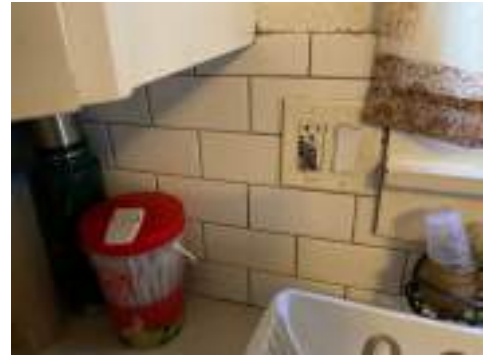
DAMAGED GFCI OUTLET

I noted some damage to a GFCI outlet, recommend replacement.

Contact a qualified professional.

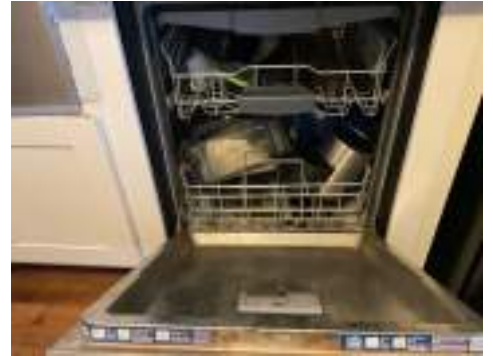
11.3.1 Dishwasher

I noted the dishwasher did not dispense water, recommend further review and correction.

Contact a qualified professional.

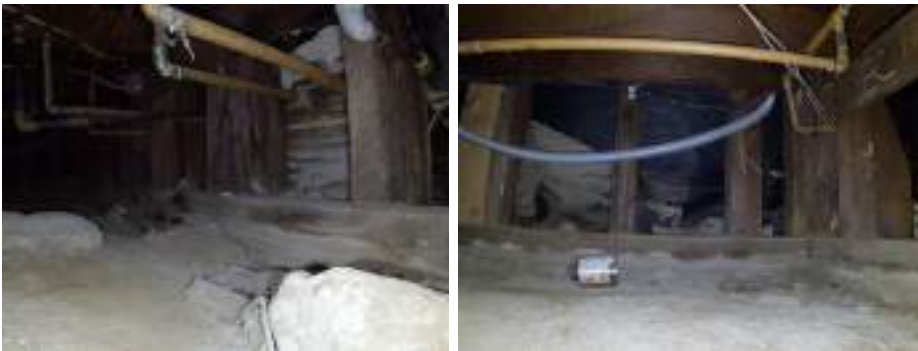
Under-Floor Crawlspace: Type of Under-Floor Crawlspace Foundation Described

Concrete

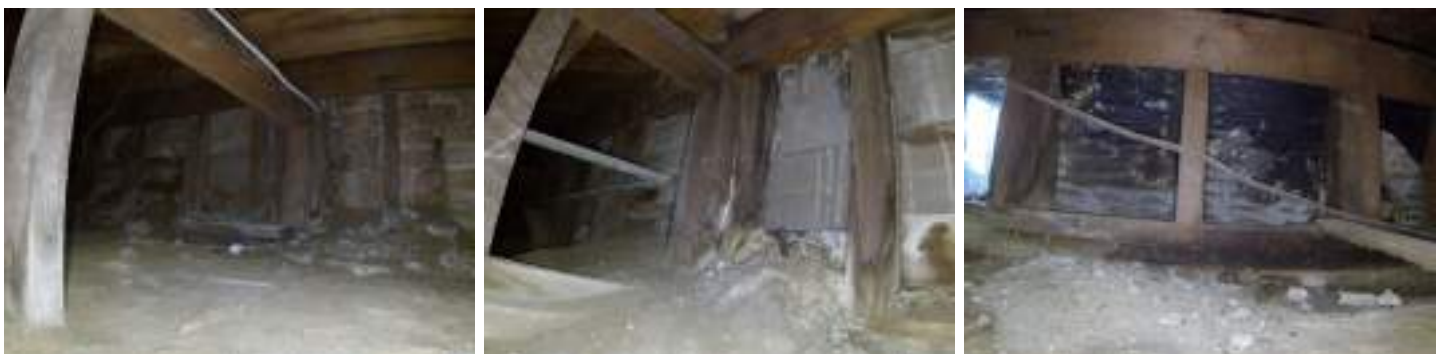
12.1.1 Under-Floor Crawlspace

PRIOR WATER PENETRATION OBSERVED

I observed indications that sometime in the past, there was water penetration or intrusion into the crawlspace.

Correction and further evaluation is recommended.

Recommend monitoring.

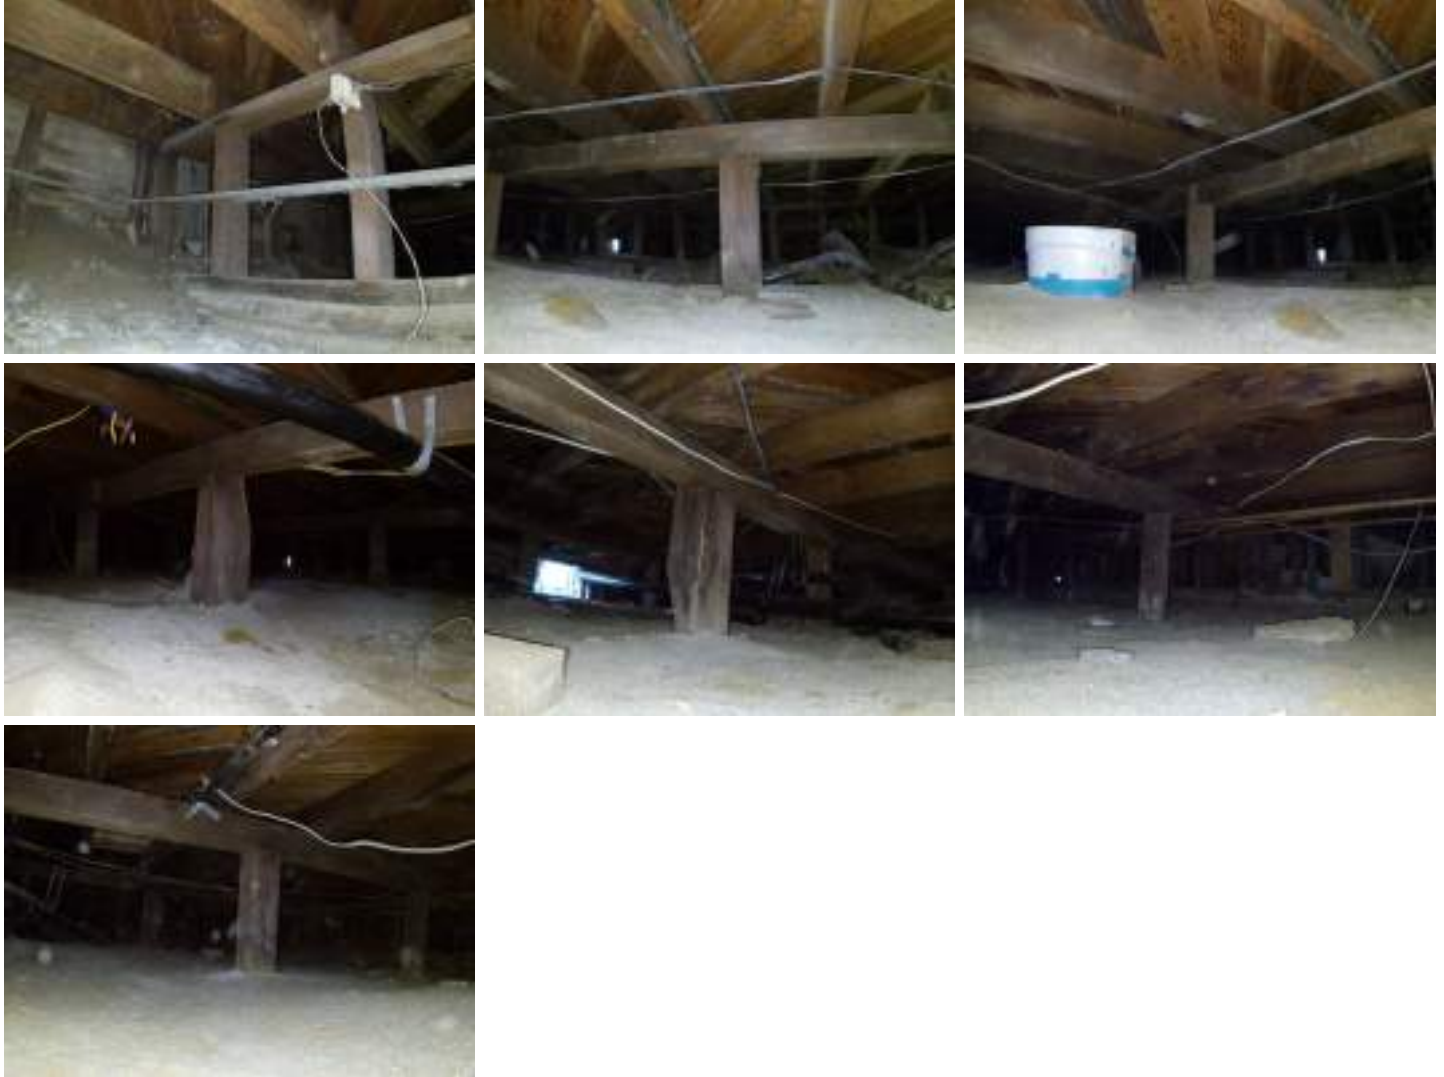
12.1.2 Under-Floor Crawlspace

I observed indications of wooden structural components in contact with soil or in close proximity with soil. This condition is prone to water penetration into the structural materials resulting in water damage.

Correction and further evaluation is recommended.

Contact a qualified general contractor.

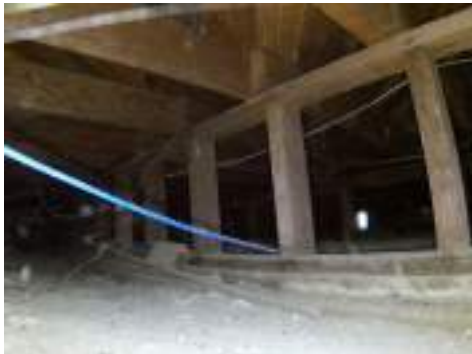
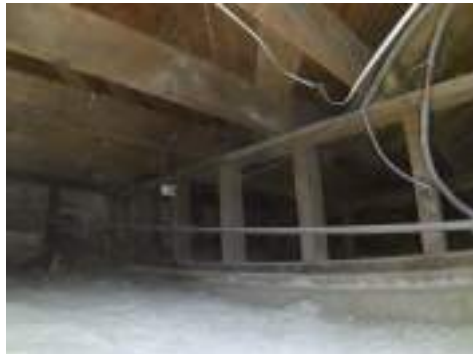
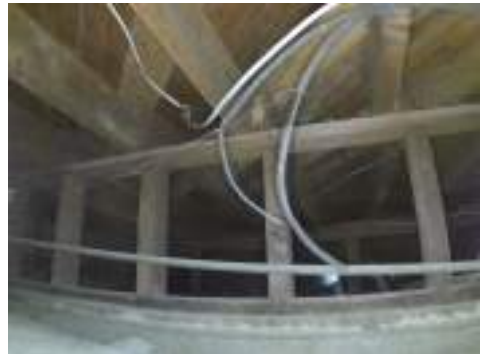
12.1.3 Under-Floor Crawlspace

UNSUPPORTED ELECTRICAL

I noted unsupported electrical lines. Recommend securing every 4-6 feet

Contact a qualified professional.

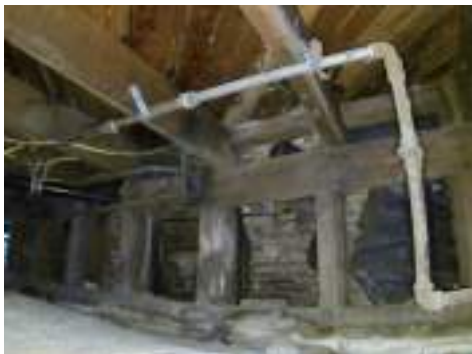
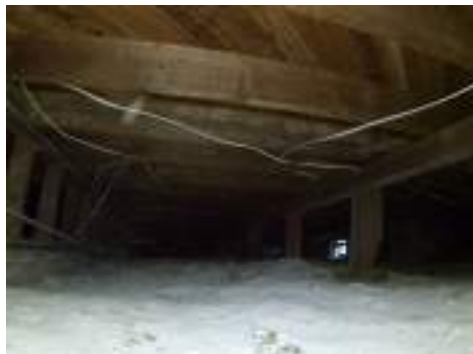
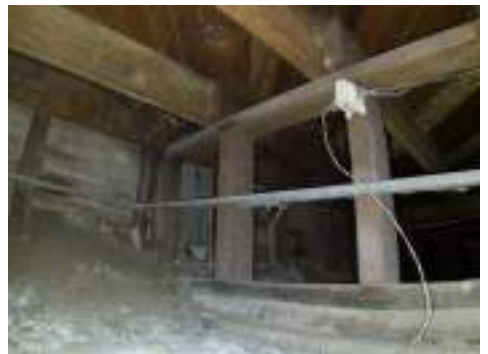
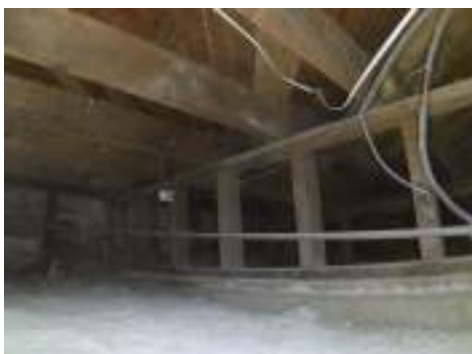
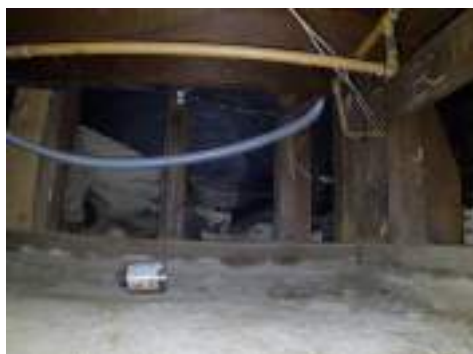
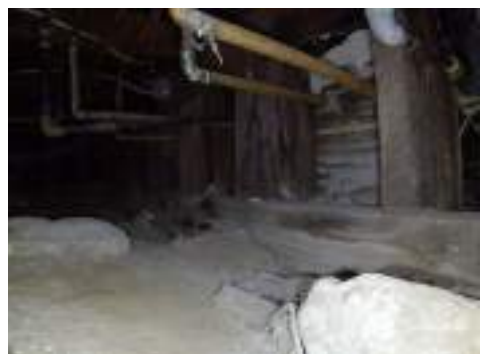
12.1.4 Under-Floor Crawlspace

FOUNDATION WAS NOT BOLTED

I noted the foundation was not bolted down, recommend further review by a foundation contractor.

Contact a qualified professional.
