WOOD DESTROYING PESTS AND ORGANISMS INSPECTION REPORT

Street 81172 Camino Lampazos	City Indio	ZIP 92203	Date of Inspection 02/18/2026	Number of Pages

WD0218261

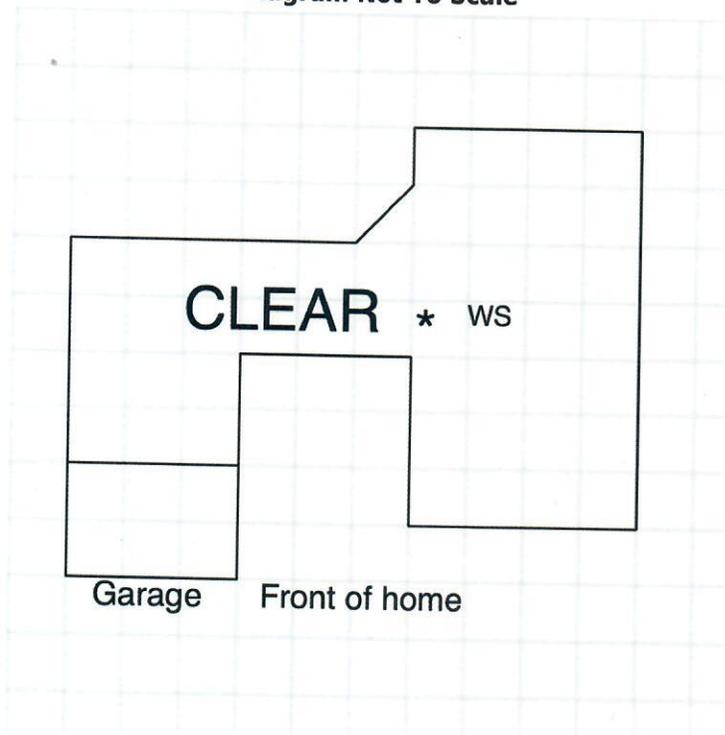
Diagram Not To Scale

Water stains noted at time of inspection under the kitchen sink. Arrest A Pest does not guarantee the presence or non-presence of any leaks or hidden damage from same. See "WS" on diagram.

Weathered at the side garage door frame, and at the baseboard behind the refrigerator noted at time of inspection. This appears to be cosmetic damage not caused by wood destroying organisms. See "*" on diagram.
