10904 First Avenue, Whittier, Ca.

County: Los Angeles
Address: 10904 First Avenue
City: Whittier

Reg. #: 251219-3
Date: 12-19-25
Weather: Sunny & Cool

Major Systems Report

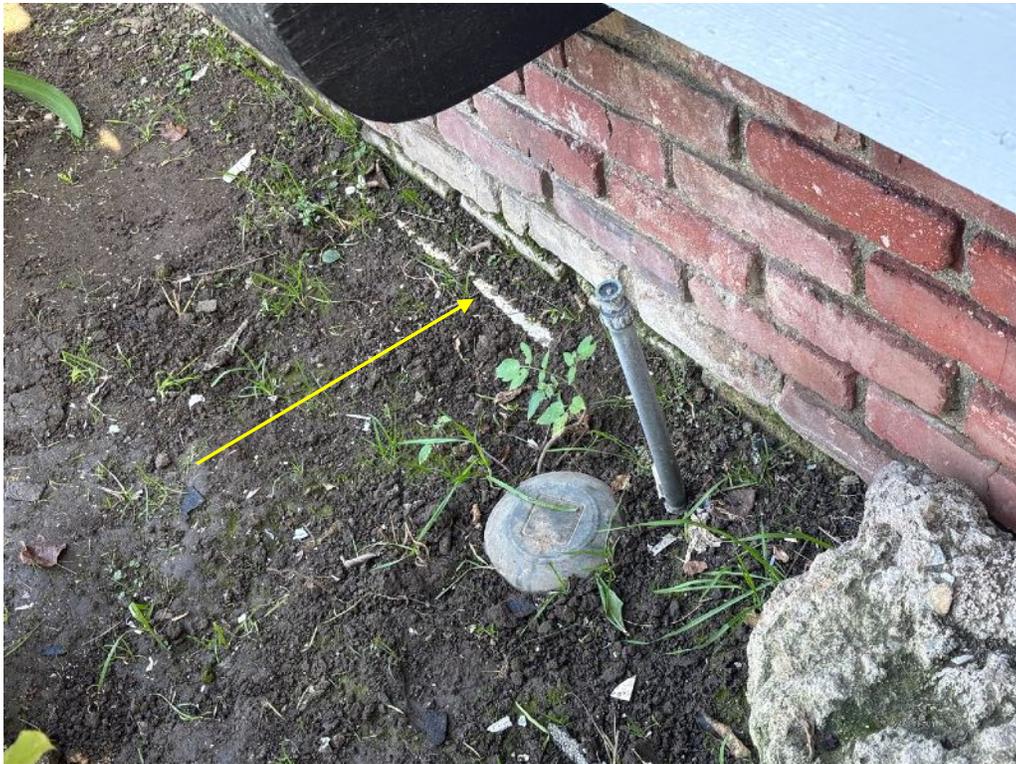
104 Sprinklers

- ***The sprinkler system is controlled by an automatic timing device, and could not be tested at the time of the inspection.***
 - ***The sprinkler system has exposed PVC piping in some areas. Contact a licensed plumber to check for safety code/repair.***

- ***Contact the seller for any further information and/or demonstration of the automatic sprinkler system.***

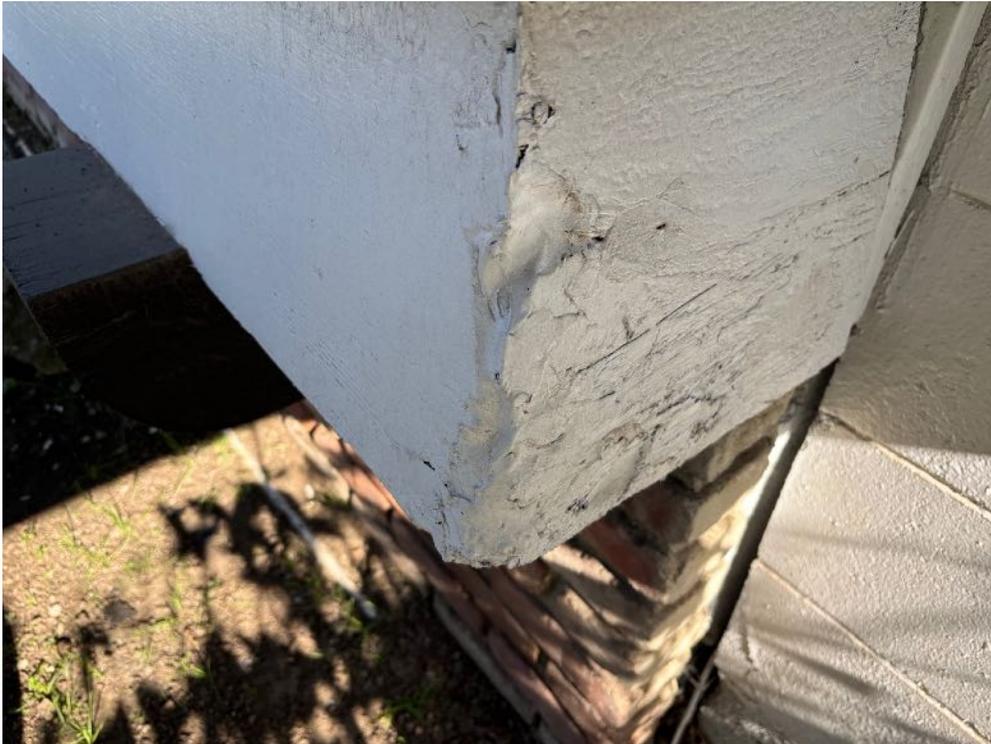
105 Walls

- *The stucco walls are chipped, cracked, and have visible patches.*

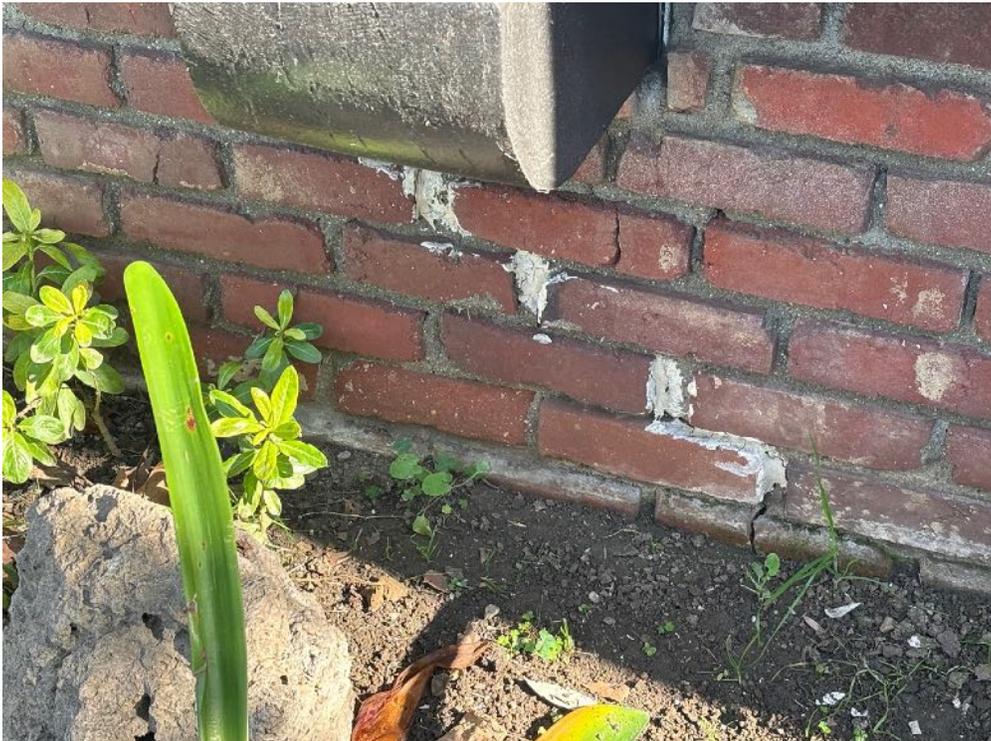
- *The bricks facing has cracks in some bricks and mortar joints, and some bricks and mortar joints have been patch repaired.*

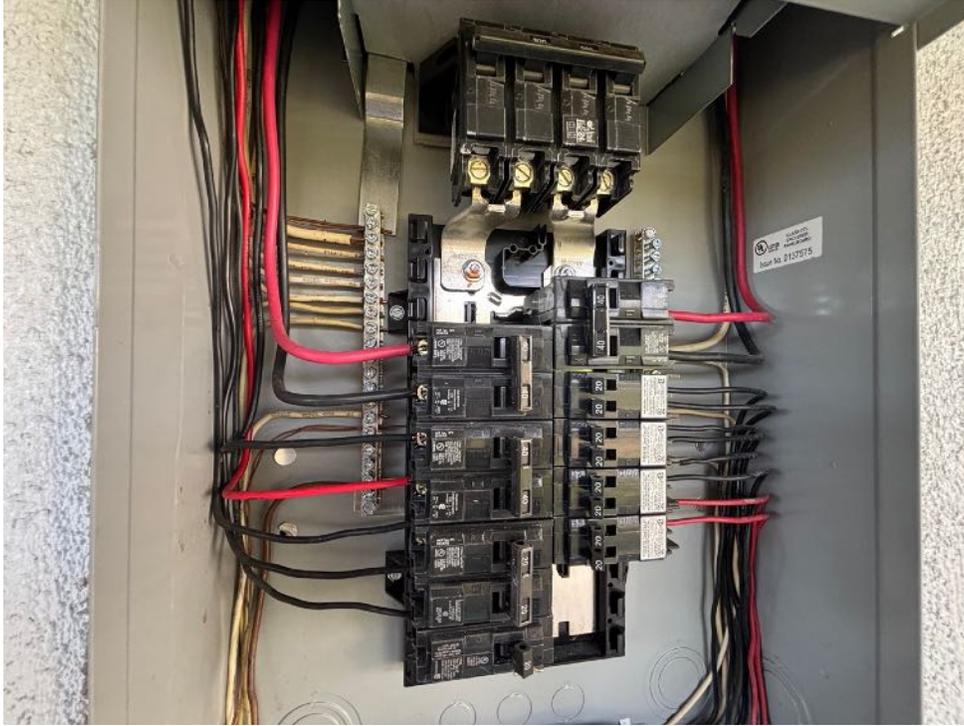
106 Electrical Service

- **200 Amp Main. Copper Wiring**
 - *The main electrical panel is located in the back exterior wall.*

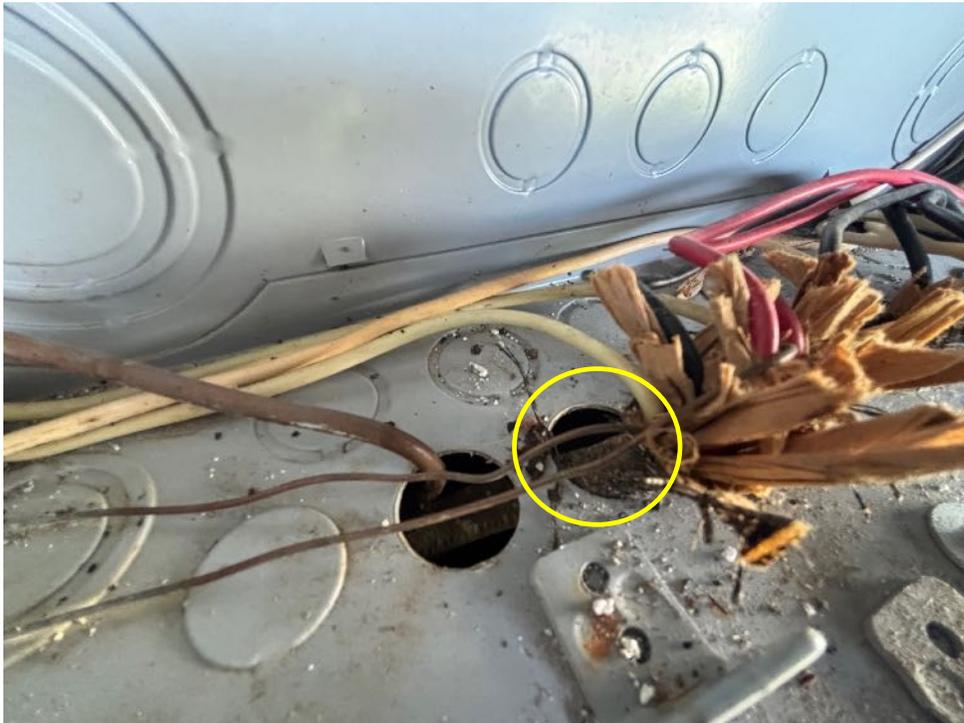
- *Circuits installed through the bottom of the electrical panel do not have romex connectors. (See Photos Below on Next Page) Contact a licensed electrician to check for safety code/repair.*

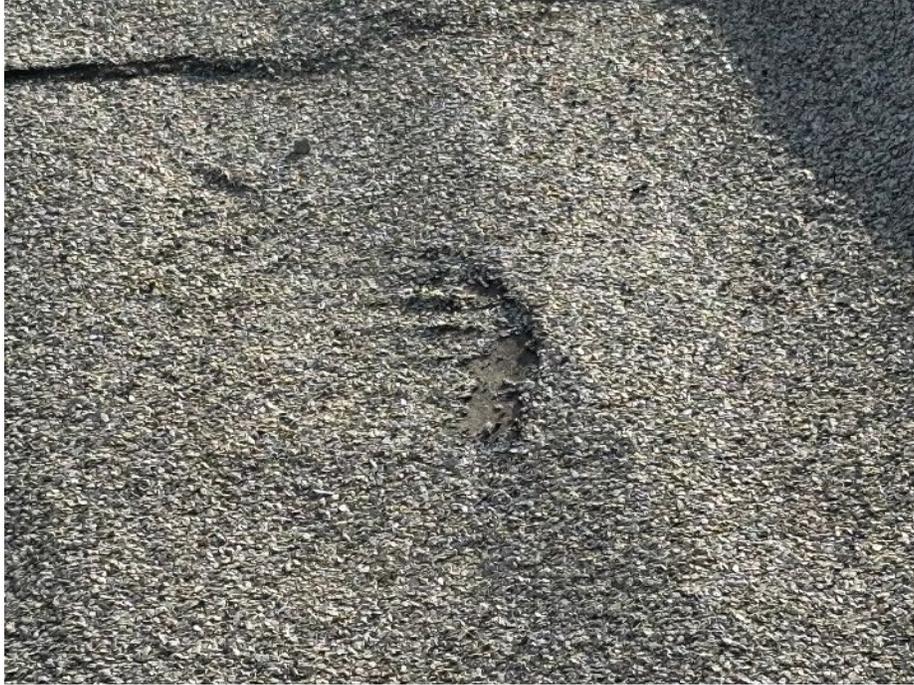
Roof (Cont'd)

- *The roof has some deflection in spots.*
- *The roof was stripped and sheeted before the current installation of roofing material.*
- *Tree limbs are in contact with the edge of the roof and should be removed.*
- **Composition Roll/Torch-Down Roof: (Patio Roof)**
 - *Normal Wear*
 - *Some granules of the roofing material are missing in spots. (Minor)*

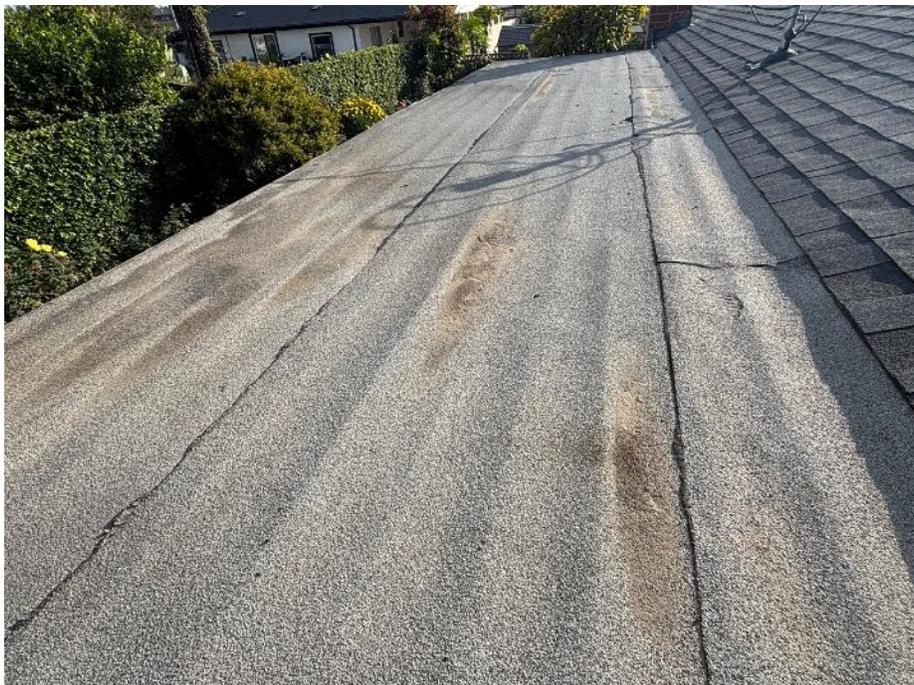
- *The roof has evidence of pooling water in some areas.*

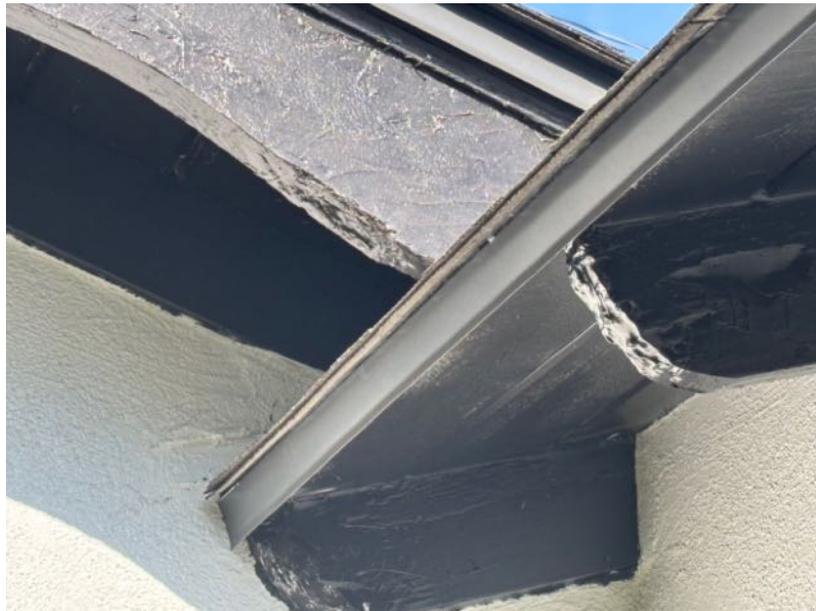
110 Eaves Satisfactory

- *The fascia boards and eaves have visible patches.*

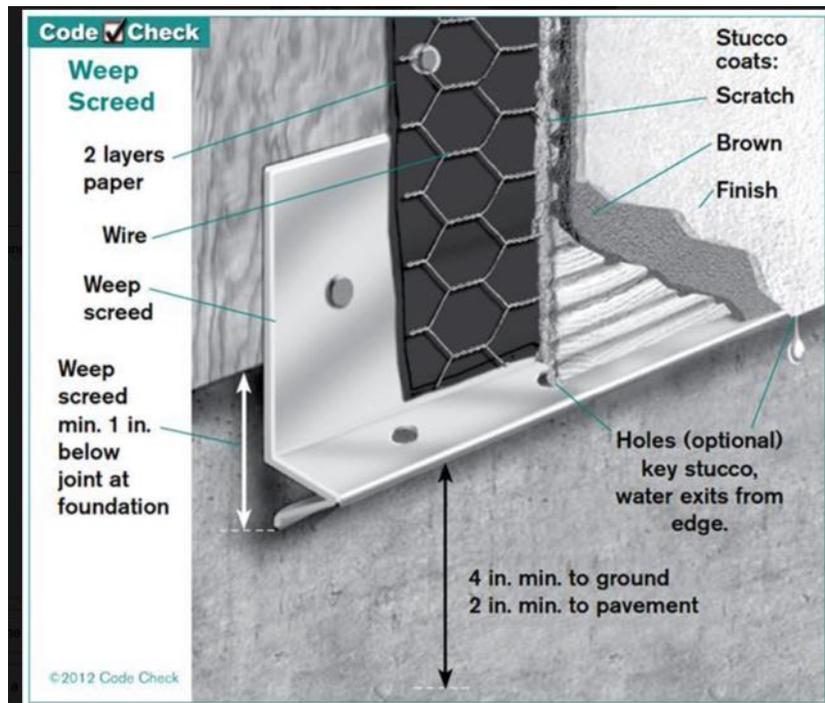
113 Other

- *The front porch receptacle has reversed polarity. Contact a licensed electrician for repair.*
- *The exterior hardscape and landscape have been installed/placed less than 2" below the siding at the bases of some walls. Contact a licensed contractor to check for safety code/repair.*

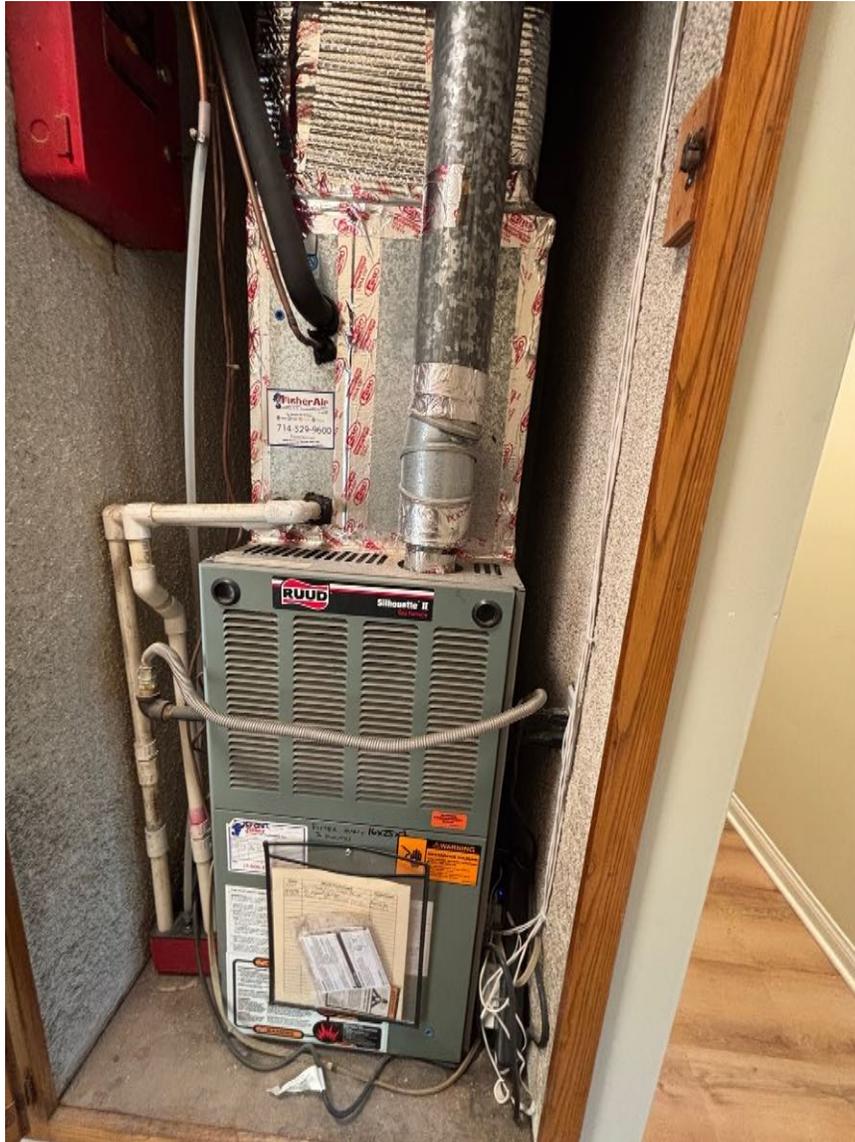
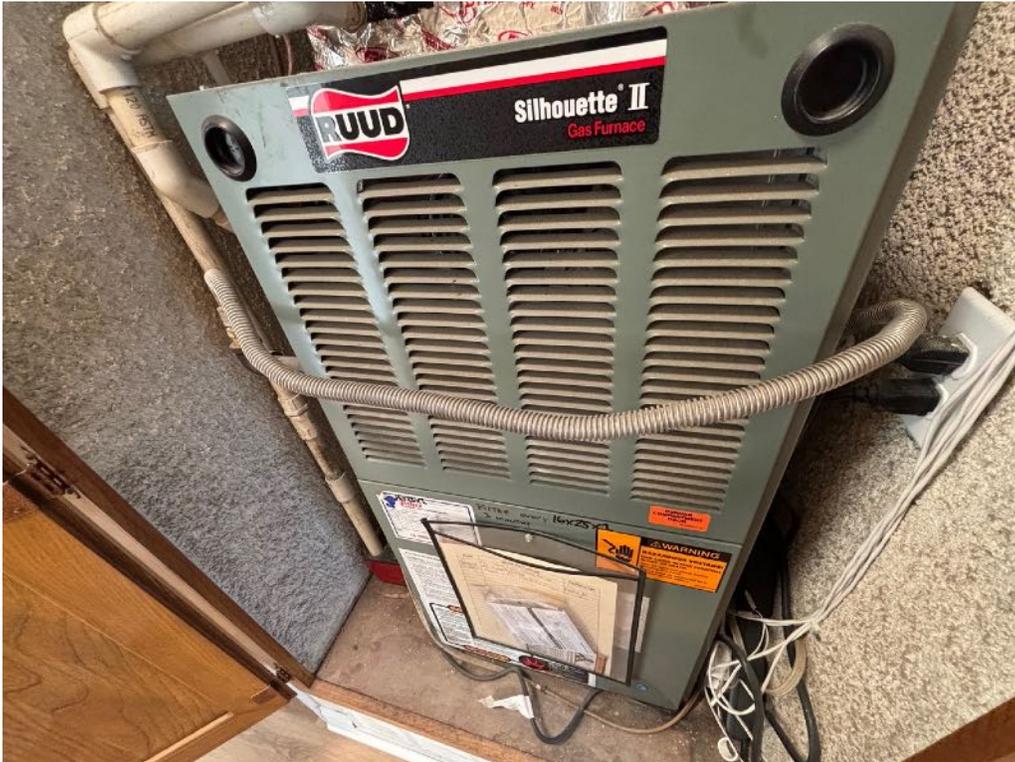
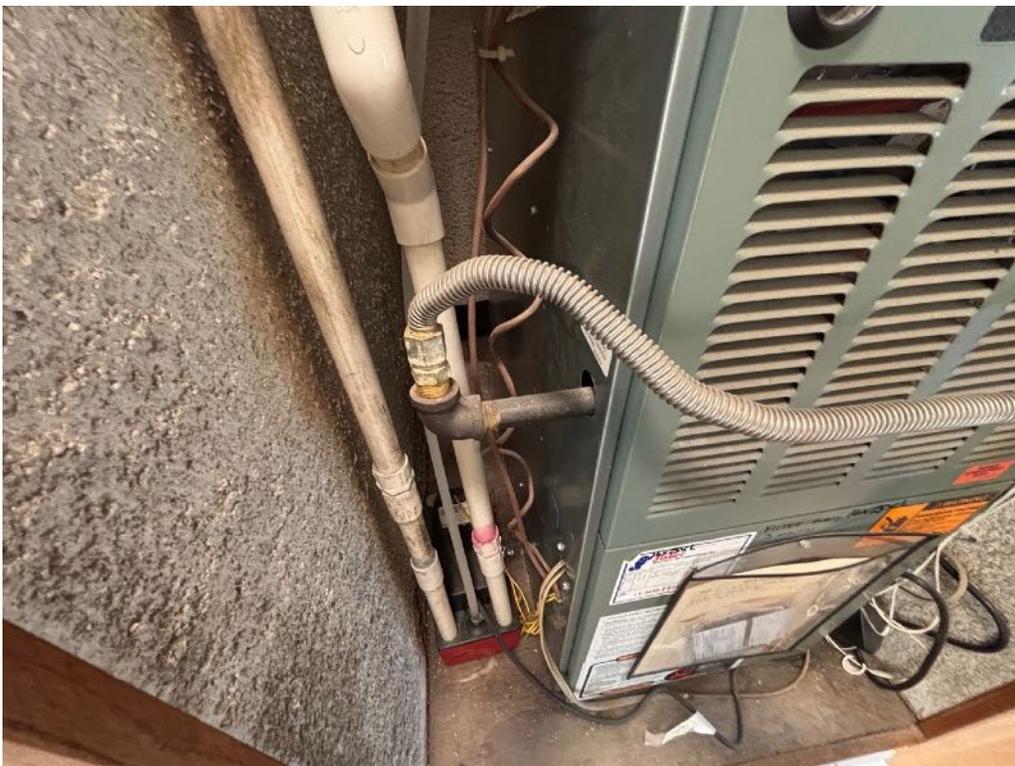
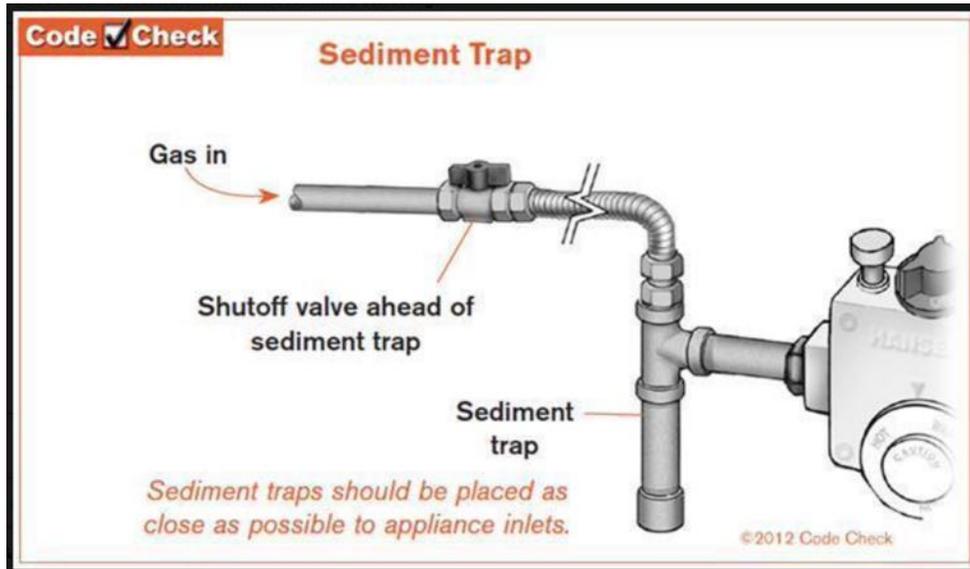
201 Heating:

- *The forced air heater has a manufacture date of 2000.*
- *The gas line to the forced air heater does not have a "drip leg/sediment trap." (See Photos & Diagram on Following Pages) Contact a licensed plumber to check for safety code/repair.*

- *The filter for the HVAC systems is dirty, and there is typical rust and scale in the burner chamber.*
 - *Recommend the HVAC system be cleaned and serviced as necessary prior to operating.*
- *The forced air heater appeared to work satisfactorily at the time of the inspection.*
- *RPM Inspection Service does not inspect and will not be responsible for heat exchangers and burner boxes in heating systems.*
- *The platform for the HVAC system is water stained. Contact the seller for any further information or explanation concerning this condition.*

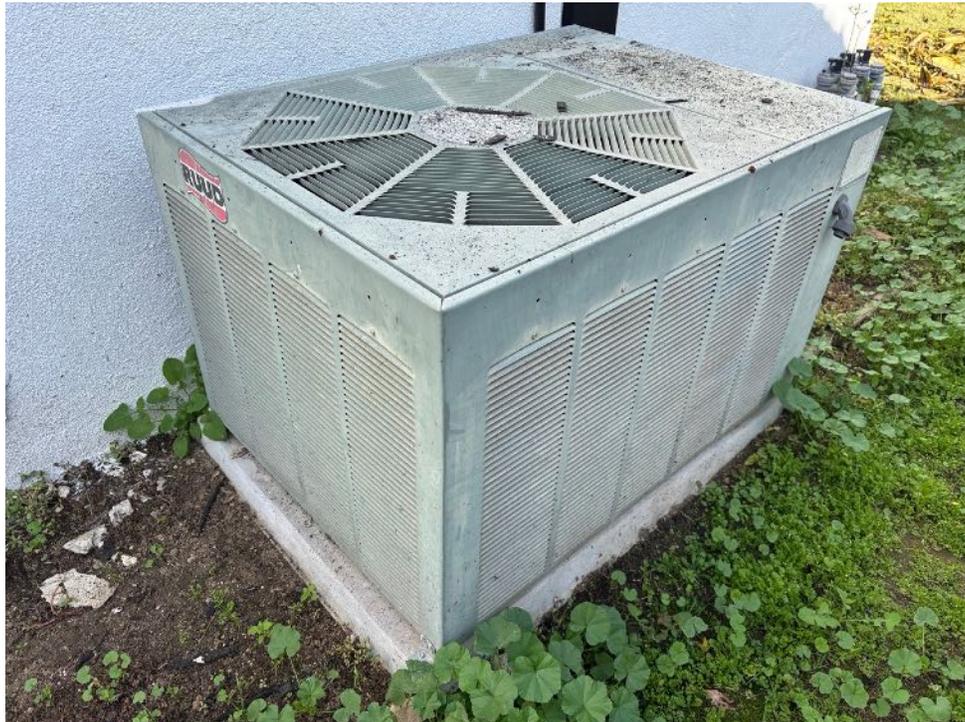
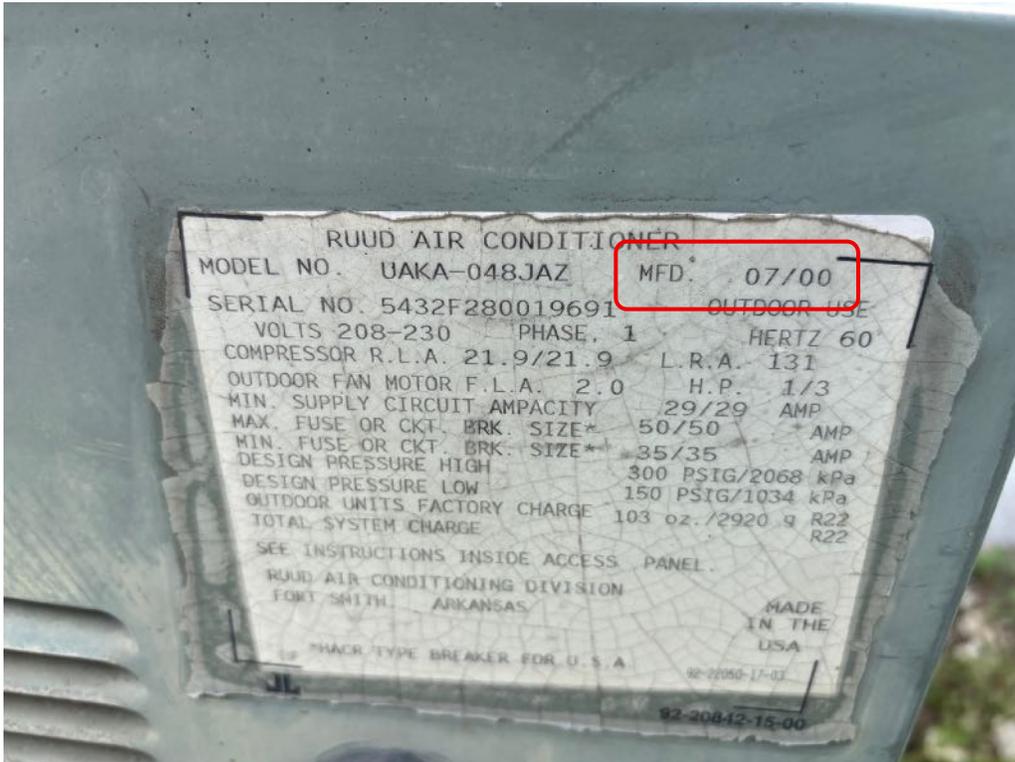
Air Conditioning:

- *The central air conditioner has a manufacture date of 2000, and appears to be a 4-ton unit.*

- *The insul-foam is torn and missing in spots on the air conditioning lines in the attic.*
 - *The ambient temperature was too cool to adequately test the central air conditioner.*
 - *The central air conditioner appeared to work satisfactorily at the time of the inspection.*
- 203 Solar None

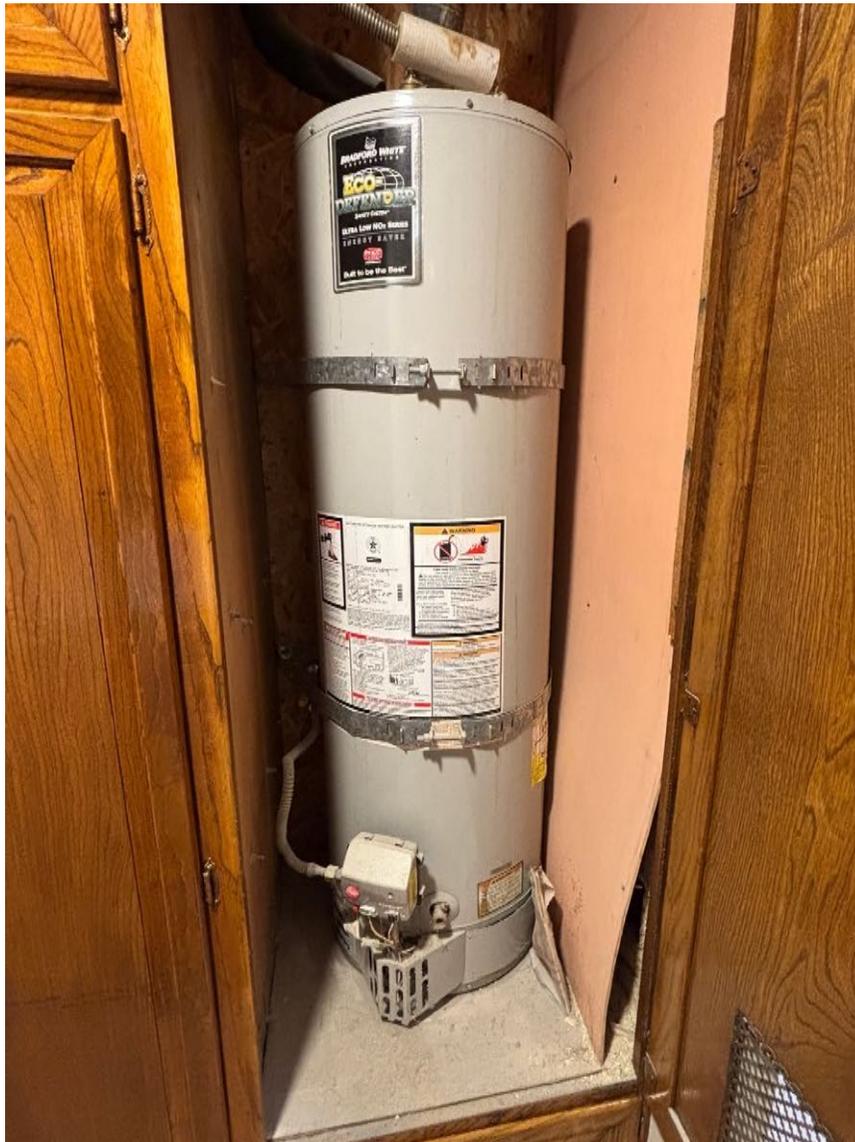
204 Hot Water Heater

- *The water heater is a 2016, 40-gallon, gas unit.*

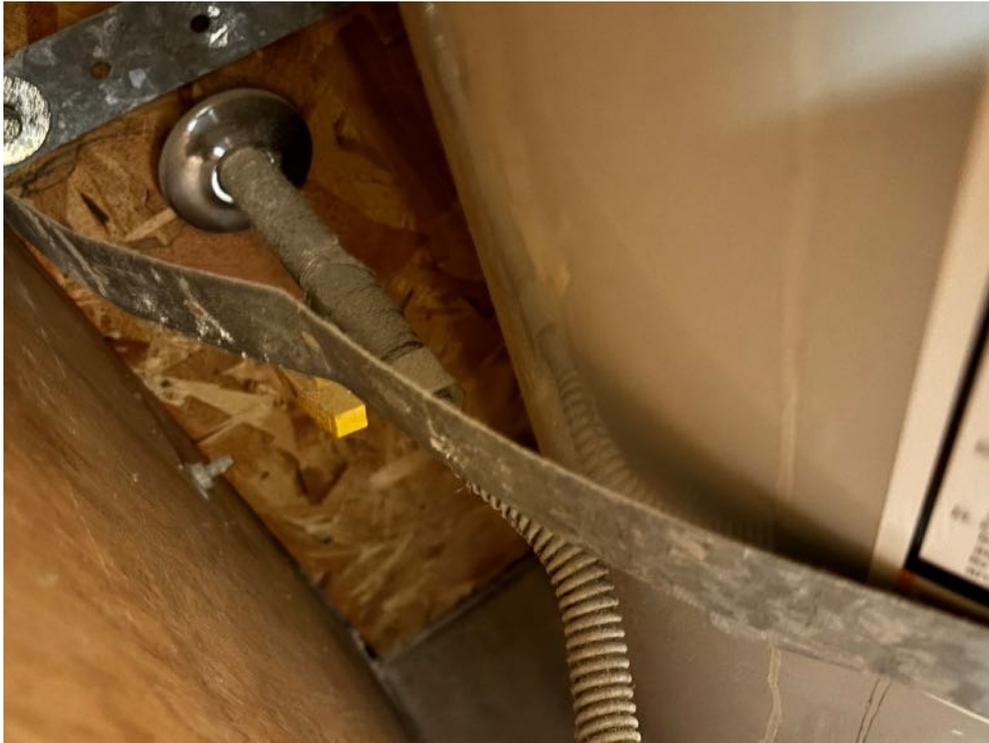
- *The hot water heater is earthquake strapped. However, the straps were not wrapped completely around the tank prior to be secured to the structure. The lower strap on the water heater is greater than 4" up off the gas line. (See Photo on Next Page) Contact a licensed plumber to check these conditions for safety code/repair.*

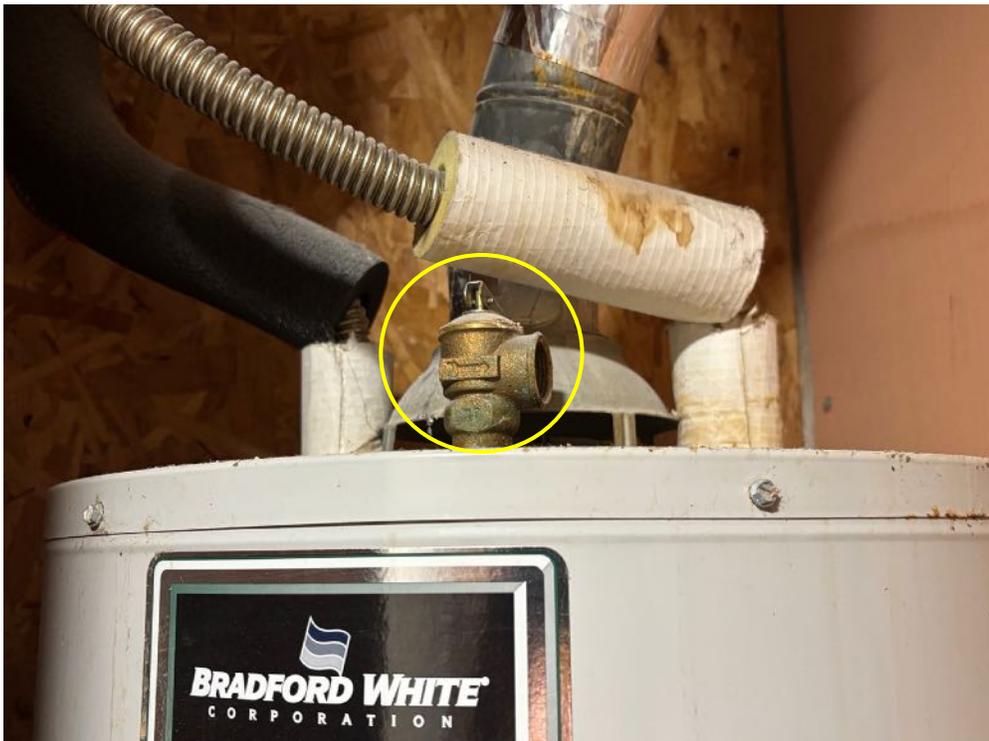
- *The water heater has a pressure/temperature valve. However, the pressure/temperature valve has not been piped to the exterior of the structure. Contact a licensed plumber to check for safety code/repair.*

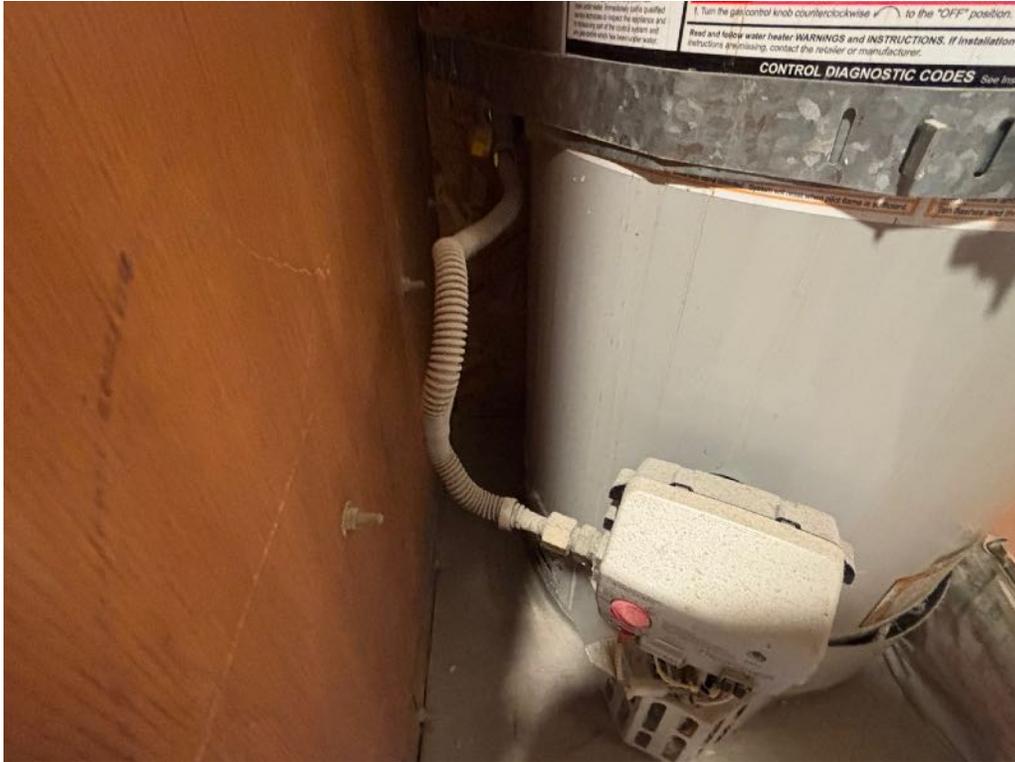
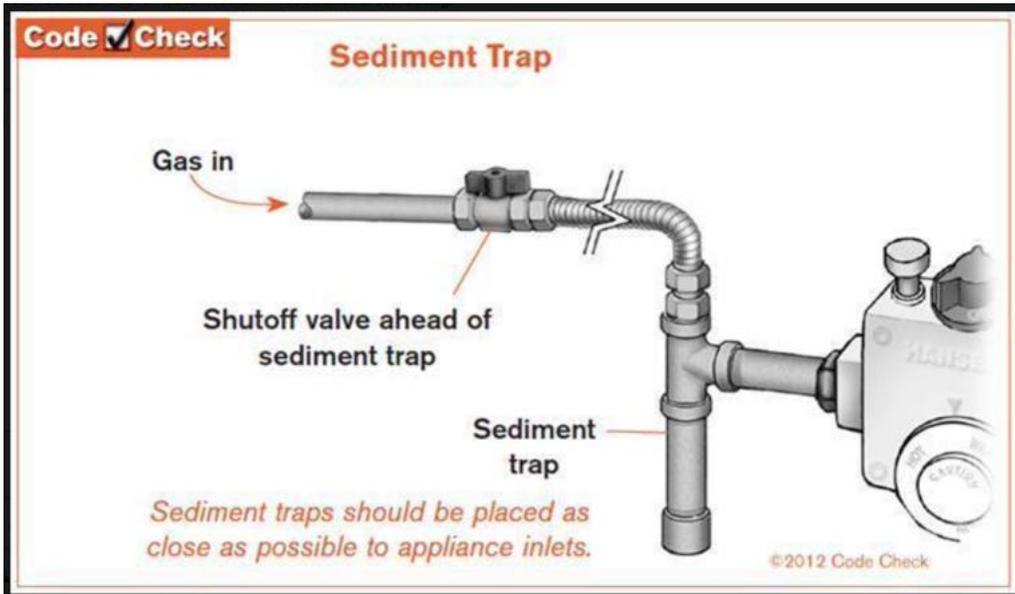
- *There is typical rust and scale in the burner chamber.*
- *The gas line to the water heater does not have a "drip leg/sediment trap." Contact a licensed plumber to check for safety code/repair.*

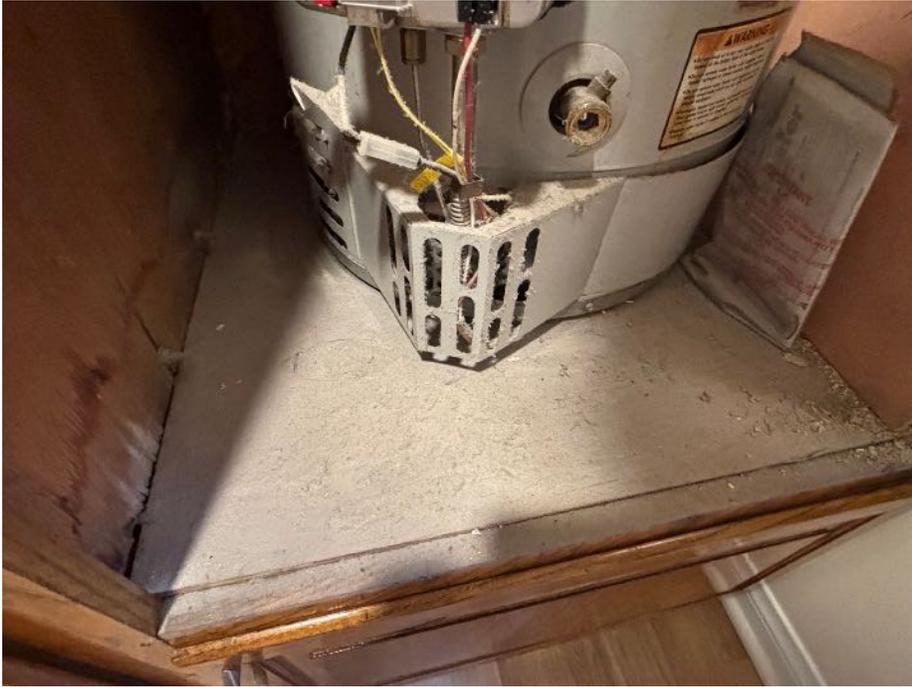
- *A "smitty" pan has not been installed underneath the water heater.*

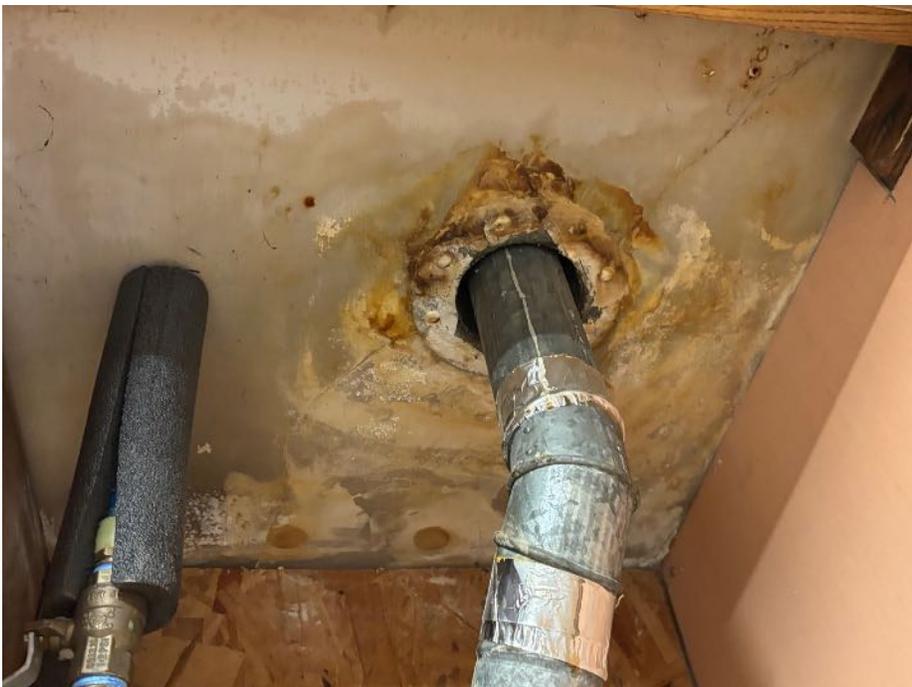
- *The water heater does not have a bonding wire attached to the plumbing pipes. Contact a licensed plumber to check for safety code/repair.*
- *The water heater does not have an expansion tank.*
- *There were no visible signs of any leaking, and the water heater appeared to work satisfactorily at the time of the inspection.*
 - *The cabinet ceiling is water stained and discolored.*

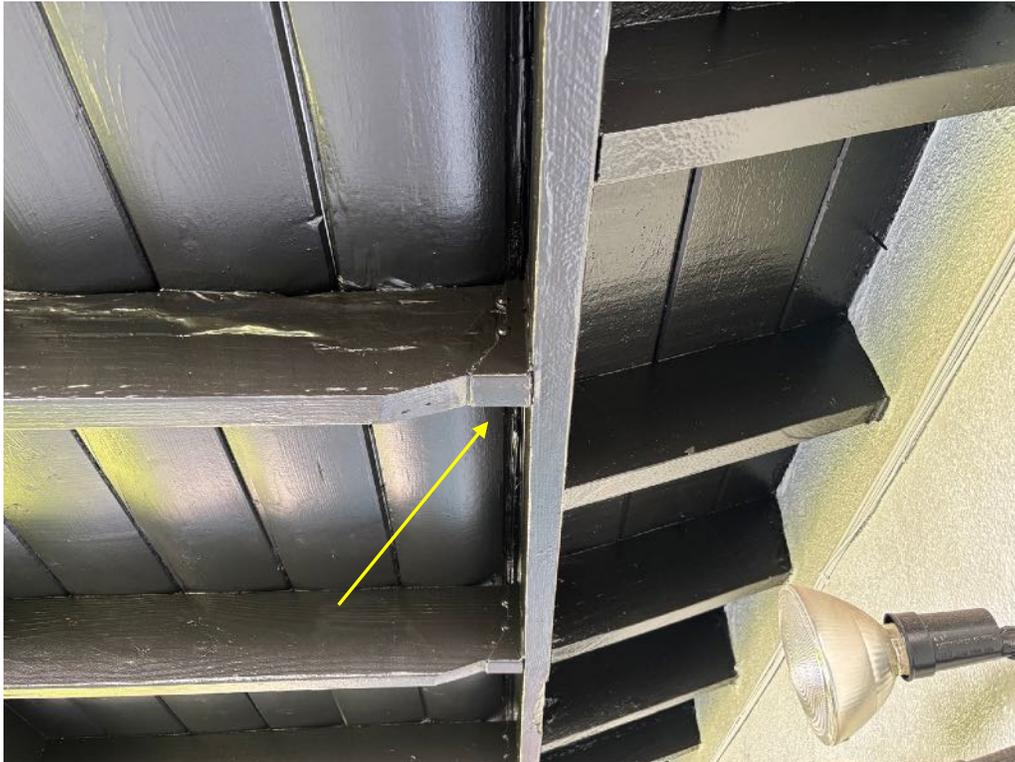
300 Patio (Cont'd)
301 Cover (Cont'd)

- **The patio cover uses the fascia board as a ledger. The rafters for the patio cover are secured in place with mounting brackets, but the roof rafter tails have not been secured to the fascia/ledger board with mounting brackets. (See Photo on Next Page) Contact a licensed electrician to check for safety code/repair.**

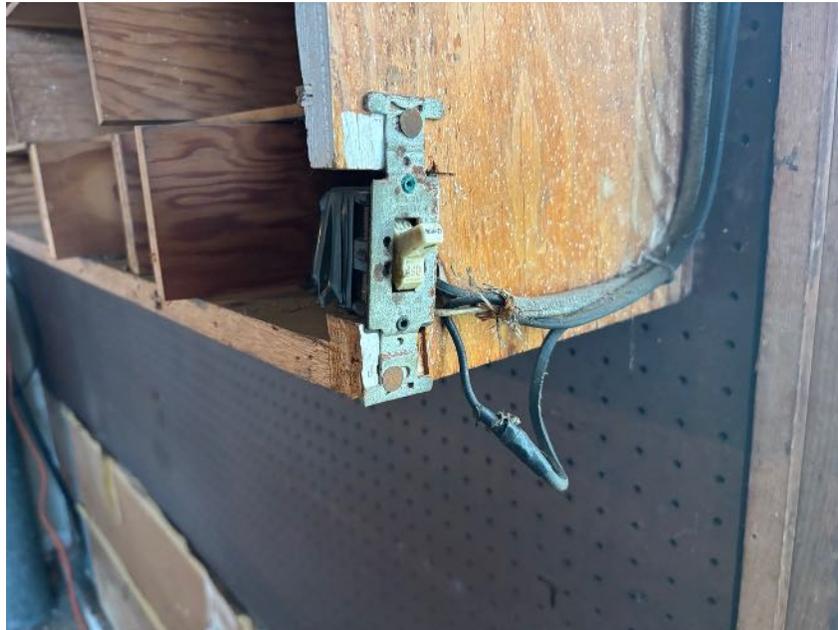
503 Elect. (Switch)

- ***Exposed romex wiring has been installed below 8' to one switch, and the switch is not contained in an electrical junction box. Contact a licensed electrician to check for safety code/repair.***

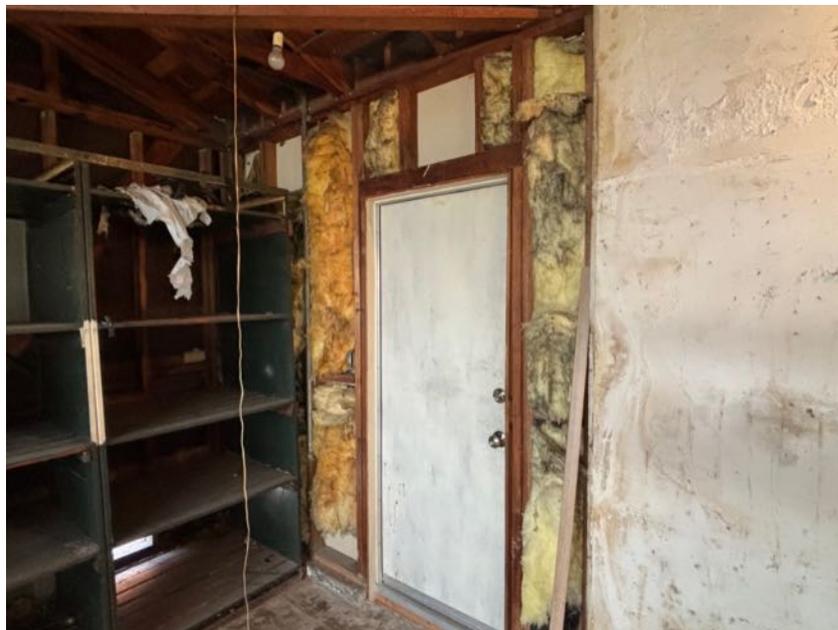
506 Firewall

- ***The garage firewall is water stained, discolored, and has some efflorescence and minor deterioration.***
- ***The garage firewall has not been completely covered and sealed with 5/8" thick wall board. Contact a licensed contractor to check for safety code/repair.***

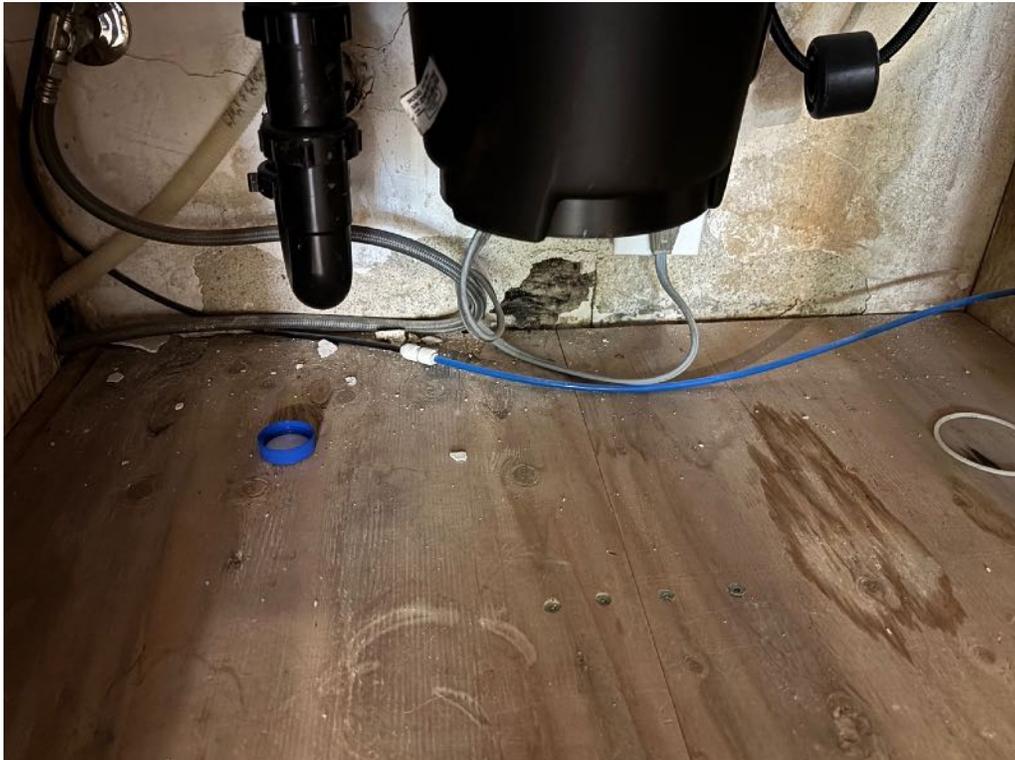
601 Walls

- *The walls have minor cracks and visible patches.*
- *The wall underneath the sink is water stained, discolored, and has some deterioration. Contact the seller for any further information or explanation concerning this condition.*

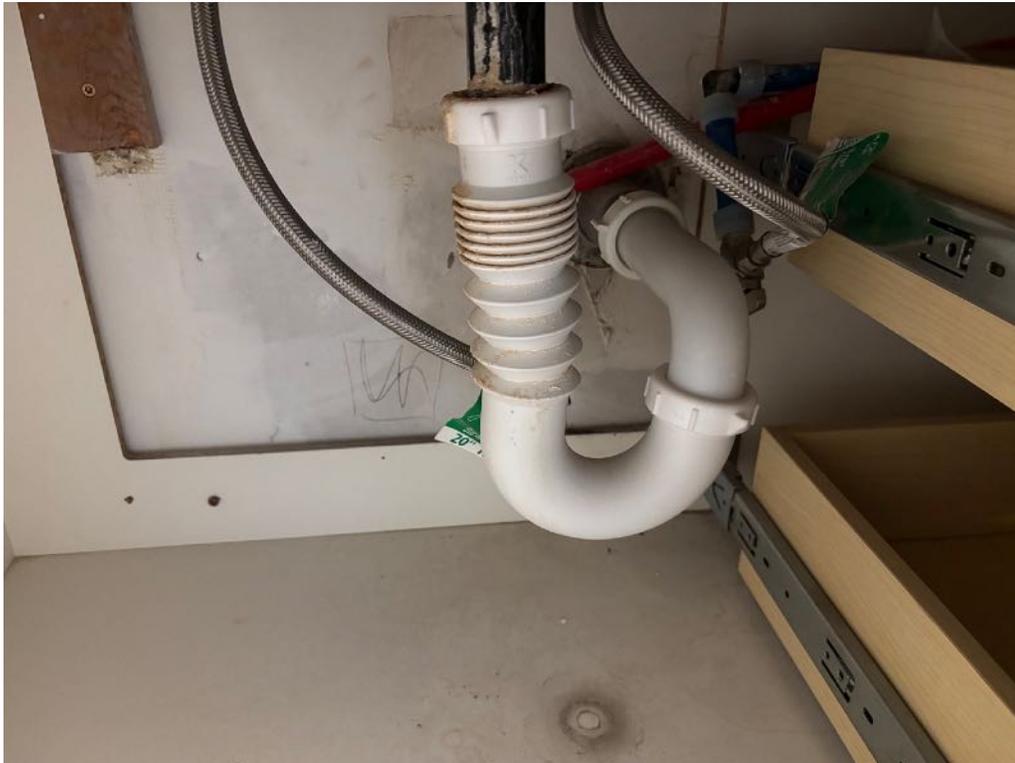
1560 Sink Traps/Drains

- ***A corrugated drain has been attached as part of the waste pipe underneath the left sink. The corrugated tailpiece characteristically allows bacteria to be trapped inside the pipe.***
