Inspection Report

70 Lupoyona Drive, Lakeport, California 95453

AP-381-003308

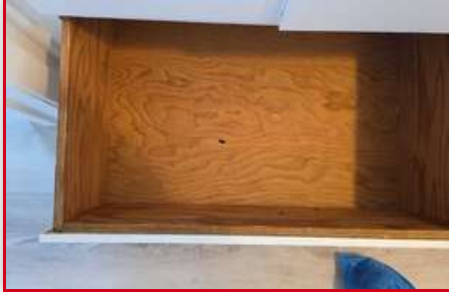
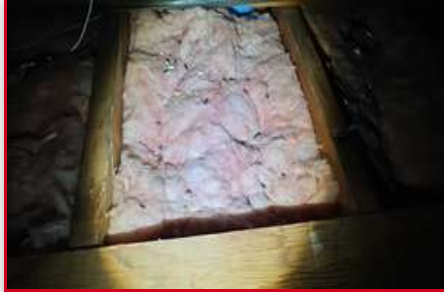
Location: ATTIC

### 12.1.1 Rodent feces found

One or more areas had rodent feces/bait/traps visible. We recommend that a pest control company be called out to evaluate the area to see if the nesting is recent. If it is then they will need to exterminate the rodents and clean the affected areas.

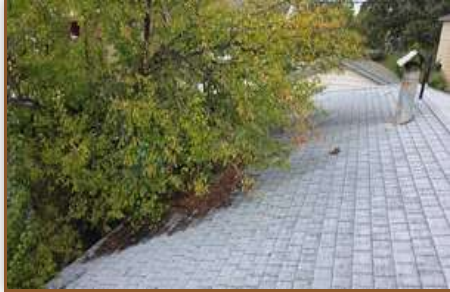
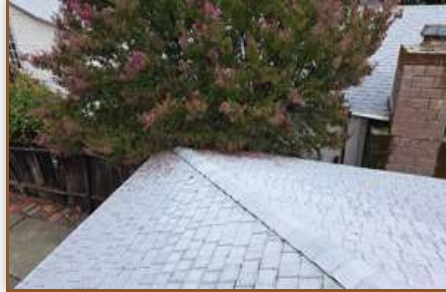
There was vegetation/tree branches close to the roof. We recommend that the vegetation in question be trimmed or removed to at least several feet away from the roof.

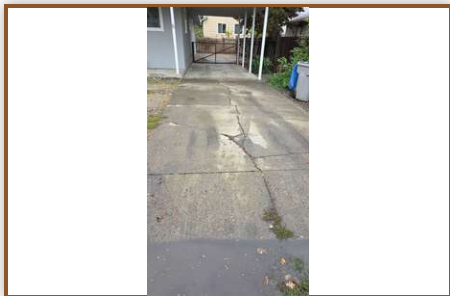
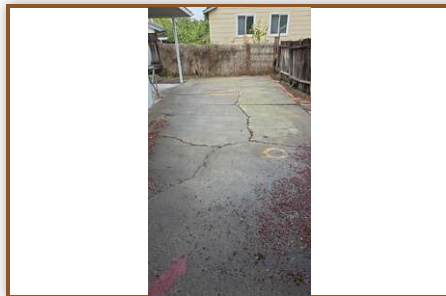
There was settling in the driveway that has cracked and offset. These settled area(s) are a trip concern. The Inspector recommends that the affected area(s) be evaluated, replaced or repaired, as needed, by a professional concrete contractor.

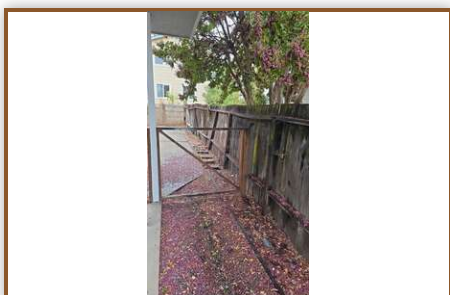
## 2.9.1 End of the fence and/or gates useful life

The fence and/or gates were leaning or in poor condition and will need to be replaced in the inspectors opinion. All work should be done as needed by a professional fence repair contractor.

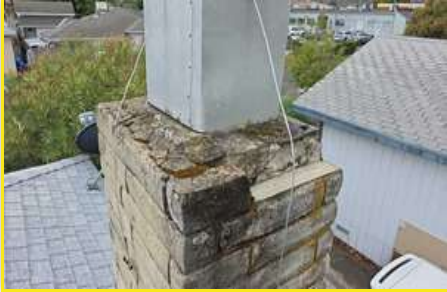
### 1.1.1 Chimney crown damage (Replace)

At the time of inspection, the chimney crown was damaged and in need of replacement. The inspector recommends that the affected area(s) be evaluated, replaced or repaired, as needed, by a professional mason.

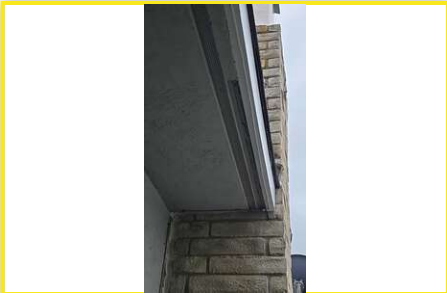
Location: WEST SOFFIT

### 2.1.2 Damaged Stucco

Stucco was damaged/cracked in one or more areas. Evaluation and repair by a stucco contractor is recommended.

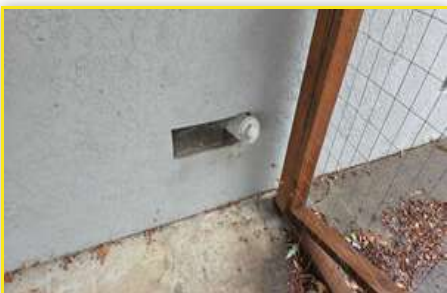
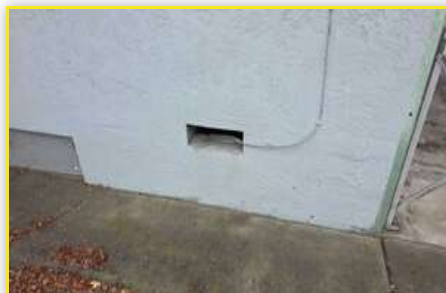
### 2.4.1 Vents Screens are Damaged/Missing

The crawlspace vents had screens that were damaged or missing which can allow for animals to enter. Repairs are recommended.

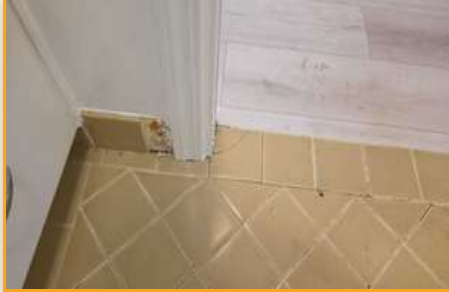
Location: BATHROOM

### 3.1.1 Tile floor damage

There were one or more areas with damaged tiles/grout in the residence. The inspector recommends that the area be evaluated and replaced as needed by a professional tile repair contractor.

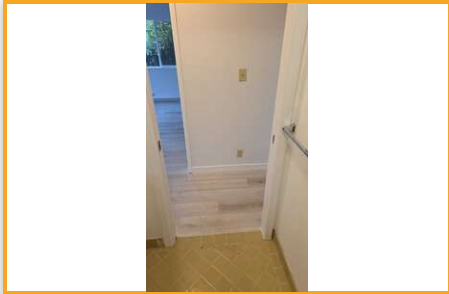
Location: HALLWAY BATHROOM

One or more handles/locks do not function in this room. The inspector recommends that the inoperable components be replaced by a professional interior door repair contractor.

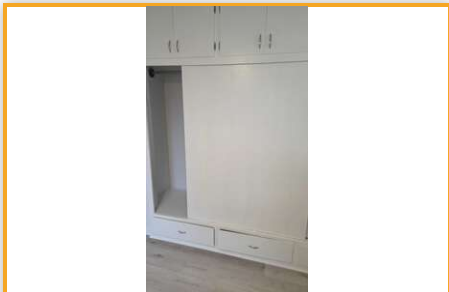
Location: REAR BEDROOM

### 3.6.2 Closet Door Off Track

The closet doors in one or more locations were off track or difficult to operate. Recommend repairs as needed by a contractor or handy man.

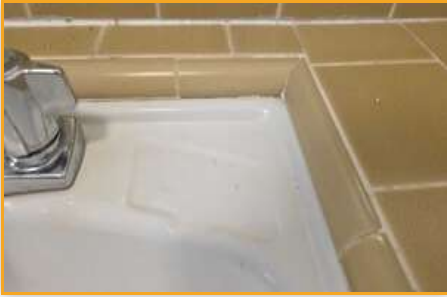
### 5.4.1 Damaged Caulk/Grout (Wall/Sink)

The bathroom counter caulking/grout used to seal the sink or wall were cracked or damaged and in need of maintenance. We recommend that the affected areas be repaired as needed by a professional contractor.

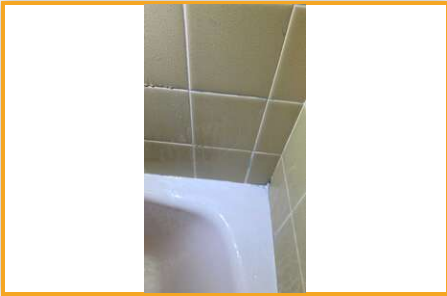
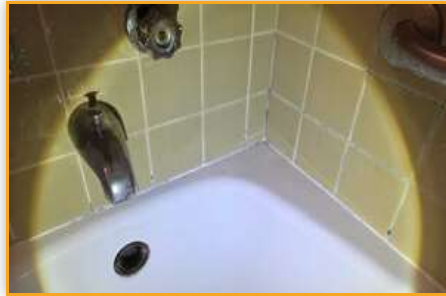
### 5.7.2 Bathtub (Multiple Defects)

At the time of the inspection, caulking surrounding the tub was dark in color, indicating microbial growth. This happens to caulking periodically. The inspector recommends that the caulking be removed and reinstalled.

The tub surround had one or more damaged tiles, which can allow for moisture intrusion. Repair by a tile contractor is recommended.

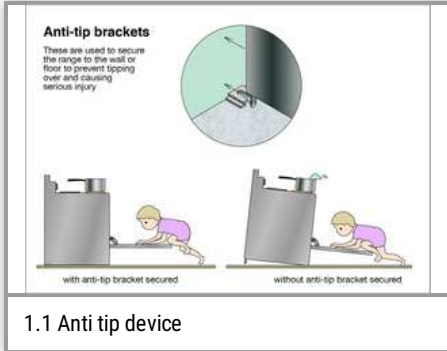
The stove does not have an anti-tip device. This is a bracket that attaches behind the oven at the wall/floor and the rear "foot" of the stove locks into it. Should you happen to have a child in the house learning to walk and they decide to pull-up on the oven handle it prevents the stove from tipping forward and injuring the child.

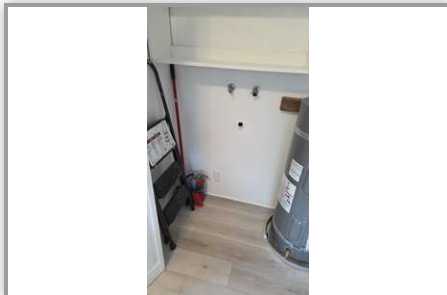
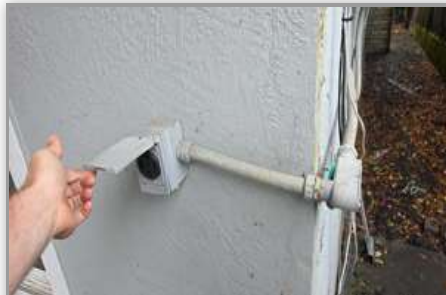
Location: NW

### 6.4.1 Dryer Hookups

There are no dryer hookups present in the laundry area. There is a 240 volt outlet installed outside of the back door. However, this is not connected to a breaker in the breaker box. Hookups for a dryer should be installed as needed by a contractor.

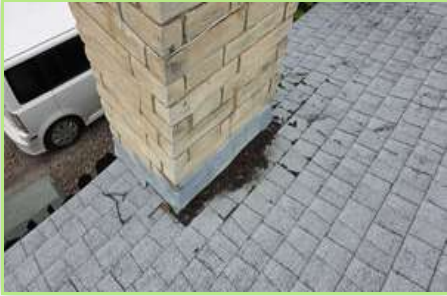
At the time of inspection one or more chimneys had no cricket installed on the slope side. As a result water can damage the chase and possibly leak into the home in times of high rain. We recommend that a cricket be installed as needed by a professional roofing contractor to industry standard.

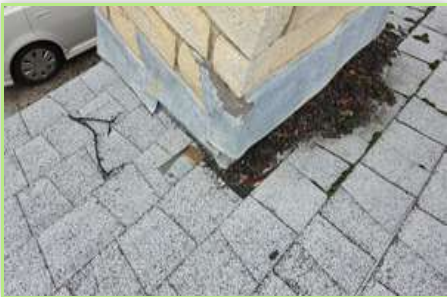
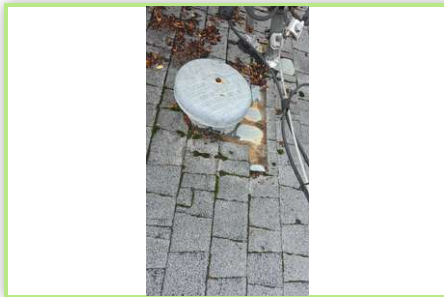
### 1.2.1 Corroded roof flashing

There were one or more areas of the metal roof flashing had corrosion. The Inspector recommends that the affected area(s) be replaced when the roof is replaced.

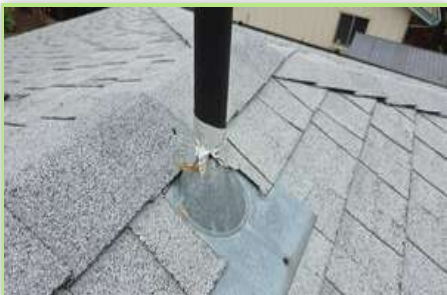
### 1.3.1 Vent not sealed

There is no sealant or boot on the plumbing vent, or the sealant has cracked. This may allow for a water leak. It is recommended to be sealed with tape or other means by a contractor.

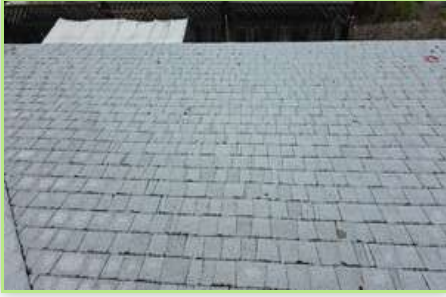
There were no gutters installed on the home or other structures. Moisture related issues affecting the home or its foundation/ support. The Inspector recommends the installation of gutters, by a professional contractor.

Moss or mold was observed on the roof material. In excess, moss can allow for roof leaks. Roofs can be rinsed with a PH solution specified for killing moss (or bleach water).

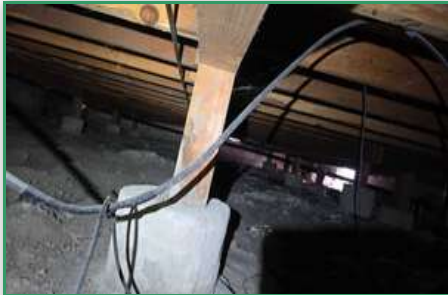
1.1 3/4 inch per foot

### 11.2.1 Column not plumb

One or more columns were found to not be plumb. Evaluation and repairs are recommended by a professional contractor.

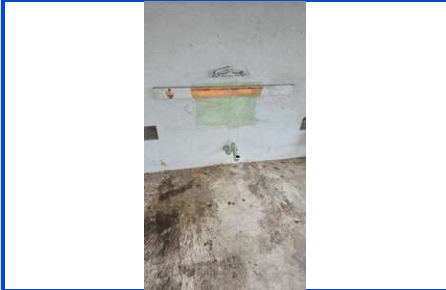
Location: NORTH EXTERIOR

### 2.6.1 Missing Sewer Cap

A drain was missing its cap. Recommend for a plumber to install a cap, or a sink with a p trap, to prevent sewer odors.

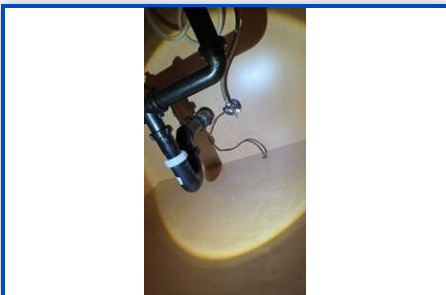
When the cold water is operated at the kitchen sink, water squirted out of the water line for the fridge. This will either need to be connected or capped to prevent water damage.

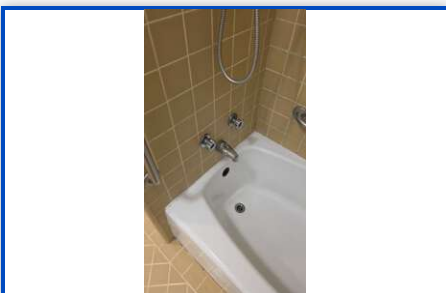
### 5.7.1 Spout/handles - loose

The tub/shower spout/control fixtures were loose. This can allow for moisture intrusion and possible damage to the plumbing. The fixture needs to be secured.

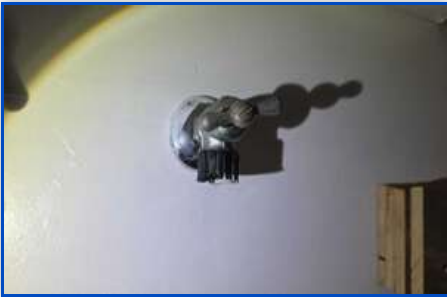
### 6.3.1 Washer Supply Drips When Off

There were one or more areas where the water supply lines were actively leaking. If a hose to the washer were connected here, there would not be a leak. However, the valve should be working properly. The inspector recommends that the affected areas be repaired as needed by a professional plumbing contractor.

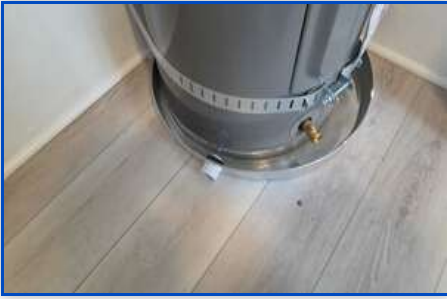
### 8.1.1 Drain pan had no overflow

The drip pan had no overflow. The inspector recommend that an overflow be installed to the exterior as needed by a professional contractor.

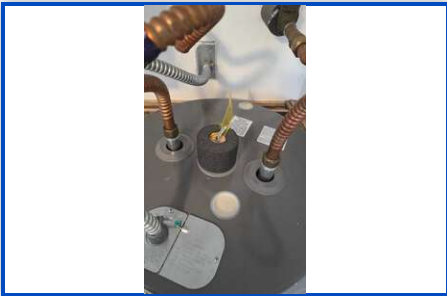
### 8.1.2 Missing Discharge Pipe

The discharge pipe was missing from the water heater TPR discharge leaving the unit unsafe. Discharged water will not be controlled and may cause a burn or other damage. We recommend that it be repaired as needed for safety.

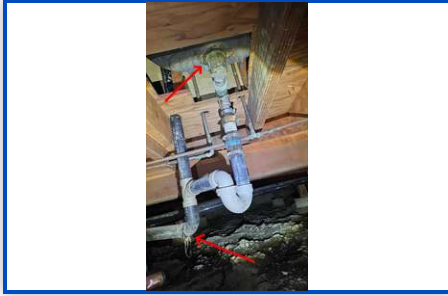
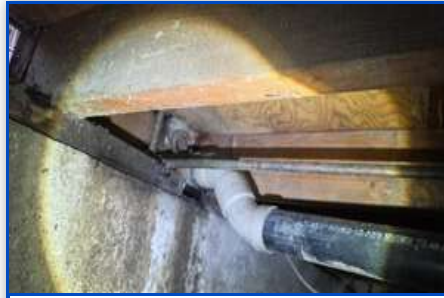
Location: KITCHEN CRAWLSPACE

### 11.7.1 Active Drain Leak

The inspector found one or more active drain leaks. The drain leak under the kitchen sink is an open drain pipe. This can allow for sewer gases to exit and debris may enter the pipe. We recommend that the affected drains be repaired as needed by a professional contractor.

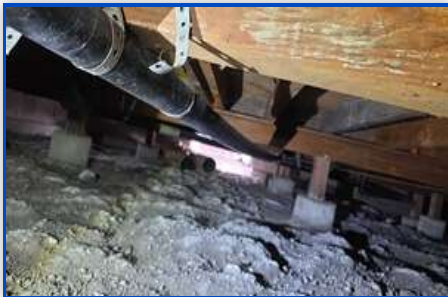
### 11.7.2 Inadequate Drain Line Hangers

One or more hangers for the drain lines in the home were missing or installed incorrectly. The inspector recommends that the affected areas be repaired. ABS piping should be supported at least every 4 ft.

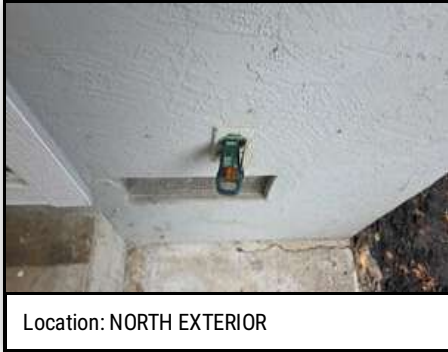
Location: NORTH EXTERIOR

At the time of inspection, exterior electrical receptacle had hot and neutral wires reversed. The Inspector recommends that the affected area(s) be evaluated, replaced or repaired, as needed, by a professional contractor.

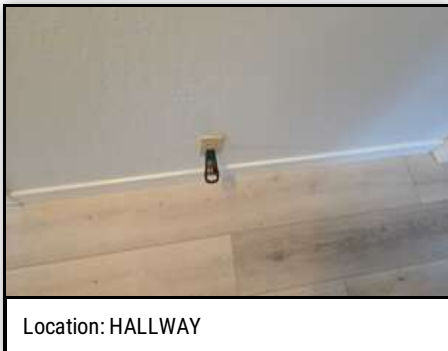
Location: HALLWAY

### 3.9.1 Loose plug/box

There were one or more loose electrical outlets in the residence at the time of the inspections. The affected outlets should be replaced as needed by a professional electrical contractor.

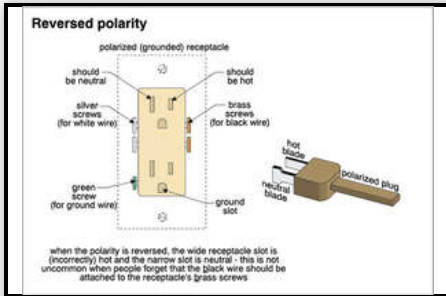
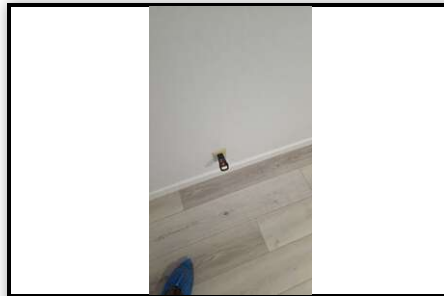
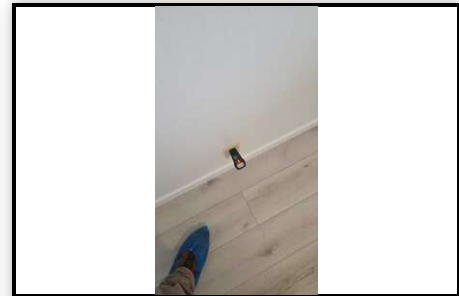
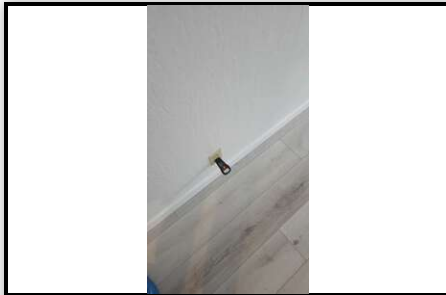
2.1 Hot Nuetral Reverse

### 3.9.2 Outlet (Hot Neutral Reverse)

One or more electric outlets had wiring that was hot and neutral wires were reversed. This is a shock concern. We recommend that this repaired as needed by a professional electrical contractor.

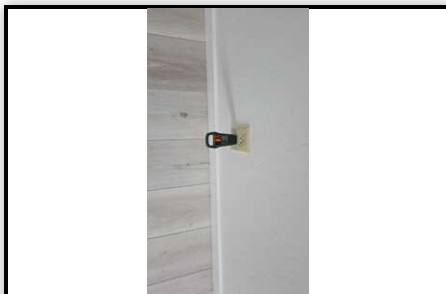
Location: LIVING ROOM, 2 OUTLETS

### 3.9.3 Open Ground

One or more three slot outlets were found that are not grounded. This is a safety hazard as three pronged appliances can malfunction if plugged in here. Evaluation and repairs are recommended by a professional electrician. Possible repairs include grounding back to the electrical panel or installing GFCI protection.

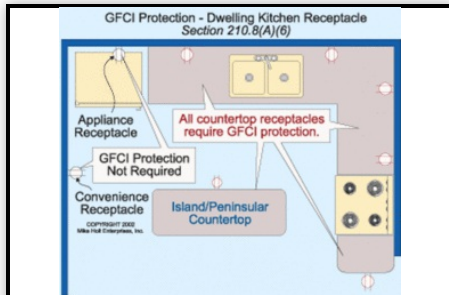
1.1 GFCI placement illustration

GFCI outlets were not installed located within 6 feet of a plumbing fixture or on kitchen counters. The Inspector recommends upgrading to GFCI protected outlets as a safety precaution. GFCI protection has been required in kitchens within 6 of a sink since 1987 and all countertop outlets since 1996.

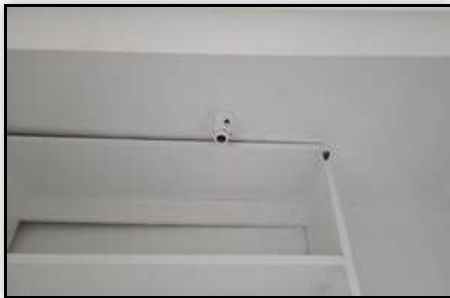
### 6.1.1 Laundry Lights (Burnt Out Bulbs)

One or more light bulbs in the laundry room had burnt out or missing bulbs. Bulb replacement is recommended. If that does not work further evaluation by an electrician will be needed.

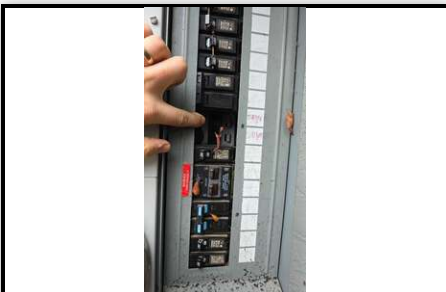
Location: WEST EXTERIOR

There were one or more slots where the panel cover had gaps. We recommend that the gaps be filled with listed cover caps.

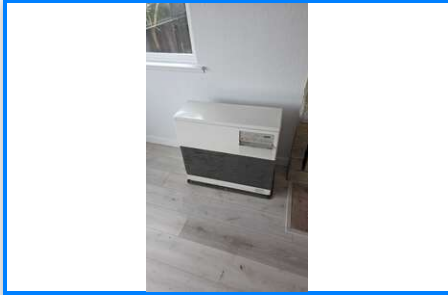
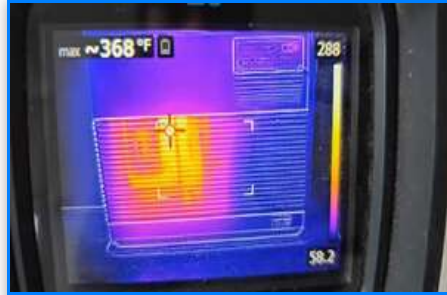
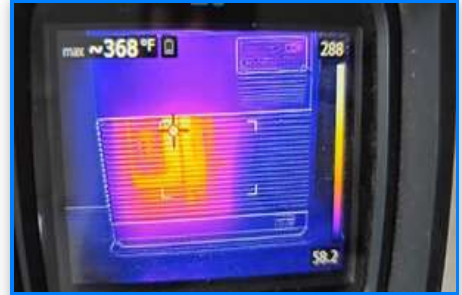
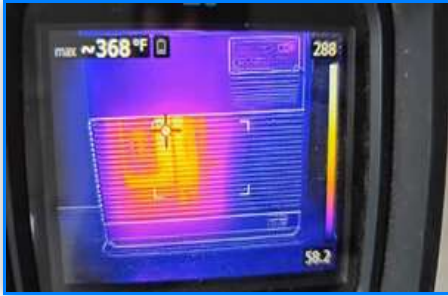
### 7.1.1 Old wall heater

Electric wall heater(s) found in the house are known fire hazards. Most of these no longer have controls or a response. Replacement of these heater(s) is recommended.
