**Property address: 5142 Warner Ave Apt 112
Huntington Beach CA 92649-4044**

Inspection date: Saturday, February 7, 2026

Property Inspection Report Pre-Listing

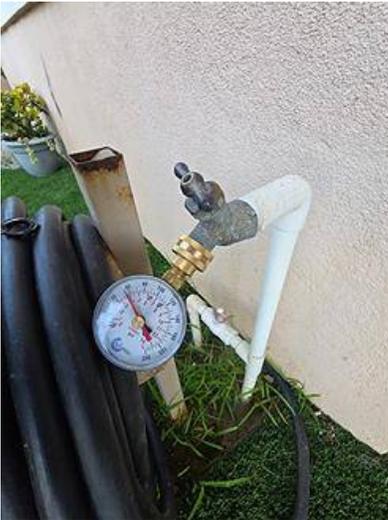
Photo 4-1

4) Serviceable - Water Pressure=55

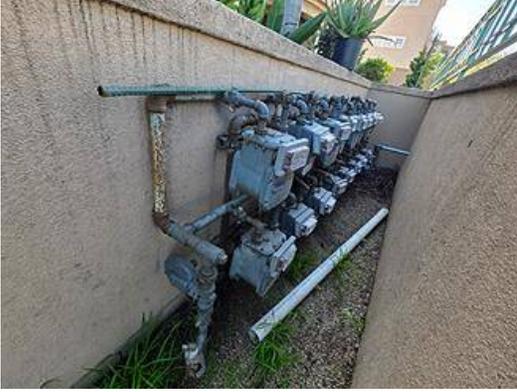
Photo 5-1

5) Serviceable - Gas Meter. Commons location. Gas meters were not numbered dedicated meter for this unit was not identified.

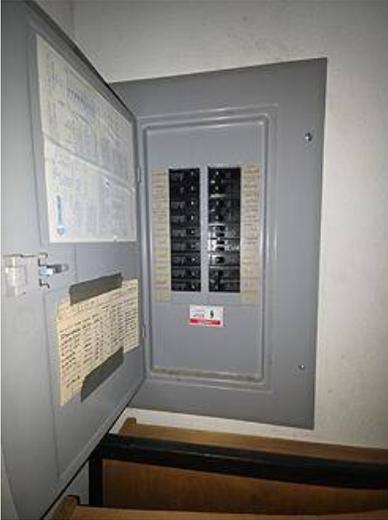
Photo 6-1

6) **Serviceable** - Sub-Panel

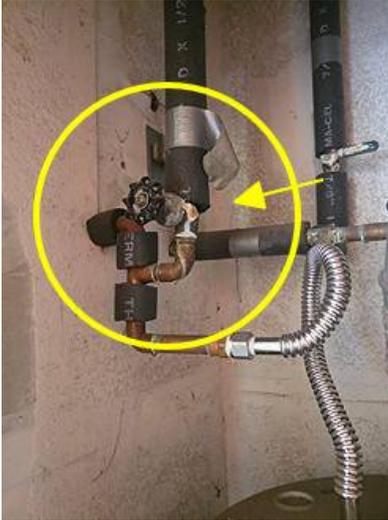
Photo 9-1

Concern: Corrosion was observed at the water shutoff valve connection. No active leakage was noted at the time of inspection; however, this condition may increase the potential for future leakage.

Recommendation: Repair as required or monitor for signs of future leakage and repair as needed.

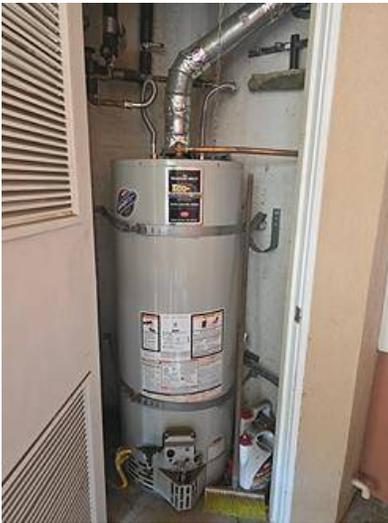
Photo 10-1

Comment: The Water Heater was operable at the time of the inspection.

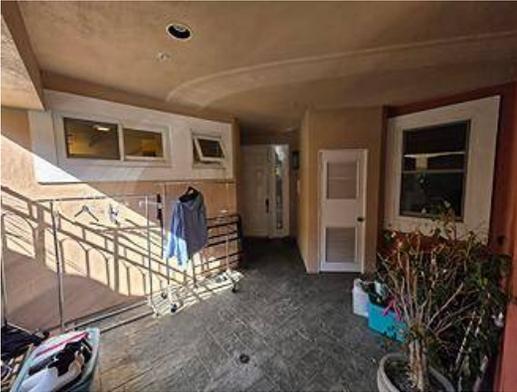
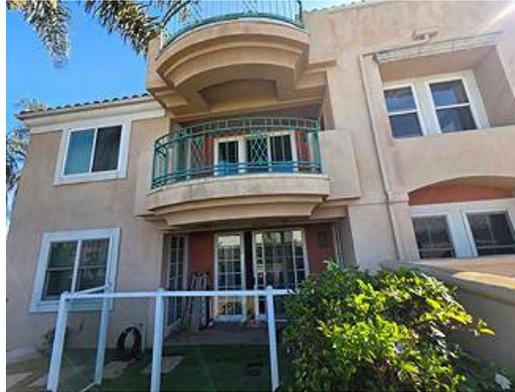
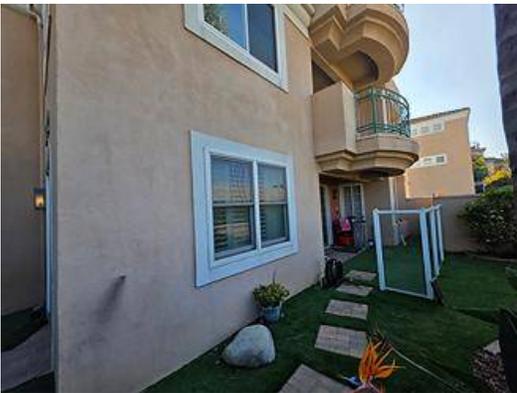
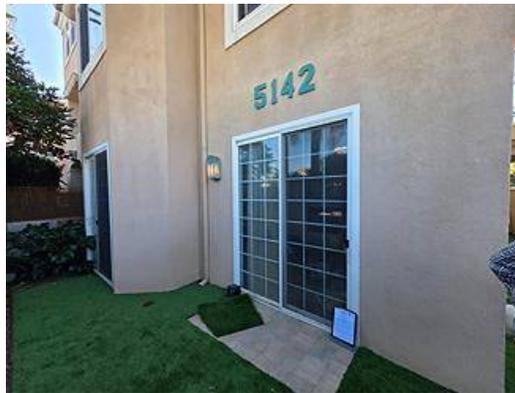
11) *Serviceable* - Exterior Views

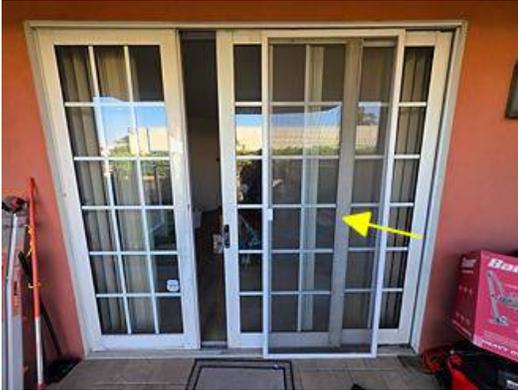
**Photo 12-1****13) Needs Attention, Replace, Comment -** French Doors-Inoperable

Concern: The patio door screen was observed to be off its track at the time of inspection.

Recommendation: Evaluate the screen for reinstallation, adjustment, or repair

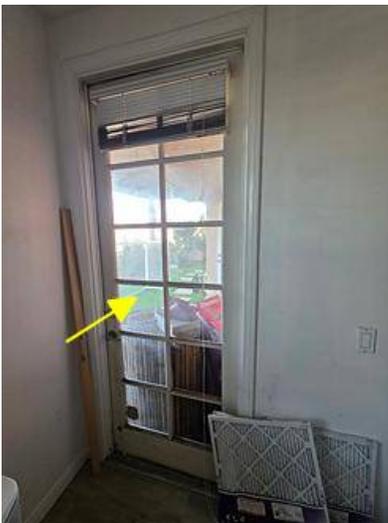
**Photo 13-1**

Concern: The French doors serving the primary bedroom and the formal dining room were inoperable and could not be opened at the time of inspection.

Comment: The owner stated that the doors were known prior to be inoperable and damaged and are scheduled for replacement.

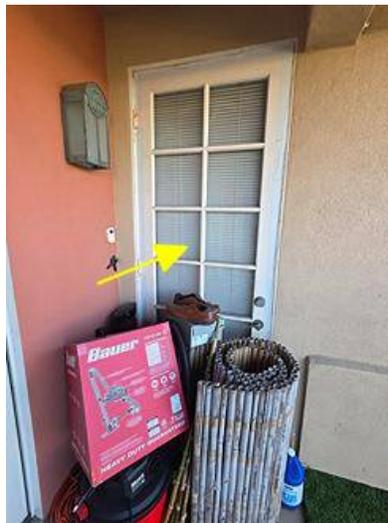
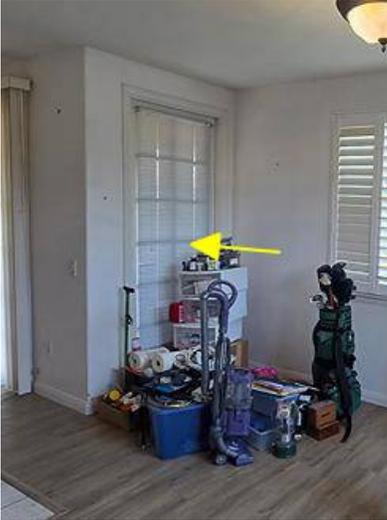
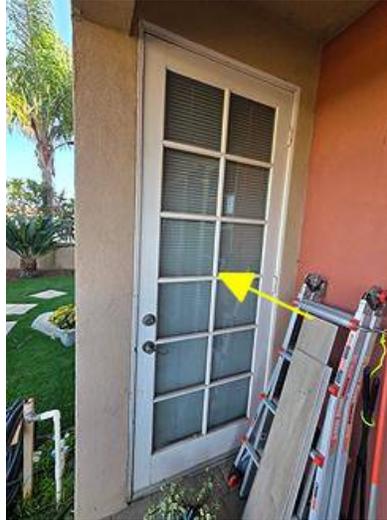
13) **Needs Attention, Replace, Comment** - French Doors-Inoperable

Comment: The owner stated that the doors were known prior to be inoperable and damaged and are scheduled for replacement.

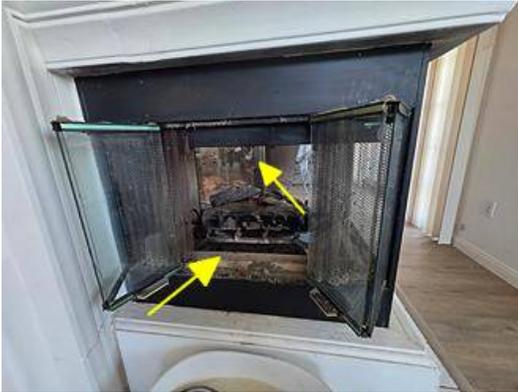
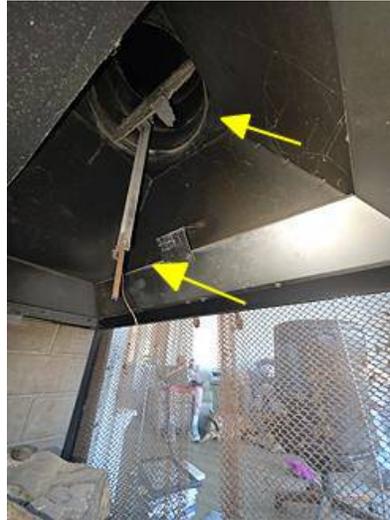
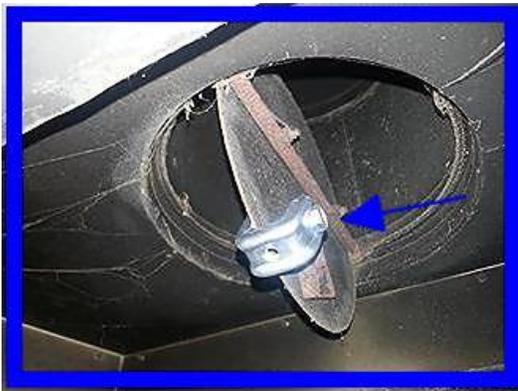
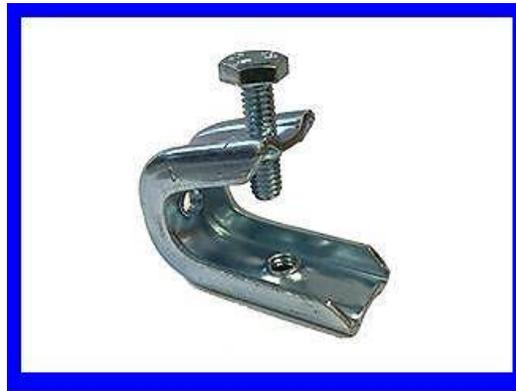
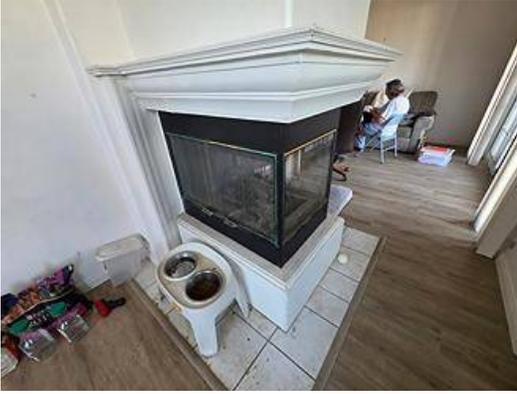
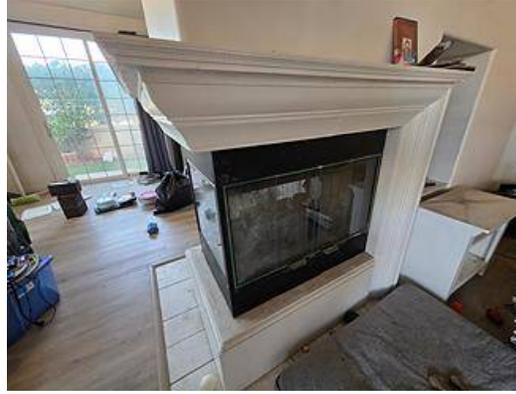
15) **Safety, Needs Attention, Repair, Install/Missing** - Fireplace & Chimney

1) The chimney damper was observed to be disconnected, which may have been done to prevent the damper from being closed due to the presence of a gas log system. Gas utility and manufacturer requirements typically call for an approved damper clamp to be installed to ensure the damper remains permanently open when a gas log set is in use. While the disconnected damper may currently keep the flue open, it does not provide the same positive locking method as a clamp.

2) The firebox and chimney were observed to require cleaning and servicing.

2) Have the firebox and chimney cleaned and serviced prior to use.

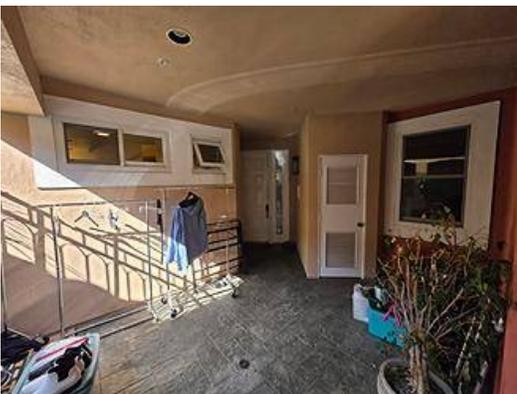
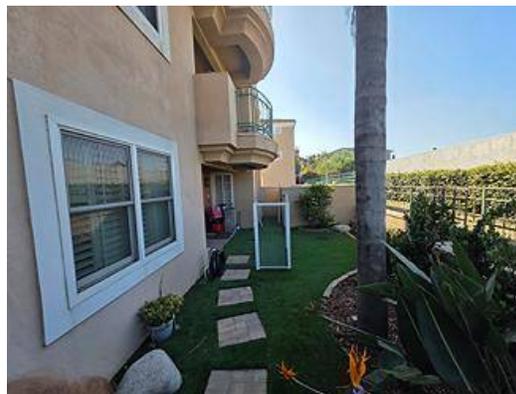
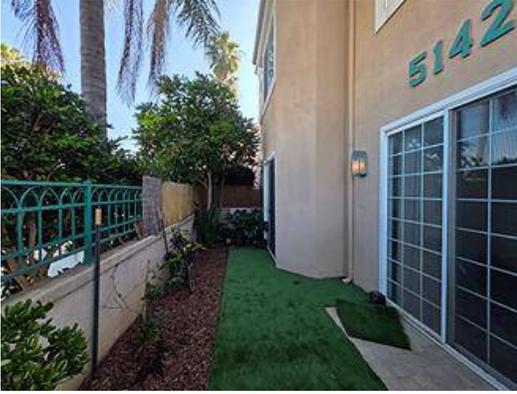
16) *Maintain* - Yard Views – General

Comment: Normal, ongoing yard maintenance is needed as part of regular home care.

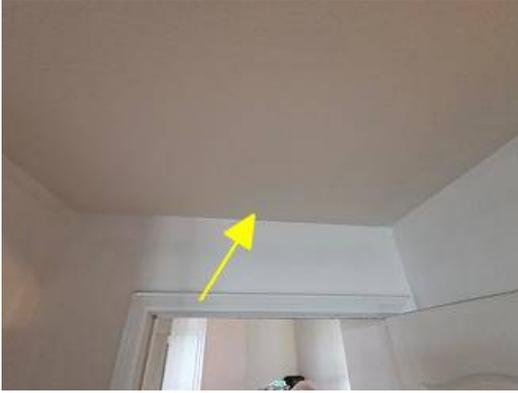
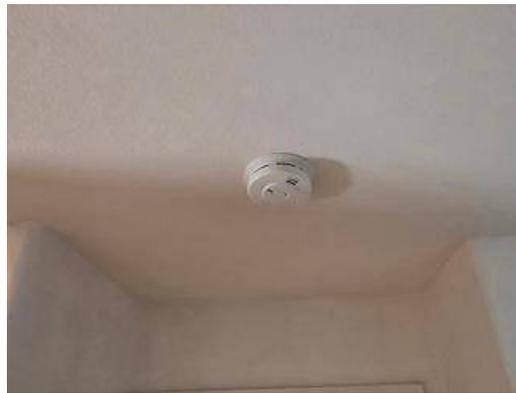
Photo 17-1

Note: Smoke detectors were otherwise installed in the hallway areas adjacent to Bedrooms 1 and 2.

Recommendation: Install smoke detectors inside Bedrooms 1 and 2, typically on the ceiling or high on the wall above and near each room door for improved life safety.

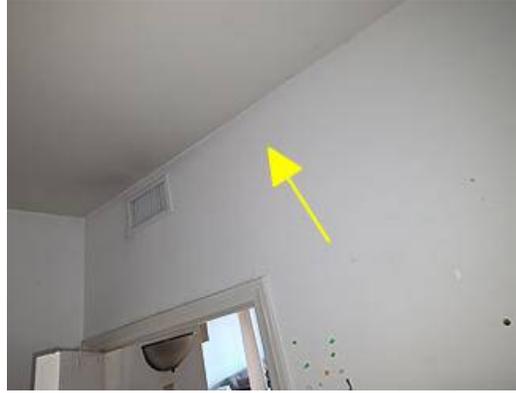
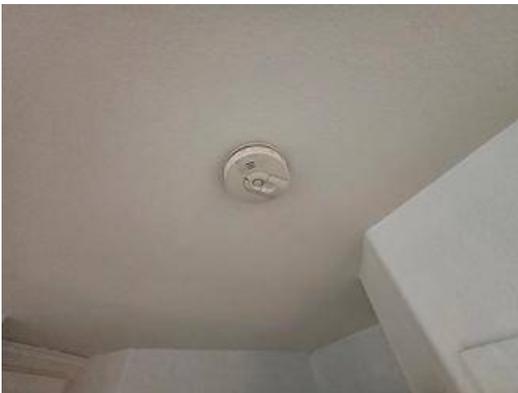
17) Safety, Needs Attention, Install/Missing - Smoke Detectors-Missing

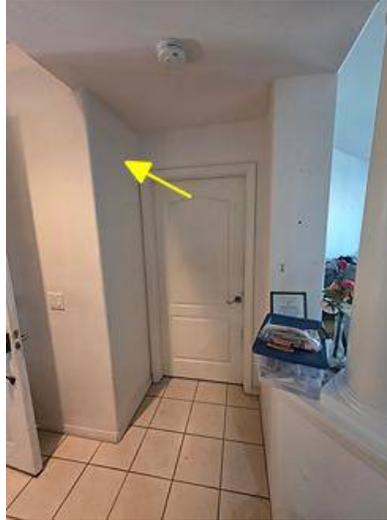
Photo 18-2

18) Safety, Needs Attention, Install/Missing - Carbon Monoxide Detectors-Additional Locations

Concern: A carbon monoxide detector was installed in the family room, which may be considered a central location to the bedroom areas. However, no dedicated carbon monoxide detectors were observed in the hallway entry areas serving the bedrooms.

Recommendation: Install additional carbon monoxide detectors in each bedroom hallway entry area to improve coverage and occupant safety.

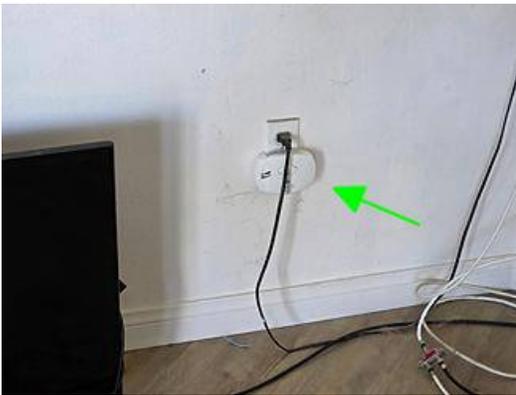
Photo 18-1

Concern: A carbon monoxide detector was installed in the family room, which may be considered a central location to the bedroom areas. However, no dedicated carbon monoxide detectors were observed in the hallway entry areas serving the bedrooms.

Recommendation: Install additional carbon monoxide detectors in each bedroom hallway entry area to improve coverage and occupant safety.

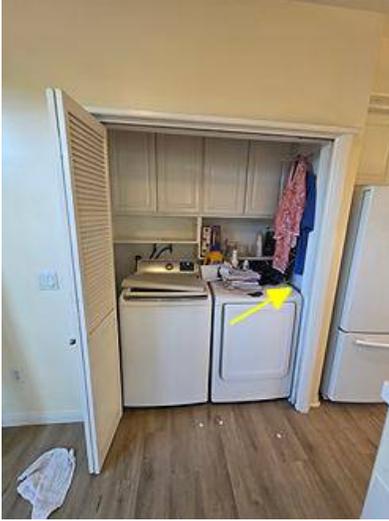
Photo 19-1

Concern: One of the two bifold doors at the laundry closet was observed set aside and not installed.

Recommendation: Reinstall the bifold door.

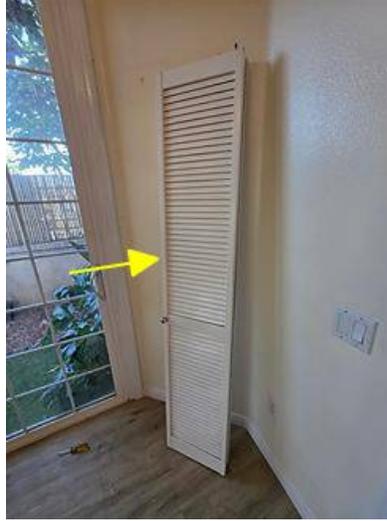
Photo 19-2

19) Needs Attention, Repair - Laundry Closet Bifold Door-Not Installed

Concern: One of the two bifold doors at the laundry closet was observed set aside and not installed.

Recommendation: Reinstall the bifold door.

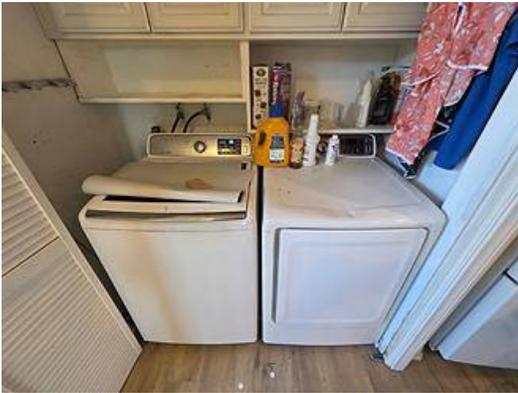
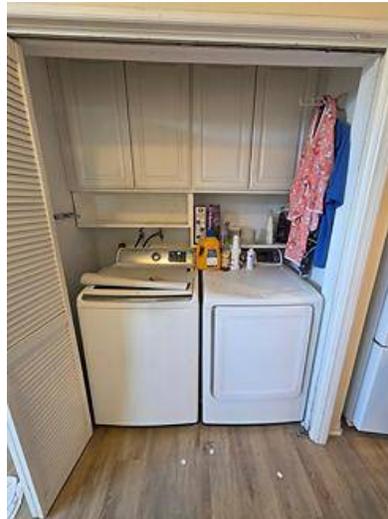
20) Comment - Laundry Area View ***See above Concern***

Note: Washer and Dryers, if present, are not operated during a Home Inspection, however a visual examination of the units, connections, and surrounding areas for signs of damage, leaks, or improper installation is performed.

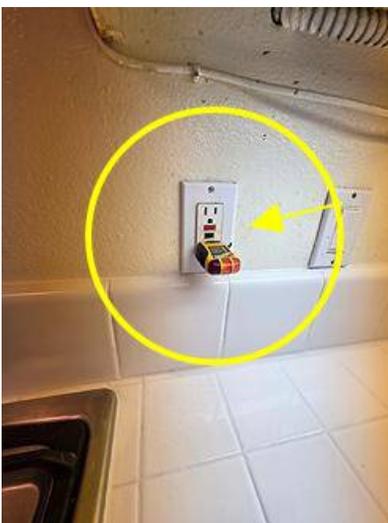
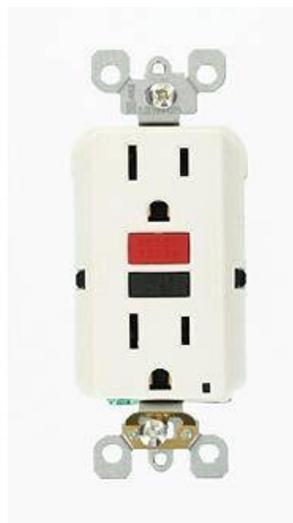
Photo 21-1

Concern: The GFCI outlet did not trip when tested, indicating it may not provide proper ground-fault protection.
Recommendation: Have the GFCI outlet evaluated and repaired or replaced as needed to ensure proper protection.

Recommendation: Have the GFCI outlet evaluated and repaired or replaced as needed to ensure proper protection.

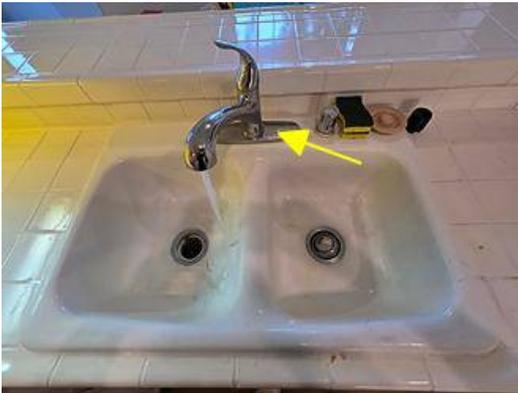
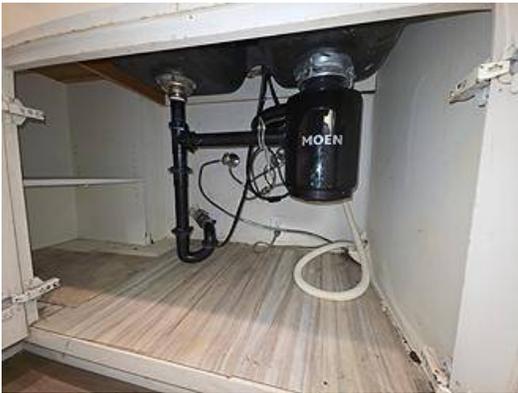
Photo 22-1

Concern: The sink faucet was observed to be worn and loose at the base where the spout connects to the faucet body.

Recommendation: Secure and repair the faucet as needed, or replace if proper tightening cannot be achieved.

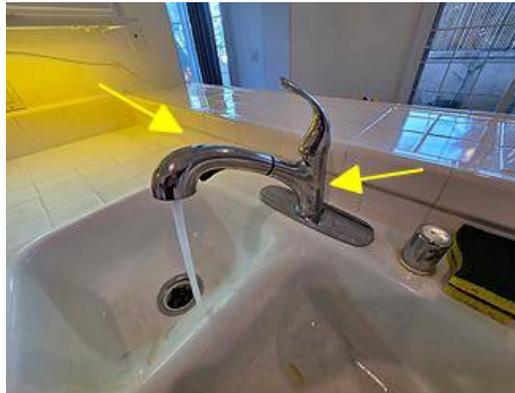
Photo 22-2

22) Needs Attention, Repair, Replace, Evaluate - Sink Faucet-Loose/Worn at Base

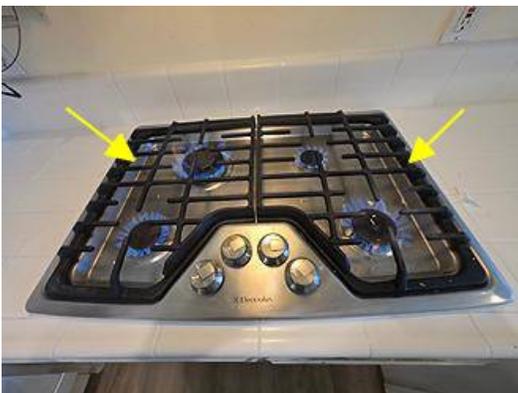
Photo 23-1

Concern: When the cooktop burners were turned on, a brief burst was noted at initial ignition. Minor flame movement, including slight dancing or jumping, was also observed during operation.

Recommendation: Have the cooktop evaluated and serviced as needed to ensure proper ignition and stable burner operation.

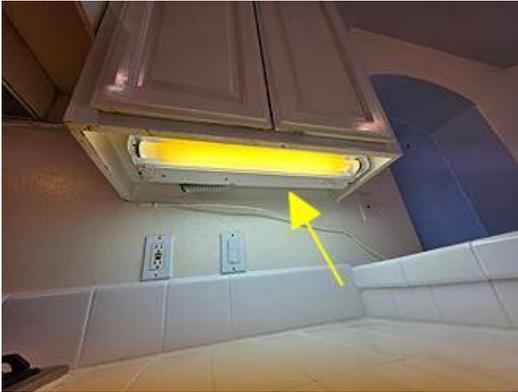
Photo 24-1

Concern: The under-counter fluorescent light fixture flickered during operation.
Recommendation: Replace the bulb and evaluate further if flickering continues.

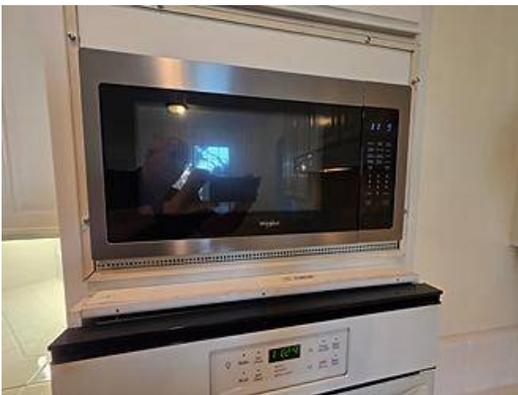
Photo 25-1

25) Serviceable, Comment - Microwave – The microwave was operable at the time of the inspection
Note: Microwaves are operated briefly using a water container or paper towel test to confirm heating. The unit responded to controls and heated as expected, but this limited test does not necessarily represent full functionality of all settings, features, or power levels.

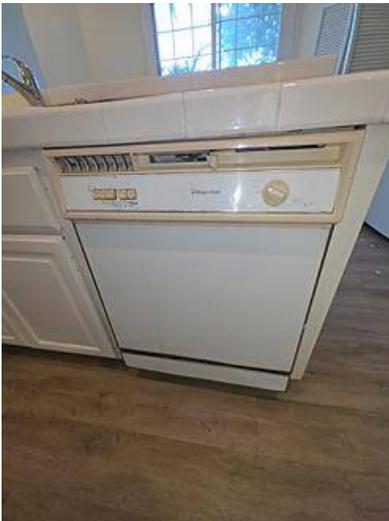
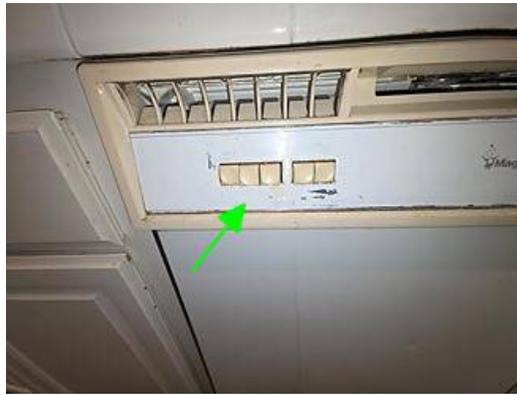
Photo 26-1

26) Serviceable, Comment - Dishwasher-Age/Wear Noted
Comment: The dishwasher appeared to be original to the home and was operable at the time of inspection. Age-related deterioration was noted. The control panel legend for the system selection buttons was worn, which limited identification of settings.

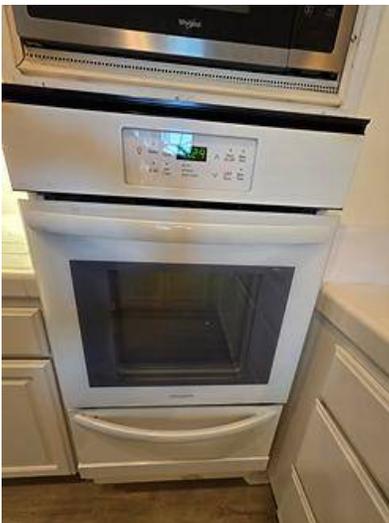
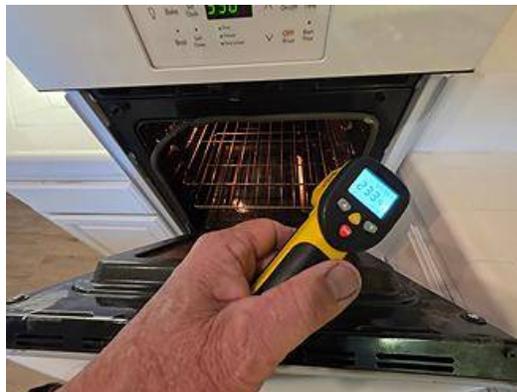
27) Serviceable - Oven – The oven was operable at the time of the inspection
 Note: Ovens are operated for a short period of time to test basic heating function. The unit responded to controls and produced heat, but this limited operation does not necessarily represent full functionality of all settings, features, or temperature calibration.

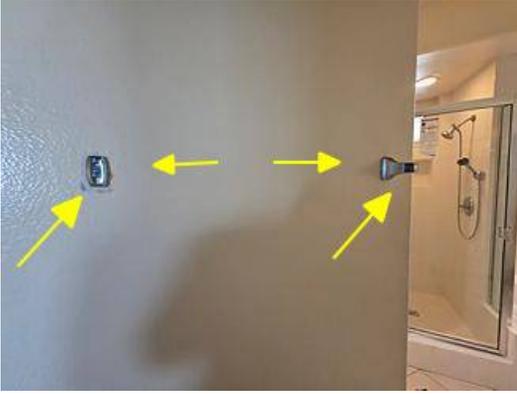
Photo 30-1

Concern: The towel bar was observed to be damaged and missing components.

Recommendation: Repair or replace the towel bar as needed

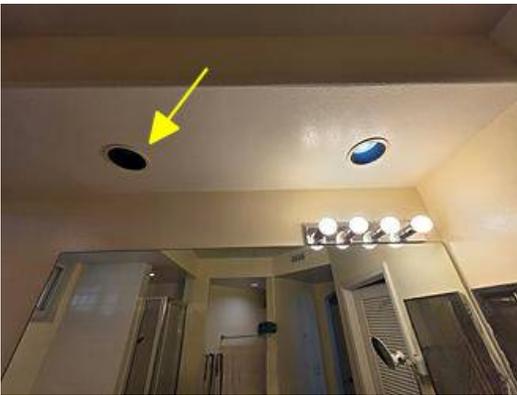
Photo 31-1

Concern: One of two recessed lights over the vanity sink was inoperable at the time of inspection.

Recommendation: Replace the bulb and evaluate further if the light remains inoperable.

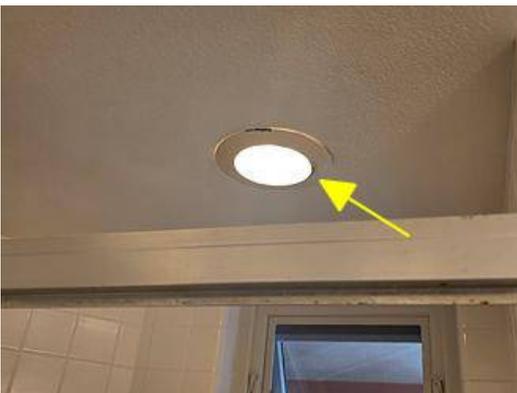
Photo 32-1

Concern: Debris was observed under the recessed light cover.

Recommendation: Remove the debris

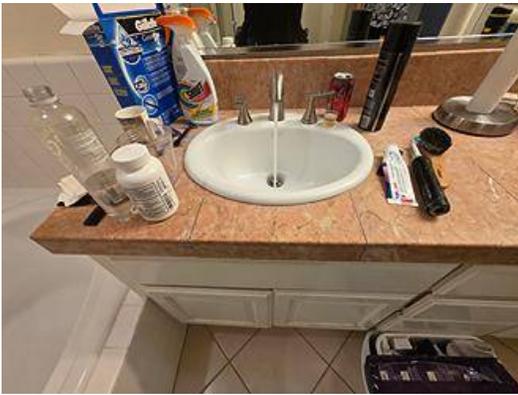
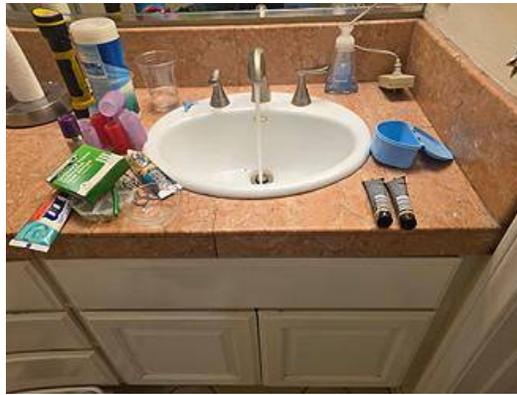
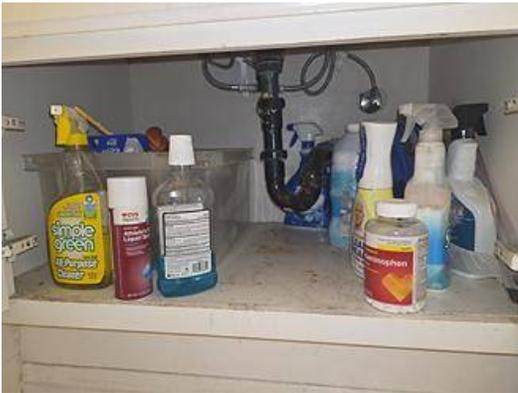
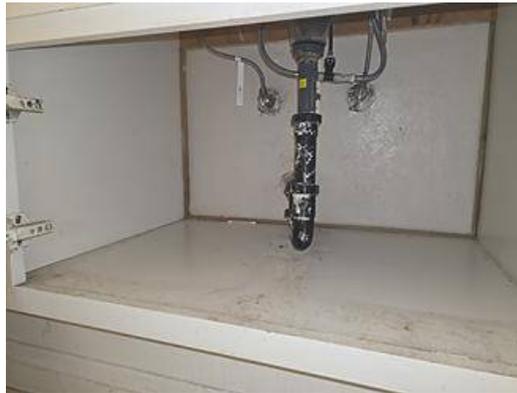
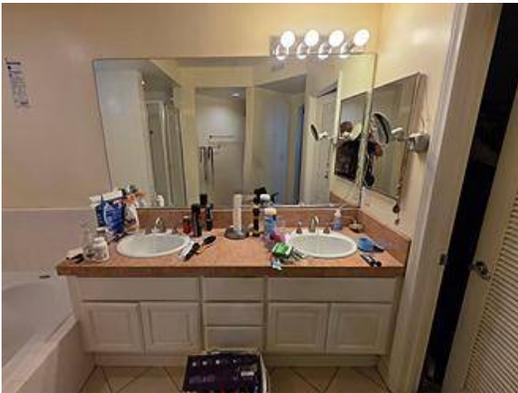
33) Serviceable, Comment - Vanity

Comment: Plumbing fixtures were operated and flowed normally at the time of inspection. Drains, supply valves, and accessible components functioned as expected, and no adverse conditions were observed during testing.

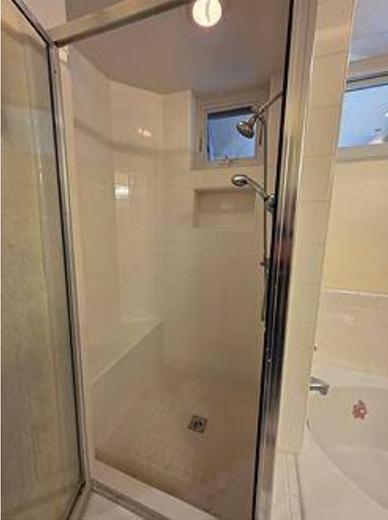
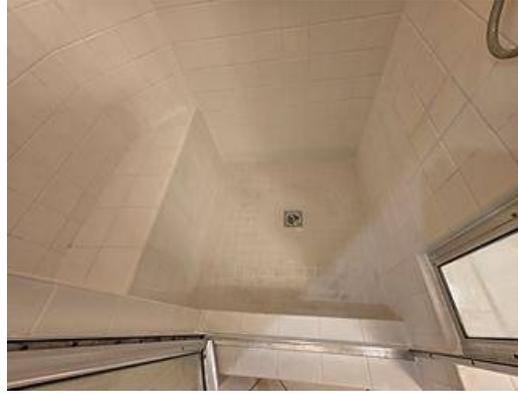
34) Serviceable, Comment - Shower

Comment: Plumbing fixtures were operated and flowed normally at the time of inspection. Drains, supply valves, and accessible components functioned as expected, and no adverse conditions were observed during testing.

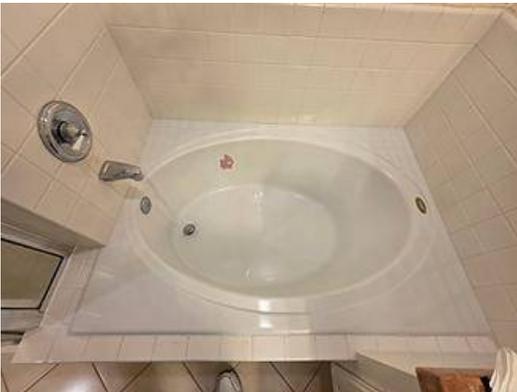
Photo 35-1

35) Serviceable, Comment - Bathtub

Comment: Plumbing fixtures were operated and flowed normally at the time of inspection. Drains, supply valves, and accessible components functioned as expected, and no adverse conditions were observed during testing.

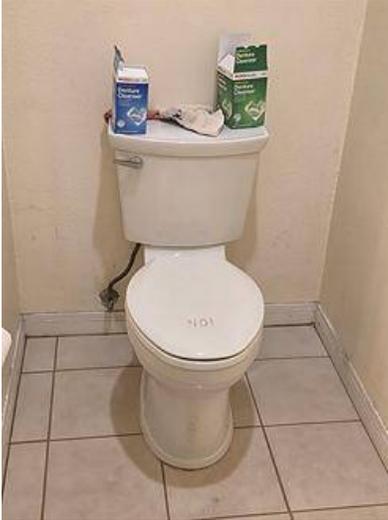
Photo 36-1

36) Serviceable, Comment - Toilet

Comment: The toilet was operated and functioned normally at the time of inspection. Flushing performance, refill operation, and bowl stability appeared serviceable, and no adverse conditions were observed during testing.

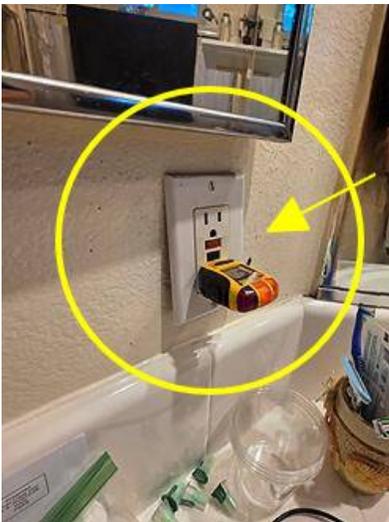
Photo 38-1

Concern: The GFCI electrical receptacle and/or the electrical box was observed to be loose and not securely anchored.

Recommendation: Secure the receptacle and electrical box to prevent movement and potential wiring damage.

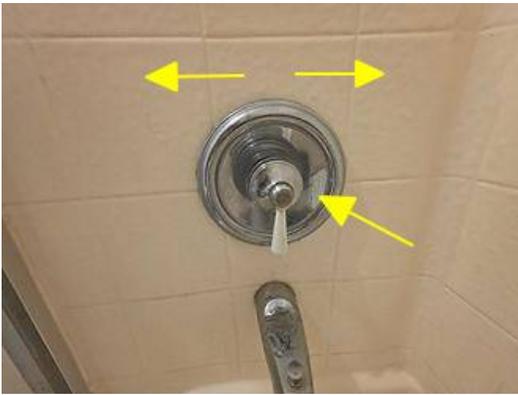
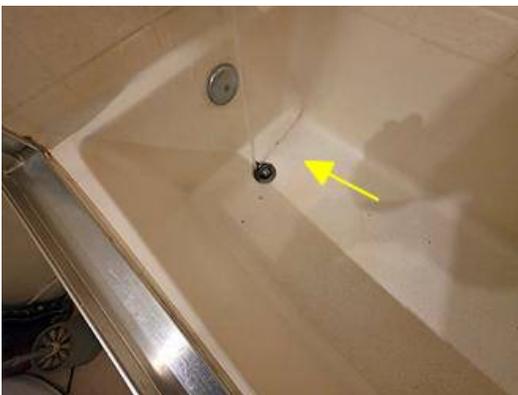
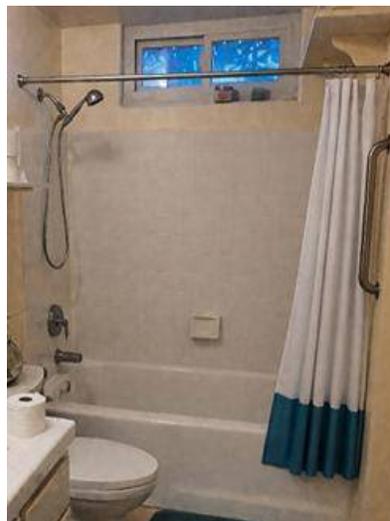
Photo 39-1

- 1) The hot and cold water supplies at the bathtub mixer valve were reversed at the time of inspection, with cold water on the left and hot water on the right.
- 2) Water leakage was observed from the control valve when it was operated.
- 3) The tub spout and the backplate at the water control valve were not properly sealed to the wall.
- 4) Minor surface chipping was noted at the bathtub.

- 1) Correct the plumbing connections so hot and cold water are in their conventional locations.
- 2) Repair the leaking control valve and properly seal the tub spout and valve backplate to the wall to prevent water intrusion.
- 3) Repair the minor tub surface chipping as needed.

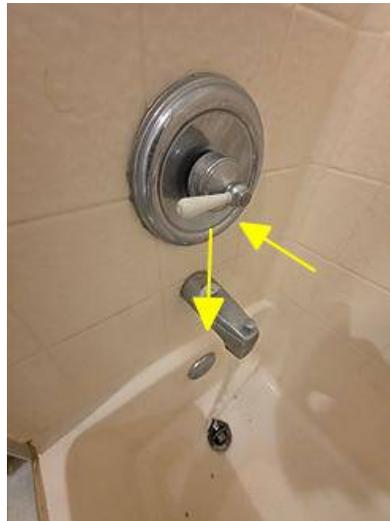
Photo 39-2

39) Needs Attention, Repair, Evaluate - Bathtub Mixer Valve-Multiple Conditions

- 1) The hot and cold water supplies at the bathtub mixer valve were reversed at the time of inspection, with cold water on the left and hot water on the right.
- 2) Water leakage was observed from the control valve when it was operated.
- 3) The tub spout and the backplate at the water control valve were not properly sealed to the wall.
- 4) Minor surface chipping was noted at the bathtub.

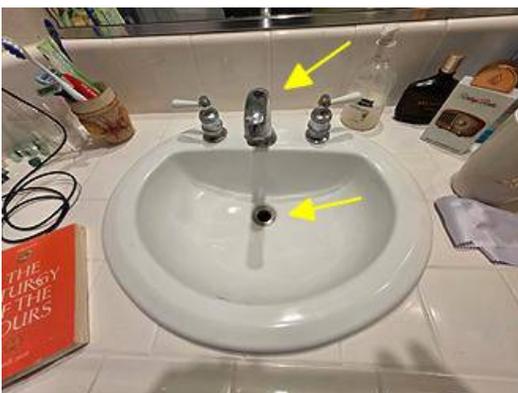
Photo 40-1

Concern: The sink stopper mechanism was missing or inoperable at the time of inspection.

Recommendation: Install, reconnect, or adjust the stopper mechanism as needed to restore normal operation.

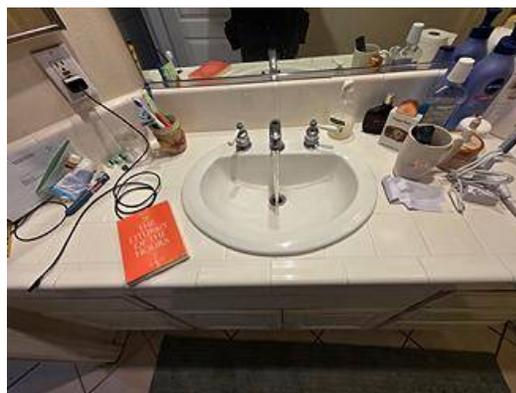
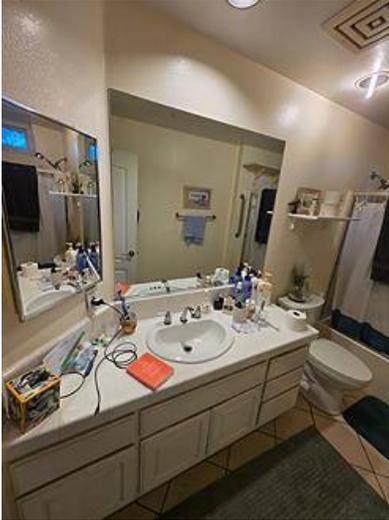
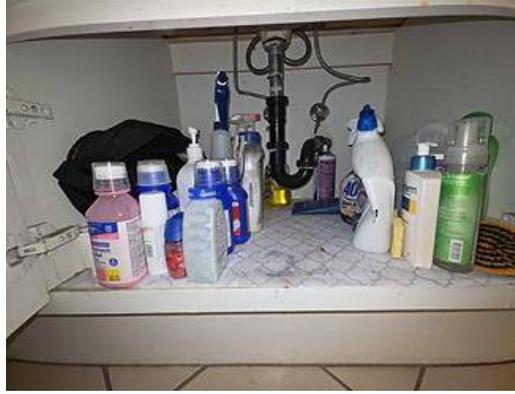
40) Needs Attention, Repair - Vanity Sink Stopper-Missing/Inoperable

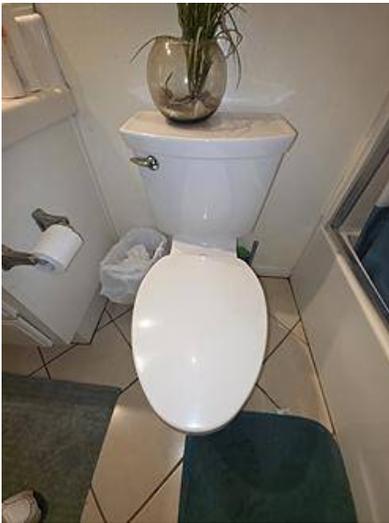
**Photo 41-1**

41) Serviceable, Comment - Toilet

Comment: The toilet was operated and functioned normally at the time of inspection. Flushing performance, refill operation, and bowl stability appeared serviceable, and no adverse conditions were observed during testing.

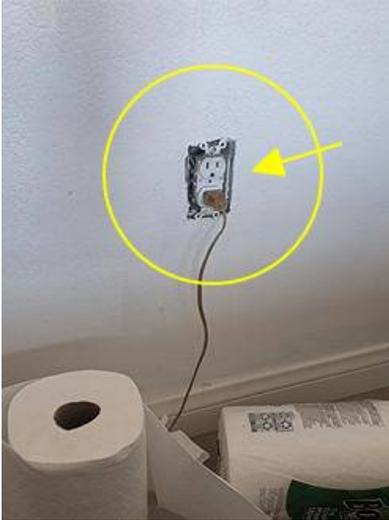
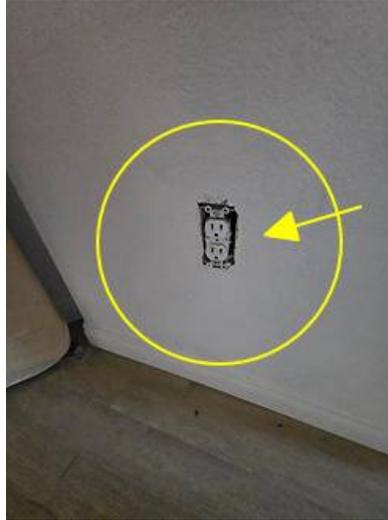
Photo 43-1

Concern: Multiple electrical cover plates were missing, leaving device wiring exposed.

Recommendation: Install proper cover plates at all uncovered locations.

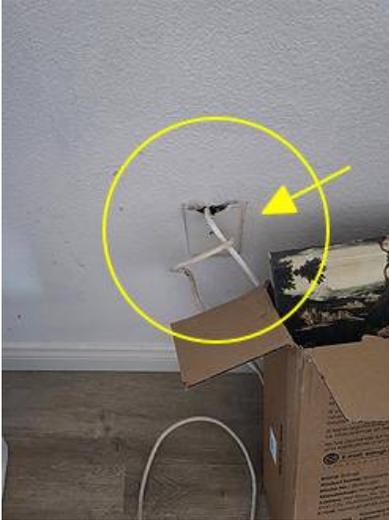
Photo 45-1

Concern: The cable TV outlet cover plate was damaged/broken.

Recommendation: Replace the damaged cover plate.

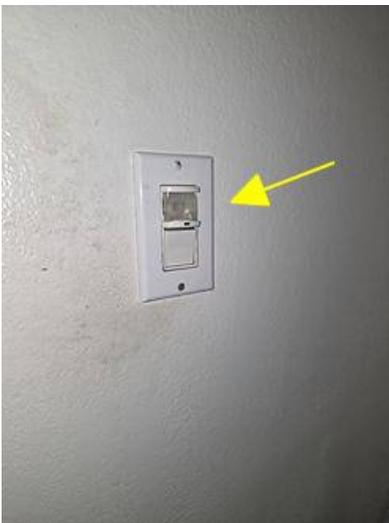
Photo 46-1

46) Needs Attention, Replace - Closet Light Switch-Motion Sensor Damaged
Concern: The motion sensor cover on the light switch in the closet was missing/damaged.
Recommendation: Replace the motion sensor light switch

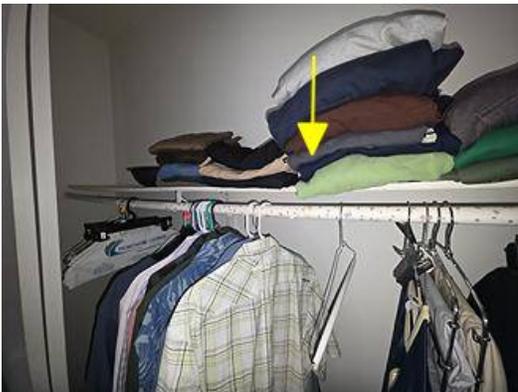
Photo 48-1

Concern: The bedroom closet shelf and hanging rod were observed to be sagging, likely due to long-term weight placed on the shelf.

Recommendation: Reinforce, adjust, or replace the shelf and rod supports as needed

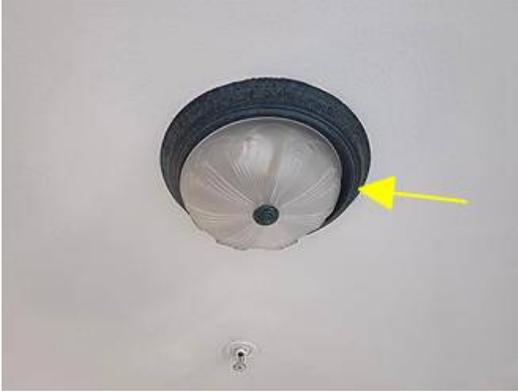
Photo 54-1

Concern: The ceiling light cover was observed to be loose at the time of inspection.

Recommendation: Reset and re-secure the light cover.

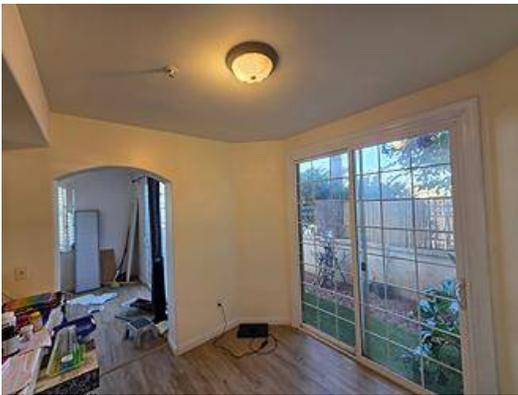
Photo 55-1

55) Serviceable, Comment - Room View(s)

Comment: No adverse functional issues were observed at interior walls, ceilings, floors, doors, windows or accessible electrical fixtures at the time of inspection.
