3B PROPERTY INSPECTIONS

RESIDENTIAL INSPECTION REPORT

14911 Caminito Ladera
Del Mar, CA 92014

Anni Lipper
FEBRUARY 9, 2026

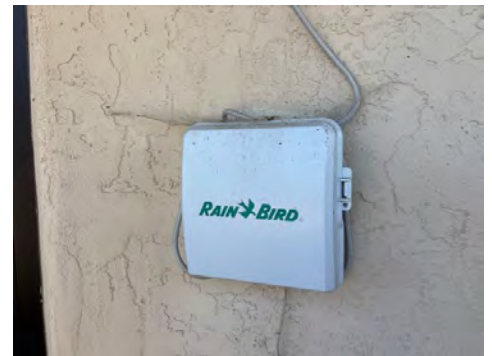
GARDEN SPRINKLER SYSTEM NOT TESTED

The garden sprinkler system was not tested. Recommend that the seller demonstrate the sprinkler system is operating properly and that the seller provides a zone map for the sprinkler system.

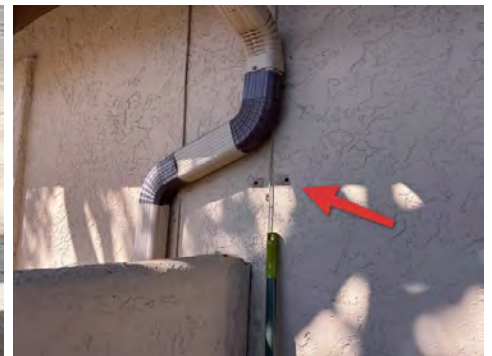
South

SIDING: HOLES/DETERIORATION

In some areas around the exterior, holes and/or deterioration to the siding. Holes/deterioration could allow water and pests to intrude behind the siding. Recommend a qualified professional to repair.

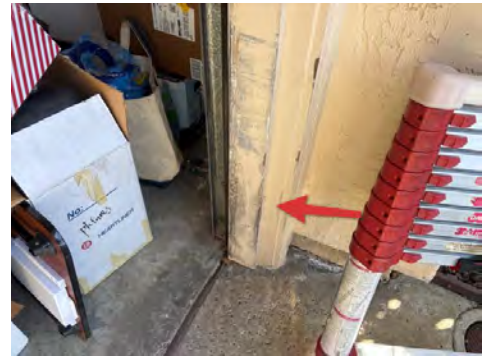
Garage trim

TRIM: DETERIORATION/DAMAGE

One or more exterior trim areas are deteriorated and/or damaged. Recommend a qualified professional to repair.

Contact a qualified professional.

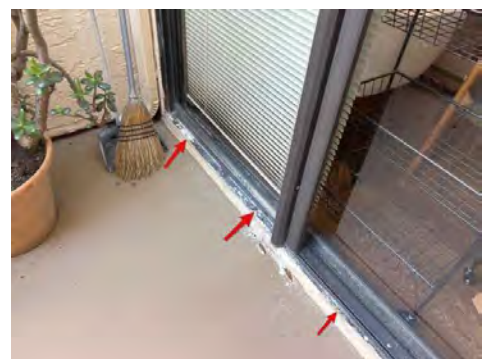
DOOR JAMB: DETERIORATION

Deterioration was visible on one or more exterior door jambs. Recommend a qualified professional to evaluate and repair.

North Office, metal door jamb corroded

Contact a qualified professional.

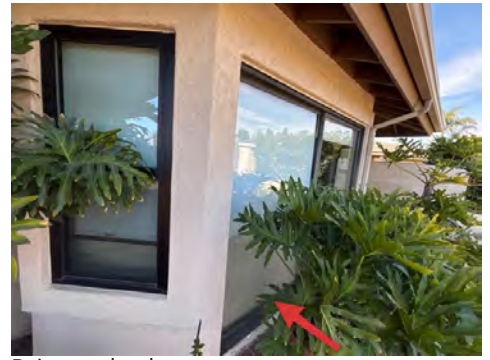
Primary bedroom

SCREEN DOOR: MISSING/NOT INSTALLED

One or more screen doors are not installed, are coming off the track, or are missing. Recommend a qualified professional to repair.

Contact a qualified professional.

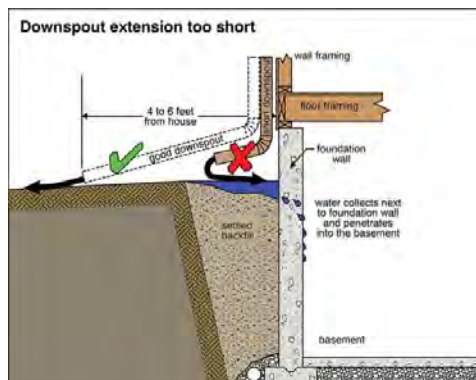
Extensions Too Short Diagram

GUTTER DOWNSPOUTS: EXTENSIONS MISSING

Extensions are missing on the gutter downspouts in some areas around the building. Extensions flow water away from the building, preventing water from ponding near the foundation and siding. Recommend a qualified professional to repair.

Contact a qualified professional.

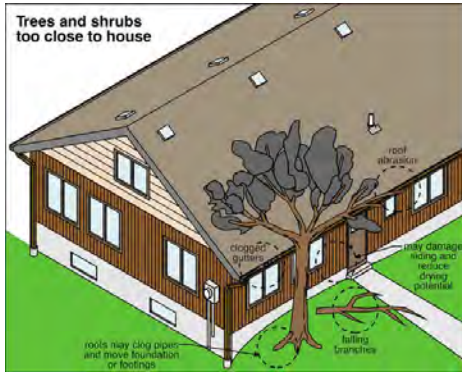
Trees To Close To Home Diagram

Some trees were overhanging the roof. This can cause deterioration to the roof and prevent proper drainage in gutters. Recommend a qualified professional to repair.

Contact a qualified professional.

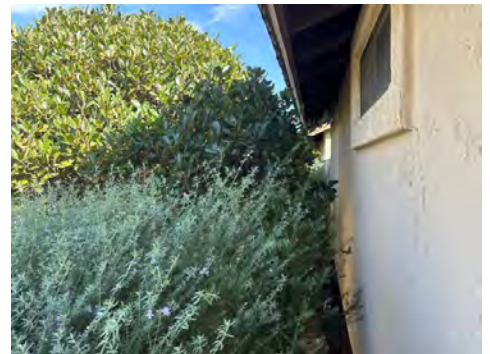
North

Some vegetation is in contact with the home. Vegetation can bring unwanted moisture to the home's siding/trim/fascia boards. Recommend a qualified professional to repair.

Contact a qualified professional.

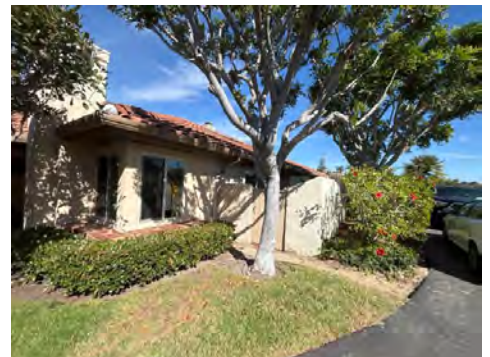
Large tree roots are visible around the property. Large roots can uplift concrete areas (driveway, porch, patio, walkways). Large roots can cause damage to the foundation. Recommend monitoring tree roots and/or having a qualified professional evaluate and repair/remove.

Contact a qualified professional.

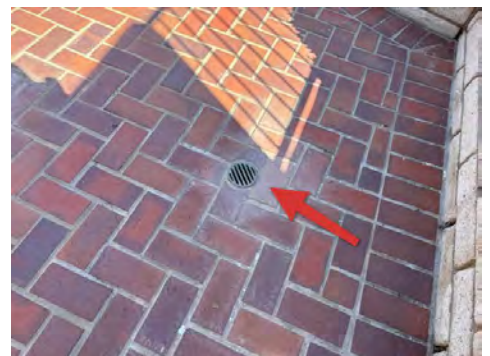
In-Ground Drainage system

It is unknown when the in-ground drain system was last cleaned. Debris can build up in the system over time which can cause clogs to occur. Recommend a qualified professional to evaluate and clean.

Contact a qualified professional.

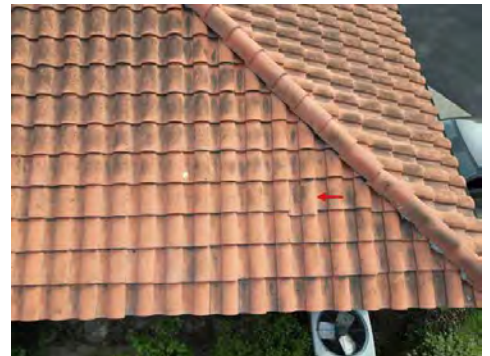
ROOF: LOOSE TILES

Some tiles were loose and not properly secured. Recommend a qualified professional to evaluate and repair.

Contact a qualified professional.

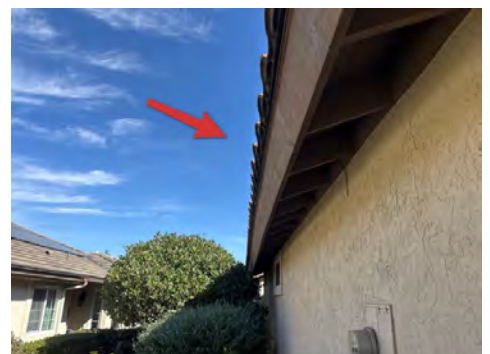
North

GUTTER(S): MISSING

Roof gutters are missing in some areas around the home. Roof gutters collect water from the roof and flow the water to proper exit locations around the house. Missing gutters can cause water to pond around the home and its foundation and cause deterioration to siding, trim, and fascia boards. Recommend a qualified professional to evaluate and repair.

Contact a qualified professional.

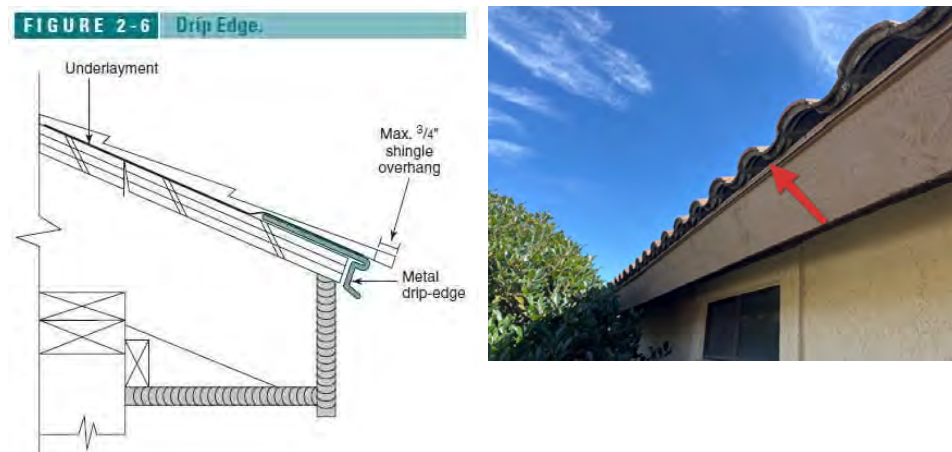
FLASHING: MISSING DRIP EDGE

Some areas around the roof are missing drip edge flashing. Drip edge flashing protects the fascia board from water flowing off the roof. Recommend a qualified professional to evaluate and repair.

Contact a qualified professional.

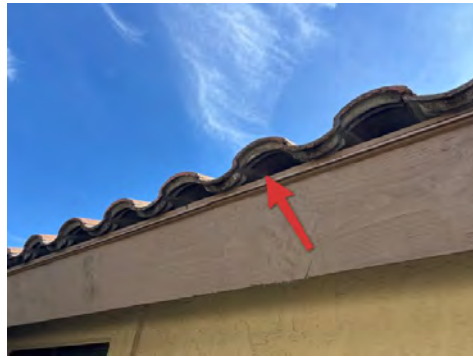
FIGURE 2-31 Tile Rake Trim.

FLASHING: BIRD STOPS MISSING

Bird stops missing in some areas around the perimeter of the roof. Bird stop prevents birds and pests from getting under roof tiles. Recommend a qualified professional to evaluate and repair.

Contact a qualified professional.

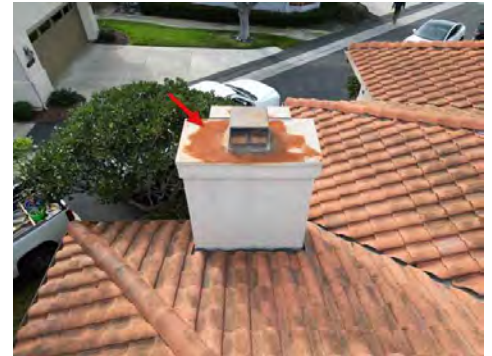
FLASHING: CORRODED

Roof flashing showed signs of corrosion around the roof and chimney. Corrosion can cause holes in flashing which can allow water to intrude. Recommend a qualified professional to evaluate and repair.

Contact a qualified professional.

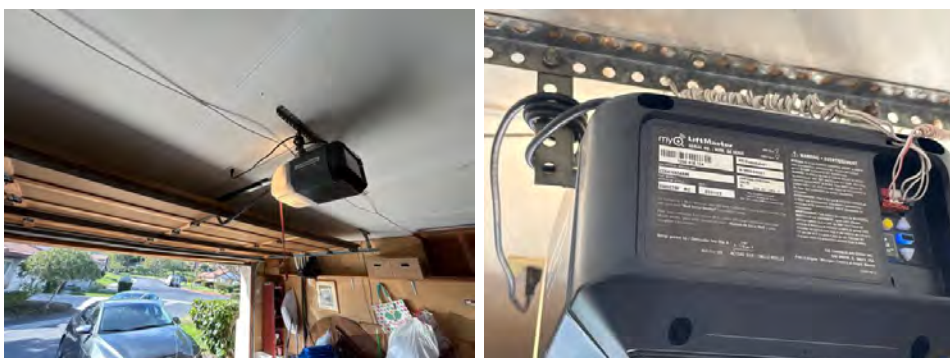
No visible service dates for the overhead garage door, motor, and components. Garage door equipment needs service annually or according to manufacturer recommendations. Service typically includes cleaning, tightening/adjusting rollers, checking spring condition, checking the track for debris, checking bolts, hinges, and cables, testing door balance, lubricating, and checking motor gears. Recommend a qualified professional to service the garage door.

Contact a qualified professional.

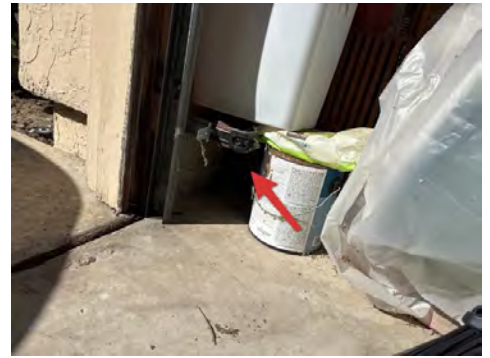
GARAGE DOOR: REVERSE SENSORS HEIGHT

Garage door reverse sensors are installed too high off the floor. Garage door reverse sensors should be installed 4-6" above the garage floor. Recommend a qualified professional to evaluate and repair.

Contact a qualified professional.

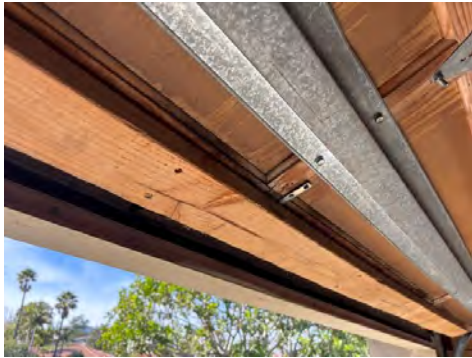
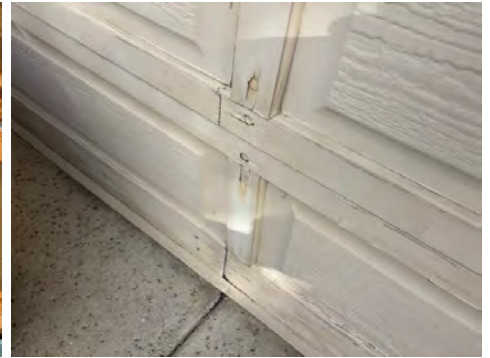
GARAGE DOOR: WEATHERED

One or more garage doors were weathered. Cracked, peeling paint and stain were visible. Recommend a qualified professional to evaluate and repair.

Contact a qualified professional.

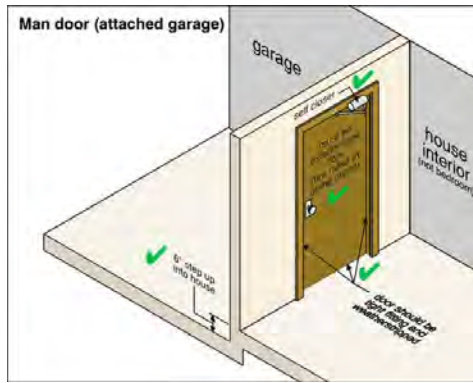
Self-Closing Garage Door

GARAGE: AUTO-CLOSURE HINGES

The door between the garage and interior is missing or has auto-closure hinges that aren't operating correctly. The door between the garage and interior acts as a fire separation, and the auto-closure hinges keep the door closed when not in use. Recommend a qualified professional to evaluate and repair.

Contact a qualified professional.

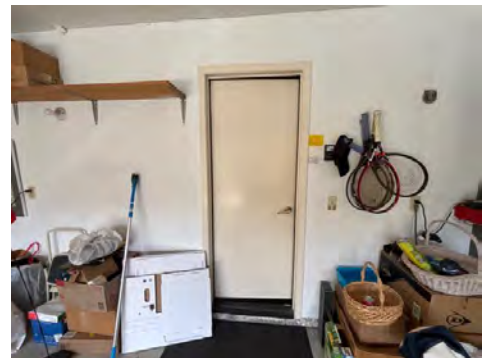
Unable to determine if the door between the garage and the home's interior is fire-rated. No visible fire-rated data plate. Fire doors can help reduce the time it takes for a fire to spread from the garage to the interior. Recommend a qualified professional to evaluate and repair.

Contact a qualified professional.

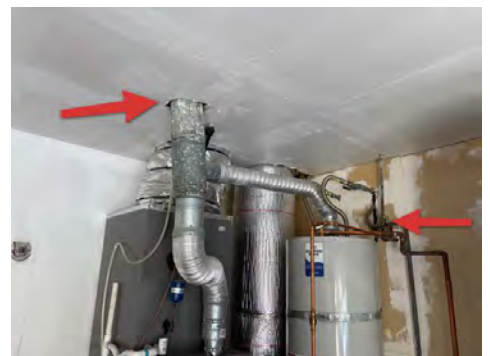
Holes/Air gaps were observed around pipes leading into walls/ceiling in the garage. Recommend a qualified professional to evaluate and repair/patch.

Airs gaps between flue pipe, water pipes and ceilings/walls.

Contact a qualified professional.

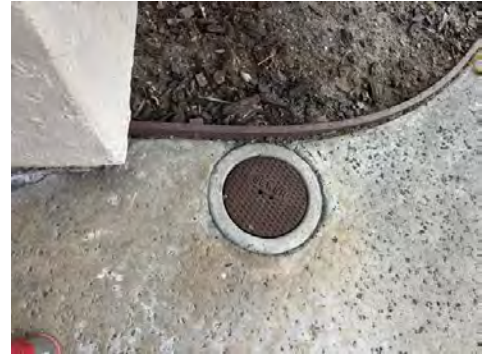
Driveway

SEWER LATERAL NOT INSPECTED

The sewer lateral was not inspected. It is recommended that a sewer lateral camera inspection be performed to determine the condition of the sewer lateral.

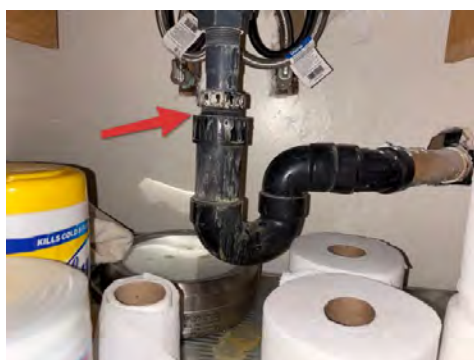
Entry bathroom

5.3.1 Drain / Sewer Pipes

Recommendation

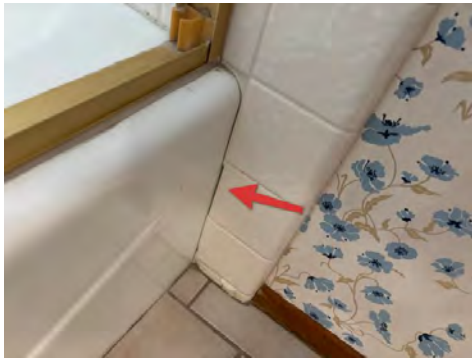
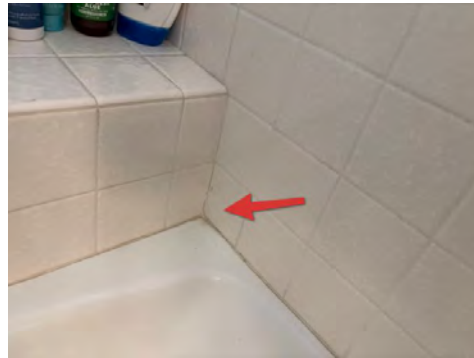
Hallway Bathroom

5.4.1 Fixtures / Faucets

Recommendation

Contact a qualified professional.

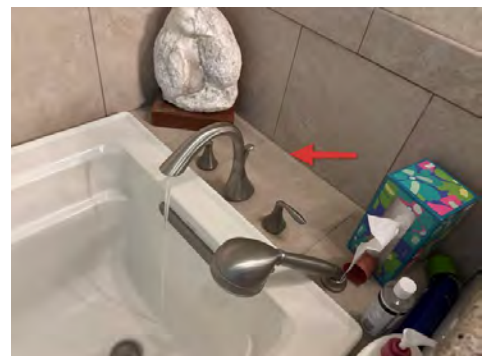
Primary Bathroom

5.4.2 Fixtures / Faucets

Recommendation

Contact a qualified professional.

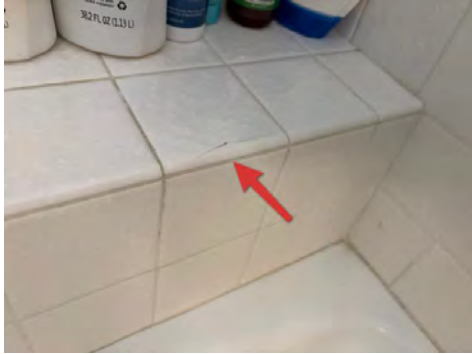
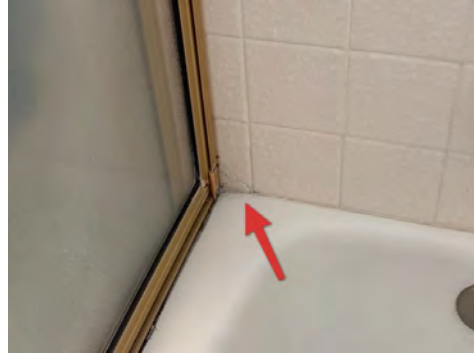
Hallway Bathroom

5.4.5 Fixtures / Faucets

Recommendation

Contact a qualified professional.

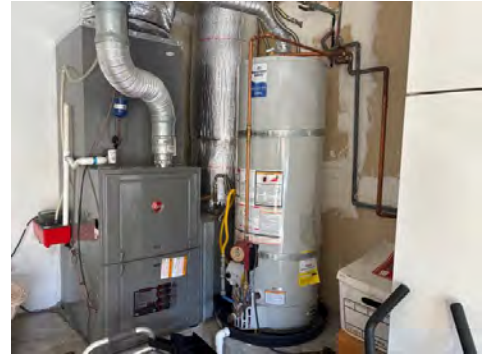
WATER HEATER: CORROSION AT WATER SUPPLY LINE

Recommendation

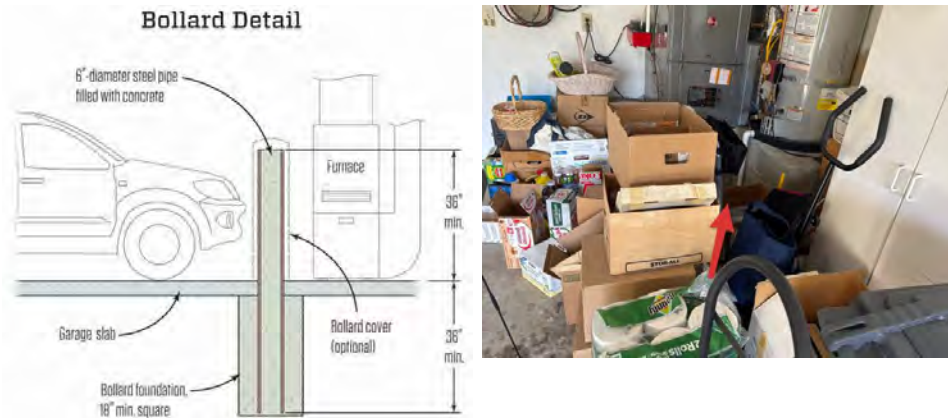
WATER HEATER: MISSING BOLLARDS

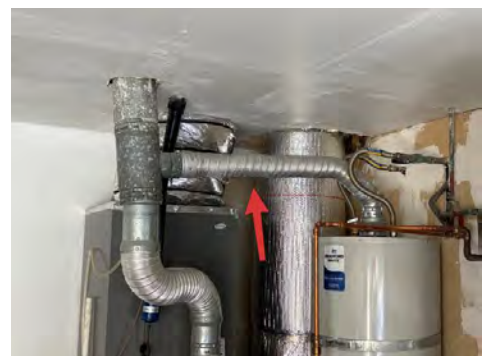
WATER HEATER: EXPANSION TANK MISSING

Contact a qualified professional.

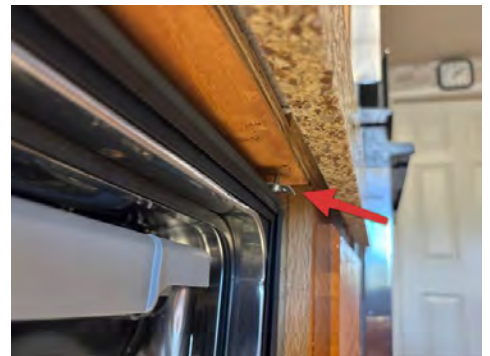
Not screwed in

Contact a qualified professional.

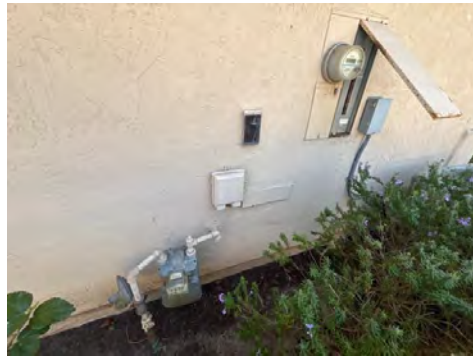
Recommendations**8.3.1 Main Electrical Service Panel / Sub-Panel / Service and Grounding Equipment****MAIN PANEL: CLEARANCES**

Inadequate clearances around the main electrical service panel. Recommend providing proper clearances around main electrical service panels.

Contact a qualified electrical contractor.

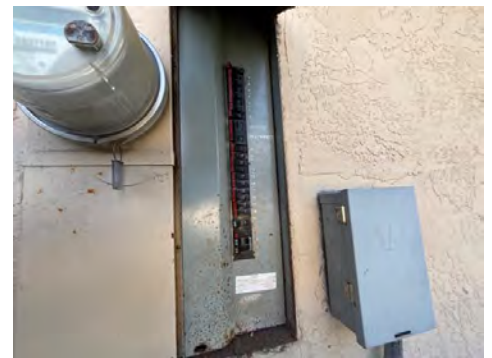
Circuit breakers in an electrical panel are not correctly labeled. Labels indicate which circuit breaker control which area of the home. Recommend a qualified professional to repair.

Contact a qualified electrical contractor.

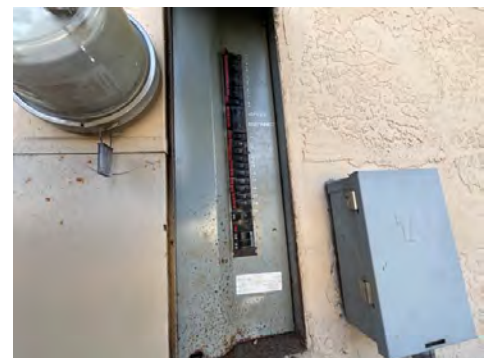
Federal Pacific Electrical Company (FPE) style circuit breaker panels are a known style of electrical panels that have failed to protect homes adequately. FPE panels can appear to work fine for years, but after one overcurrent or short circuit, they can overheat and become fire hazards. Recommend a licensed electrician with experience with FDE-style circuit breaker panels to evaluate electrical panels immediately.

Contact a qualified electrical contractor.

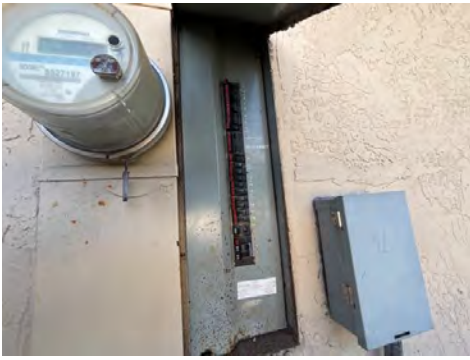
The electrical panel appears to be original. The components in the electrical panel are past their life expectancy. Recommend a qualified professional to evaluate the electrical panel.

Contact a qualified professional.

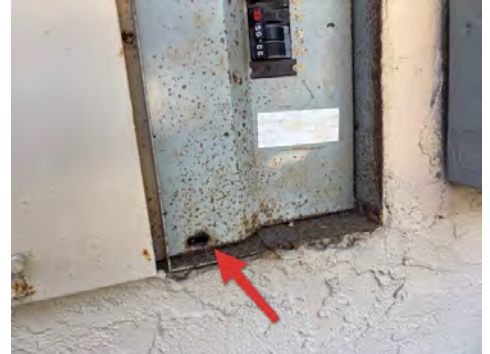
ELECTRICAL PANEL: COVER LOOSE

The electrical panel cover is missing securement screws. Recommend a qualified professional to repair.

Contact a qualified electrical contractor.

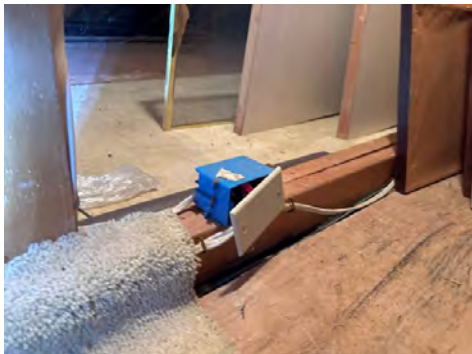
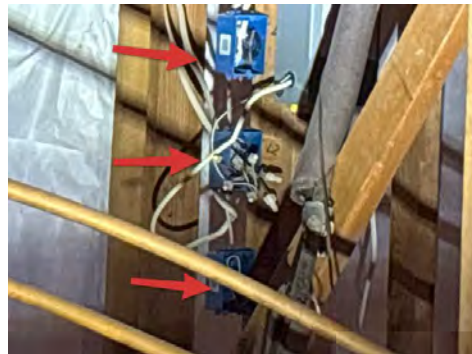
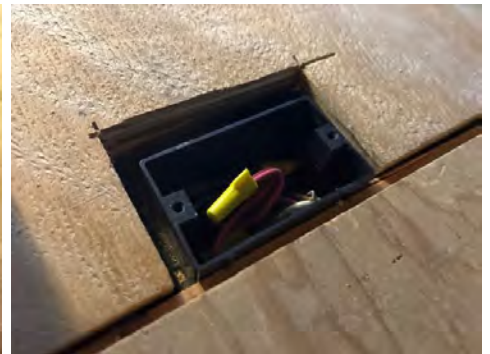
One or more open electrical junction boxes. Recommend a qualified professional to install cover plates to conceal wires in junction boxes.

Contact a qualified professional.

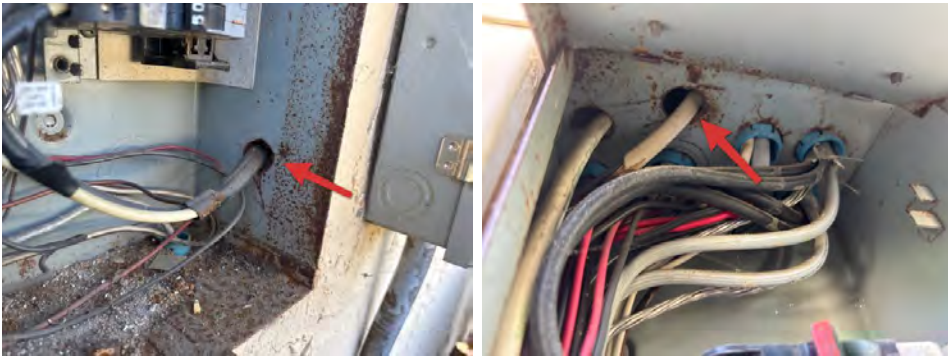
One or more electrical wires entering an electrical junction box are missing a box connector/wire clamp or plastic bushing. These protect the wire as it enters the junction box. Recommend a qualified professional to repair.

Contact a qualified professional.

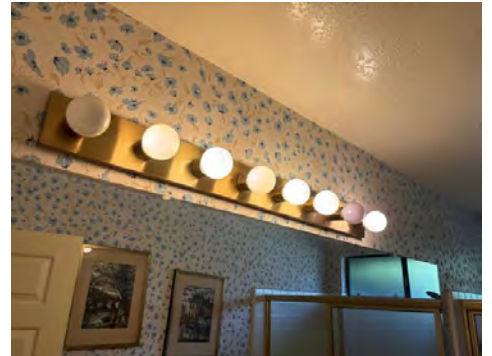
Hallway Bathroom

LIGHT BULB(S): NOT OPERATING

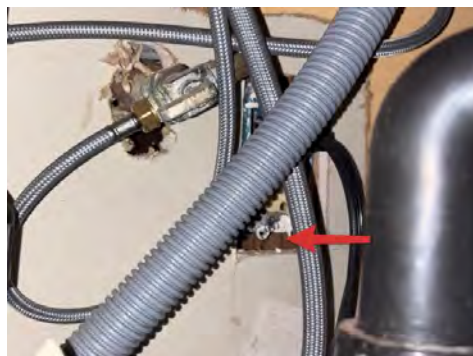
Kitchen Sink

ELECTRICAL OUTLET(S): COVER PLATES MISSING/DAMAGED

One or more electrical outlets are missing and/or have a damaged cover plate. Recommend a qualified professional to repair.

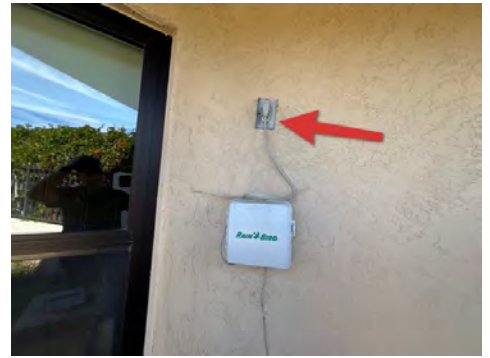
Northeast

EXTERIOR OUTLET COVERS: DAMAGED/MISSING

The electrical covers on one or more exterior outlets are damaged and/or missing. Recommend a qualified professional to repair.

Contact a qualified professional.

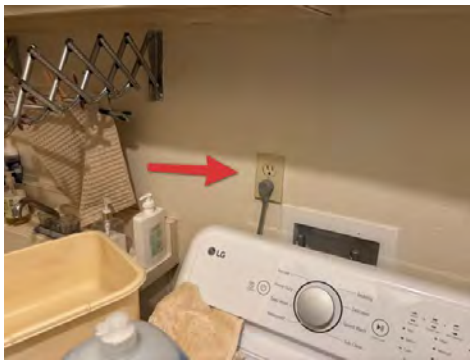
Laundry

GFCI OUTLET(S): MISSING

One or more electrical outlets in specific areas (Exterior, Bathrooms, Garages, Kitchens, Laundry) had no visible GFCI (ground fault circuit interrupter) protection, and/or the inspector could not determine if GFCI protection was present. GFCI outlets help protect against shock hazards posed in these potential wet areas. In some older homes, GFCIs may not have been required during the construction of the house, but these types of safety outlets are recommended. Recommend a qualified professional to evaluate and repair.

Contact a qualified electrical contractor.

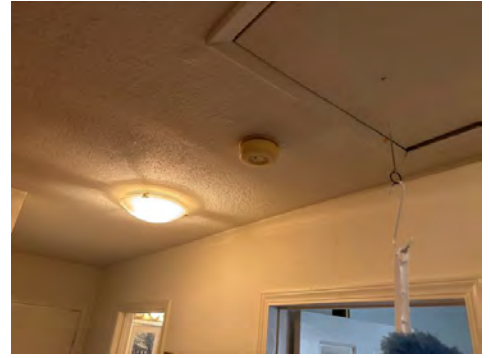
Some smoke detectors in the home appear to be past their life expectancy or there is no visible date on the detector. Smoke detectors should be replaced every 10 years. Recommend replacing with new smoke detectors in proper locations if the date of the detector cannot be determined.

Contact a qualified professional.

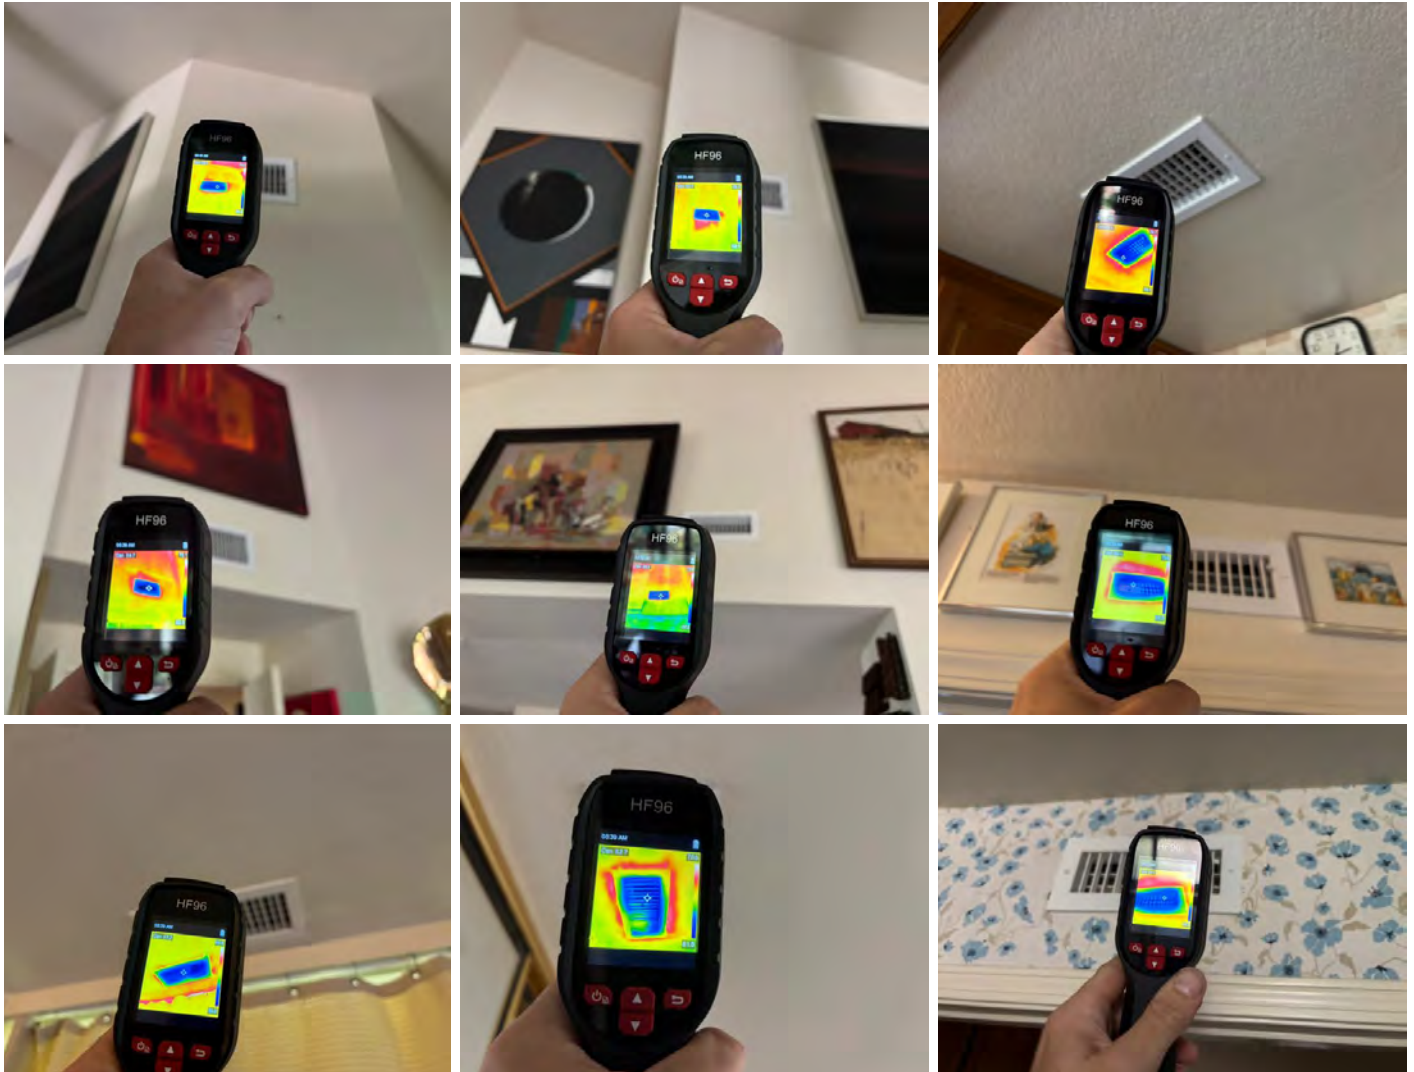
General: Temperature Differential

14-16+

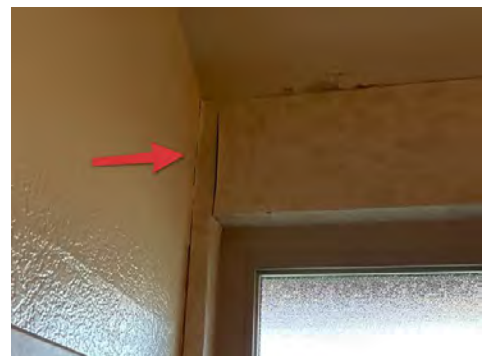
Primary Bathroom

11.3.1 Ceilings

CEILING: STAINS

One or more stains on the ceiling. Recommend a qualified professional to repair.

Contact a qualified professional.

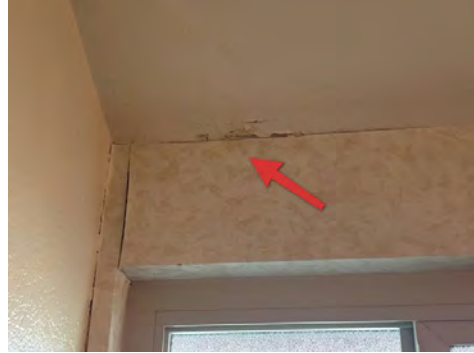
Primary Bathroom

11.3.2 Ceilings

CEILING: CRACK(S)

Cracks were observed in one or more areas on the interior ceilings. This appears to be the result of long-term settling. Improper drainage around the home can also affect the foundation and settling. Improper installation of drywall tape on joints can also cause cracks. Some settling is not unusual in a house of this age but should be monitored. Recommend a qualified professional to evaluate and repair.

Contact a qualified professional.

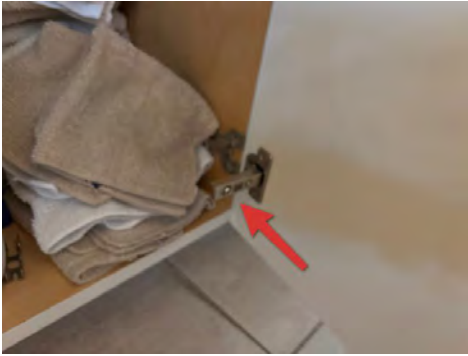
Primary Bathroom, right hand sink cabinet

11.6.1 Countertops & Cabinets

CABINET DOOR(S): HARDWARE LOOSE / DAMAGED / MISSING

One or more cabinet hardware was loose, damaged, and/or missing. Recommend a qualified professional to repair.

Contact a qualified professional.

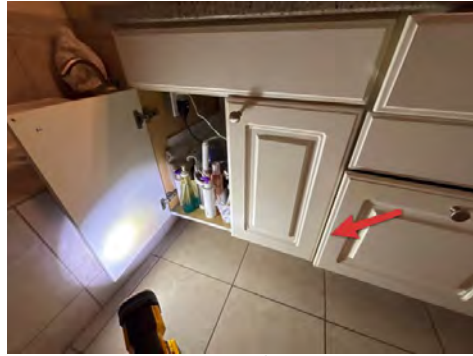
Primary Bathroom, left hand sink cabinet, loose hinge

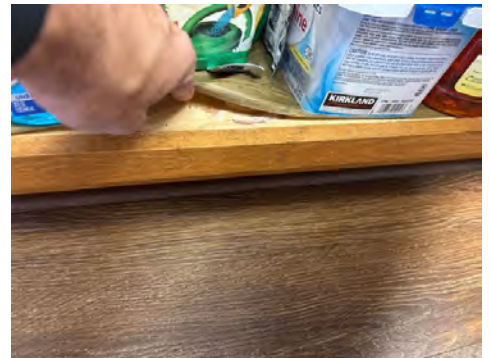
Base of kitchen sink cabinet

11.6.2 Countertops & Cabinets

CABINET(S): WEAR & TEAR

One or more cabinets have wear and tear. Recommend a qualified professional to repair.

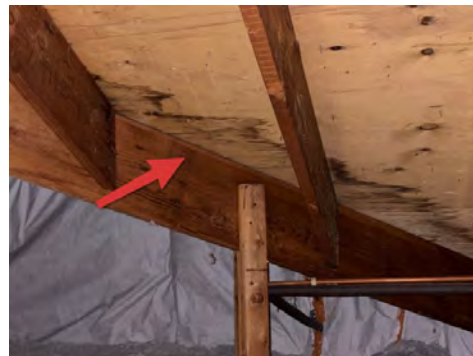
Under roof valley

ATTIC: STAINS ON ROOF SHEATHING

Stains in roof sheathing and joists. No significant moisture was detected in these areas using a pin-style moisture meter. Recommend a professional roof contractor to evaluate and repair any water leaks in the roof.

Contact a qualified roofing professional.

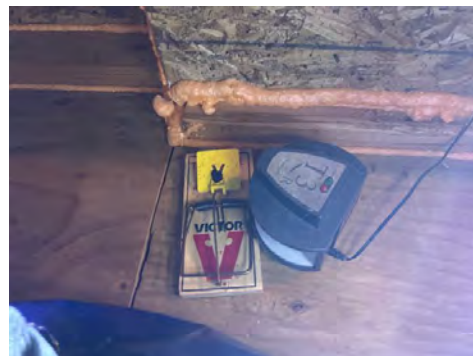
Rodent traps were visible in the attic area. Recommend a qualified professional to monitor traps periodically for activity.

Recommend monitoring.

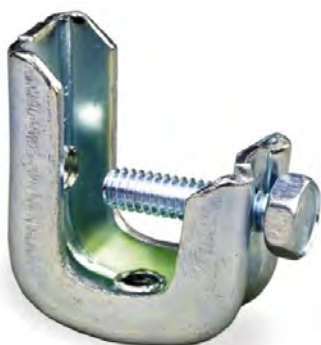
FIREPLACE: DAMPER CLAMP MISSING

A damper clamp is either missing and/or improperly installed for the gas fireplace. The damper clamp keeps the fireplace flue damper locked in the open position. Gas appliances should have damper clamps that keep the flue damper in the open position to allow any carbon monoxide or gas to flow out of the house. Recommend a qualified professional to install a proper fireplace damper clamp.

Example of a damper clamp

Contact a qualified fireplace contractor.

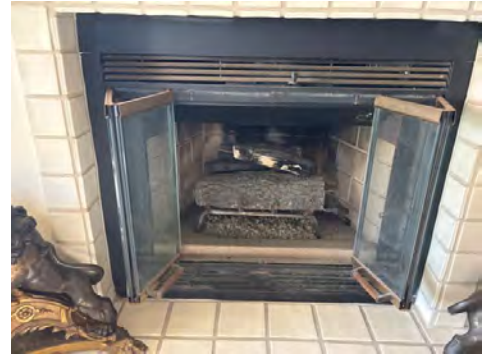
FIREPLACE: RECOMMEND ANNUAL FIREBOX/CHIMNEY CLEANING

Fuel-burning appliances and chimneys should be inspected, serviced, and cleaned annually by a qualified fireplace and chimney professional. Recommend inquiring with the seller about service schedules and the last time the system was serviced/cleaned.

Contact a qualified fireplace contractor.

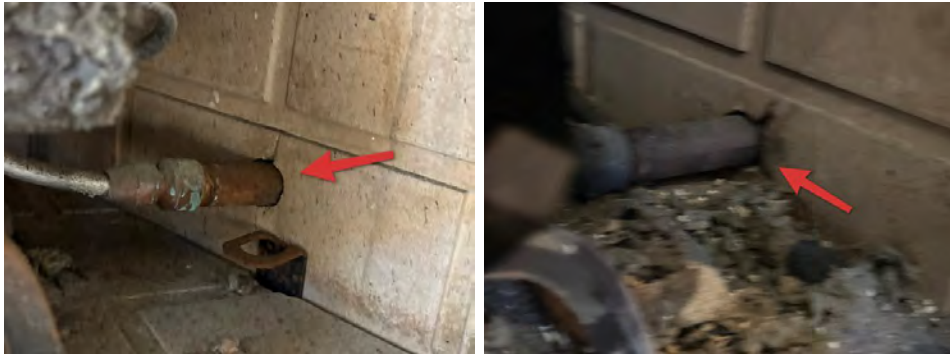
Family Room

FIREPLACE GAS LINE: NOT SEALED AROUND GAS PIPES

Contact a qualified professional.
