# Inspection Report

## IB Property Inspection

910 W Valencia Mesa Dr, Fullerton, CA 92835

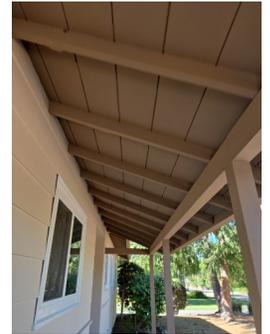
Fascia, Soffits, Trim, & Soffit Vents were in average condition.

Visible/accessible Fascia, Soffits, Trim, & Soffit Vents show signs of normal wear for age with no major visible defects at the time of the inspection.
