WOOD DESTROYING PESTS AND ORGANISMS INSPECTION REPORT

| Building No. 1981 | Street Bending Oak | City Chico | ZIP 95928 | Date of Inspection 02/27/2026 | Number of Pages 4 |
| GENERAL DESCRIPTION: Single family residence; vacant, attached garage | | | | Inspection Tag Posted: Garage | |

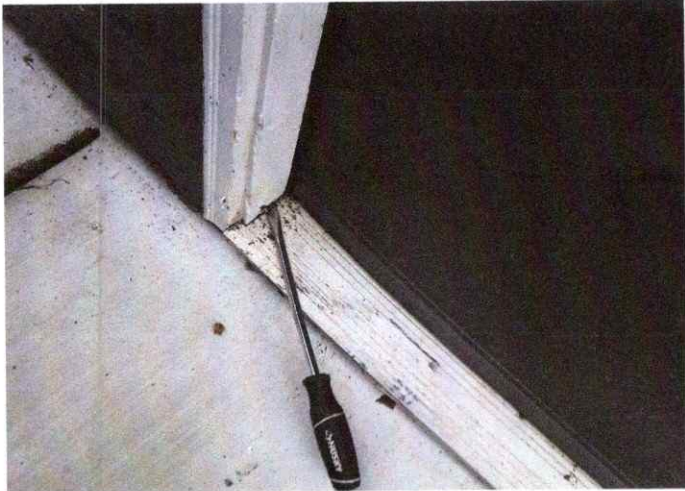
8A

FINDING: Stains and fungus damage noted at the garage door jambs.

RECOMMENDATION: Interested parties should engage the services of a licensed contractor to check for leaks and to perform any corrective work needed. Remove the fungus damaged portions of the door jambs and replace with new material.

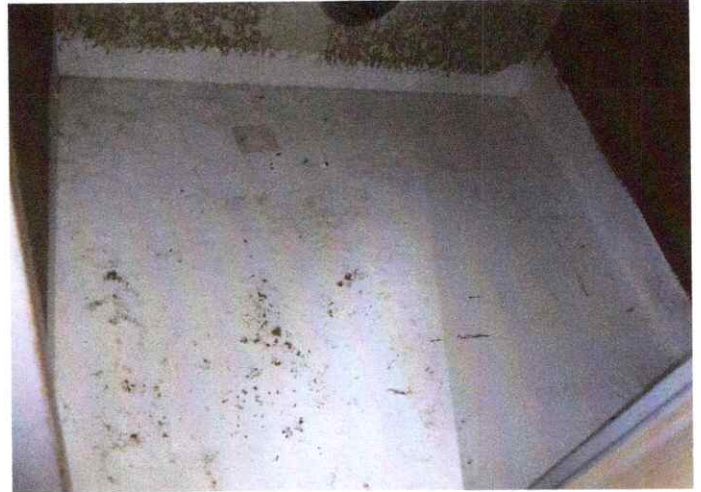
10A

FINDING: Stains (dry) were noted at the kitchen and bathroom sink cabinets. No visible leaks were noted at time of inspection.

RECOMMENDATION: Periodic inspection advised.

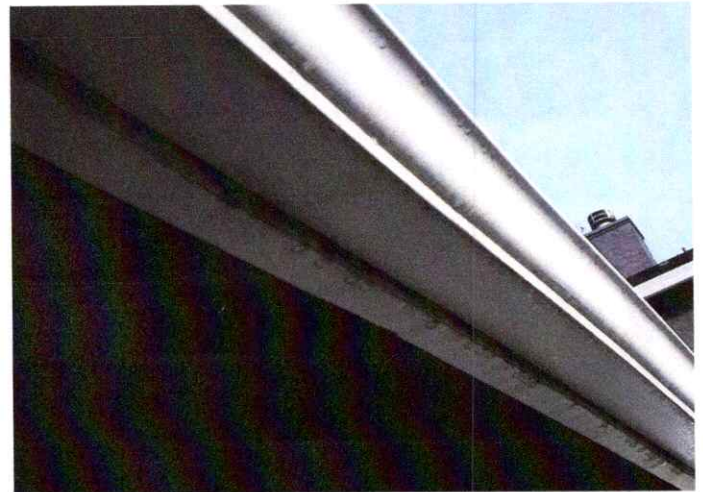
11A

FINDING: Wet stains were noted at the eave fascia.

RECOMMENDATION: Interested parties should engage the services of a licensed contractor to check for leaks and to perform any corrective work needed.
