**POST REMEDIATION MOLD INSPECTION REPORT
(MOLD CLEARANCE)**

Property: 138 Mira Del Sur, San Clementine, CA 92673

Project Number: 2602261

Subject: Post Remediation Mold Inspection

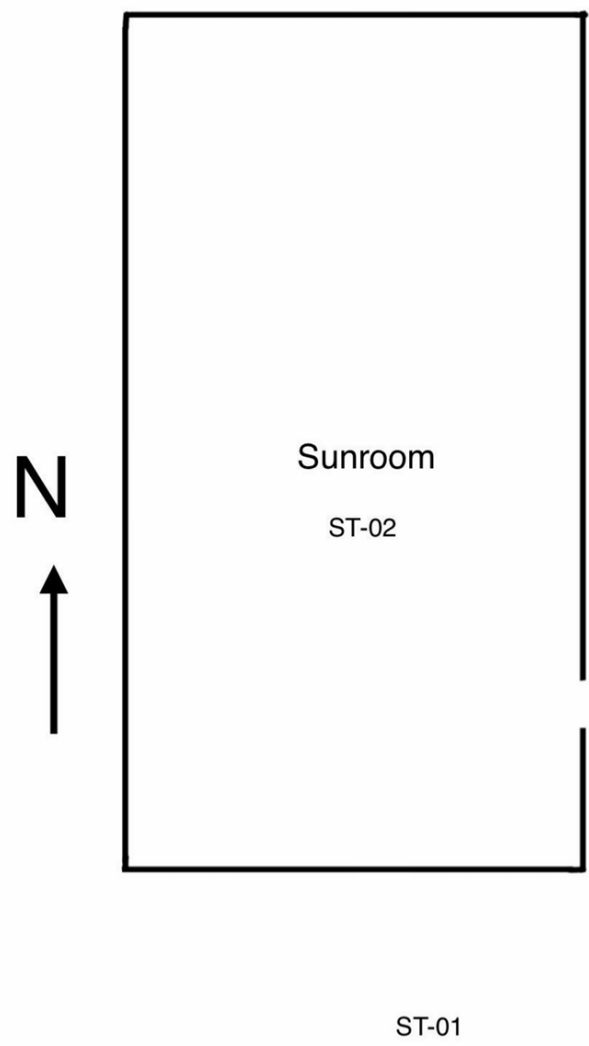
SITE DIAGRAM

Description:
Project Number: 2602261-MC
Project Name: Tina Downey
Address: 138 Mira Del Sur, San Clementine, CA 92673
Date of Testing: 02/26/2026
