# Property Inspection Report

INSPECTION ADDRESS: **140 22<sup>ND</sup> STREET CHICO CA.**

DATE OF INSPECTION: **4/04/2026**

JOB#: **9069**

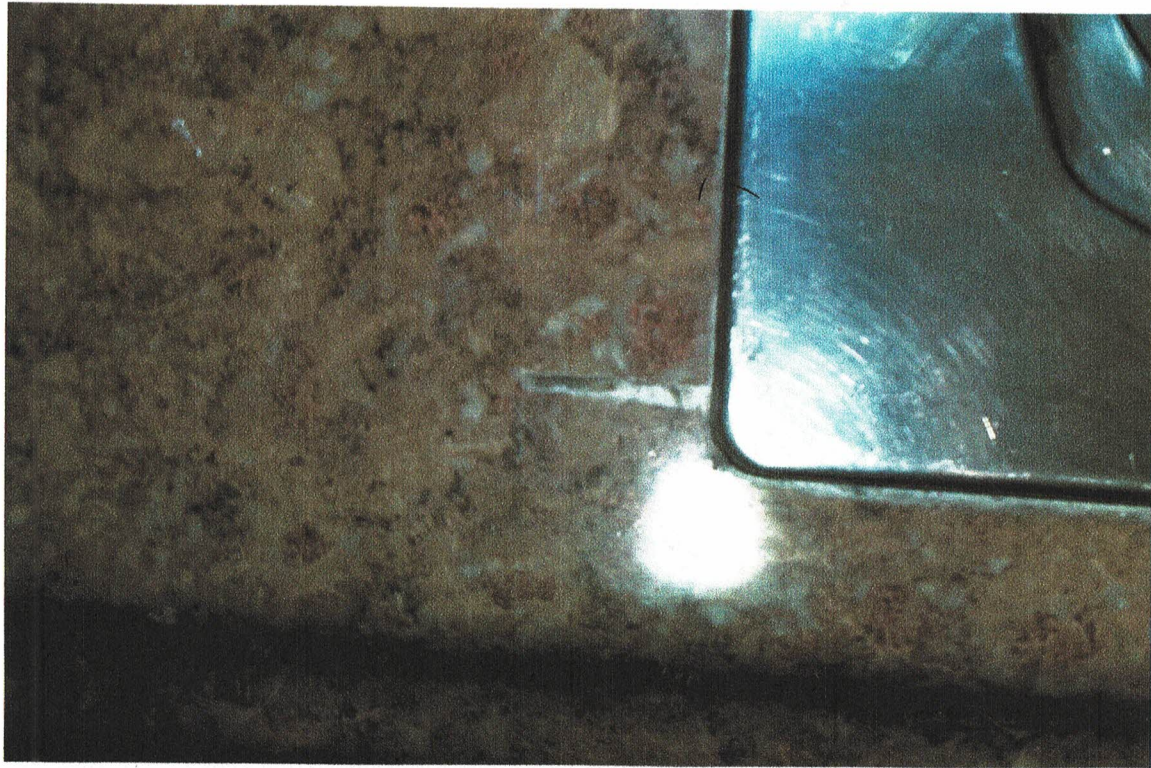
VIEW: KITCHEN

3.	WINDOWS/SCREENS	GOOD	
4.	DOORS		SEE THE ENTRY HALL
5.	COUNTER TOPS	GOOD	EXCEPTION; COUNTER TOP SHOWS MINOR DAMAGE LEFT SIDE OF THE SINK
6.	CABINETS	GOOD

7.	SINKS/FAUCETS	GOOD	
8.	DISHWASHER		APPEARS SERVICEABLE
9.	AIR GAP	GOOD	
10.	DISPOSAL		NONE
11.	PLUMBING		APPEARS SERVICEABLE
12.	RANGE/OVEN	GOOD	EXCEPTION; STOVE ANTI TILT BRACKET IS MISSING

13.	VENTING TYPE	GOOD	UPDRAFT
14.	ELECTRICAL	FAIR	EAST AND WEST WALL OUTLETS NOT GROUNDED
15.	G.F.I.		<input checked="" type="checkbox"/> GOOD <input type="checkbox"/> POOR <input type="checkbox"/> NONE

REPORT PAGE: 3

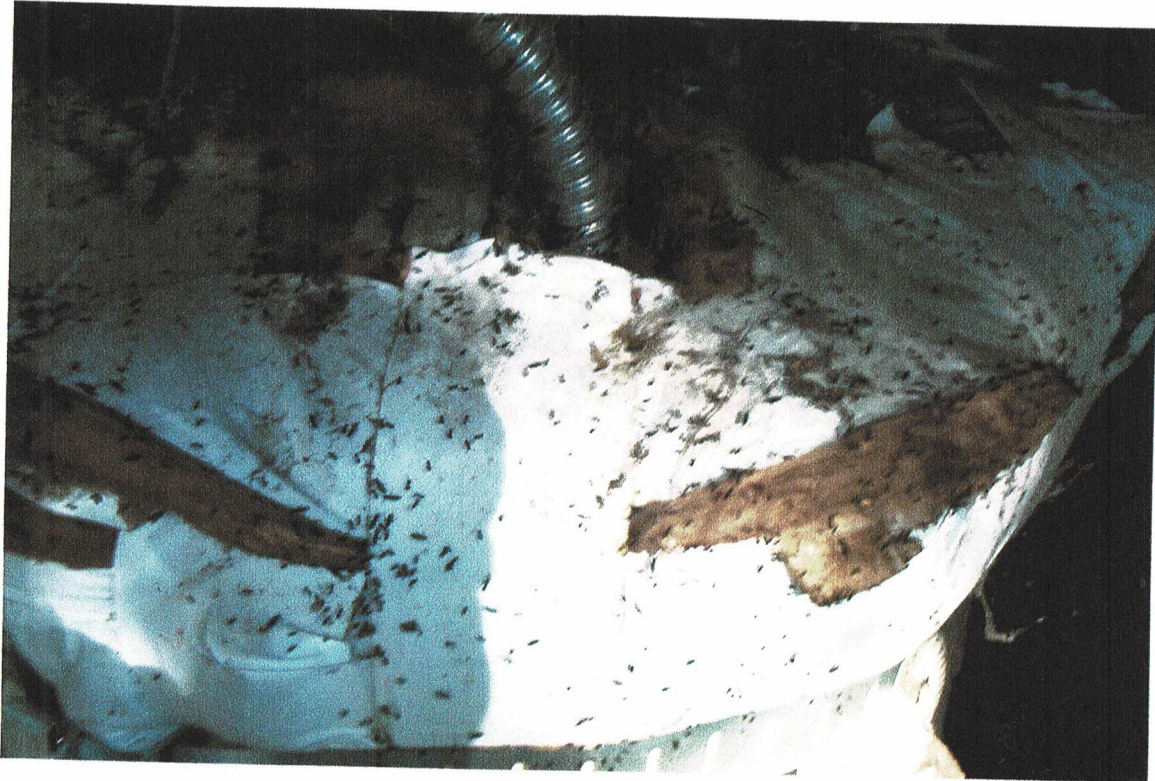
VIEW: WATER HEATER

- 8. HEATING UNIT - RECOMMEND ROUTINE SERVICE**
- 9. WATER HEATER - UNABLE TO FULLY INSPECT DUE TO ANT INFESTATION**
- 10. EXTERIOR ITEMS - AREAS OF STUCCO PATCHING EVIDENT**

REPORT PAGE: 8

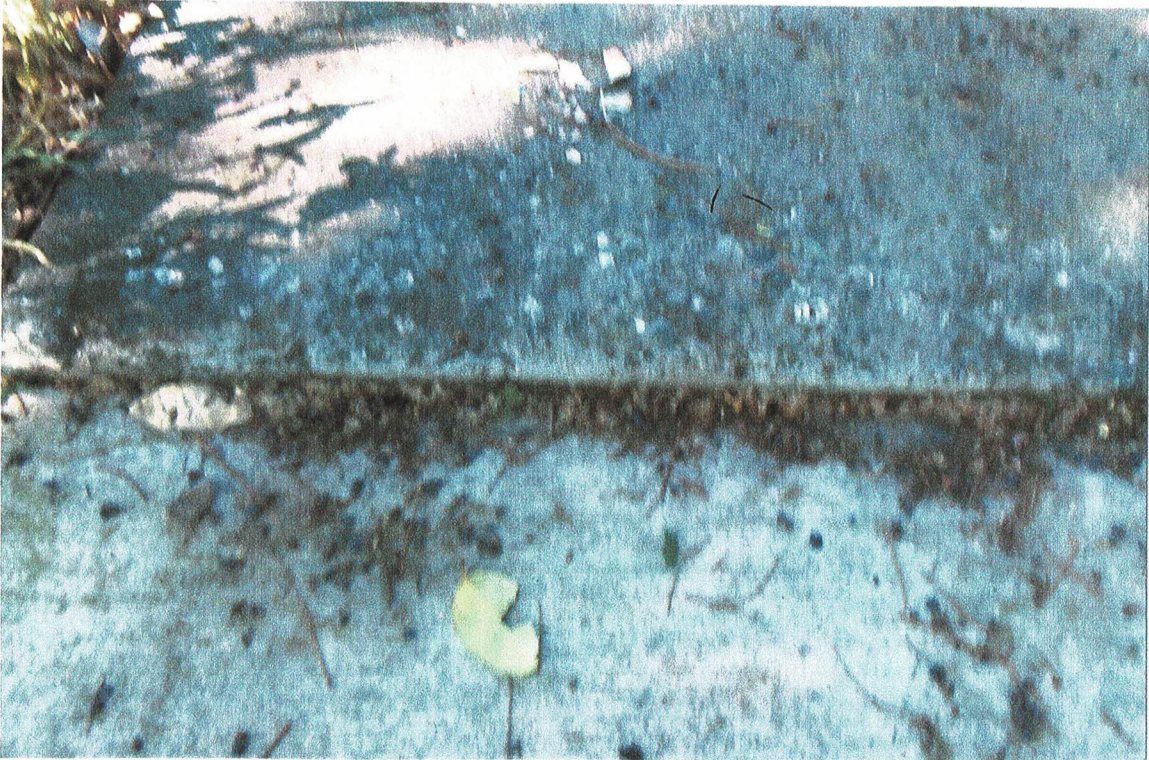
VIEW:    GROUND

- 11. GROUNDS - SIDEWALK SHOWS AREAS OF SLAB LIFTING, (TRIP HAZZARD)**

REPORT PAGE:    11
