# WOOD DESTROYING PESTS AND ORGANISMS INSPECTION REPORT

Building No. 1675	Street Manzanita Ave. Space 110,	City Chico	Zip 95926-1633	Date of Inspection 05/22/2026	Number of Pages 1 of 7
----------------------	-------------------------------------	---------------	-------------------	----------------------------------	---------------------------

General Description: Single Story, Single Family Manufactured Home, Manufactured Siding / Trim, Unoccupied, Unfurnished.	Inspection Tag Posted: Substructure
	Other Tags Posted: None Noted

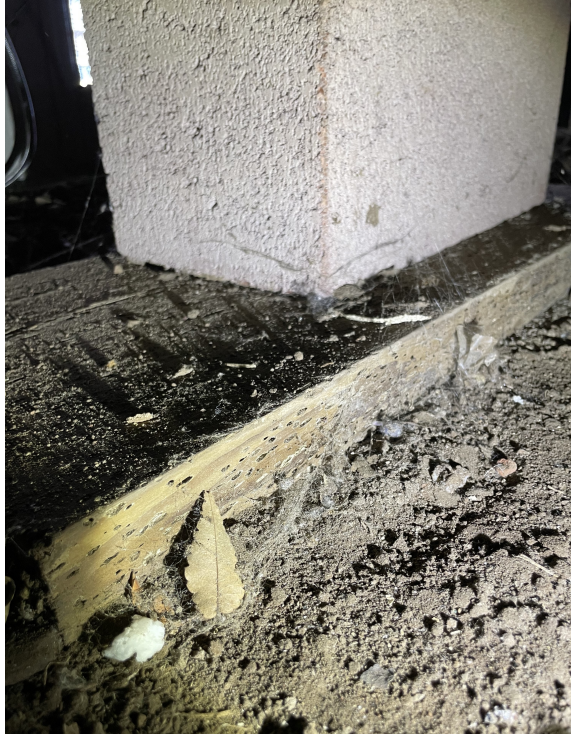
Finding: 1A Evidence of wood boring beetles was noted to the support pads at the substructure.  
Recommendation: Locally treat for the control of wood boring beetles in the accessible wood members.  
Treatment to be applied by a state licensed applicator.  
Price: \$550.00

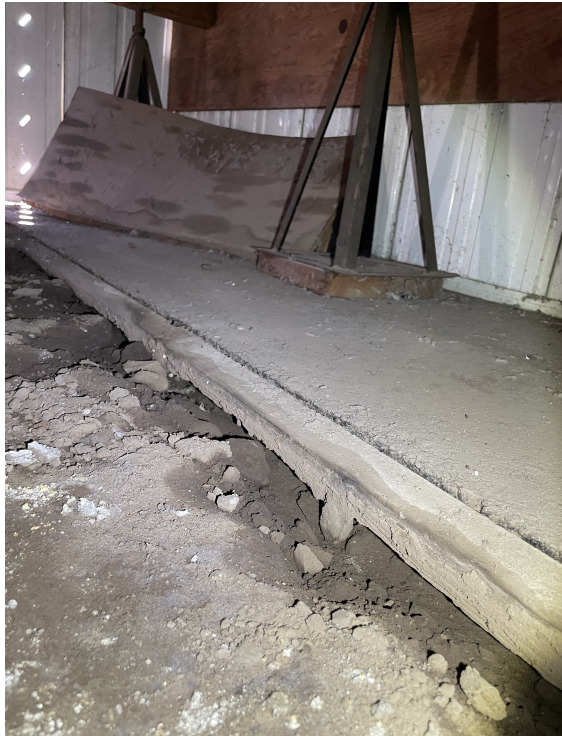
Finding: 1B  
Recommendation:

Evidence of subterranean termites was noted to the form wood at the substructure. Remove the form wood and if the form wood cannot be removed, locally treat the form wood and surrounding area(s) for the control of subterranean termites. Localized treatment shall consist of applying a registered termiticide to the soil and/or structural areas at and immediately adjacent to the location of observed activity in accordance with product label directions and accepted industry practices. Treatment to be applied by a state licensed applicator according to label instructions. Treatment methods may include, but are not limited to: Trenching and/or rodding soil in the immediate area of infestation. Drilling and treating attached or abutting concrete slabs, expansion joints, or cold joints where applicable. Drilling and treating areas of brick veneer, stone veneer, or similar construction where termite entry is possible. Registered termiticides that may be used include products containing active ingredients such as Fipronil, Imidacloprid, Bifenthrin, Cypermethrin, or other approved materials applied according to label directions. Accessible termite shelter tubes will be removed or scraped down when feasible. Localized treatment addresses only the visible or accessible areas of activity and may not eliminate termites present in other concealed areas of the structure. Upon completion of the treatment, treatment completion tag will be posted or provided as required. Warranty information for this type of treatment will be provided upon request by the owner or their authorized agent. Localized treatments are considered corrective for the area of visible activity only and are not intended to provide protection to the entire structure. A proposal for a full structural treatment for subterranean termites is available upon request.
