## IM HOME INSPECTIONS INC - RESIDENTIAL REPORT

2843 Los Olivos Ln  
La Crescenta-Montrose, CA 91214

02/21/2026

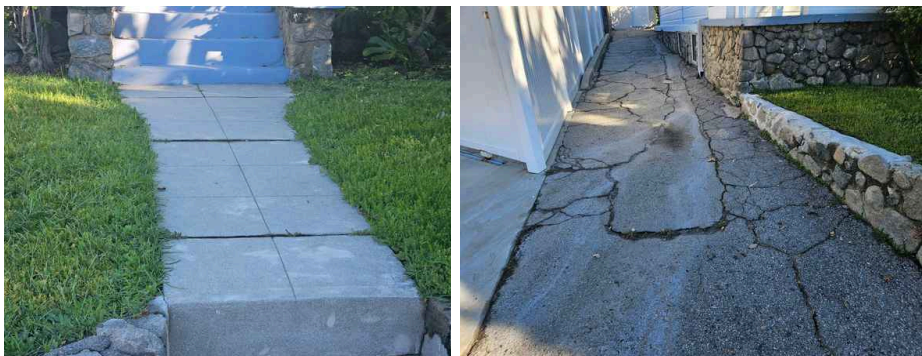
#### Driveway and Walkway Condition: Driveway and Walkway

Concrete Walkways, Asphalt driveway noted.

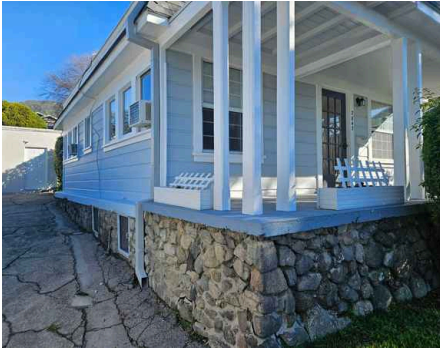
#### Exterior Material : Exterior Materials

Stone siding, Wood Siding

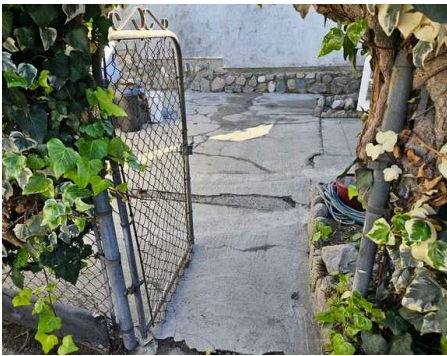
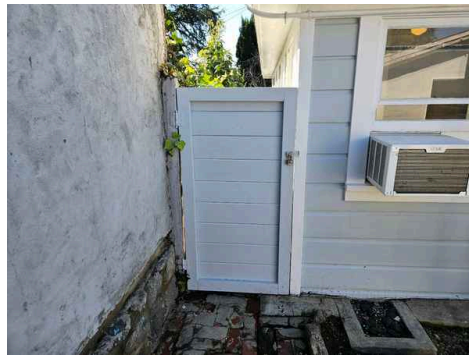
**Gate Condition: Gate Material**

Chain link, Wood

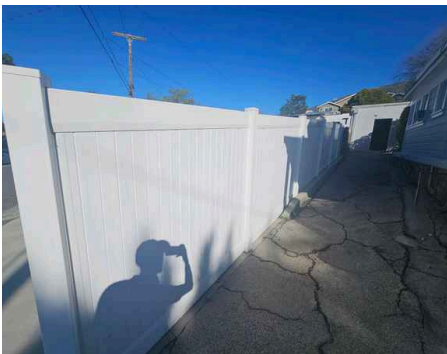
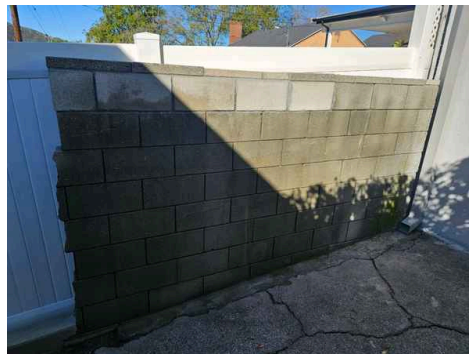
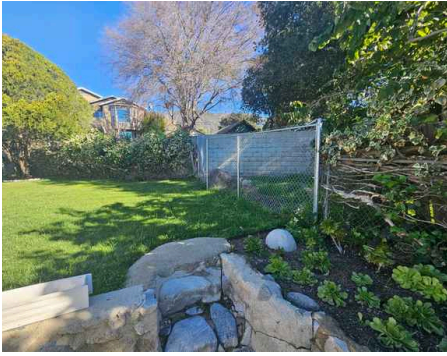
**Fence Condition: Fence or Wall Material**

Block, Vinyl, Chain Link

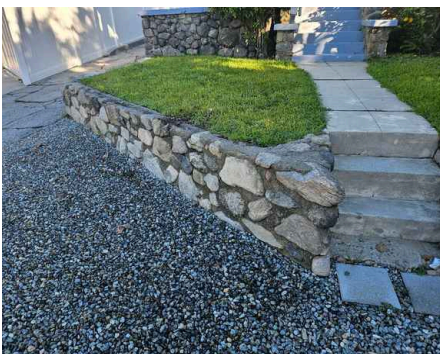
**Retaining wall: Photo**

Retaining wall noted. These structures are designed to hold back soil at a slope. Retaining walls hold a very large amount of pressure and must be designed by an engineer to strict construction standards and must include a way to drain water from soil behind wall.

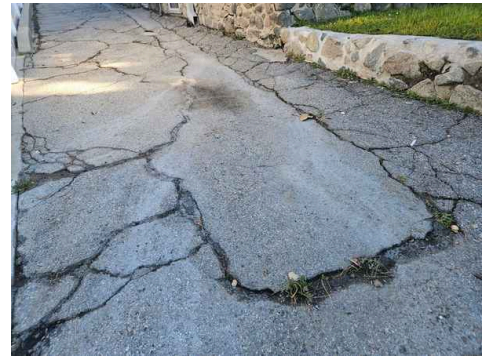
## 2.2.1 Driveway and Walkway Condition

**HEAVY CRACKING -DRIVEWAY**

Drive way has heavy cracking and significant deterioration. Recommend repair by qualified contractor.

Contact a qualified professional.

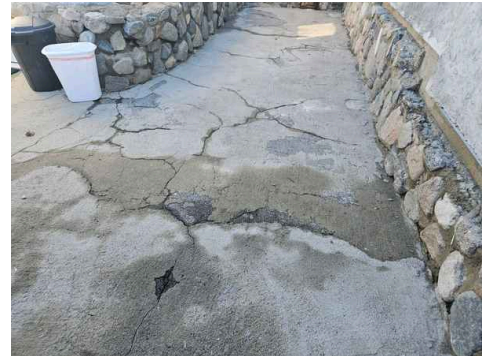
## 2.2.2 Driveway and Walkway Condition

**MODERATE CRACKING WALKWAYS**

Walkways have moderate cracking and deterioration. Recommend repair by qualified contractor.

Contact a qualified professional.

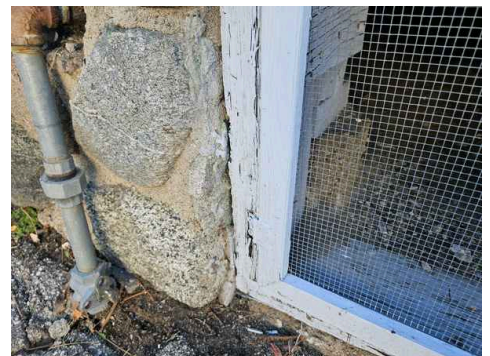
## 2.3.1 Exterior Material

**WOOD DETERIORATION**

Wood deterioration was noted at siding/trim. Recommend pest inspection for possible wood-destroying organisms.

Contact a qualified pest control specialist.

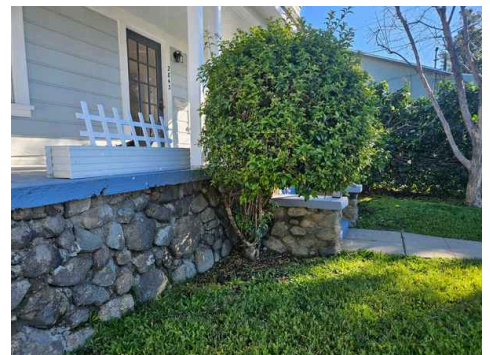
## 2.4.1 Vegetation Observations

Maintenance Tip: When landscaping keep plants, even at full growth, at least a foot (preferably 18 inches) from house siding and windows. Keep trees away from the foundation and roof. Plants in contact or proximity to the home can provide pathways to wood destroying insects and abrade and damage siding, screens, and roofs. Read more [here](#).

Contact a qualified landscaping contractor

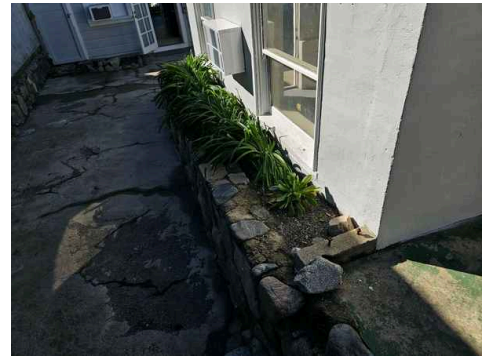
## 2.4.2 Vegetation Observations

Planter beds were noted attached to the home exterior. This can result in high levels of moisture at the home exterior near planters. This a conducive condition for wood-destroying organisms. Planter boxes should have adequate drainage so as to not hold water against the home. Recommend removing planters, or repairing so there is a gap of at least 2 inches between planters and the building exterior for better airflow, with drainage system, to allow building exteriors to dry quickly. Read more [here](#).

Contact a qualified professional.

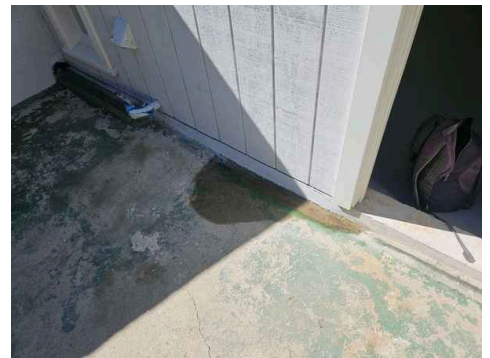
## 2.5.1 Grading

There is inadequate grading to allow water to go around home. Recommend qualified contractor evaluate and add drainage measures, such as swales and/or area drains, and/or other measures. Failure to add drainage can undermine the foundation over time.

Contact a qualified grading contractor.

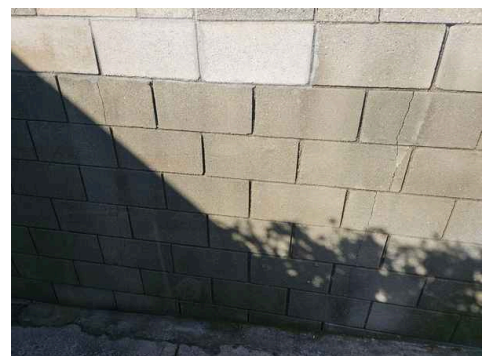
## 2.7.1 Fence Condition

**CRACKED FENCING**

Cracks in block wall fencing noted.

Contact a qualified professional.

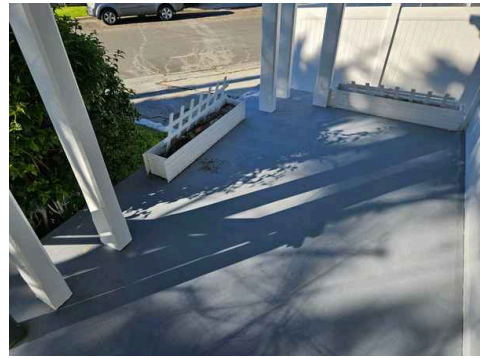
2.9.1 Patio

**MISSING GAIRD RAILS**

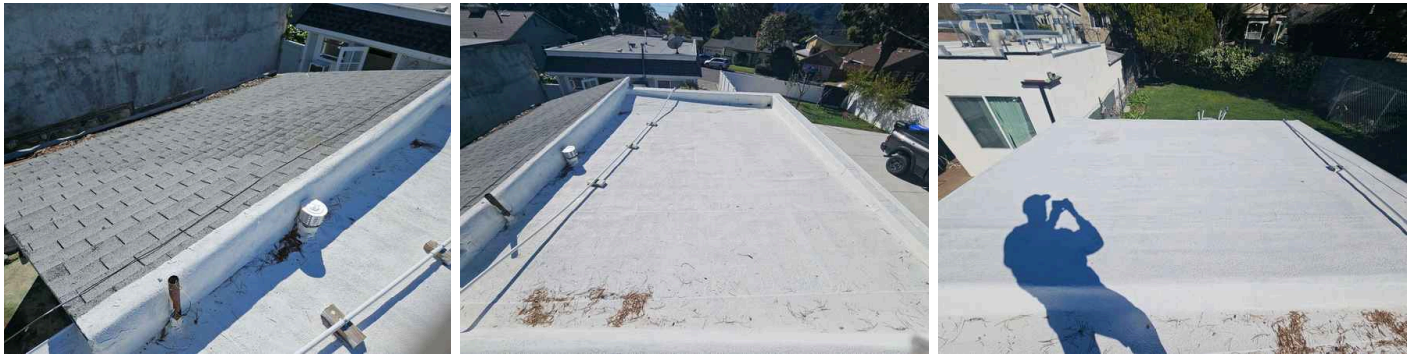
**Garage Roof: Roof Materials**

Composition Shingles, Torch Down Membrane (flat roof)

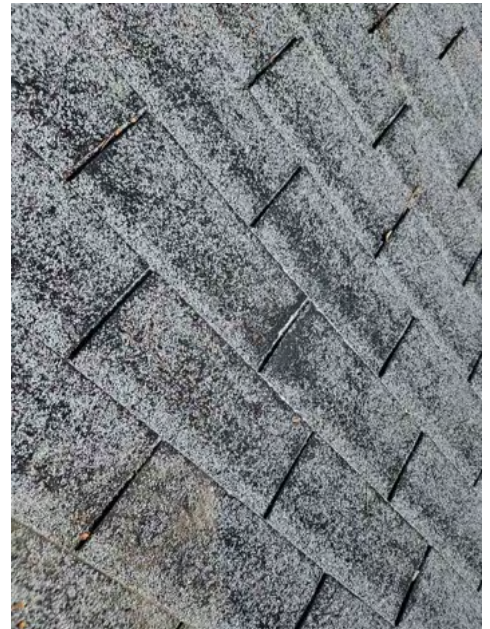
Numerous shingles had moderate to significant granule loss. This is an indication the roof is nearing the end of its useful life. Recommend consulting with a qualified roofing contractor to discuss the necessity, timeline, options and costs for eventual replacement.

Contact a qualified roofing professional.

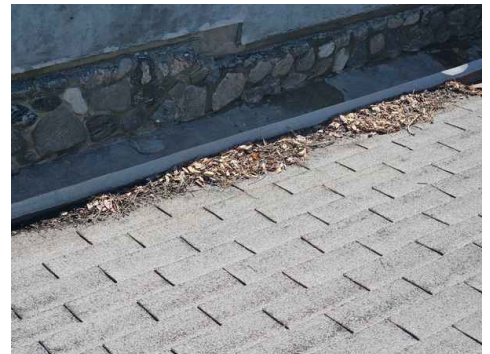
## 3.2.2 Garage Roof

Vegetation and debris noted on roof. This can hold moisture against the roof and can lead to leaks or wood destroying organisms. Recommend cleaning roof now and in the future.

Contact a qualified professional.

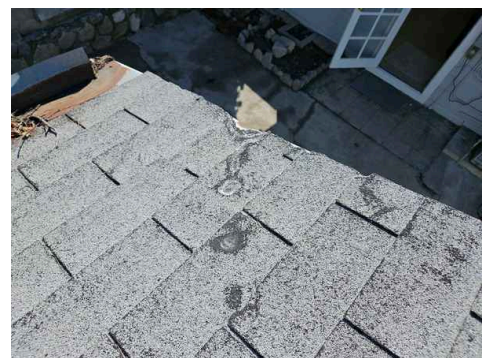
## 3.2.3 Garage Roof

**DAMAGED SHINGLES**

Damaged shingles were noted on roof. Recommend repair/replacement by qualified roofer.

Contact a qualified professional.

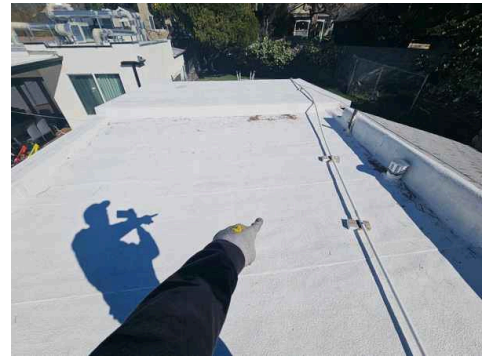
### 3.2.4 Garage Roof

Area of roof noted to be soft. This is usually an indication of the wood under the roofing materials having sustained moisture damage.

Contact a qualified professional.

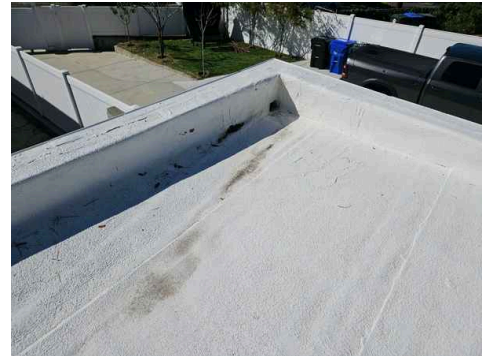
### 3.2.5 Garage Roof

Areas noted where water may pond, which could potentially lead to leaks in heavy rains

Contact a qualified professional.

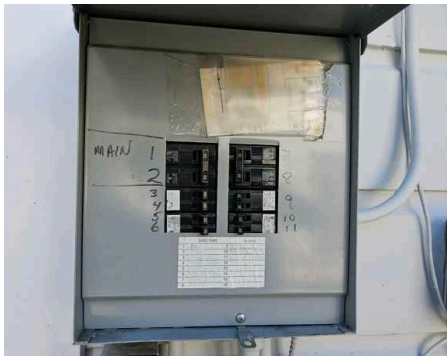
### Panel: Main Panel Location

Main Location: Exterior

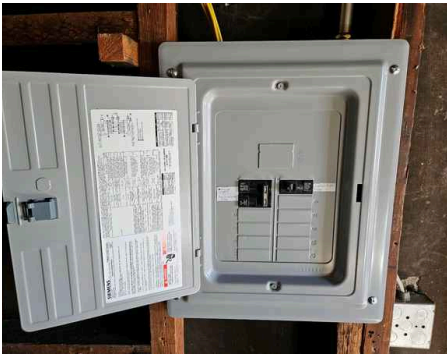
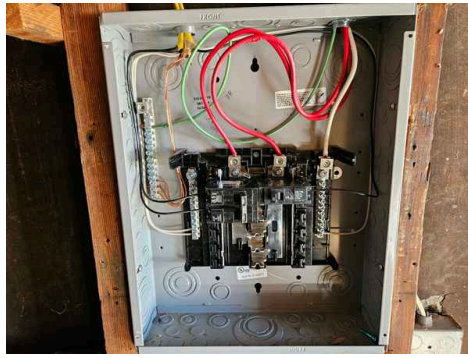
### Panel: Sub Panel Location

Garage

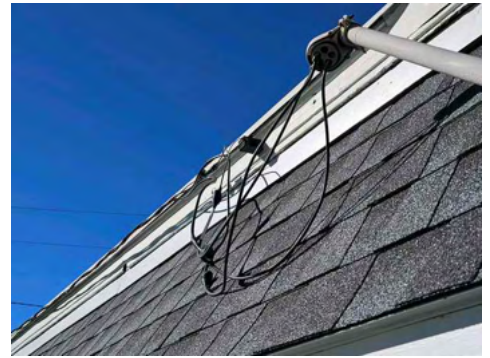
Wires from home to garage are touching roof. This is a safety hazard. Recommend correction by a qualified electrician.

Contact a qualified professional.

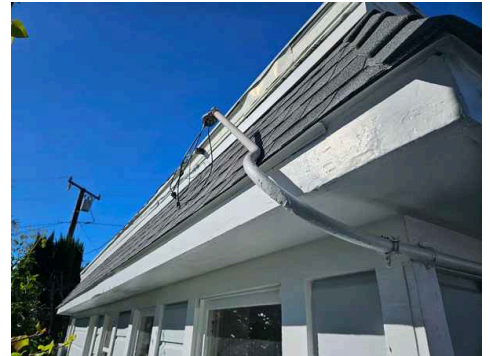
## 4.2.2 Service Wires

**CLEARANCE ABOVE ROOFTOP**

The overhead service drop conductors had inadequate clearance above the roof. The minimum clearances are as follows: 1.) 4:12 or less roof pitch requires 8 feet minimum clearance; 2.) Steeper than 4:12 requires 3 feet minimum clearance. The Inspector recommends that before the expiration of your Inspection Objection Deadline, you consult with your electrical service provider to discuss options and costs for correction. Any work on the service conductors should be performed by a qualified personnel only.

Contact a qualified professional.

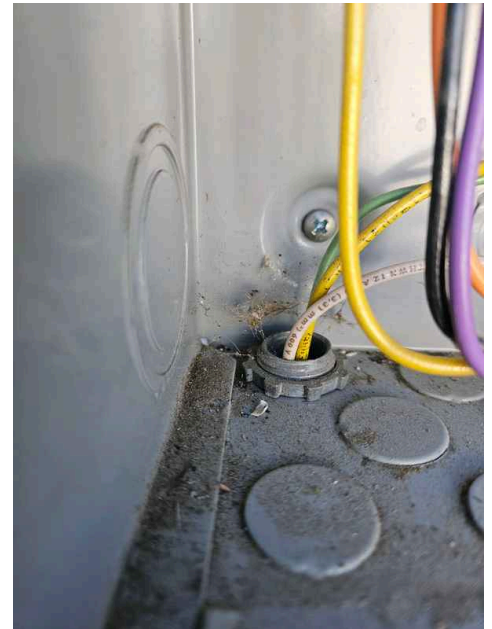
**COBWEBS NOTED IN ELECTRICAL PANEL**

Contact a qualified professional.

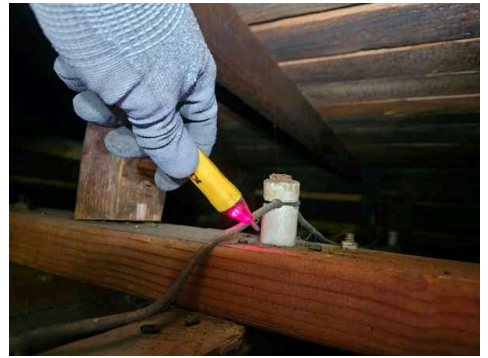
4.7.1 Wiring

Active knob and tube wiring were noted. Commonly referred to as K&T wiring. Knob and tube wiring was once common up until the 1940s. While it may still be functional, it is no longer considered safe by today's standards due to it being ungrounded. Knob and tube wiring is also easily damaged if it comes into contact with insulation, other wiring, or objects. Over time the wiring also becomes brittle and subject to failure. Recommend consulting with a qualified electrical contractor to discuss the necessity, timeline, options, and costs for upgrading all necessary wiring to modern standards.

Contact a qualified professional.

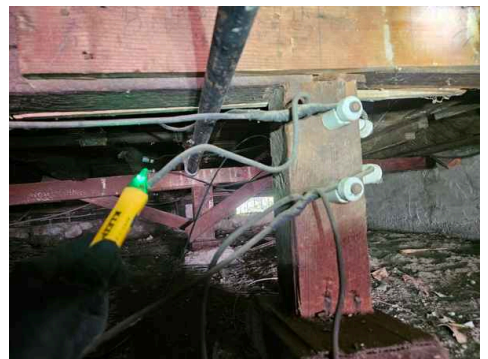
Older style wiring no longer in use. Recommend qualified electrician remove.

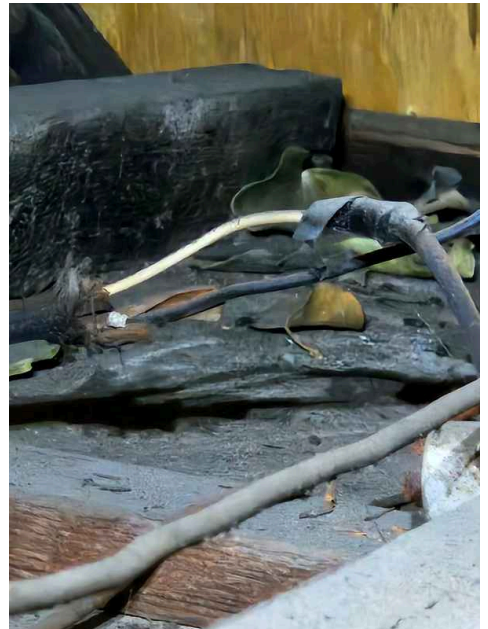
4.7.3 Wiring

**OLDER NM WIRING NOTED**

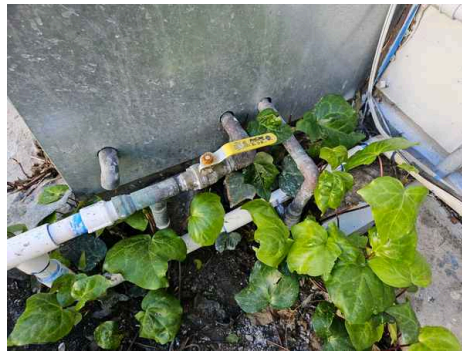
#### - Supply: Main shutoff valve

Main shutoff w/ out pressure valve (see below)

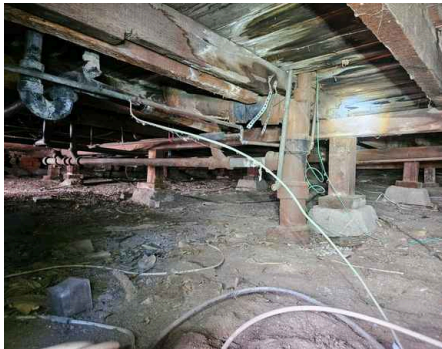
### - Drain & Waste: Visible Materials

Cast Iron (see below)

Cast Iron drain pipes noted. Simply looking at the exterior of the pipes might not indicate that there are problems with the drainage system since cast iron typically deteriorates from the inside out. Cast iron pipe over time gets corroded (corrosion) creating rust flakes or scaling or rust built up, which decreases the inside diameter of the pipe and creates a rough surface for waste and toilet tissue to pass over. With age, cast iron also becomes brittle, and can easily break without notice. The average life of cast iron drain pipes is 50-70 years, but may fail much sooner.

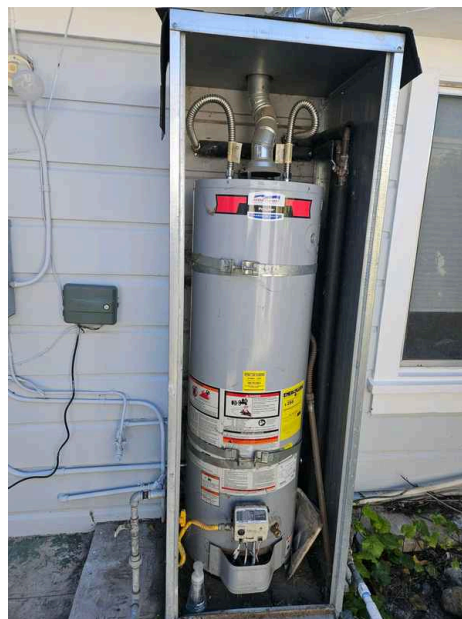
Gas water heater noted.

Exterior closet

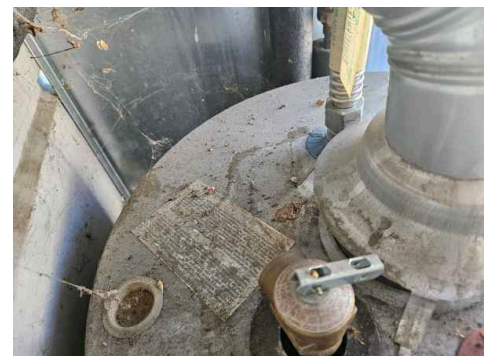
Safety Hazard
**NO DISCHARGE PIPE**

TPR valve had no discharge pipe. This is a potential safety hazard due to the risk of scalding or property damage should the valve open. Discharge pipe are recommend to terminate at the exterior. Recommend having qualified plumber install discharge pipe.

Contact a qualified professional.

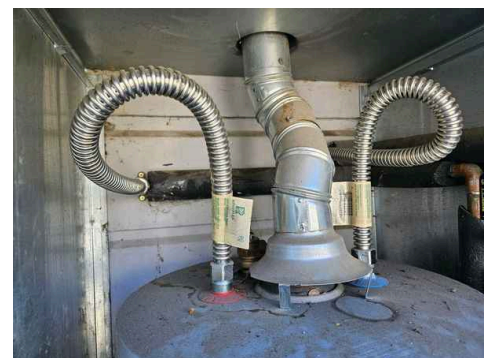
## 7.4.1 Plumbing Connections

Repair/Upgrade
**NO BONDING WIRE AND EXPANSION TANK PRESENT**

Recommend a qualified plumber install bonding wire and expansion tank to meet modern safety standards. CPC 608.3

Contact a qualified professional.

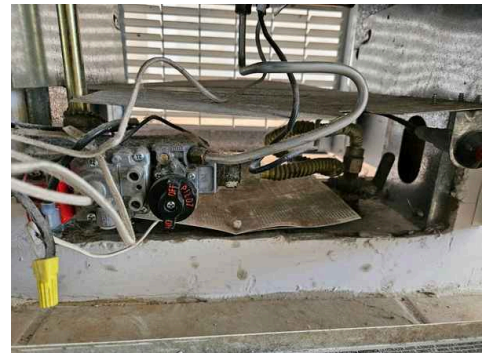
### 8.2.1 Heater Condition

Contact a qualified professional.

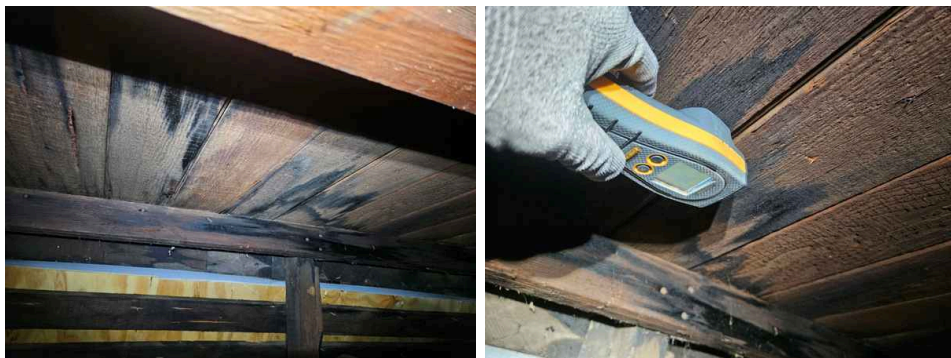
#### **MOISTURE STAINS DRY**

Moisture stained noted that were dry at time of inspection.

Contact a qualified professional.

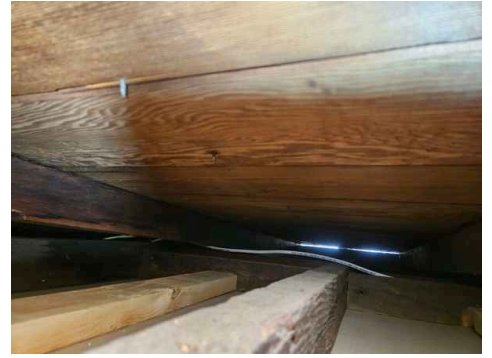
Repair/Upgrade

Contact a qualified professional.

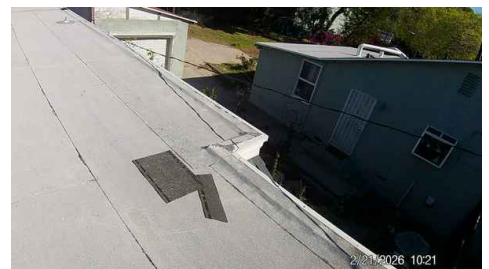
Excess roofing materials were left on roof. These materials may fall off the roof in a wind storm or earthquake and injure people. They may also trap moisture on the roof and lead to premature aging of sections of the roof. Recommend having a qualified person remove excess roofing materials.

Contact a qualified professional.

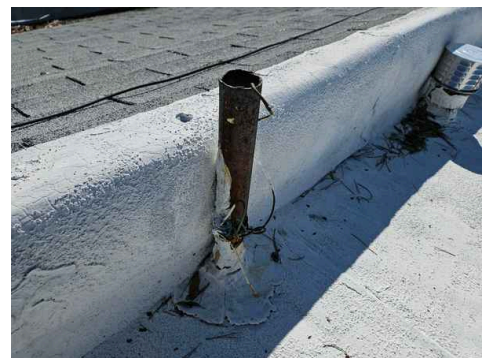
11.3.2 Vent Caps

**VENT CAP(S) NOTED TO BE RUSTED.**

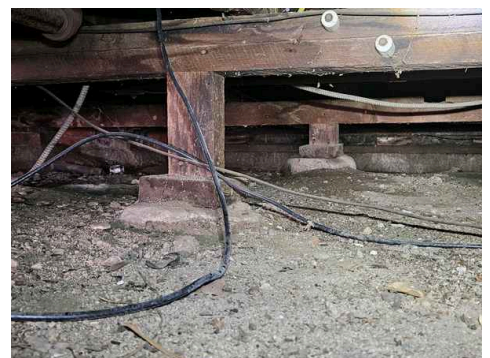
Pier and beam

Contact a qualified professional.

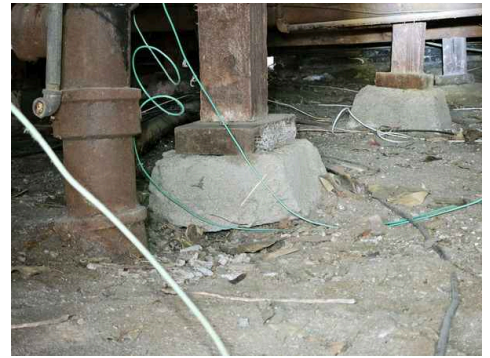
13.2.2 Pier and Beam

**UNDERMINING NOTED**

Contact a qualified professional.

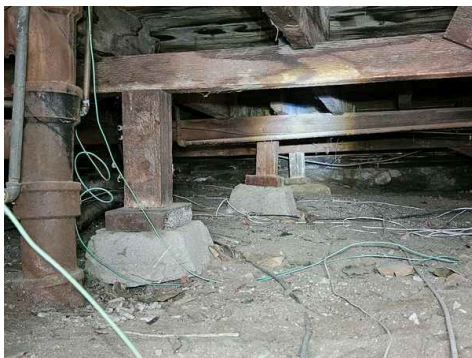
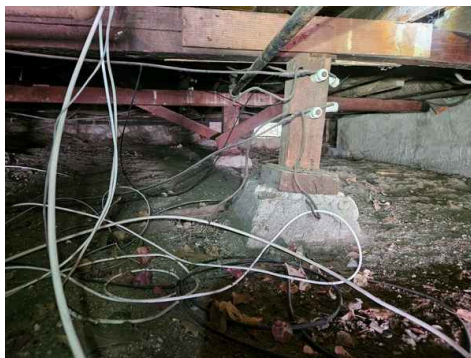
13.2.4 Pier and Beam

**LEANING**

Posts are leaning. Recommend further evaluation by a structural engineer, and repair as necessary by a qualified foundation contractor.

Contact a qualified professional.

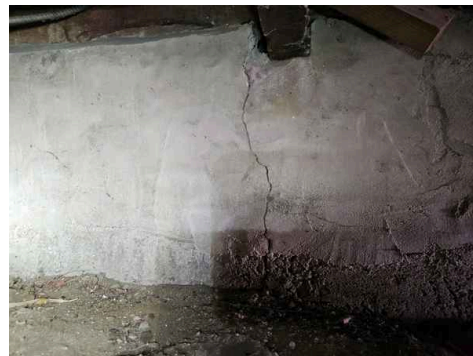
13.3.1 Crawlspace Walls and Floor

**CRACKS**

Cracks were noted in foundation block walls. Some beams may not be fully supported. Settlement and/or sagging floors may result. Recommend repair by qualified foundation specialist.

Contact a qualified professional.

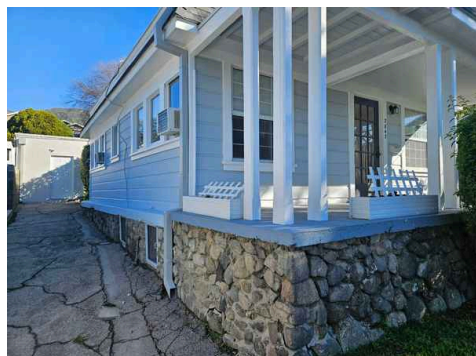
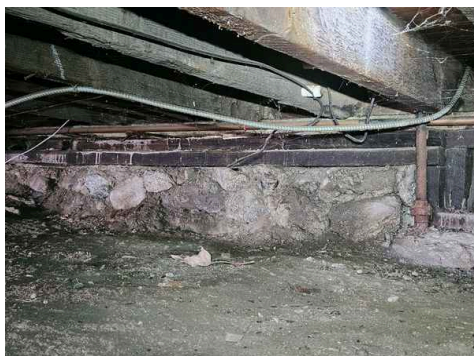
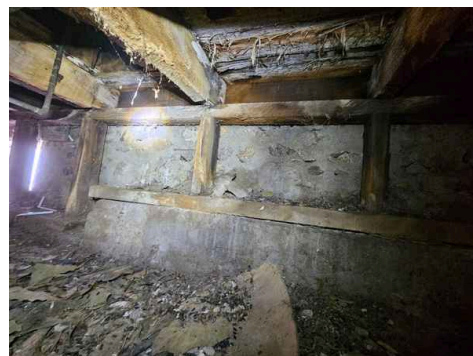
**RIVER ROCK FOUNDATION**

River Rock foundation noted. This type of foundation can not be reinforced or bolted into for seismic retrofitting. Recommend further evaluation and repair/replacement by a foundation specialist.

Contact a qualified professional.

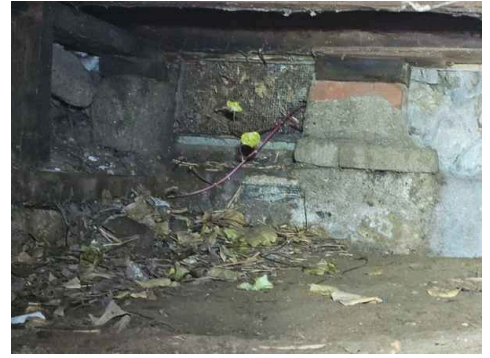
## 13.3.4 Crawlspace Walls and Floor

Repair/Upgrade
**VEGETATION NOTED TO BE GROWING IN CRAWLSPACE**

Contact a qualified professional.

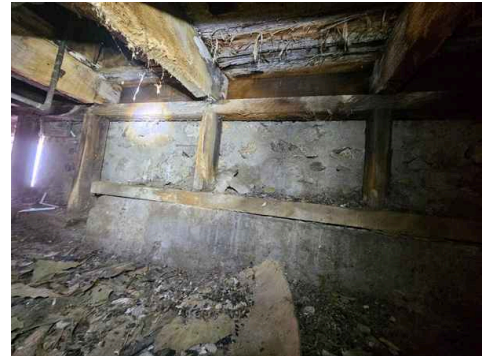
## 13.3.5 Crawlspace Walls and Floor

Repair/Upgrade
**CRIPPLE WALLS HAVE NOT BEEN COVERED WITH SHEER PANELS**

Sheer panels are recommended upgrades to strengthen the structure in older homes in case of an earthquake. Note: Some insurance companies may require sheer panels to be installed for earthquake coverage.

Contact a qualified professional.

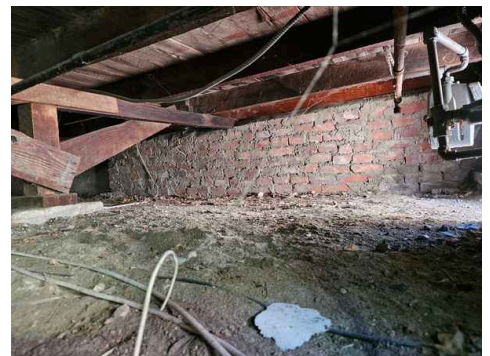
## 13.3.6 Crawlspace Walls and Floor

Safety Hazard
**BRICK STYLE**

Brick style foundation noted. Brick style was common before 1920, however, stopped being used due to concerns about its ability to withstand seismic activity. Further, brick style can not be bolted. Recommend further evaluation by a structural engineer and repair as necessary by a qualified foundation contractor.

Contact a qualified professional.

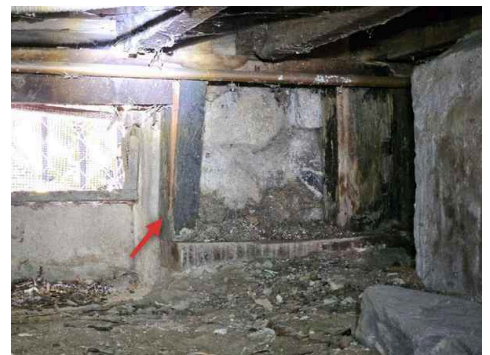
## 13.3.7 Crawlspace Walls and Floor

Repair/Upgrade
**DAMAGE NOTED**

Recommend repair by a qualified contractor.

Contact a qualified professional.

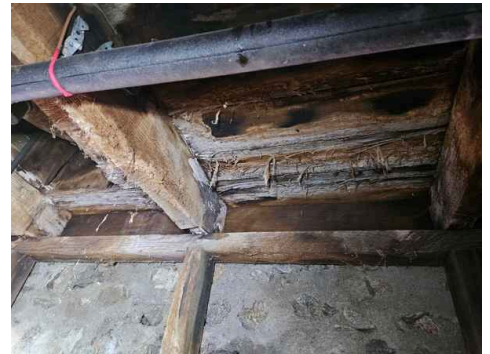
**WOOD DETERIORATION**

Wood deterioration noted. Recommend pest inspection for possible wood-destroying organisms. Recommend repair by a qualified contractor.

Contact a qualified professional.

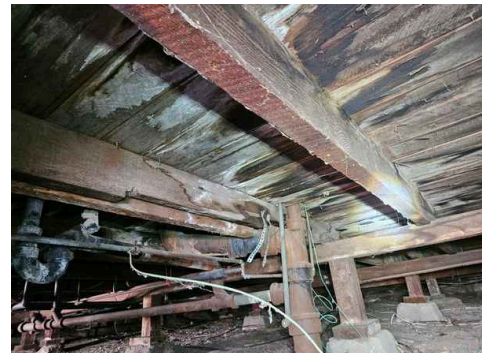
## 13.6.2 Framing and Subfloor

**MOISTURE STAINS NOTED AT FLOOR JOISTS**

Recommend pest inspection for any possible wood-destroying organisms.

Contact a qualified professional.

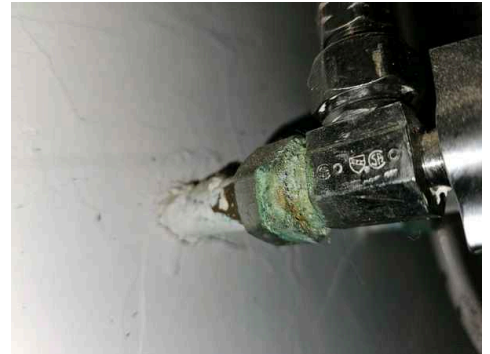
14.2.2 Sinks

**CORROSION AT PLUMBING UNDER SINK**

Contact a qualified professional.

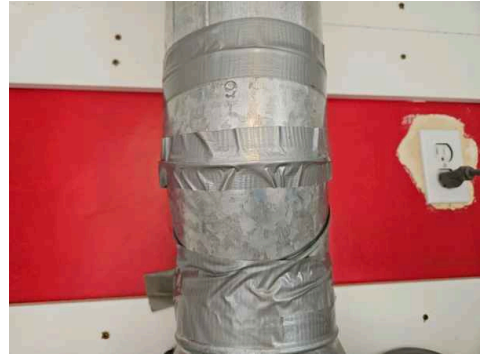
**NOT APPROVED TAPE**

Improper Tape Noted: Non-foil tape was observed on the kitchen exhaust vent pipe. Tapes such as cloth-backed, plastic, masking, or other general-purpose adhesives are not rated for the high heat and moisture produced by kitchen exhaust systems. These materials can degrade, dry out, or fail over time, potentially causing air leaks or fire hazards. Only UL 181-rated foil tape or an approved mechanical fastener should be used to ensure a durable, heat-resistant, and code-compliant connection.

Contact a qualified professional.

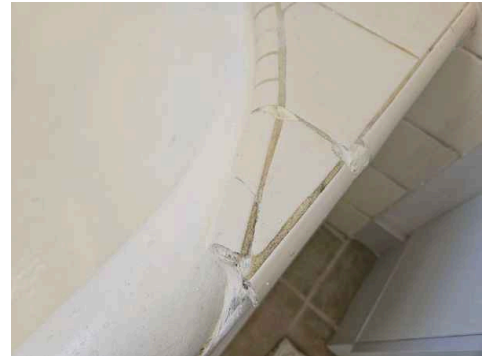
## 15.3.1 Tub with Shower

**DAMAGED TILE**

Contact a qualified professional.

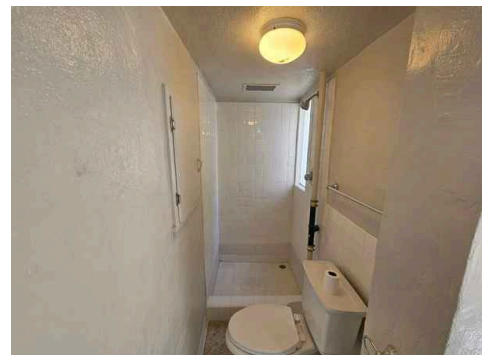
No vent fan or window noted . A vent fan or working window is required to prevent moisture build up and prevent moisture related problems. Recommend correction by qualified contractor.

Contact a qualified professional.

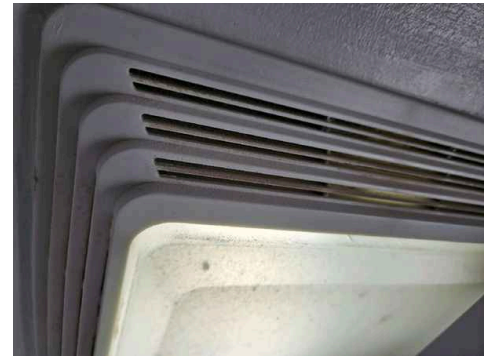
15.6.2 Exhaust Fan

**BUILD UP ON SCREENS NOTED**

Contact a qualified professional.

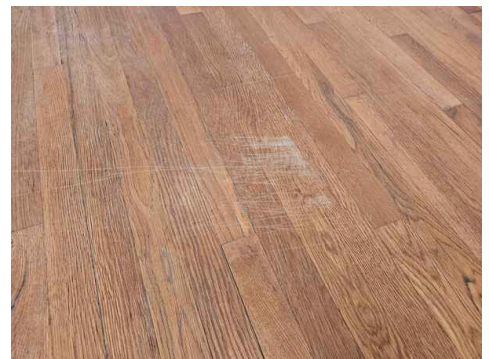
**STAIN NOTED**

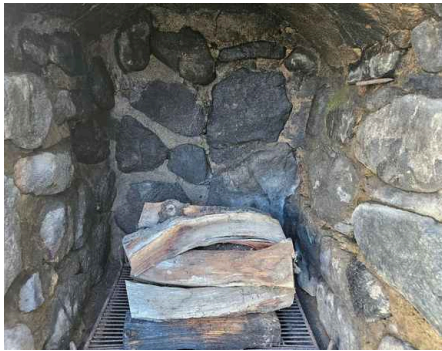
### Fireplace: Fireplace Type

Wood burning

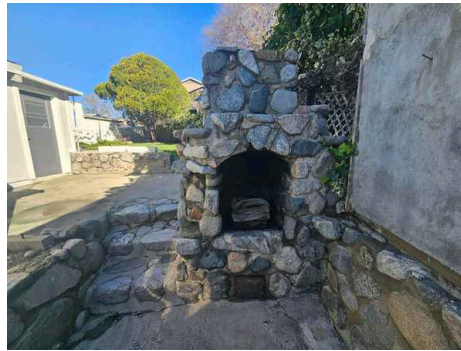
### Fireplace: Fireplace Locations

Exterior

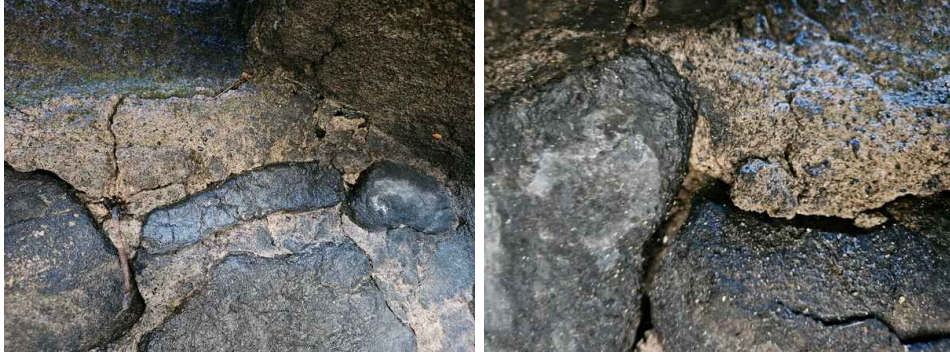
Mortar around the firebox was noted to have gaps. This is a potential fire hazard. Recommend repair by qualified fireplace specialist.

Contact a qualified professional.

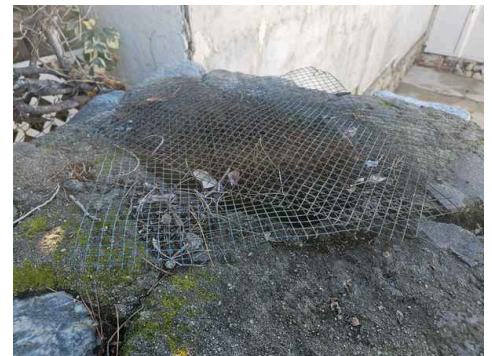
## 19.3.1 Spark Arrestor

**NO RAINDCAP**

Contact a qualified professional.
