Subject: Site Investigation Report for the Subject Property Located at 1327 5th Avenue, Chula Vista, CA 91911.

In accordance with your request, we have inspected the residence located at the above-mentioned address. The purpose of our investigation was to size footings for the exposed stem wall foundation. A registered civil engineer from our firm inspected this residence on October 26, 2022, and noted the following:

stem wall & footing detail for 1327 5th Avenue C.V. CA 91911

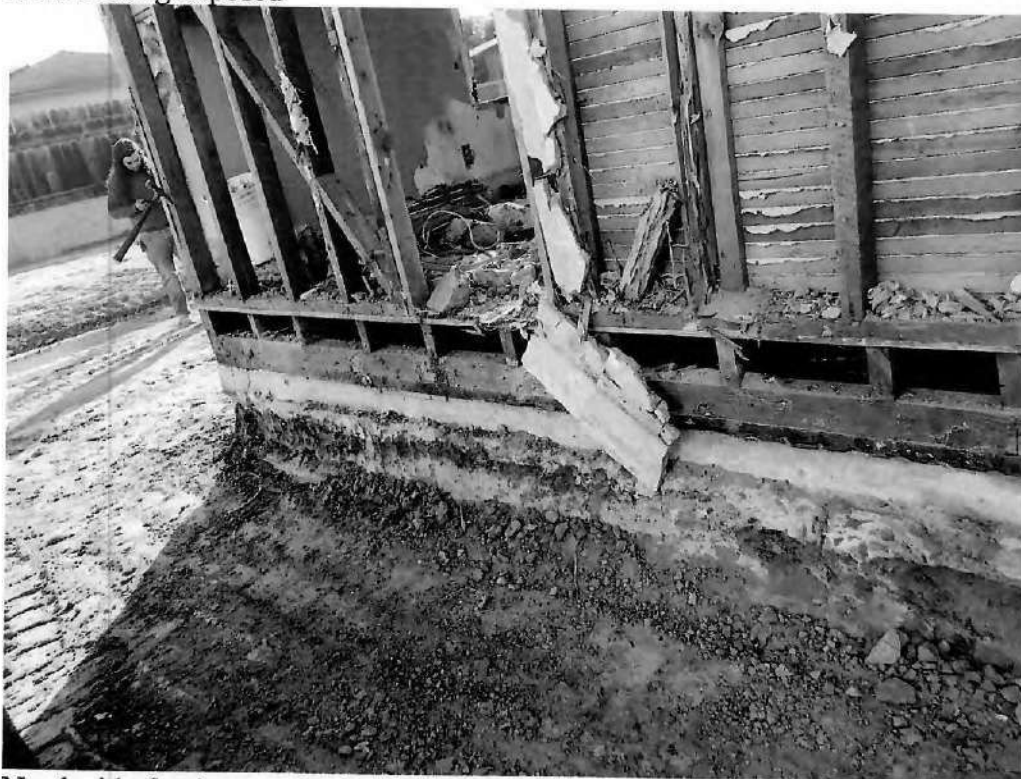
1. For the purposes of this report the front residence faces west.
2. The foundation system of the residence consists of a perimeter stem wall with isolated interior post and pier system. The footings of the stem wall were exposed on the east and north sides of the residence when an excavation was made as part of the grading for room addition to the residence. The existing footings of the exposed stem walls are approximately 6" deep and 8" wide.
3. Drainage at the subject property is poor to moderate and will require some mitigation.

North side footing exposed

1. The existing footings are currently not sufficient to bear the loads of the single-story structure.

1. An extended footing shall be added to the existing footings that conforms to the attached detail.
2. Jacks shall be placed beneath the existing footing at 6' on center for support. The jacks shall be poured into the footing. If pipes are to be substituted – 2" Thick-walled steel pipe shall be used. This pipe can be purchased at sprinkler supply outlets.

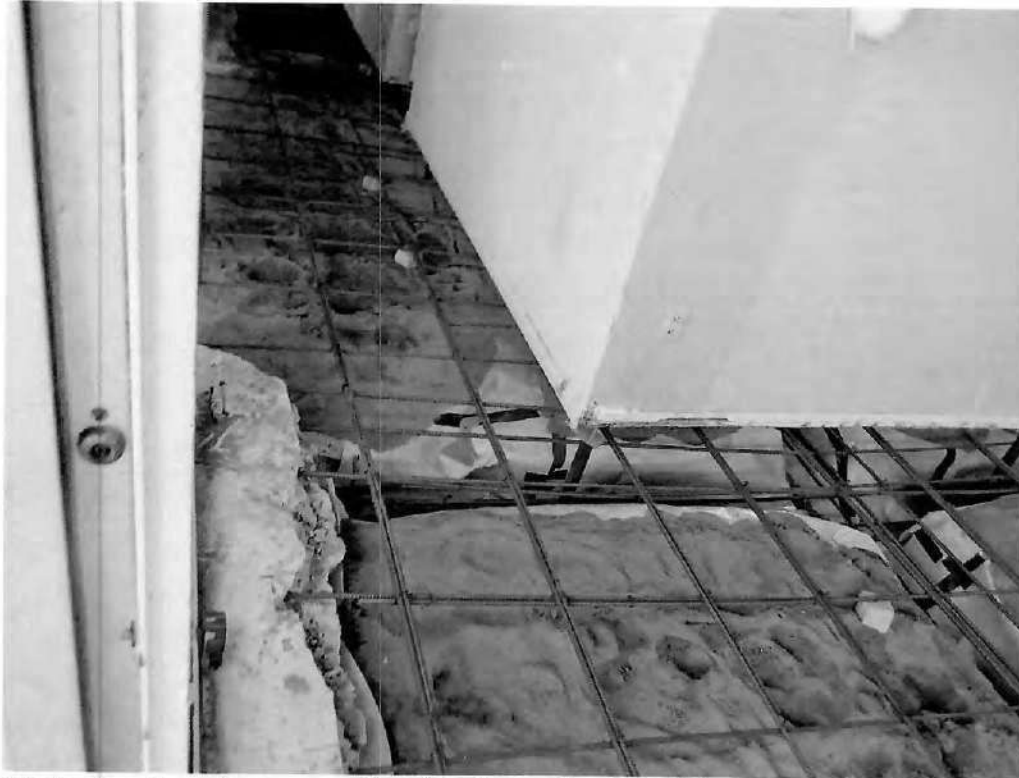
Photo showing pipes supporting interior wall of a residence
