PROPERTY INSPECTION V 5.0

7330 Quill Drive 59
Downey, CA 90242

Gustavo Herrera
05/04/2026

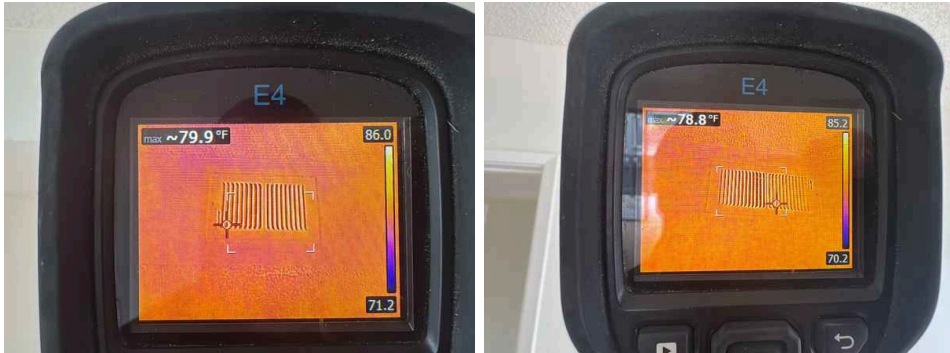
The HVAC system was operated using normal controls; however, the system did not produce cold air while the air conditioning was on. This may indicate a malfunction with the condenser, refrigerant levels, or other components. Recommend further evaluation and servicing by a licensed HVAC professional to restore proper cooling performance and ensure efficient operation.

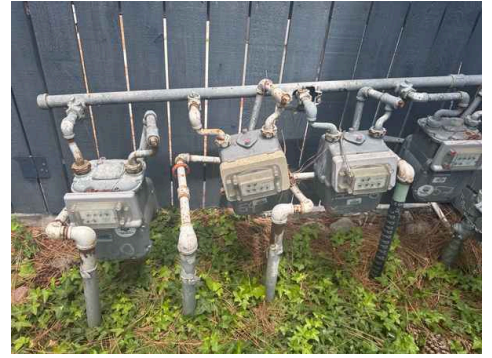
11.5.1 Gas Meter

GAS PIPES ARE RUSTED AND DETERIORATED

Rust and deterioration noted at gas line. We suggest contacting the gas company to review gas line to correct.

Recommendation

Contact a qualified professional.

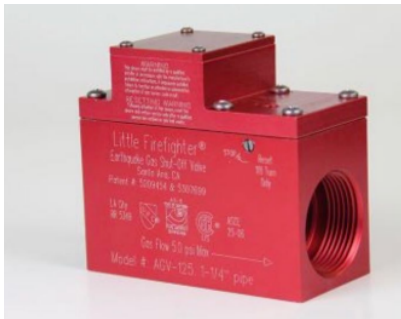
The gas main does not have an automatic seismic shut-off valve. This inexpensive device is required in some jurisdictions and is a recommended upgrade for safety.

Recommendation

Contact a qualified professional.

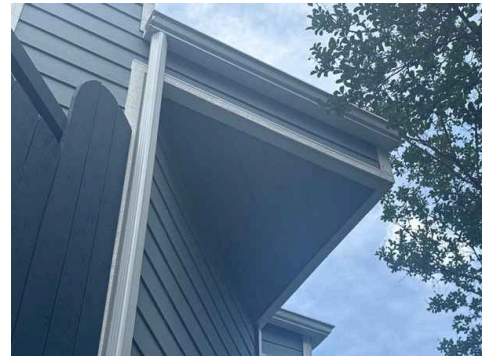
Due to the construction style and configuration of the enclosed eaves, a thorough visual inspection of these areas was not possible. Enclosed eaves restrict access to inspect the interior components, including but not limited to framing, insulation, and potential signs of pest activity or moisture intrusion.

While efforts were made to observe accessible areas and identify any visible issues from the exterior, the presence of closed soffits, fascia, or other obstructions limited our ability to evaluate conditions within the eaves. As a result, potential defects, damages, or infestations within these areas may not have been identified.

If concerns exist regarding the condition of the enclosed eaves, we recommend consulting with a licensed contractor or pest control professional who can perform a more invasive inspection if necessary.
