## INSPECTION REPORT BY THI INSPECTIONS

8531 Vicki Dr  
Whittier, CA 90606

Eduardo Ávalos  
05/13/2026

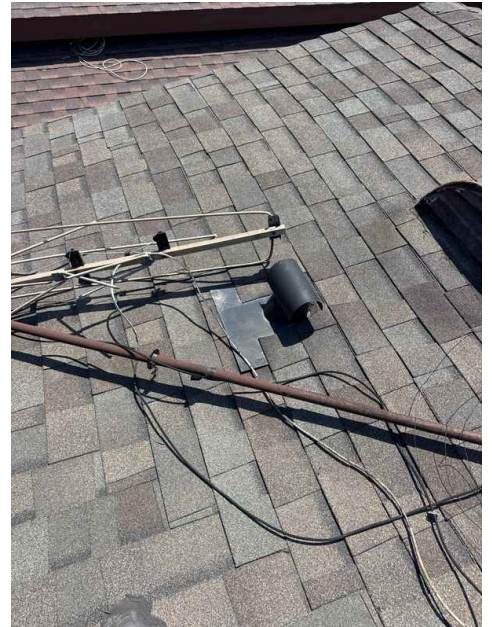
### 2.2.1 Flashing

#### **LOOSE FLASHING**

Loose flashing found in some areas of the roof.

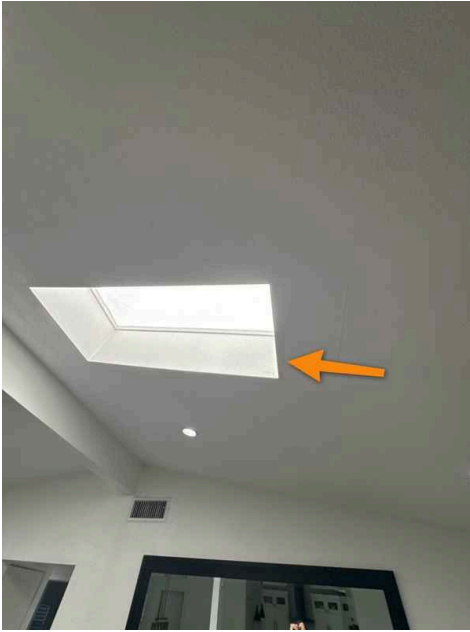
### 2.4.1 Skylight

#### **STAINING NEAR SKYLIGHT**

There was staining found near the skylight. Recommend monitoring the area after a rain. Also recommend having the area evaluated.

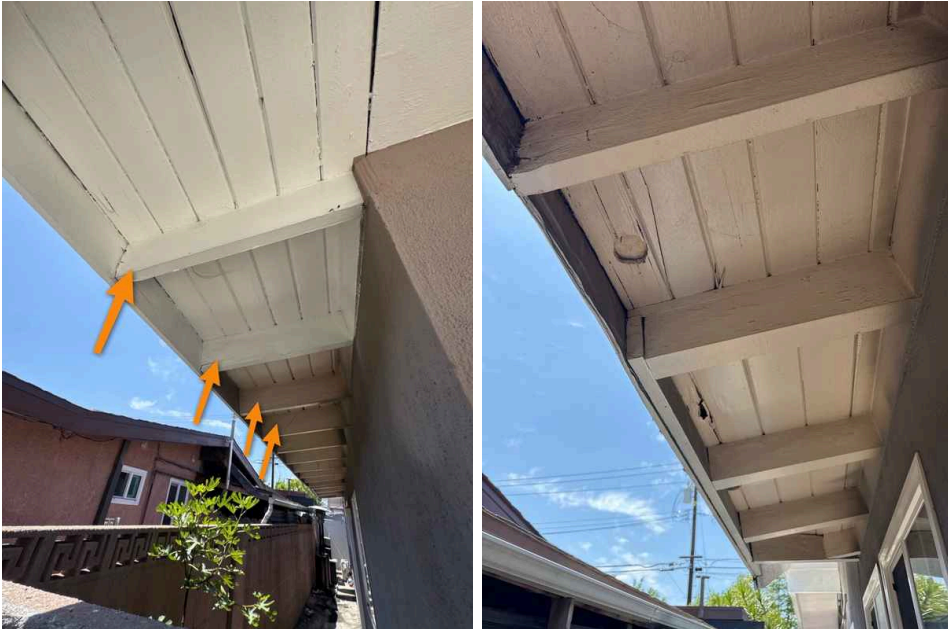
#### **DAMAGE OBSERVED AT EAVES**

I observed indications that one or more areas of the eaves were damaged.

Correction and further evaluation is recommended.

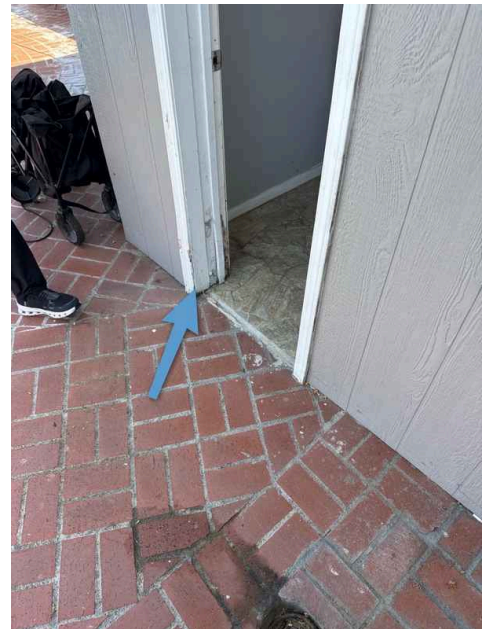
### 3.3.1 Wall-Covering, Flashing & Trim

#### **DAMAGED WALL-COVERING MATERIAL**

I observed indications of a defect at the exterior wall-covering material. Correction and further evaluation is recommended.

Contact a qualified professional.

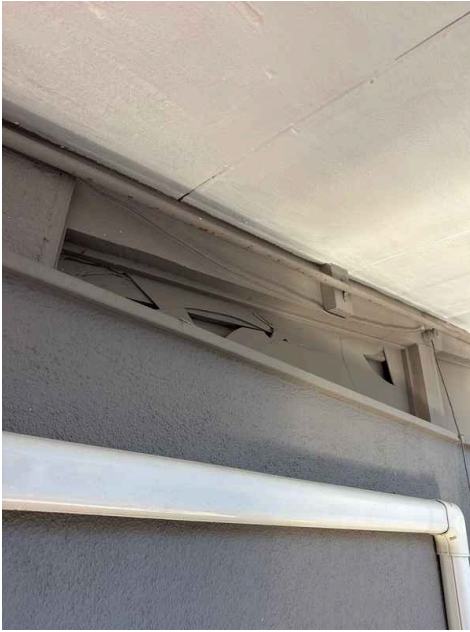
### 3.3.2 Wall-Covering, Flashing & Trim

#### **GAPS OR HOLES**

Gaps and holes have been identified in the exterior of the house, which could potentially serve as entry points for pests or allow water infiltration. It is imperative to address these openings promptly to prevent unwanted pests and water damage.

Contact a qualified professional.

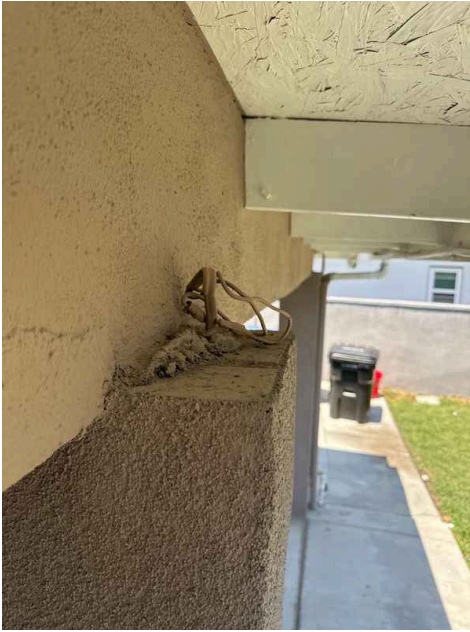
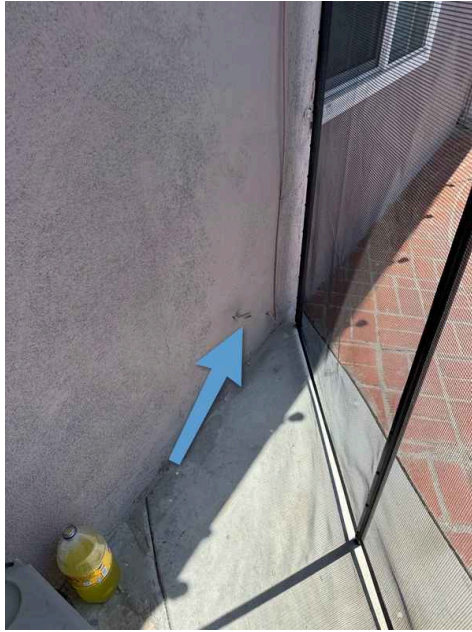
### 3.5.2 GFCIs & Electrical

#### **ELECTRICAL DEFECT**

I observed indications of an electrical defect at the exterior. Exposed wiring.

Contact a qualified electrical contractor.

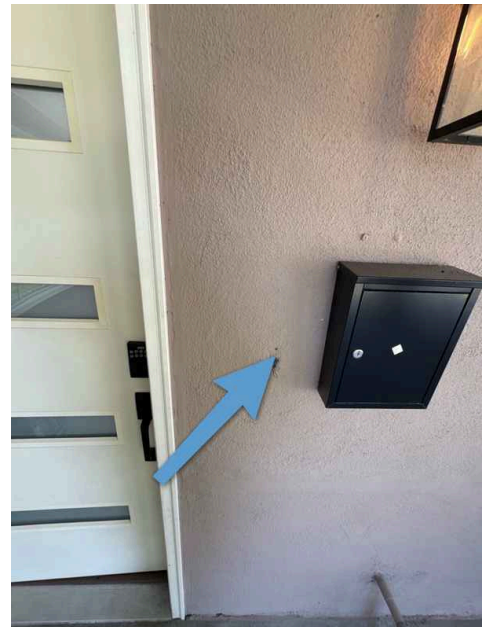
## 3.9.1 Exterior Doors

**MISSING DOORBELL**

The doorbell is missing from the exterior door entrance. This was observed during the exterior inspection. Without a functional doorbell, visitors cannot easily alert occupants to their presence. A replacement doorbell should be installed to restore this convenience feature.

Contact a qualified professional.
