RESIDENTIAL HOME INSPECTION

301 W 1st Ave
La Habra, CA 90631

MAY 6, 2026

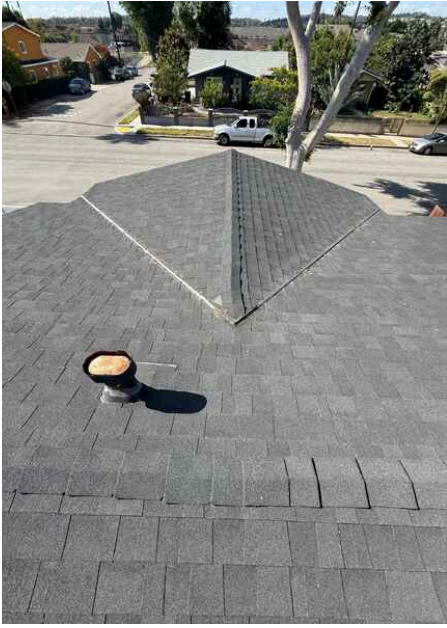
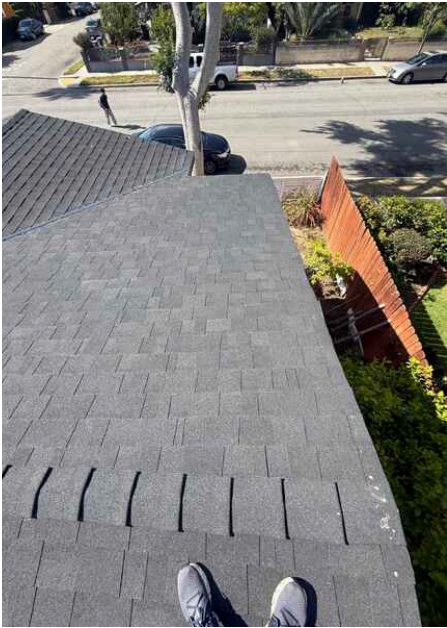
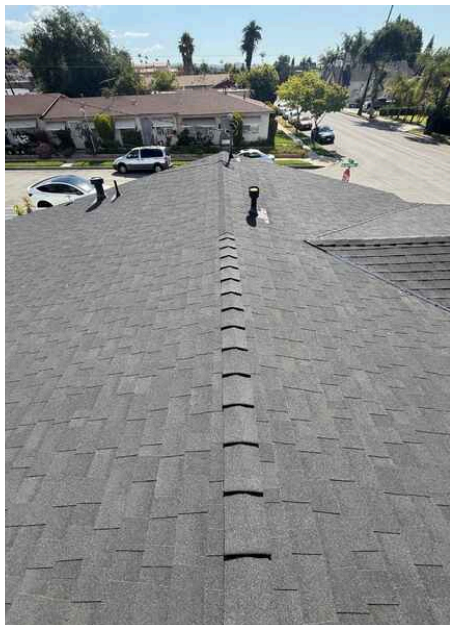
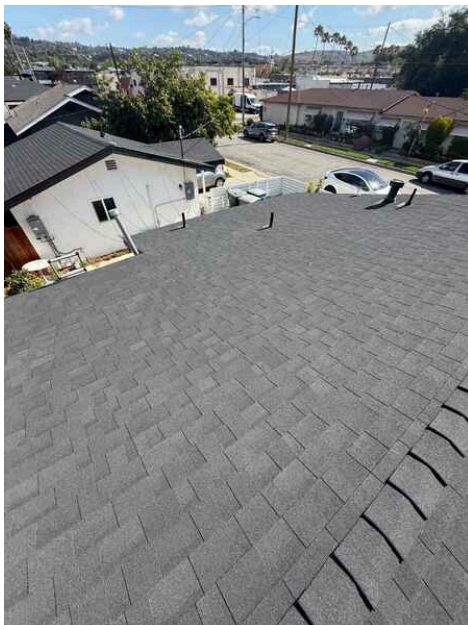
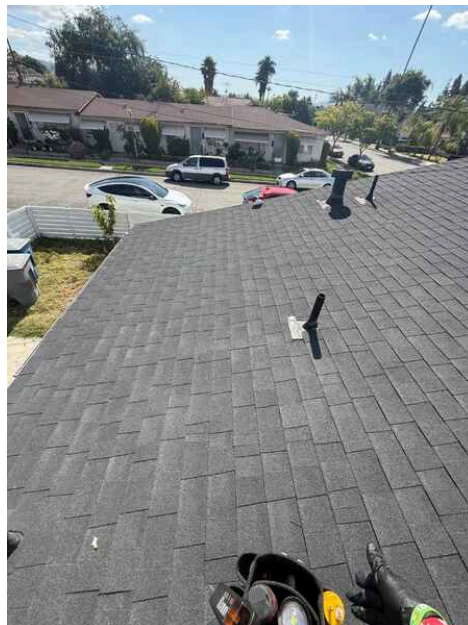
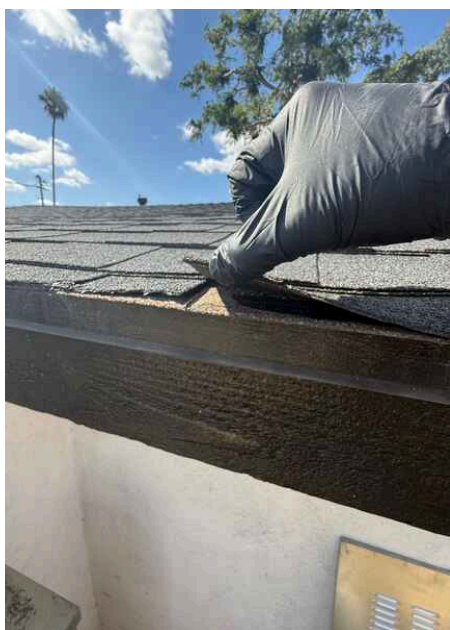
Coverings: Roof Was Inspected

We attempted to inspect the roof from various locations and methods.

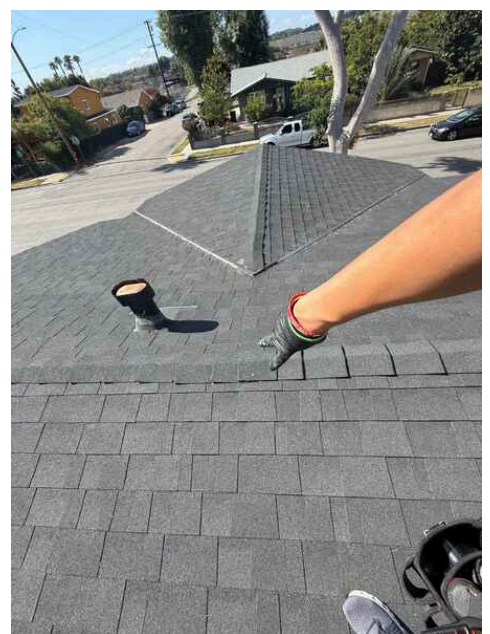
Exposed fasteners were observed on the roof surface particularly on the roof ridges. These fasteners are susceptible to corrosion and water penetration over time, which may lead to leaks and premature roof deterioration.

Servicing is recommended.

Contact a qualified professional.

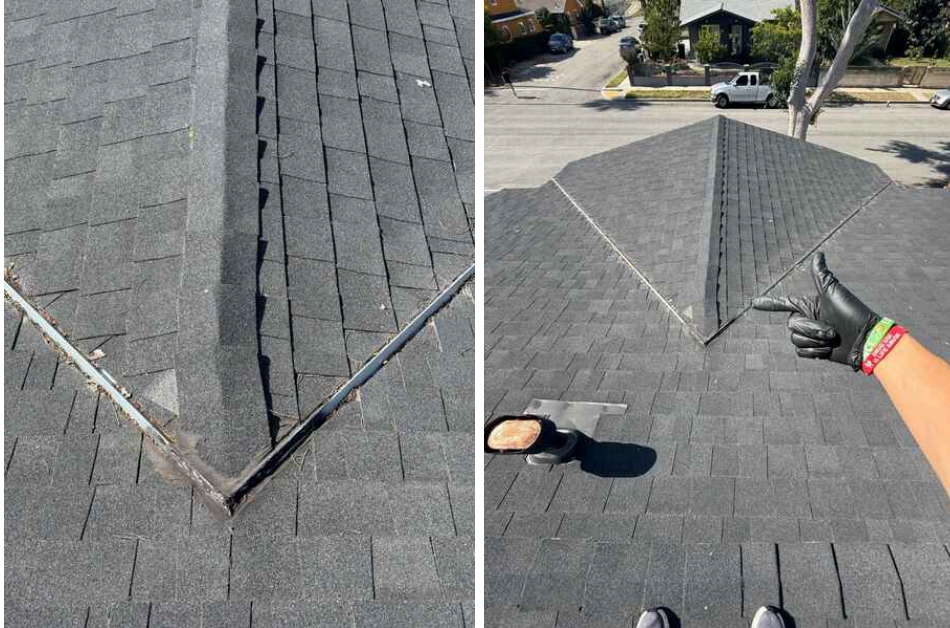
2.2.2 Coverings

PREVIOUS PATCHING

Roof patch repairs were noted at the time of inspection. These areas may indicate prior leaks or repairs.

Ask the seller about past roofing issues and monitor the patched areas. Proper sealing and maintenance are advised to help prevent future moisture intrusion.

Recommend monitoring.

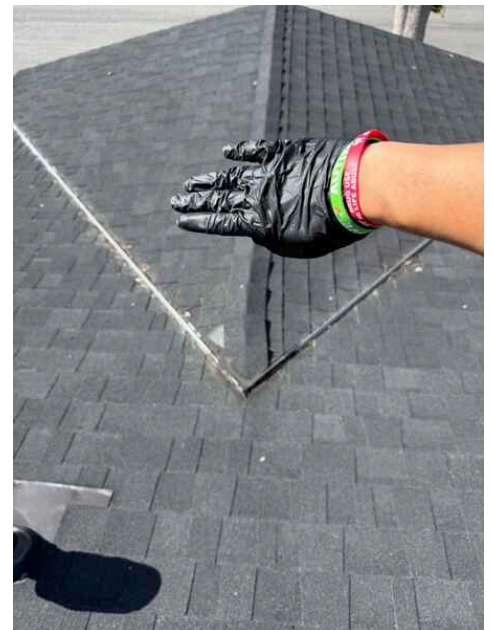
2.2.3 Coverings

SOFT SPOT DETECTED

- Trapped moisture beneath the roofing membrane or insulation
- Deterioration of underlying insulation or roof decking
- Delamination of roofing materials
- Compromised roof decking, possibly due to water intrusion

We recommend further evaluation by a licensed roofing contractor to assess the extent of the issue and perform any necessary repairs. Delayed repairs may lead to further deterioration, including roof leaks or structural damage.

Contact a qualified professional.

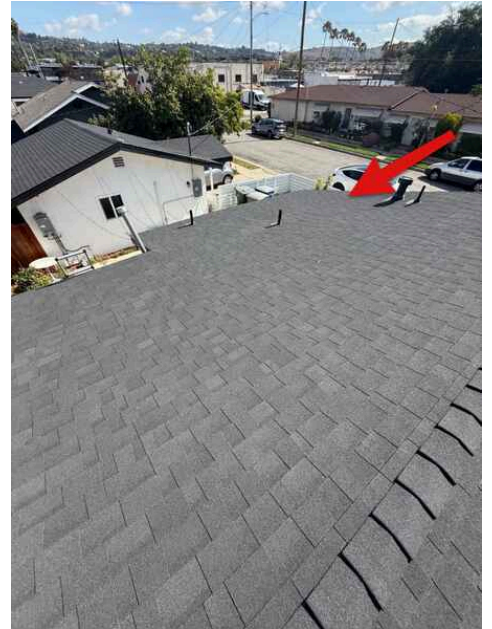
2.2.4 Coverings

UNEVEN ROOF SLOPE OBSERVED

A section of the roof appeared to flatten or transition to a lower slope compared to the surrounding roof areas. This condition may hinder proper water drainage and could contribute to premature wear or moisture intrusion over time.

Recommend further evaluation by a qualified roofing contractor and repairs or corrections as needed.

Contact a qualified professional.

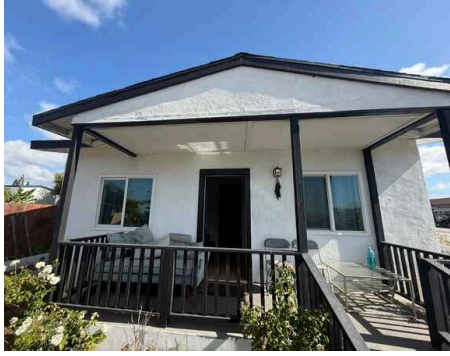
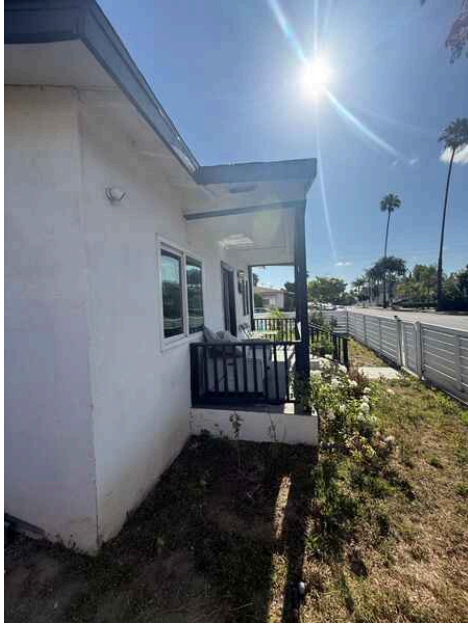
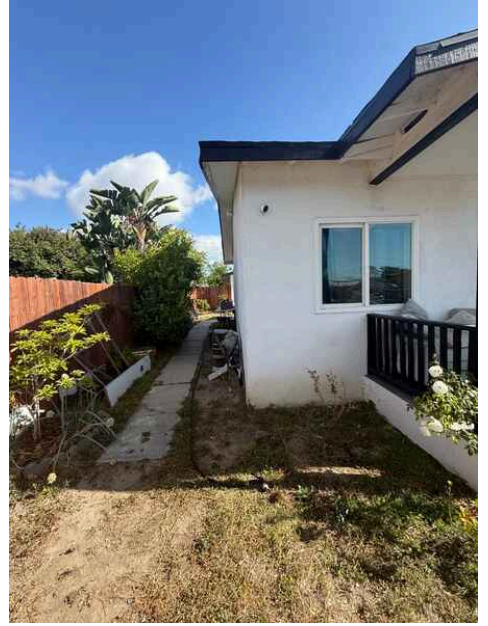
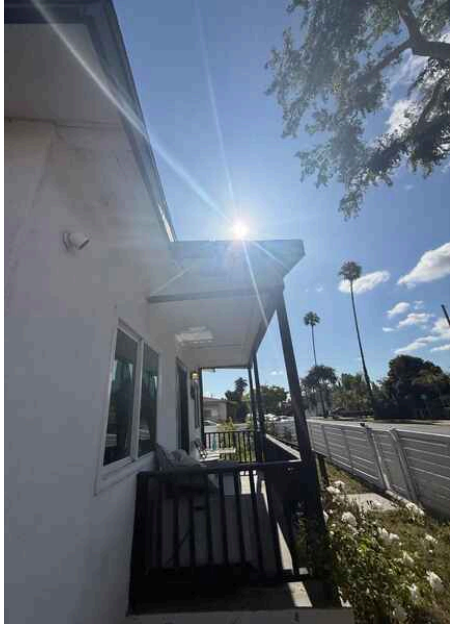
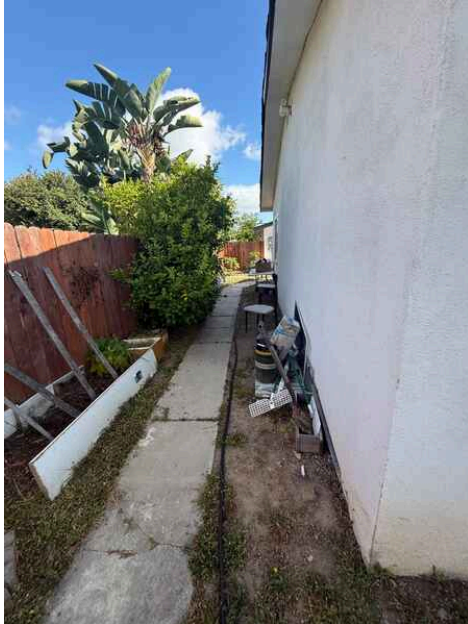
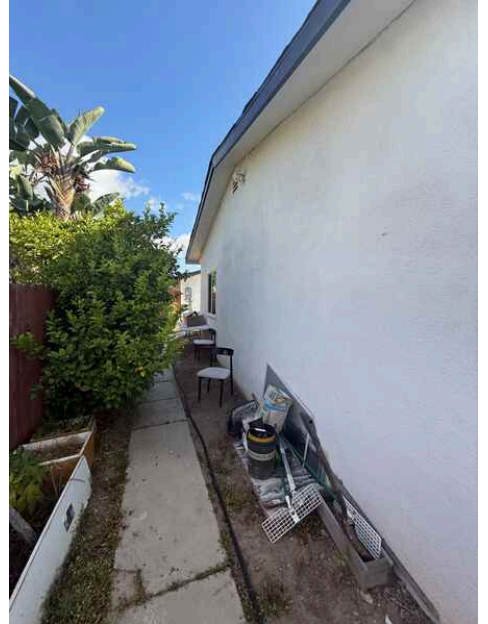
Exterior Was Inspected

The exterior of the house was inspected.

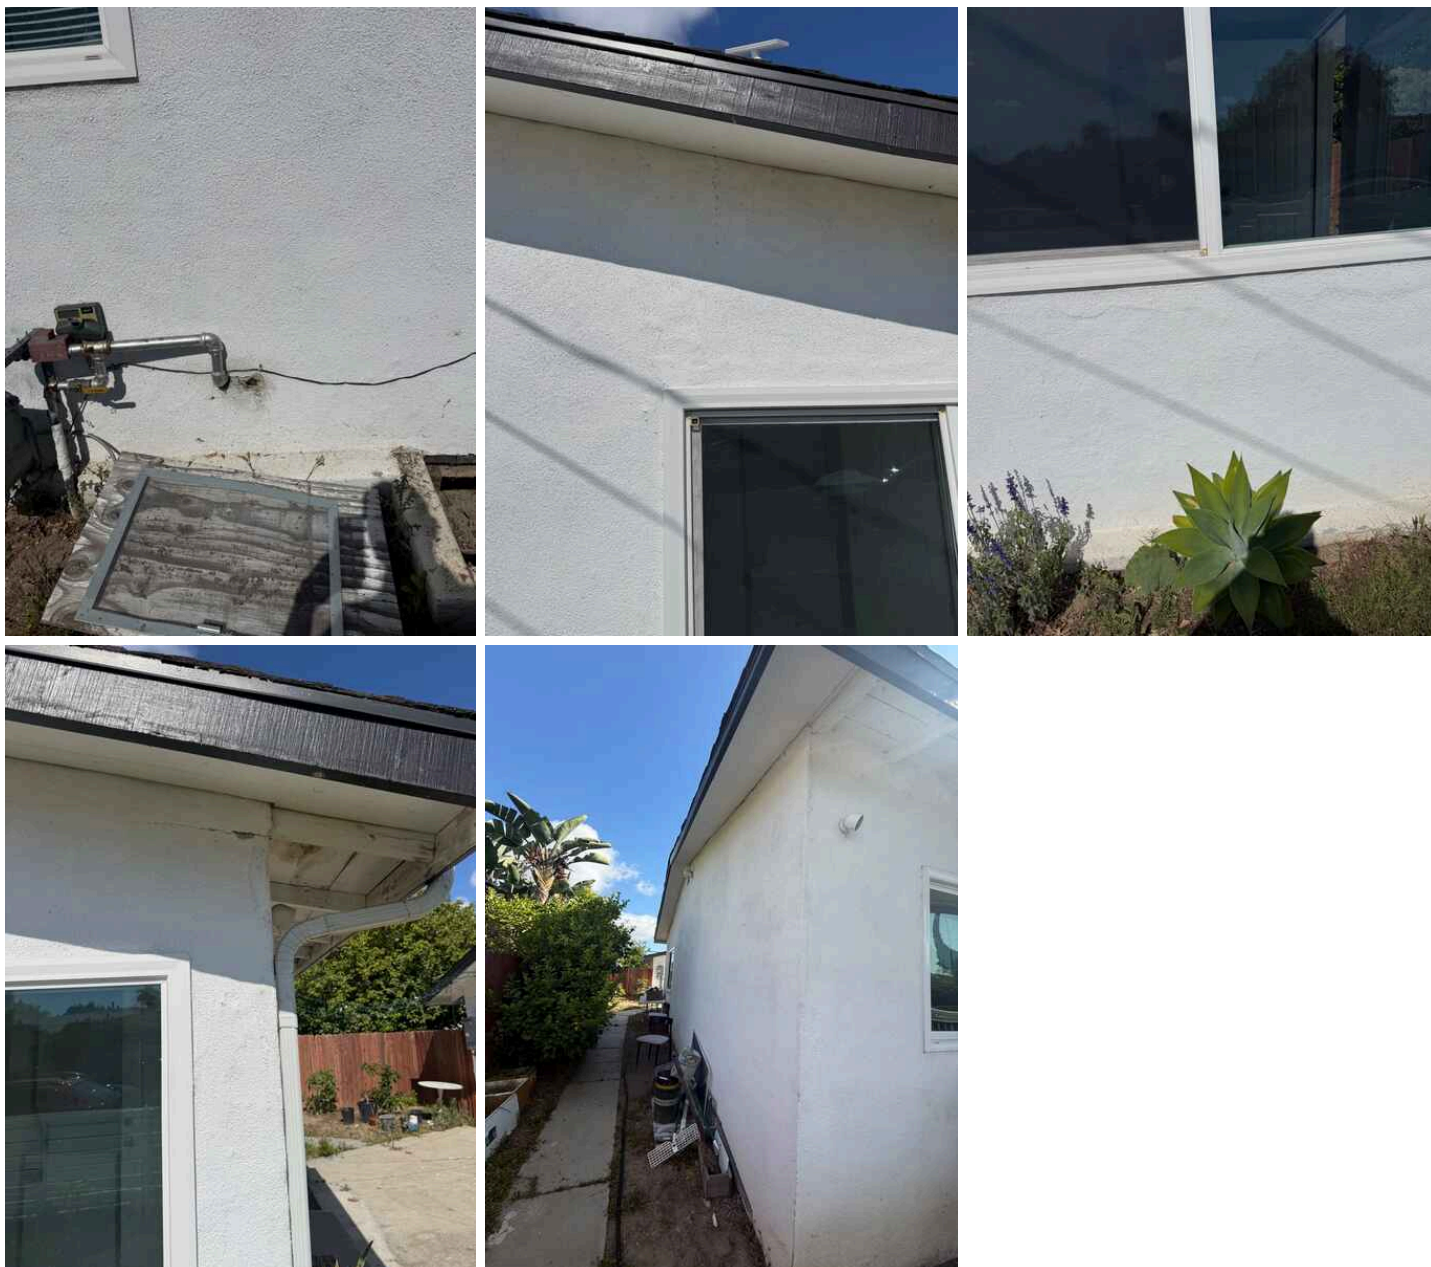
4.2.1 Wall-Covering, Flashing & Trim

DAMAGED WALL-COVERING MATERIAL

Contact a qualified professional.

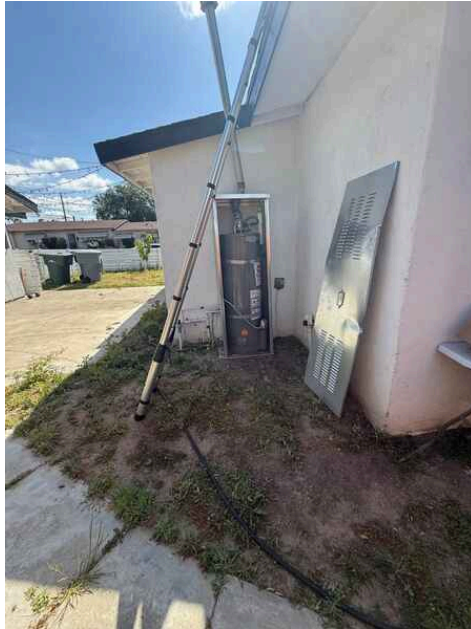
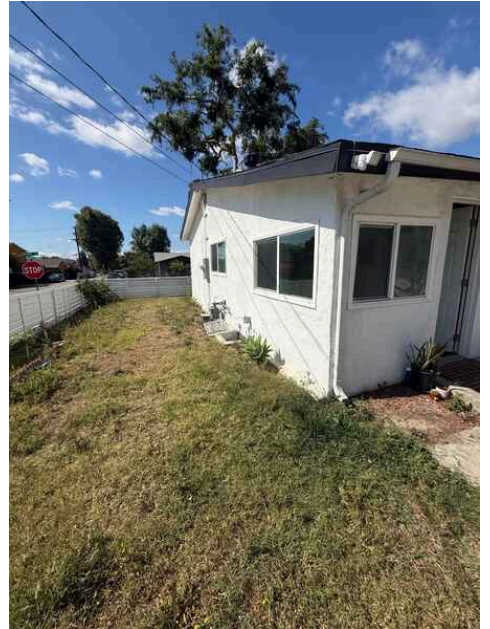
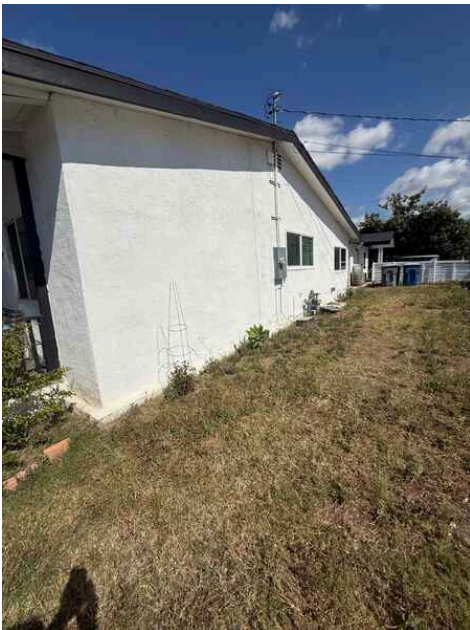
4.3.1 Vegetation, Grading, Drainage & Retaining Walls

NEGATIVE GRADING

Contact a qualified professional.

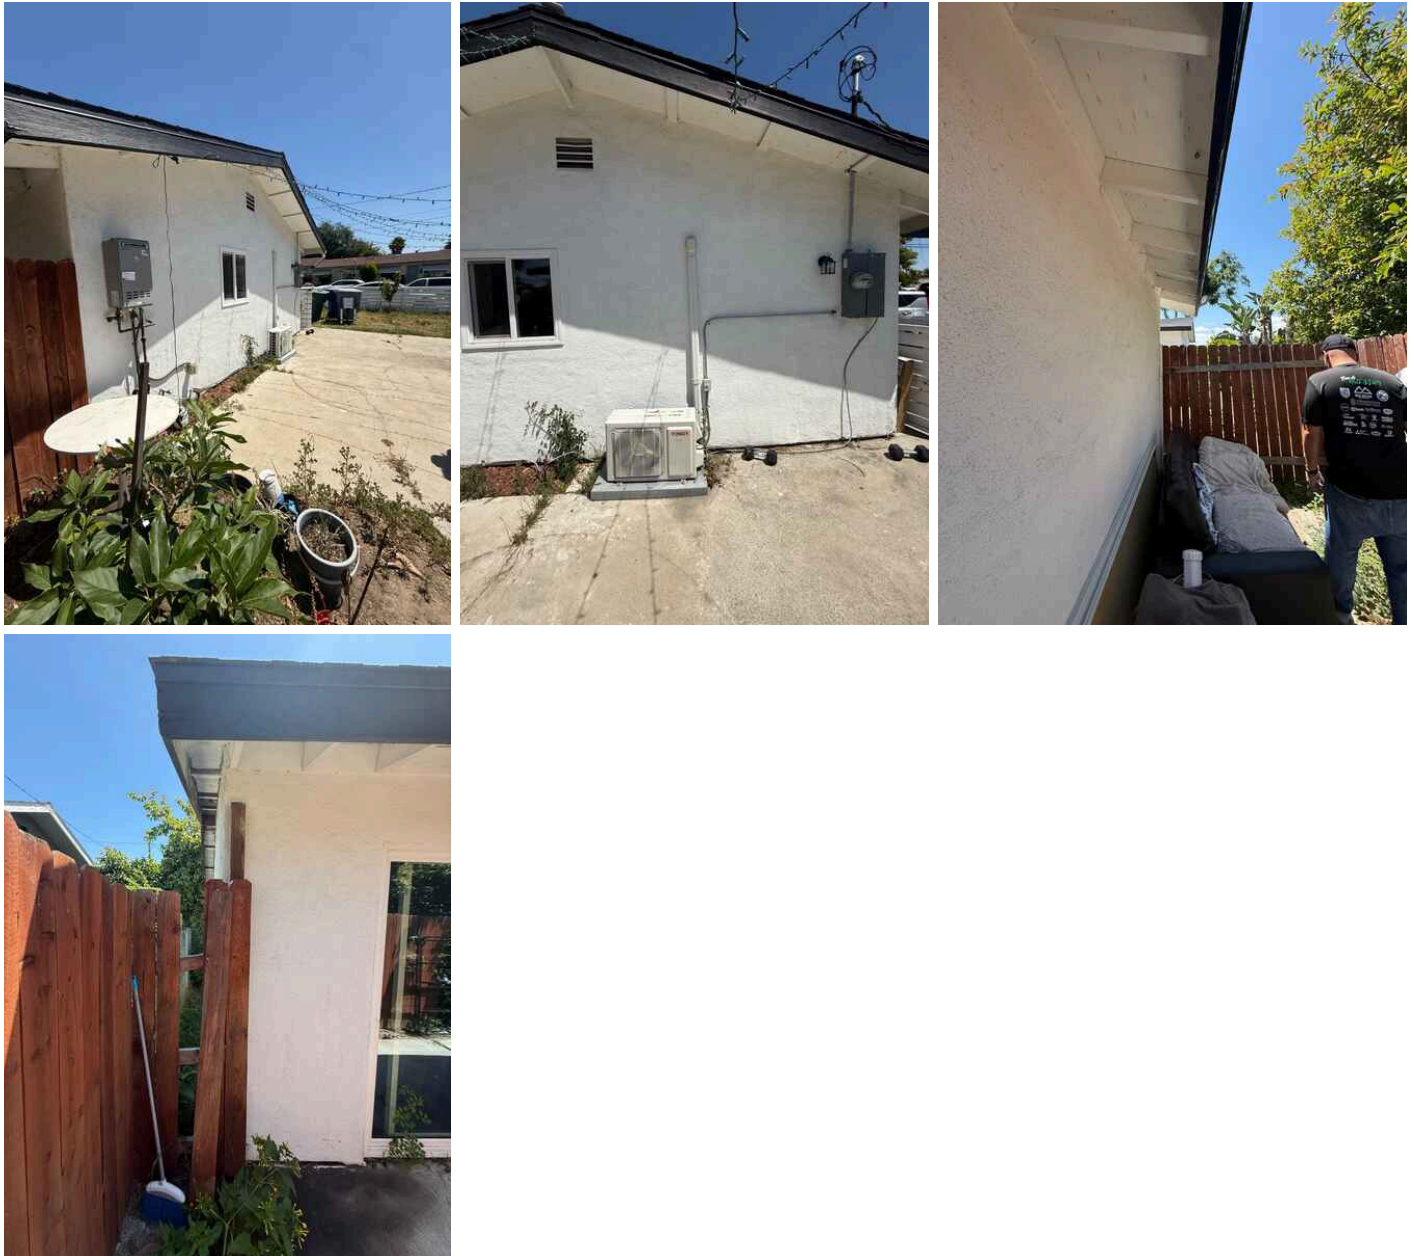
Exterior Was Inspected

The exterior of the house was inspected.

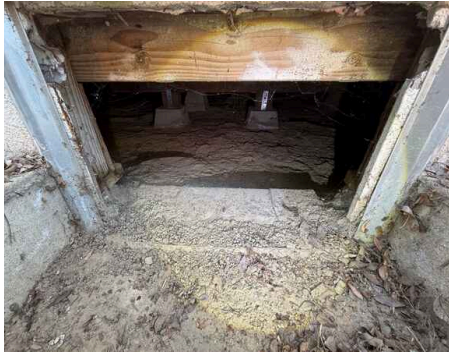
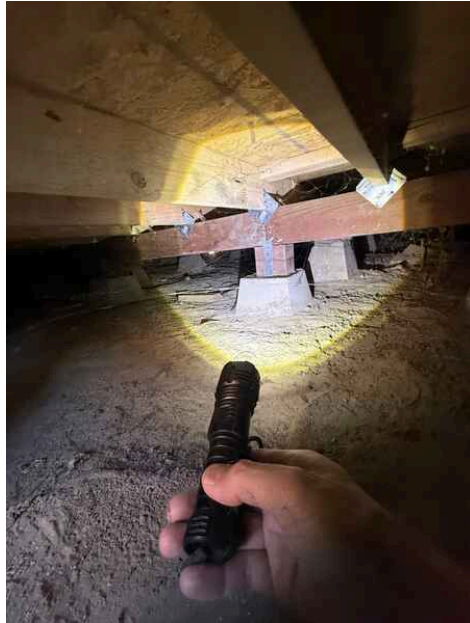
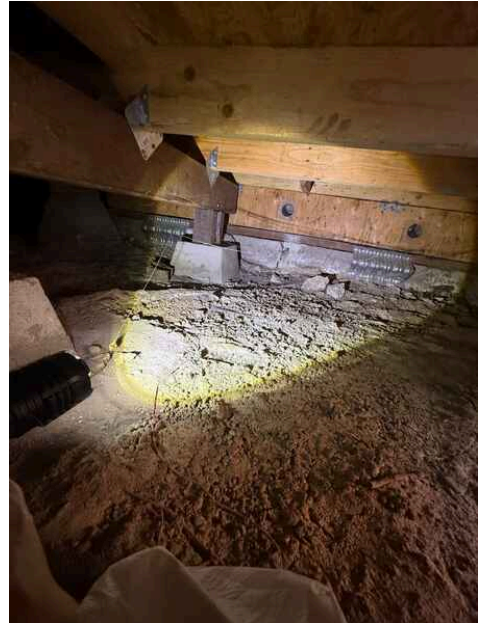
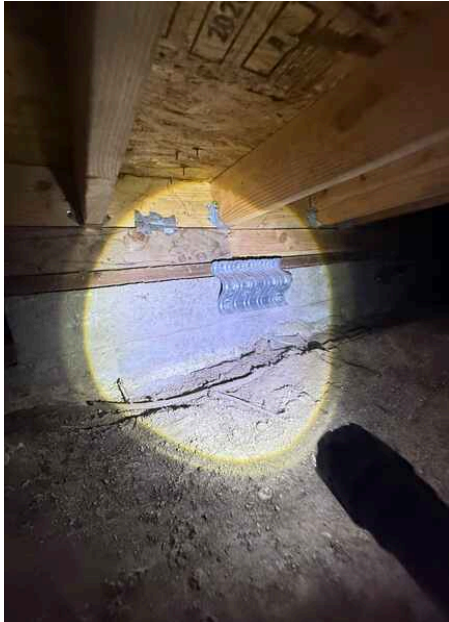
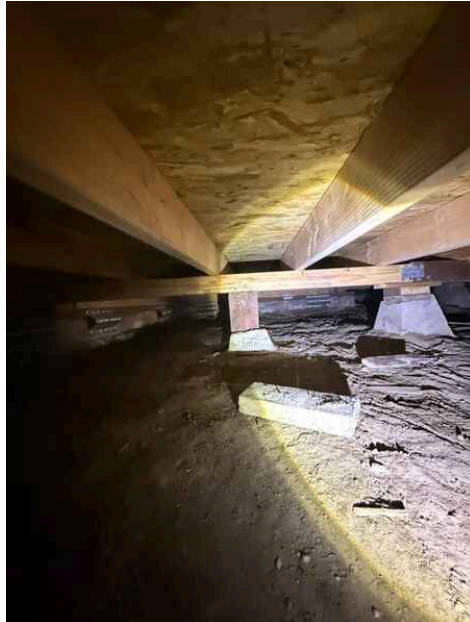
I inspected the accessible systems and components within the crawlspace to the best of my ability while maintaining safe inspection practices. The inspection was limited to readily accessible and safely reachable areas at the time of inspection.

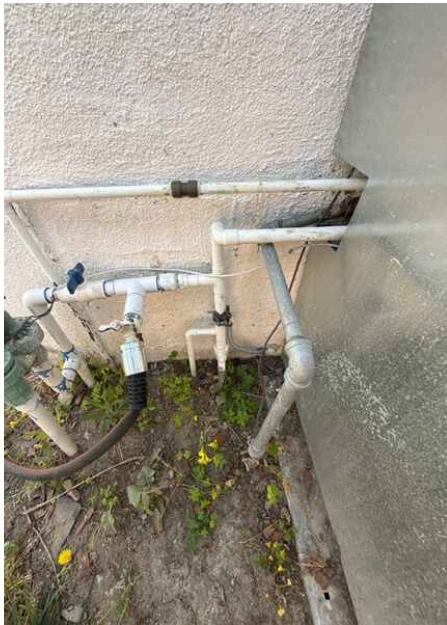
Main Water Shut-Off Valve: Homeowner's Responsibility

It's your job to know where the main water and fuel shutoff valves are located. And be sure to keep an eye out for any water and plumbing leaks.

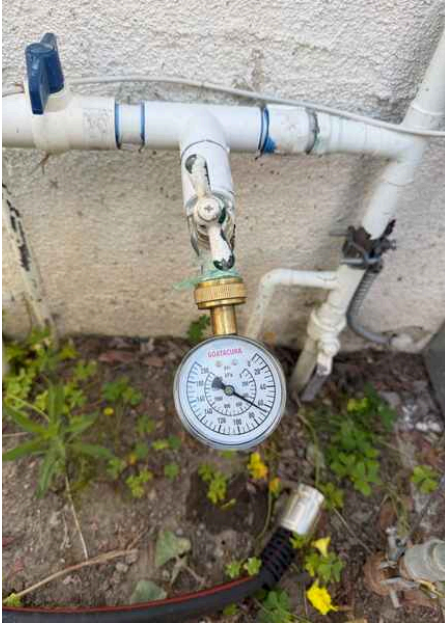
The reading of the water pressure was tested.. For residential homes, the ideal water pressure should be between 40 and 80psi (pounds per square inch). Pressures above 80 psi can cause excessive wear and tear on plumbing fixtures and appliances, while pressures below 40 psi may not provide sufficient water flow. Most homeowners aim for a water pressure reading of around 60-70 psi for optimal performance.

65-70

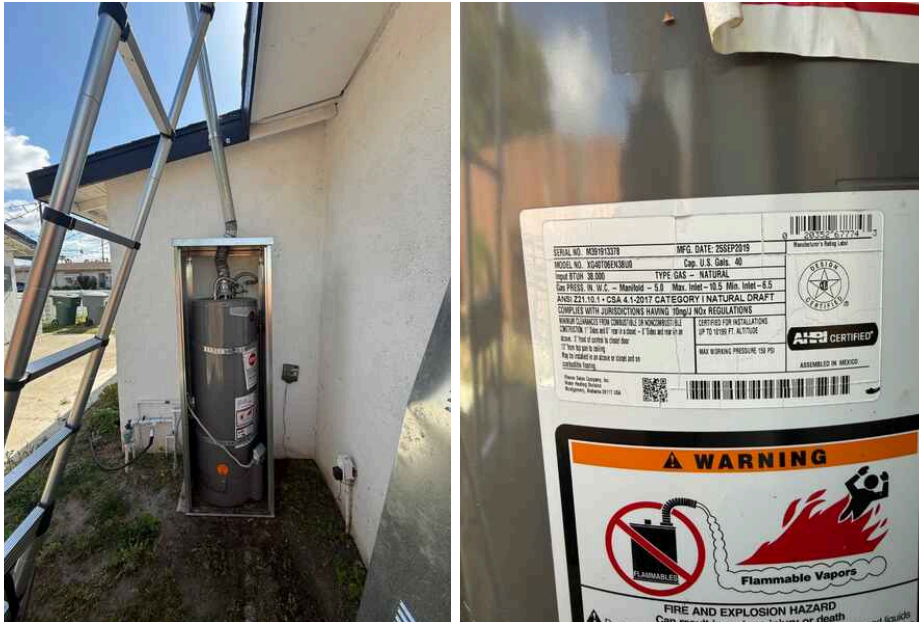
Water Heater #1 (Tank Type)

- * Brand: Rheem
- * Model: XG40T06EN38U0
- * Type: Natural Gas Water Heater
- * Capacity: 40 Gallons
- * BTU Input: 38,000 BTU/hr
- * Manufactured Date: September 25, 2019
- * Approximate Age: 6 years
- * Notes: Category I natural draft gas water heater. Certified for installation up to 10,100 ft elevation

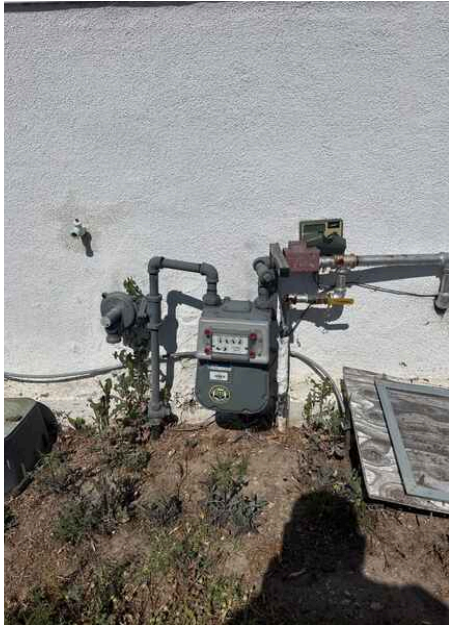
Gas meter was observed with an automatic seismic shut off.

Monitoring is recommended, servicing by utility company should be performed if necessary.

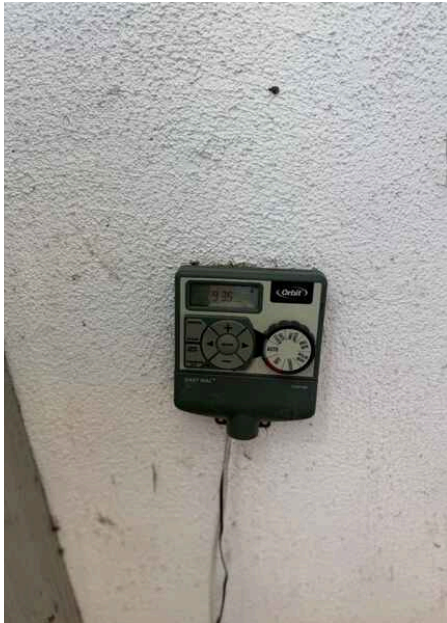
Sprinkler System : Sprinkler System

Observed a sprinkler system. System is set on auto. Please verify with seller for overall and past performance.

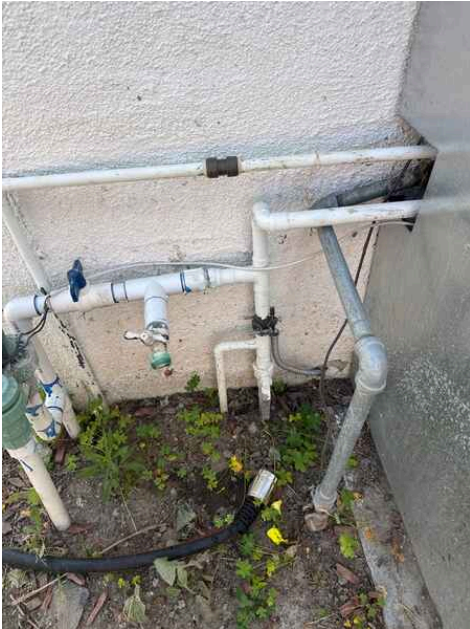
MISSING WATER PRESSURE REGULATOR

Missing water pressure regulator was observed at the main line that helps keep your pressure within range.

Recommend servicing and installing a water pressure regulator to help regulate the water pressure.

Contact a qualified professional.

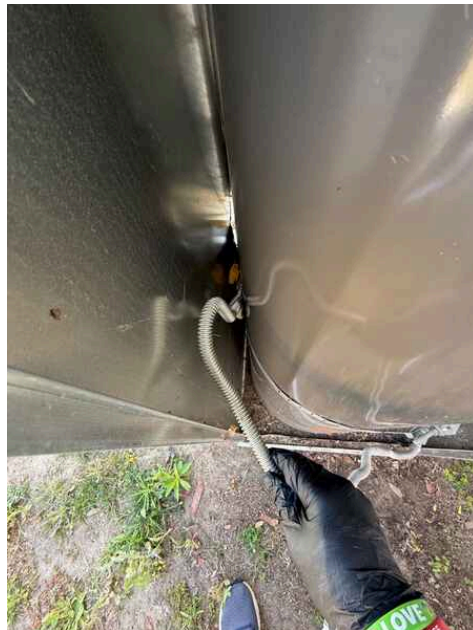
7.3.1 Hot Water Source

WATER HEATER - MISSING SEDIMENT TRAP

A sediment trap (drip leg) was not observed at the gas line serving the water heater. Sediment traps help prevent debris from entering the gas control valve and are required by current standards and manufacturer requirements.

Contact a qualified plumbing contractor.

Sediment traps should be placed as close as possible to appliance inlets.

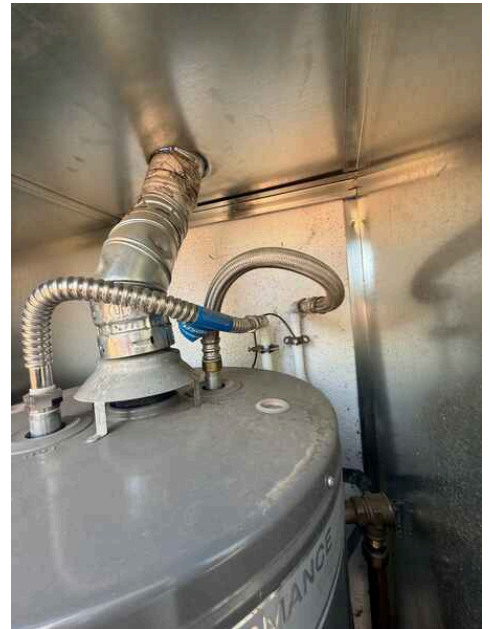
7.3.2 Hot Water Source

MISSING SHUT-OFF VALVE

Contact a qualified professional.

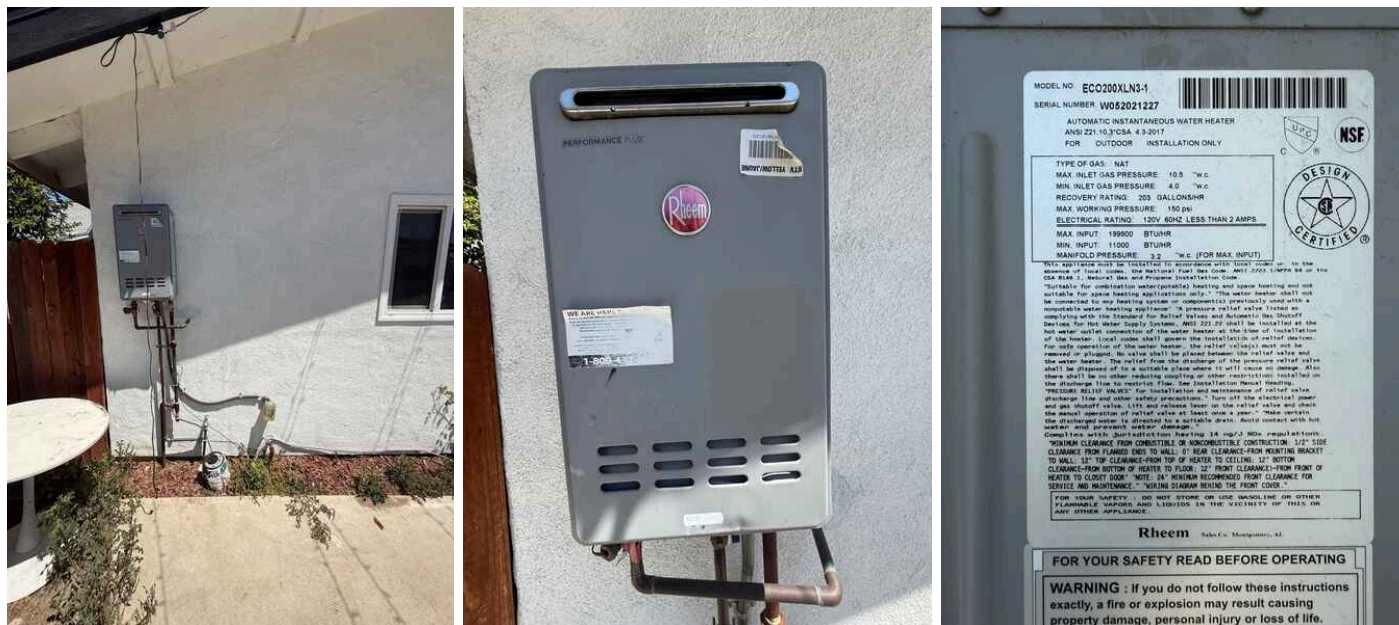
Tankless Water Heater

- * Brand: Rheem
- * Model: ECO200XLN3-1
- * Type: Outdoor Natural Gas Tankless Water Heater
- * Max Input: 199,900 BTU/hr
- * Recovery Rating: 203 Gallons/hr
- * Approximate Manufacture Year: 2021 (based on serial number)
- * Approximate Age: 4-5 years
- * Notes: Outdoor installation only. Automatic instantaneous water heater.

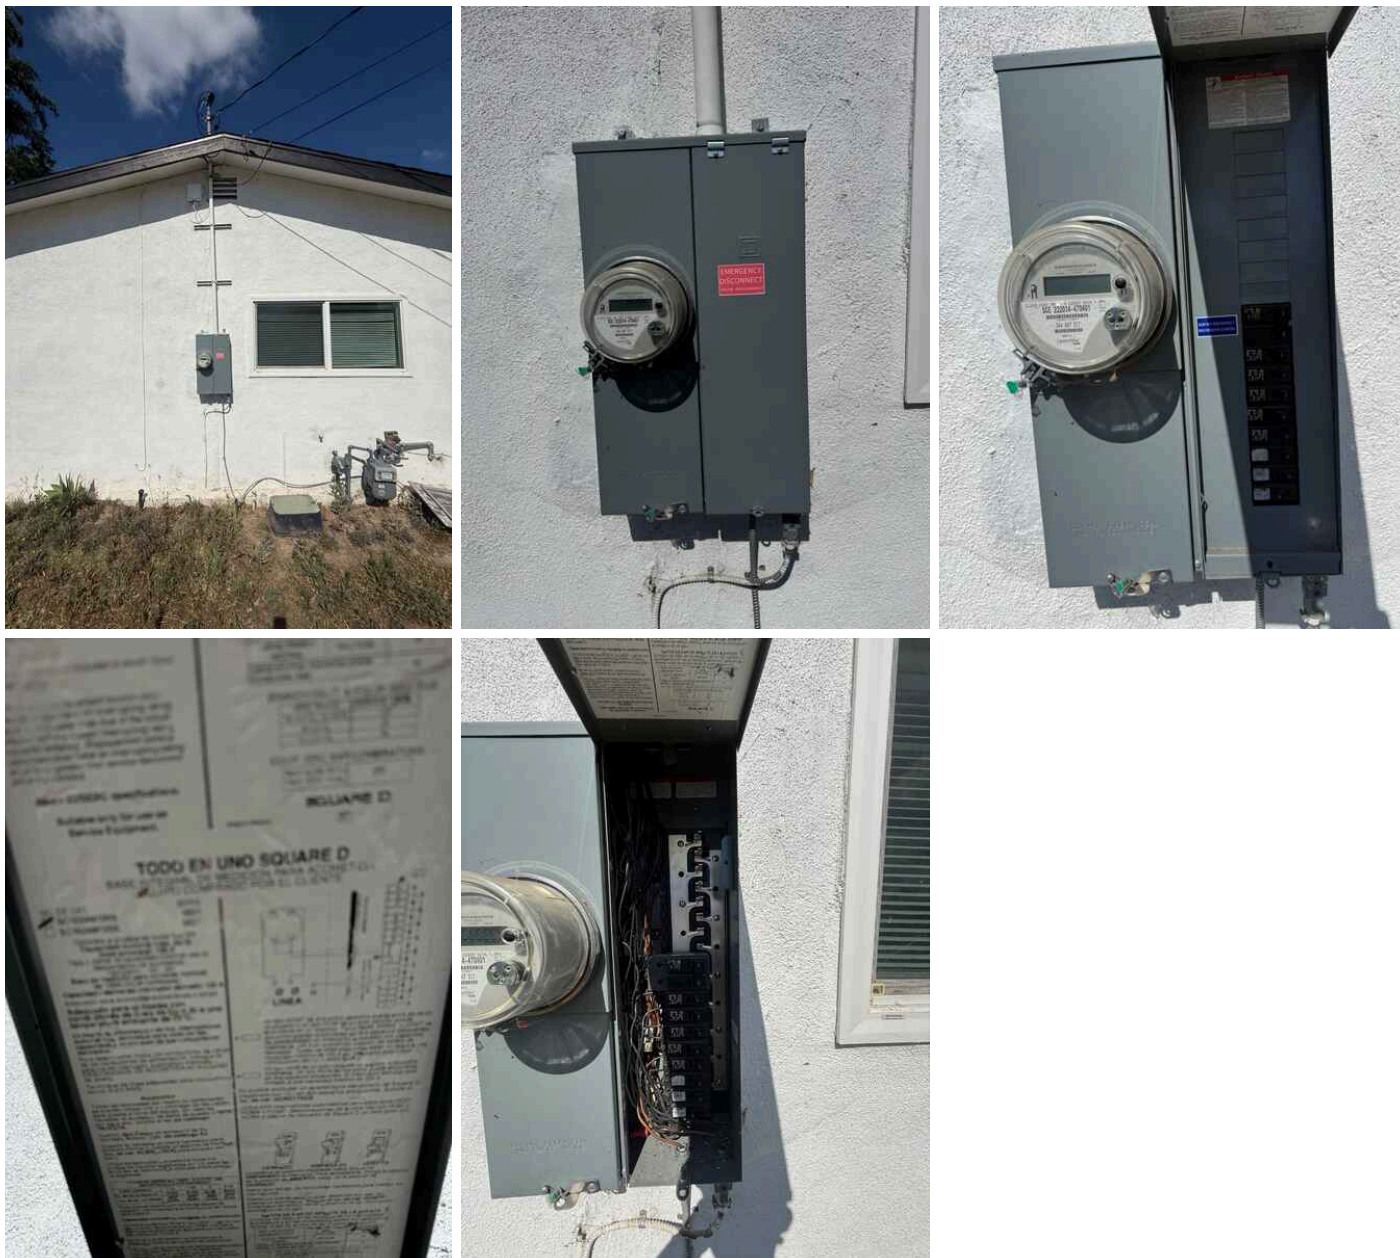
Panelboards & Breakers: Inspected Main Panelboard & Breakers

I inspected the electrical panelboards and over-current protection devices (circuit breakers and fuses).

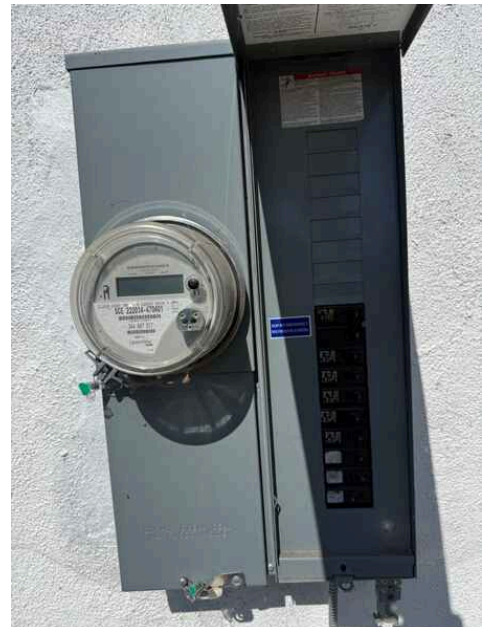
9.7.1 AFCIs

MISSING AFCI & GFCI BREAKERS

Contact a qualified professional.

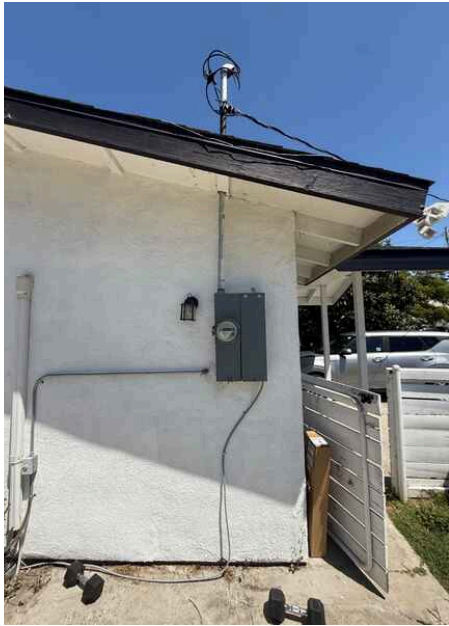
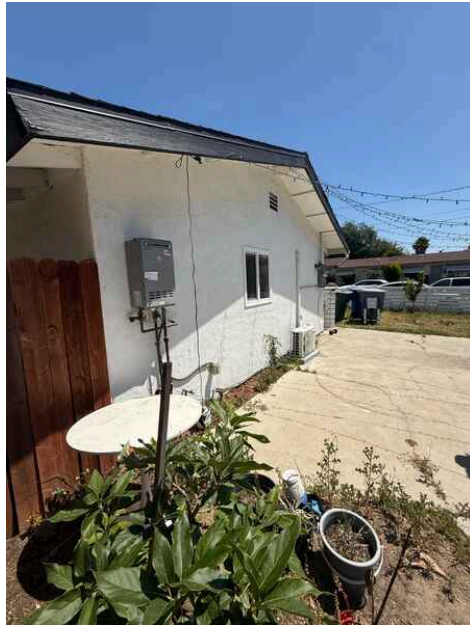
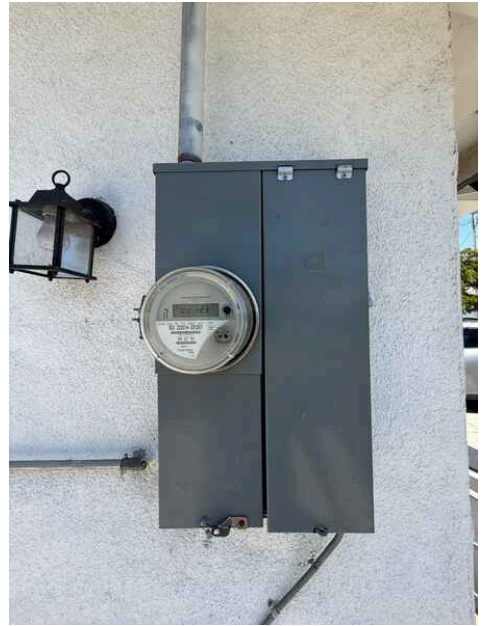
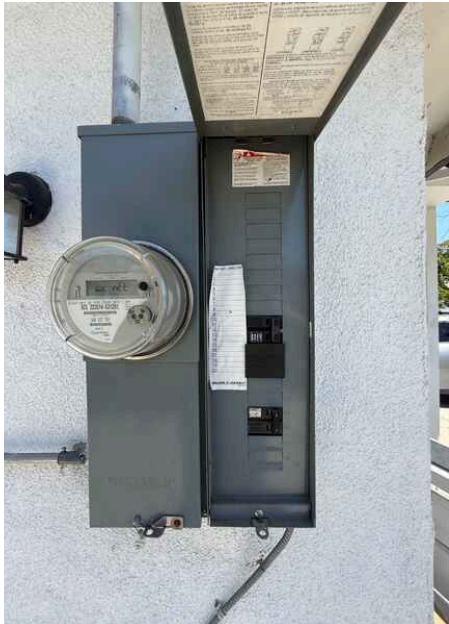
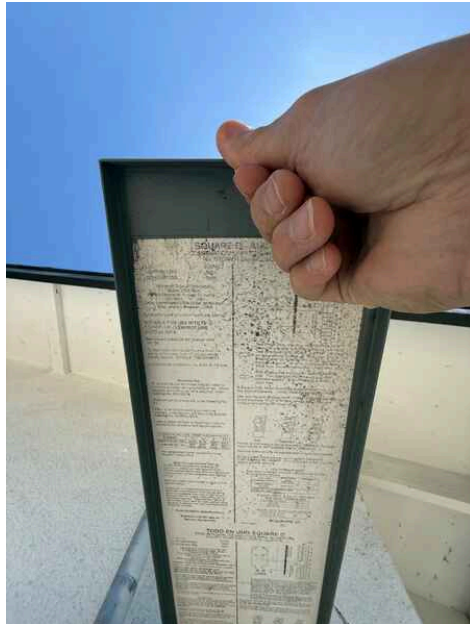
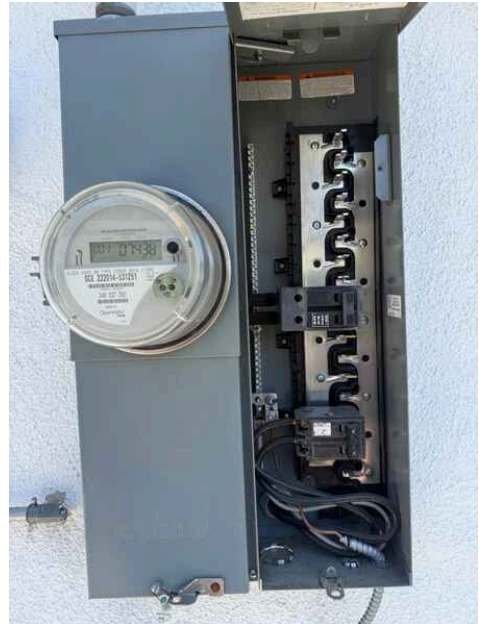
Panelboards & Breakers: Inspected Main Panelboard & Breakers

I inspected the electrical panelboards and over-current protection devices (circuit breakers and fuses).

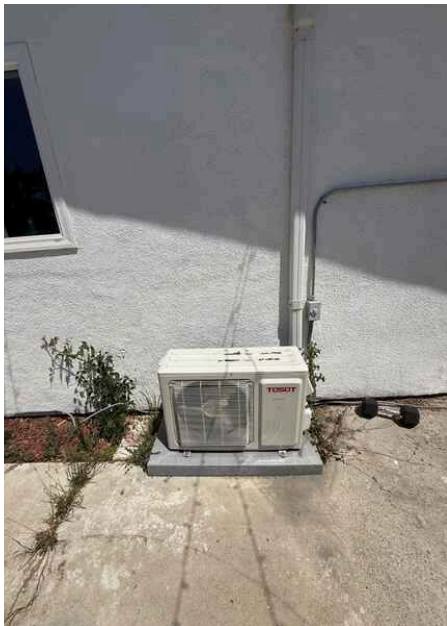
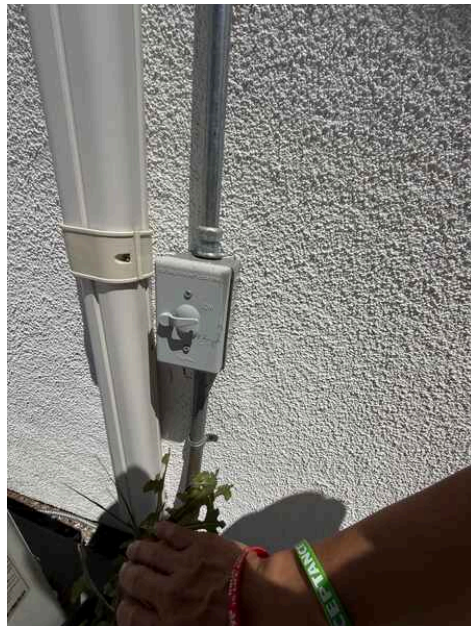
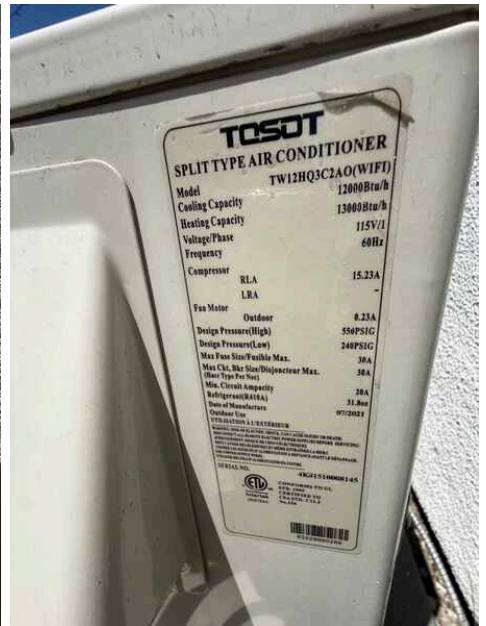
Mini Split HVAC System

- * Brand: TOSOT
- * Model: TW12HQ3C2AO(WIFI)
- * Type: Split-Type Air Conditioner / Heat Pump
- * Cooling Capacity: 12,000 BTU/hr
- * Heating Capacity: 13,000 BTU/hr
- * Refrigerant: R-410A
- * Voltage: 115V, Single Phase
- * Manufacture Date: July 2021
- * Approximate Age: 4 years
- * Notes: Outdoor condenser unit for mini-split HVAC system.

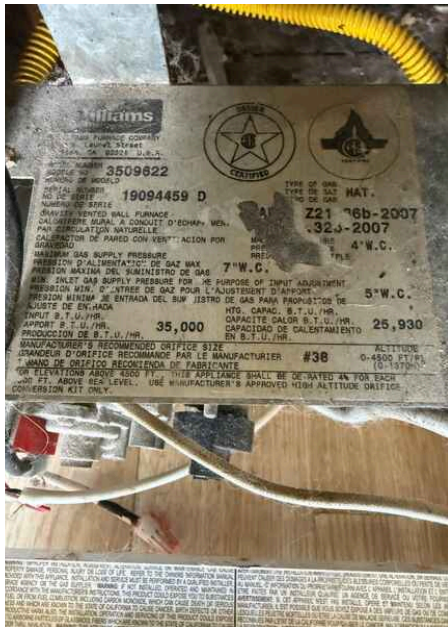
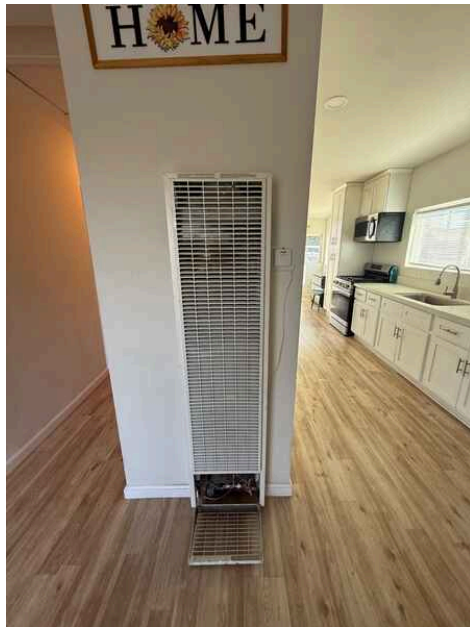
Heating System Information: Heating System Approximate Age , Information,

Possibly manufactured date labeled :2007

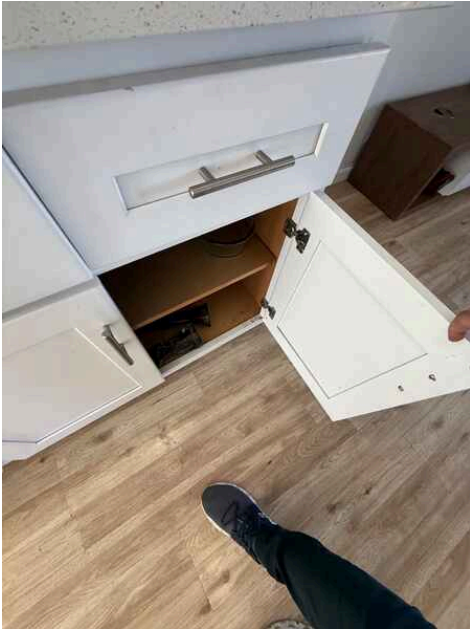
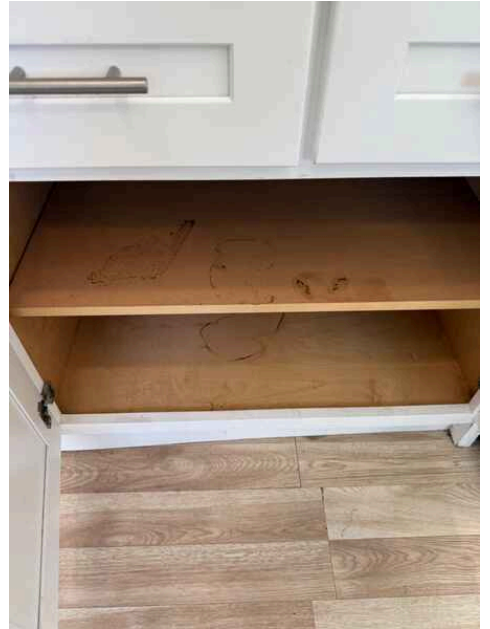
STAINS OBSERVED

Stains were observed at various parts of the kitchen including walls, cabinets and ceilings.

Servicing is recommended.

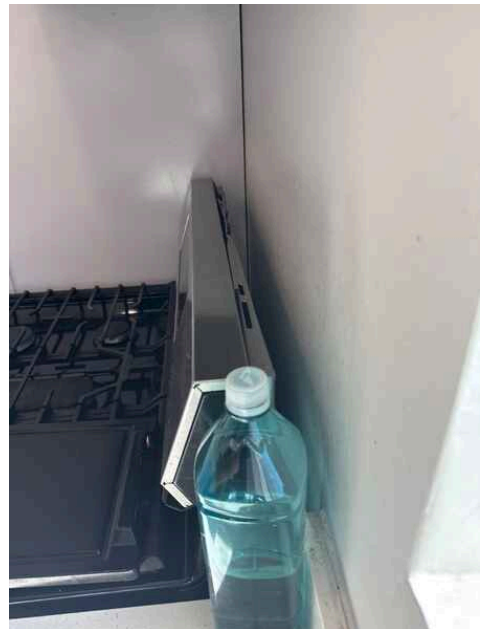
15.6.1 Appliances

MISSING ANTI-TIP BRACKET ON OVEN

Recommendation:
Have a qualified professional install an anti-tip bracket per manufacturer guidelines.

Recommendation
Contact a qualified professional.

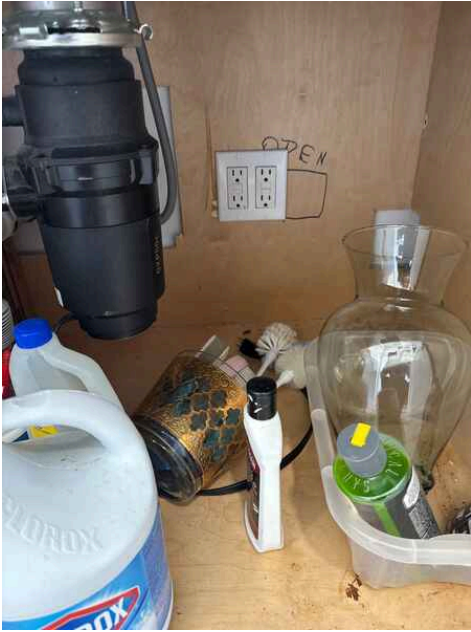
15.6.2 Appliances

GARBAGE DISPOSAL INOPERABLE

I attempted to test the garbage disposal however it did not operate. Power was found unplugged. Further evaluation and correction is recommended.

Recommendation
Contact a qualified professional.

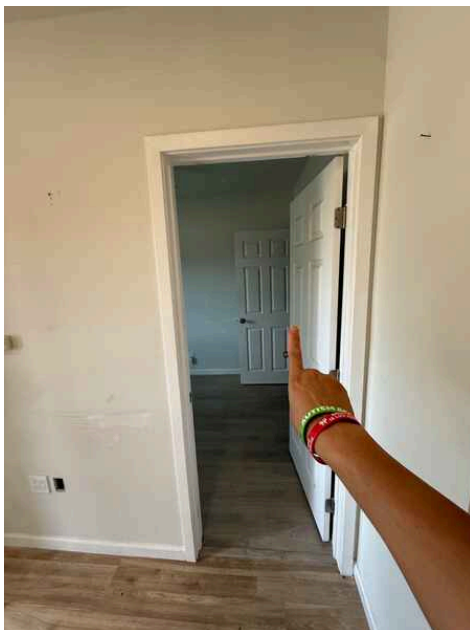
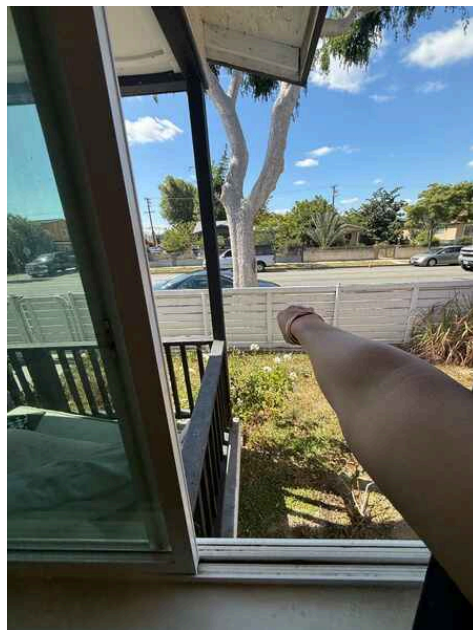
MISSING WINDOW SCREEN

A missing window screen was observed in the bedroom.

Installation of window screens is recommended.

Contact a qualified window repair/installation contractor.
